Building and Timber Pest Inspection Report

Inspection Date: Tue, 10 Feb 2026

Property Address: 309/9-11 Arncliffe St, Wollri Creek NSW
2205, Australia

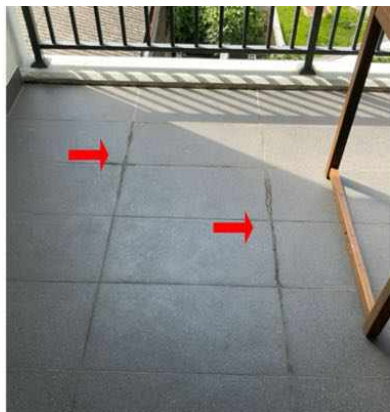
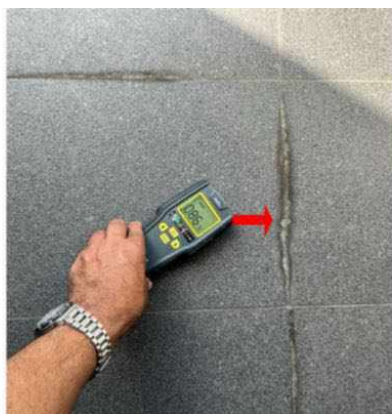
Finding 3.01

Building: Main Building
Location: Balconyx2
Finding: Balcony – Elevated Moisture to Tiled Floor Area
Information: Elevated moisture readings were detected to the tiled balcony floor with visible efflorescence and discolouration to grout lines indicating prolonged or recurring moisture presence beneath the tile finish. This condition is commonly associated with failed grout or sealant joints, insufficient surface drainage and/or inadequate waterproofing allowing moisture to become trapped within the balcony substrate. While no internal water ingress was evident at the time of inspection, the readings exceed what would be expected under normal dry conditions and warrant further investigation. This issue is considered a minor defect at present, with the potential to escalate if moisture migration continues, and assessment by a suitably qualified strata appointed waterproofing specialist is recommended.

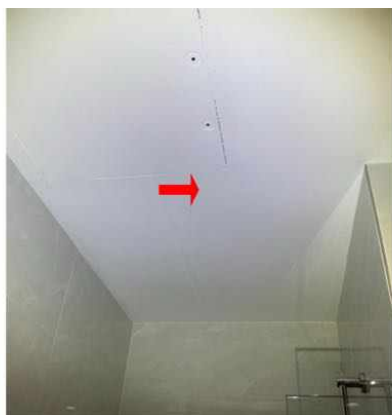
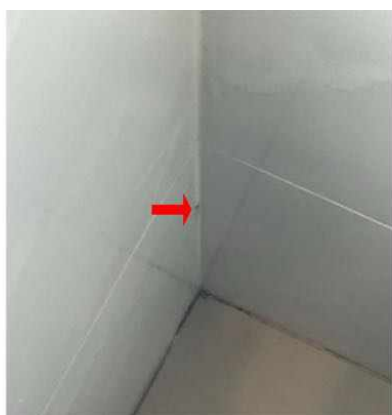
Finding 3.03

Building:	Main Building
Location:	Bathroom
Finding:	Water Staining - Humidity or Ventilation
Information:	The ceiling surface shows peeling paint and water staining on the walls faint commonly consistent with humidity-related staining, often found in bathroom or wet areas with insufficient ventilation. While there is no visible sagging or major water damage, the pattern suggests prolonged moisture exposure, possibly due to steam accumulation or minor condensation issues. According to AS 4349.1-2007 (Appendix C), this would be classified as a minor defect unless further deterioration or active leaks are found. Recommend improving mechanical or natural ventilation, cleaning the

surface with mould treatment, and monitoring for recurrence.

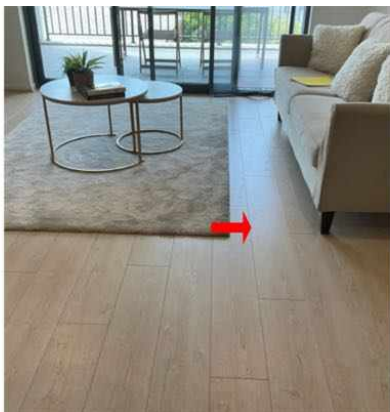
Finding 3.04

Building:	Main Building
Location:	All Areas
Finding:	Uneven Laminate Floor
Information:	unevenness was observed to sections of the laminate flooring. This condition is typically associated with installation tolerances, minor subfloor irregularities, or natural movement of a floating floor system. While not considered a major defect, the unevenness may present a minor trip hazard and lead to accelerated wear of the flooring if left unrectified. Monitoring and, if required, localised rectification by a flooring contractor is recommended.

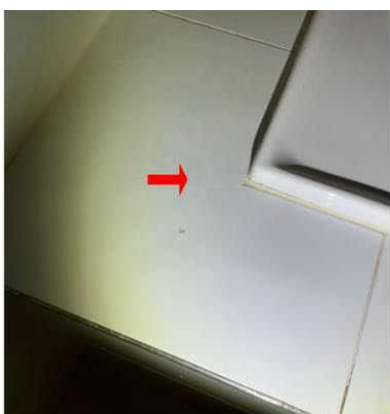
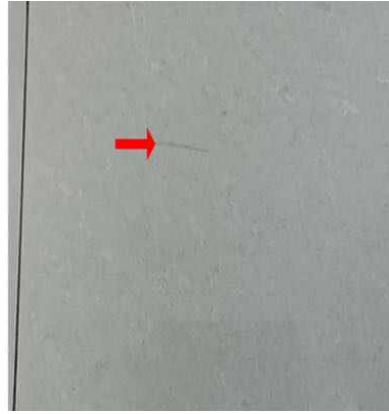
Finding 3.05

Location: Bathroom

Finding: Tiles - Cracked or damaged

Information: Cracking was evident to the tiling in this area at the time of inspection. While the cracking appears to be minor, this area is frequently exposed to water, allowing potential for water penetration into adjoining sections of walls or flooring.

If left unmanaged, water penetration to these areas may lead to subsequent water damage, which is likely necessitate repair work to affected building elements.

A tiling contractor should be appointed to ensure that no further water damage occurs. The re-application of silicone and grouting throughout remaining tile work is also advised, to further protect the area against water penetration.

Where water penetration has led to water damage, appointment of a relevant tradesperson may be required to repair damaged building elements.

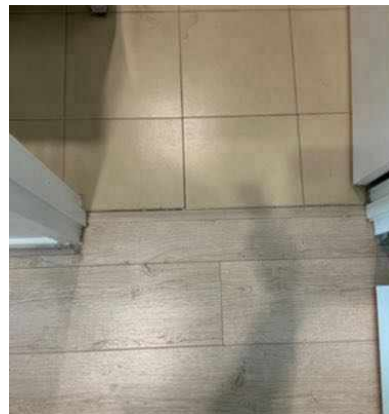
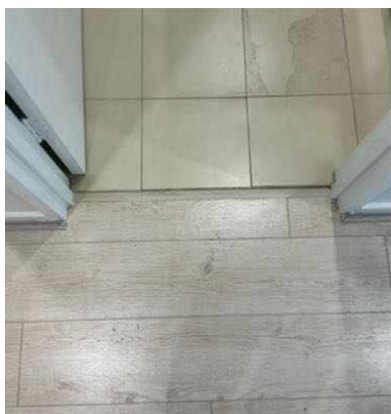
Finding 3.06

Location: Ensuite, bathroom

Information: The bathroom floor is at the same level as the adjoining timber flooring. This configuration is typical in modern apartments and is permitted where compliant waterproofing and floor falls are provided. No evidence of moisture damage was observed at the time of inspection; however, waterproofing performance cannot be confirmed without invasive inspection.

Care should be taken to avoid excessive water migration beyond the bathroom during use.

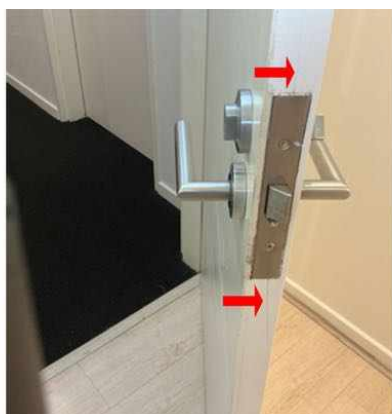
Finding 3.07

Building:	Main Building
Location:	All Internal Areas
Finding:	Building element - Damaged - Door frame minor split
Information:	Breakage occurs generally when the building materials have either aged and decayed, or as a result of damage (accidental or deliberate).

Repair and/or replacement of broken elements is advised to ensure that additional secondary defects do not arise as a consequence. Such works are necessary, as all building elements play a key role in the operation and function of the overall structure and its performance.

A relevant tradesperson should be appointed to repair or replace the affected building element prior to any subsequent damage being caused.

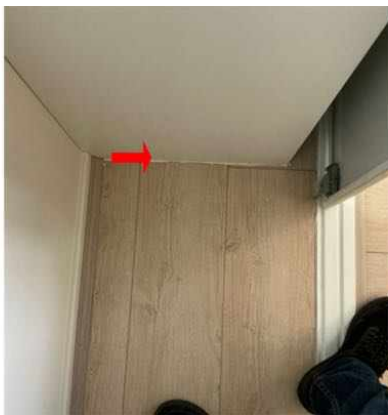
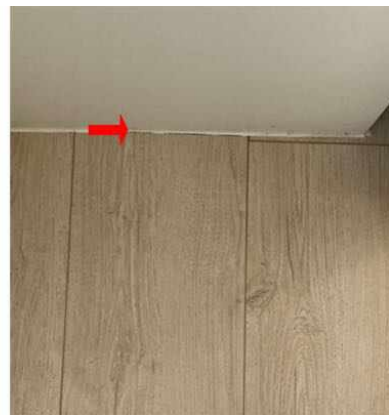
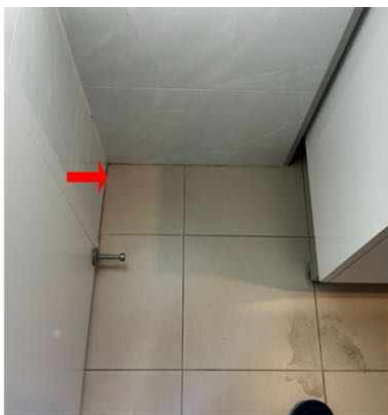
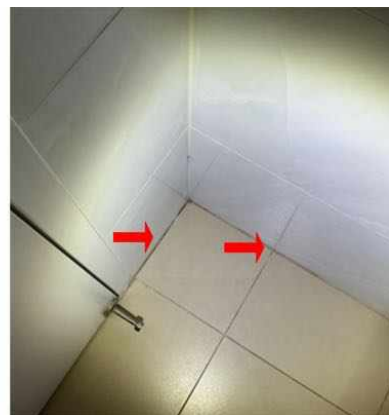
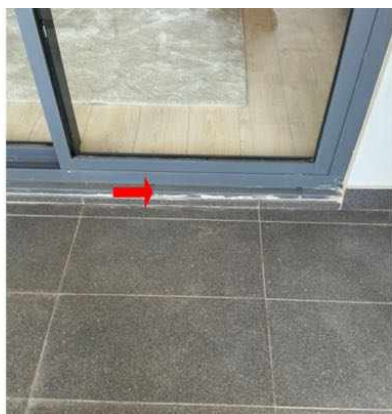
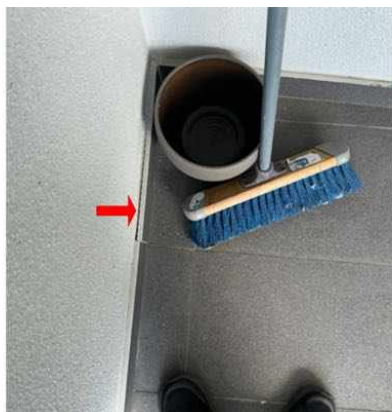
Finding 3.08

Building:	Main Building
Location:	All Internal Areas
Finding:	Sealant and grouting - Missing or degraded
Information:	It was noted on inspection that sealant or grout is degraded. There is also evidence of poor workmanship and excessive use of sealant. Silicone should never be used as a

first line of defence against waterproofing. Further inspection by a licensed waterproofing contractor is highly recommended.

Different materials and floor areas move at different rates, generally causing cracking to grout or sealant at this point. A flexible sealant is required to allow for expected expansion and contraction, while keeping the joint water tight and protective of all associated building materials.

There appears to be excessive mould to the sealant and grout which will likely require scraping out and replacement.

Flexible and mould resistant materials should be applied to affected areas to prevent any subsequent water damage that is likely to occur. Regular maintenance and replacement of damaged or missing or damaged sealant and grout is highly recommended to the wet areas, as this is a regular wear and tear defect. Sealant and grouting in areas that come into regular contact with water should be maintained for the long term care of your property.

A sealant specialist or tiling contractor should be appointed to complete these works as soon as possible.

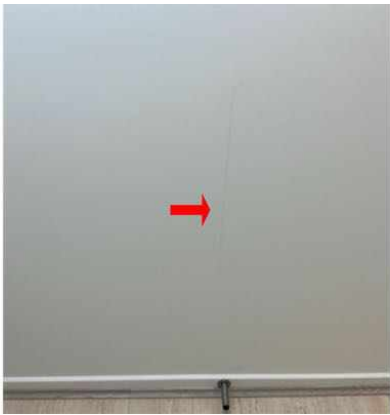
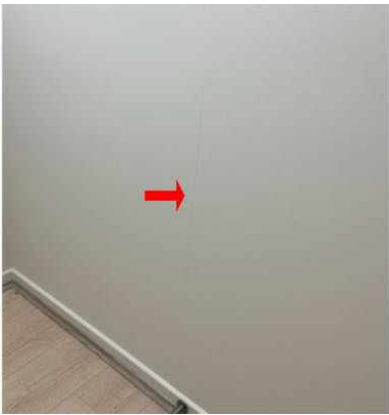
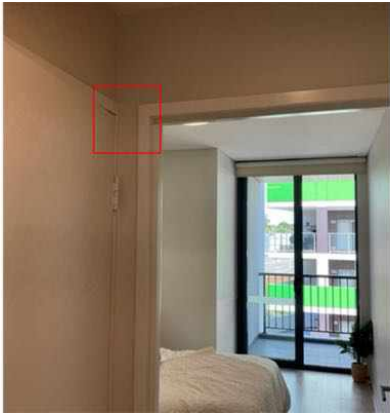
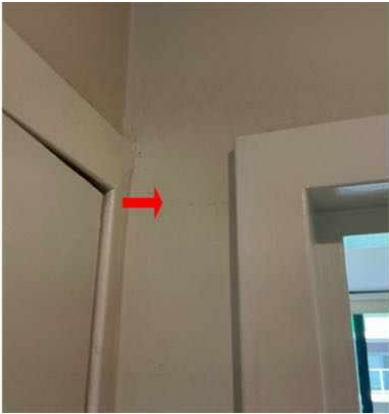
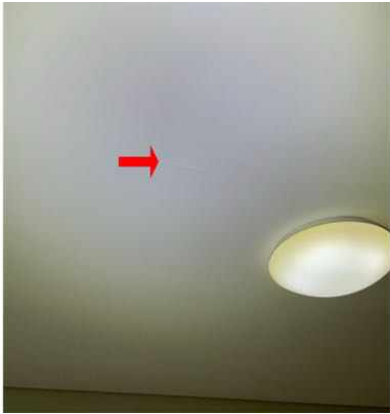
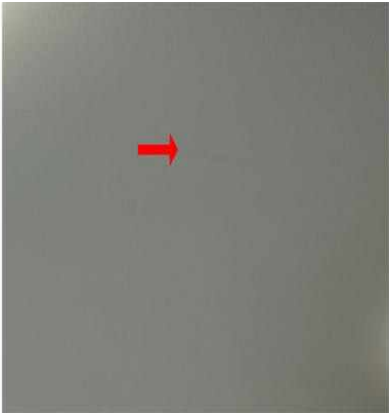
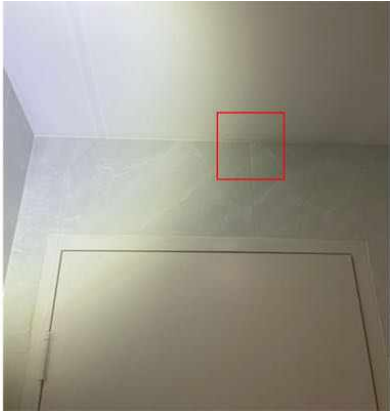
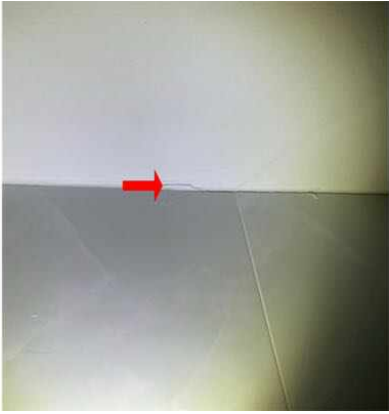
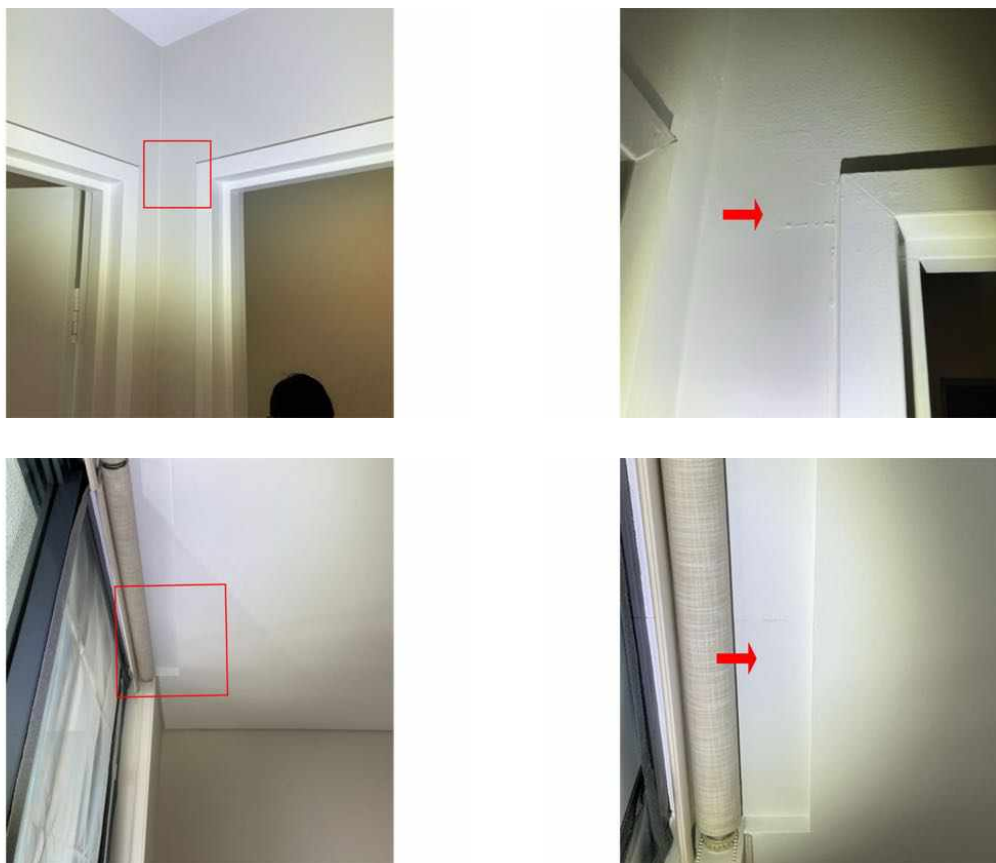
Finding 3.09

Building:	Main Building
Location:	All Internal Areas
Finding:	Paint finish and hairline cracking
Information:	The paint finish in this area was identified as being incomplete at the time of inspection including some hairline minor cracking.

Whilst incomplete or missing paint finish is generally an appearance defect, it can also lead to the development of secondary building defects over time. Incomplete areas of paint finish expose the area to moisture, potentially accelerating the deterioration of underlying building materials.

Incomplete paint finishes should be sanded back, filled, leveled and painted, as applicable. Where inadequate or missing paint protection has led to the deterioration of the associated building element, repair and/or replacement of this building element may be required.

A painting contractor should be appointed as soon as possible to perform necessary works to aid the appearance of the affected area and to ensure the area is protected against further deterioration. Alternatively, the homeowner following manufacturer instructions may perform these works.

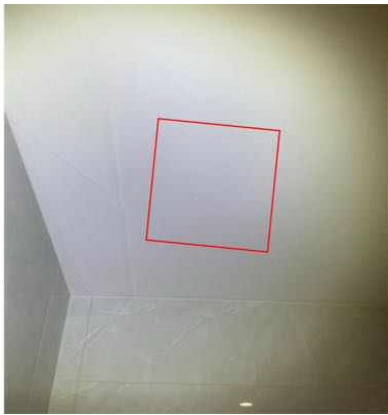
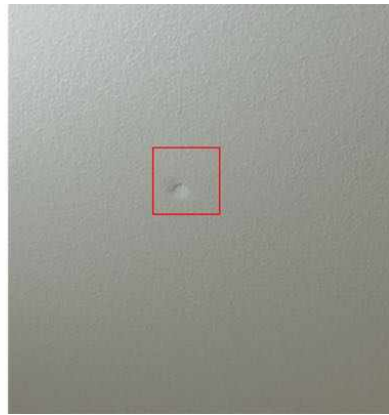
Finding 3.10

Building:	Main Building
Location:	Bathroom, ensuite
Finding:	Ceiling nails - Popping
Information:	Numerous popped nails were identified in the internal ceiling at the time of inspection. Nails and screws hold simply by the friction between them and the surface they are applied to. Over time, the nails and screws can back out, which is often a result of general ageing and deterioration of the building structure.

If left unmanaged, the ceiling sheets may become loose and unstable, increasing the rate of deterioration of the internal ceiling and creating potential for the development of secondary defects.

Re-fastening of popped nails will help to maintain the stability of the internal ceiling and associated building elements. Such minor works will also help to improve the appearance of the affected area and secure the ceiling sheets, so as to prevent the onset of ceiling sagging. These works should be performed by a qualified carpenter or plasterer at client discretion.
