Building Inspection Report

Inspection Date: Thu, 2 Apr 2026

Property Address: 65 Highgate Dr, Flagstone QLD 4280,
Australia

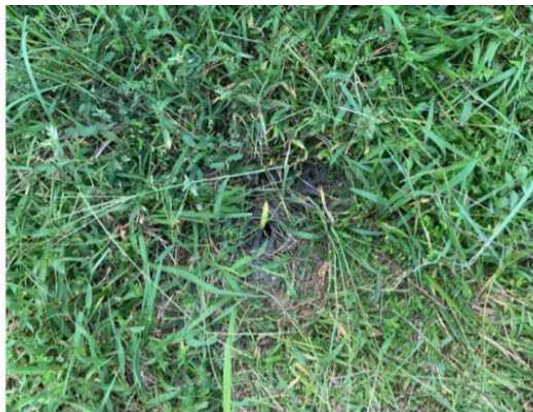
Defects 3.01

Building: Yard
 Location: Yard - Front > Front
 Finding: Yard drainage blocked
 Information: At the time of of inspection it was noted that the yard drainage are blocked.

Blacked drains may be detrimental to surrounding building elements or may cause excessive moisture to external walls.

Where excessive moisture is noted to areas where timber building elements are exposed this may also be conducive to timber pest.

It is recommended that drains be cleared as soon as possible.

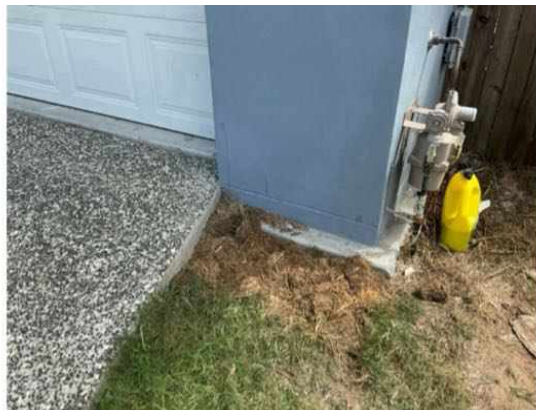
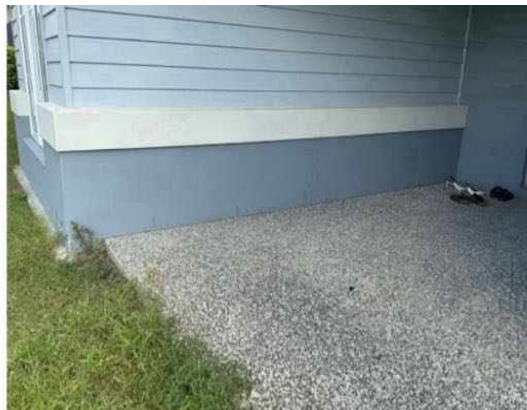
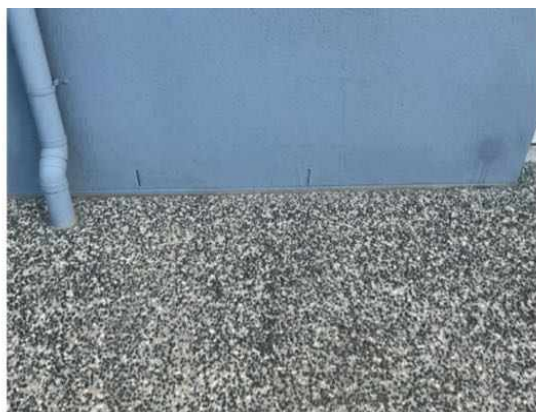
Defects 3.02

Building: Main Building
 Location: Exterior walls - front > Existing
 Finding: Weep hole obstructions
 Information: It is important to maintain visuals of the external walls of the for timber pest activity.

Where visuals are obstructed by vegetation or stored items this may allow timber pest to enter the building undetected.

Where visual of walls are obstructed it is recommended that items be removed or gardens to be trimmed back.

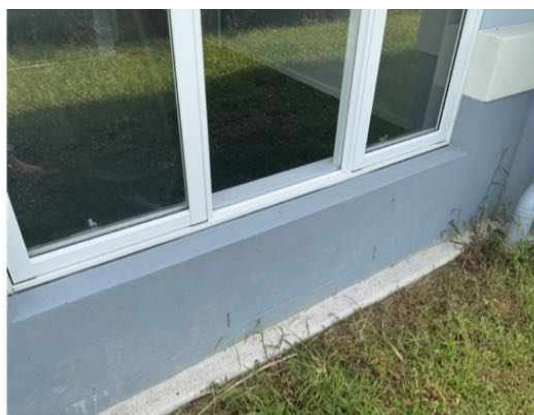
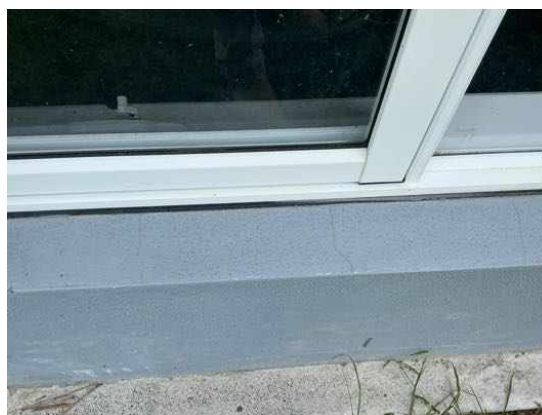
Defects 3.04

Building:	Main Building
Location:	Exterior walls - front > Front Left
Finding:	Cracks to external render - Category 1
Information:	It has been observed that cracking to rendered surfaces has occurred. The degree of damage falls within Category 1, described as fine cracks that do not need repair and which are less than 1.0mm in width limit.

Damage of this category is not considered a defect for rectification. Always contact your building inspector should cracks widen, lengthen, or become more numerous.

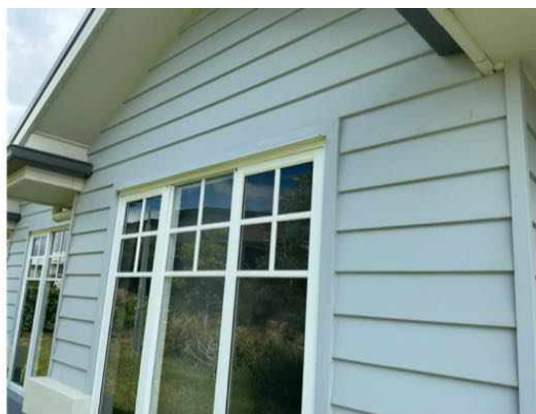
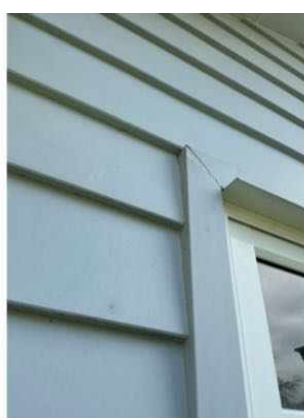
Defects 3.05

Building:	Main Building
Location:	Cladding > Front
Finding:	Gaps - in external cladding gaps
Information:	Gaps are present in sealant to external cladding joints.

The sealant has deteriorated leaving openings at junctions, this may allow water ingress into the wall cavity which may cause moisture damage to framing and wall linings.

This may also result in premature deterioration of adjoining building elements.

A handyman or sealant technician may be required to rectify this condition.

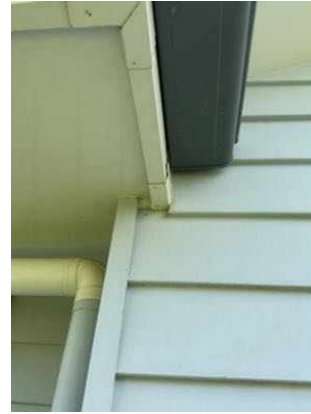
Defects 3.06

Building:	Main Building
Location:	Roof plumbing > Front
Finding:	Water staining
Information:	Water staining was evident in this area at the time of inspection. Water staining indicates that surfaces have been exposed to excessive moisture over time. The minerals and other elements in the water lead to staining, which may graduate to corrosion and deterioration if left unmanaged.

While mostly an appearance defect, water staining can be indicative of more serious defects, which may be currently concealed by other building elements.

Where water staining is active, a licensed plumber must be consulted to identify the cause of the staining and to provide advice on any reparation works that may be required. Replacement of any broken or damaged structures is advised.

Conversely, where water staining is old and inactive, affected building materials may be repaired or replaced at client discretion. A qualified carpenter or registered builder may be appointed to perform these works.

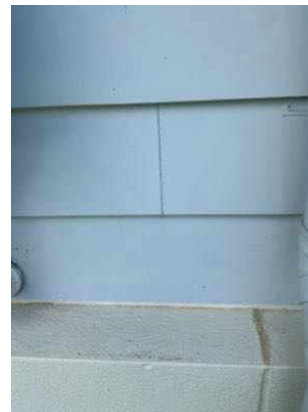
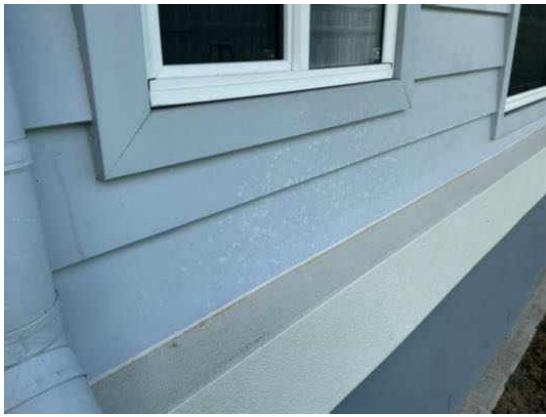
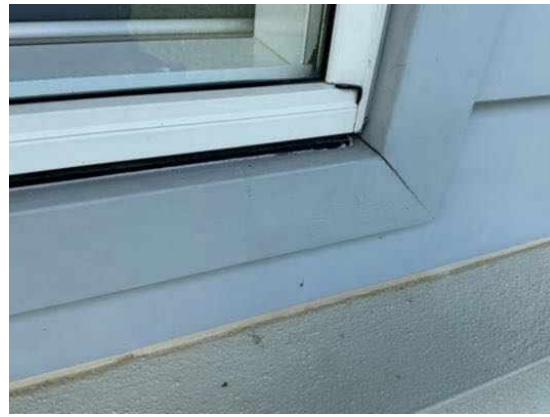
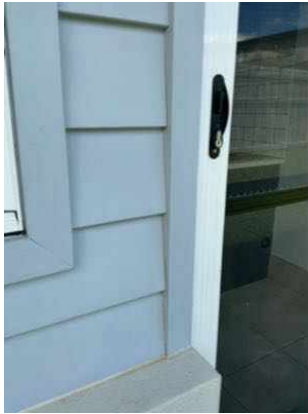
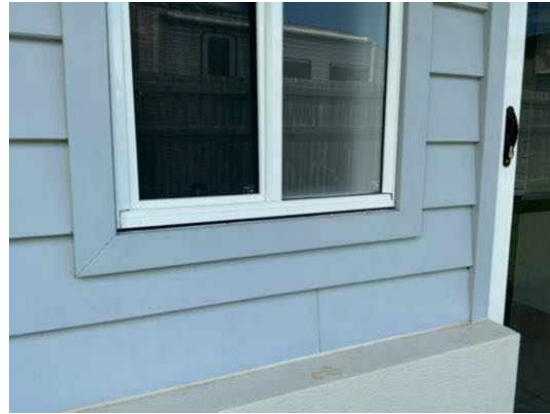
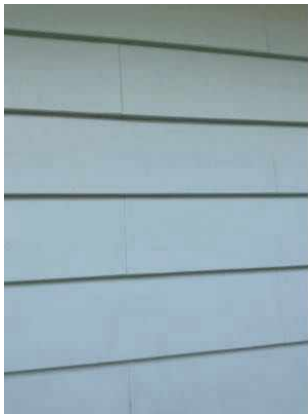
Defects 3.10

The sealant has deteriorated leaving openings at junctions, this may allow water ingress into the wall cavity which may cause moisture damage to framing and wall linings.

This may also result in premature deterioration of adjoining building elements.

A handyman or sealant technician may be required to rectify this condition.

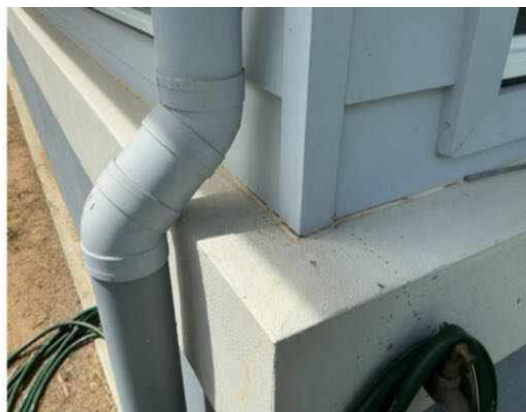
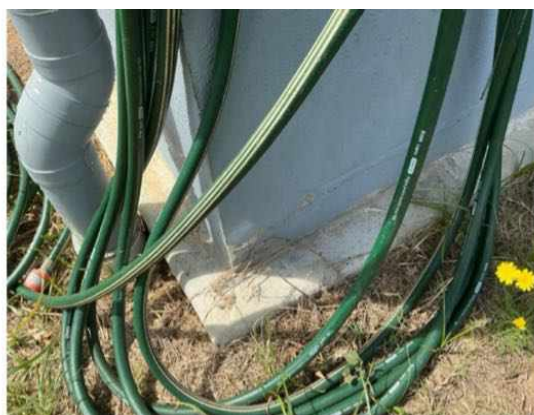
Defects 3.11

Building: Main Building
Location: Cladding > Rear Left
Finding: External - sealant gap
Information: There is noticeable gaps in sealant to render walls adjoining cladding.

The gap comprises the weatherproofing of the opening and may allow water ingress moisture penetration or air leakage.

Re sealing and painting is required.

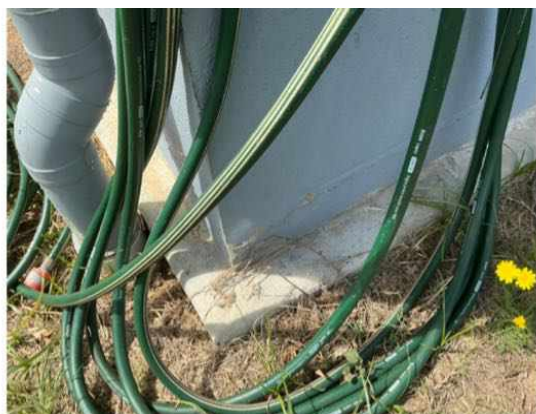
Defects 3.12

Building:	Main Building
Location:	Exterior walls - left side > Rear Left
Finding:	Cracks to external render - Category 1
Information:	It has been observed that cracking to rendered surfaces has occurred. The degree of damage falls within Category 1, described as fine cracks that do not need repair and which are less than 1.0mm in width limit.

Damage of this category is not considered a defect for rectification. Always contact your building inspector should cracks widen, lengthen, or become more numerous.

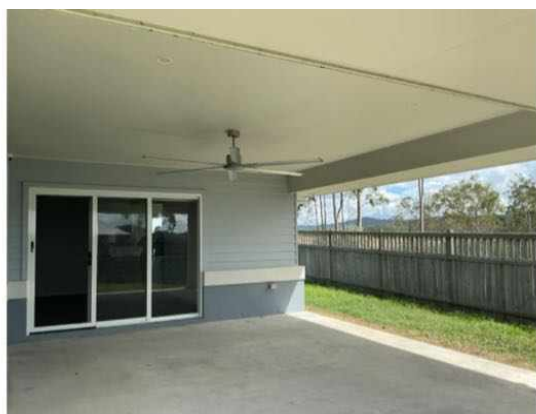
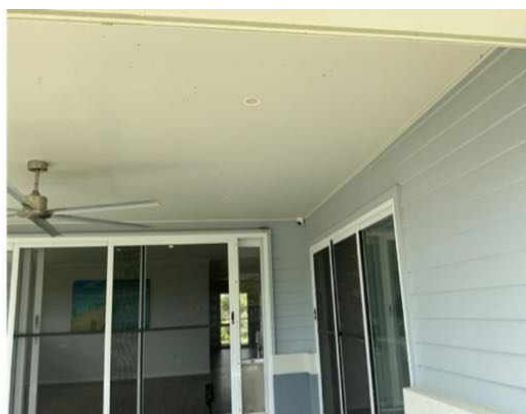
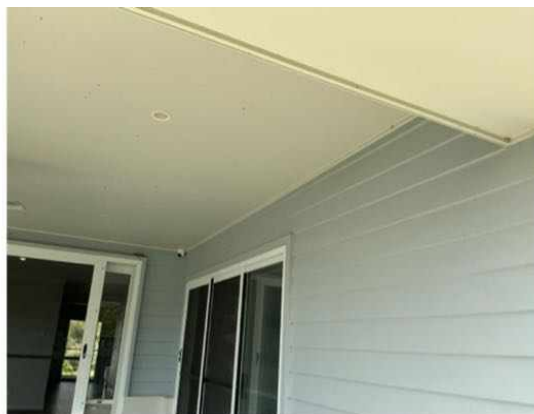
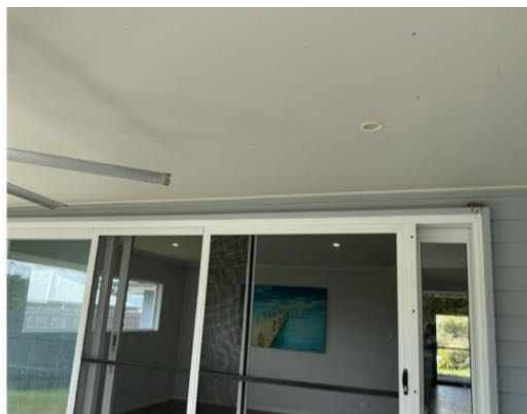
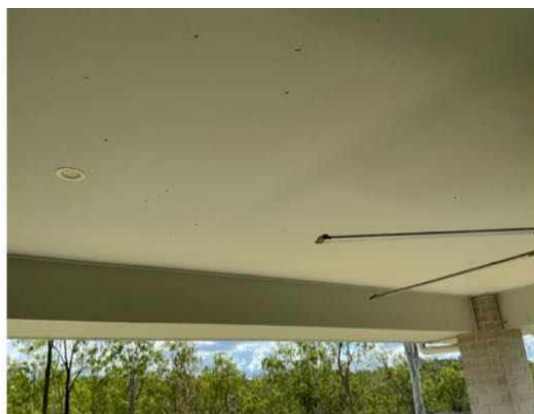
Defects 3.13

Information: Sections of the ceiling were found to be sagging at the time of inspection. Sagging to the fixed ceiling structure generally indicates that the building materials have swollen, due to contact with water, or that fixings (e.g. nails or glue) have become loose and require reattachment.

In some cases, sagging ceiling linings may also indicate that there are structural issues, causing surfaces to warp, twist or sag. Where sagging appears to be major, appointment of a structural engineer is advised to further inspect the property and identify the source and rectification works required.

Where minor sagging is evident, comparatively minor works, such as re-gluing of ceiling sheets, may be required. Such works may be performed by relevant tradespeople, such as plasterers and painters. Where excessive moisture has caused the roofing structure to swell and sag, the source of the water leak should primarily be identified prior to any remedial works being performed.

The appropriate action should be taken by the client as soon as possible to ensure that any potential further damage is limited.

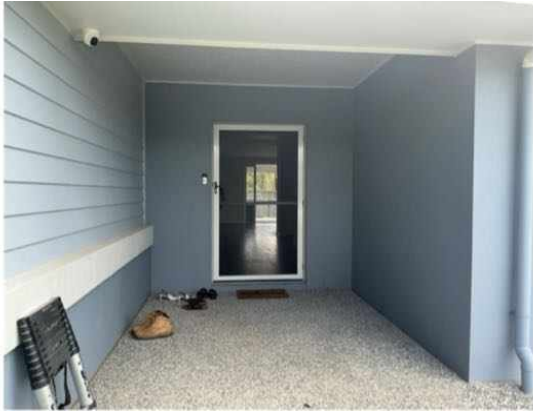
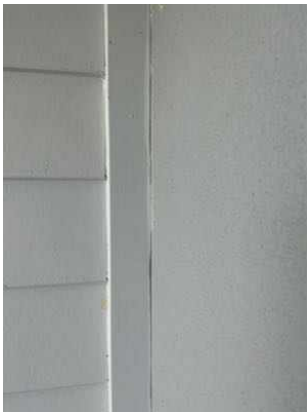
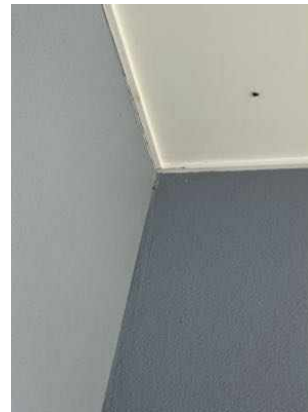
Defects 3.14

Building:	Main Building
Location:	Porch > Front
Finding:	Beading - gap
Information:	Beading acts (like cornice or skirtings) to cover the intersection or joins of building materials. It was noted at the time of inspection that beading in this area has minor gaps. This deterioration is suspected to have been caused by general ageing, which is expected in a building of this age and condition.

Beading is important in weatherproofing the surrounding building elements and preventing termite or pest ingress. Furthermore, beading works to protect the joins of building materials, which are more susceptible to deterioration and decay.

Repair or replacement of the beading is advised to ensure the protection and longevity of any associated building elements. Such works may be performed by a general handyperson or qualified carpenter.

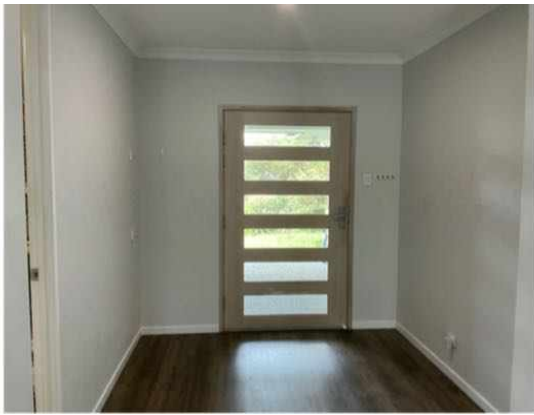
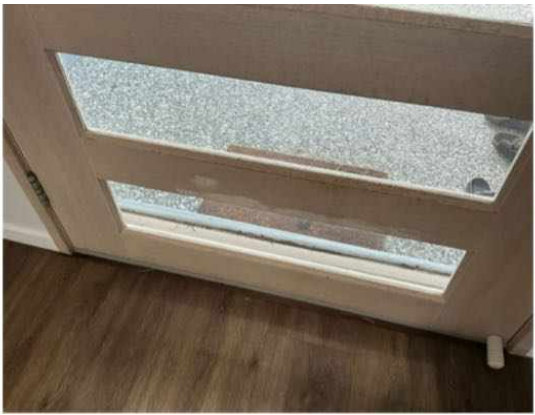
Defects 3.15

Building: Main Building
Location: Entry/hallway > Front
Finding: Door skin-split
Information: At time of inspection it was noted that the door skin was split.

This may be due to accidental damage or minor impact.

The door maybe required to be re paired by a qualified carpenter.

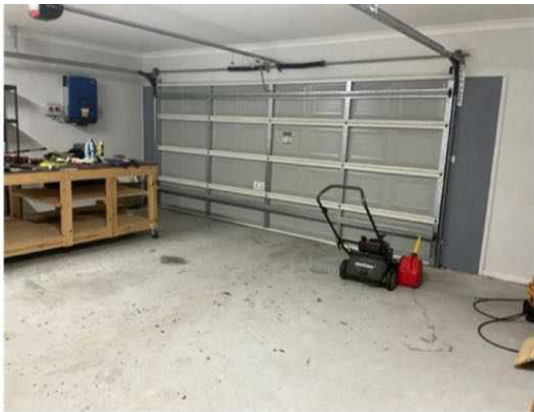
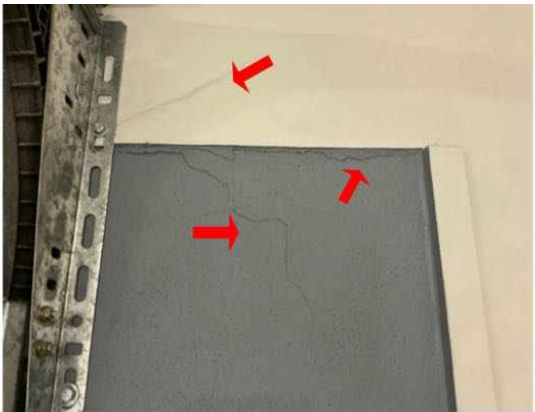
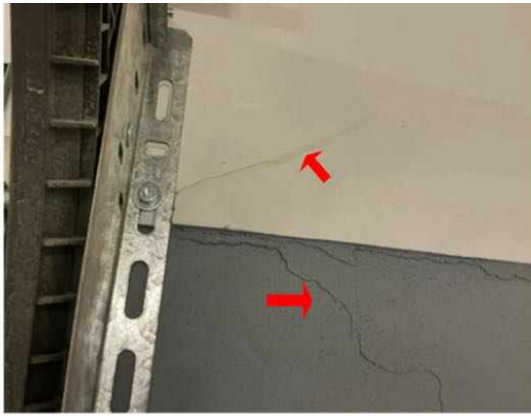
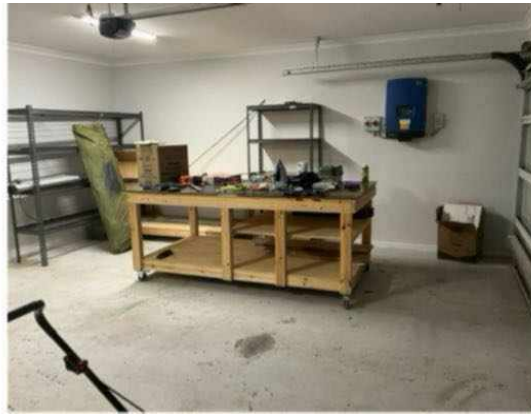
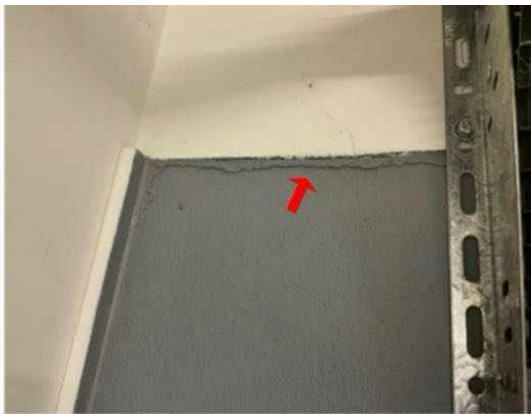
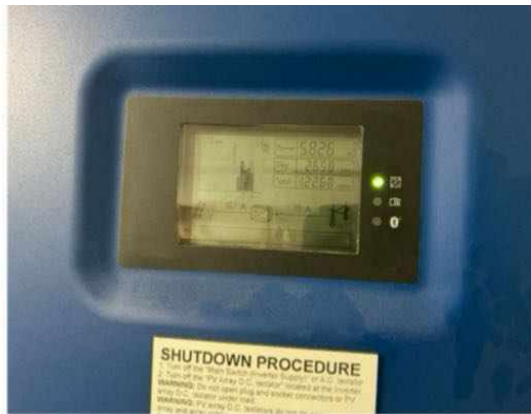
Defects 3.16

Building: Main Building
 Location: Garage > Front
 Finding: Cracks to internal render - Category 3
 Information: It has been observed that cracking to internal rendered surfaces has occurred. The degree of damage falls within Category 3, described as cracks which can be repaired with consideration that a section of wall may need to re-rendered.

The cracks are generally 5-15mm in width, or may present as a number of cracks 3mm or more in a group. Damage of this category is a defect that requires rectification work, which may be more extensive.

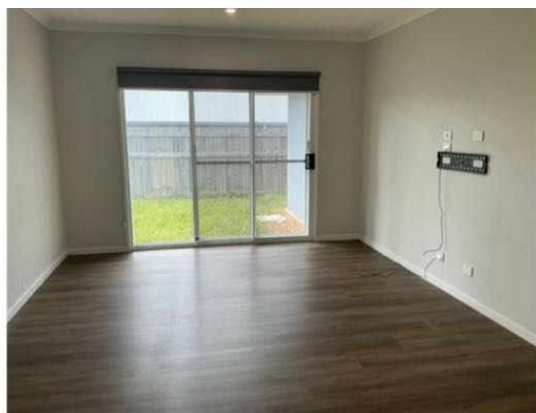
Defects 3.17

Building: Main Building
 Location: Theatre Room > Rear
 Finding: Beading - Missing
 Information: Where beading (also known as 'quad' or rubber seals) are missing from glazing, the area is more susceptible to deterioration and decay, and is more likely to allow water ingress.

If the lack of beading or rubber seals is not addressed, the structure will generally age more quickly. This deterioration may subsequently lead to secondary building defects in adjoining building materials, as well as reducing the insulation properties of the

window.

A general handyman or window specialist should be appointed as soon as possible to install adequate sealing to this area.

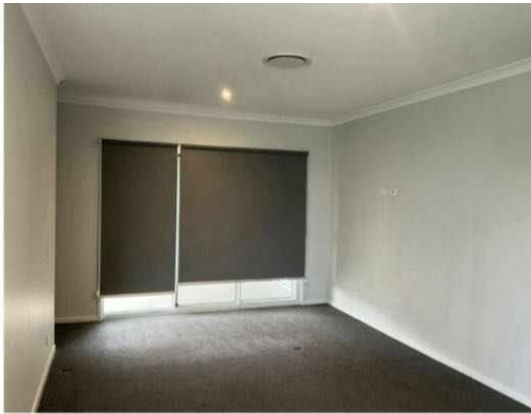
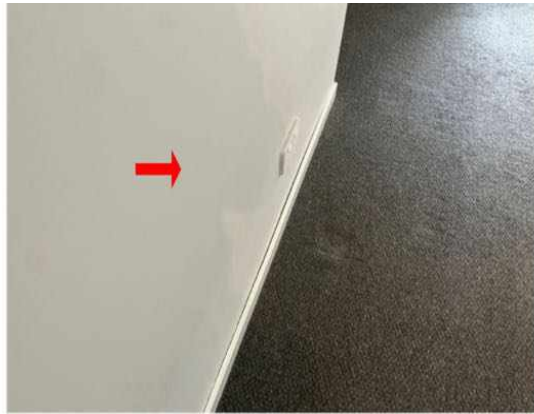
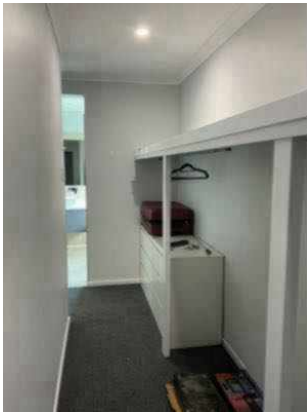
Defects 3.18

Building:	Main Building
Location:	Bedroom - Master > Centre
Finding:	Plaster - Drummy
Information:	Sections of plaster sheeting in this area appear to be drummy. The term 'drummy' is used to describe plaster which, whilst solid, has become detached from its original fixing.

The most common causes of plaster failure are physical damage and moisture damage. Moisture causes plaster to swell and shrink as the humidity of the air changes, or as a consequence of leaks, which can be enough to create drumminess or cracking.

Ensure that the general environment is free of moisture and humidity to aid in the prevention of drummy plaster and plaster damage. Appointment of a qualified

plasterer is advised in order to complete remedial works as necessary.

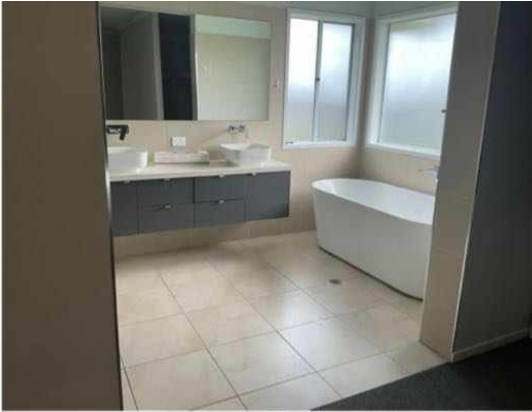
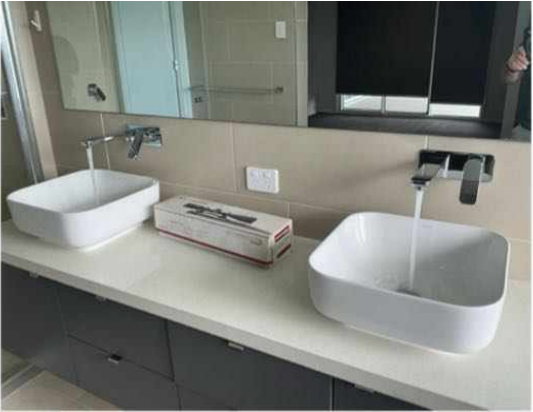
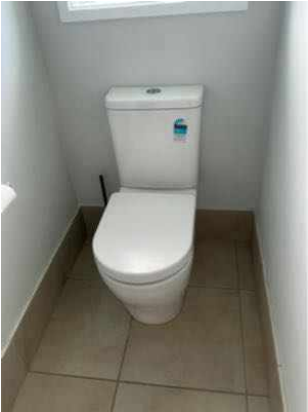
Defects 3.19

Building:	Main Building
Location:	Ensuite - Master > Existing
Finding:	Tap - Loose
Information:	The tap in this area has not been installed correctly, or has deteriorated with age, and is consequently loose. This tap being loose creates potential for water leaks and subsequent water damage to the surrounding area.

Where taps or spouts are loose, a qualified plumber should be appointed to re-fix the

plumbing fitting.

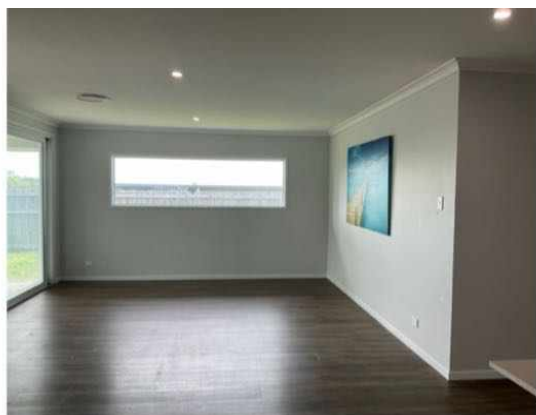
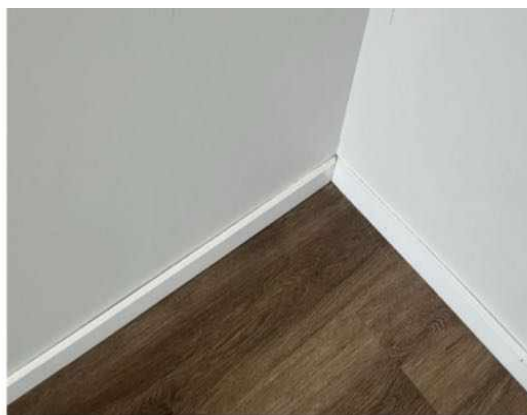
Defects 3.21

Building:	Main Building
Location:	Living Room > Front
Finding:	Beading - gap
Information:	Beading acts (like cornice or skirtings) to cover the intersection or joins of building materials. It was noted at the time of inspection that beading in this area has minor gaps. This deterioration is suspected to have been caused by general ageing, which is expected in a building of this age and condition.

Beading is important in weatherproofing the surrounding building elements and preventing termite or pest ingress. Furthermore, beading works to protect the joins of building materials, which are more susceptible to deterioration and decay.

Repair or replacement of the beading is advised to ensure the protection and longevity of any associated building elements. Such works may be performed by a general

handyperson or qualified carpenter.

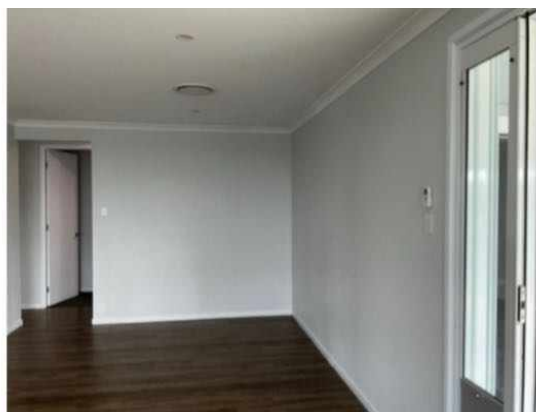
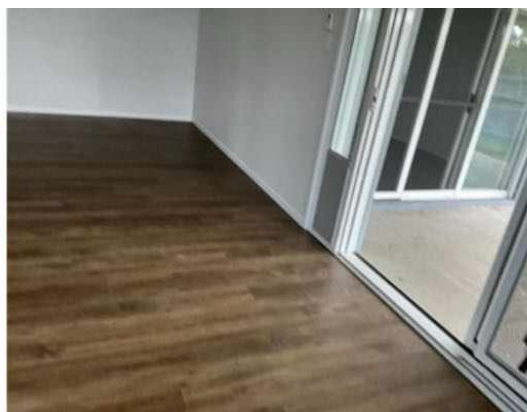
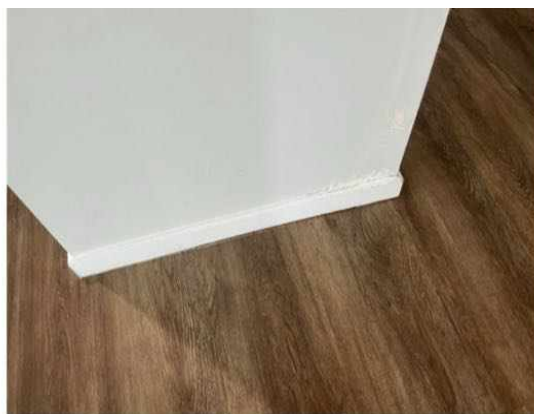
Defects 3.22

Building:	Main Building
Location:	Dining Room > Existing
Finding:	Evidence of animal damage
Information:	Impact damage was found to be detracting from the appearance and functionality of this building element. It is suspected that this damage has been sustained as result of wear and tear on the building element caused by personal pets. Most damage is superficial.

Depending on the location of the animal damage and the surface area that it has affected, animal damage may generally be repaired by maintenance to surface finishes (i.e. sanding, filling, or painting). Where building elements have sustained major damage, replacement may be required to ensure that no secondary defects occur.

These works can usually be performed by a qualified carpenter or general handyperson and should be completed at the discretion of the client.

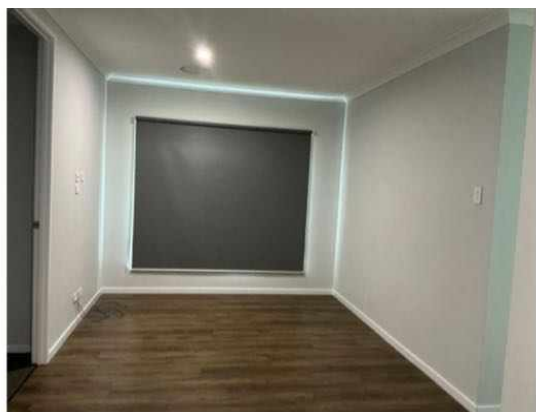
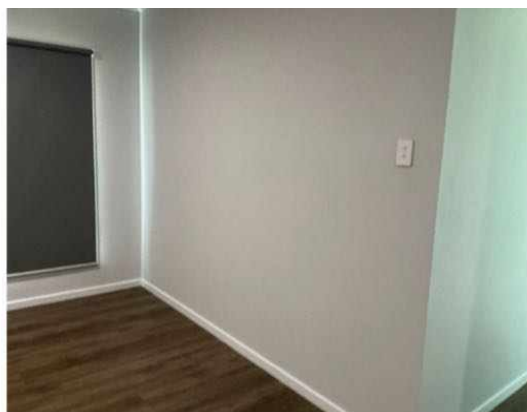
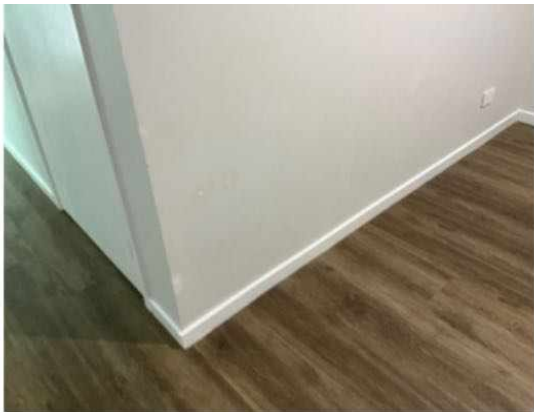
Defects 3.24

Building: Main Building
Location: Family Room > Existing
Finding: Walls - Scuffed
Information: Superficial scuff marks were noted to the internal walls in this area at the time of inspection. Marked and scuffed surfaces, while detracting from the overall appearance of the affected building element, do not indicate any operational or structural damage. This degree of surface damage is consistent with general wear and tear.

Marked surfaces may be left at client discretion, as no repair/replacement is necessarily required. Marked surfaces are unlikely to result in the development of secondary damage; however, the client may wish to seek quotations for the cost to refurbish or replace the affected wall linings.

A general handyman or cleaning contractor may be appointed to rectify marked or scuffed surfaces at the client's discretion.

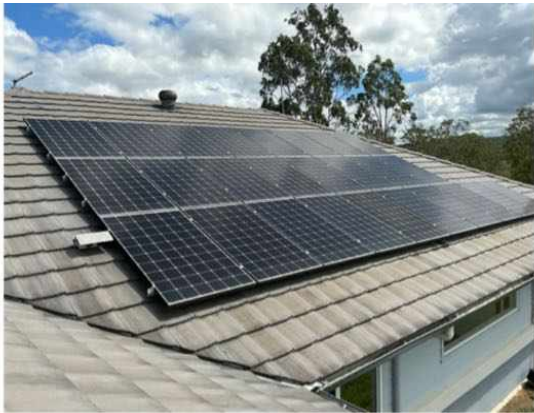
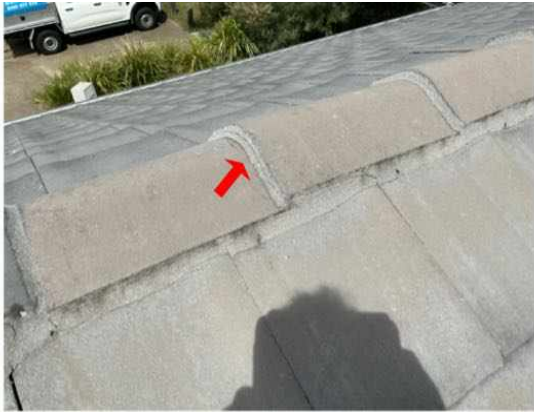
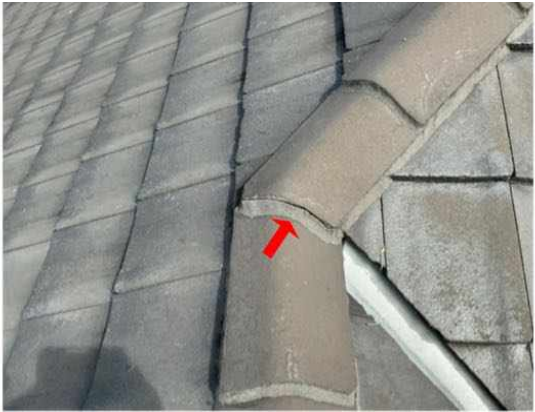
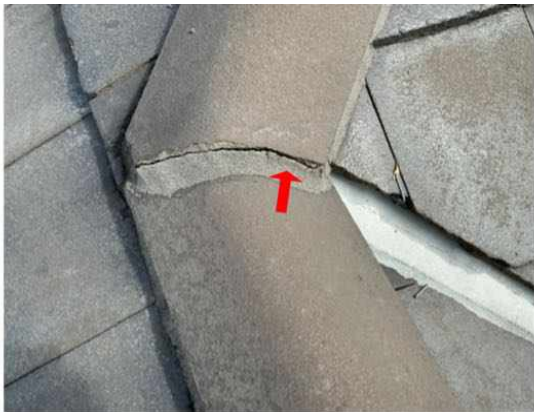
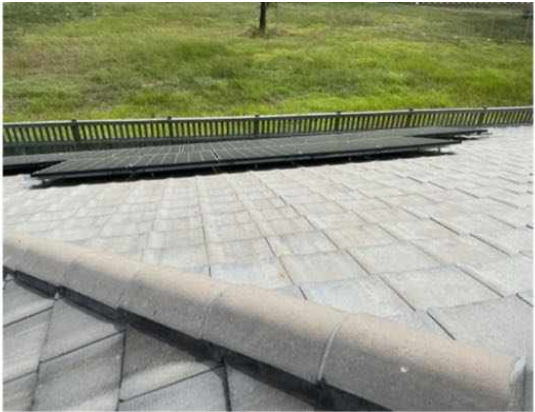
Defects 3.25

Building: Main Building
Location: Roof Exterior > Existing
Finding: Roof pointing- minor repairs
Information: At the time the of the inspection it was noted that the pointing in sections of the roof capping has deteriorated and minor repairs are required.

This due to age and uv damage which is common in properties of this age.

A roof tiler may be required to rectify this condition.
