Building and Timber Pest Inspection Report

Inspection Date: Thu, 2 Apr 2026

Property Address: 49 Melba Rd, Lalor Park NSW 2147,
Australia

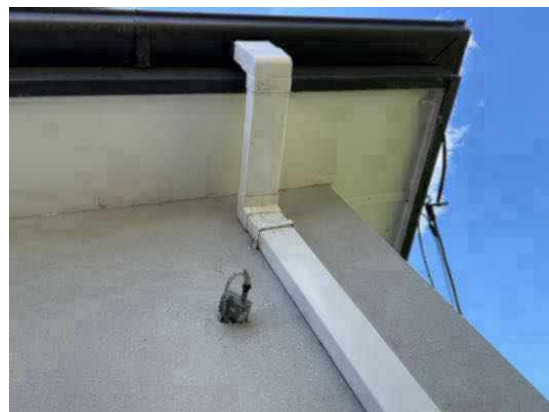
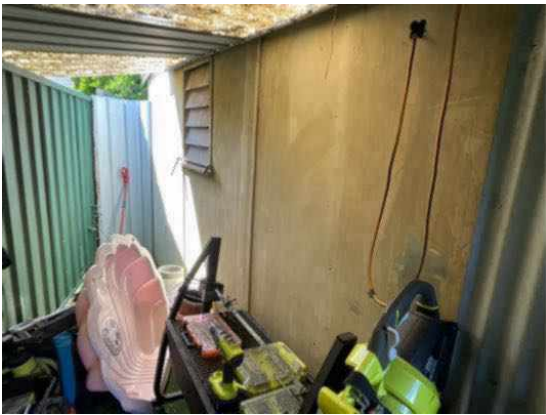
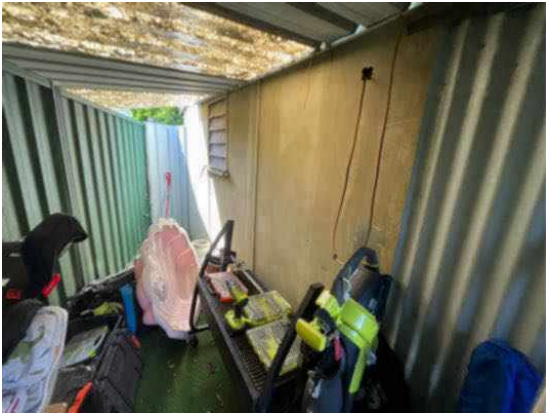
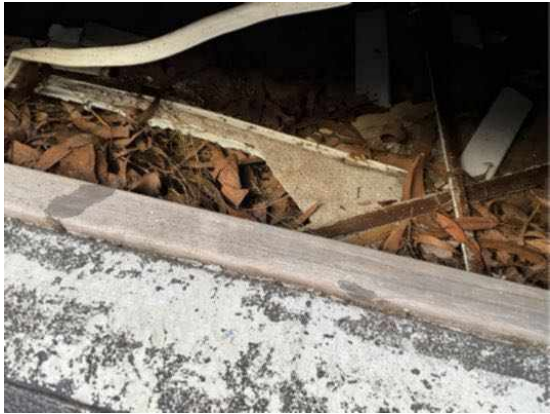
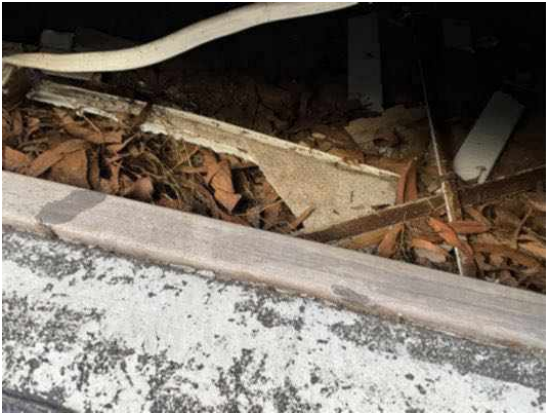
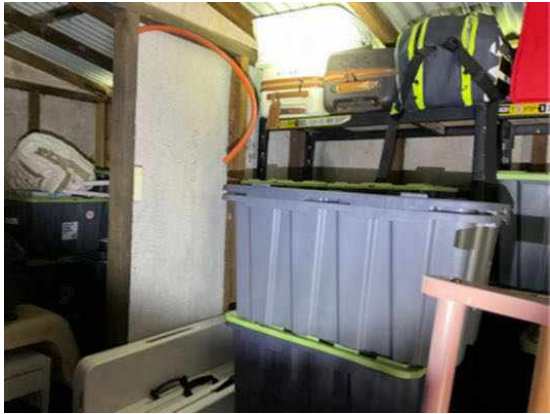
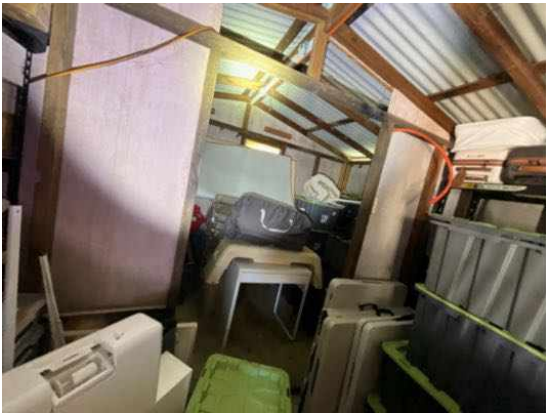
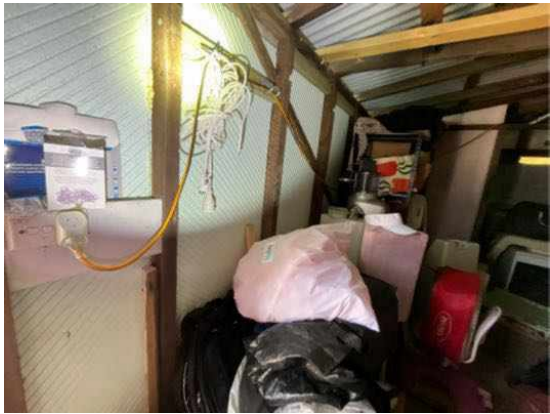
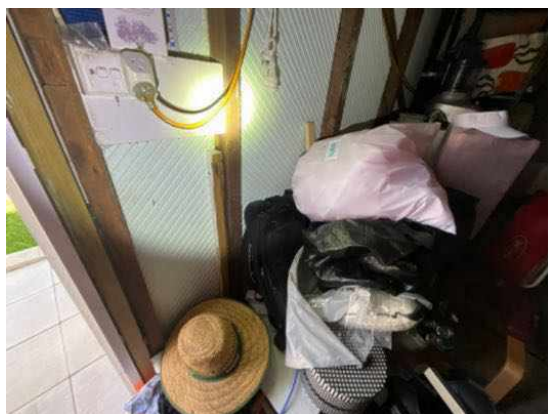
Information: Reporting on Asbestos is outside the Scope of this Report. This suspected defect is highlighted as a caution only. We suspect, based on our experience in the building industry, that there is a higher risk of the identified building element containing asbestos.

As Asbestos Reporting is outside the scope of this report, we advise that you consider a separate Asbestos Inspection and Condition Audit, which can include the taking of samples for definitive confirmation of the presence of Asbestos.

In the interim, the client is advised to act with caution, especially when considering any damage to building materials general wear and tear renovations extensions demolition and general maintenance activities due to the suspected presence of Asbestos.

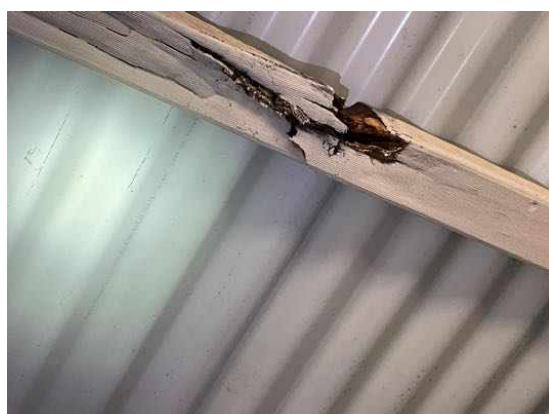
Finding 2.01

Building:	Main Building
Location:	Pergola
Finding:	Rot weakening the timber structure
Information:	Cracks and signs of wood rot have been observed, weakening the timber structure. The deterioration could be due to moisture exposure, aging, or insect infestation, compromising the structural integrity of the timber.

- ****Structural Instability:**** The cracks and wood rot can compromise the load-bearing capacity of the timber, potentially leading to structural failure or collapse, especially in load-bearing walls, beams, or frames.
- ****Safety Hazard:**** Weakening of the timber structure increases the risk of accidents, such as falling debris or collapse, posing a danger to occupants.
- ****Progressive Damage:**** If left unaddressed, wood rot can spread, further degrading the timber and accelerating the risk of structural failure.
- ****Pest Infestation:**** Wood rot can attract pests such as termites, which may cause additional damage.

A structural engineer or professional carpenter should be contacted to assess the extent of the damage. Depending on the severity, repairs may involve replacing the affected timber sections, treating the wood with preservatives, or reinforcing the structure. If there is extensive rot, a specialist in wood restoration or pest control may also be required to prevent further decay or infestation.

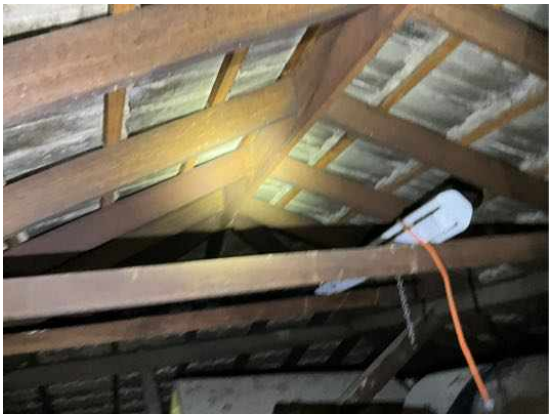
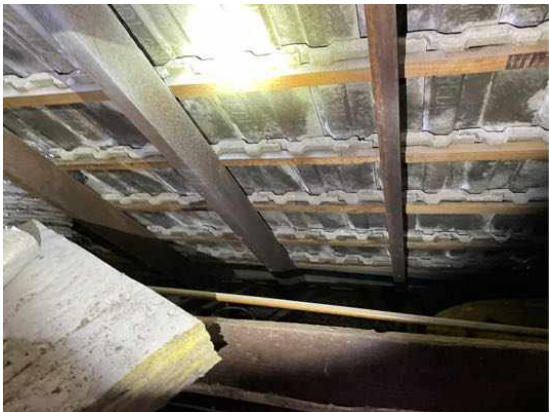
Finding 2.02

Building:	Main Building
Location:	Roof Void
Finding:	Roof void - Suspected water leak
Information:	Suspected water leak in the roof void, as evidenced by the presence of water stains indicating potential gaps or holes.

- **Structural Damage:** Continuous water leakage can weaken the structural integrity of the roof and ceiling, leading to potential collapse.
- **Mold and Mildew:** Persistent moisture can promote the growth of mold and mildew, posing health risks such as respiratory problems and allergic reactions.
- **Electrical Hazard:** Water intrusion near electrical wiring can create a risk of short circuits, fires, or electrical shocks.
- **Insulation Damage:** Prolonged exposure to moisture can damage insulation, reducing its effectiveness and increasing energy costs.

A licensed roofing contractor should be contacted immediately to inspect, diagnose, and repair the source of the leak to prevent further damage.

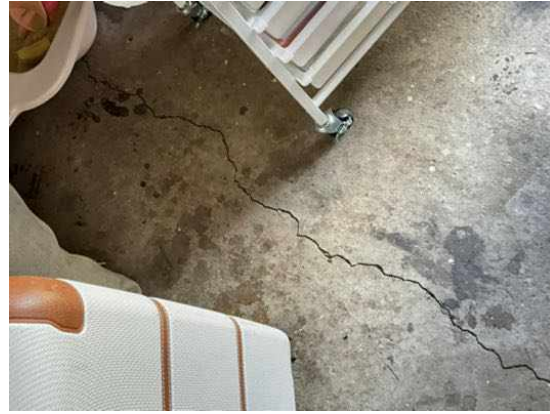
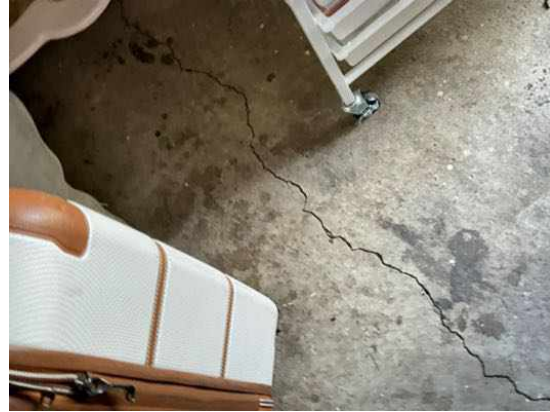
Building:	Main Building
Location:	All Areas
Finding:	Noticeable Cracking in Concrete Slab
Information:	Noticeable cracking has been observed in the concrete slab, failing to meet the required construction and quality standards.

- Cracks are visible on the surface and may extend through the depth of the slab.
- Evidence of improper curing or inadequate reinforcement leading to cracking.

- Compromised structural integrity of the slab, potentially leading to failure under load.
- Water ingress through cracks, causing corrosion of reinforcement and further weakening the structure.

- A structural engineer should be engaged to assess the extent of the cracking and recommend appropriate repair methods.

- A licensed contractor or concrete repair specialist should carry out the recommended repairs under the guidance of the structural engineer.

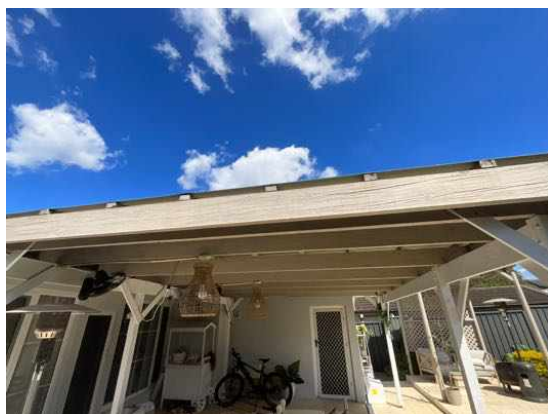
Finding 3.03

Building:	Main Building
Location:	All Areas
Finding:	Timber - exposed to weather
Information:	External timbers that are frequently exposed to harsh weather conditions require adequate protection in order to maintain their condition. Where timbers have not been painted or treated adequately, general deterioration is likely to occur at an accelerated rate.

If left unattended, replacement of these timbers is likely to be necessary in the short-term future. Adequate treatment of these timbers is required as soon as possible by a painting contractor or general handyman.

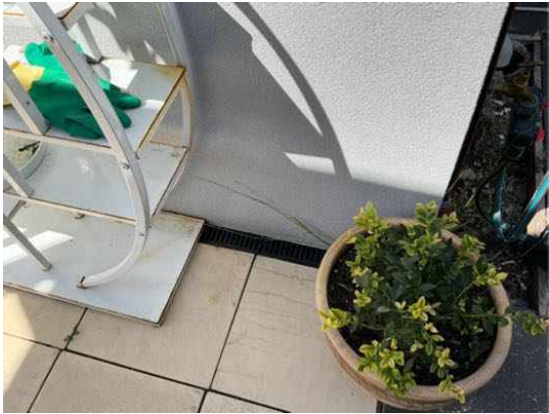
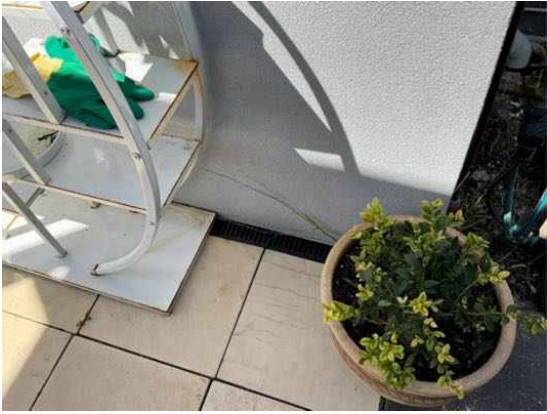
Building:	Main Building
Location:	Subfloor
Finding:	Subfloor ventilation - Inadequate - blocked airflow
Information:	The subfloor of the property has inadequate ventilation due to blocked airflow from all sides, preventing proper circulation of air beneath the building.

- ****Moisture Build-Up****: Poor ventilation can lead to excessive moisture accumulation in the subfloor area, promoting mold growth, wood rot, and deterioration of structural elements, such as floor joists and beams.
- ****Pest Infestation****: Stagnant, damp environments create ideal conditions for termites and other pests, which can compromise the integrity of the building's foundation and structure.
- ****Health Hazards****: The accumulation of moisture and mold can pose health risks to occupants, particularly those with respiratory conditions, due to the growth of allergens and mold spores.

A licensed builder or ventilation specialist should be consulted to assess and install adequate subfloor ventilation. This may include installing vents, mechanical fans, or other solutions to improve airflow and prevent moisture buildup. Proper ventilation will ensure the longevity of the building's structural components and reduce health risks associated with dampness.

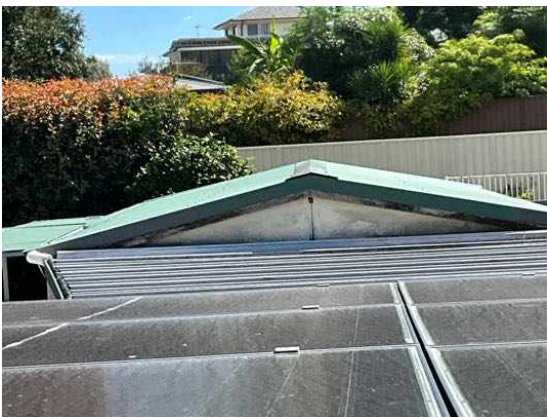
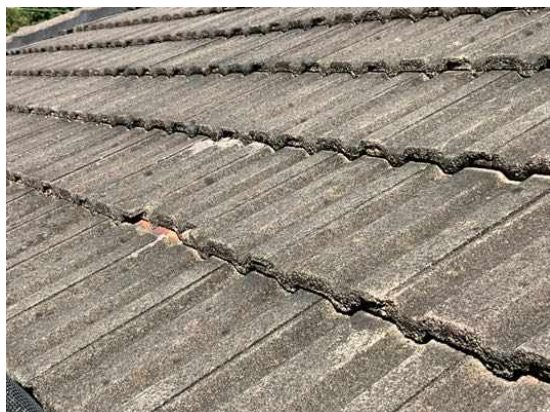
Finding 3.06

Building: Main Building
Location: Roof Exterior
Finding: Roof Weathered
Information: Upon inspection of the exterior roofing, the majority of roof was not in a fair condition. While weathering of the roof is consistent with the age of the property, maintenance works are required.

Isolated areas of mortar have come loose in the valleys and minor cracking is also present. Re-pointing and re-sealing the may be considered as an interim solution by the client to help preserve and extend the life span of the tiles.

Where left unmanaged, deteriorating roof are likely to lead to a number of secondary defects, including minor water leaks and weather exposure to internal roofing structures.

Consultation with a roofing contractor is highly advised to gain advice on cost of remedial works that may be required in the short to medium term. Remedial works are likely to increase the longevity of the exterior roofing structure.

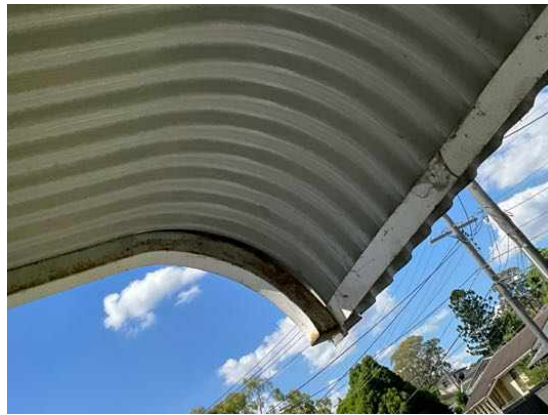
Finding 3.07

Building:	Main Building
Location:	Front porch
Finding:	Building element - Rusted or corroded
Information:	This building element shows evidence of rusting and corrosion, which is likely to have developed as a result of excessive exposure to moisture and or inadequate coatings.

As surface rust provides no protection to the underlying iron, the deteriorating condition is likely to worsen if not addressed in the short-term future.

Rusting and corrosion should be managed by ideally removing or limiting the affected surface from exposure to moisture. A registered builder may be appointed to replace any building elements that have been severely affected by rust or water damage.

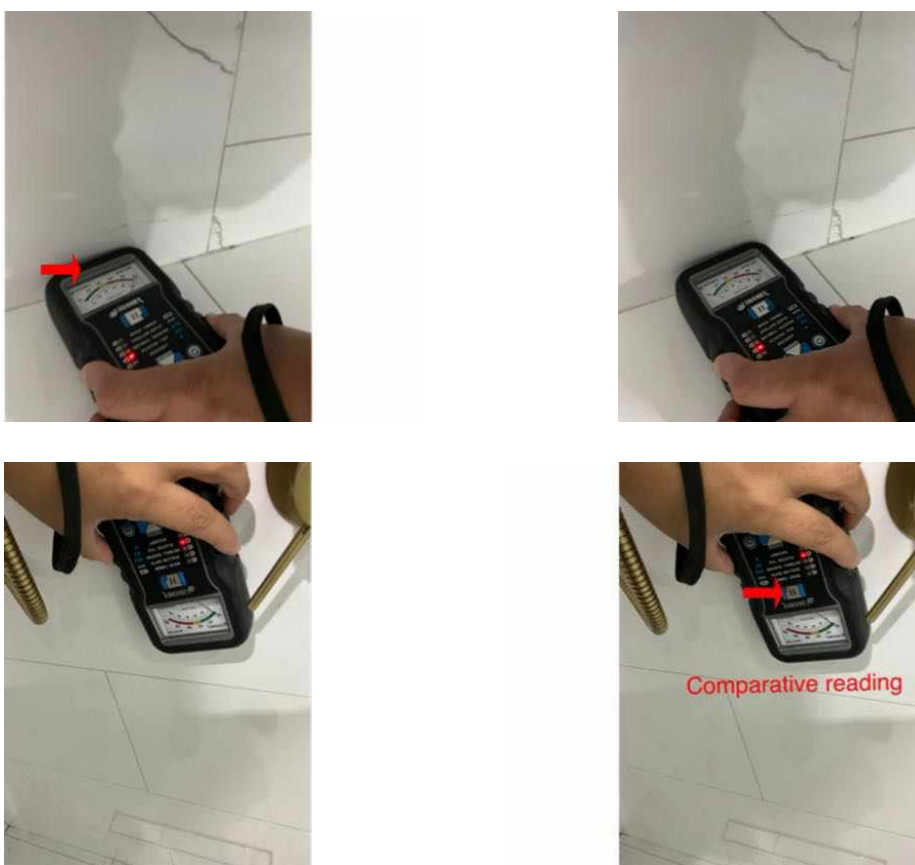
Finding 3.08

Building:	Main Building
Location:	Bathroom
Finding:	Evidence of excessive moisture was present at the time of inspection
Information:	Excessive moisture is present behind the bathroom tiles, indicating a potential water leakage issue within the wall.

The prolonged presence of moisture can lead to mold growth, deteriorate the structure, and create an environment conducive to health hazards. Additionally, it may compromise the adhesive holding the tiles, leading to their detachment.

Damp is evident to the lower 300mm of wall to the shower alcove. This defect is quite common, and is suspected to have been caused by moisture permeating through the grouting in this area, which shows evidence of deterioration. Leaking pipes within the adjoining wall is also a possible cause.

A licensed plumber or a qualified contractor specializing in water damage remediation should investigate the source of the moisture, fix any leaks, and address the damage. Additionally, replacing affected tiles and ensuring proper waterproofing are crucial to preventing future issues.

Consultation with a qualified plumber or bathroom specialist is advised immediately to identify the cause of damp and to perform remedial works as required. Where excessive mould growth is present, further inspection by a specialist environmental health inspector should also be considered.

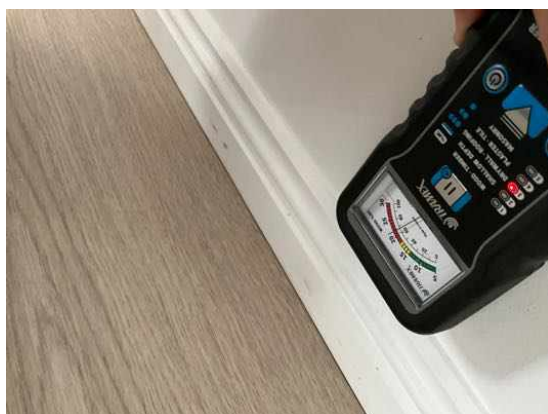
Finding 3.10

Building: Main Building
Location: All Areas

Rising damp is generally managed by the installation of a damp proof course during construction. A Damp Proof Course (DPC) is an impermeable barrier at the base of the wall above ground level. However, many 19th Century buildings have no damp course installed, or the materials have failed. The DPC may have been omitted as a consequence of poor workmanship, or it may have been bridged where materials built up against the side of the house allow moisture ingress above the DPC level.

Consultation with a qualified plumber is advised immediately to identify the cause of the damp and perform remedial works as required.

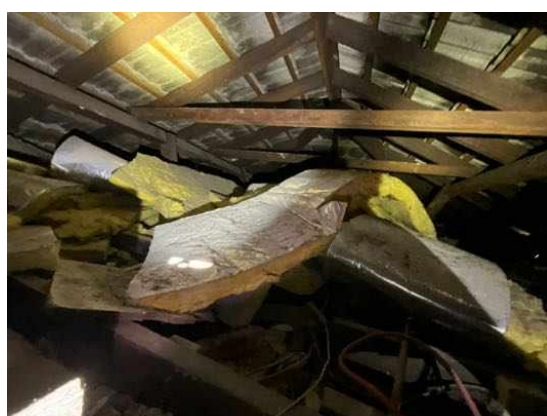
Finding 3.11

Building:	Main Building
Location:	Roof Void
Finding:	Sarking - Missing
Information:	Sarking is missing under the roof sheeting. Sarking acts as an insulator that helps with noise reduction and protects against water penetration. Sarking plays a key role in the operation and function of the overall roofing structure and its performance.

Sarking may be retrospectively fitted by a registered builder at the discretion of the client.

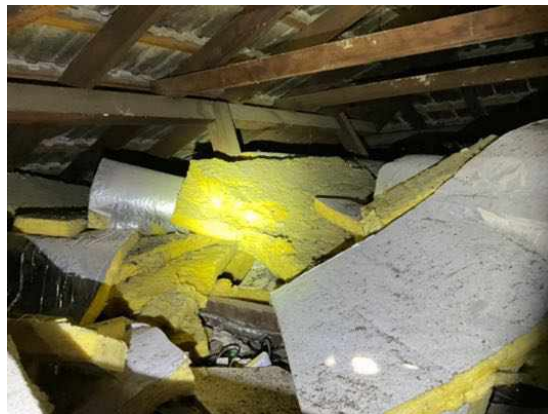
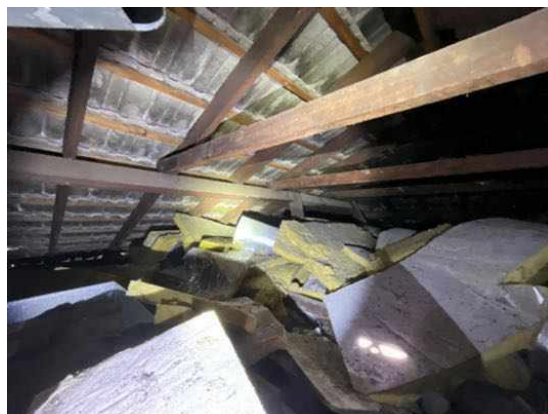
Finding 3.12

Building:	Main Building
Location:	Roof Void
Finding:	Insulation poorly placed
Information:	During the roof void inspection, it was observed that multiple insulation batts have

- Reduced Energy Efficiency: Exposed areas without insulation can lead to increased heating and cooling costs as they allow for thermal bridging.
- Increased Moisture Risk: Uneven insulation may lead to condensation issues, especially in colder climates, potentially affecting timber framing and ceiling materials.
-

- Qualified Insulation Installer – A licensed insulation contractor should be engaged to reposition or replace the insulation batts, ensuring consistent and complete coverage across the ceiling.

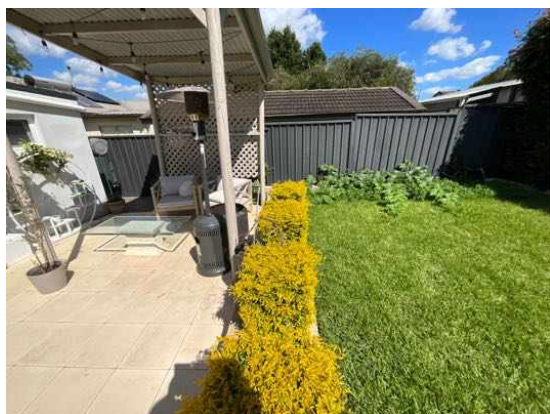
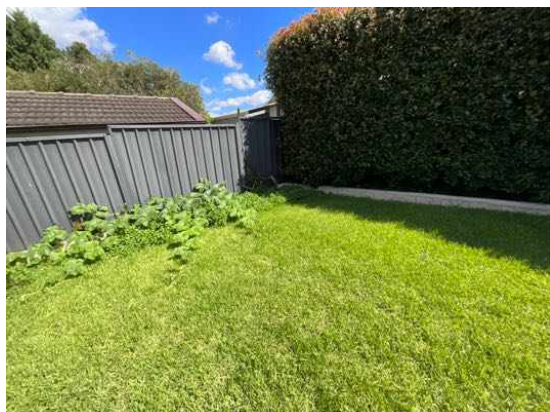
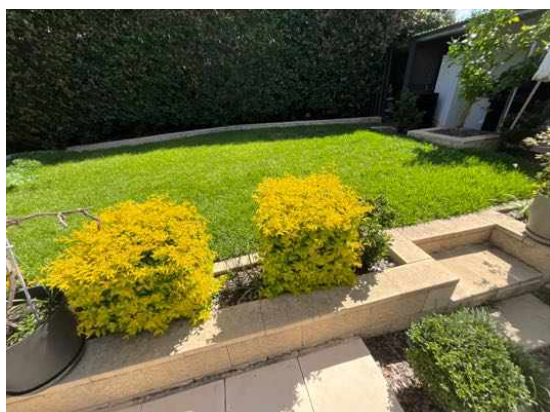
Building: Main Building
Location: Exterior walls - left side
Finding: No Evidence of Termite Management System - Durable notice / Legible Sticker
Information: The application of a pre & post-construction chemical termite barrier is highly recommended for all properties. Such barriers are highly effective in preventing termite attack on any timber building elements throughout the property.

Client must seek further information from the vendor or real estate agent if the conditions of termite management systems were maintained.

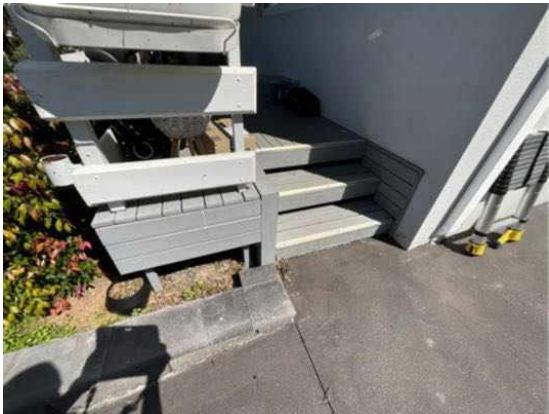
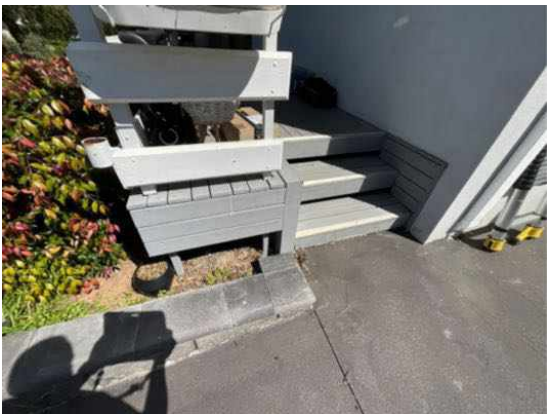
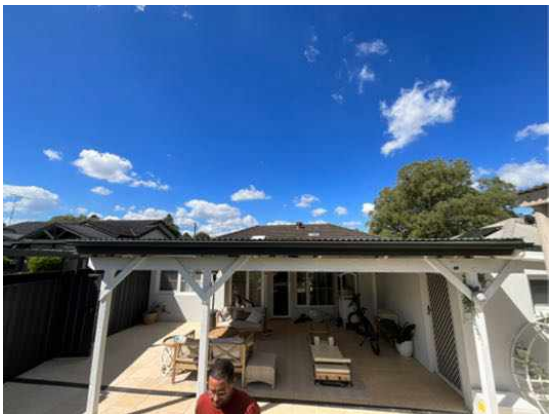
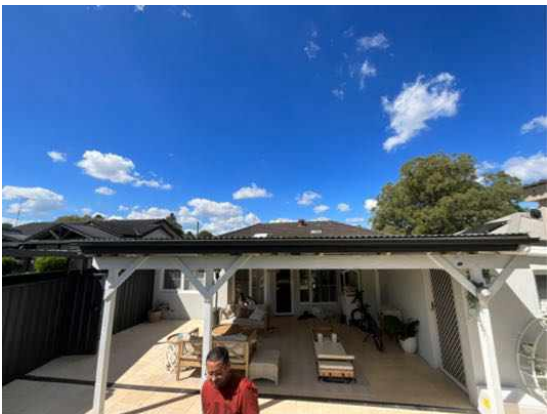
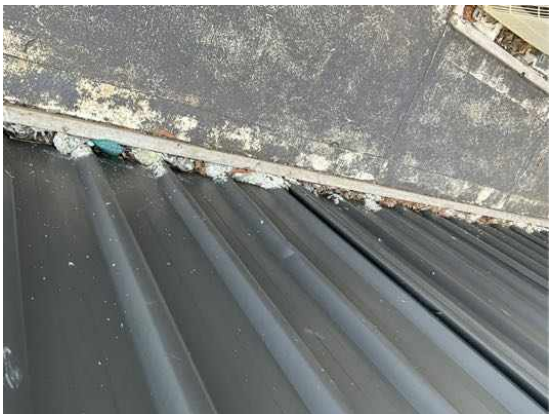
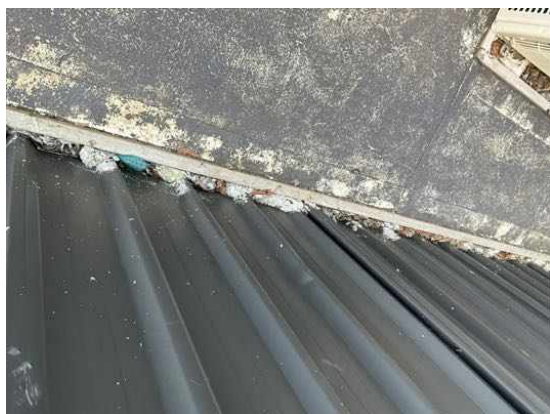
Finding 6.03

Building:	Main Building
Location:	All Areas
Finding:	Timber on ground / conducive conditions to termite damage
Information:	Timber on the ground is indeed conducive to termite damage. Termites are known to thrive in moist environments, and wood in contact with soil or moisture is more susceptible to infestation.

To prevent this, it's important to keep timber elevated and away from direct ground contact. Regular inspections and proper termite control measures are also essential to protect your wooden structures from termite damage.

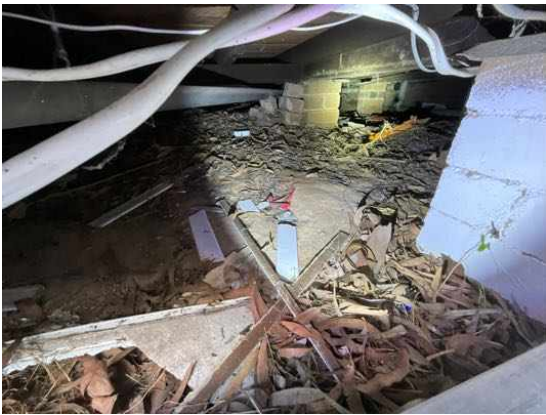
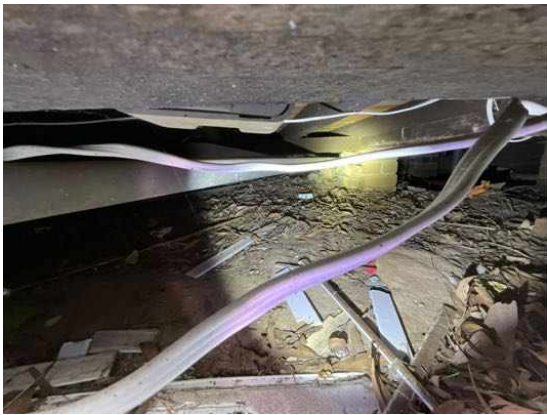
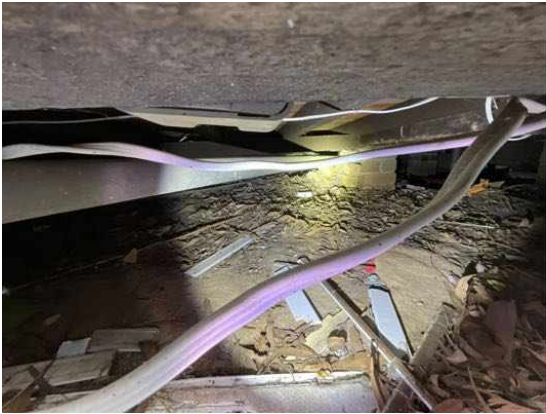
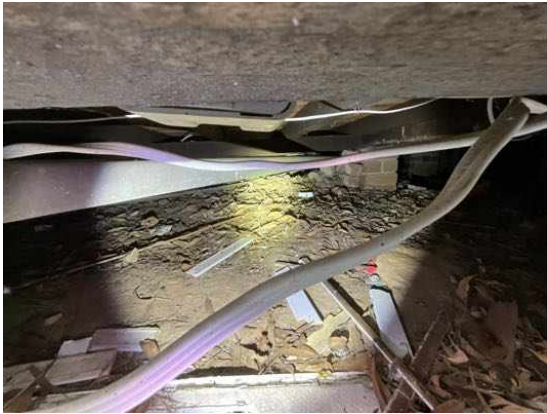
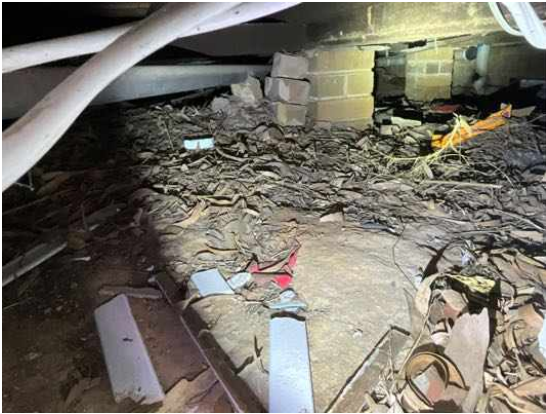
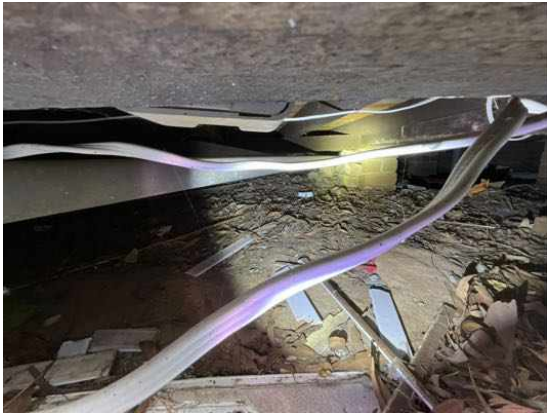
Building:	Main Building
Location:	Subfloor
Finding:	Subfloor - poor ventilation, inadequate site drainage, water stains
Information:	The subfloor lacks adequate ventilation, suffers from inadequate site drainage, exhibits water stains, creating conducive conditions for timber pests such as termites.

Risk: The combination of poor ventilation, inadequate drainage, water stains significantly increases the risk of timber pest infestations. Termites are attracted to moist environments and can thrive in subfloors with high humidity levels and water damage. The lack of proper ventilation and drainage exacerbates moisture retention, providing an ideal habitat for timber pests to establish colonies and cause extensive damage to the subfloor structure. Additionally, water stains indicate previous or ongoing moisture issues, which further attract timber pests and contribute to the deterioration of timber materials.

A licensed pest control professional specializing in timber pest management should be consulted to assess the extent of the infestation and develop a comprehensive treatment plan. They can implement strategies to eliminate existing timber pests, such as termites and prevent future infestations by addressing underlying moisture issues. Additionally, a qualified plumber or builder may be needed to improve subfloor ventilation, enhance site drainage, repair water-damaged areas. Regular inspections and maintenance are essential to ensure ongoing protection against timber pests and maintain the structural integrity of the subfloor.

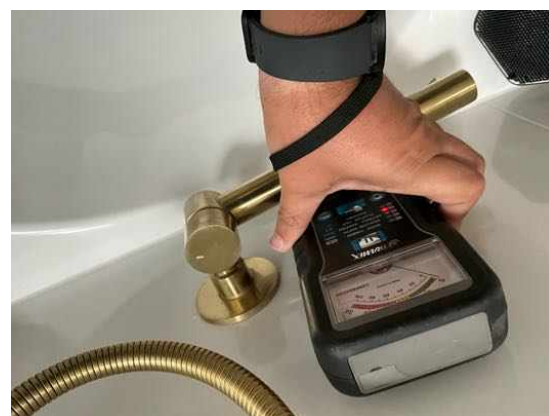
Finding 6.07

Building:	Main Building
Location:	Ensuite

Finding: Excessive moisture - Conducive to Timber pest
 Information: Excessive moisture can attract termites and produce conditions that promote fungal growth and wood decay.

Prior to any remedial works being performed a qualified plumber should be appointed to further inspect the property and to identify the cause of the excessive moisture. Works to remove affected building elements may then be necessary and should be performed by an appropriate tradesperson.

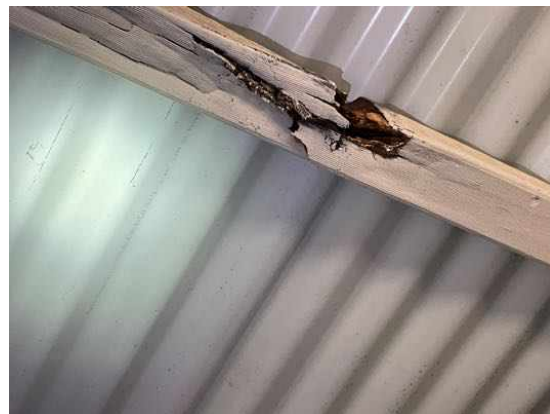
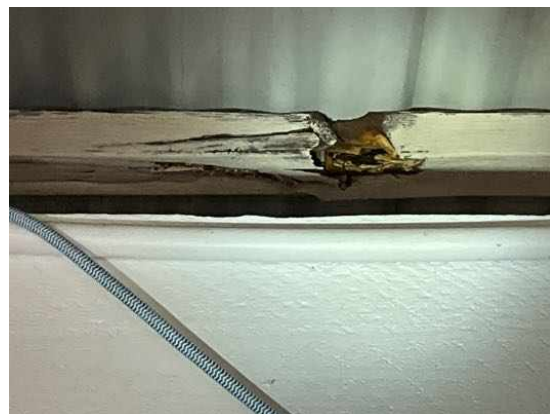
Building: Main Building
 Location: Pergola
 Finding: Wood rot
 Information: This building element shows evidence of wood rot. Wood rot, also known as Fungal Decay, occurs when timbers and other cellulose building materials are exposed to damp conditions on an ongoing basis. This could be the result of exposure to weathering over a prolonged period of time, or the attraction of excessive moisture from other abutting building materials. Contributing factors also include poor air ventilation in the area.

A qualified plumber may be appointed to assess the cause of excessive moisture and to provide advice on any remedial works as required. A qualified carpenter or registered builder may also be required to replace affected building materials.
