Building and Timber Pest Inspection Report

Inspection Date: Wed, 1 Apr 2026

Property Address: 161 Russell Street, Emu Heights NSW 2750

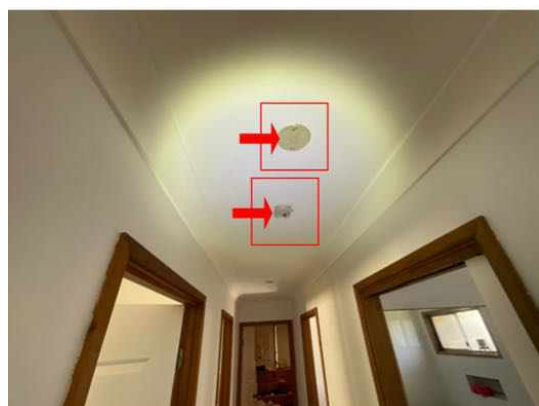
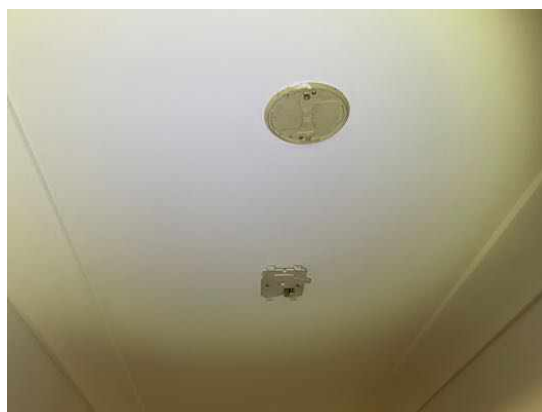
To ensure compliance and safety, further inspection and/or advisory services from a qualified specialist are recommended. These services can confirm the sufficiency, type, location, and functionality of all smoke detection devices within the property.

- All smoke detectors be tested monthly by the homeowner.
- All systems comply with the requirements of AS 3786 and any applicable state-based legislation.

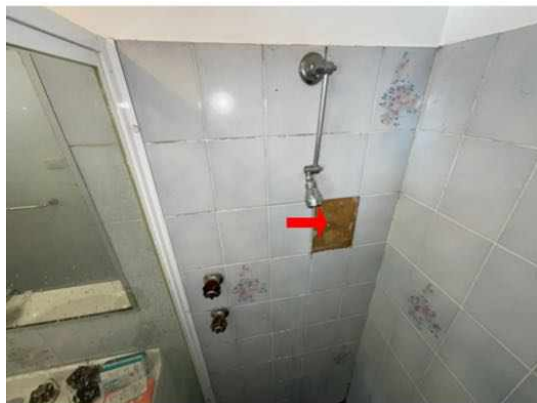
Finding 2.01

Building:	Main Building
Location:	Ensuite
Finding:	Major Defect – Tiling Failure (Shower Area and Bathroom Floor)
Information:	Observation

At the time of inspection, multiple wall tiles within the shower recess were found to be “drummy” when tested, indicating a loss of adhesion to the substrate. In addition, at least one wall tile was noted as missing within the shower area, leaving the underlying surface exposed.

A missing mosaic floor tile was also observed to the main bathroom floor area outside the shower recess.

Drummy and missing tiles are indicative of failure in the tile adhesion system and may also suggest potential deterioration of the underlying substrate or waterproof membrane.

The missing wall tile within the shower presents a direct pathway for water ingress during use, significantly increasing the risk of concealed moisture damage.

The missing floor tile to the main bathroom area may allow water penetration into the substrate and may also present a minor trip hazard.

Given the location within a wet area, these conditions are considered a major defect requiring prompt attention.

- Moisture ingress beneath or behind tiles
- Inadequate adhesive application or poor surface preparation at the time of installation
- Movement in the structure or substrate
- Impact damage
- Age-related degradation of adhesives and bonding materials

- Removal and replacement of all drummy and missing tiles
- Inspection of the underlying substrate for damage or deterioration
- Verification of the condition and integrity of the waterproofing membrane
- Rectification or replacement of waterproofing where defects are identified
- Reinstatement of tiles using appropriate materials and installation methods compliant with current standards

Further invasive investigation may be required to determine the full extent of damage, particularly in concealed areas behind the shower wall and floor finishes.

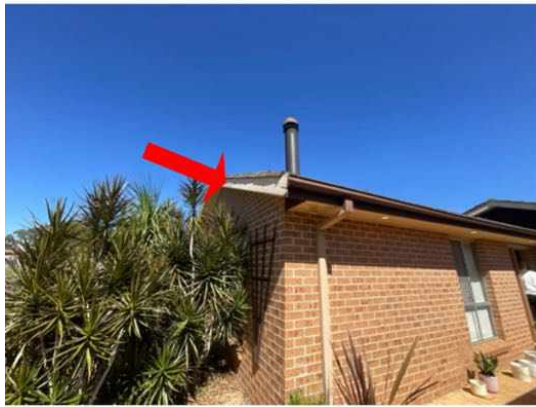
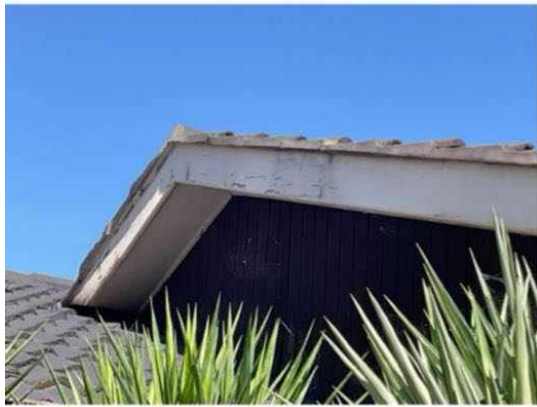
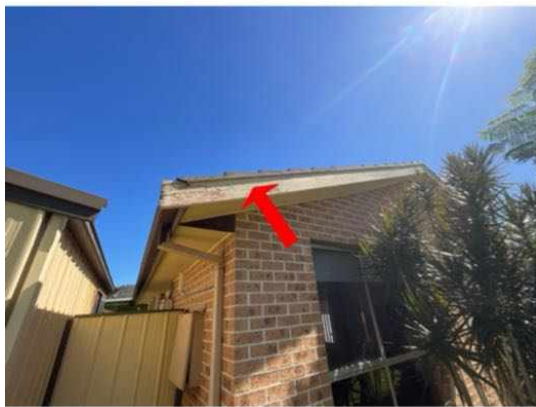
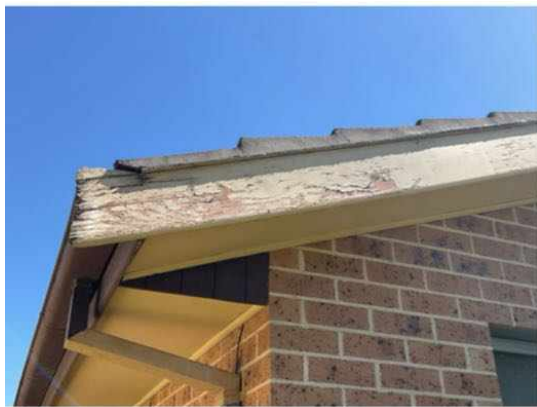
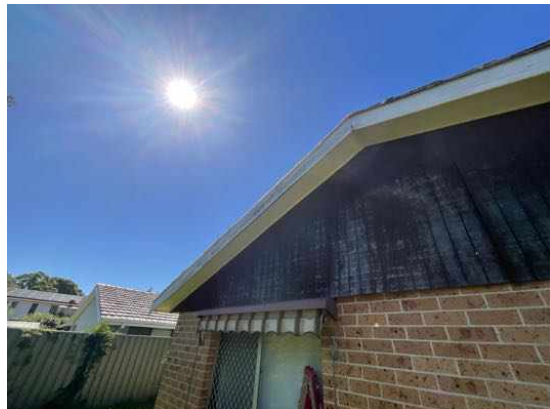
Finding 3.01

- External timber components of the building, which are frequently exposed to harsh weather conditions, show signs of wear and lack adequate protective treatment.
- In areas where timbers have not been properly painted or sealed, deterioration is likely to progress at an accelerated rate due to constant exposure to moisture, UV radiation, and temperature changes.
- Without timely intervention, the condition of these timbers may continue to degrade, potentially requiring replacement in the short-term future.

- Where timber elements have already deteriorated beyond restoration, repairs or replacement will be necessary.

- A qualified carpenter should be appointed to assess and carry out any required structural or cosmetic timber repairs.

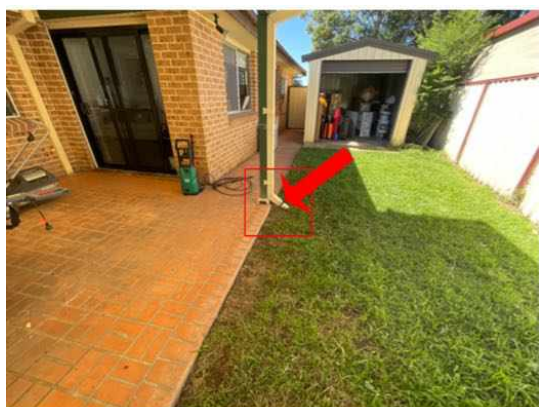
Finding 3.05

Building:	Main Building
Location:	All External Areas
Finding:	Site/Yard Drainage – Below Average.
Information:	Defect – Below Average Site Drainage

Site drainage in the inspected areas appears to be below average, with no surface drains observed at the time of inspection. Ground surfaces and paved areas adjacent to the building do not appear to be adequately graded to facilitate effective surface water runoff.

- A licensed plumber and/or landscaping contractor should be engaged to:
 - Evaluate the current site grading and surface runoff conditions
 - Install or upgrade surface water drainage (e.g. strip drains, spoon drains, grated channels) as required
 - Improve grading around the building to ensure water flows away from the structure

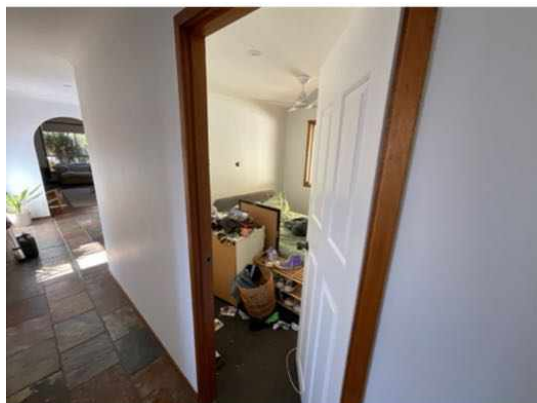
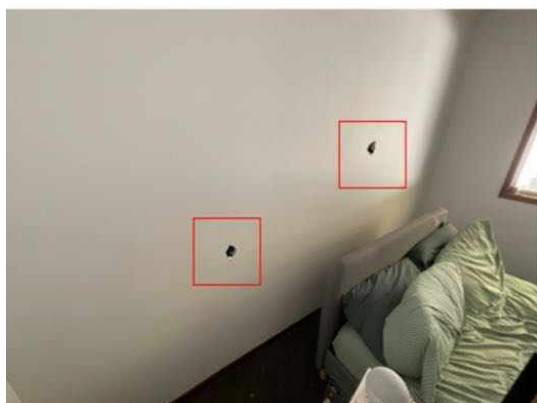
Building:	Main Building
Location:	Bedroom
Finding:	Minor Defect – Internal Wall Damage (Impact Holes)
Information:	Observation

Repairs should be carried out by a suitably qualified plasterer or tradesperson. Works should include patching, setting, and finishing of the affected areas to restore the wall surface to an acceptable standard.

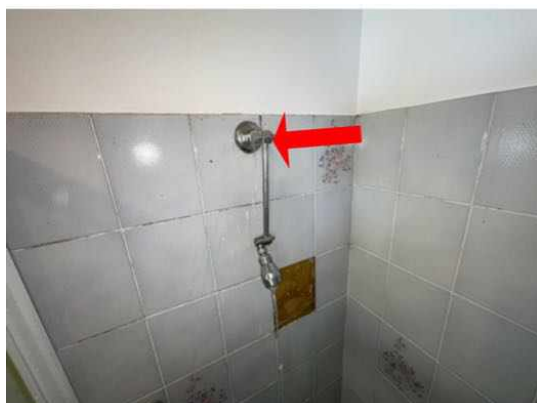
Finding 3.09

Building:	Main Building
Location:	Ensuite
Finding:	Shower Minor Defect – Leaking Shower Hose
Information:	Observation

Repairs may be undertaken by a suitably qualified handyman or licensed plumber at the client's discretion. Following rectification, the shower taps should be tested to confirm correct operation and to ensure no further issues are present.

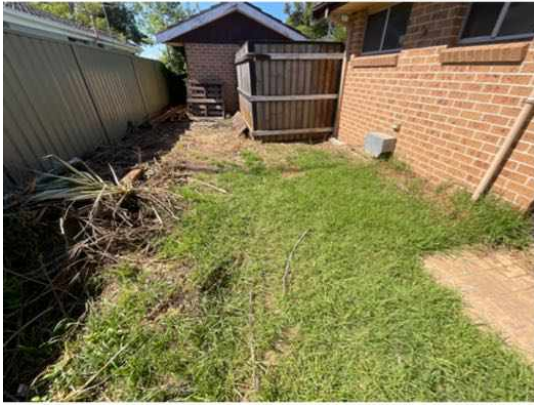
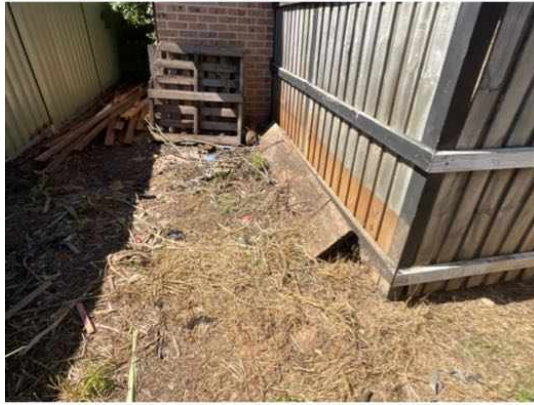
Finding 6.03

Building:	Main Building
Location:	All External Areas
Finding:	Stored timbers - External Area..
Information:	Stored Timbers Around External Property

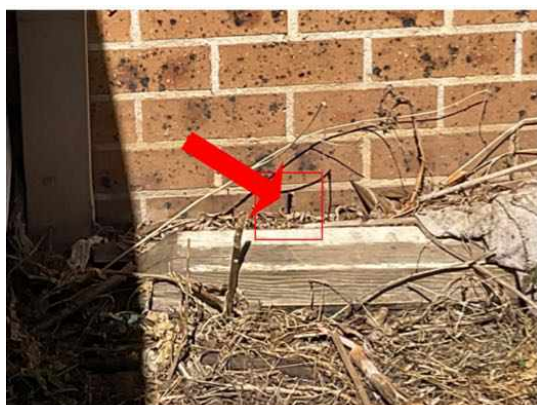
Finding 6.04

Building: Main Building
 Location: All External Areas
 Finding: Bridging of Termite Barriers – Concealed Weep Holes..
 Information: Observation:

- All weep holes should remain exposed and unobstructed across the entire property to allow for effective drainage and visual termite inspections.
- It is strongly advised that any material or structure covering weep holes be removed promptly, and a re-inspection carried out to ensure termite entry is not occurring undetected.
- Where removal of obstructions is not feasible, it is recommended that the area be inspected regularly, ideally every 3 to 6 months, to monitor for signs of termite activity or moisture-related damage.
