Building and Timber Pest Inspection Report

Inspection Date: Thu, 19 Feb 2026

Property Address: 545 Wyndham St, Shepparton VIC 3630,
Australia

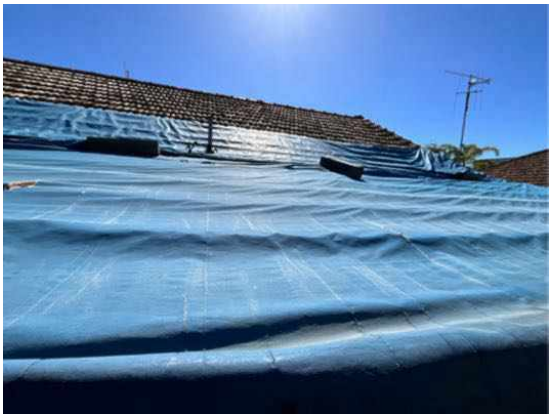
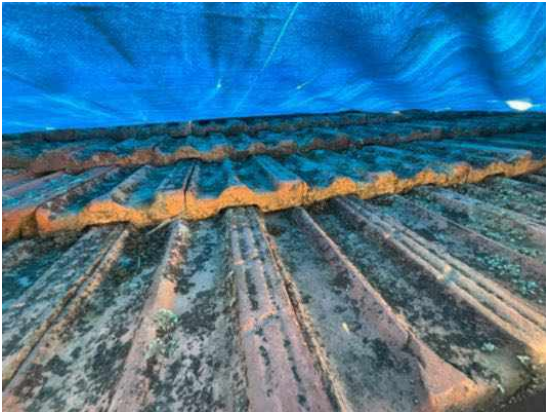
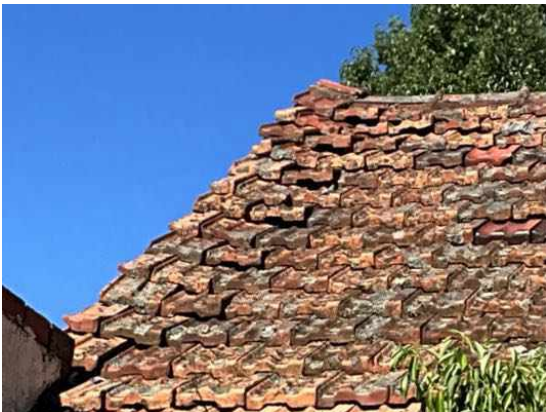
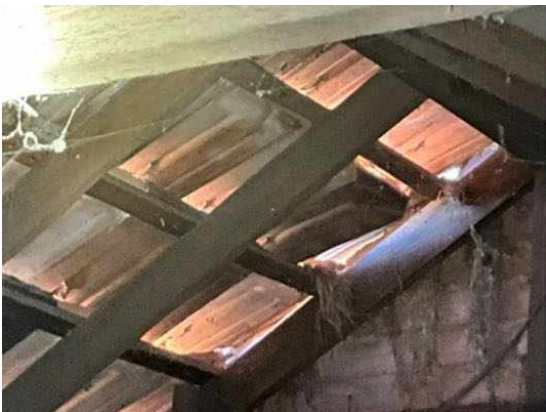
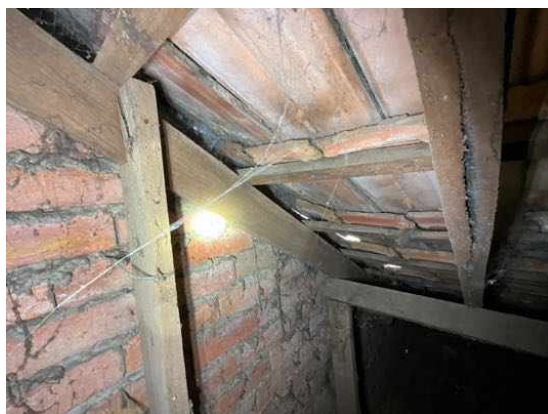
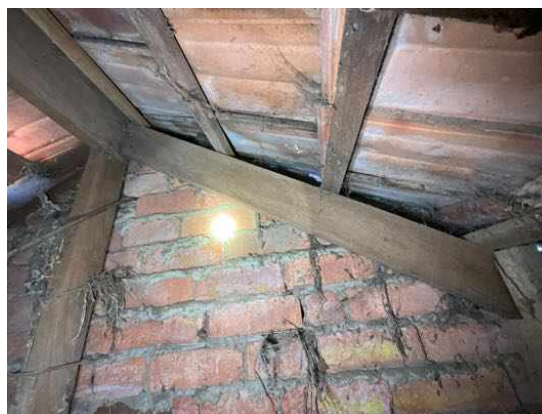
Building: Building 1
Location: Roof Exterior
Finding: Roof tiles - Slippage. General condition
Information: Upon inspection of the exterior roof covering, it was noted that numerous tiles have slipped from their original fixing. Tiles may slip over time due to a number of minor causes, including breakage of tiles, failings in the adjoining battens, or fixings that may have failed.

Roof tiles that have moved from their original position are very likely to allow water penetration into the roof void, exposing roofing structures to excessive moisture. This creates an environment that is conducive to water damage and accelerated deterioration of all associated building elements.

The blue tarp cannot be explained. Leaks may have been apparent at the time of installation but no significant evidence of leaks exists now.

The roof structure appears to be poorly supporting the northern section of the tiles. No movement can be seen in the timber structure. This may be due to poor original installation that has deteriorated over time.

Replacement of loose or missing roofing tiles is recommended immediately to prevent the development of any secondary defects. A roofing restoration specialist should be appointed to complete such works as necessary.

Consultation with a registered builder or structural engineer is recommended to immediately advise on improvements needed to better support the roof tiles.

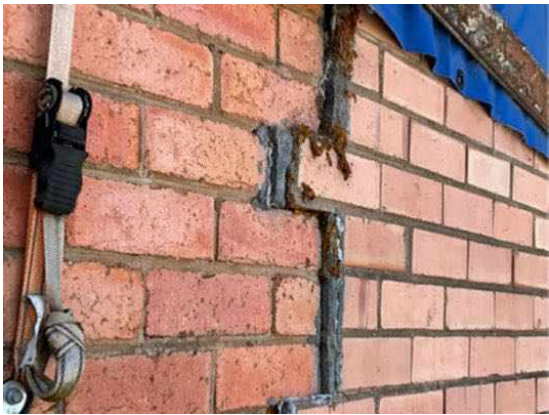
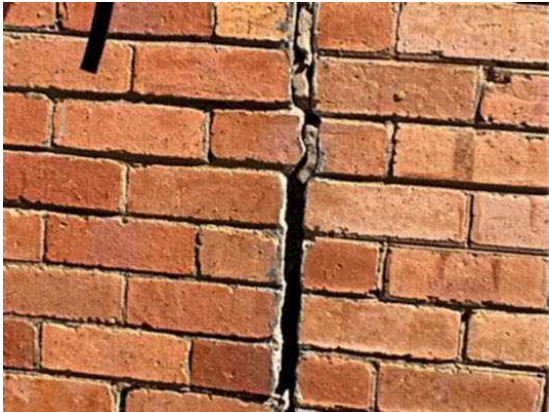
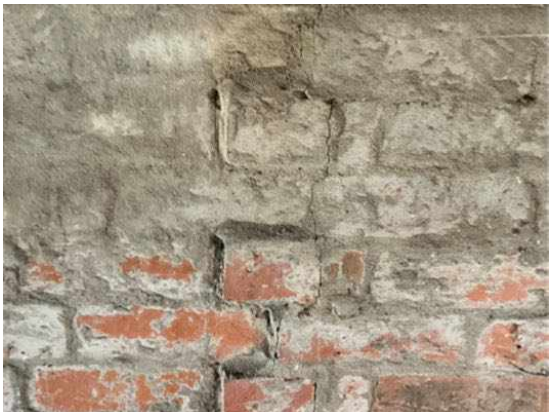
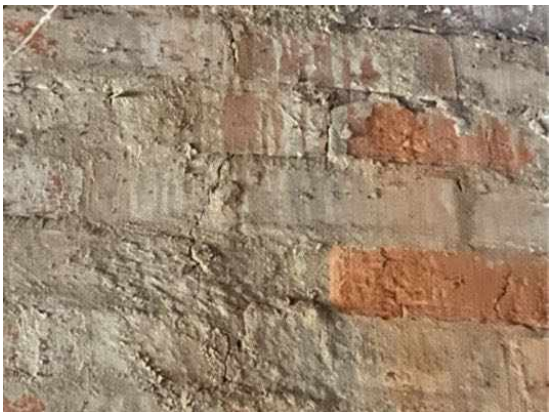
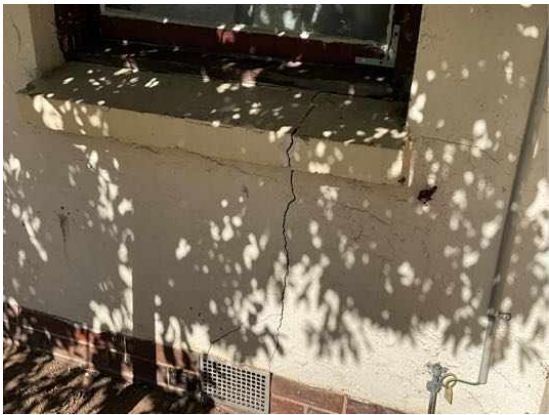
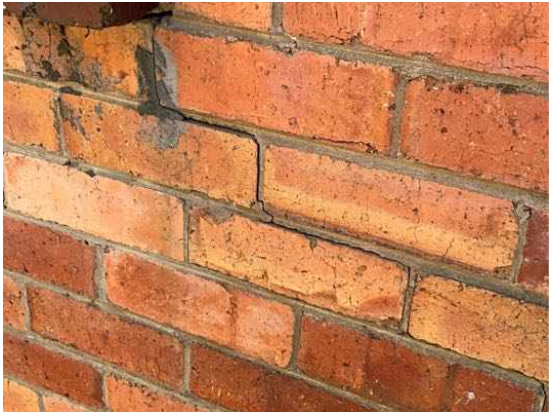
Finding 2.02

Building:	Building 1
Location:	Side, front walls
Finding:	Brickwork - Cracking [Extensive repairs required]
Information:	Major cracking is evident to the brickwork in this area. When managing this degree of cracking, major extensive repair work is generally required. Such work is likely to involve replacement of sections of affected brickwork.

Structural issues are generally the underlying cause of such cracking. It is suspected that this damage has been created due to movement of key structural elements or general subsidence of associated footings.

A structural engineer and bricklayer should be appointed immediately to inspect the structural integrity of the affected brickwork and to assess the safety of the associated structures. The engineer can also nominate a scope of works required for rectification.

Always contact a building inspector or engineer should cracks widen lengthen or become more numerous, even after repair works have been completed.

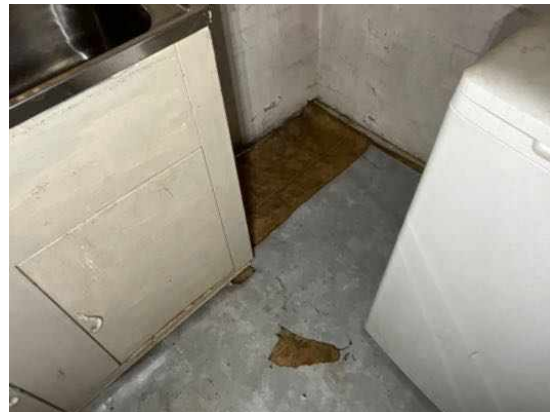
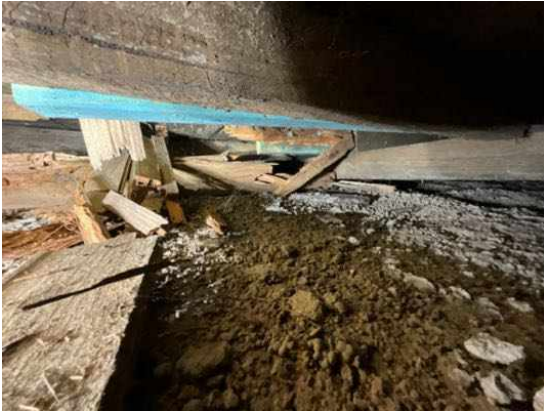
Bouncy floors generally indicate that the floorboards or the subfloor structures are coming loose from the joists that they are installed on. Bouncy flooring may also be the result of gaps between flooring and stumps or joist structures, which require packing.

The client is advised to seek quotations for required repairs from a Registered Builder specialising in re-stumping. The potential resolution may range from packing gaps in subfloor structures through to replacement of subfloors stumps and refixing of flooring.

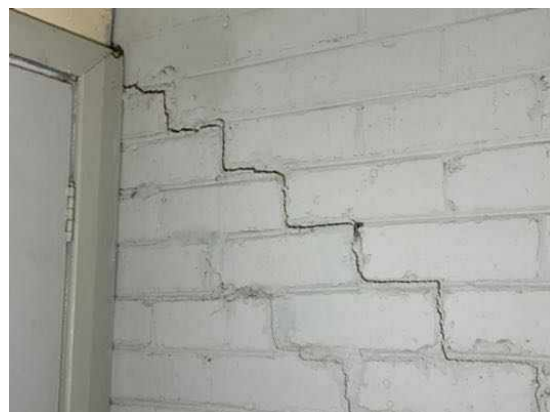
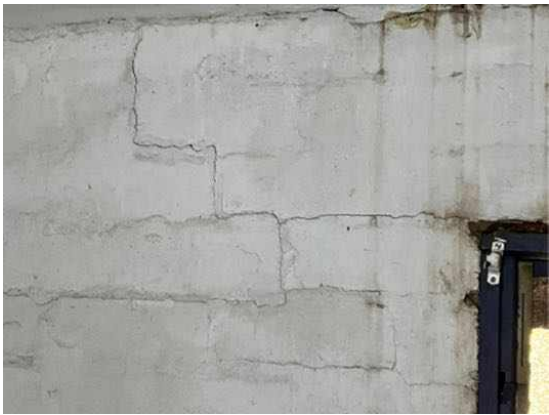
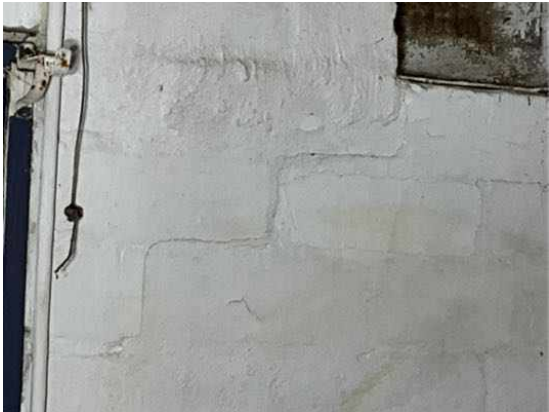
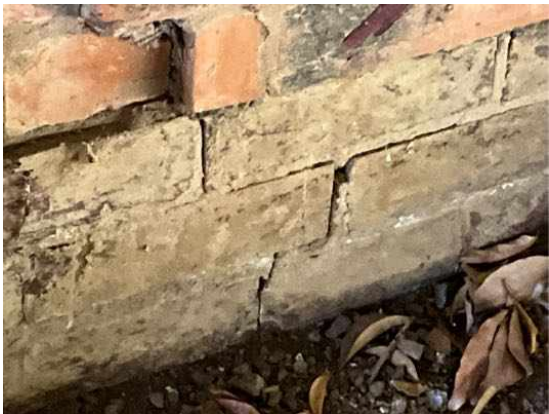
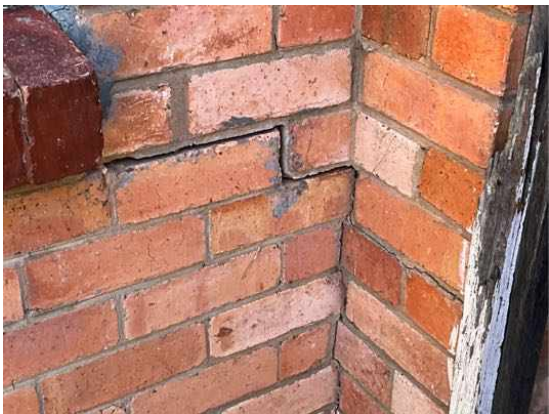
Finding 3.01

Building:	Building 1
Location:	Laundry, carport area
Finding:	Brickwork - Step cracking
Information:	Step cracking was identified to the brickwork in this area at the time of inspection. Step cracking, which is similar to other forms of cracking, has a variety of possible causes. However, the most common is the subsidence of adjacent footings.

Step cracking is a relatively common defect, and is most likely to occur adjacent to windows, doors and other openings. Mortar failure in the gaps between affected bricks indicates the stresses and tensions affecting the wall.

Where step cracking is extensive or severe, the client is advised to consult a structural engineer. Minor step cracking can be used as a warning sign to address factors causing stress to the wall, which can include the effect of surrounding trees, water leaks, soil erosion, or even the presence of reactive soils in the surrounding area.

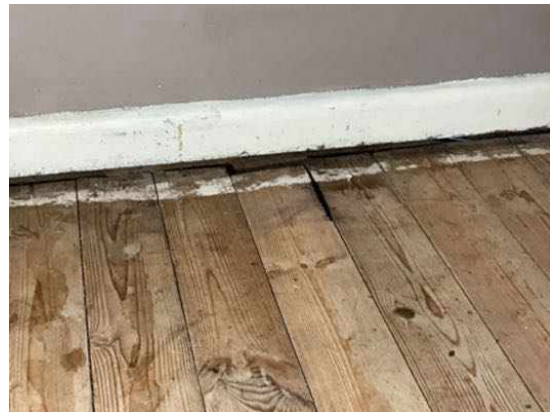
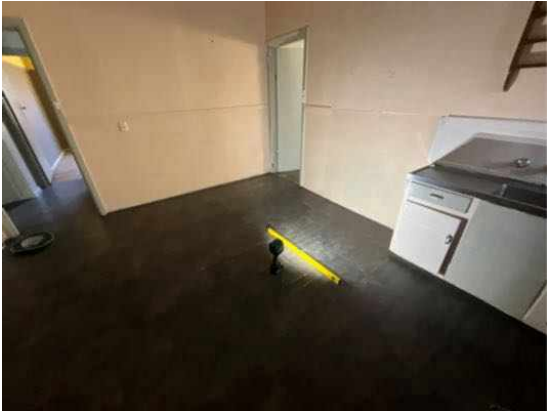
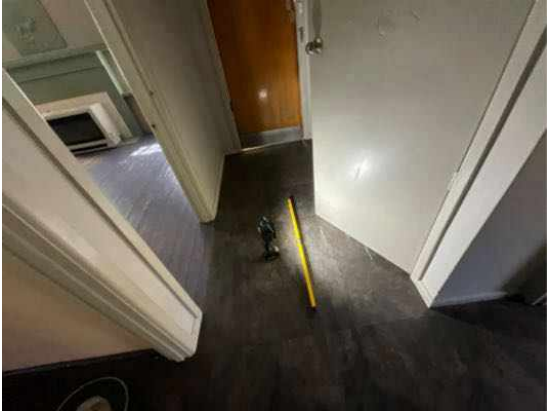
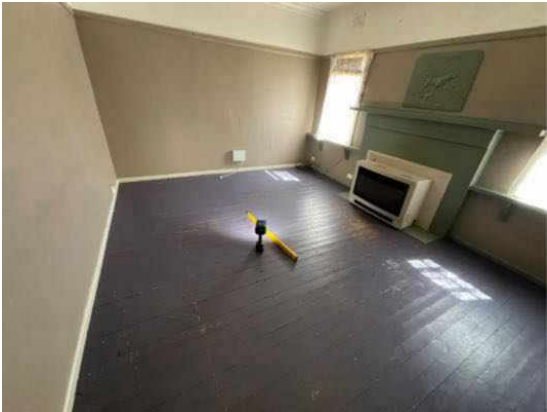
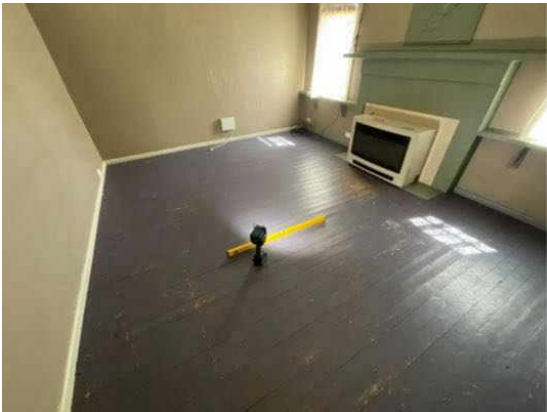
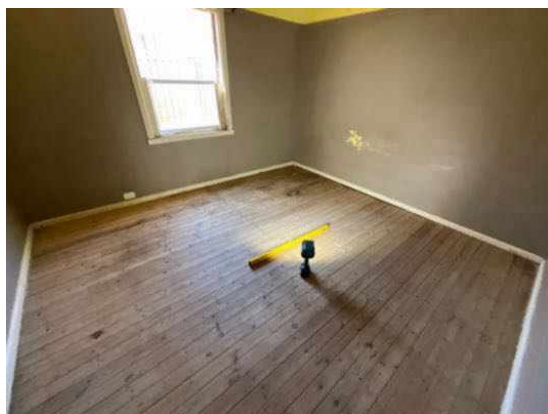
Finding 3.02

Building: Building 1
Location: All Internal Areas
Finding: Flooring - Uneven
Information: The internal flooring in this area is out of level and uneven. Uneven flooring is likely to indicate minor defects such as expected movement of the foundations of the property, but may also indicate subsidence of the associated subfloor stumps.

It is advised that the flooring be closely monitored to identify any further movement. Where flooring remains relatively unchanged for an extended period of time (i.e. several months), it is likely that this defect has been caused by expected movement of the foundations of the property.

However, where flooring is uneven further, potentially invasive inspection of the subfloor structures and stumps in this area is required. In this case, works to repair are likely to be required, and would be carried out by a registered builder specialising in re-stumping.

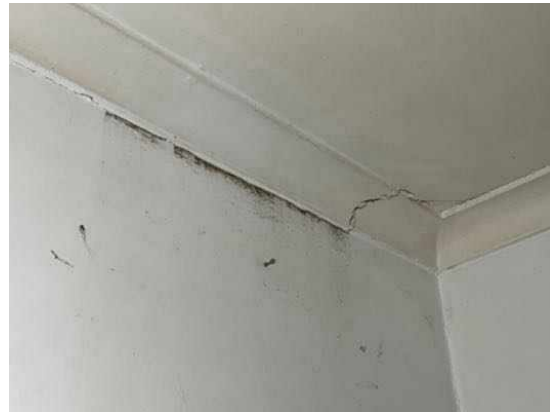
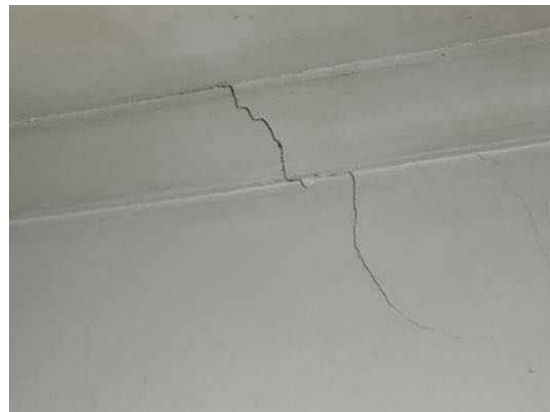
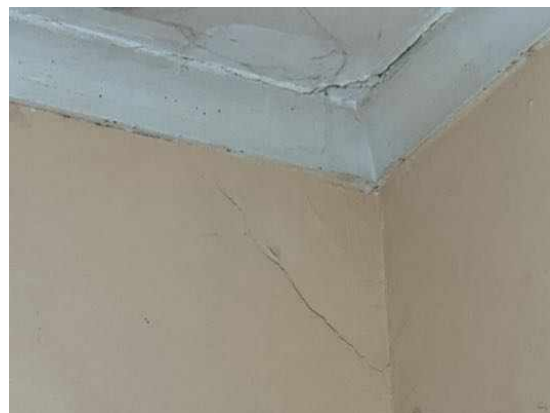
Finding 3.03

Building:	Building 1
Location:	Bedroom 3, kitchen, store room,
Finding:	Cracking - Damage Category 2 - Noticeable (up to 5mm)
Information:	<p>Noticeable cracks are a common occurrence as a result of many primary defects. Such causes may include age, general wear and tear, expected building movement, general expansion/contraction of building materials in different weather conditions, and/or minor failings in the installation or application of building materials.</p> <p>Noticeable cracks may result in minor sticking or jamming of associated doors and windows, which require easement. However, noticeable cracks are easily filled and repaired. A plasterer can be consulted to install an expansion joint at this point to allow</p>

for this movement during different weather conditions.

Monitoring of all cracking should be conducted frequently. Always contact a building inspector should cracks widen, lengthen, or become more numerous. Additionally, your building inspector should also be contacted if associated building elements such as doors and windows become more difficult to operate over time.

Relevant tradespeople, such as carpenters, painters and plasterers, should be appointed to perform remedial works, as deemed necessary.

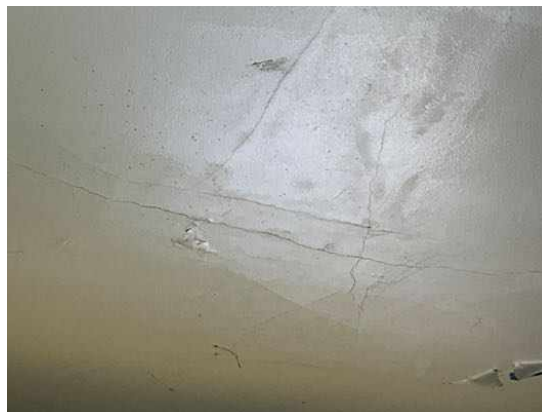
Building:	Building 1
Location:	Bedroom 2
Finding:	Ceiling - Sagging
Information:	Sections of the ceiling were found to be sagging at the time of inspection. Sagging to the fixed ceiling structure generally indicates that the building materials have swollen, due to contact with water, or that fixings (e.g. nails or glue) have become loose and require reattachment.

Where minor sagging is evident, comparatively minor works, such as re-gluing of ceiling sheets, may be required. Such works may be performed by relevant tradespeople, such as plasterers and painters. Where excessive moisture has caused

the roofing structure to swell and sag, the source of the water leak should primarily be identified prior to any remedial works being performed.

In some cases, sagging ceiling linings may also indicate that there are structural issues, causing surfaces to warp, twist or sag. Where sagging appears to be major, appointment of a structural engineer is advised to further inspect the property and identify the source and rectification works required.

The appropriate action should be taken by the client as soon as possible to ensure that any potential further damage is limited.

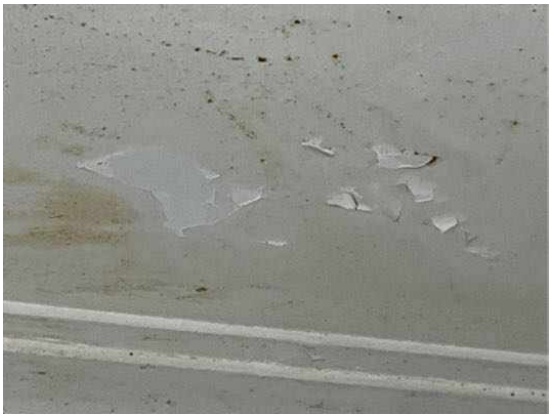
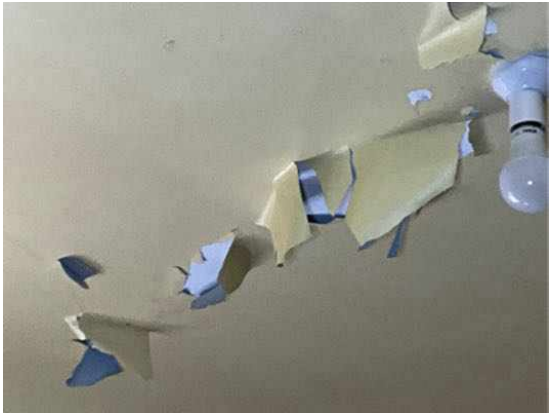
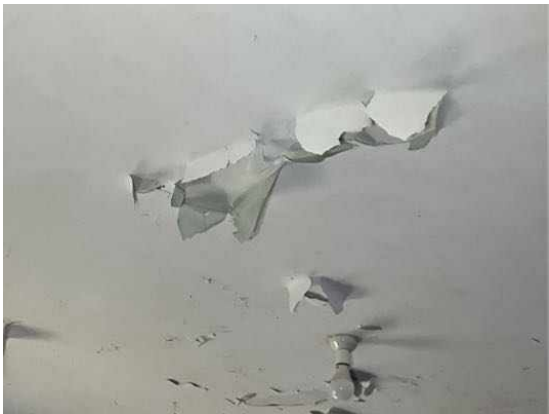
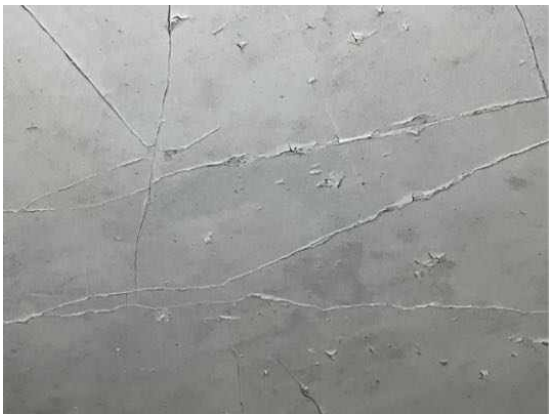
Finding 3.05

Building:	Building 1
Location:	Hall, bed 1,2,bathroom
Finding:	Painted surface - Flaking
Information:	Sections of paint in this area was found to have deteriorated. Paint flaking is generally an indication of excessive moisture in the area, that is currently hidden by the painted surface.

The presence of excessive moisture can have major implications on associated building elements if left unattended. While only seemingly minor at this stage, the damage cannot be determined due to the paint obstructing any further inspection of the damage.

A qualified Painter should be contacted at the Owner's discretion to re-paint the ceiling.

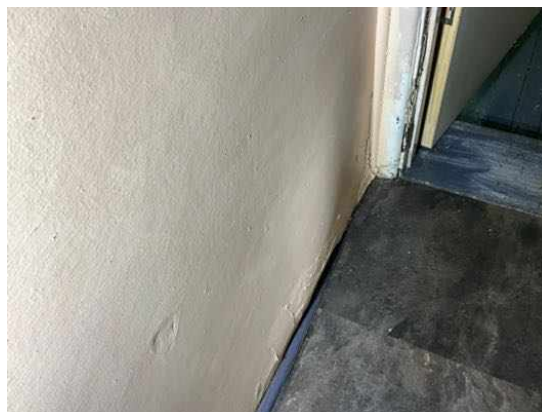
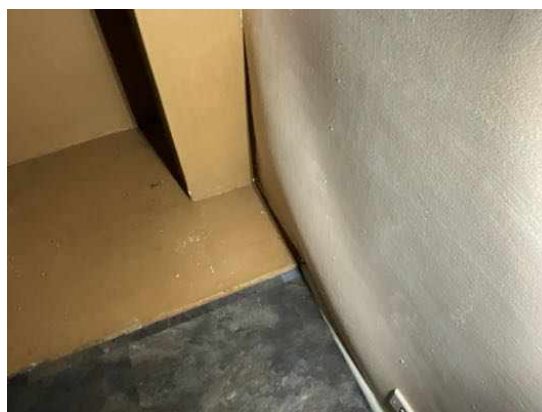
Finding 3.06

Building: Building 1
 Location: Kitchen
 Finding: Wall lining failing
 Information: The wall lining in this area shows signs of warping. This is most probably a result of excess moisture over time. No excess moisture or termite activity was noted at the time of inspection.

More investigation may be needed. Replacement of the lining should be done by suitable trades, at the discretion of the client, to avoid further deterioration.

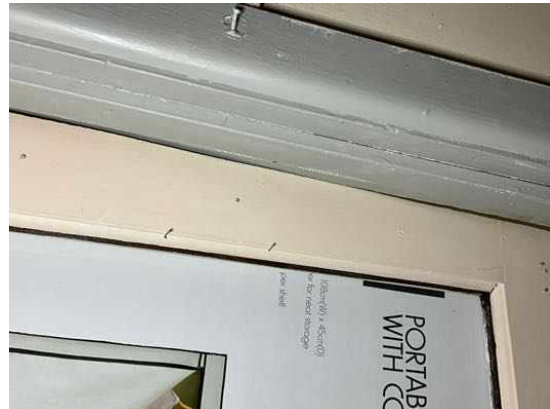
Finding 3.07

Building: Building 1
 Location: Store Room
 Finding: Door- Binding/jamming
 Information: Binding and/or jamming of this door is evident during standard operation. This defect inhibits the functionality of the affected door as well as creating potential for secondary defects to associated building elements, such as damage to the floor covering.

A door that binds to flooring or to the associated door frame may have several causes, ranging from minor defects, such as poor installation of the door or deteriorated hinges, through to major structural issues, such as damage to subfloor structures.

A qualified carpenter or general handyperson should be appointed to perform minor rectification works at client discretion.

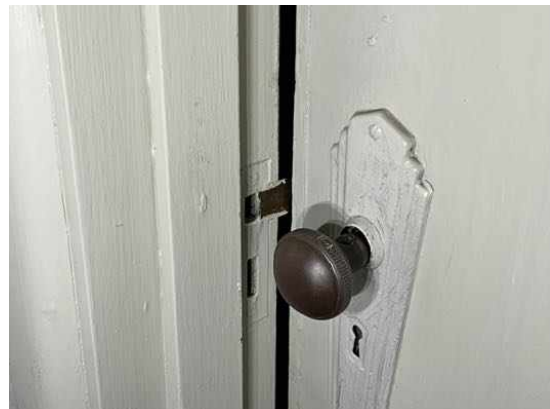
Finding 3.08

Building:	Building 1
Location:	Bathroom
Finding:	Door - Striker plate misaligned
Information:	The striker plate to this door appears to have become misaligned and has consequently resulted in the door's operation being compromised.

This is a common defect and is expected in a property of this age, whether being due to substandard installation or general deterioration of the door hardware.

Readjustment of the striker plate is recommended at client discretion. Works such as these can be completed by a general handyman or qualified carpenter.

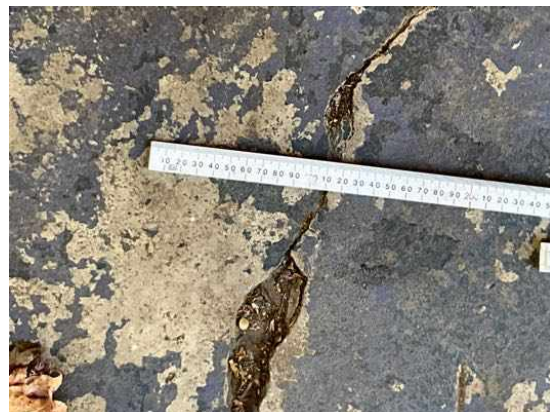
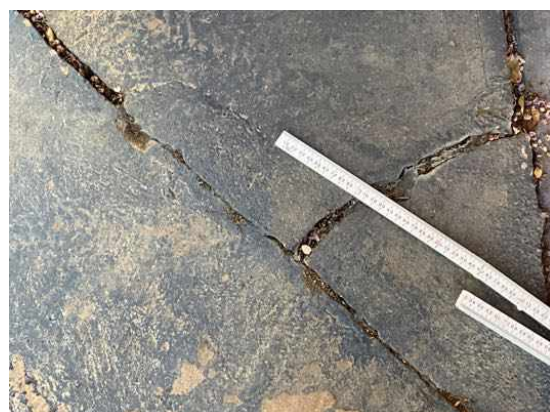
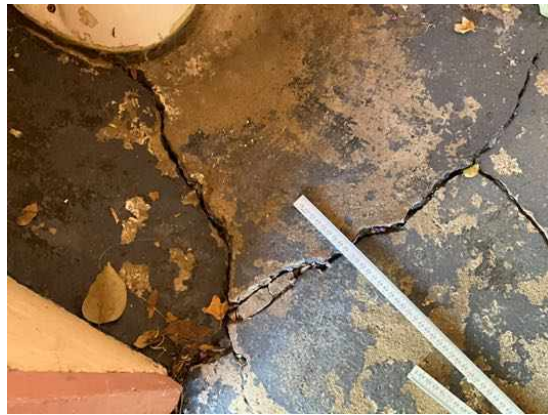
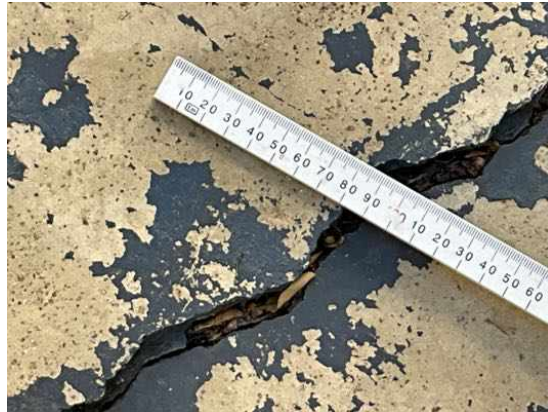
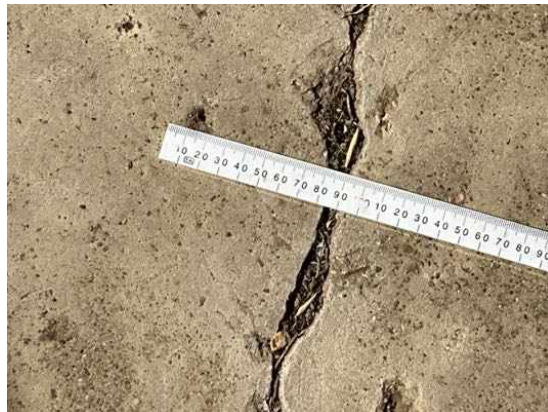
Finding 3.09

Building:	Building 1
Location:	Yard - Back
Finding:	Cracking - External Concrete Paving Damage Category 4 - Gaps in Slab (4mm - 10mm +)

Information: Gaps in the slab were identified in external concrete paving. Gaps in the slab are significant and are likely to lead to the development of safety hazards and secondary defects if left unmanaged, such as the creation of a trip hazard.

General age and expected deterioration of the paved areas is a common cause of this type of cracking. However, expansion and contraction of the slab may also have occurred due to environmental factors. Such factors include variable moisture and weather conditions, the presence of trees and their roots having a settling or lifting affect on the soil, or the effect of load bearing, e.g. heavy vehicles over a sustained period of time.

Cracking to this degree may also be due to poor original installation of the concrete. Factors such as poor compaction of the sub surface and/or inadequate reinforcing of the slab may create cracking and other secondary defects. Gaps in the concrete paving may also have a more significant structural cause, such as subsidence of soils.

Where gaps in the concrete paving are adjacent to structural elements of the building, the advice of a Structural Engineer is advisable before undertaking repairs. Significant repair and likely replacement of the concrete paving is probable.

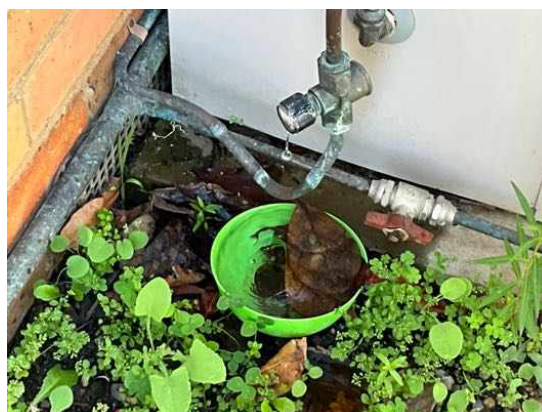
Building: Building 1
 Location: Hws
 Finding: Water leak - Active
 Information: Generally, water leaks occur when a particular area of the property is not weather or water tight. As the surrounding area was found to be damp at the time of inspection, the leak is considered ongoing and hence requires urgent action.

Regardless of the location, even minor leaks that are left unmanaged can lead to serious damage of associated building elements and result in the need for replacement of building materials. Mould and other hazards such as electrical hazards may also arise if the leak is left to develop.

It is highly advised that the cause of the leak be identified and resolved immediately by a licensed plumber to prevent any further damage. Depending on the extent of the damage previously sustained, repair and/or replacement of any affected building materials may be required.

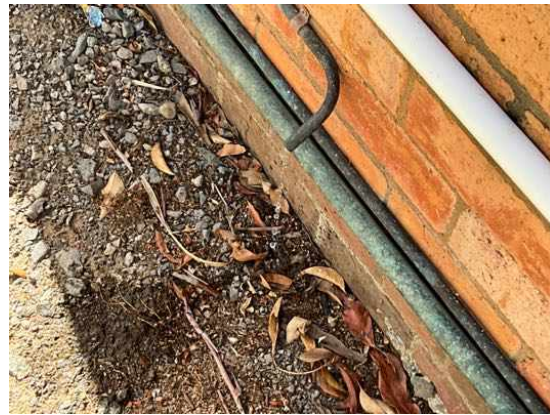
Finding 6.02

Building: Building 1
 Location: Yard - Side
 Finding: HWS Overflow - Not Connected
 Information: The Hot Water System (HWS) overflow was found to be disconnected from storm water drainage and is creating excessive moisture in the surrounding area.

These damp conditions can lead to secondary defects such as rot, rust or corrosion of associated building elements, the formation of fungal decay, or even the creation of potential slip hazards. When coupled with poor site drainage, pooling of water may also attract termite activity to this area.

It is highly recommended that a licensed plumber be appointed to connect the HWS overflow in order to prevent such an environment from being created. These minor works should be carried out as soon as possible.

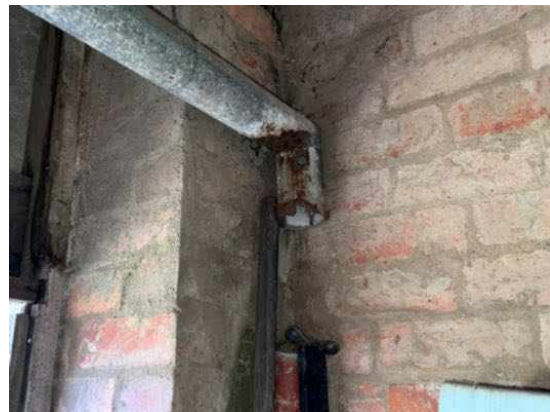
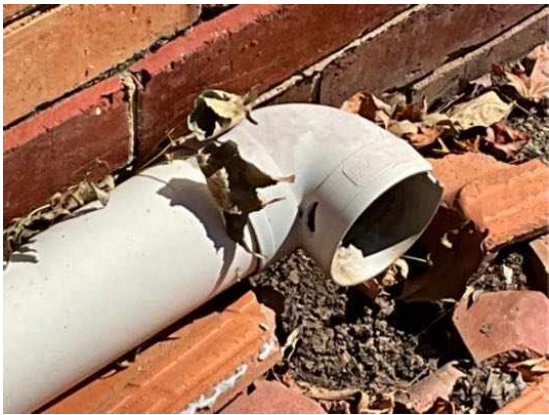
Finding 6.03

Building:	Building 1
Location:	Carport, yard - back
Finding:	Stormwater drain - Not connected
Information:	The roof plumbing is not adequately connected to stormwater drainage on the site. This disconnection negatively impacts the functional capacity of the roof plumbing.

Where roof plumbing doesn't drain adequately, the area at the base perimeter can become excessively damp, potentially creating an environment that is susceptible to rust and corrosion of surrounding building elements, as well as attracting termites and other pests.

It is highly recommended that a plumber be appointed to further inspect the area and to install adequate drainage equipment where necessary.

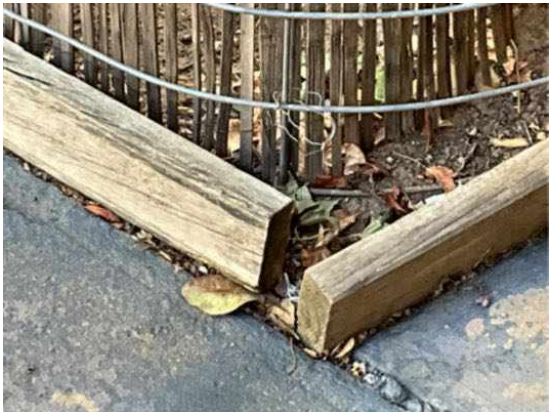
Finding 6.04

Building: Building 1
 Location: Yard - Back, front
 Finding: Untreated or non-durable timbers in a hazardous environment
 Information: To reduce the risk of timber pest attack it is essential that timber used in a hazardous environment (e.g. in direct contact with the ground or frequently exposed to damp conditions) is of sufficient durability and/or is adequately preservative treated.

Untreated timbers in direct contact with the ground are likely to develop severe wood rot and/or fungal decay if left unattended creating attraction for subterranean termites to infest the timbers from surrounding areas.

If untreated or non-durable timbers are found to be in a hazardous environment it is highly advised that replacement of these building elements be performed as soon as possible to aid the protection of the property against termite / timber pest attack.

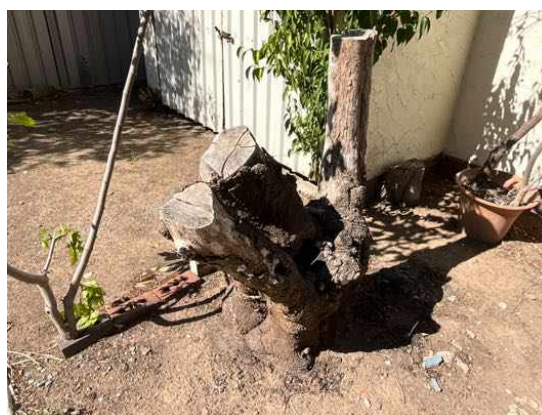
Finding 6.05

Building: Building 1
 Location: Yard - Front
 Finding: Tree Stump in Ground
 Information: Any tree stumps in the yard not removed during the tree removal process provides the opportunity for Termite infestation and is likely to be subject to decay from damp conditions against the stump.

Services for tree stump removal should be contacted as soon as possible to reduce the risk of timber pest attack.

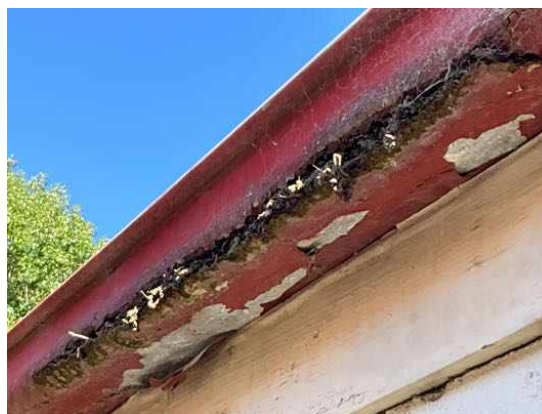
Finding 6.06

Building: Building 1
 Location: Carport
 Finding: Gutters- Deteriorated
 Information: The guttering and some downpipes have deteriorated.

Although not a major problem now, they will deteriorate further if left for an extended period.

A Licensed Plumber should be engaged as soon as possible to advise on any repairs or maintenance that may be required.

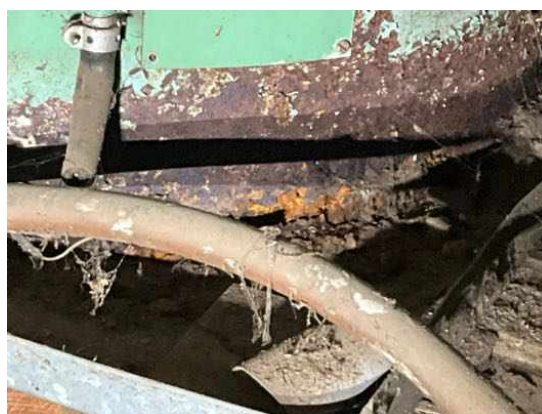
Finding 6.07

Building:	Building 1
Location:	Roof Void
Finding:	Gravity-Fed HWS - Disconnected
Information:	It was noted at the time of inspection that a disconnected gravity-fed hot water system (HWS) remains in this area.

Despite this plumbing structure being unused, it is likely to be storing residual water, and is therefore susceptible to rust and corrosion. If allowed to continue, rust and corrosion is likely to lead to damage to adjoining building elements, and may also make the area susceptible to termite or timber pest activity.

While it is a costly exercise to remove the disused gravity-fed HWS, it is advisable in the short-term future to prevent any further damage to the area. Further consultation with a licensed plumber is required to gain further advice on removal of the structure.

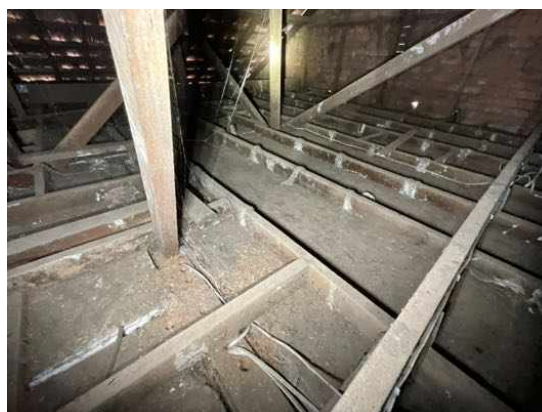
Where insulation is absent, the area does not meet current Australian Standards. Installation of adequate insulation is required and should be conducted as soon as possible.

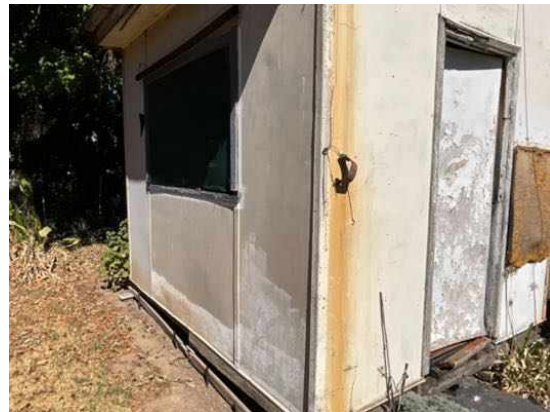
Building:	Building 1
Location:	All Areas
Finding:	Asbestos - Suspected ACM Identified on Site
Information:	Reporting on Asbestos is outside the Scope of this Report. This suspected defect is highlighted as a caution only. We suspect, based on our experience in the building industry, that there is a higher risk of the identified building element containing asbestos.

In the interim, the client is advised to act with caution, especially when considering any damage to building materials general wear and tear renovations extensions demolition and general maintenance activities due to the suspected presence of Asbestos.

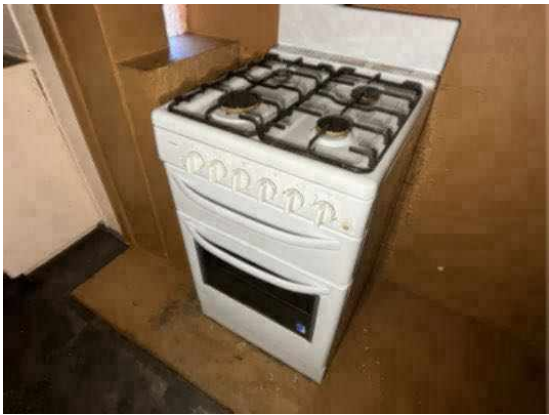
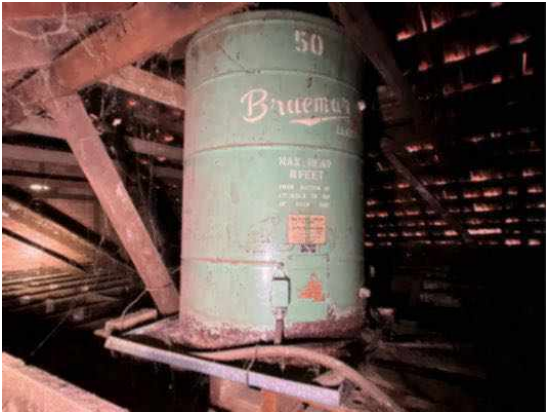
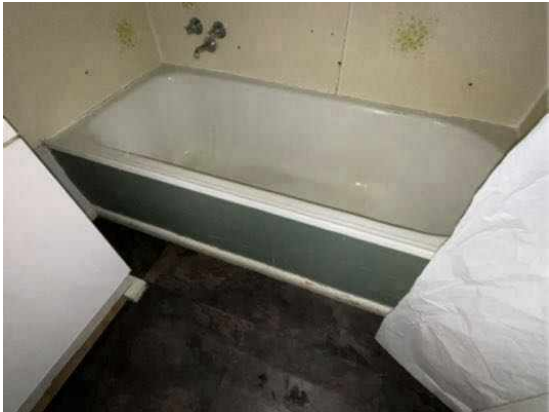
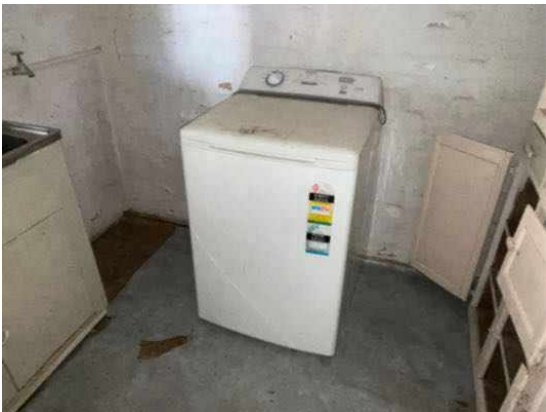
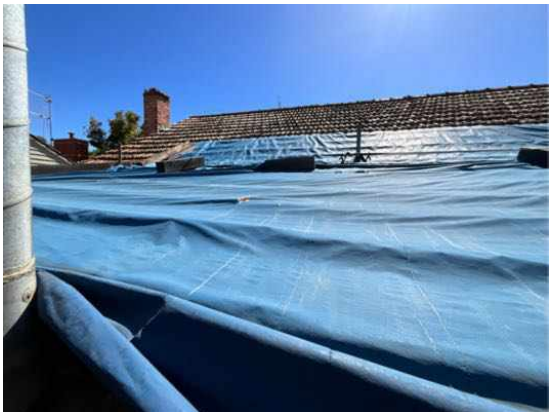
Building: Building 1
Location: All Areas
Finding: Additional Photos - Obstructions and Limitations
Information: These photographs are an indication of the obstructions and limitations which impeded full inspection of the property at the time of inspection. These obstructions can hide an array of defects and should be removed to allow full inspection to be carried out. A re-inspection is recommended once the areas are made accessible.
