# Building and Timber Pest Inspection Report

Inspection Date: Wed, 14 Jan 2026

Property Address: 9/120 Oxford Rd, Ingleburn NSW 2565,  
Australia

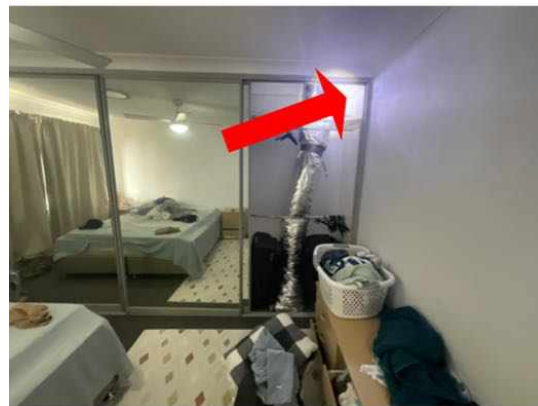
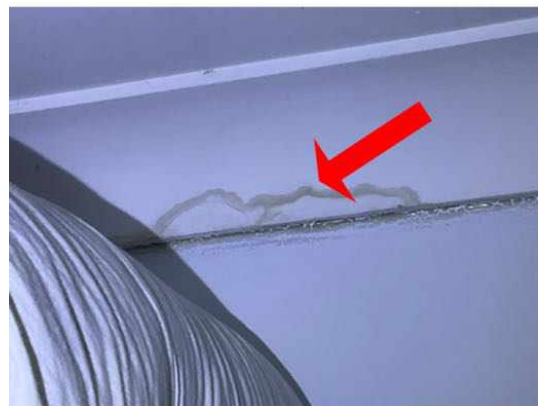
Finding: Ceiling - Water damaged

Information: Water damage to the ceiling lining is generally an indication of excessive moisture being present in the roof void, usually via a leak to the roof covering.

Where water damage is evident to the ceiling, the primary requirement is to identify and rectify the source of the leak. A roofing plumber should be appointed as soon as possible to identify the leak and perform rectification works as necessary, ensuring the water damage is restricted.

Once the leak is repaired, consultation with relevant tradespeople, including plasterers and painters, is advised. Rectification works may include replacement of ceiling lining or minor repainting, depending on the extent of the damage.

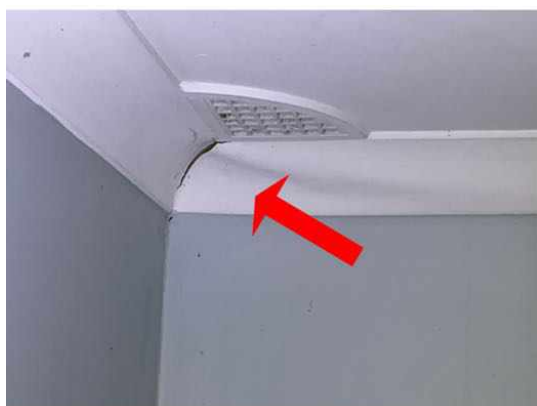
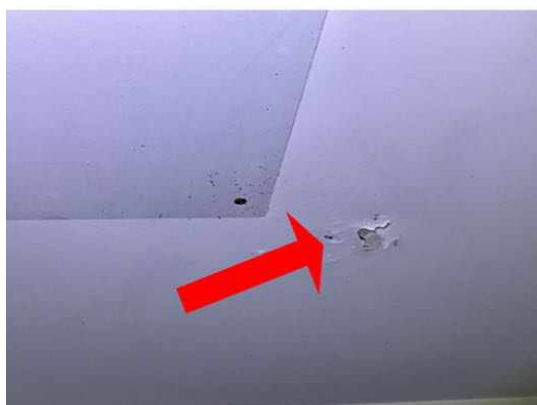
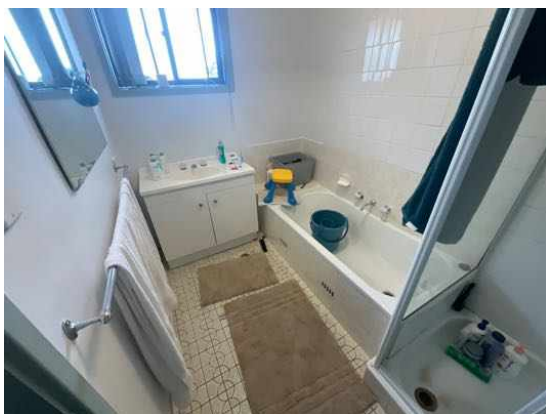
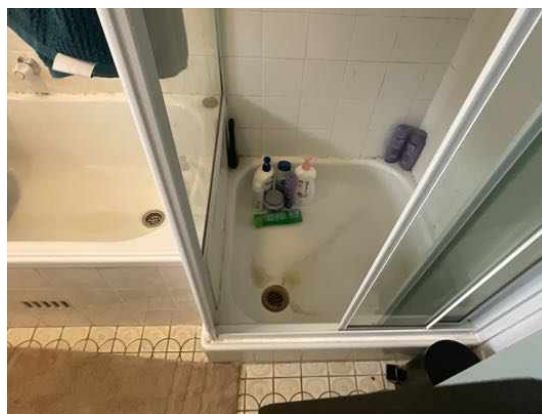
Building: Main Building  
Location: Laundry  
Finding: Water Damage to Laundry Ceiling (Below Bathroom)  
Information: Water damage and staining were observed to the laundry ceiling located beneath the bathroom above. This condition is generally indicative of a plumbing leak or failure of the bathroom waterproofing system, which may include leaking pipework, shower base, floor wastes, or deteriorated waterproof membranes.

Ongoing moisture ingress may result in further deterioration of ceiling linings and concealed structural elements. It is recommended that a licensed plumber and/or waterproofing contractor be engaged to investigate and rectify the source of the leak. Once repaired, damaged ceiling linings should be replaced or repaired and repainted as required.

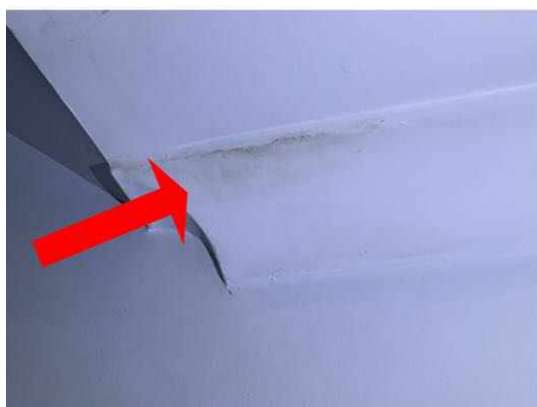
### Finding 2.04

Building:	Main Building
Location:	Stairs - Internal
Finding:	Walls - Water damaged
Information:	Water damaged to sections of the walls in this area was evident at the time of inspection. Water staining indicates that surfaces have been exposed to excessive moisture over time. The minerals and other elements in the water lead to staining, which may graduate to corrosion and deterioration if left unmanaged.

While mostly an appearance defect, water staining can be indicative of more serious defects, which may be currently concealed by wall linings.

Where water staining is active, a licensed plumber must be consulted to identify the cause of the staining and to provide advice on any reparation works that may be required. Replacement of any broken or damaged structures is advised.

Conversely, where water staining is old and inactive, affected building materials may be repaired or replaced at client discretion.

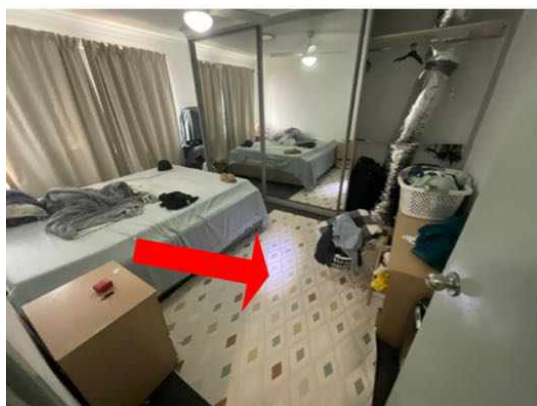
Bouncy floors / stairs generally indicate that the floorboards or the structures are coming loose from the joists that they are installed on. Bouncy flooring may also be the result of gaps between flooring and stumps or joist structures, which require packing.

The client is advised to seek quotations for required repairs from a qualified carpenter. The potential resolution may range from packing gaps in the structures through to replacing and refixing of flooring.

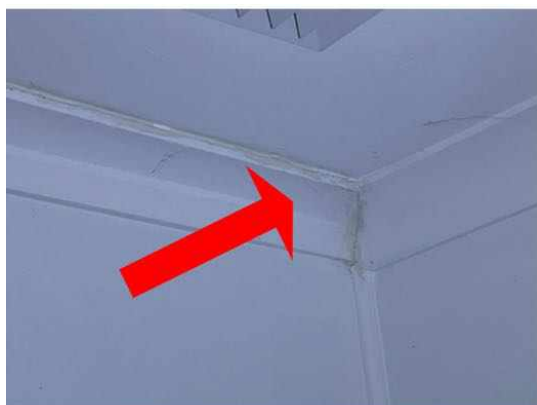
### Finding 3.02

Building:	Main Building
Location:	All Internal Areas
Finding:	Cornices - Sagging
Information:	Sagging and uneven cornices generally indicate that the building materials have swollen, due to contact with water, or the movement of the ceiling joints or that fixings (e.g. nails or glue) have become loose and require reattachment. In some cases, sagging and uneven surfaces may also indicate that there are structural issues causing surfaces to warp, twist, or sag.

Where sagging appears to be major, appointment of a structural engineer is advised to further inspect the property. Otherwise, minor works such as re-gluing of wall/ceiling sheets may be required and should be performed by an aptly qualified plasterer or carpenter.

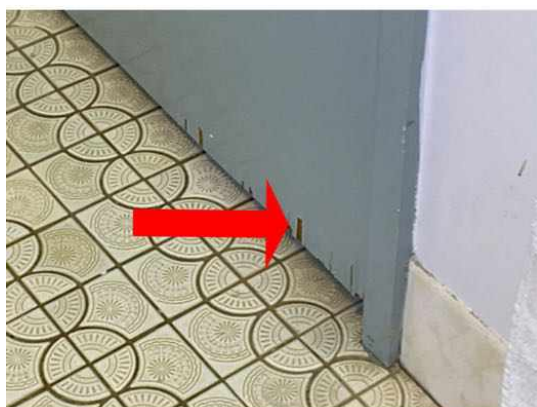
Building: Main Building  
 Location: Bathroom  
 Finding: Door - swelling and damage at the bottom edge  
 Information: Swollen and damaged door base in bathroom due to moisture exposure. Edges show fraying and surface degradation.

Replace or seal the affected door. Ensure door edges are properly sealed to prevent future water damage.

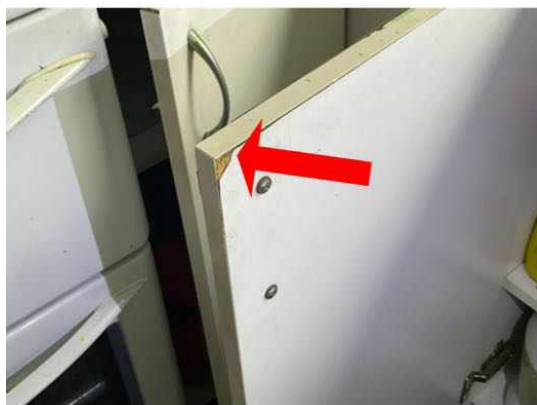
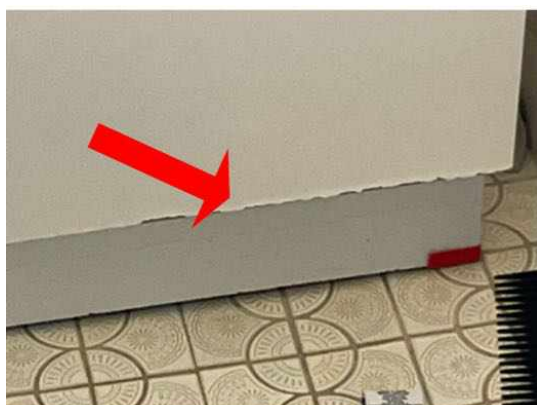
Building:	Main Building
Location:	Kitchen/ Bathroom
Finding:	Delamination of timbers
Information:	Delamination is one means by which composite materials (e.g. layered timber composites) may fail over time. In laminated materials, repeated cyclic stresses may lead to the formation of mini-structures of separate layers, with significant loss of mechanical toughness. Water penetration or the presence of excessive moisture also generally contributes to delamination.

Where building materials have become delaminated, they lose their structural strength, and are likely to have a variety of appearance and serviceability defects as a result.

Delamination of timbers may be repaired where the area affected is minor and/or easily accessible, by gluing and screwing layers back together. However, this is an interim repair, and where delamination has occurred, the client should plan for the replacement of affected timbers sooner than would otherwise be expected.

All timber structures affected by delamination should be replaced as soon as possible to avoid any further damage. Repair and replacement estimates should be sought from a registered builder or qualified carpenter.

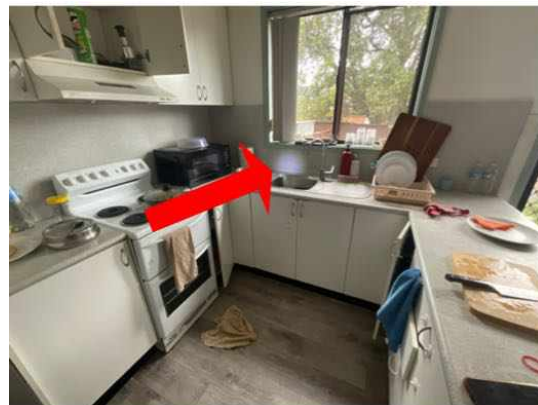
**Finding 3.07**

Building: Main Building  
Location: Kitchen / Bathroom  
Finding: Sealant and grouting - Missing or damaged  
Information: It was noted on inspection that sealant or grout is degraded to the tiled shower alcove and or other areas of the bathroom.

Different materials and floor areas move at different rates, generally causing cracking to grout or sealant at this point. A flexible sealant is required to allow for expected expansion and contraction, while keeping the joint water tight and protective of all associated building materials.

There appears to be excessive mould to the sealant and grout which will likely require scraping out and replacement.

Flexible and mould resistant materials should be applied to affected areas to prevent any subsequent water damage that is likely to occur. Regular maintenance and replacement of damage or missing or damaged sealant and grout is highly recommended to the wet areas, as this is a regular wear and tear defect. Sealant and grouting in areas that come into regular contact with water should be maintained for the long term care of your property.

A sealant specialist or tiling contractor should be appointed to complete these works as soon as possible

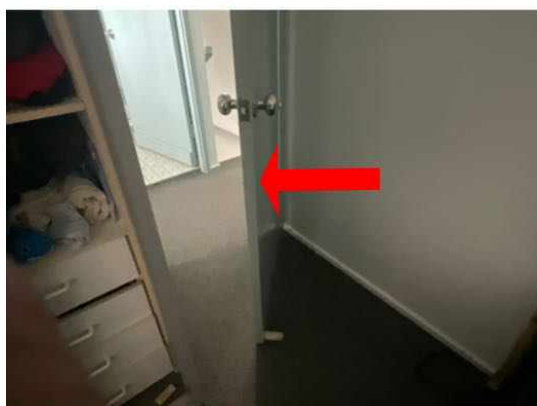
### Finding 3.08

Building:	Main Building
Location:	Bedroom 3
Finding:	Door frames - not square
Information:	It appears that one and / or more doors have been installed in a manner which is not consistent with acceptable standards of workmanship. The door frames are not square and or plumb and require rectification.

Deviation from the manufacturer's installation instructions is considered a defect with reference to Standards and Tolerances.

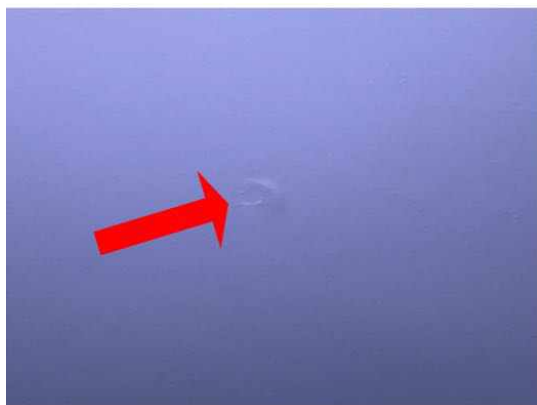
### Finding 3.09

Building:	Main Building
Location:	Bedroom 2
Finding:	Ceiling nails - Popping
Information:	Numerous popped nails were identified in the internal ceiling at the time of inspection. Nails and screws hold simply by the friction between them and the surface they are applied to. Over time, the nails and screws can back out, which is often a result of general ageing and deterioration of the building structure.

If left unmanaged, the ceiling sheets may become loose and unstable, increasing the

rate of deterioration of the internal ceiling and creating potential for the development of secondary defects.

Re-fastening of popped nails will help to maintain the stability of the internal ceiling and associated building elements. Such minor works will also help to improve the appearance of the affected area and secure the ceiling sheets, so as to prevent the onset of ceiling sagging. These works should be performed by a qualified carpenter or plasterer at client discretion.

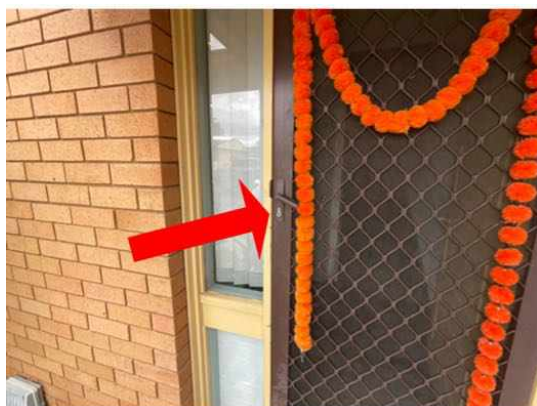
### Finding 3.10

Building:	Main Building
Location:	Entry
Finding:	Door - Binding/jamming
Information:	Binding and/or jamming of this door is evident during standard operation. This defect inhibits the functionality of the affected door as well as creating potential for secondary defects to associated building elements, such as damage to the floor covering.

A door that binds to flooring or to the associated door frame may have several causes, ranging from minor defects, such as poor installation of the door or deteriorated hinges, through to major structural issues, such as damage to subfloor structures.

Where door binding/jamming appears to indicate major structural issues, a registered builder specialising in re-stumping should be appointed to provide an estimate on the cost of rectification.

For minor causes, a qualified carpenter or general handyperson should be appointed to perform minor rectification works at client discretion.

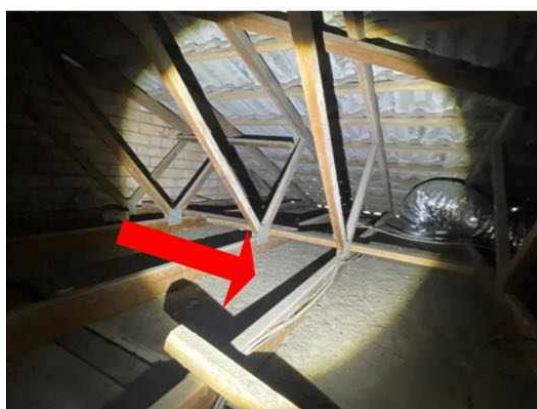
Building:	Main Building
Location:	Roof Void
Finding:	Insulation and Sarking - inadequate
Information:	Upon inspection of the roof void it was noted that insulation is not present. Insufficient insulation will result in a comparatively higher cost to heat and cool a property as there is a lack of Insulation (or uneven coverage of insulation) which works

as a barrier to heat transfer. This helps to keep out unwanted heat in summer and preserves warmth inside your home in winter. It can also help soundproof your home from unwanted airborne noise transfer. Where insulation is absent, the area does not meet current Australian Standards. Installation of adequate insulation is required and should be conducted as soon as possible. Sarking is missing under the roof sheeting. Sarking acts as an insulator that helps with noise reduction and protects against water penetration. Sarking plays a key role in the operation and function of the overall roofing structure and its performance. Although not a requirement at the time of construction, replacement of any missing building element is advisable (although this can be quite expensive to do after the time of construction). Where sarking is missing, regular inspections of the roof tiles for cracking and potential moisture penetration is required. Sarking may be retrospectively fitted by a registered builder at the discretion of the client.

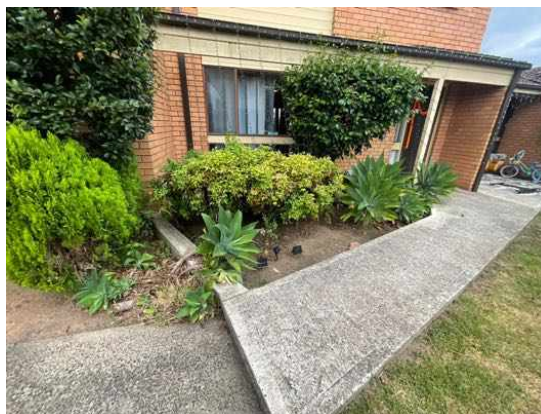
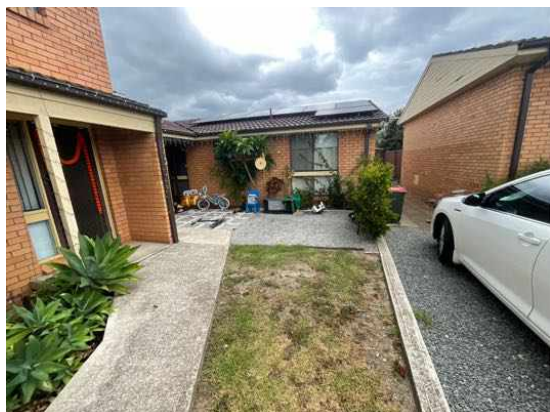
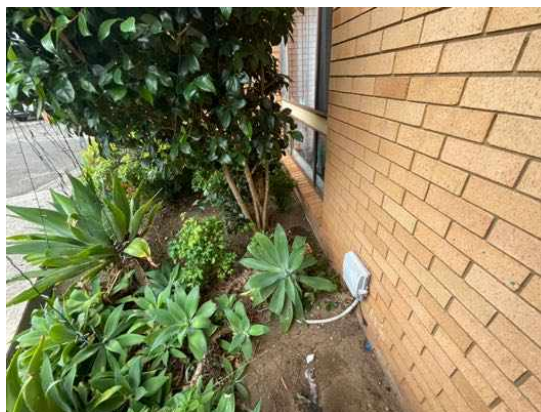
### Finding 6.01

Building:	Main Building
Location:	All Areas
Finding:	Garden Beds - Conditions Conducive to Termites
Information:	Garden beds were found to be evident in the garden area. These garden beds can include untreated timber, and with a combination of moisture from watering hosing can make conditions conducive to termite activity and termite ingress.

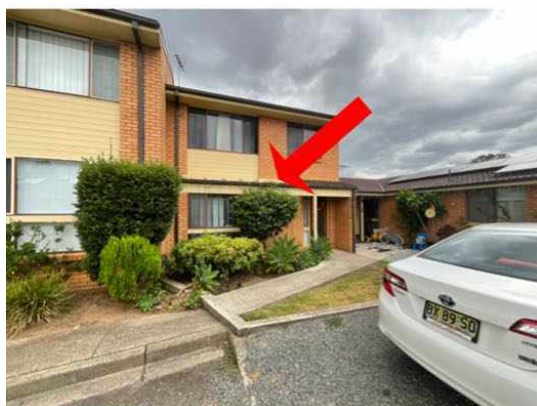
## Finding 6.02

Building:	Main Building
Location:	All Areas
Finding:	Timber - exposed to weather
Information:	External timbers that are frequently exposed to harsh weather conditions require adequate protection in order to maintain their condition. Where timbers have not been painted or treated adequately, general deterioration is likely to occur at an accelerated rate.

If left unattended, replacement of these timbers is likely to be necessary in the short-term future. Adequate treatment of these timbers is required as soon as possible by a painting contractor or general handyman.

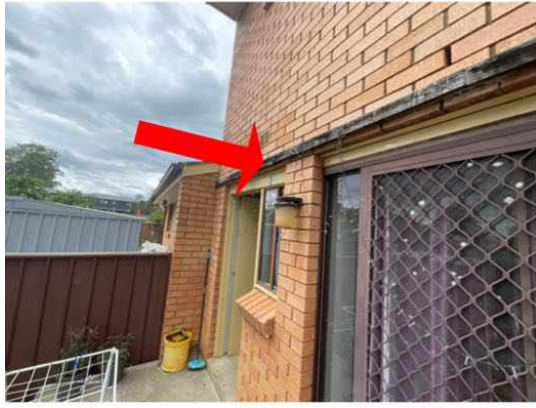
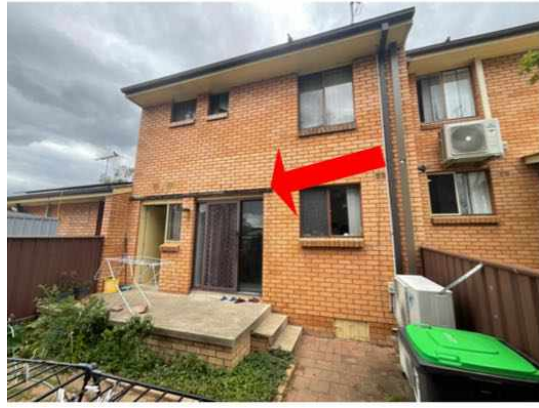
### Finding 7.01

Finding: Wood rot

Information: This building element shows evidence of wood rot. Wood rot, also known as Fungal Decay, occurs when timbers and other cellulose building materials are exposed to damp conditions on an ongoing basis. This could be the result of exposure to weathering over a prolonged period of time, or the attraction of excessive moisture from other abutting building materials. Contributing factors also include poor air ventilation in the area.

Wood rot is often associated with general damp problems and is evidenced by a 'musty' smell or mould and mildew occurring on surfaces. If left unmanaged, damp conditions can lead to further health problems and the decay of timbers will continue.

Early intervention and regular maintenance, particularly of exterior timbers, will prolong the useful life of these building elements. Prior to any works being performed, the cause of the moisture that has created the visible wood rot should be identified and addressed in a suitable manner. Replacement of affected timbers may then be a necessary step in protecting surrounding building elements from such deterioration.

A qualified plumber may be appointed to assess the cause of excessive moisture and to provide advice on any remedial works as required. A qualified carpenter or registered builder may also be required to replace affected building materials.
