Building and Timber Pest Inspection Report

Inspection Date: Wed, 8 Apr 2026

Property Address: 1 Campaspe St, West Wodonga VIC 3690,
Australia

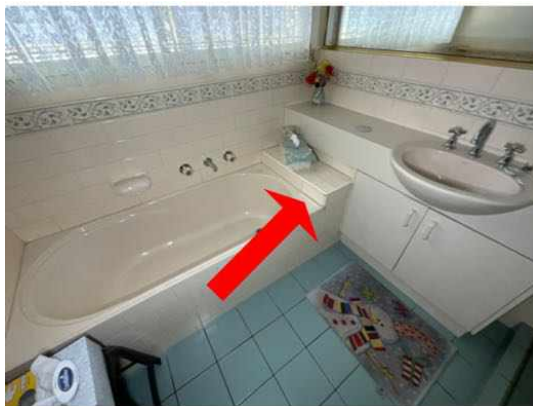
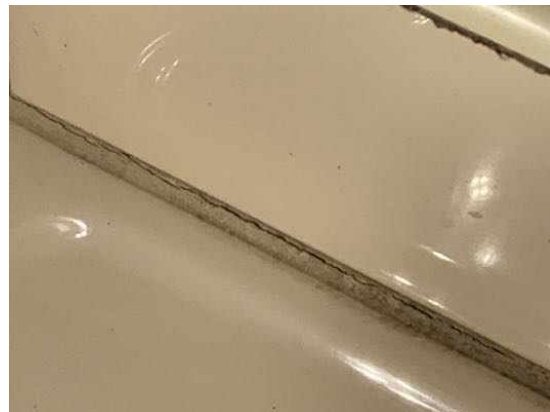
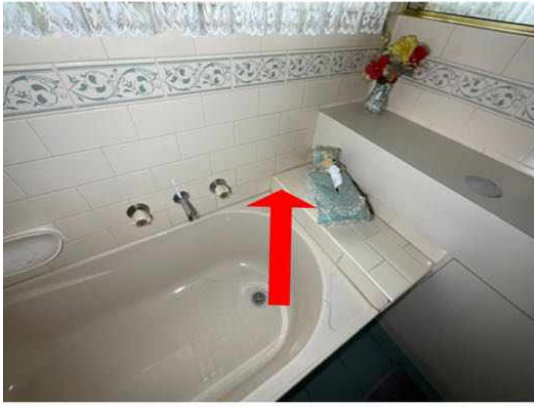
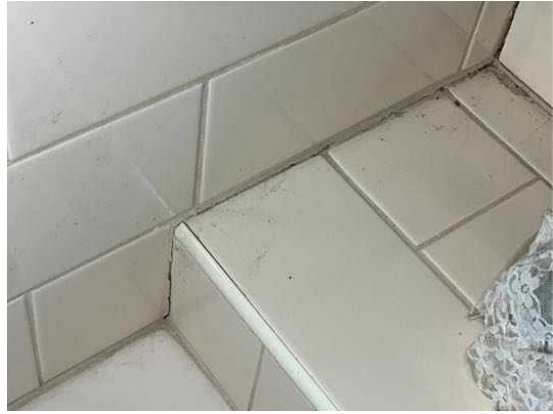
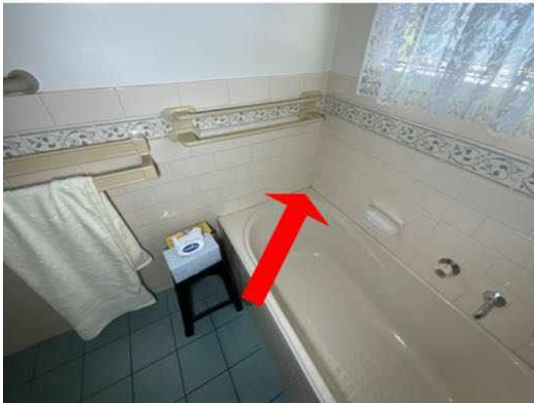
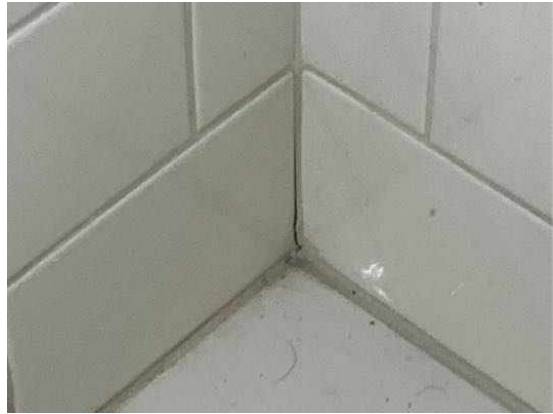
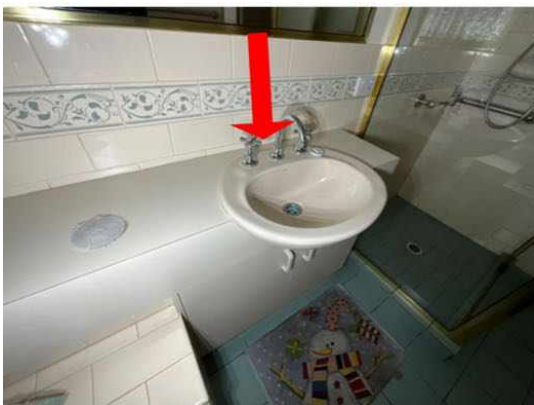
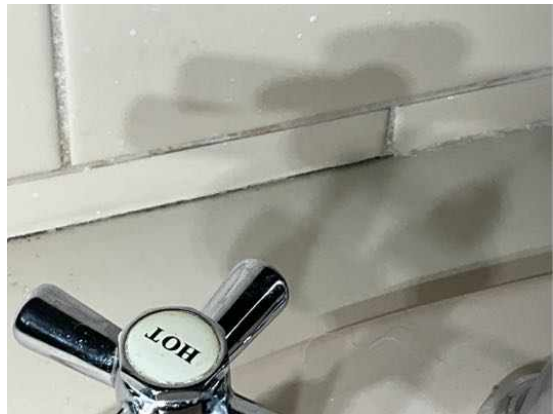
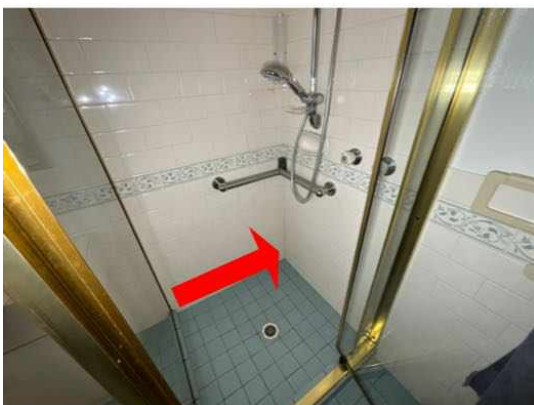
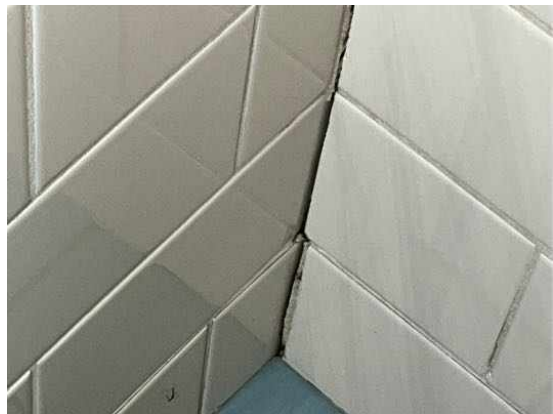
Finding 3.01

Building: Building 1
Location: Bathroom
Finding: Inadequate sealant or Grout
Information: This area has a lack of effective Sealant or Grout. This is allowing the ingress of water to the structure inside the wall.

The presence of water encourages Termite attack, Mould and Fungal Decay.

A Tiler or General Handy person must be contacted as soon as possible to effect repairs and prevent further deterioration.

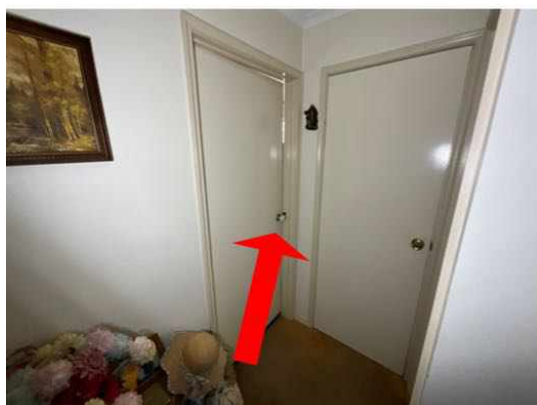
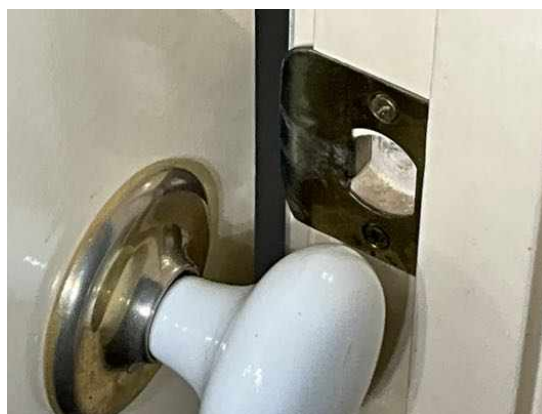
Finding 3.02

Building: Building 1
 Location: Laundry
 Finding: Door - Striker plate misaligned
 Information: The striker plate to this door appears to have become misaligned and has consequently resulted in the door's operation being compromised.

This is a common defect and is expected in a property of this age, whether being due to substandard installation or general deterioration of the door hardware.

Readjustment of the striker plate is recommended at client discretion. Works such as these can be completed by a general handyman or qualified carpenter.

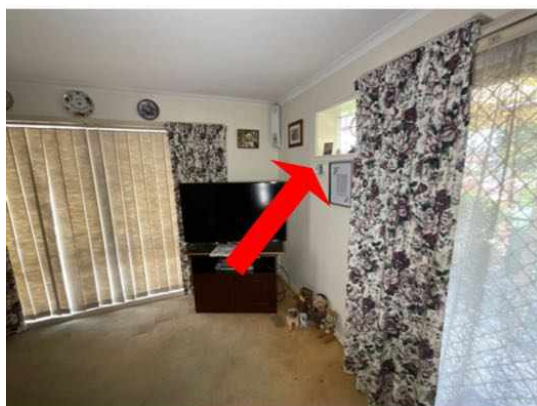
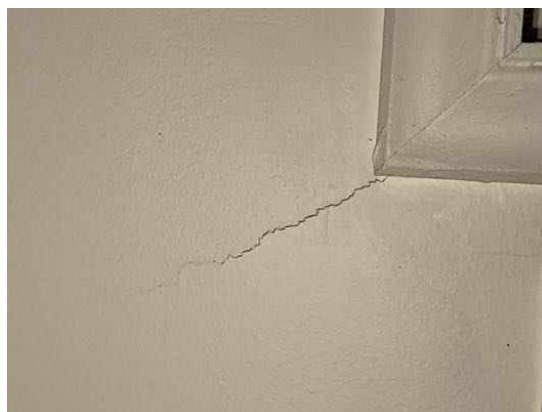
Finding 3.03

Building: Building 1
 Location: Living Room
 Finding: Cracking - Damage Category 1 - Fine (up to 1mm)
 Information: Although fine cracks are quite noticeable, they are often only considered to be an appearance defect, and usually do not indicate any structural damage. Generally, the cause of a fine crack is indicative of a separation between building materials and finishes (e.g. paint, plaster, etc.) along joins.

Cracking of this nature can generally be repaired with minor sanding, filling and/or repainting. Such works should be performed by a qualified painter or a general handyman.

Monitoring of all cracking should be conducted frequently. Always contact a building inspector should cracks widen, lengthen, or become more numerous.

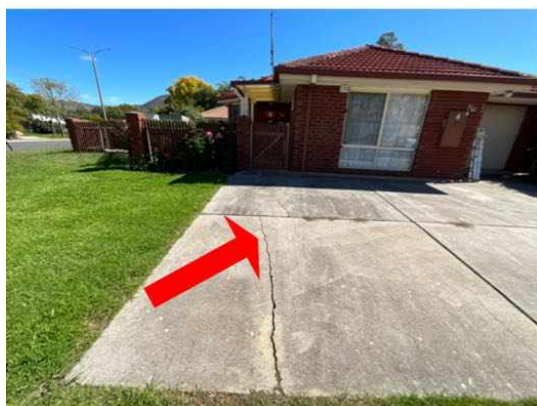
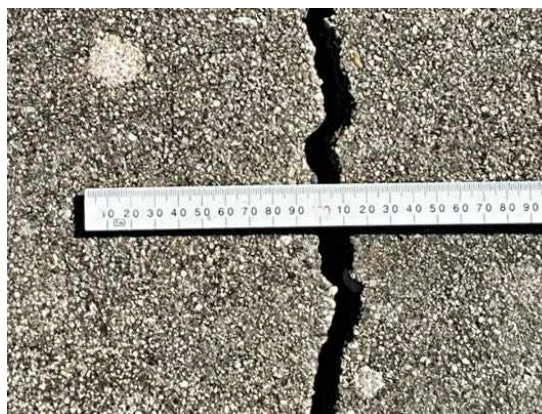
Finding 3.04

Building:	Building 1
Location:	Driveway area
Finding:	Cracking - External Concrete Paving Damage Category 4 - Gaps in Slab (4mm - 10mm +)
Information:	Gaps in the slab were identified in external concrete paving. Gaps in the slab are significant and are likely to lead to the development of safety hazards and secondary defects if left unmanaged, such as the creation of a trip hazard.

General age and expected deterioration of the paved areas is a common cause of this type of cracking. However, expansion and contraction of the slab may also have occurred due to environmental factors. Such factors include variable moisture and weather conditions, the presence of trees and their roots having a settling or lifting affect on the soil, or the effect of load bearing, e.g. heavy vehicles over a sustained period of time.

Cracking to this degree may also be due to poor original installation of the concrete. Factors such as poor compaction of the sub surface and/or inadequate reinforcing of the slab may create cracking and other secondary defects. Gaps in the concrete paving may also have a more significant structural cause, such as subsidence of soils.

Where gaps in the concrete paving are adjacent to structural elements of the building, the advice of a Structural Engineer is advisable before undertaking repairs. Significant repair and likely replacement of the concrete paving is probable.

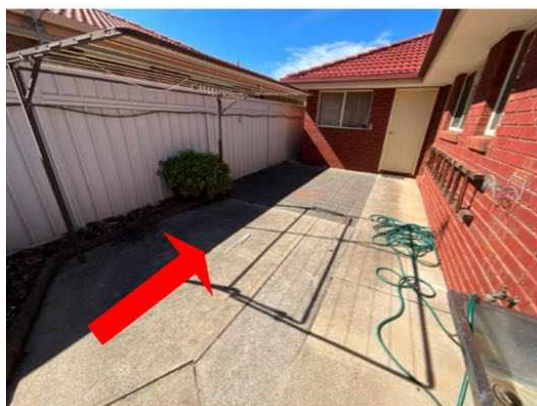
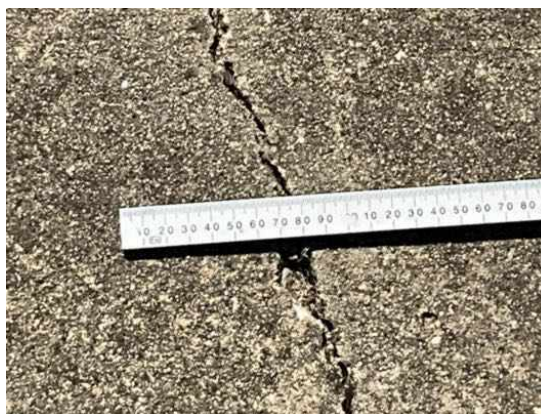
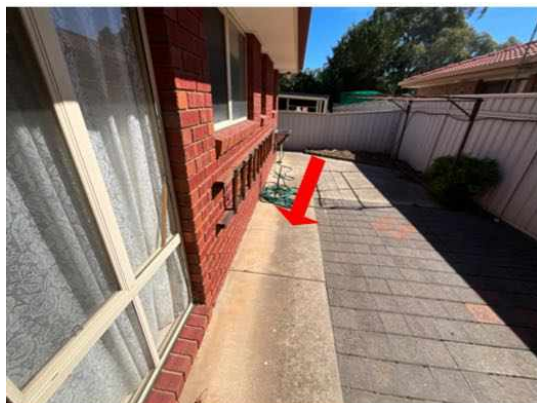
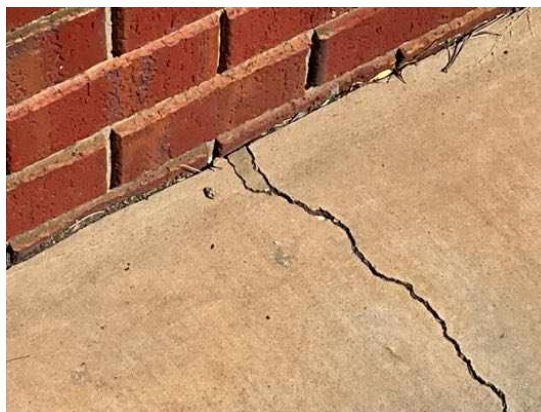
Finding 3.05

Building:	Building 1
Location:	Yard - Side
Finding:	Cracking - External Concrete Paving Damage Category 3 - Wide Cracks (2mm - 4mm)
Information:	Wide cracks were identified in external concrete paving. Wide cracks are significant and are likely to lead to the development of safety hazards and secondary defects if left unmanaged.

General age and expected deterioration of the paved areas is a common cause of this type of cracking. However, expansion and contraction of the slab may also have occurred due to environmental factors. Such factors include variable moisture and weather conditions, the presence of trees and their roots having a settling or lifting affect on the soil, or the effect of load bearing, e.g. heavy vehicles over a sustained period of time.

Cracking to this degree may also be due to poor original installation of the concrete. Factors such as poor compaction of the sub surface and/or inadequate reinforcing of the slab may create cracking and other secondary defects. Wide cracks may also have a more significant structural cause, such as subsidence of soils.

Where the crack is located adjacent to structural elements of the building, the advice of a Structural Engineer is advisable before undertaking repairs. Significant repair and likely replacement of the concrete paving is probable.

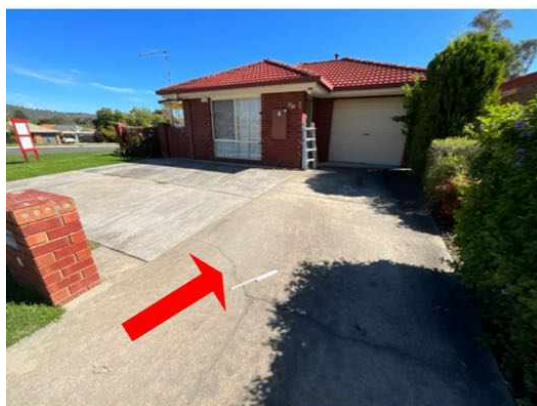
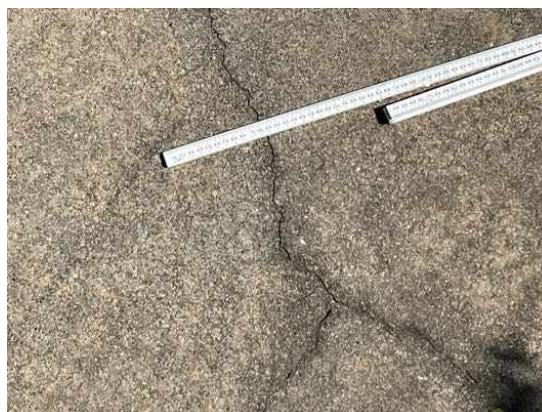
Finding 3.06

Building:	Building 1
Location:	Driveway
Finding:	Cracking - External Concrete Paving Damage Category 1 - Fine (less than 2mm)
Information:	Fine cracks were identified in external concrete paving. Although fine cracks are quite noticeable, they are often only considered to be an appearance defect, and usually do not indicate any structural damage. To be considered a Category 1 or fine crack, the crack is found to be less than 2mm in width.

Generally the cause of a hairline crack in existing concrete paving such as driveways and pathways is indicative of the expansion and contraction of the concrete. Such causes are generally due to environmental factors, such as moisture levels, weather conditions, root systems of nearby trees or the soil types on which they are laid.

Fine cracks may also be due to poor original installation of the concrete. Factors such as poor compaction of the sub surface and/or inadequate reinforcing of the slab may create cracking and other secondary defects.

Monitoring of all cracking should be conducted frequently. Always contact a building inspector should cracks widen, lengthen, or become more numerous.

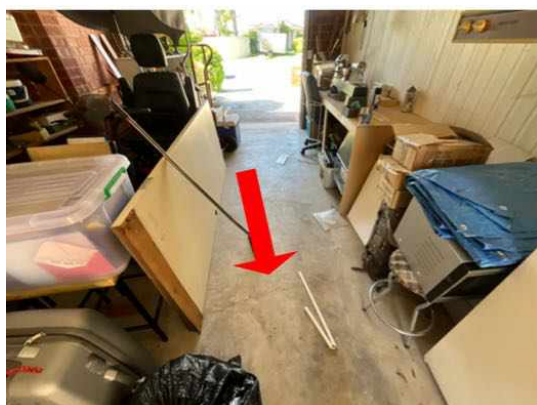
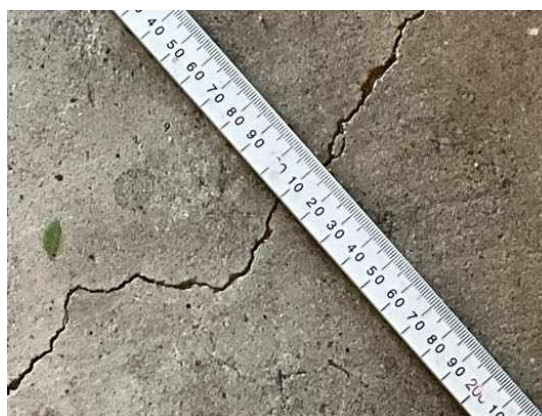
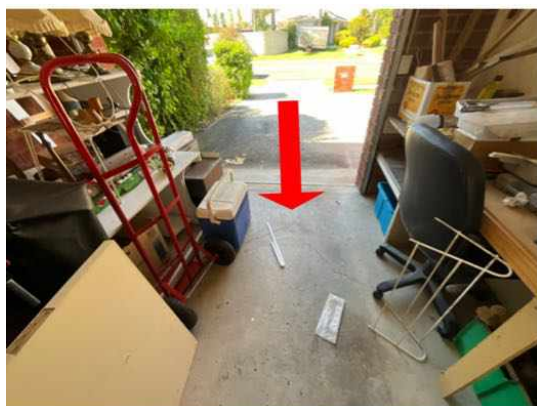
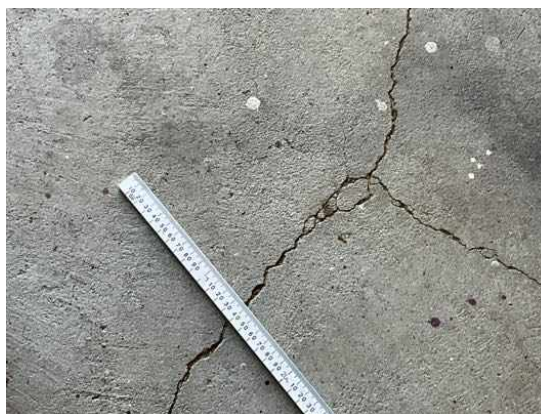
Finding 3.07

Building:	Building 1
Location:	Garage
Finding:	Crack in concrete slab - Category 1
Information:	A crack coded as Category 1 was identified in the slab. A Category 1 crack is described as a fine but noticeable crack, with the slab at an otherwise reasonable level.

To be considered Category 1, the approximate width of the crack is less than 1.0mm, or a less than 10mm change in offset when a 3m straight edge is placed over the defect.

Category 1 cracks should be monitored for a period of 12 months. At the end of the monitoring period, identified cracks that are rated greater than Category 2 are considered defects, and require rectification.

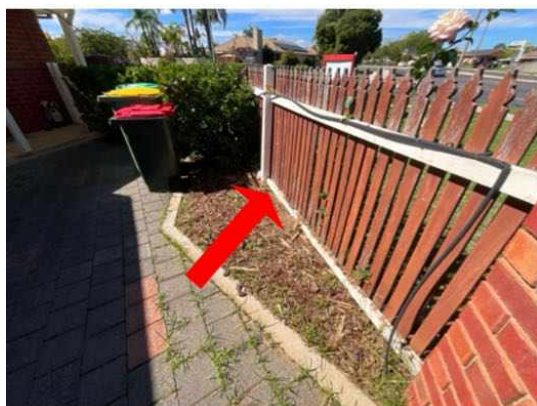
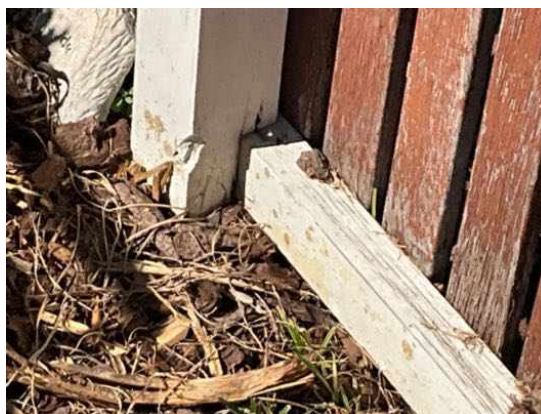
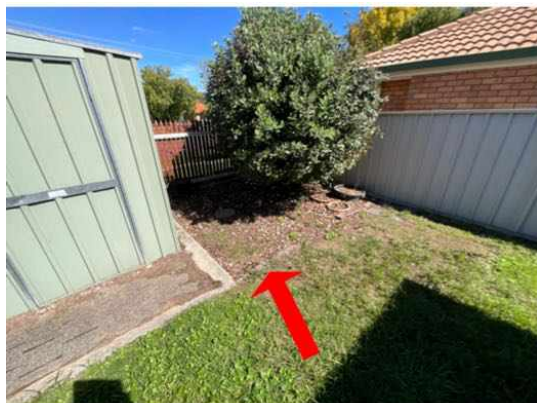
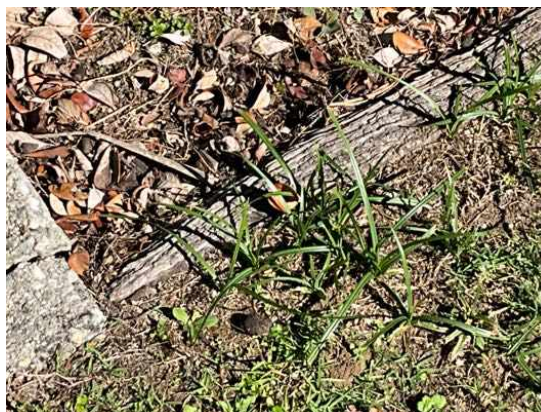
Finding 6.01

Building:	Building 1
Location:	Yard - back
Finding:	Untreated or non-durable timbers in a hazardous environment
Information:	To reduce the risk of timber pest attack it is essential that timber used in a hazardous environment (e.g. in direct contact with the ground or frequently exposed to damp conditions) is of sufficient durability and/or is adequately preservative treated.

Untreated timbers in direct contact with the ground are likely to develop severe wood rot and/or fungal decay if left unattended creating attraction for subterranean termites to infest the timbers from surrounding areas.

If untreated or non-durable timbers are found to be in a hazardous environment it is highly advised that replacement of these building elements be performed as soon as possible to aid the protection of the property against termite / timber pest attack.

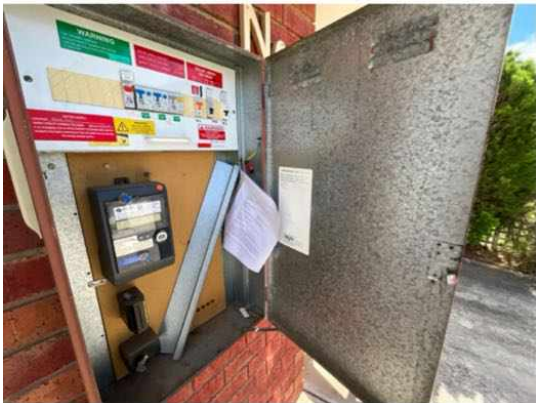
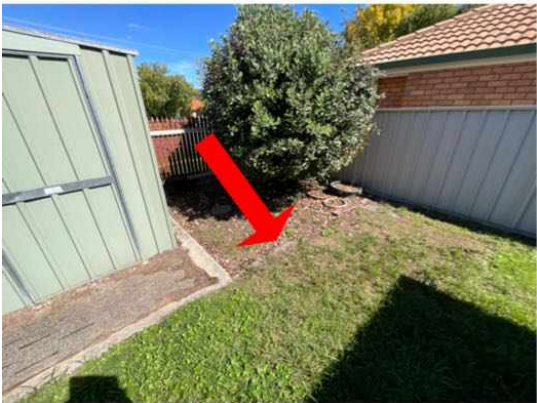
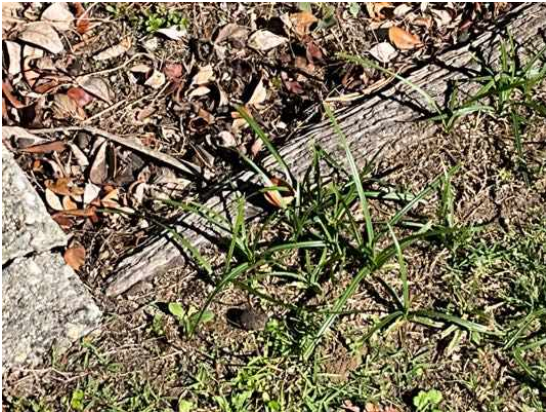
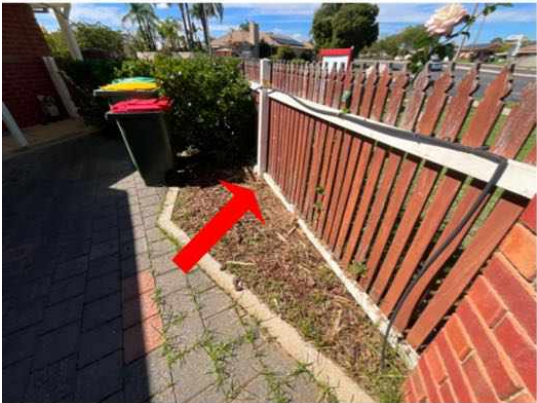
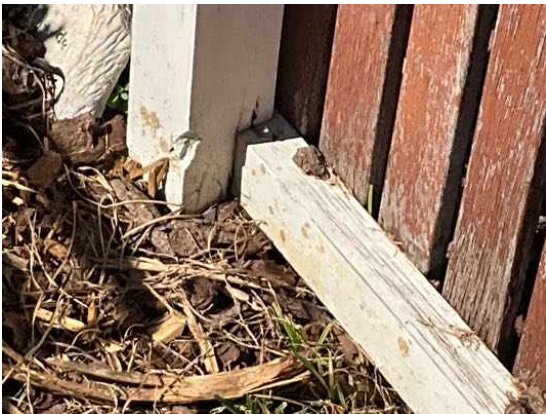
Finding 6.02

Building:	Building 1
Location:	All External Areas
Finding:	Termite Management System - no evidence of a chemical installation
Information:	The application of a post-construction chemical termite barrier is highly recommended for all properties, particularly if live termite activity has been found on the site previously. Such barriers are highly effective in preventing termite attack on any timber building elements throughout the property.

A durable notice should be placed in the switchboard unit to indicate current termite barriers. At the time of inspection, it appeared as though no termite management system has been installed, with no evidence to suggest preventative works taking place.

The client may consider gaining further advice from a pest controller as to the costs and procedures involved with this application. It is recommended that obtaining such advice be a short-term priority.

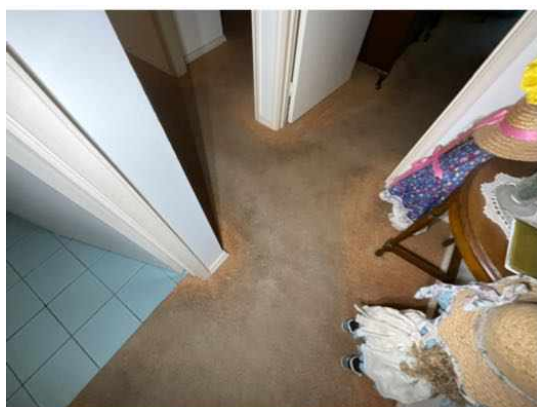
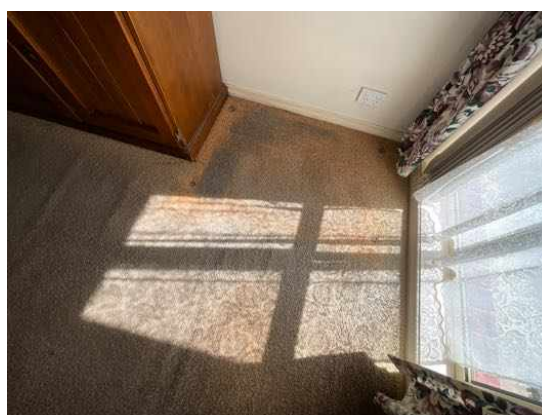
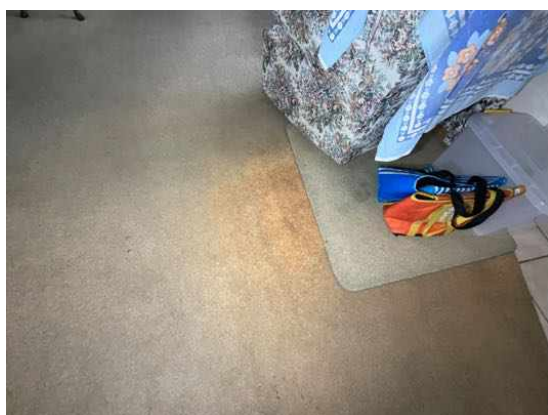
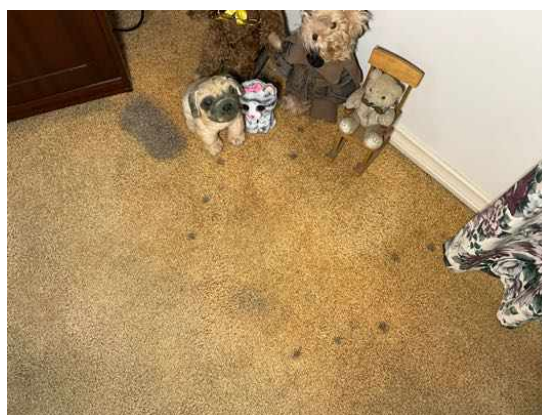
Building: Building 1
 Location: All Internal Areas
 Finding: Carpet -deterioration
 Information: The carpet in these areas is deteriorated. Sections can be seen to be frayed or worn.

A carpet specialist should be contacted at the discretion of the client to make any improvements and prevent further deterioration.

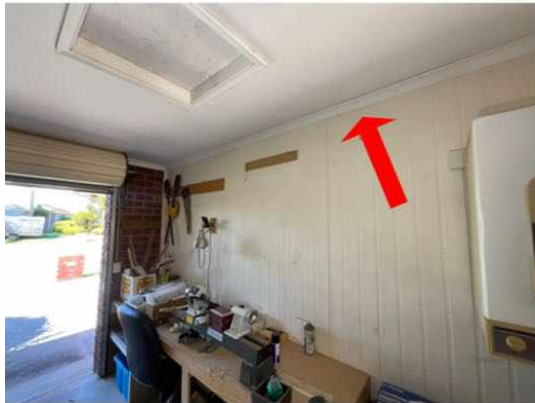
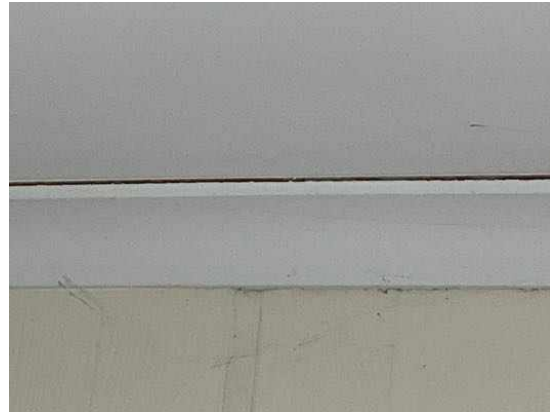
Building: Building 1
 Location: Garage
 Finding: Cornice- sagging
 Information: The cornice in this area is sagging. This may be due to age or poor initial installation.

A plasterer or handyman should be contacted soon to restore the area and prevent further deterioration.

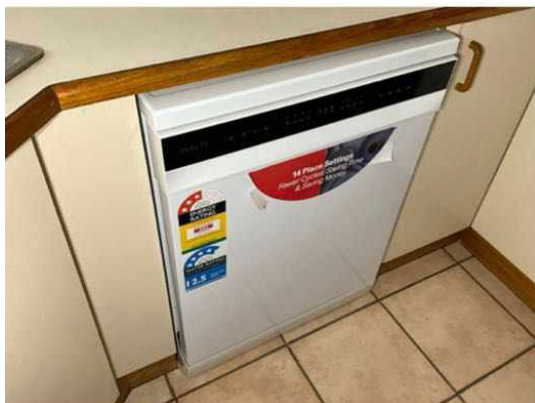
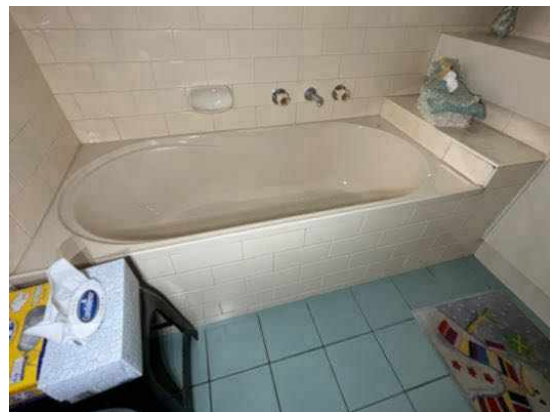
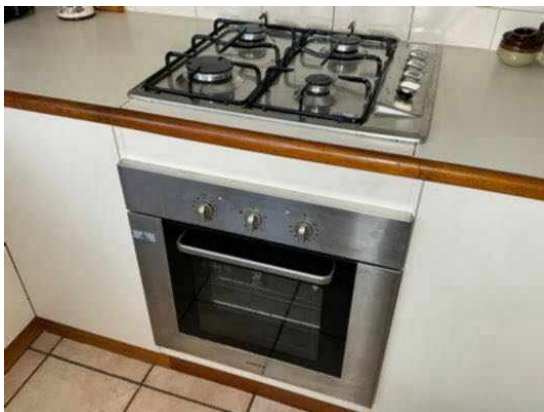
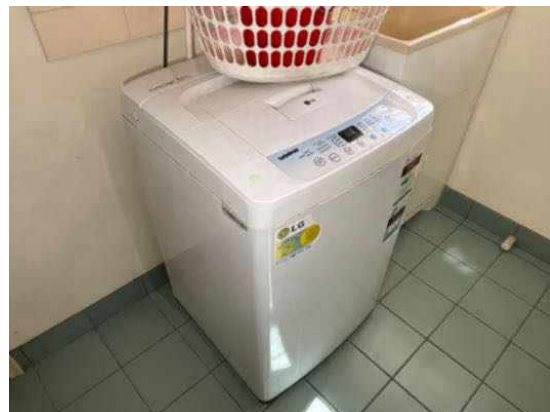
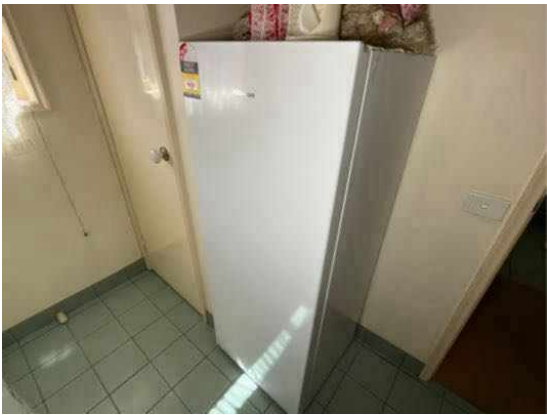
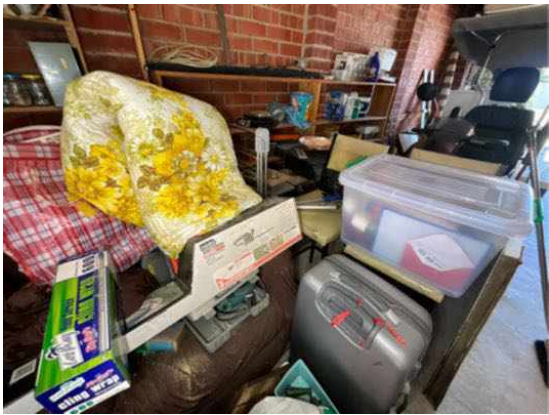
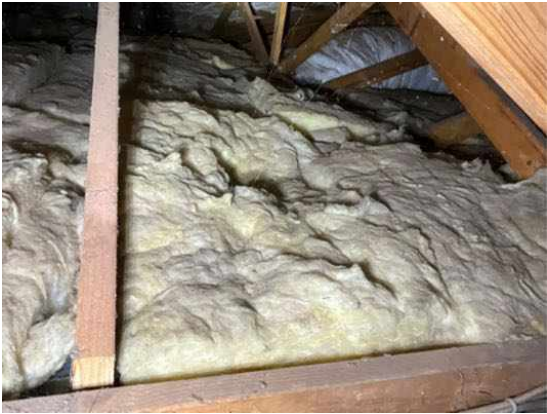
Building: Building 1
 Location: All Areas
 Finding: Additional Photos - Obstructions and Limitations
 Information: These photographs are an indication of the obstructions and limitations which impeded full inspection of the property at the time of inspection. These obstructions can hide an array of defects and should be removed to allow full inspection to be carried out. A re-inspection is recommended once the areas are made accessible.
