Building and Timber Pest Inspection Report

Inspection Date: Tue, 10 Mar 2026

Property Address: 1/118 Good St, Granville NSW 2142, Australia

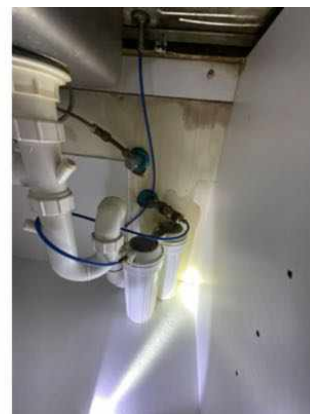
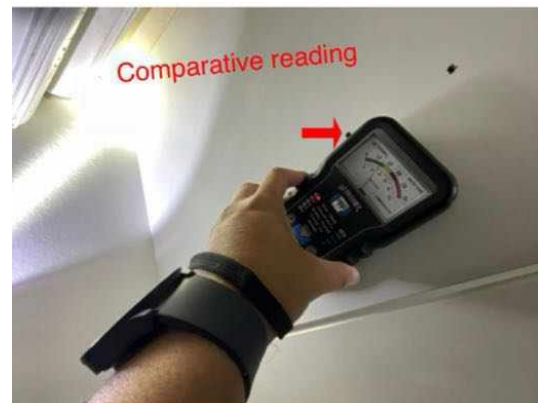
Finding 2.01

Building: Main Building
Location: Kitchen
Finding: Water damage
Information: The area has sustained water damage resulting in potential structural issues. This damage compromises both the aesthetic and functional aspects.

1 ****Plumber:**** If the water damage is due to plumbing issues, a plumber can fix leaks and ensure there are no further water-related problems.

2 ****General Contractor:**** If the damage is extensive and affects the surrounding area, a general contractor can coordinate the repair work, including any related structural or cosmetic repairs.

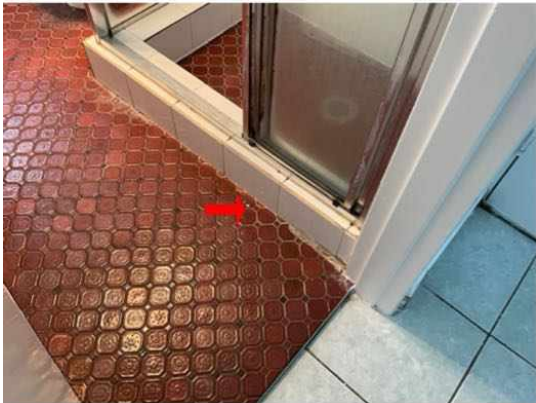
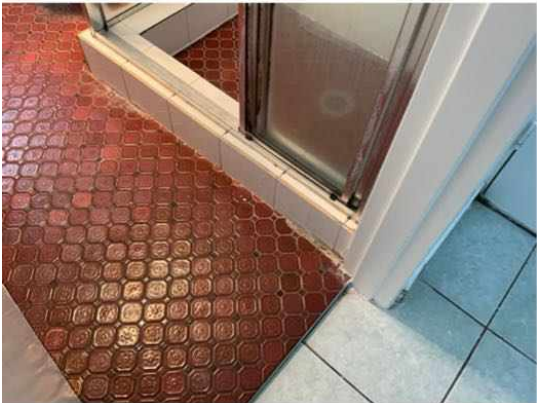
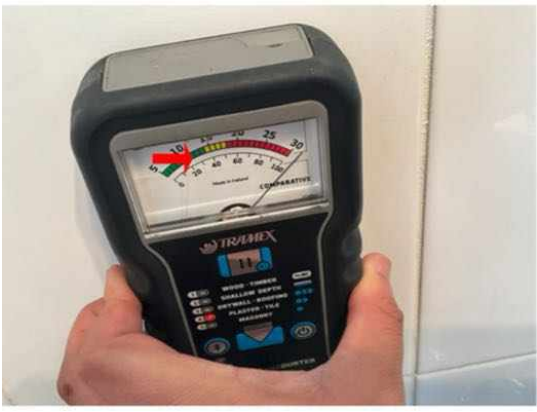
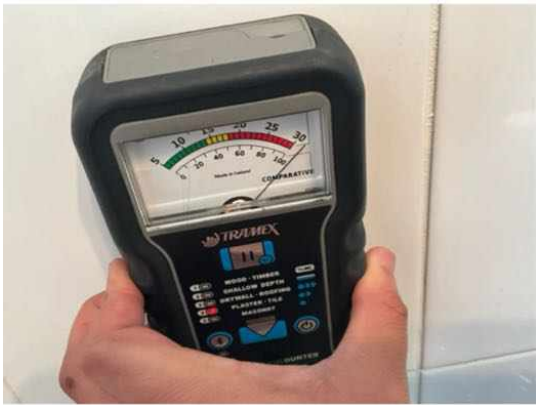
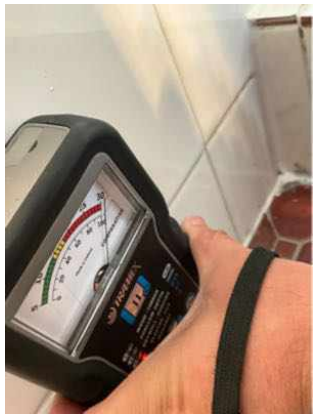
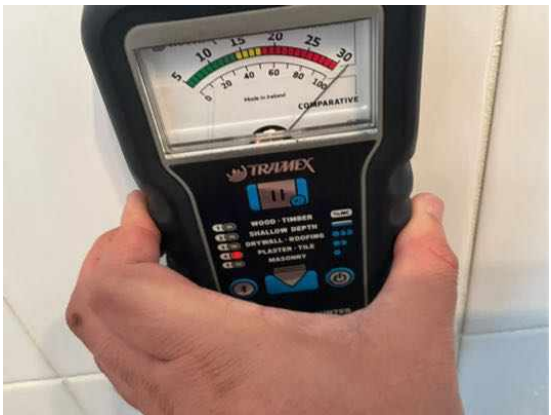
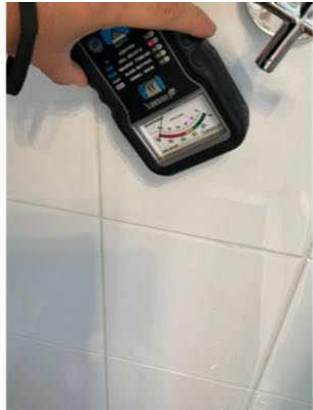
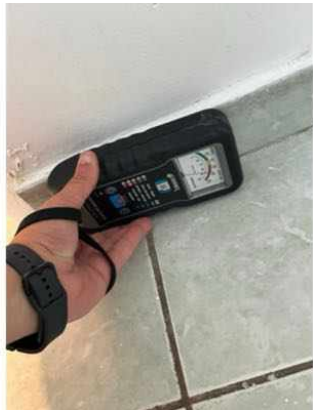
Finding 2.02

Building:	Main Building
Location:	Bathroom
Finding:	Evidence of excessive moisture was present at the time of inspection
Information:	Excessive moisture is present behind the bathroom tiles, indicating a potential water leakage issue within the wall.

The prolonged presence of moisture can lead to mold growth, deteriorate the structure, and create an environment conducive to health hazards. Additionally, it may compromise the adhesive holding the tiles, leading to their detachment.

A licensed plumber or a qualified contractor specializing in water damage remediation

should investigate the source of the moisture, fix any leaks, and address the damage. Additionally, replacing affected tiles and ensuring proper waterproofing are crucial to preventing future issues.

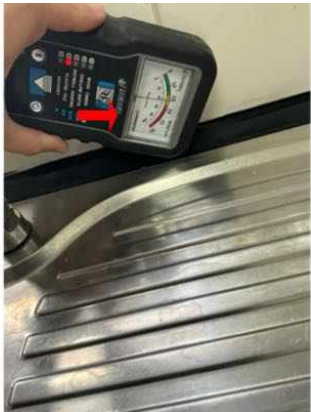
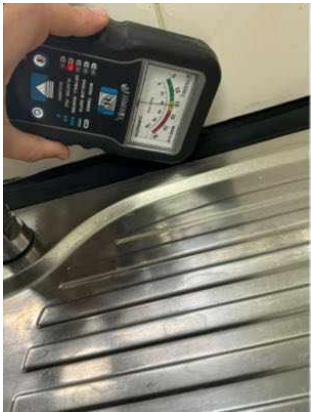
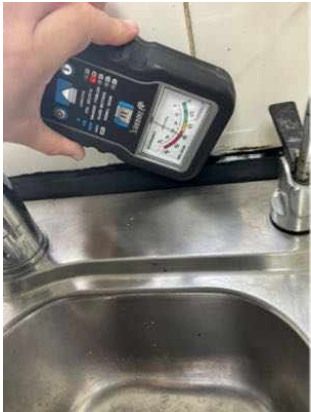
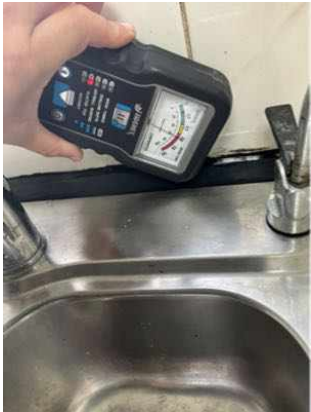
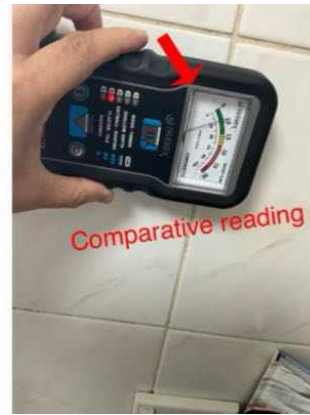
Finding 3.01

Building: Main Building
Location: Kitchen
Finding: Evidence of excessive moisture was present at the time of inspection
Information: Excessive moisture is present behind the bathroom tiles, indicating a potential water leakage issue within the wall.

The prolonged presence of moisture can lead to mold growth, deteriorate the structure, and create an environment conducive to health hazards. Additionally, it may compromise the adhesive holding the tiles, leading to their detachment.

A licensed plumber or a qualified contractor specializing in water damage remediation should investigate the source of the moisture, fix any leaks, and address the damage. Additionally, replacing affected tiles and ensuring proper waterproofing are crucial to preventing future issues.

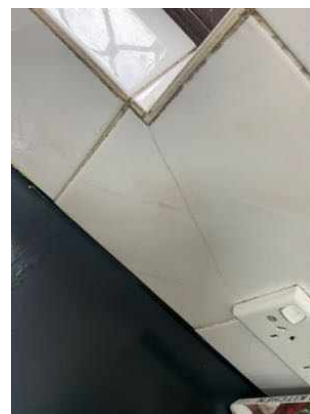
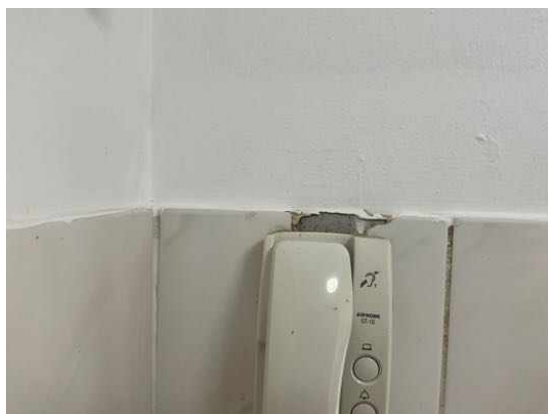
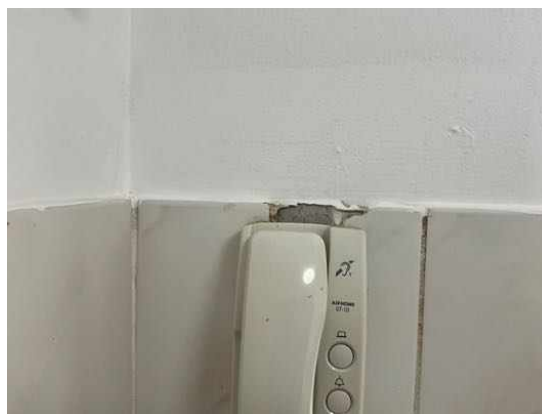
Finding 3.02

Finding: Tiles - Cracked or damaged

Information: Cracking was evident to the tiling in this area at the time of inspection. While the cracking appears to be minor, this area is frequently exposed to water, allowing potential for water penetration into adjoining sections of walls or flooring.

If left unmanaged, water penetration to these areas may lead to subsequent water damage, which is likely necessitate repair work to affected building elements.

A tiling contractor should be appointed to ensure that no further water damage occurs. The re-application of silicone and grouting throughout remaining tile work is also advised, to further protect the area against water penetration.

Where water penetration has led to water damage, appointment of a relevant tradesperson may be required to repair damaged building elements.

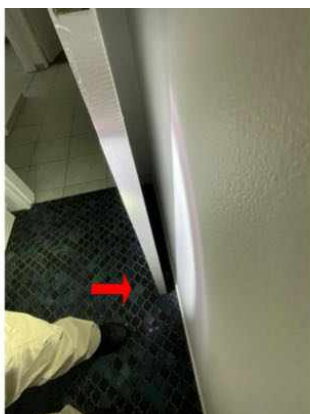
Finding 3.03

Finding: Missing Door Stopper

Information: The door lacks a stopper, which is essential to prevent the door from swinging too far and potentially damaging the wall or the door handle. The absence of a door stopper increases the likelihood of impact damage to both the door and surrounding surfaces over time.

- **Damage Risk:** Moderate risk of damage to the door handle, wall, or door itself from repeated impacts when the door is opened forcefully or by a gust of wind.
- **Wear and Tear Risk:** Increased wear on door hardware and hinges due to the potential for abrupt stops without a dedicated stopper.

- **Engage a Handyperson or Carpenter:** A handyperson or carpenter should install a suitable door stopper to prevent excessive door movement. This could be a floor-mounted or wall-mounted stopper depending on the space and door design.

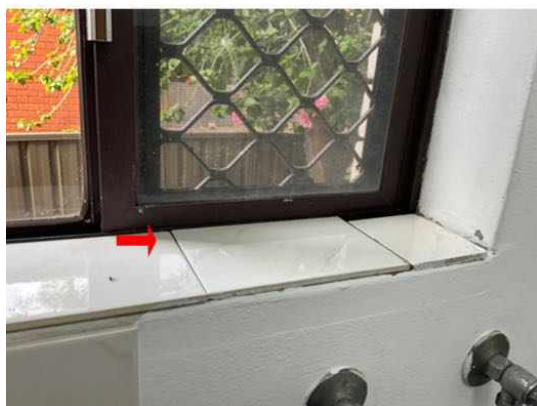
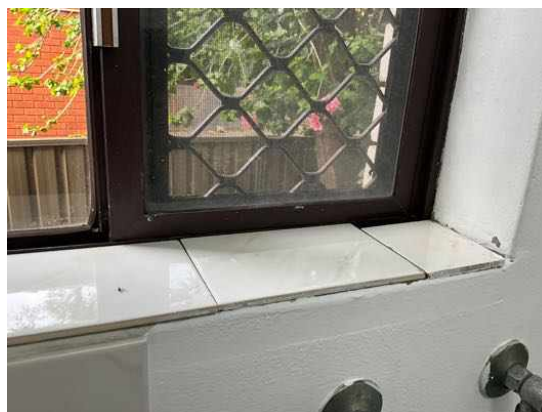
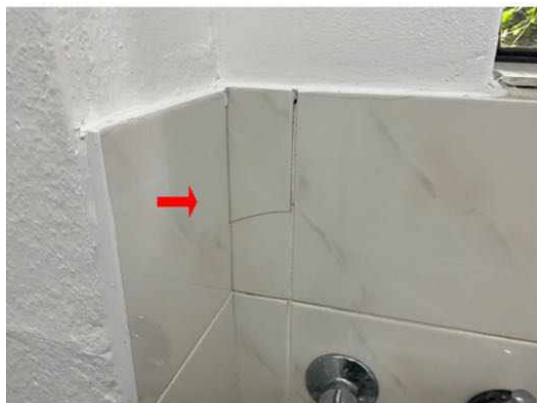
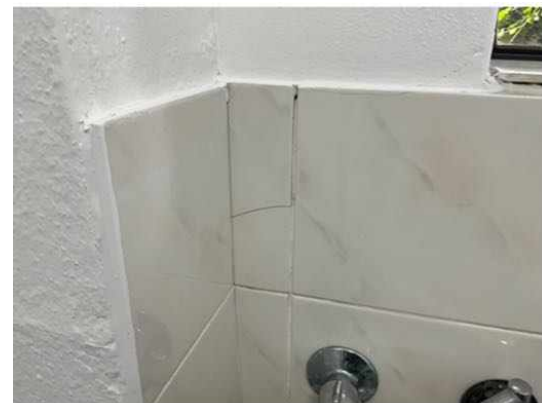
Finding 3.04

Building:	Main Building
Location:	Laundry
Finding:	Tiles - Cracked or damaged
Information:	Cracking was evident to the tiling in this area at the time of inspection. While the cracking appears to be minor, this area is frequently exposed to water, allowing potential for water penetration into adjoining sections of walls or flooring.

If left unmanaged, water penetration to these areas may lead to subsequent water damage, which is likely necessitate repair work to affected building elements.

A tiling contractor should be appointed to ensure that no further water damage occurs. The re-application of silicone and grouting throughout remaining tile work is also advised, to further protect the area against water penetration.

Where water penetration has led to water damage, appointment of a relevant tradesperson may be required to repair damaged building elements.

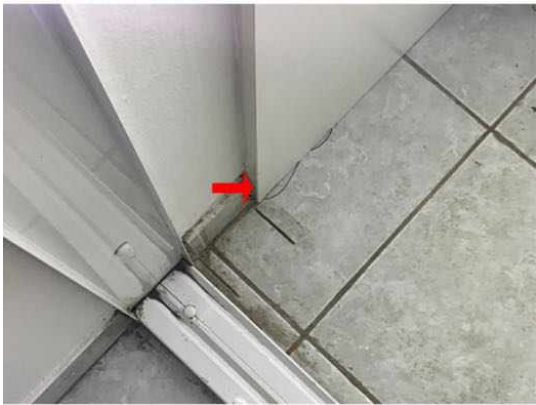
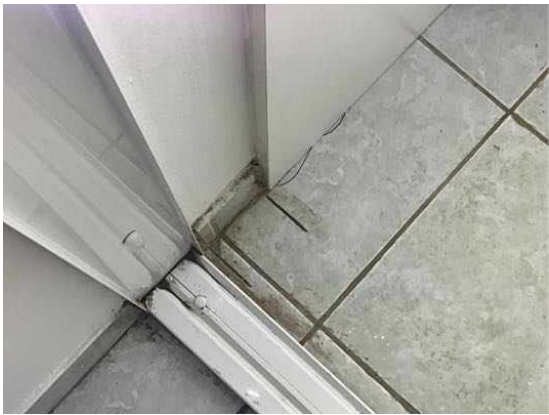
Finding 3.05

Building: Main Building
 Location: Bedroom
 Finding: Floor Tile crack
 Information: A floor tile has a visible crack on the surface.

The damaged tile presents a trip hazard, may lead to cuts if stepped on barefoot, and can allow moisture ingress into the substrate, which may cause further deterioration or loosening of adjacent tiles. It also affects the overall appearance of the floor.

A licensed tiler should be engaged to remove the damaged tile and install a matching replacement. If spare tiles are unavailable, additional remedial work may be required to blend the repair with surrounding finishes.

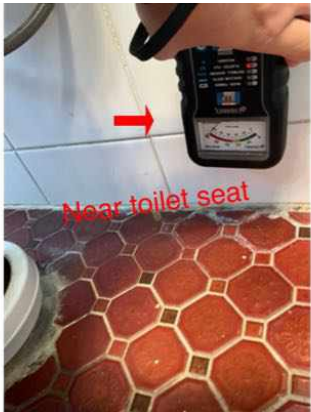
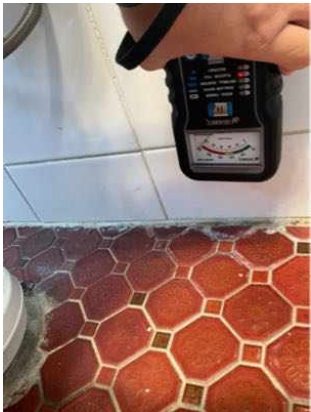
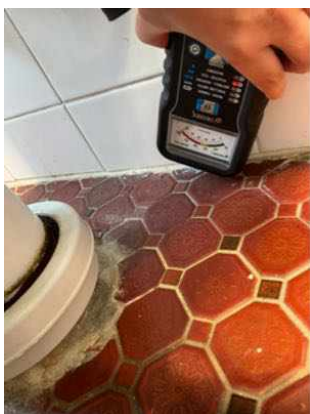
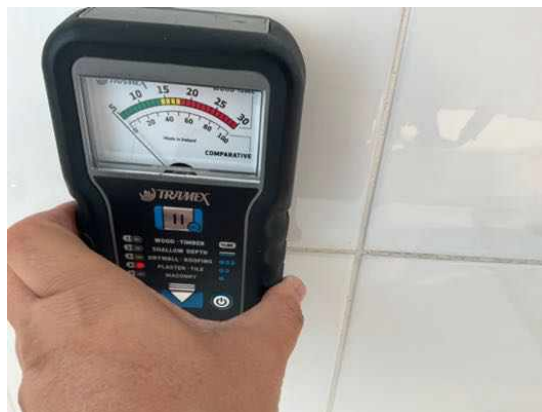
Finding 3.06

Building: Main Building
Location: Bathroom
Finding: Evidence of excessive moisture was present at the time of inspection
Information: Excessive moisture is present behind the bathroom tiles, indicating a potential water leakage issue within the wall.

The prolonged presence of moisture can lead to mold growth, deteriorate the structure, and create an environment conducive to health hazards. Additionally, it may compromise the adhesive holding the tiles, leading to their detachment.

A licensed plumber or a qualified contractor specializing in water damage remediation should investigate the source of the moisture, fix any leaks, and address the damage. Additionally, replacing affected tiles and ensuring proper waterproofing are crucial to preventing future issues.

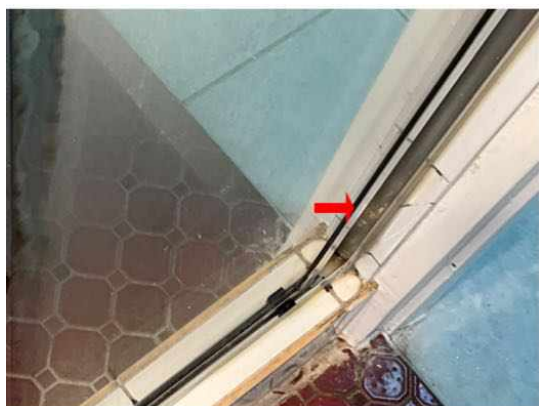
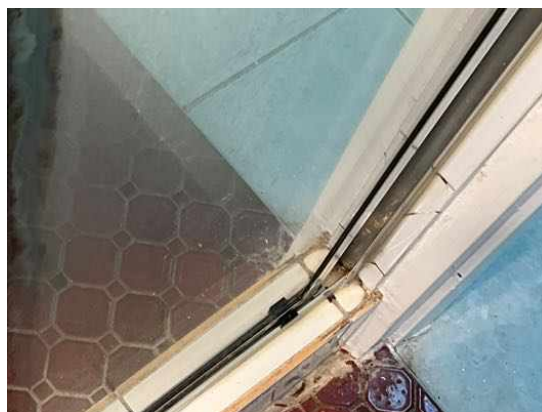
Finding 3.07

Building:	Main Building
Location:	Bathroom
Finding:	Tiles - Cracked or damaged
Information:	Cracking was evident to the tiling in this area at the time of inspection. While the cracking appears to be minor, this area is frequently exposed to water, allowing potential for water penetration into adjoining sections of walls or flooring.

If left unmanaged, water penetration to these areas may lead to subsequent water damage, which is likely necessitate repair work to affected building elements.

A tiling contractor should be appointed to ensure that no further water damage occurs. The re-application of silicone and grouting throughout remaining tile work is also advised, to further protect the area against water penetration.

Where water penetration has led to water damage, appointment of a relevant tradesperson may be required to repair damaged building elements.

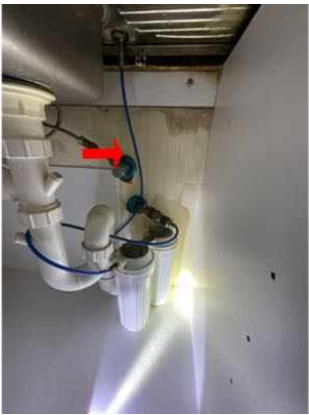
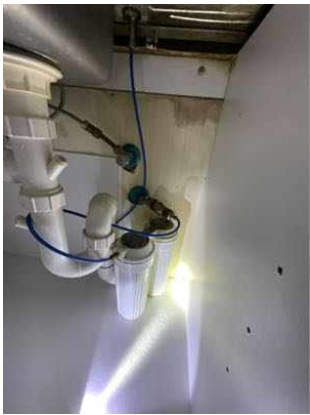
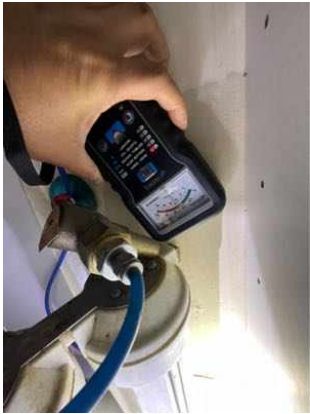
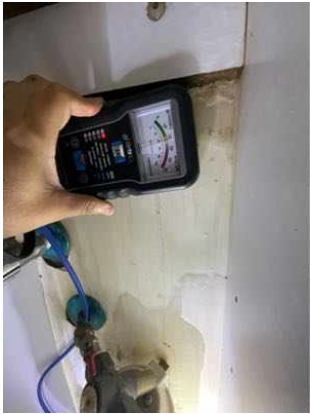
Building:	Main Building
Location:	Kitchen
Finding:	Excessive moisture - Conducive to Timber pest
Information:	Excessive moisture can attract termites and produce conditions that promote fungal growth and wood decay.

Excessive moisture is generally caused by deteriorated inadequate or missing roof drainage leaking plumbing pipes or fixtures poorly plumbed HWS overflows or condenser units and poor site drainage.

Prior to any remedial works being performed a qualified plumber should be appointed to further inspect the property and to identify the cause of the excessive moisture. Works to remove affected building elements may then be necessary and should be performed by an appropriate tradesperson.

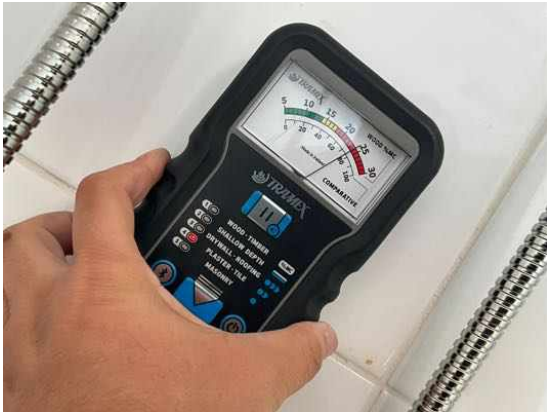
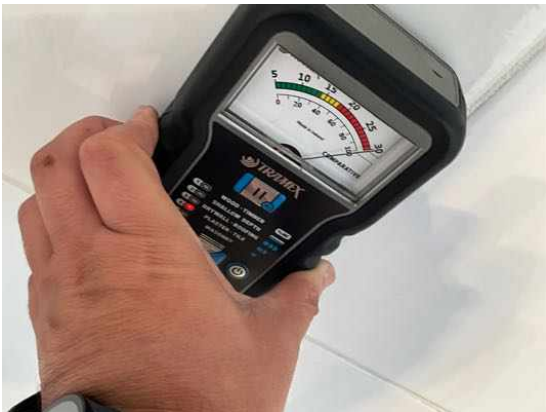
Finding 6.03

Building:	Main Building
Location:	Bathroom
Finding:	Excessive moisture - Conducive to Timber pest
Information:	Excessive moisture can attract termites and produce conditions that promote fungal growth and wood decay.

Excessive moisture is generally caused by deteriorated inadequate or missing roof drainage leaking plumbing pipes or fixtures poorly plumbed HWS overflows or condenser units and poor site drainage.

Prior to any remedial works being performed a qualified plumber should be appointed to further inspect the property and to identify the cause of the excessive moisture. Works to remove affected building elements may then be necessary and should be performed by an appropriate tradesperson.
