Building and Timber Pest Inspection Report

Inspection Date: Wed, 4 Mar 2026

Property Address: 6 Corlis Ave, Eudlo QLD 4554, Australia

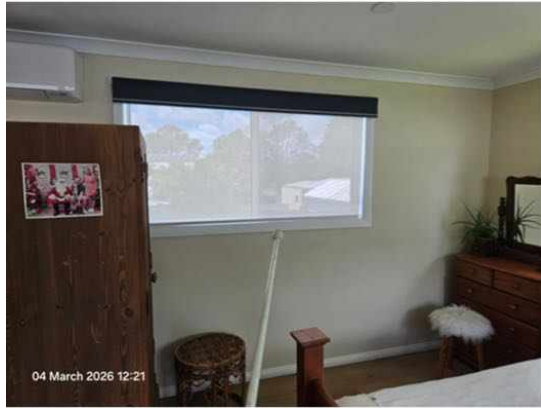
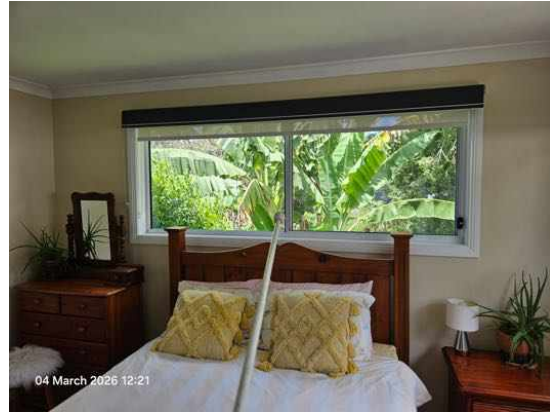
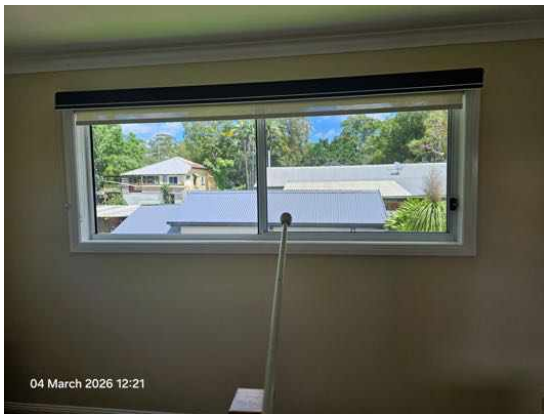
Windows to be protected Windows are defective if they do not comply with provision 3.9.2.6 of Volume 2 of the BCA that requires that a window opening must have protection if the floor below the window in a bedroom is 2m or more above the ground surface beneath.

Type of protection Windows requiring protection are defective if they are not fitted with a device to restrict the window opening or a screen, with secure fittings. The device or screen, where required, is defective if it permits a 125mm sphere to pass through the window or screen or is unable to resist an outward horizontal action of 250 N.

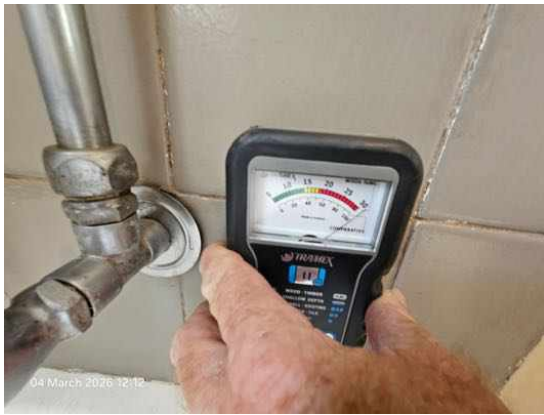
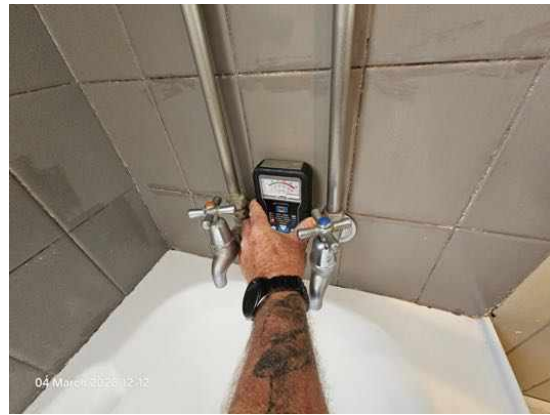
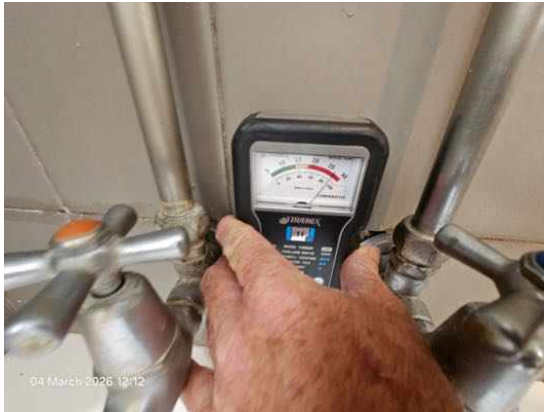
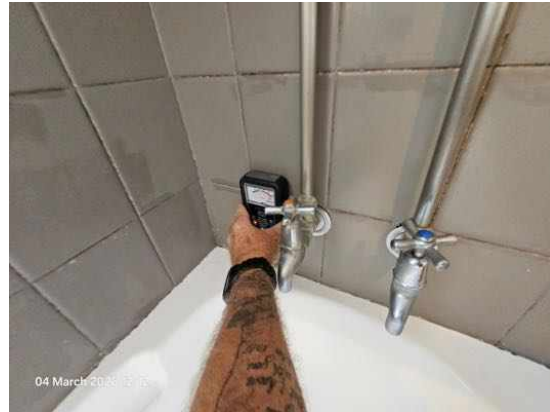
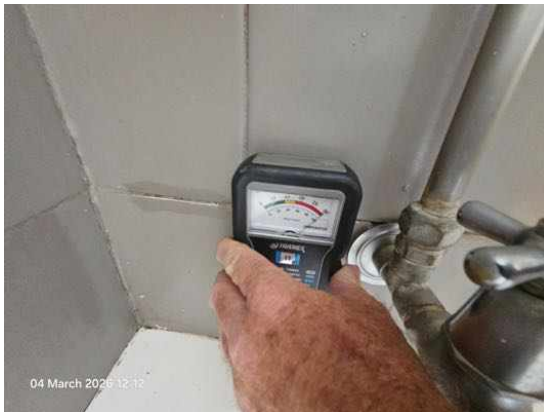
Finding 3.02

Building:	Main Building
Location:	Bathroom
Finding:	Elevated moisture present at the time of inspection - bathroom
Information:	Elevated moisture was noted in the tiled wall surfaces of the bathroom shower.

The levels varied at differing points throughout the recess. This could possibly be due to deteriorated grout and silicone sealants and / or plumbing fittings and fixtures. The grouts and sealants can break down over time and become porous, allowing moisture to enter the wall sheet surface behind the tiles.

Elevated moisture can attract timber pests and vermin, and produce conditions that promote timber pest attack, fungal growth and wood decay.

Tile sheet underlay to the alcove may be an asbestos containing fibre cement product. Exercise caution when renovating.

The moisture readings in the shower recess are limited to the lower courses of tiles, which can usually indicate grout and silicone degradation. Care should be taken when renovating the bathroom as the risk of an asbestos fibre cement tile backing sheet is increased in buildings of this age.

It is recommended that the moisture levels in these areas be monitored over time and the grout and silicone could be renewed to possibly eliminate any further moisture penetration.

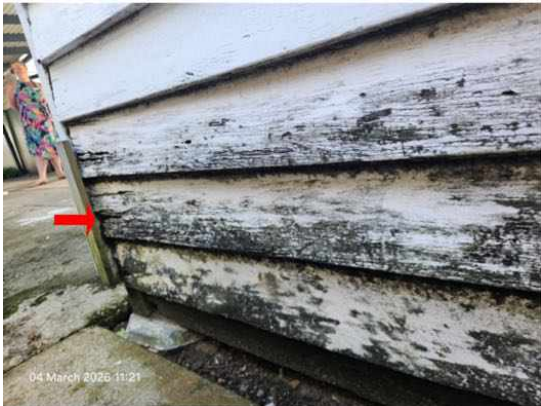
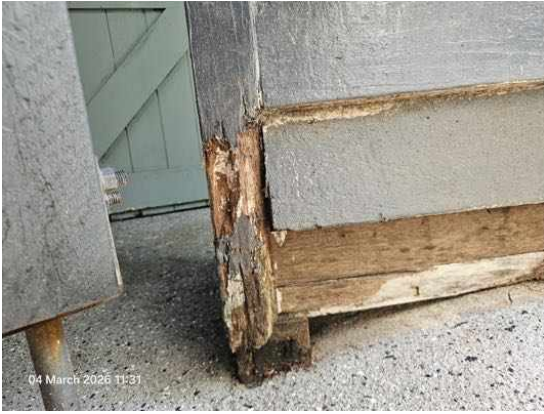
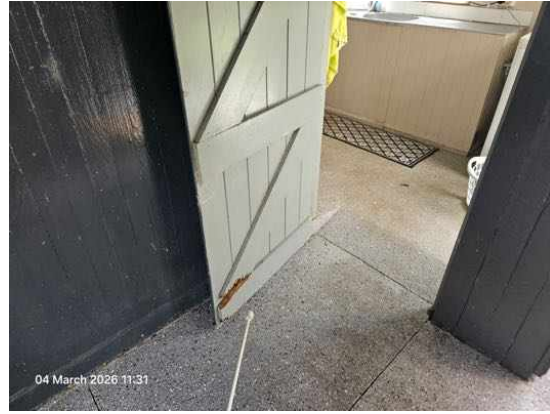
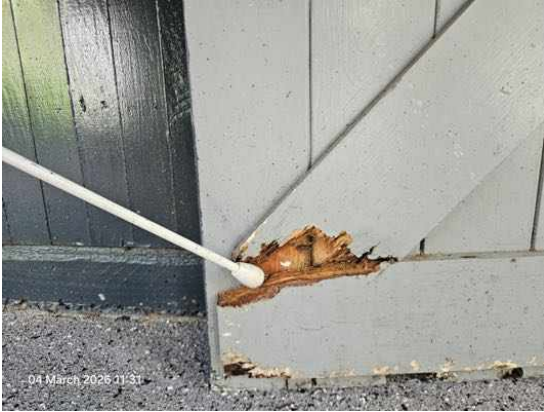
Building: Main Building
Location: As shown
Finding: Wood rot / fungal decay
Information: These timber components show evidence of wood rot in various sections of the timber.

Wood rot, also known as Fungal Decay, occurs when timbers and other cellulose building materials are exposed to damp conditions on an ongoing basis. This could be the result of exposure to weathering over a prolonged period of time, or the attraction of excessive moisture from other abutting building materials.

Early intervention and regular maintenance, particularly of exterior timbers, will prolong the useful life of these building elements. Prior to any works being performed, the cause of the moisture that has created the visible wood rot should be identified and addressed in a suitable manner. Replacement of affected timbers may then be a necessary step in protecting surrounding building elements from such deterioration.

A licensed carpenter or licensed builder should be consulted to advise on a solution for the affected building materials.

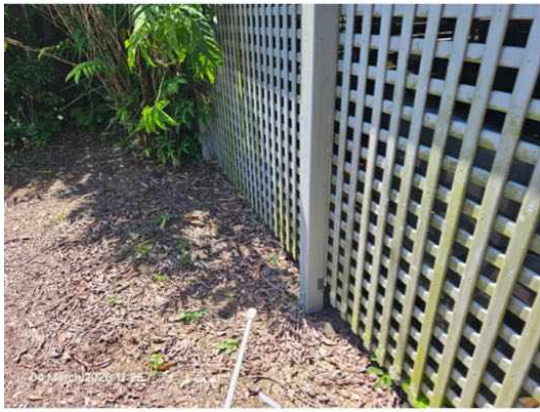
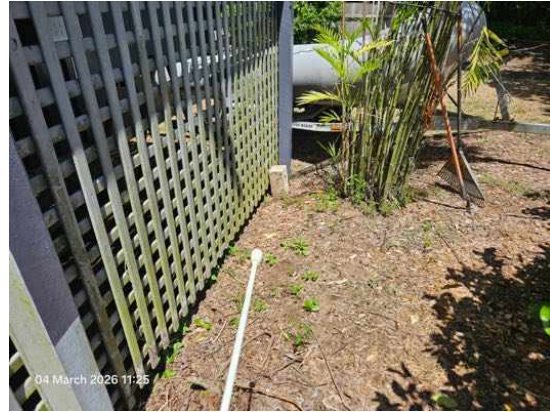
Finding 6.02

Building:	Main Building
Location:	As shown
Finding:	Timber contact with ground - posts
Information:	It was noted during inspection, that many of the timber post supports of the deck in the subfloor are in contact with the ground and do not have sufficient clearance to provide an adequate inspection zone.

These could be a possible entry point for timber pests.

The soil and debris should be cleared away from the base of all timber structural members to provide clear visible access to view the post bases.

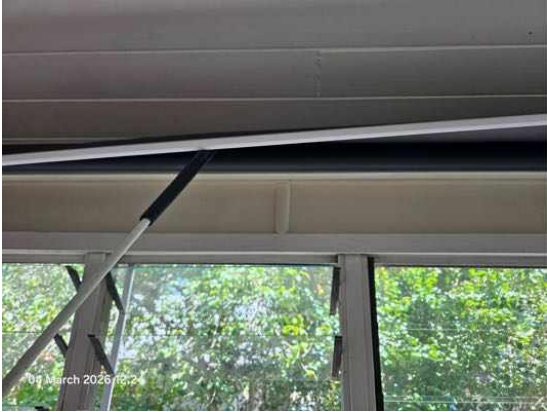
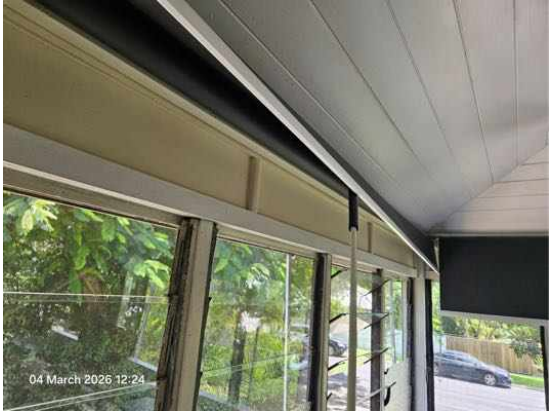
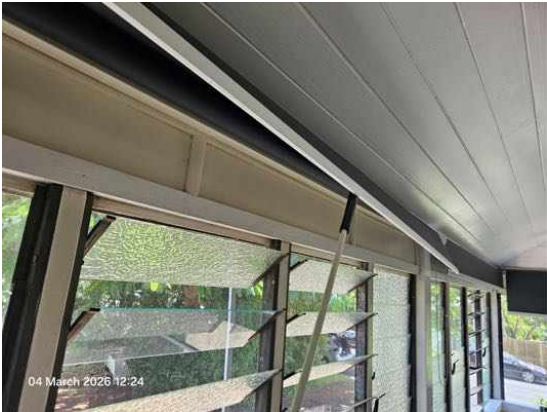
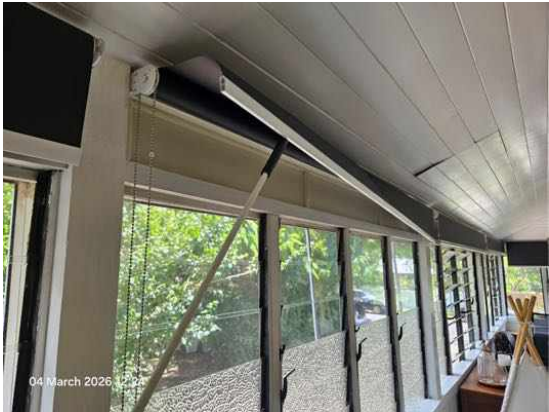
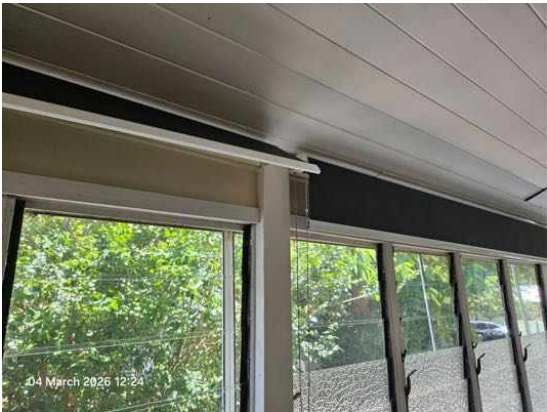
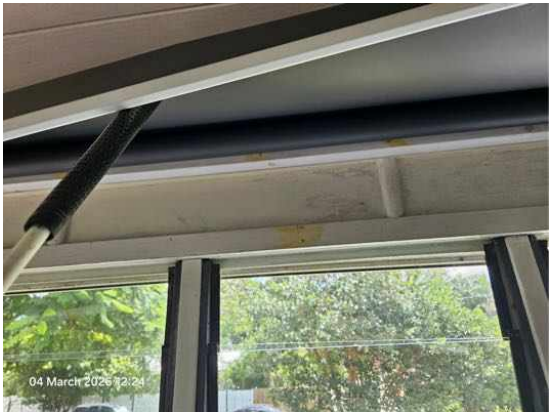
The observable areas of wall sheeting appear to have no obvious signs of major damage or deterioration, indicating that the asbestos is currently encapsulated and reasonably well contained. If maintained in good condition, ACM sheets pose little risk; therefore care should be taken to maintain the walls.

Damaged and deteriorated ACMs have a higher probability of releasing airborne asbestos fibres, creating a significant health safety risk.

Where the client elects to retain the ACM, the client should regularly monitor the condition of the wall sheets to identify any further damage or deterioration. Such monitoring should be conducted at least annually, but more frequently should damage or evidence of deterioration occur. Additional remedial work is a potential short to medium term solution to reduce the risk presented by the ACM.

No works should be carried out to the ACM or associated building elements without further specialist advice.

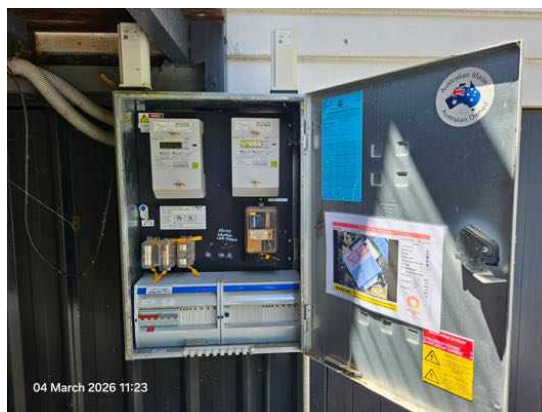
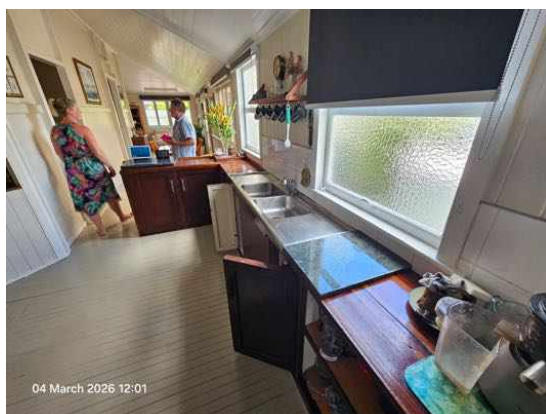
Building: Main Building
 Location: Meter box, kitchen cupboard
 Finding: Durable pest inspection notice - not assessable
 Information: On the day of inspection it was noted that the durable timber pest inspection / treatment notice was missing, not visible or out of date. These notices / stickers are to verify the timber pest inspection dates, the inspector, the currency and type of timber pest system / barrier in place or being used in and around the property.

Annual, or more regular, inspections are crucial in maintaining and managing the properties timber pest risk profile. By not having regular inspections of the property raises the properties risk of undetected defects and damage. Without regular inspection at intervals of not greater than annually the buildings risk profile will categorised as high. Properties with trees within 50m and with gardens close to the building are at greater risk and will have a high risk profile.

It is recommend that a licensed timber pest controller be contacted to assess the properties needs and provide costings for an annual inspection programme.

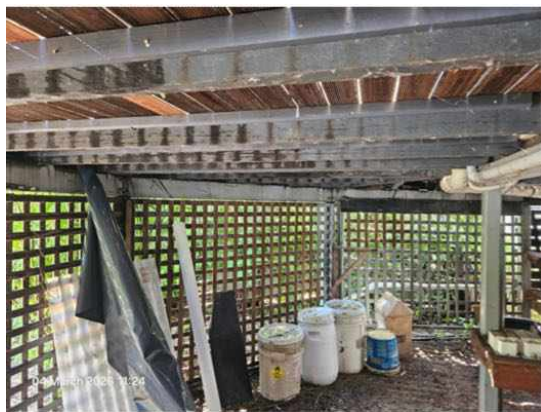
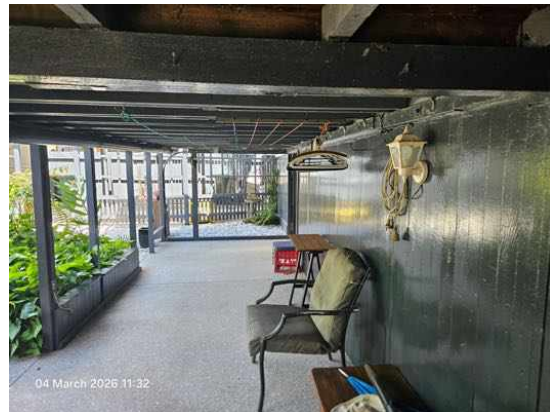
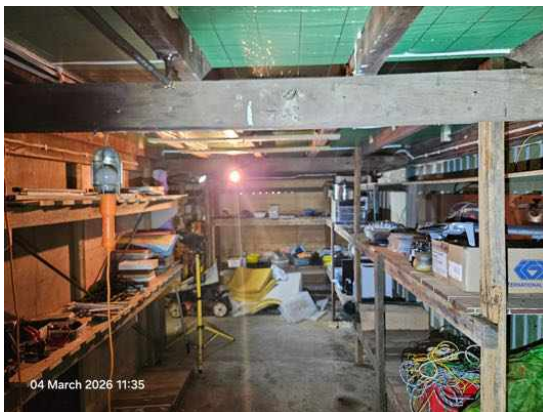
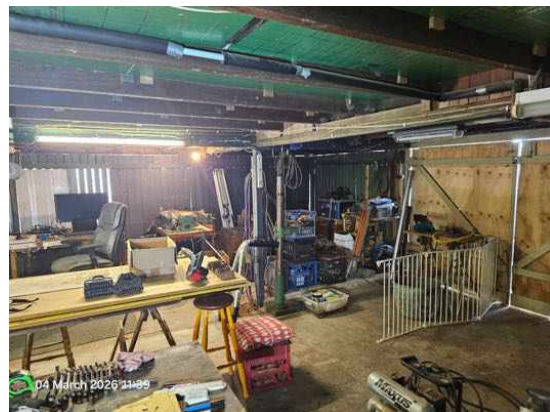
Where a Termite Management System has been identified you should refer to the type of barrier date of installation warranty conditions and any documentation provided by a builder or past owner. Consult the company who installed the barrier to confirm whether the system is still under warranty.

Due to the multiple areas of cladding and underfloor insulation through out the building, it is recommended that a licensed pest controller be consulted on the efficacy of the existing measures and, if required, a system proposal sought.
