Building and Timber Pest Inspection Report

Inspection Date: Fri, 13 Feb 2026

Property Address: 34 Foam St, Elwood VIC 3184, Australia

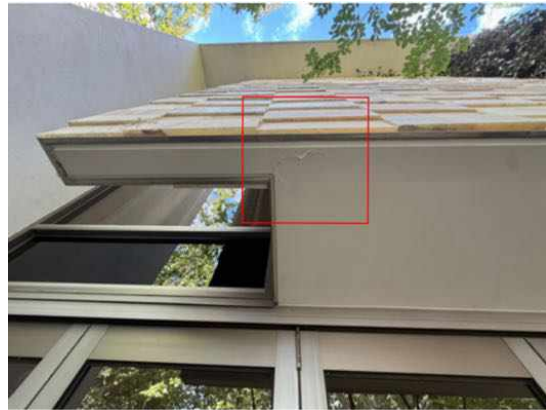
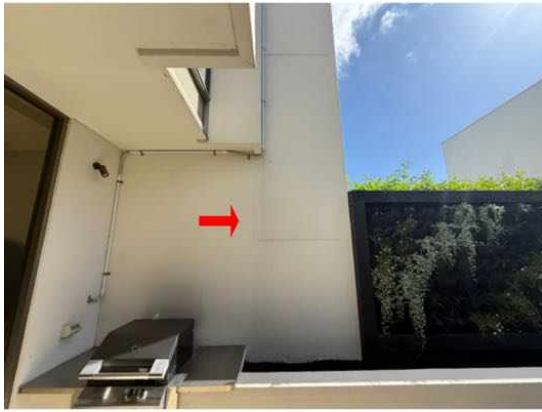
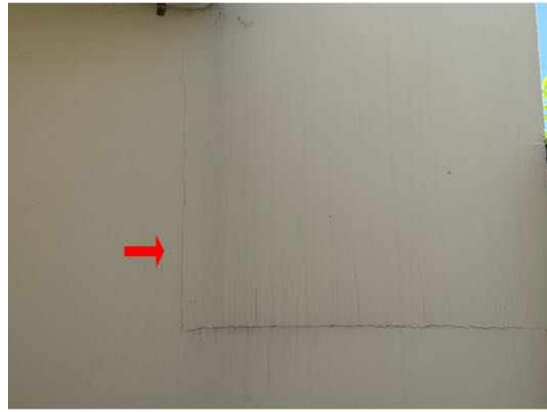
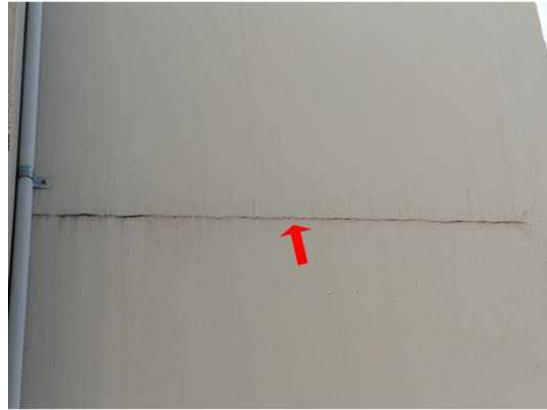
Building: Main Building
Location: Yard - Front & rear
Finding: Cracking Exterior Render - Damage Category 0 - Hairline (less than 1mm)
Information: At the time of inspection cracking in the render at the front and rear of the house, was noticed.

Hairline cracks are very minor in nature and generally are only ever an appearance defect.

While such cracking may be noticeable in some cases, it is quite common and does not indicate any structural damage.

Cracking of this nature can generally be repaired with minor filling and/or repainting. Such works should be performed by a qualified painter or a general handyman.

Monitoring of all cracking should be conducted frequently. Always contact a building inspector should cracks widen, lengthen, or become more numerous.

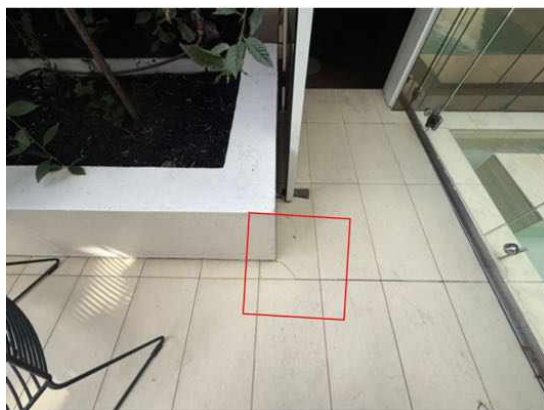
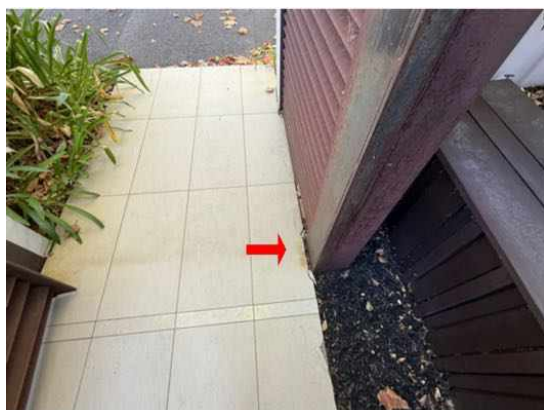
Finding 3.02

Building:	Main Building
Location:	Yard - Back
Finding:	Cracked floor tiles
Information:	Cracking in the floor tiles was evident to the back patio area and front footpath at the time of inspection. It is suspected that this cracking has occurred as a result of minor settlement or shrinkage of the slab.

Cracked tiles throughout the household detract from the overall appearance of the affected areas however it is unlikely to create or lead to any secondary defects.

While not considered a matter of urgency, replacement of cracked floor tiles is recommended at the clients discretion. A tiling contractor may be appointed to perform these works. Where cracks become more numerous, contact a licensed building inspector for further investigation.

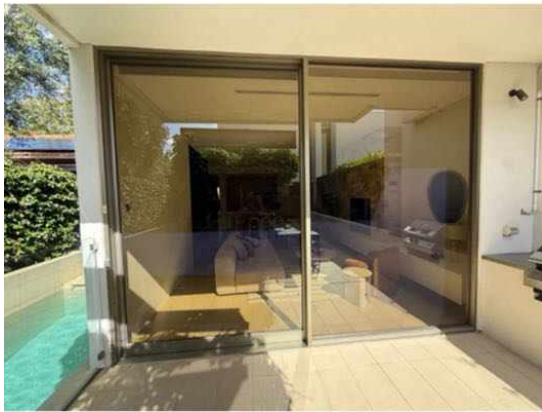
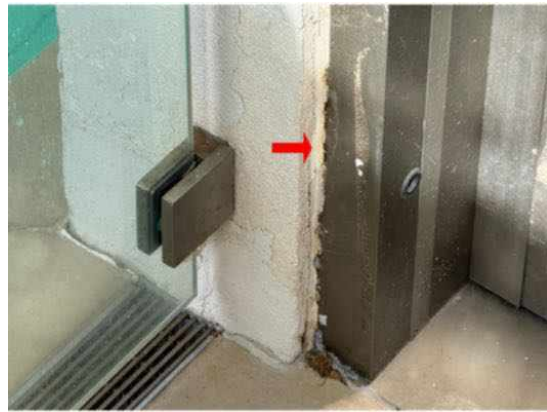
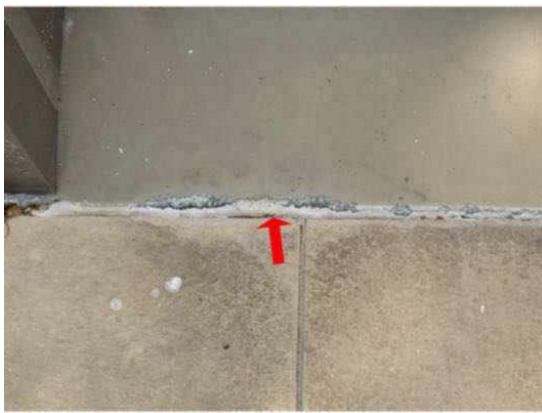
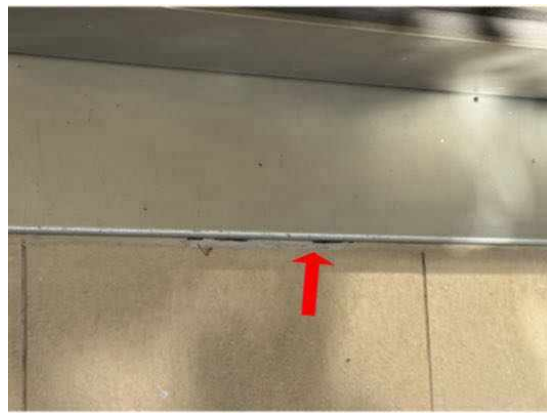
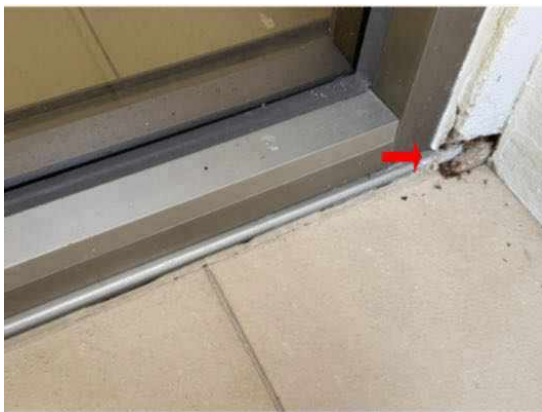
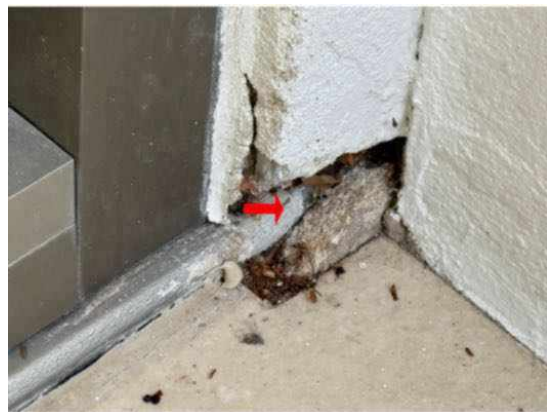
Finding 3.03

Building:	Main Building
Location:	Yard - Back
Finding:	Silicone Missing - Around sliding door Window
Information:	It was noted on inspection that silicone sealant was missing to the surrounds of the exterior sliding door.

This is due to a lack of proper maintenance. Missing sealant around window allows for water egress, pests such as spiders and other insects, increased air flow resulting in a drop in the internal thermal rating.

Flexible, UV and mould resistant materials should be applied to affected areas to prevent any subsequent water damage that is likely to occur. Regular maintenance and replacement of damage or missing or damaged sealant and grout is highly recommended to the wet areas, as this is a regular wear and tear defect. Sealant and grouting in areas that come into regular contact with water should be maintained for the long term care of your property.

A sealant specialist or tiling contractor should be appointed to complete these works

immediately. As a minor sealant problem, if left unchecked, can become a major problem.

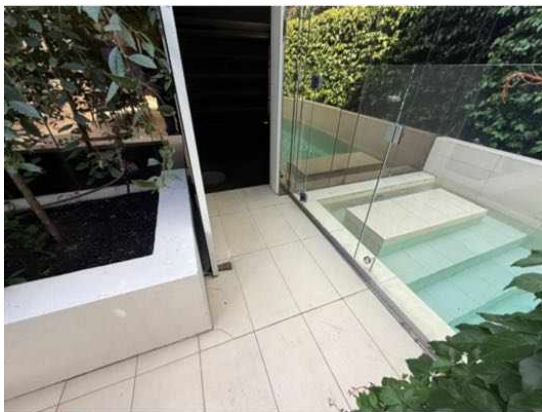
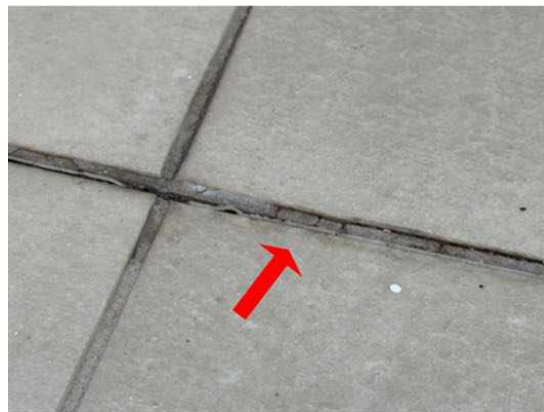
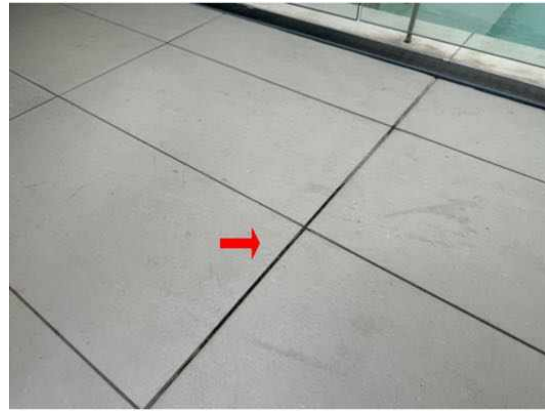
Finding 3.04

Building: Main Building
 Location: Pool Area
 Finding: Sealant and grouting - Missing or damaged
 Information: It was noted on inspection that sealant or grout is degraded to the tiled area around the pool area.

Different materials and floor areas move at different rates, generally causing cracking

There appears to be excessive mould to the sealant and grout which will likely require scraping out and replacement.

Flexible and mould resistant materials should be applied to affected areas to prevent any subsequent water damage that is likely to occur. Regular maintenance and replacement of damage or missing or damaged sealant and grout is highly recommended to the wet areas, as this is a regular wear and tear defect. Sealant and grouting in areas that come into regular contact with water should be maintained for the long term care of your property.

A sealant specialist or tiling contractor should be appointed to complete these works as soon as possible

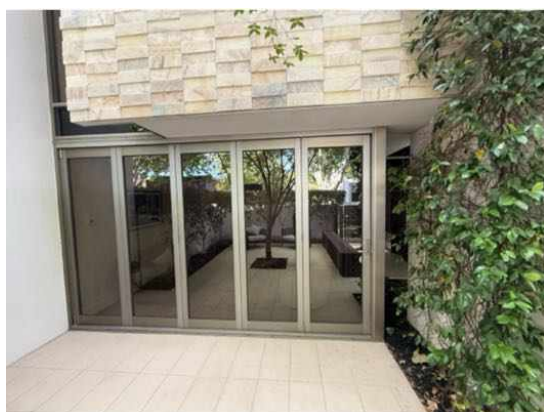
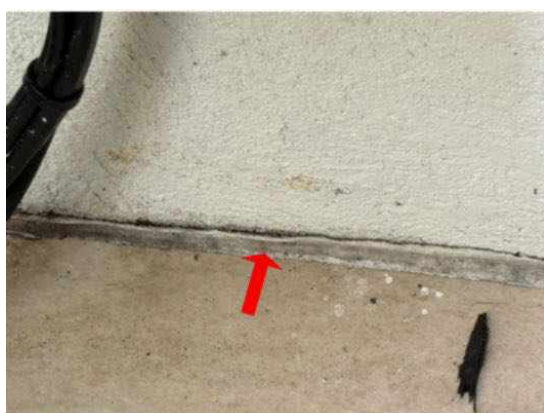
Building:	Main Building
Location:	Yard - Front
Finding:	Silicone Missing - Around sliding door Window

Information: It was noted on inspection that silicone sealant was missing to the surrounds of the sliding door window.

This is due to a lack of proper maintenance. Missing sealant around window allows for water egress, pests such as spiders and other insects, increased air flow resulting in a drop in the internal thermal rating.

Flexible, UV and mould resistant materials should be applied to affected areas to prevent any subsequent water damage that is likely to occur. Regular maintenance and replacement of damage or missing or damaged sealant and grout is highly recommended to the wet areas, as this is a regular wear and tear defect. Sealant and grouting in areas that come into regular contact with water should be maintained for the long term care of your property.

A sealant specialist or tiling contractor should be appointed to complete these works immediately. As a minor sealant problem, if left unchecked, can become a major problem.

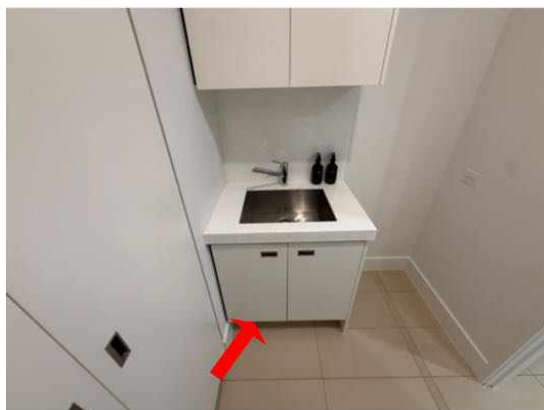
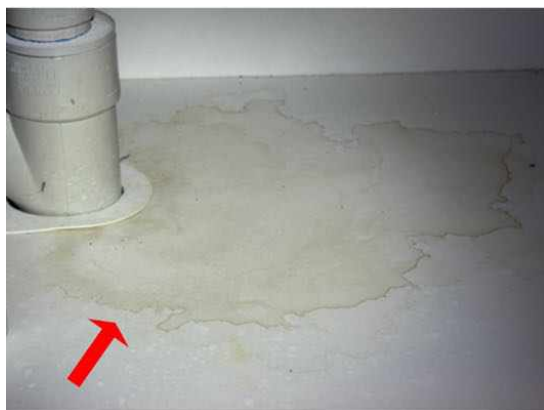
Finding 3.07

Finding: Water staining

Information: Water staining was evident in the laundry cupboard at the time of inspection. Water staining indicates that surfaces have been exposed to excessive moisture over time. The minerals and other elements in the water lead to staining, which may graduate to corrosion and deterioration if left unmanaged.

While mostly an appearance defect, water staining can be indicative of more serious defects, which may be currently concealed by other building elements.

Where water staining is active, a licensed plumber must be consulted to identify the cause of the staining and to provide advice on any reparation works that may be required. Replacement of any broken or damaged structures is advised.

Conversely, where water staining is old and inactive, affected building materials may be repaired or replaced at client discretion. A qualified carpenter or registered builder may be appointed to perform these works.

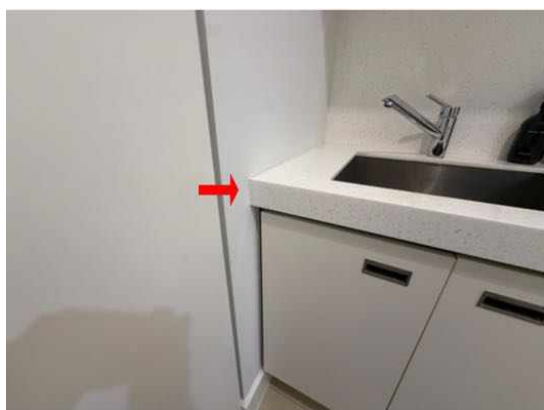
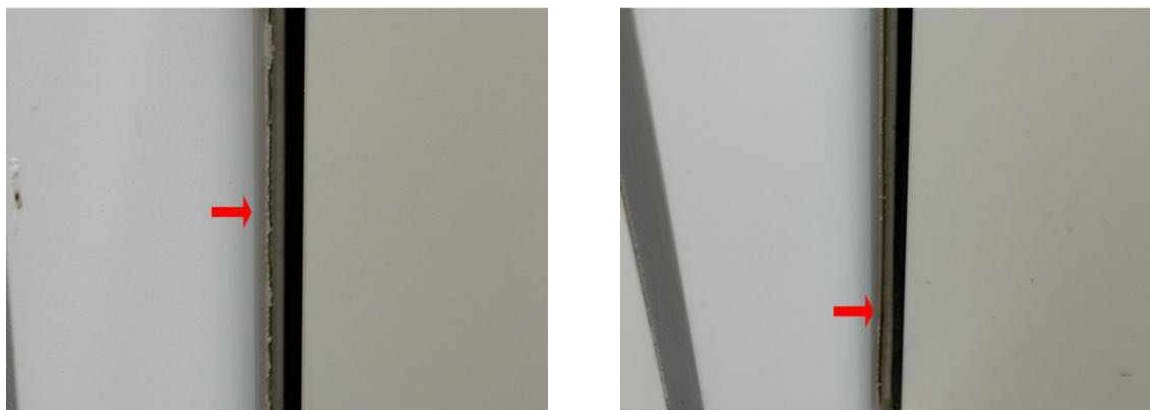
Finding 3.08

Finding: Silicone Deteriorated - laundry

Information: The silicone sealant to the perimeter of the laundry cupboard was observed to be deteriorated, split, and partially missing in sections. Gaps were noted between the basin, wall tiles, and benchtop/wall junctions, indicating loss of effective waterproof sealing.

Failed or deteriorated silicone sealant allows water to penetrate behind finishes during normal use. Over time, this may result in moisture damage to wall linings, cabinetry, or benchtop substrates, and can contribute to mould growth and hygiene concerns within the amenities area.

It is recommended that all deteriorated silicone sealant be removed and replaced with a suitable sanitary-grade waterproof silicone by a plumber or sealant specialist. Works should be carried out immediately, to all basin junctions to reinstate effective waterproofing and maintain hygiene standards.

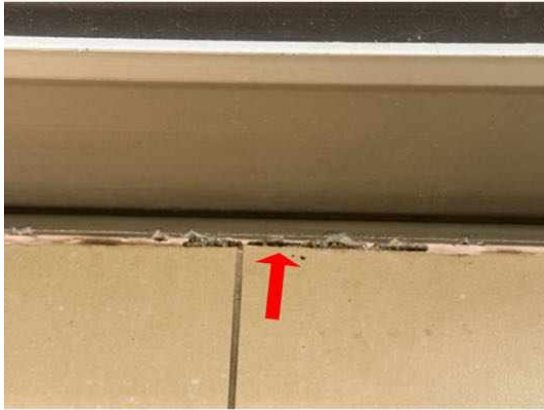
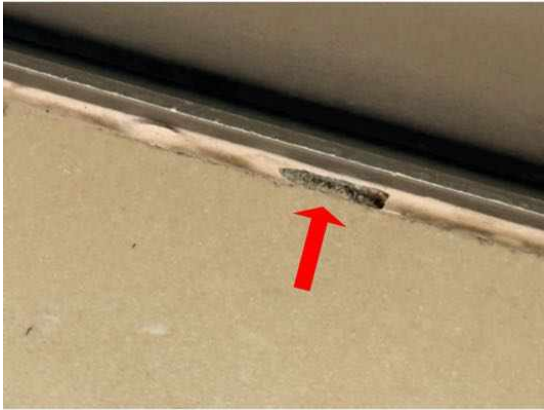
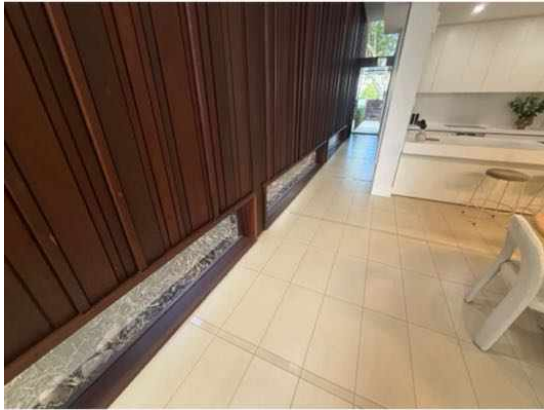
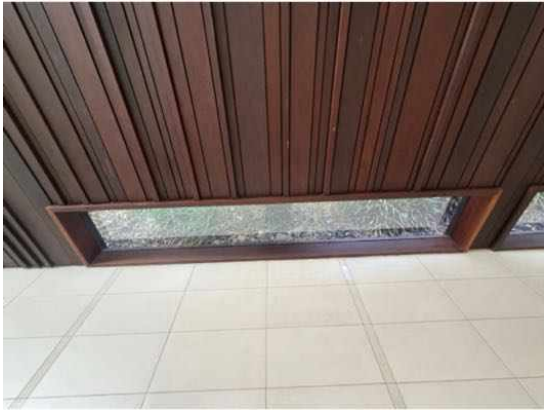
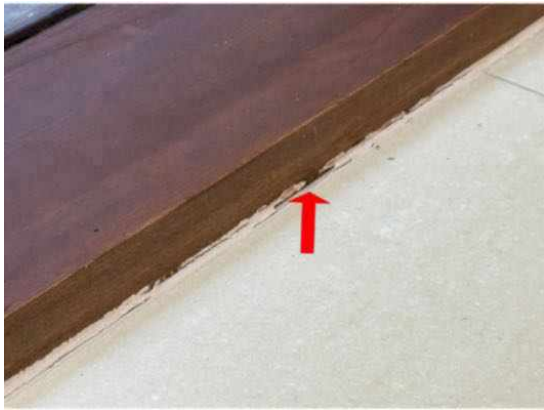
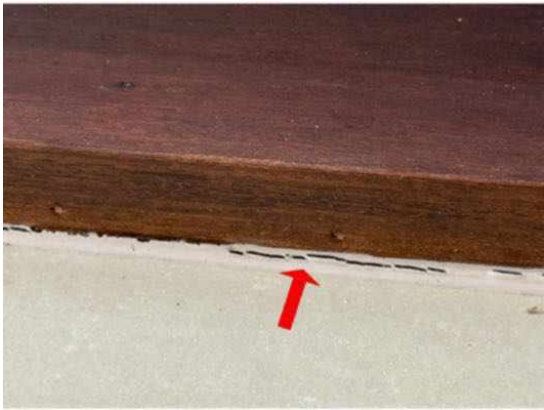
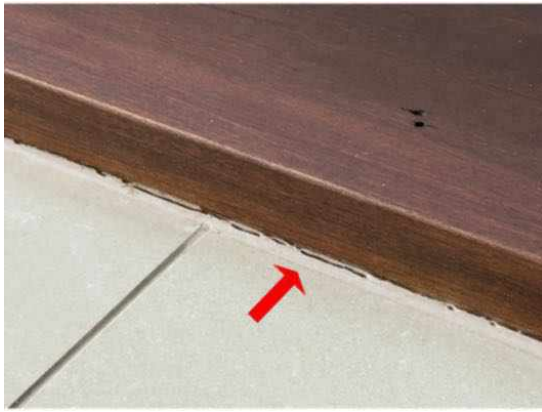
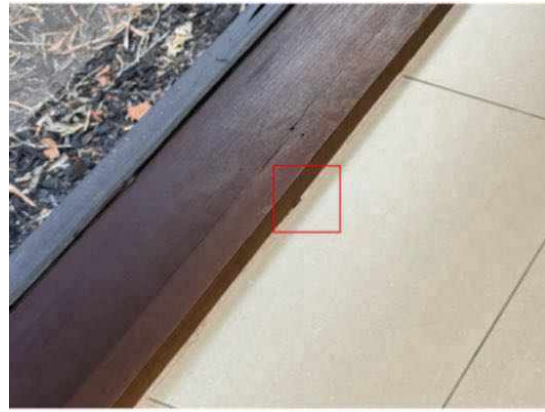
Finding 3.09

Building:	Main Building
Location:	Lounge Room
Finding:	Silicone Missing - Around Windows
Information:	It was noted on inspection that silicone sealant was missing to the surrounds of all the timber windows interior.

This is due to a lack of proper maintenance. Missing sealant around window allows for water egress, pests such as spiders and other insects, increased air flow resulting in a drop in the internal thermal rating.

Flexible, UV and mould resistant materials should be applied to affected areas to prevent any subsequent water damage that is likely to occur. Regular maintenance and replacement of damage or missing or damaged sealant and grout is highly recommended to the wet areas, as this is a regular wear and tear defect. Sealant and grouting in areas that come into regular contact with water should be maintained for the long term care of your property.

A sealant specialist or tiling contractor should be appointed to complete these works immediately. As a minor sealant problem, if left unchecked, can become a major problem.

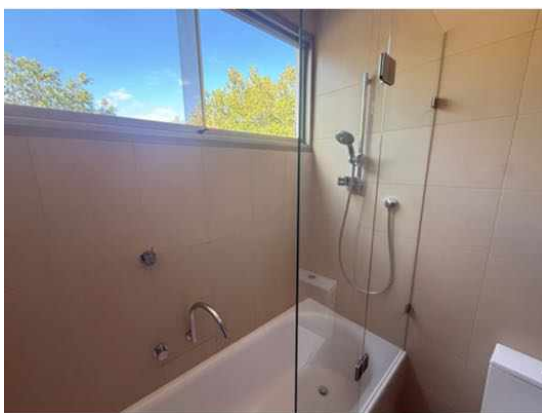
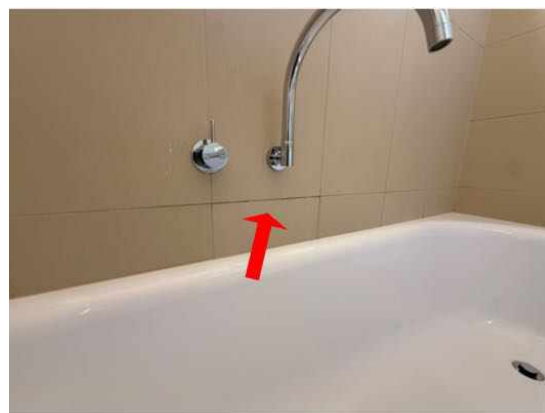
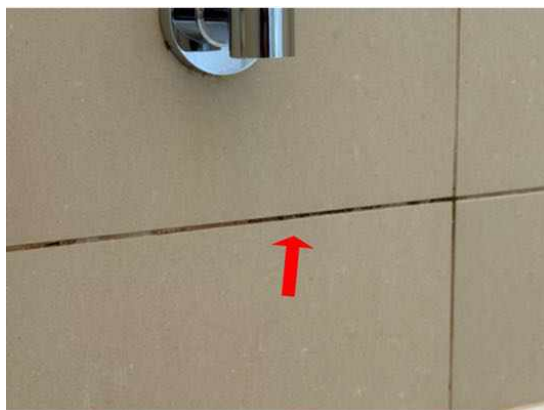
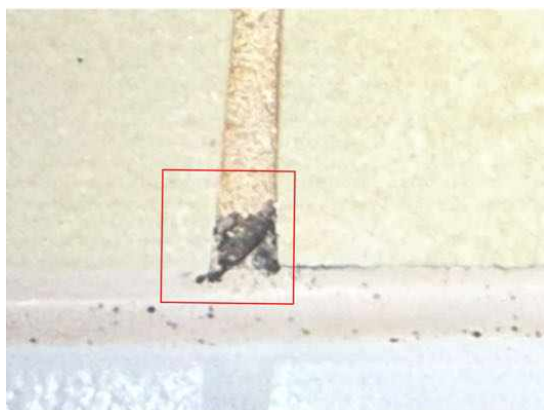
Finding 3.10

Building:	Main Building
Location:	Bathroom
Finding:	Sealant and grouting - Mouldy & Deteriorated
Information:	It was noted on inspection that sealant and grout is degraded and mouldy in the main bathroom shower recess.

When this happens the chances for water penetration of the substrate and timber elements behind the tile wall increases. Once this occurs, it creates a conducive conditions for timber pest attack.

Flexible and mould resistant materials should be applied to affected areas to prevent any subsequent water damage that is likely to occur. Regular maintenance and replacement of damage, missing or damaged sealant and grout is highly recommended to the wet areas, as this is a regular wear and tear defect. Sealant and grouting in areas that come into regular contact with water should be maintained for the long term care of your property.

A licensed plumber, sealant specialist or tiling contractor should be appointed to complete these works immediately.

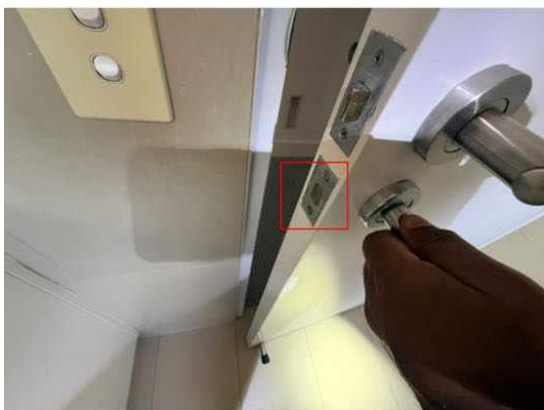
Building:	Main Building
Location:	Bathroom
Finding:	Door handle - Not latching
Information:	It was noted that the door in the bathroom was not latching during operation at the time of inspection. Whilst detracting from the functionality of this building element, this minor defect.

It is suspected that this defect has occurred due to minor issues with the associated hinges. Such damage is identified as general wear and tear, which is expected for building elements of this age.

A qualified carpenter or general handyperson may be appointed to perform rectification works as necessary, at client discretion. If left unattended, further functional impairment is likely to occur.

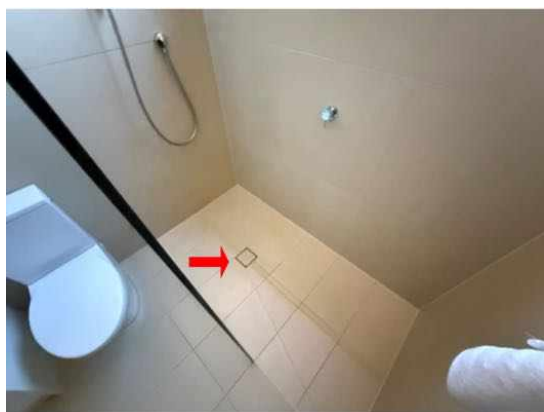
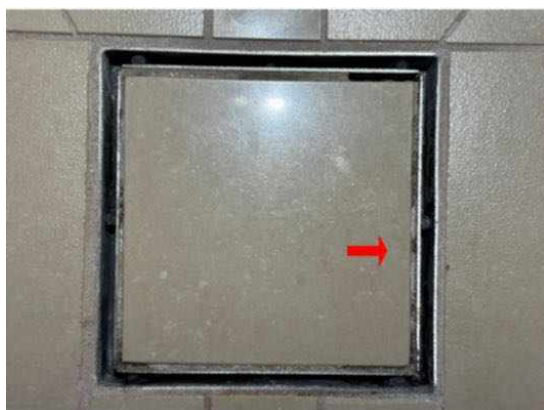
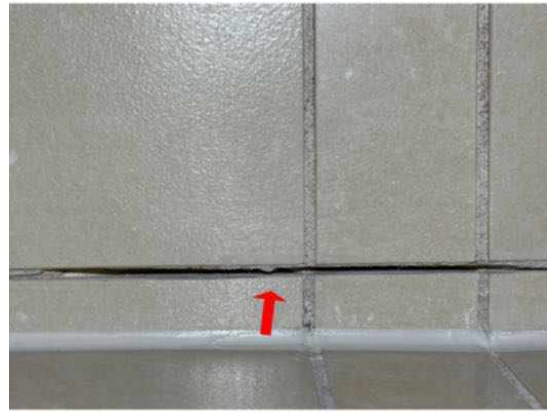
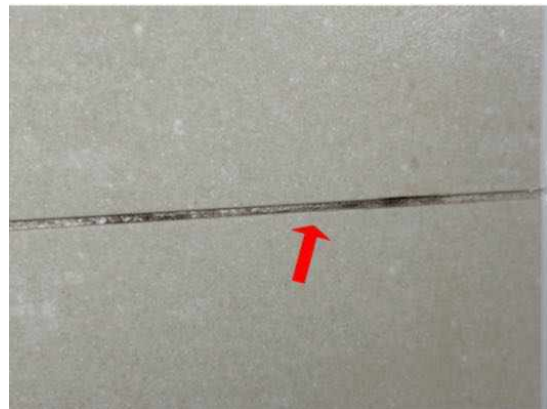
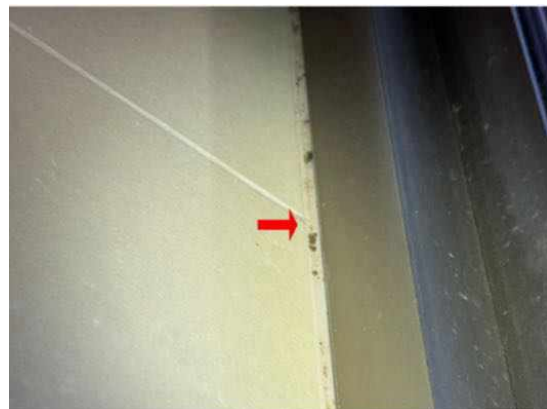
Building: Main Building
Location: Ensuite
Finding: Sealant and grouting - Missing or damaged
Information: It was noted on inspection that sealant or grout is degraded to the tiled shower alcove and or other areas of the ensuite.

Different materials and floor areas move at different rates, generally causing cracking to grout or sealant at this point. A flexible sealant is required to allow for expected expansion and contraction, while keeping the joint water tight and protective of all associated building materials.

There appears to be excessive mould to the sealant and grout which will likely require scraping out and replacement.

Flexible and mould resistant materials should be applied to affected areas to prevent any subsequent water damage that is likely to occur. Regular maintenance and replacement of damage or missing or damaged sealant and grout is highly recommended to the wet areas, as this is a regular wear and tear defect. Sealant and grouting in areas that come into regular contact with water should be maintained for the long term care of your property.

A sealant specialist or tiling contractor should be appointed to complete these works as soon as possible

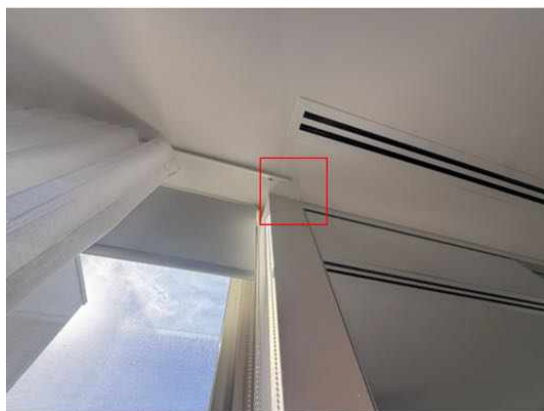
Finding 3.15

Building:	Main Building
Location:	Built In Robe
Finding:	Cracking - Damage Category 1 - Fine (up to 1mm)
Information:	Although fine cracks are quite noticeable, they are often only considered to be an appearance defect, and usually do not indicate any structural damage. Generally, the cause of a fine crack is indicative of a separation between building materials and finishes (e.g. paint, plaster, etc.) along joins.

Cracking of this nature can generally be repaired with minor sanding, filling and/or repainting. Such works should be performed by a qualified painter or a general

handyman.

Monitoring of all cracking should be conducted frequently. Always contact a building inspector should cracks widen, lengthen, or become more numerous.

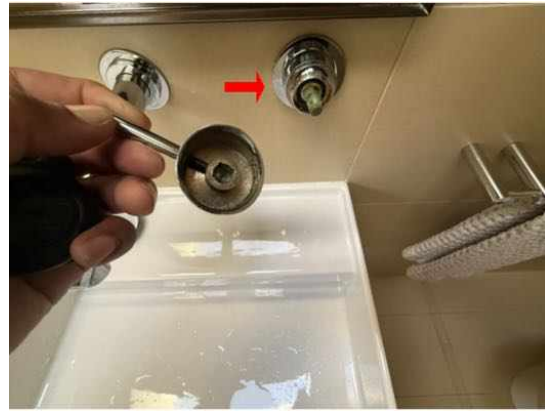
Building: Main Building
Location: Garage Ensuite
Finding: Tap - Loose
Information: The tap in this area has not been installed correctly, or has deteriorated with age, and is consequently loose and come off. This tap being loose creates potential for water leaks and subsequent water damage to the surrounding area.

Where taps or spouts are loose, a qualified plumber should be appointed to re-fix the plumbing fitting.

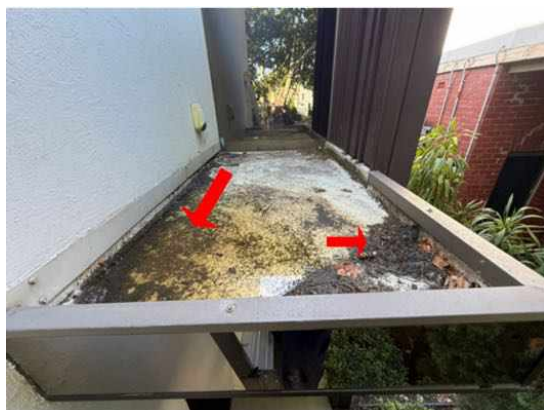
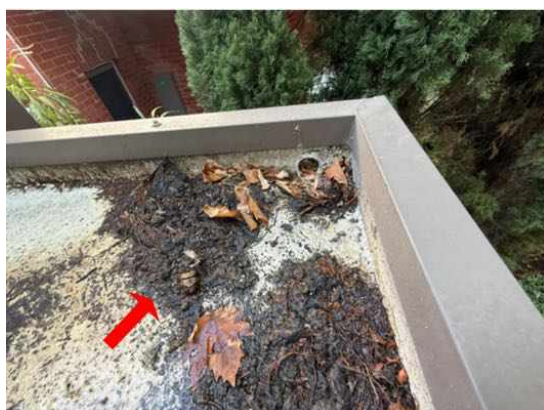
Blocked gutters are likely to lead to high levels of moisture in the affected areas. Such moisture will not only cause rust and decay of the associated building materials, but can also provide conditions that are conducive to termite and timber pest activity. Blockages in gutters should therefore be removed immediately to ensure dry conditions are maintained.

Consult a Licensed Plumber for further specific advice on remedial works that may be required. In the interim, it is highly advised that blocked gutters be removed by the homeowner or a general handyperson as a matter of urgency.

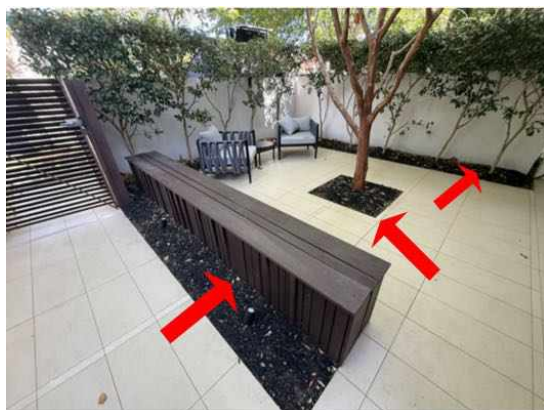
Building:	Main Building
Location:	All Areas
Finding:	Mulch - Garden Beds
Information:	Tan bark mulch has been used in garden beds surrounding the perimeter of the property. While commonly used for landscaping, this organic material retains moisture and provides a food source, thus creating conducive conditions for sub terranean termite activity.

A Reduction in mulch levels to no more than 50mm in depth, ensuring it is kept at least 75mm clear of slab edges, weep holes, and structural timbers is recommended. Consider replacing with non-organic ground cover in high-risk areas.

The property owner should consult a qualified landscaper urgently to rectify this condition.

A pest technician should reinspect periodically.

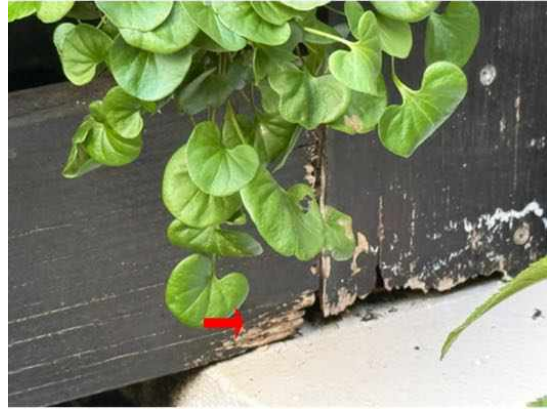
Finding 7.01

The stage of decay to the external garden timbers and fence will require removal and replacement to rectify the issue.

A general handyman, carpenter or fencing contractor, may be required to perform these works at the owners discretion.
