# Building and Timber Pest Inspection Report

Inspection Date: Tue, 17 Feb 2026

Property Address: 23 Ronald Ave, Greenwich NSW 2065, Australia

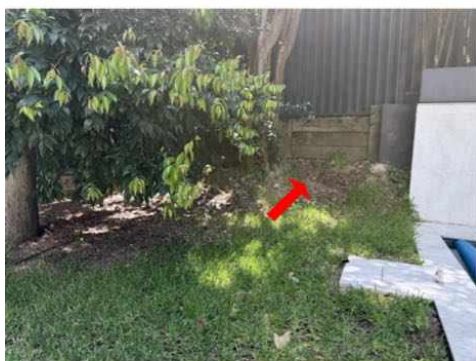
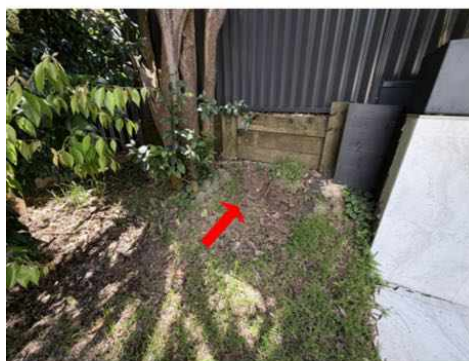
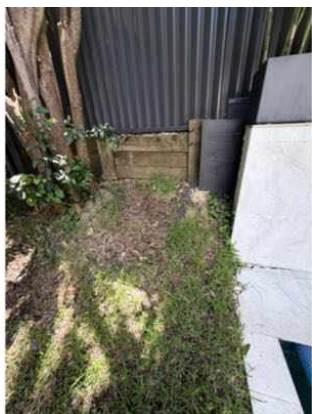
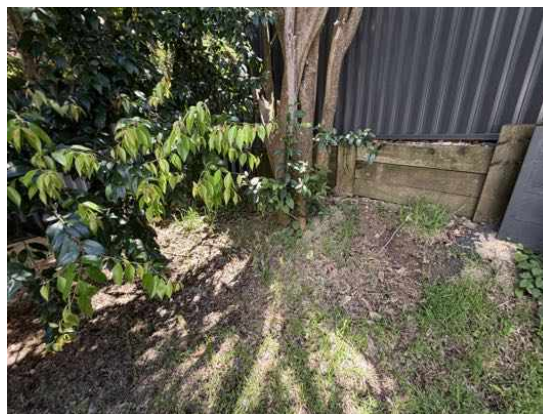
Building: Main Building  
Location: Pool Area  
Finding: Soil Erosion  
Information: Soil erosion from inadequate retaining wall to the back fence and neighbouring property is found.

The soil appears to be washing away at the back of the retaining wall.

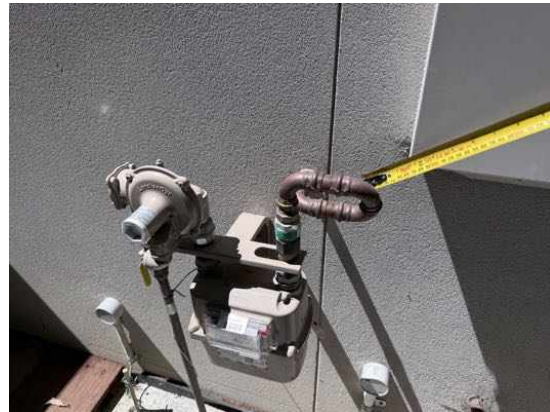
### Finding 1.02

Building: Main Building  
Location: Exterior walls - left side  
Finding: Gas Meter Distance to Electrical Meter  
Information: The gas meter and regulator is required a minimum 500mm away from the electrical meter.

Relocation of the gas meter is required.

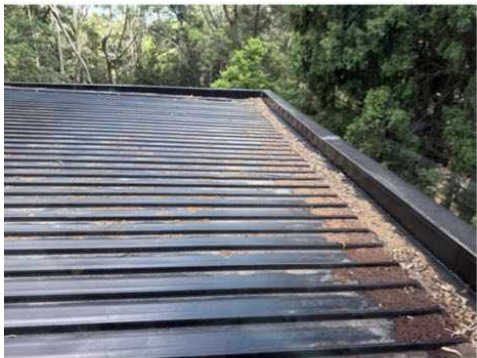
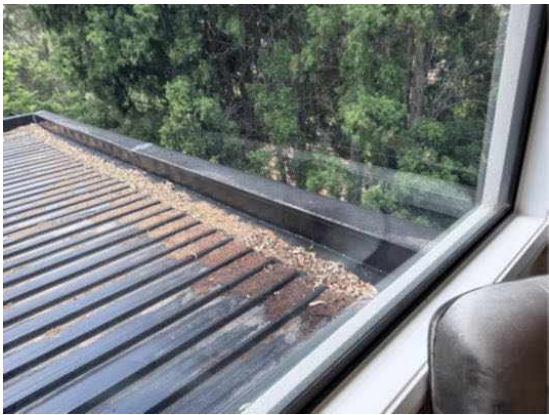
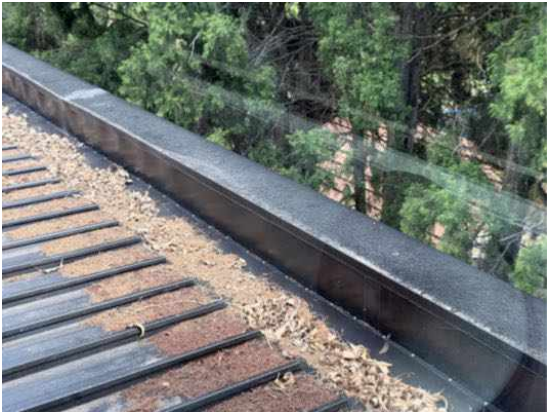
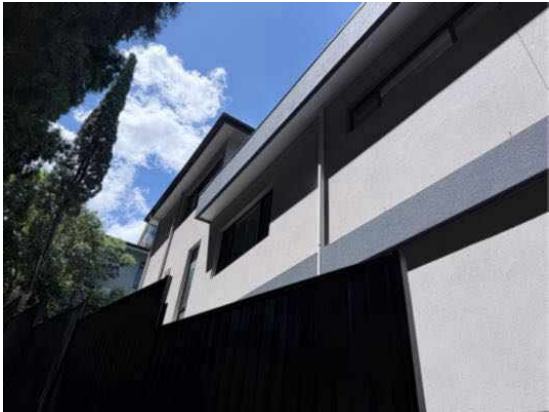
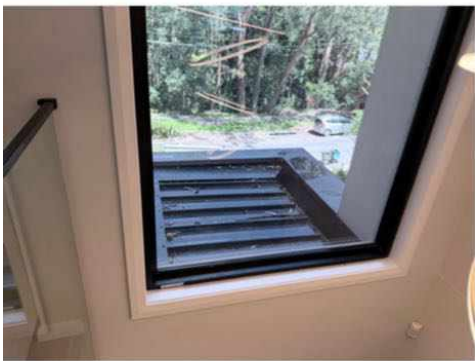
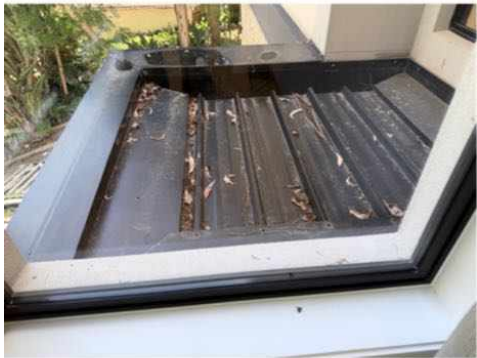
### Finding 2.01

Building: Main Building  
Location: Roof Exterior  
Finding: Overflow of Roof Box Gutter Missing  
Information: No overflow provision has been installed to the box gutter.

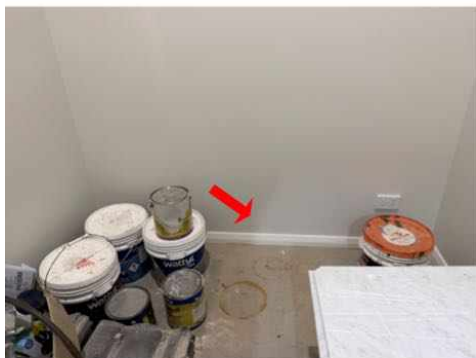
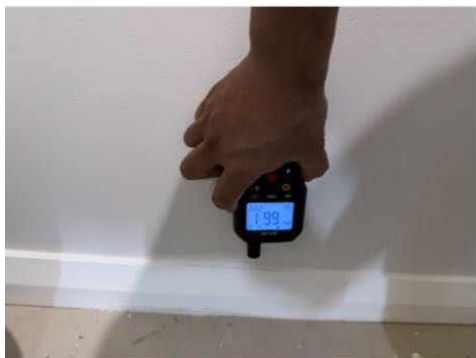
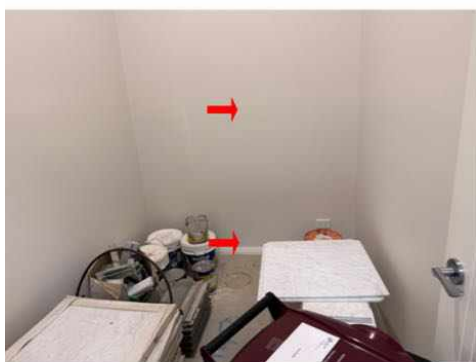
Finding 2.02

Building:	Main Building
Location:	Store Room
Finding:	Damp - Rising
Information:	Rising damp describes the upward movement of water in low sections of building elements (e.g. walls) by capillary action - the movement of water through porous materials such as bricks, sandstone or mortar.

Consultation with a qualified plumber is advised immediately to identify the cause of the damp and perform remedial works as required.

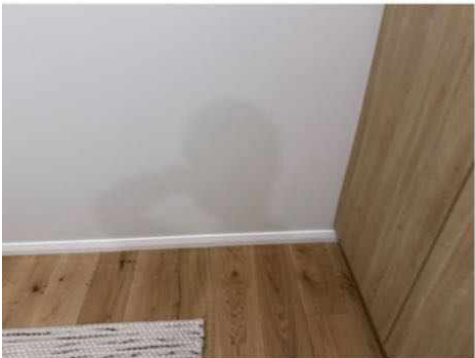
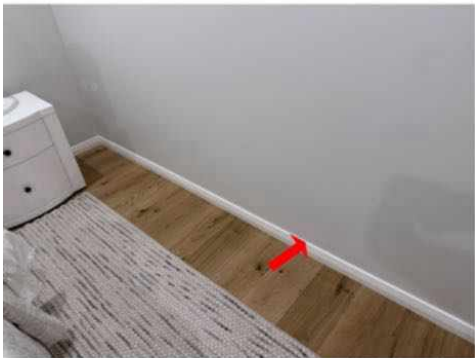
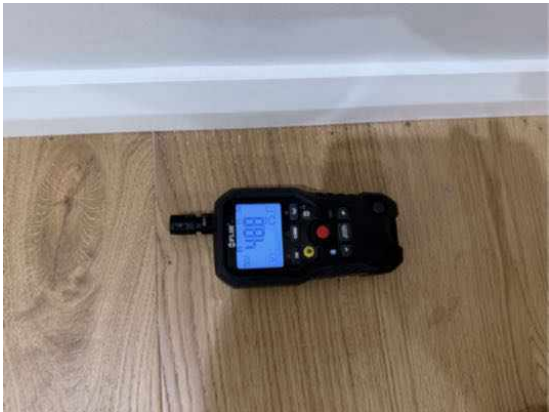
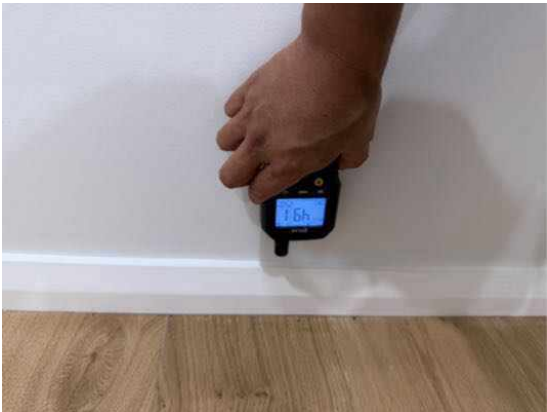
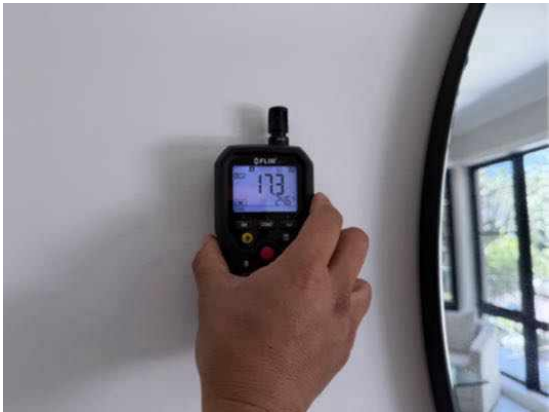
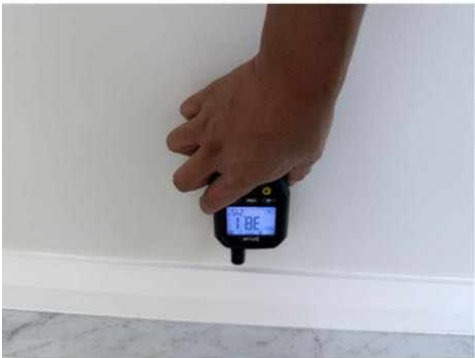
### Finding 2.03

Building:	Main Building
Location:	Bedroom
Finding:	Exterior walls - Lateral damp
Information:	Lateral penetrating damp refers to the sideways movement of moisture, predominantly from the surrounding ground, which tends to affect basement walls and other earth-retaining walls. The implications of unmanaged damp range from mould fungi growth, wood rot and decaying building materials, to finishes including lifting, bubbling, peeling and staining of paint, plaster and wallpaper.

Immediate consultation with a licensed plumber is advised to address the cause of the

damp and to perform remedial works as necessary.

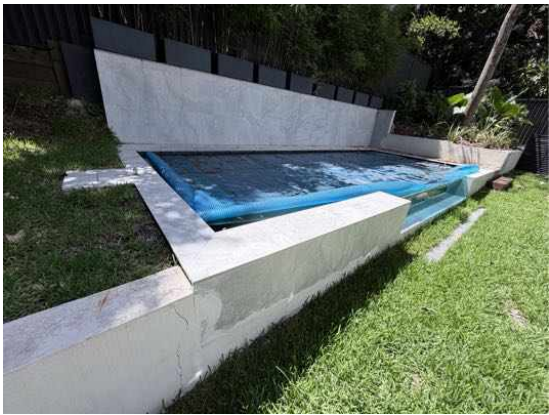
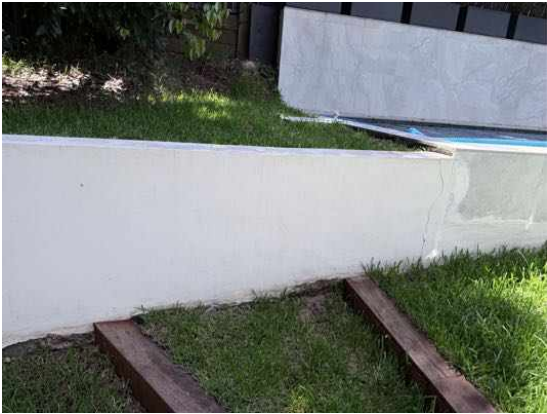
## Finding 2.04

Building:	Main Building
Location:	Pool Area
Finding:	Retaining wall - Defective
Information:	Crack is observed to the retaining wall of greater than 2mm. The retaining wall is measured to be leaning outwards indicating a movement in the retaining wall.

The retaining wall in this area was found to be defective at the time of inspection. Generally, defective retaining walls are caused by poor original design or material use. However, deteriorated retaining walls may also be a result of substandard construction, poor site drainage or unmanaged stormwater flows.

If left unmanaged, the retaining wall may become a safety hazard if it continues to destabilise. Where retaining walls further rot and decay, an environment is created that is conducive to termite and pest infestation.

Significant repair and replacement should be expected. Where retaining walls are considered structural walls, a structural engineer / surveyor should be consulted regarding required remedial works. Otherwise, a landscaper or retaining wall installer may be appointed to repair or replace the wall, at the discretion of the client.

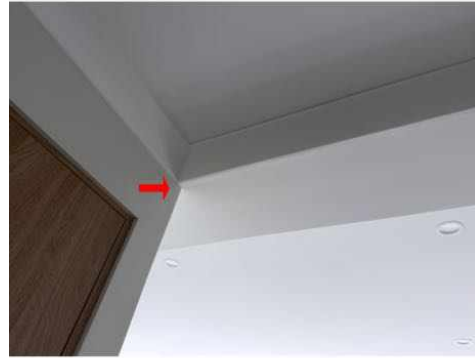
Building:	Main Building
Location:	Stair Landing
Finding:	Cracking - Damage Category 0 - Hairline (less than 1mm)
Information:	Hairline cracks are very minor in nature and generally are only ever an appearance defect. While such cracking may be noticeable in some cases, it is quite common and does not indicate any structural damage.

Cracking of this nature can generally be repaired with minor sanding, filling and/or

repainting. Such works should be performed by a qualified painter or a general handyman.

Monitoring of all cracking should be conducted frequently. Always contact a building inspector should cracks widen, lengthen, or become more numerous.

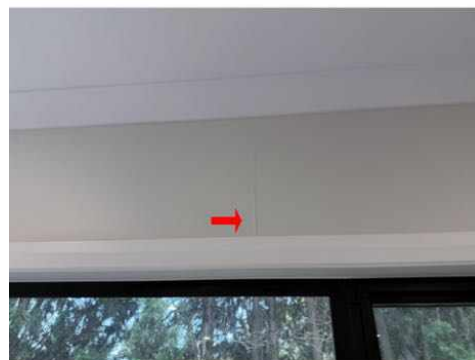
### Finding 3.04

Building:	Main Building
Location:	Bedroom - Master
Finding:	Cracking - Damage Category 0 - Hairline (less than 1mm)
Information:	Hairline cracks are very minor in nature and generally are only ever an appearance defect. While such cracking may be noticeable in some cases, it is quite common and does not indicate any structural damage.

Cracking of this nature can generally be repaired with minor sanding, filling and/or repainting. Such works should be performed by a qualified painter or a general handyman.

Monitoring of all cracking should be conducted frequently. Always contact a building inspector should cracks widen, lengthen, or become more numerous.

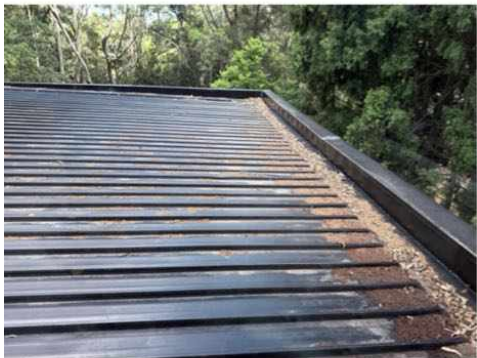
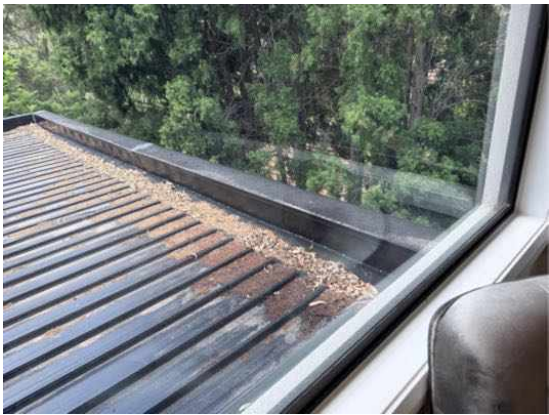
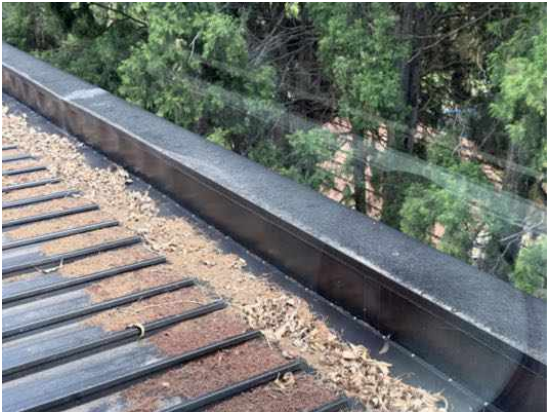
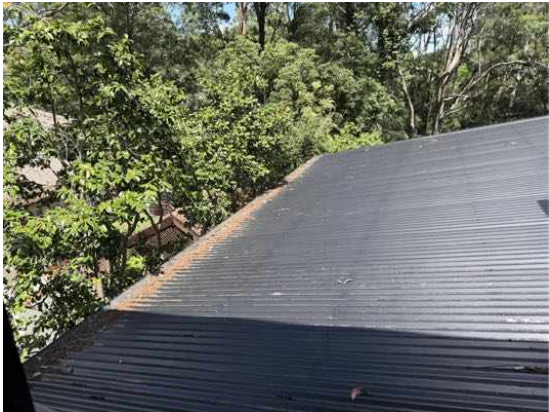
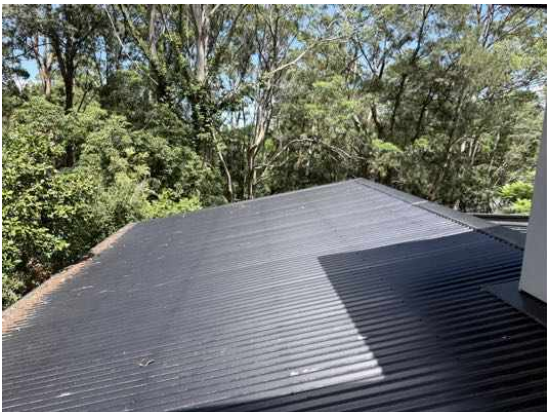
Gutters are a critical part of the building's management of storm water and rain. It is therefore important that they be kept clear to prevent secondary damage to associated building elements, including exterior and interior walls, ceiling linings and any adjoining building elements. Where gutters are blocked, pooling of rainwater is likely to occur, fast-tracking rust and corrosion of the roof plumbing elements.

It is highly advised that all overhanging tree branches be removed as soon as possible to prevent any further damage. Repair and/or replacement of sections of damaged guttering may also be required where the extent of the damage necessitates.

Such works should be performed by the homeowner; however, appointment of a landscape contractor or an arborist may be required. Consultation with a licensed roof plumber is required where guttering has been damaged.

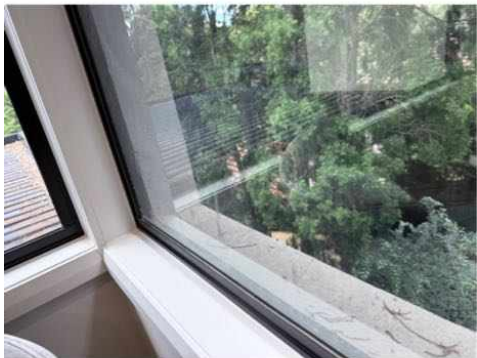
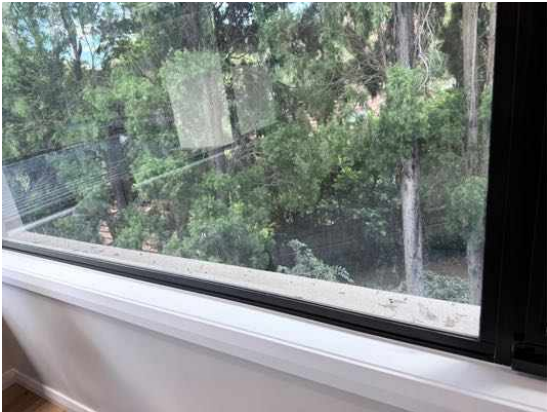
**Finding 3.07**

Building: Main Building  
Location: Bedroom - Master  
Finding: Window Not Cleaned  
Information: Construction render and concrete splashes on the windows has not been cleaned.

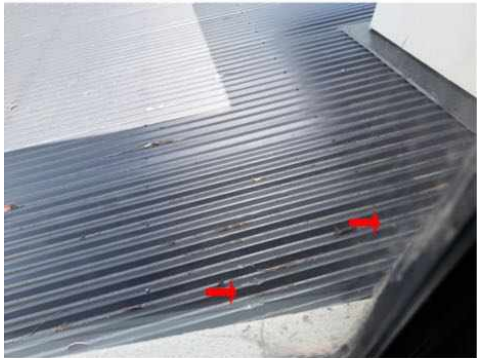
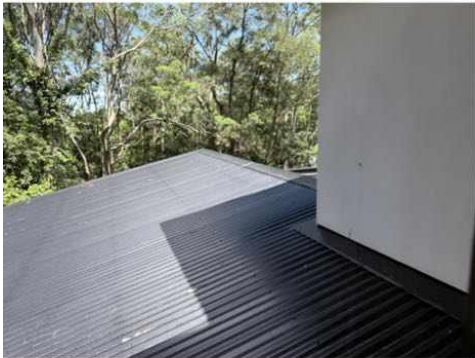
**Finding 3.08**

Building: Main Building  
Location: Roof Exterior  
Finding: Roof Sheeting Dented  
Information: Dents is observed on the roof sheets.

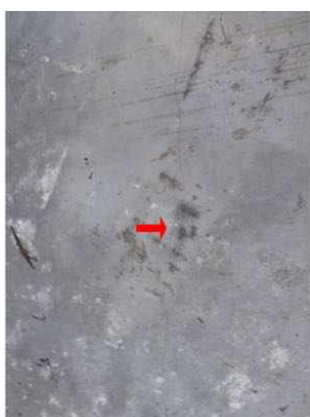
**Finding 3.09**

Building: Main Building  
Location: Garage  
Finding: Crack in concrete slab - Category 1

Information: A crack coded as Category 1 was identified in the slab. A Category 1 crack is described as a fine but noticeable crack, with the slab at an otherwise reasonable level.

To be considered Category 1, the approximate width of the crack is less than 1.0mm, or a less than 10mm change in offset when a 3m straight edge is placed over the defect.

Category 1 cracks should be monitored for a period of 12 months. At the end of the monitoring period, identified cracks that are rated greater than Category 2 are considered defects, and require rectification.

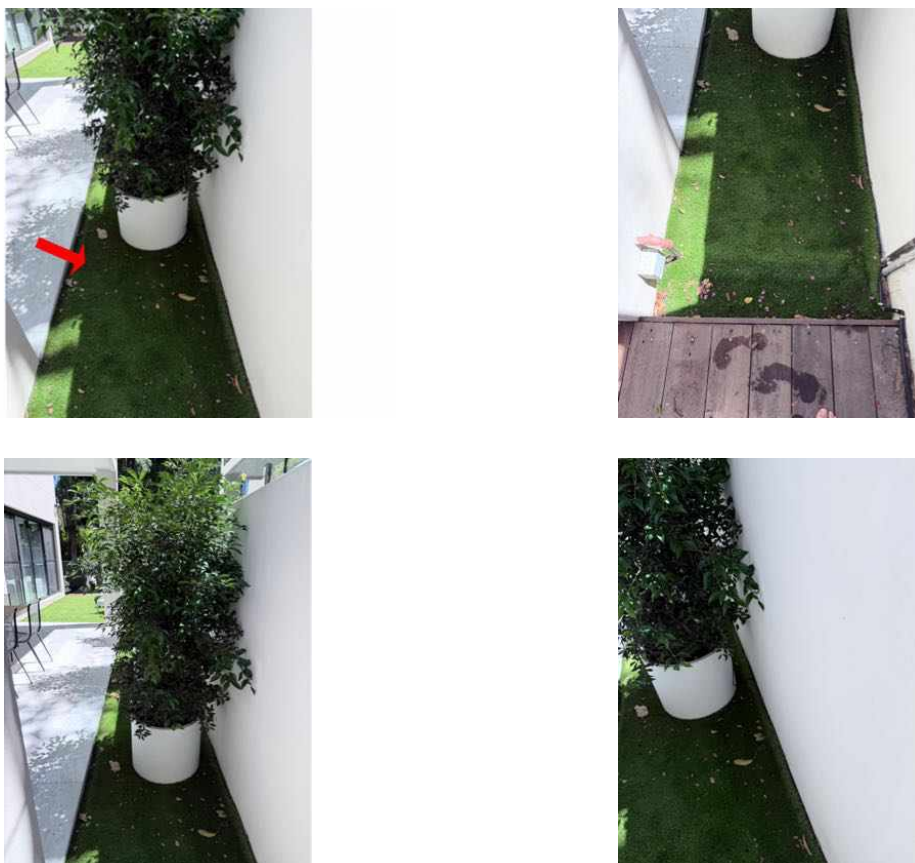
Building:	Main Building
Location:	Yard - Back
Finding:	Site drainage - Inadequate
Information:	The site drainage in this area was found to be inadequate at the time of inspection, creating potential for subsequent water damage to associated building elements.

It is important that water does not lie against the base of walls; surrounding paths and ground levels should be sloped to drain water away from walls. Downpipes should not discharge stormwater onto lower walls or plinths. Stormwater should be carried away by large, regularly cleaned drains. Ground levels may need to be lowered to expose a buried DPC.

Where site drainage is inadequate, installation of an Agricultural (Aggie) Drain may be required. A qualified plumber should be appointed to further inspect the property and perform any remedial works as necessary. Water damage and secondary defects are likely to occur if left unmanaged.

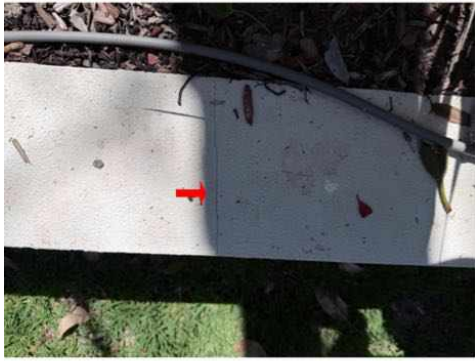
### Finding 3.12

Building:	Main Building
Location:	Yard - Back
Finding:	Cracking - Damage Category 1 - Fine (up to 1mm)
Information:	Although fine cracks are quite noticeable, they are often only considered to be an appearance defect, and usually do not indicate any structural damage. Generally, the cause of a fine crack is indicative of a separation between building materials and finishes (e.g. paint, plaster, etc.) along joins.

Cracking of this nature can generally be repaired with minor sanding, filling and/or repainting. Such works should be performed by a qualified painter or a general handyman.

Monitoring of all cracking should be conducted frequently. Always contact a building inspector should cracks widen, lengthen, or become more numerous.

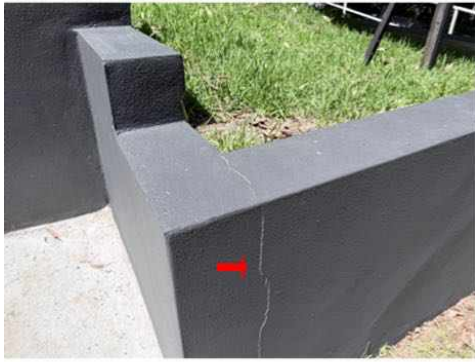
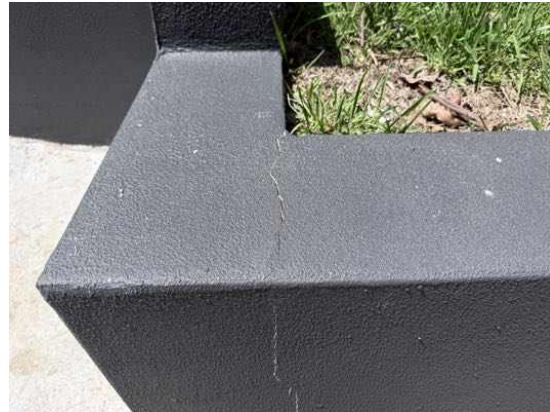
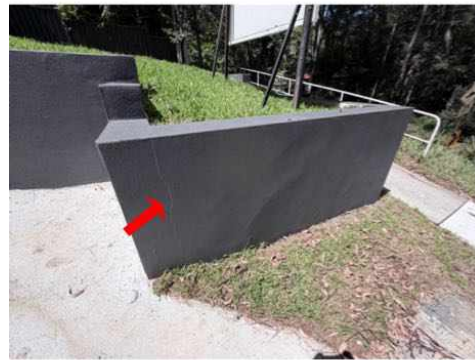
Building:	Main Building
Location:	Yard - Front
Finding:	Cracking - Damage Category 1 - Fine (up to 1mm)
Information:	Although fine cracks are quite noticeable, they are often only considered to be an appearance defect, and usually do not indicate any structural damage. Generally, the cause of a fine crack is indicative of a separation between building materials and finishes (e.g. paint, plaster, etc.) along joins.

Cracking of this nature can generally be repaired with minor sanding, filling and/or repainting. Such works should be performed by a qualified painter or a general handyman.

Monitoring of all cracking should be conducted frequently. Always contact a building inspector should cracks widen, lengthen, or become more numerous.

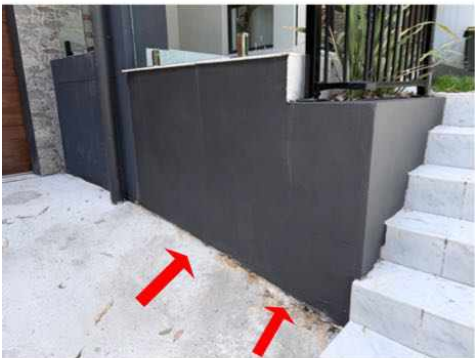
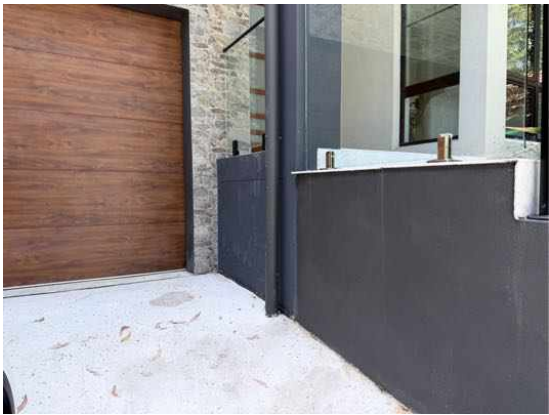
### Finding 3.15

Building:	Main Building
Location:	Yard - Front
Finding:	Water leak - External
Information:	Water leaks were found to be present to exterior plumbing work. Leaks are generally caused by deterioration of the plumbing elements over time, due to exposure to weather conditions, but may have also been caused by minor impact damage.

Such leaking creates damp conditions in the affected area, causing potential for water pooling and subsequent water damage if left unattended. These conditions may also attract termite attack, particularly if the area is subject to minimal levels of sun throughout daylight hours.

It is highly advised that a licensed plumber be appointed to rectify any water leaks that may be present. Areas of repair and replacement of plumbing fittings and fixtures may be required and, as such, a quotation should be sought.

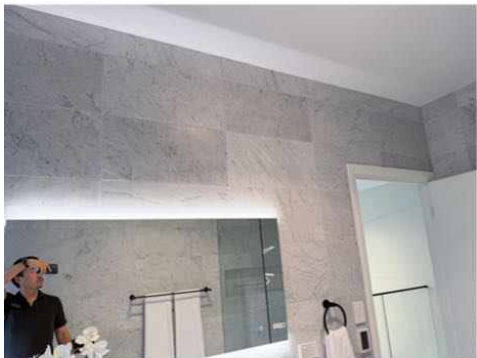
Building: Main Building  
Location: Bathroom 2  
Finding: Inconsistent Stone Batch Colour  
Information: The stone batch used for the wall tiling is inconsistent, which created a light and dark tiles to be adjacent to each other.

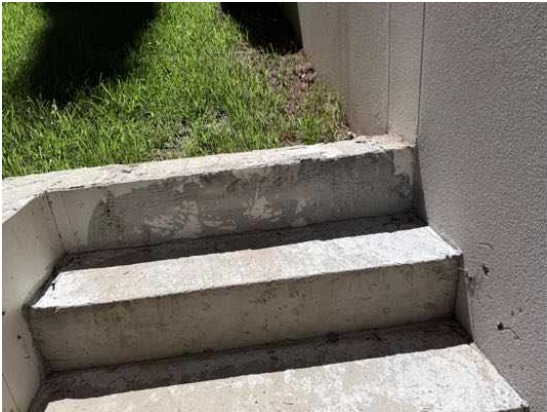
Building: Main Building  
Location: Exterior walls - left side  
Finding: Tiling and Finishing to Stair - Incomplete  
Information: The tiling and finishing to the external stair appears to be incomplete.
