Building and Timber Pest Inspection Report

Inspection Date: Wed, 01 Apr 2026

Property Address: 86 Princes St, Ryde NSW 2112, Australia

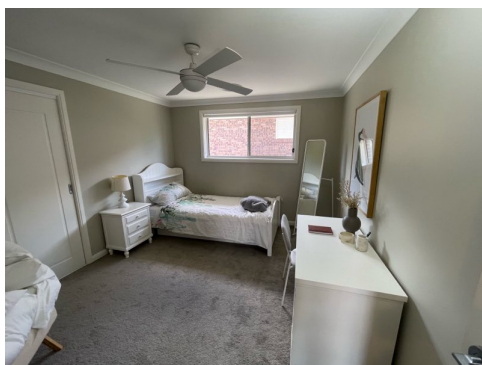
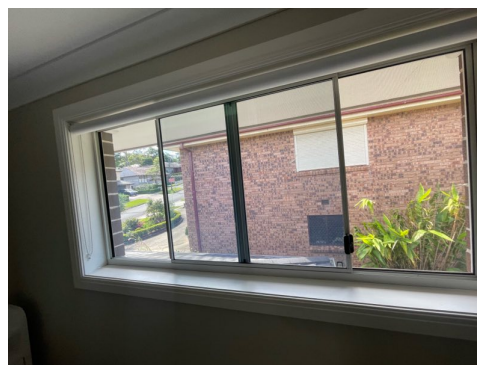
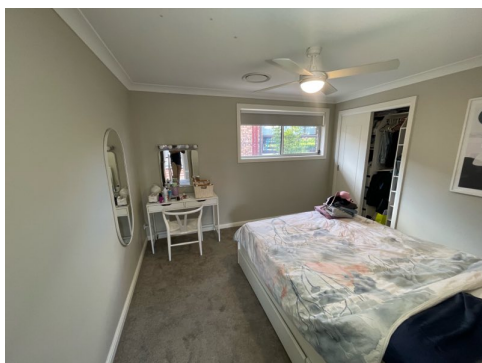
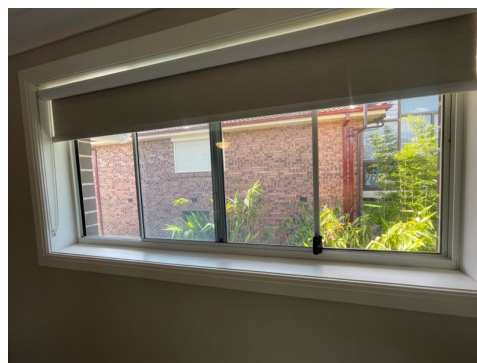
Finding: Window - Opening Restrictor / Barrier Missing

Information: During the inspection, a window was observed without an opening stopper/restrictor and with the required safety barrier protection missing. Where windows are located above lower ground levels or otherwise accessible, the absence of these safety measures may create an increased risk of falls, particularly for children.

Their absence indicates the window may not provide an adequate level of occupant protection in its current condition.

A qualified builder or suitably licensed contractor should be engaged to assess the affected window and install an appropriate window opening restrictor and/or compliant barrier system as required. This issue should be treated as a safety concern and addressed without delay.

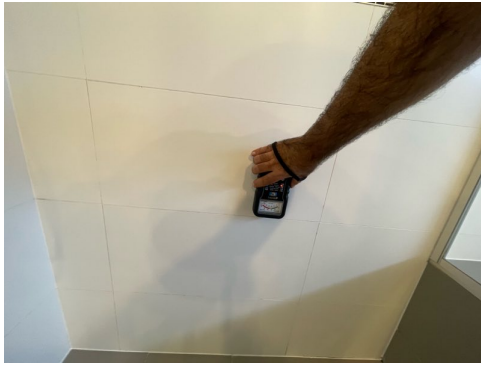
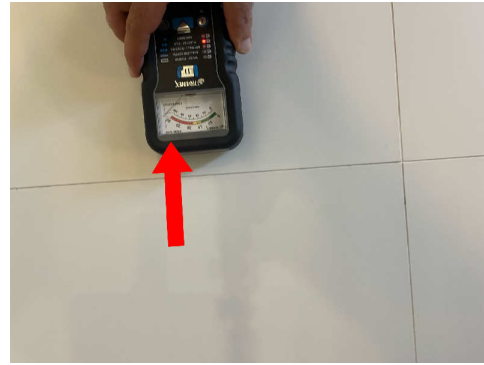
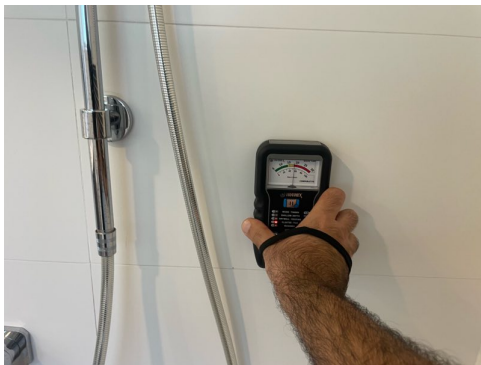
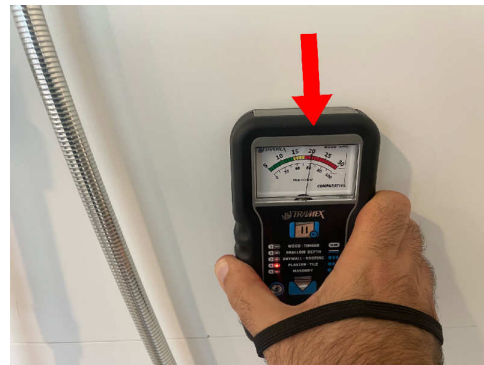
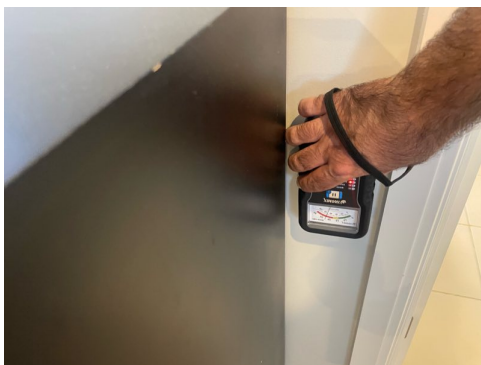
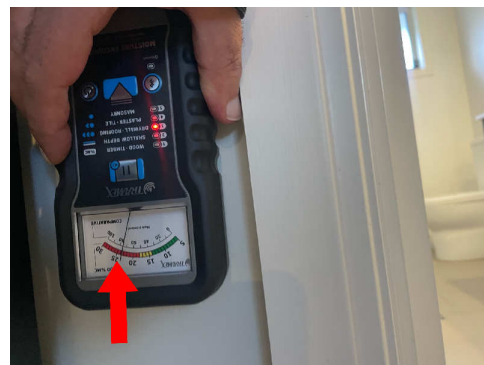
Finding 2.01

Information: During the inspection, damp was evident to the lower meter of the wall in the shower alcove. This type of defect is quite common in wet areas and is suspected to be caused by moisture permeating through deteriorated grouting and sealant. A leaking pipe within the adjoining wall remains a possible cause.

Moisture readings were also elevated on the back wall adjoining the dining room, suggesting the damp is not confined to the shower recess alone and may be affecting adjacent areas of the property.

If unmanaged, damp conditions will likely lead to the growth of mould and fungi, deterioration of building materials, and eventual compromise of structural integrity.

It is recommended that a qualified plumber or bathroom specialist be engaged immediately to determine the precise source of moisture and carry out appropriate rectification works.

If mould growth is significant, consultation with a specialist environmental health inspector should also be considered. Regular maintenance of sealants and grout in wet areas is essential to prevent recurrence of moisture-related issues in the future.

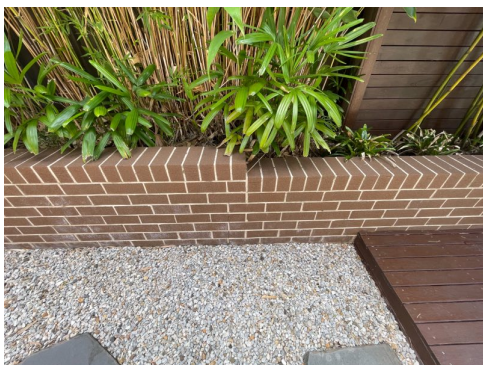
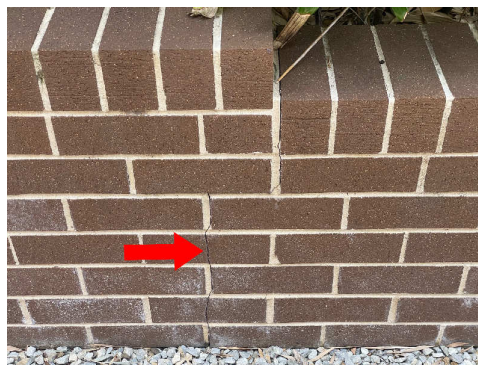
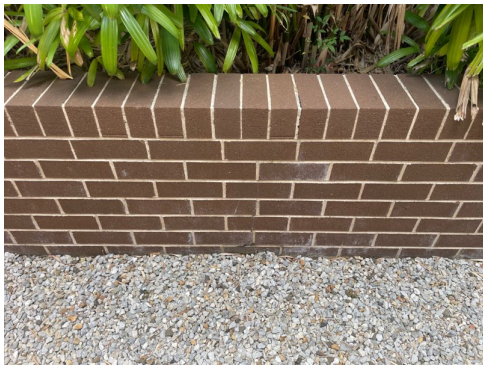
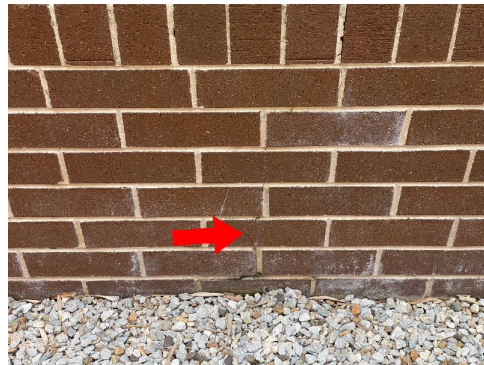
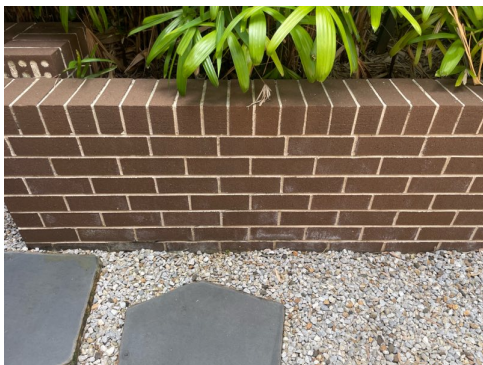
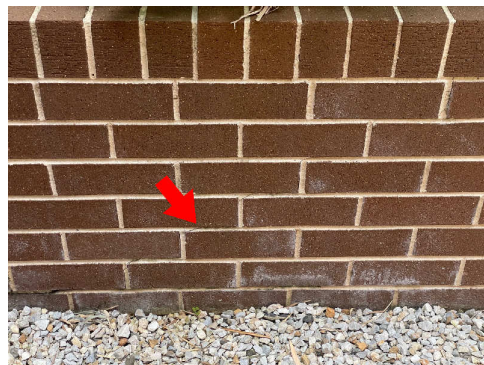
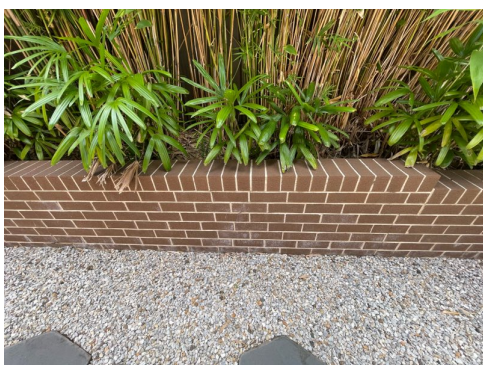
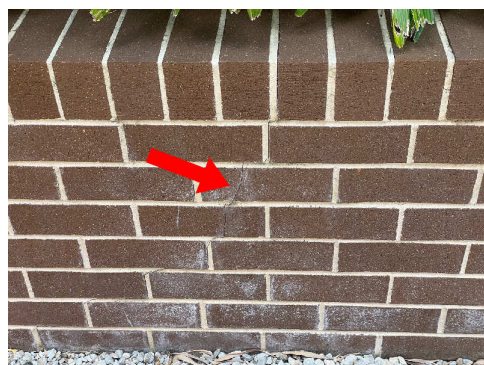
Finding 3.01

Finding: Cracked and Deteriorating Low-Height Brick Retaining Wall

Information: During inspection, it was observed that the low-height brick retaining wall has developed noticeable cracking, with deterioration of the mortar joints also evident. Such defects indicate progressive movement and weathering of the wall, which may compromise both its appearance and functionality.

The deterioration of mortar reduces the overall stability of the wall and weakens the bond between bricks.

Cracking can allow water penetration, which accelerates the breakdown of materials and may lead to further displacement or collapse if not managed. While the wall is not a major structural element, retaining walls play an important role in supporting adjacent ground and preventing soil displacement.

It is recommended that a suitably qualified tradesperson, such as a bricklayer or structural landscaper, be engaged to assess and repair the wall. Works may involve repointing mortar, replacing damaged bricks, and monitoring for any underlying soil movement. Timely maintenance will restore the wall's integrity and prevent further deterioration.

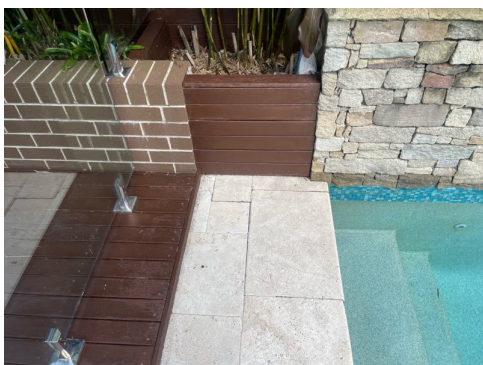
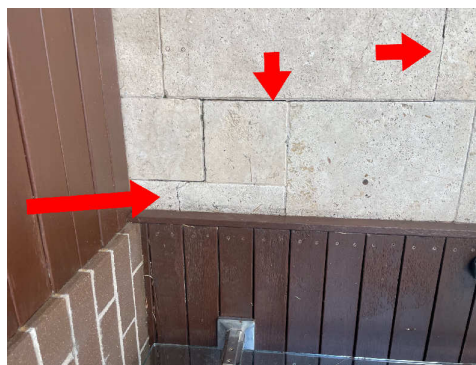
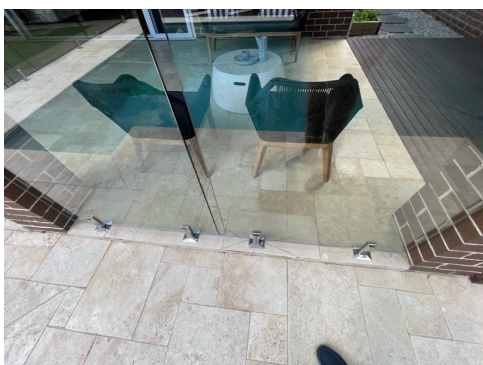
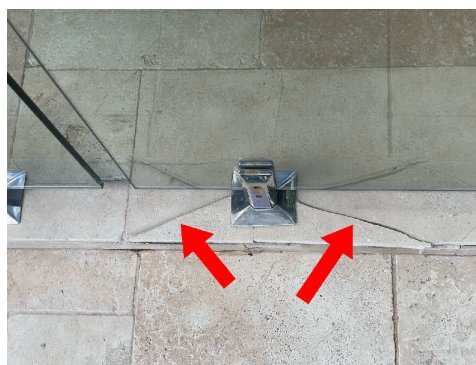
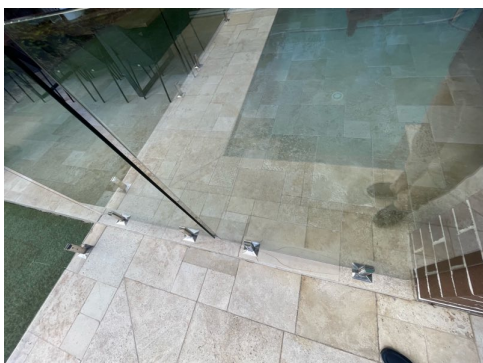
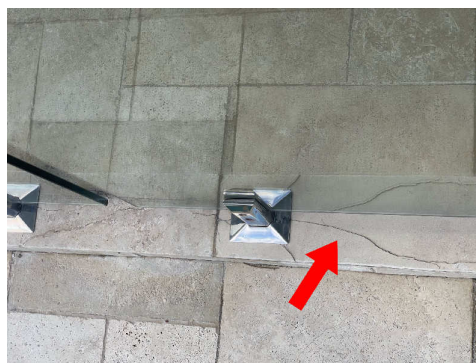
Finding 3.02

Finding: Floor tiles - Cracked

Information: Cracking in the floor tiles was evident in this area at the time of inspection. It is suspected that this cracking has occurred as a result of the floor being uneven and lacking a solid or suitable foundation for the tiles to be laid on. Settlement in the floor foundations may also have caused movement and resulted in the cracking of tiles in this area.

Cracked tiles throughout the household detract from the overall appearance of the affected areas, as well as creating potential for water penetration to adjoining building elements.

If left unmanaged, water damage may occur as a result of constant water penetration over a prolonged period of time.

While not considered a matter of urgency, replacement of cracked floor tiles is advised as a solution. A tiling contractor or general handyperson may be appointed to perform these works at client discretion. Where cracks become more numerous, consultation with a registered builder specialising in re-stumping may be required.

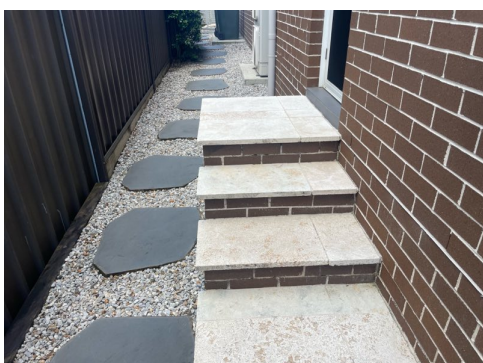
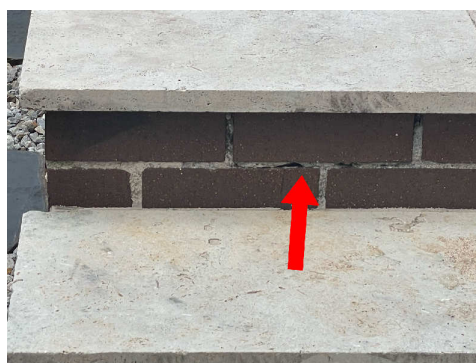
Finding 3.03

Information: During the inspection, multiple areas of the external brick wall were observed to have significant cavities within the mortar joints. These voids appear to be the result of poor mortar application or inadequate compaction during construction.

The presence of these gaps compromises the wall's integrity, allowing moisture ingress and increasing the risk of long-term deterioration, including cracking, efflorescence, and reduced structural performance.

It is recommended that a qualified bricklayer or building contractor assess all affected areas and undertake remedial works, including raking out and repointing the defective joints with appropriate mortar.

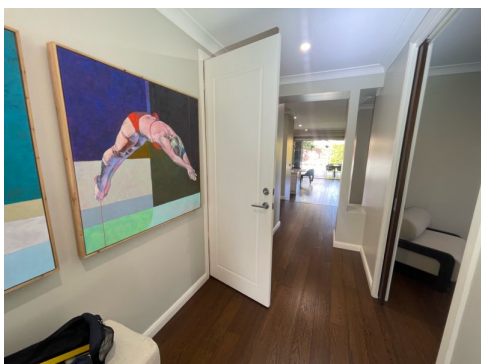
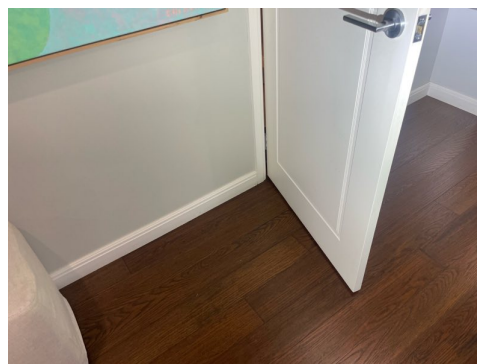
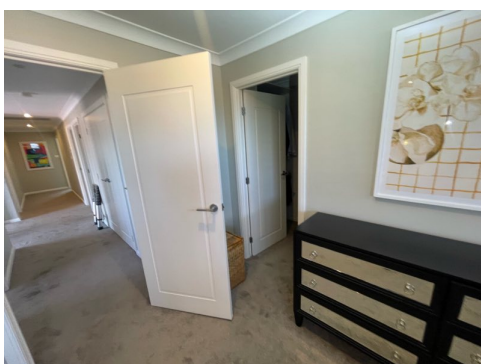
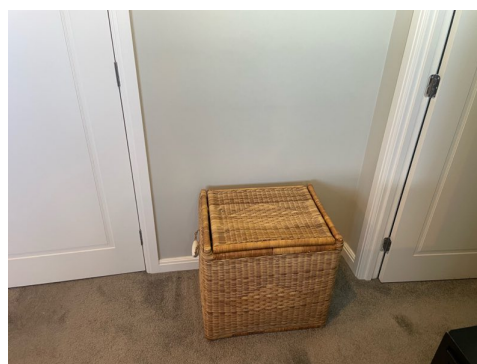
Finding 3.04

Finding: Door stop - Missing

Information: The door stop is missing or is inadequate to stop the door handle from damaging the wall. Although some building elements may seem irrelevant or unnecessary, all building elements play a key role in the operation and function of the overall structure and its performance.

Re-installation or replacement of the door stop is advised as soon as possible to prevent any subsequent damage to the door or associated structures. A general handyman may be appointed to perform these works at client discretion.

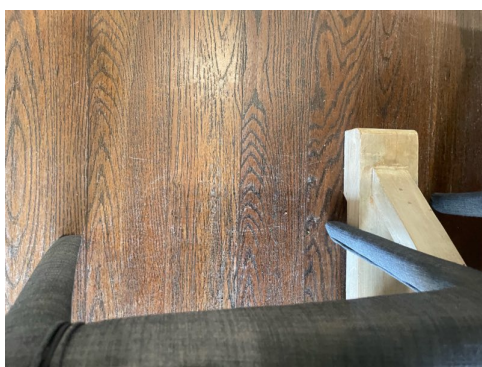
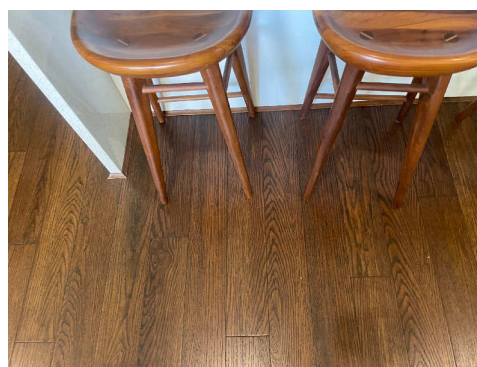
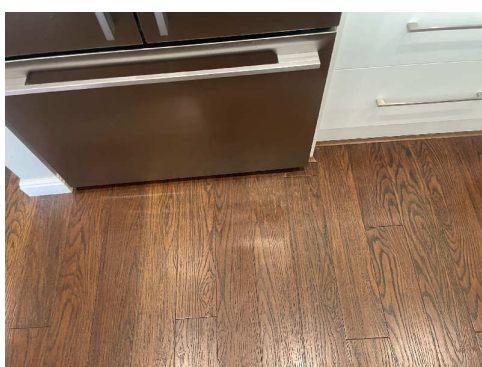
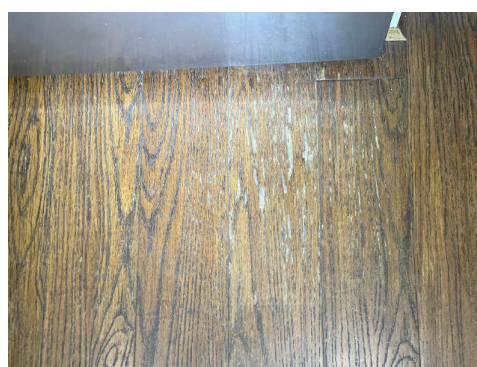
Finding 3.05

Finding: Floor Cover - Damaged

Information: Breakage and deterioration of the floor covering has been observed. This type of damage typically occurs due to wear and tear, ageing materials, or from accidental impact. Affected sections reduce both the functional performance and visual presentation of the flooring.

All flooring elements are integral to the usability and performance of the building, and failure to address defects can result in secondary issues such as trip hazards or damage to the subfloor.

Repair or replacement of the damaged floor covering is advised to restore safety, durability, and appearance, while also preventing further deterioration to the underlying structure.

It is recommended that a qualified tradesperson be appointed to carry out the necessary works promptly to reinstate the integrity of the floor covering.

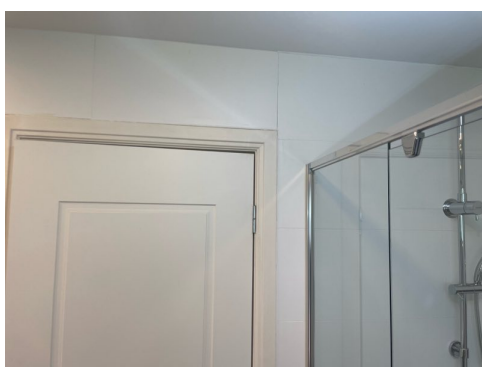
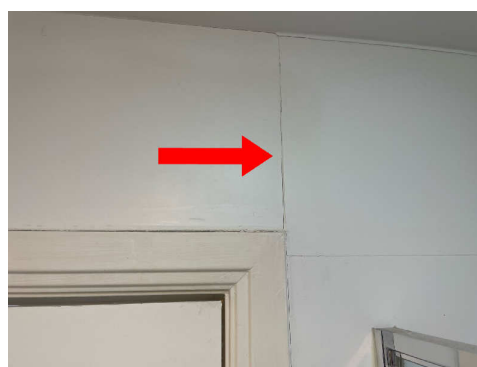
Finding 3.06

Finding: Cracked Tiles – Inadequate Sealing

Information: During the inspection, cracking was observed in the bathroom floor/wall tiles. The cracked sections create gaps in the protective surface, leaving the underlying substrate vulnerable to water penetration.

Unsealed or damaged tiles can allow moisture ingress into the wall or floor structure, potentially causing swelling, deterioration of finishes, and concealed water damage over time.

This condition also increases the risk of mould growth and structural deterioration if left unattended.

It is recommended that the affected tiles be properly sealed, and where necessary, replaced by a qualified tiler. All works should ensure a continuous waterproof barrier is maintained to protect the bathroom structure from further moisture ingress.

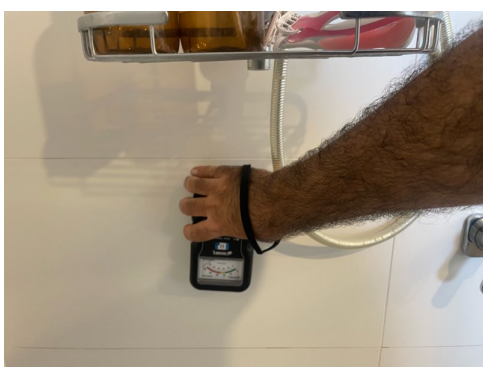
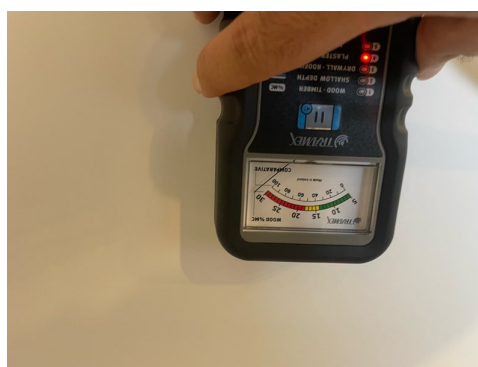
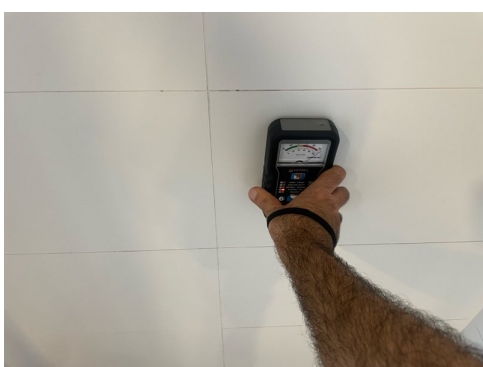
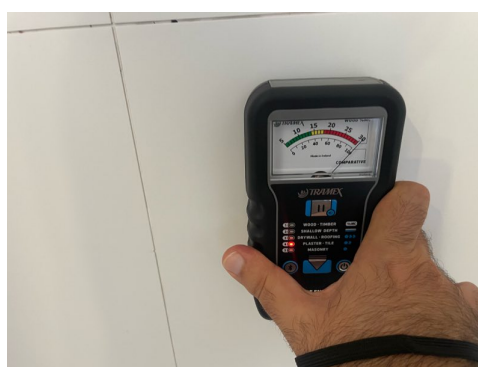
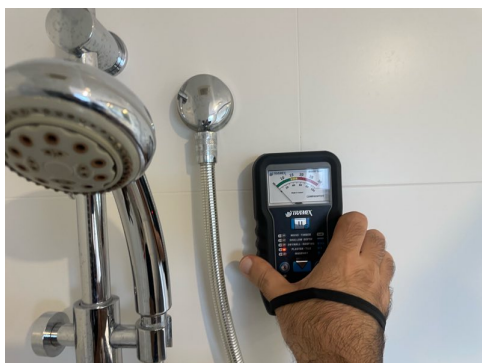
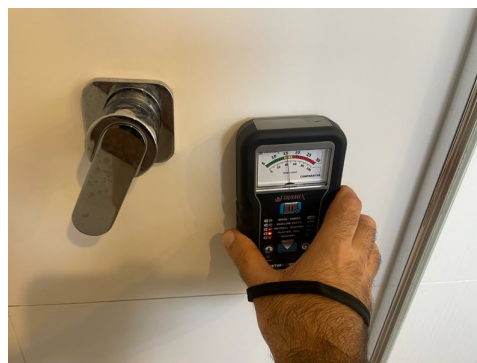
Finding 3.07

Finding: Damp in Shower Alcove – Elevated Moisture Beneath and Around Tap

Information: During inspection, damp was detected to the lower wall area of the shower alcove, extending up to approximately 1 metre in height. Elevated moisture readings were recorded beneath the shower tap and also around the tap assembly itself. This pattern raises suspicion of a possible plumbing leak within the wall cavity in addition to general moisture ingress.

Such conditions are relatively common and may result from water leaching through grout prior to recent repairs, or from concealed leakage from the tap assembly or associated plumbing.

If unmanaged, damp in a shower recess can lead to mould growth, deterioration of tiles and substrates, and potential compromise of the wall structure.

It is recommended that a licensed plumber or bathroom waterproofing specialist investigate the area, including removal of wall linings on the opposite side if necessary, to confirm the source of leakage. Prompt rectification and continued monitoring are advised.

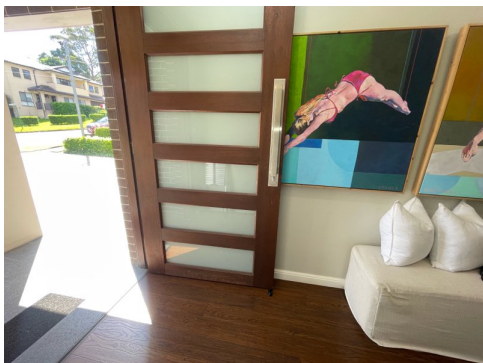
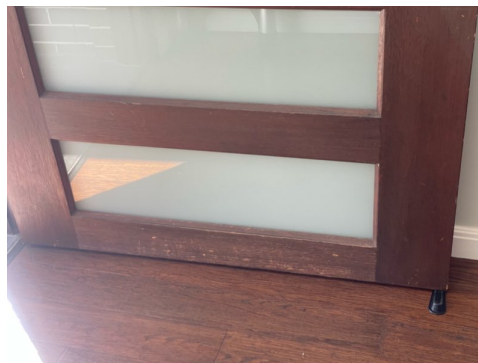
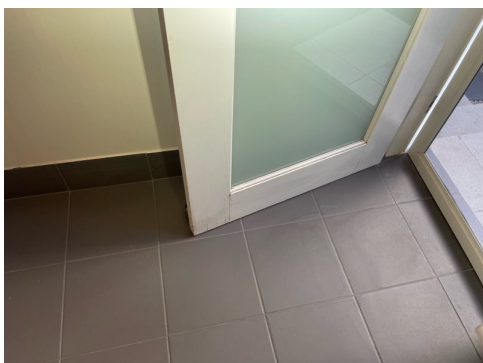
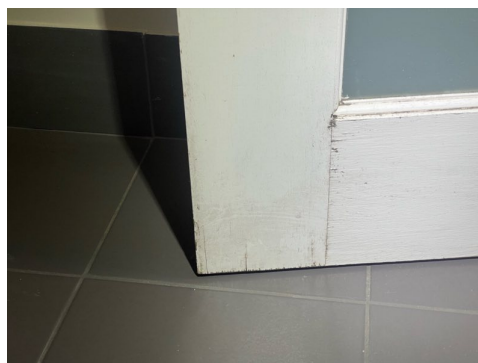
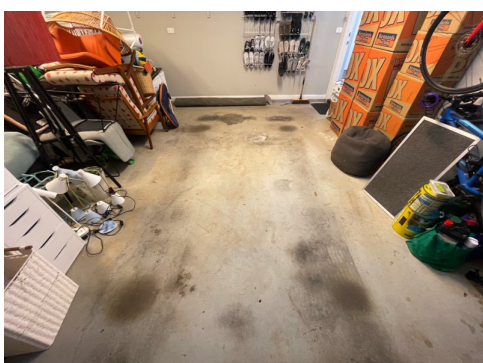
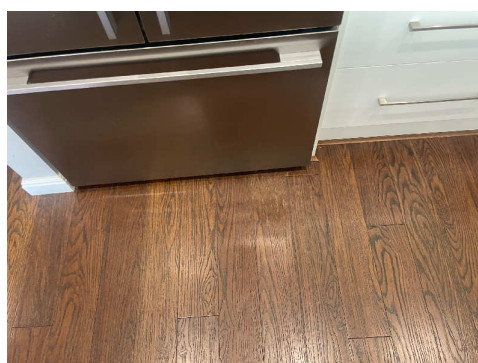
Finding 3.08

Information: Some areas of the painted wall surfaces, ceilings, door frames, and other internal finishes were observed to have marks and scuffs, likely resulting from the normal use of the property. These marks do not indicate structural damage but have affected the overall aesthetic appearance of the internal spaces.

The integrity of the paint and finishes is not compromised, but cosmetic touch-ups may be required to maintain a uniform presentation.

It is recommended that the affected surfaces be cleaned or repainted in the near future by a suitably qualified tradesperson to restore the appearance and uniformity of the internal finishes. Regular maintenance of painted surfaces, including walls, ceilings, and trims, can help prolong their life and visual quality.

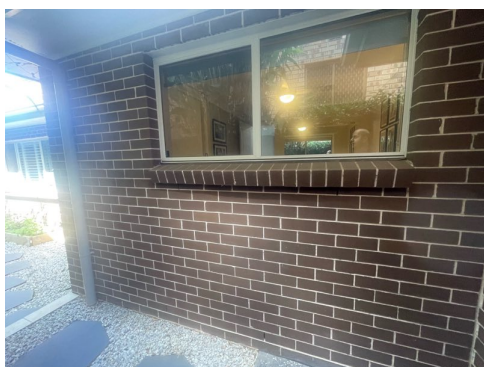
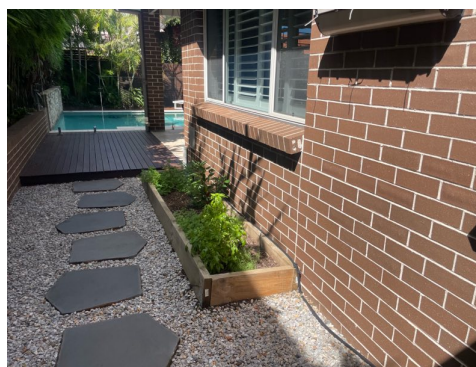
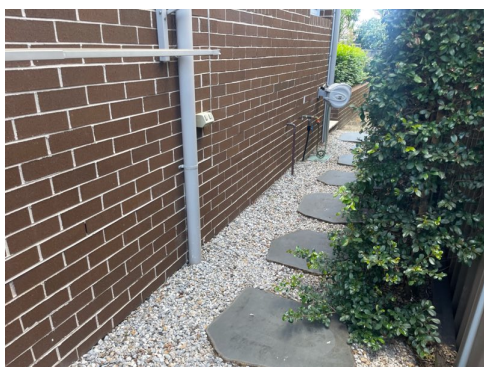
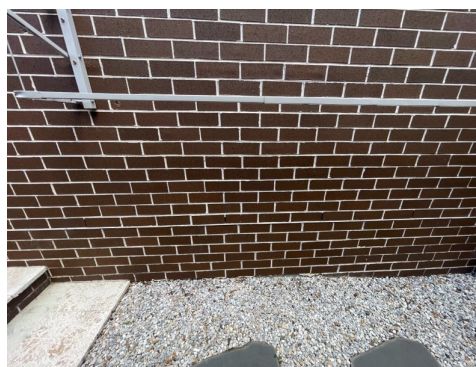
If the slab edge is not properly exposed there is a high risk of termite attack. Sometimes, in order to determine the type of slab, a suitably qualified person such as an architect or builder may be required to consult the construction plans.

Where the slab edge cannot be properly inspected, it is highly recommended that termite or timber pest inspections be carried out every 6-12 months to aid protection of the property against infestation.

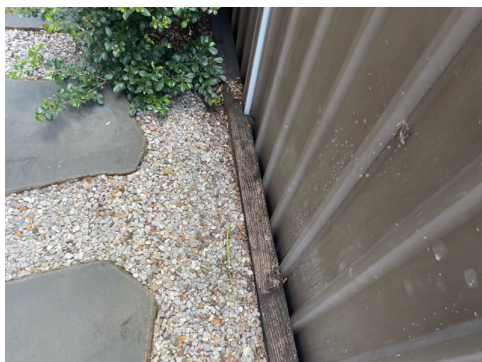
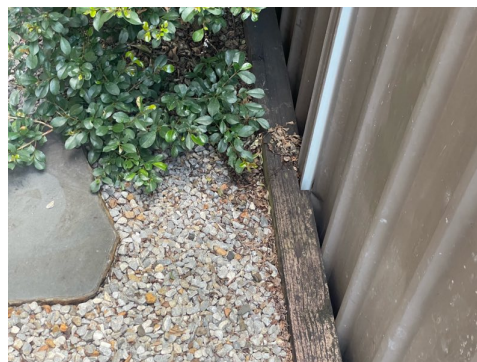
Building:	Main Building
Location:	Yard
Finding:	In ground contact
Information:	Any timbers in direct ground contact provide opportunity for concealed termite entry and are likely to be subject to premature rot and decay as the soil retains moisture or damp conditions against the timbers.

Remove untreated timber that is in direct contact with external grounds. Consider replacement with more durable materials i.e. treated timber or non timber elements. Frequent pest inspections are advised to readily identify any termite activity in these areas.

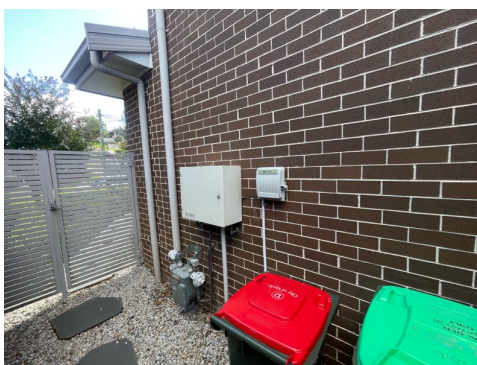
Finding 6.05

Building:	Main Building
Location:	Building perimeter/interior/subfloor/roof space
Finding:	Stored timbers - subfloor space or external area
Information:	The storing of timbers in the subfloor space or around the external property increases the risk of termite activity being present. As they are likely to come into contact with weather conditions or excessive moisture wood rot is likely to develop on timbers that are not treated.

It is highly recommended that any stored timbers be immediately removed from areas in which they may attract any termite / timber pest attack. Minimisation of risk / prevention of termite attack is far more adequate than dealing with the presence of termite activity.

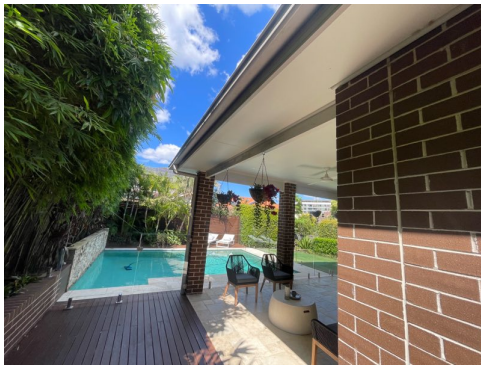
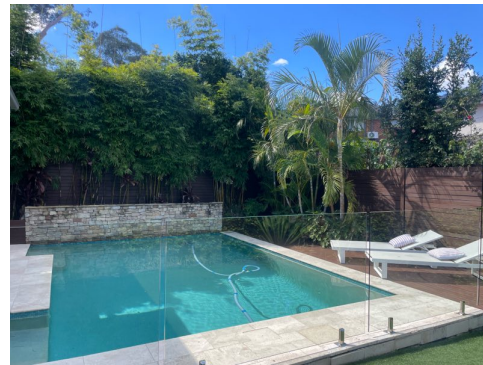
Finding: Large trees/stumps within 30m of house

Information: There are a number of large trees/stumps within 30m of the house which may contain natural termite activity. It is important to monitor these areas to ensure no natural activity is allowed to progress into the main house. Regular inspections are recommended. Consider test drilling any large trees. A pest controller can be contacted to carry out such testing at the owners discretion.
