Building and Timber Pest Inspection Report

Inspection Date: Wed, 11 Mar 2026

Property Address: 14/40 Murev Way, Carrara QLD 4211,
Australia

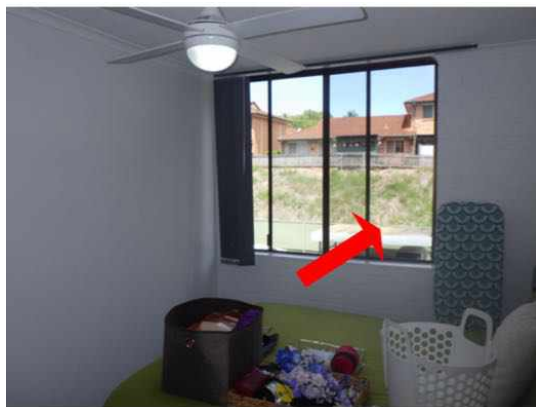
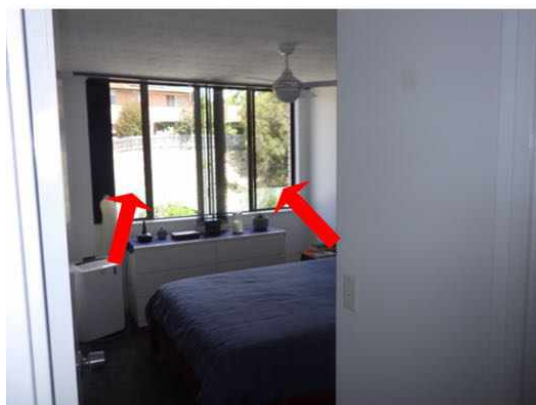
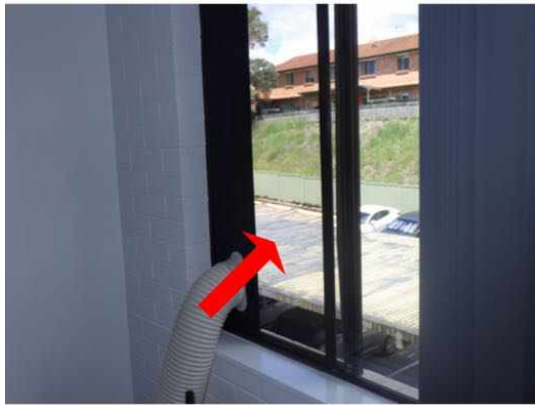
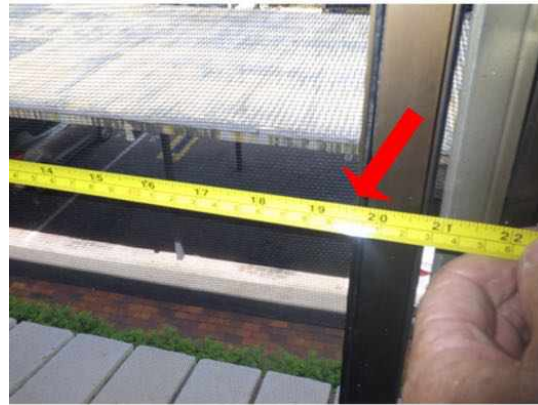
Finding 1.01

Building: Main Building
Location: Bedrooms > Existing
Finding: Window safety
Information: It was noted that the bedrooms windows are less than 1.7m from the floor and have a fall greater than 2m on the exterior from the sill and as such are required to only open upto 125mm or have security grills fitted.

This is noted as a safety concern and this regulation may not have been in place at the time of construction.

Windows are defective if they do not comply with provision 3.9.2.5 of Volume 2 of the BCA that requires that a window opening must have protection if the floor below the window in a bedroom is 2 m or more above the ground surface beneath.

Windows that are located 1.7 m above the floor level are not required to be protected.

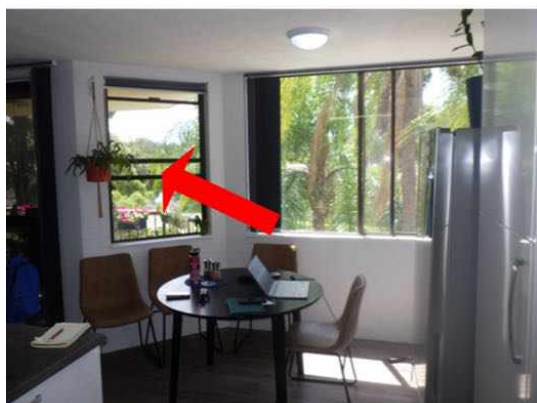
Finding 3.01

Building: Main Building
 Location: Dining Area > Front Left
 Finding: Window - Springs
 Information: The window sash to the dining area double hung window was found drop rapidly at the time of inspection. It appears the window support springs or balancing system may require adjustment.

Repair of the broken window sash is advised to improve the operational state of the associated window.

An aluminium window service agent could be appointed to repair or adjust the window at the client's discretion.

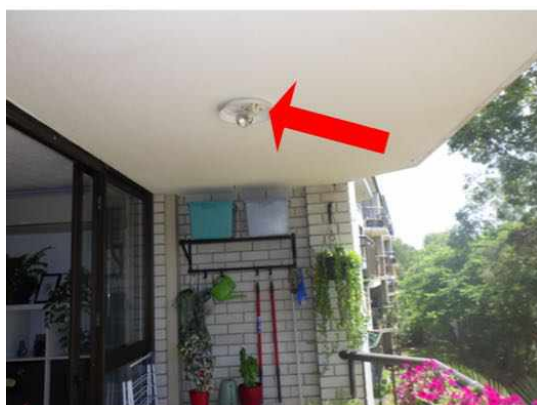
Finding 3.02

Building:	Main Building
Location:	Balcony > Centre
Finding:	Light fitting - Missing cover
Information:	The ceiling light fitting cover in the balcony area was found to be missing at the time of inspection. Damage occurs generally when the building materials have aged and decayed, but may also be indicative of impact damage to the building element (accidental or deliberate).

Left unmanaged, the fitting is unlikely to cause further damage to surrounding building elements. However, the broken light fitting may expose electrical works, and may create a minor safety hazard if there is potential contact with persons in the area.

Repair and/or replacement of the damaged fitting is advised. A Licensed electrician should be appointed to repair/replace the light fitting at the client's discretion.

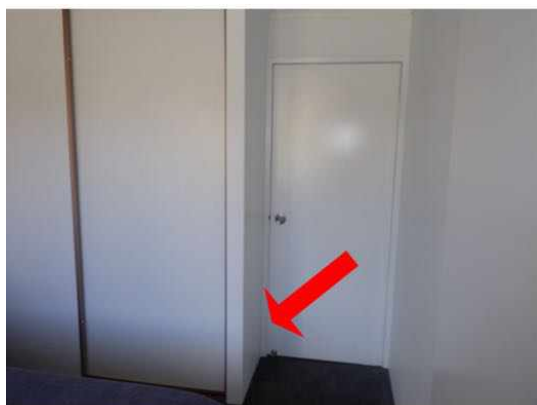
Finding 3.03

Building:	Main Building
Location:	Bedroom - Master > Front
Finding:	Door - Binding/Jamming
Information:	Minor binding and/or jamming of the main bedroom door on the door frame was

evident during standard operation. This defect can inhibit the functionality of the affected door as well as creating potential for secondary defects to associated building elements, such as damage to the door framing.

A door that binds to the associated door frame or sill may have several causes, such as poor installation of the door or deteriorated hinges.

A qualified carpenter or general handyperson could be appointed to perform minor rectification works at client discretion.

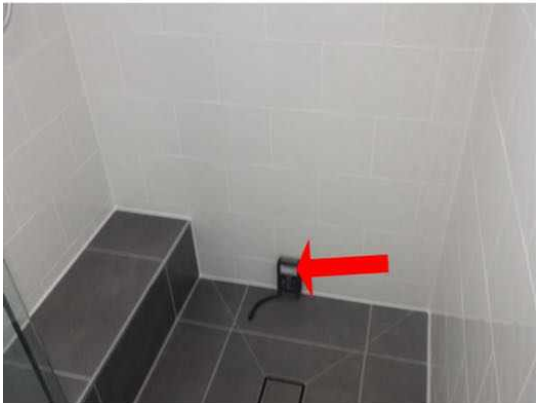
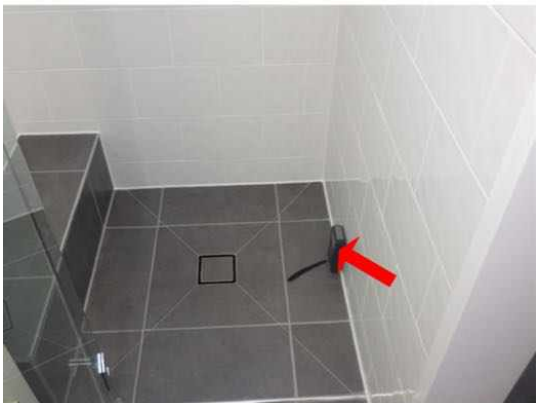
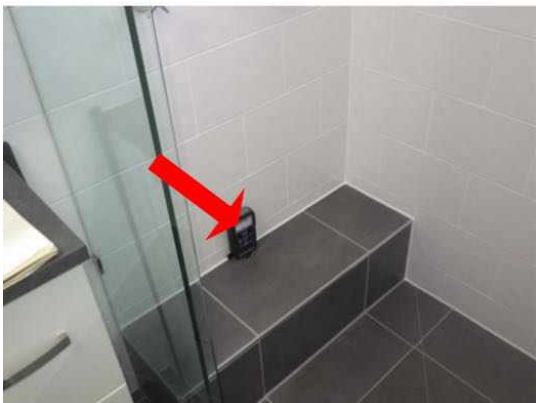
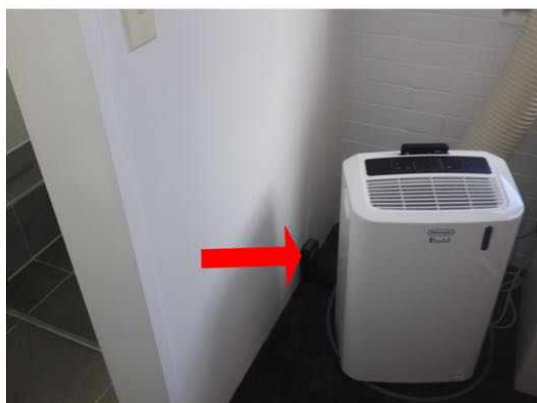
Finding 3.04

Building:	Main Building
Location:	Ensuite > Centre Right
Finding:	Shower - Monitor
Information:	Elevated moisture level readings were recorded to the lower 300mm of wall to the ensuite shower alcove at the time of inspection. There was no elevated moisture level readings around the tap area, and no elevated readings transferring to the other side of the wall in the areas where moisture readings were able to be obtained. Both sealant and grout appear in good condition at present.

This defect is quite common, and is suspected to have been caused by moisture permeating or leaching through the grouting and perhaps gaps in the sealant.

Monitoring the area is advised and if any visual signs of excessive moisture appear (peeling paint, mould) then consultation with a qualified plumber or bathroom specialist would be advised.

Always ensure that sealant and grout is in good condition to prevent any moisture issues occurring in the future.

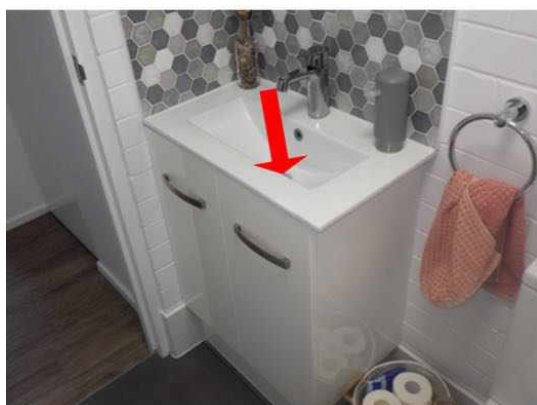
Finding 3.05

Building: Main Building
 Location: Powder Room > Front Left
 Finding: Basin - Pop up waste stiff.
 Information: The powder room basin pop up waste was stiff to operate at the time of inspection. It is advised that maintenance is carried out on the waste so as it functions as intended.

A handyman could be appointed to perform any remedial works where required.

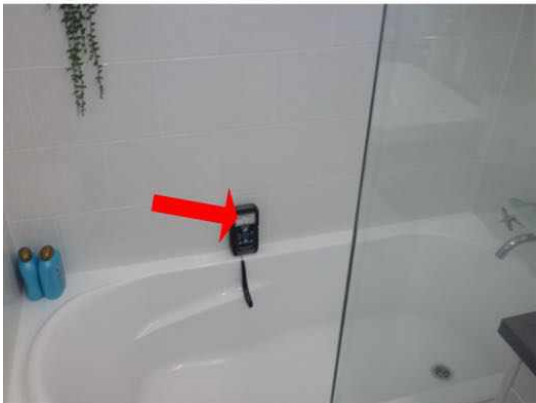
Finding 3.06

Building: Main Building
 Location: Bathroom Area > Rear Right
 Finding: Shower - Monitor
 Information: Elevated moisture level readings were recorded to the lower 200mm of right side wall to the bathroom shower alcove at the time of inspection. There was no elevated moisture level readings around the tap area. No readings to the other side of the wall were able to be obtained. Both sealant and grout appear in good condition at present.

This defect is quite common, and is suspected to have been caused by moisture permeating or leaching through the grouting and perhaps gaps in the sealant.

Monitoring the area is advised and if any visual signs of excessive moisture appear

(peeling paint, mould) then consultation with a qualified plumber or bathroom specialist would be advised.

Always ensure that sealant and grout is in good condition to prevent any moisture issues occurring in the future.

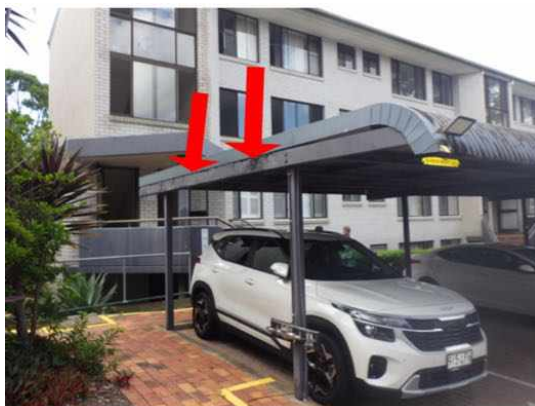
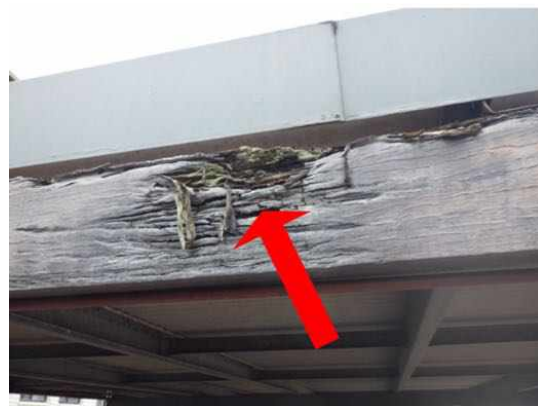
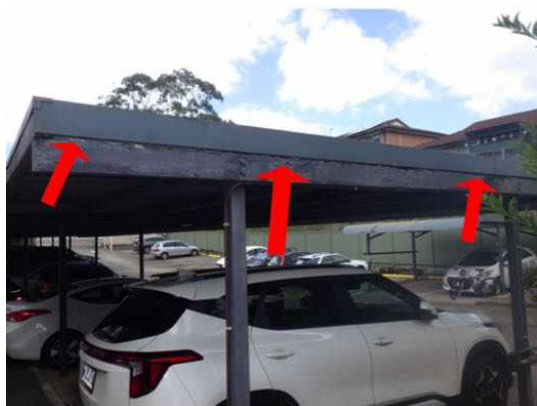
Finding 3.07

Building:	Carport
Location:	Roof Exterior > Centre Right
Finding:	Fascias - Wood rot
Information:	Wood rot was found to be affecting timber fascias and/or bargees on the carport roof area, evidenced by the presence of mould on the surface in some areas. Wood rot, also known as Fungal Decay, occurs when timbers and other cellulose building materials are exposed to damp conditions on an ongoing basis.

Frequent exposure to rain and other weather conditions make fascias and bargees susceptible to accelerated deterioration.

Early intervention and regular maintenance will prolong the useful life of these building elements. Prior to any works being performed, the cause of the moisture that has created the visible wood rot should be identified and addressed in a suitable manner.

A qualified carpenter or registered builder may be required to replace affected fascia's.

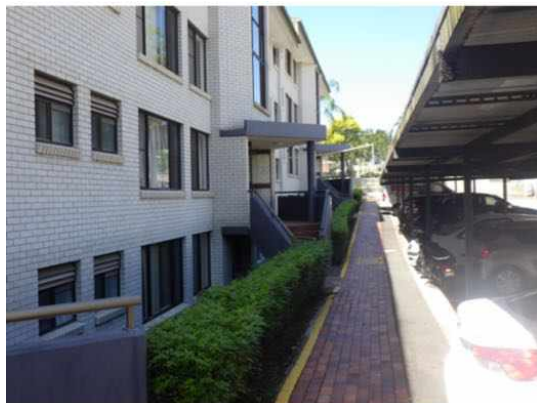
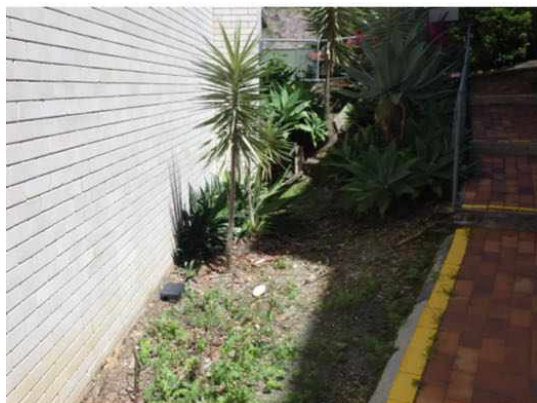
Finding 6.01

Building:	Main Building
Location:	External Areas > Ground Level
Finding:	Termite Management System - no evidence of a chemical installation
Information:	At the time of inspection, it appeared as though no termite management system has been installed on the property, with no evidence to suggest preventative works or regular inspections taking place.

Although the property is considered low risk, the application of a post-construction chemical termite barrier or in ground baiting stations is highly recommended for all properties, particularly if live termite activity has been found on the site previously. Such barriers are highly effective in preventing termite attack on any timber building elements throughout the property.

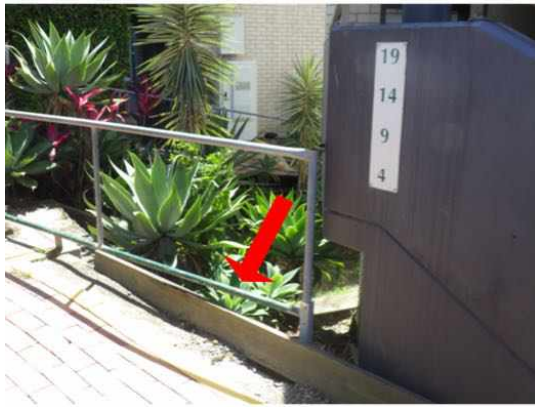
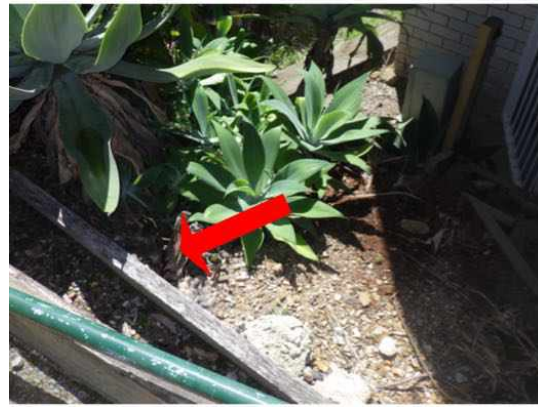
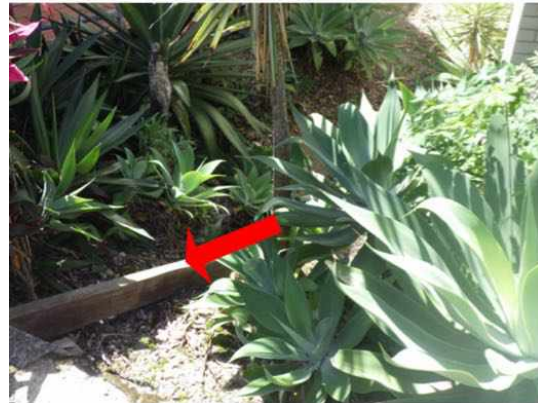
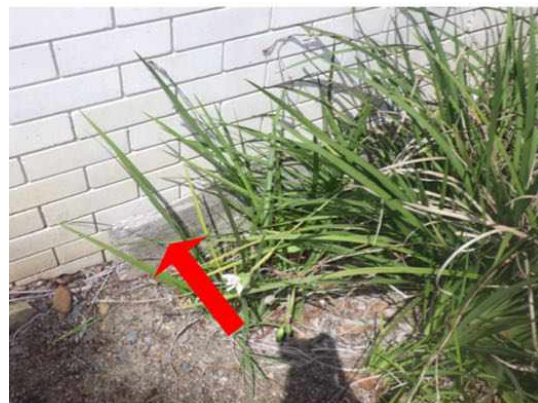
Finding 6.02

Building:	Main Building
Location:	External Areas > Ground Level
Finding:	Garden Beds - Conditions Conducive to Termites
Information:	Garden beds and external landscape areas were found to contain tree stumps, timber debris and garden waste at the time of inspection (as per example photos). These garden beds can include untreated timber, and with a combination of moisture from watering hosing can make conditions conducive to termite activity and termite ingress. Removal of any garden debris or timber is highly advised. Frequent pest inspections are advised to readily identify any termite activity in these areas.
