Building and Timber Pest Inspection Report

Inspection Date: Mon, 9 Mar 2026

Property Address: 201/1 Mahogany Ave, Macquarie Park NSW
2113, Australia

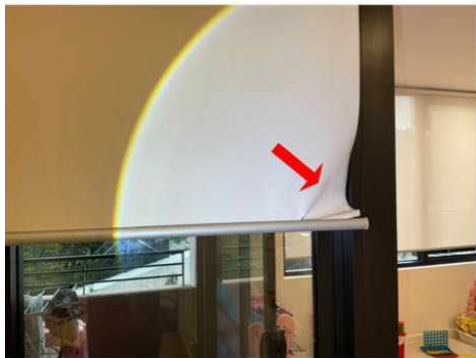
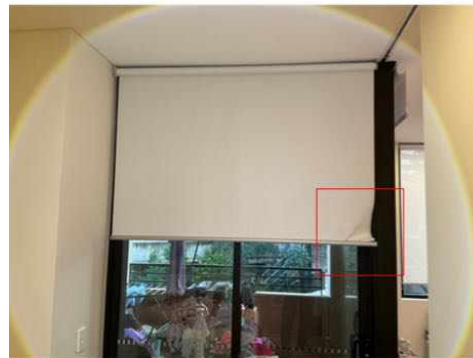
Finding 3.01

Finding: Damaged Blinds

Information: At the time of inspection, the blinds in the bedroom window were noted to be damaged.

It is recommended that a handyman or blind specialist be engaged to repair or replace the blinds to restore proper operation and appearance.

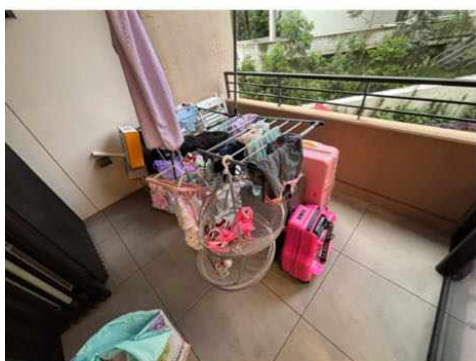
Building: Main Building
 Location: All External Areas
 Finding: Obstructions and Limitations - External Areas
 Information: The attached photographs provide a visual representation of the obstructions and limitations that impeded a full inspection of the external areas of the property at the time of assessment. These obstructions, which may include vegetation, stored items, debris, or other physical barriers, can obscure potential defects and prevent a thorough evaluation of the property's condition. Obstructions of this nature can conceal a wide range of issues, such as structural damage, water ingress, pest infestations, or deteriorating building materials, which may not be visible during the initial inspection.

It is essential that these obstructions be cleared to allow for a comprehensive inspection of the external areas. Removing these barriers will enable a more accurate assessment of the property's condition and allow any hidden defects to be identified and addressed promptly. Failure to do so could result in undetected issues worsening over time, potentially leading to more costly repairs in the future.

Therefore, it is strongly recommended that the obstructions be removed and a re-inspection be scheduled once the affected areas are made fully accessible. This will ensure a complete evaluation of the property's exterior and provide the client with a clear understanding of any potential issues that may have been concealed during the initial inspection.

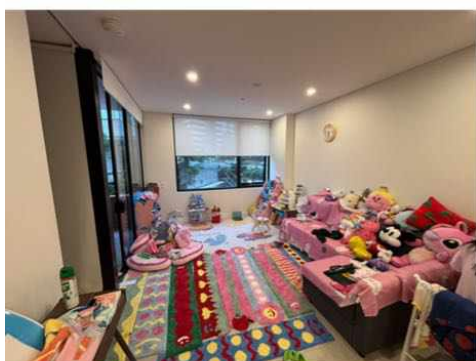
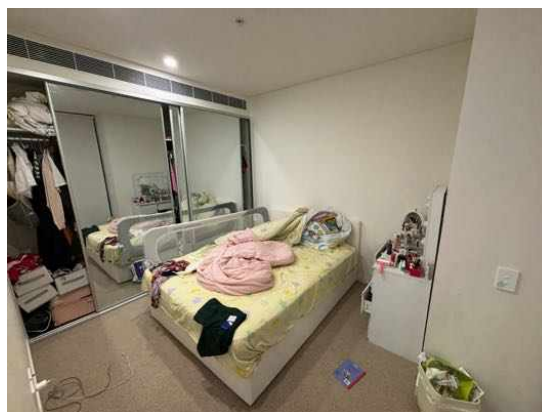
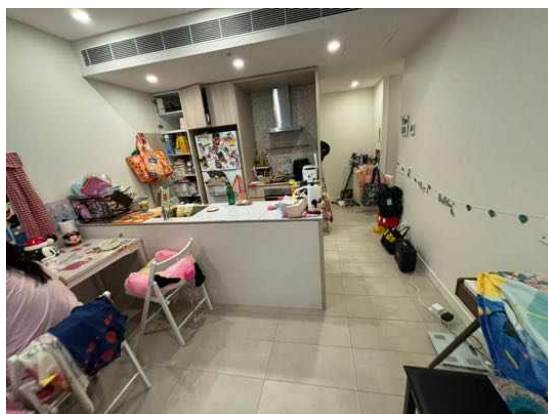
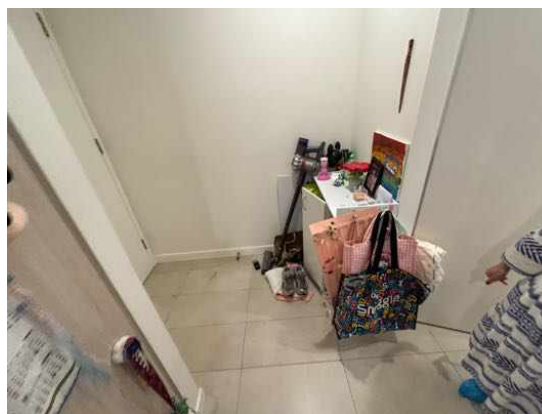
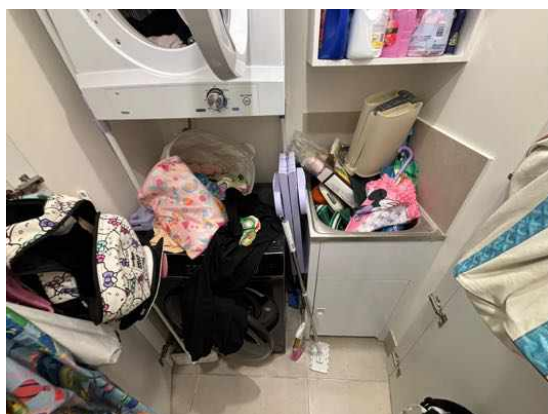
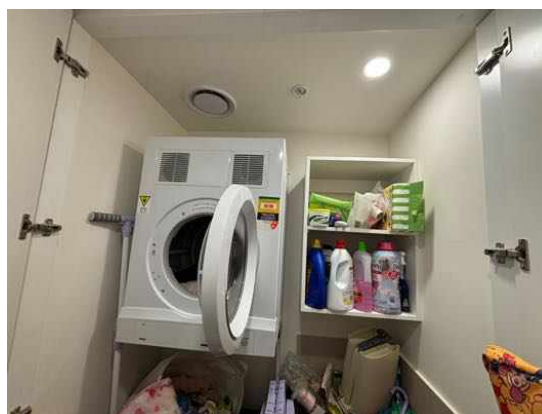
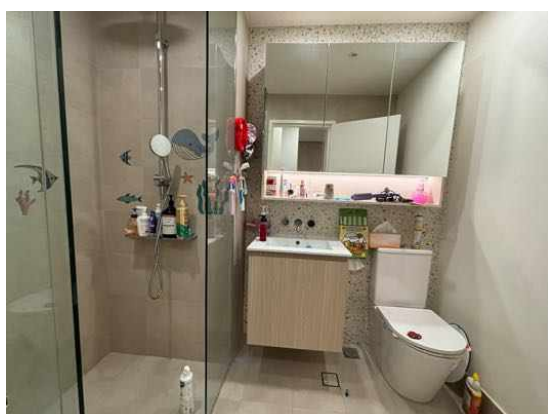
Building: Main Building
 Location: All Internal Areas

Information: The accompanying photographs provide clear evidence of the obstructions and limitations that restricted a comprehensive inspection of the internal areas of the property at the time of assessment. These obstructions, which may include furniture, personal belongings, stored items, or structural elements such as wall coverings and built-ins, significantly hindered the ability to thoroughly evaluate these areas. It is important to note that such obstructions can potentially conceal a wide array of defects, ranging from hidden structural damage, water leaks, pest infestations, or electrical issues, to deteriorating materials that may not be visible during the initial inspection.

The presence of these impediments means that critical areas of the property were not accessible, and therefore, any underlying defects that may affect the integrity and safety of the property could remain undetected. These hidden defects, if left unaddressed, could worsen over time and may result in costly repairs or pose potential safety hazards to the occupants.

It is highly recommended that all obstructions be cleared to facilitate a complete and thorough inspection of the internal areas. Once the obstructions have been removed and full access is available, a re-inspection should be carried out to ensure that any previously concealed issues can be properly identified and rectified. This follow-up inspection will provide a more accurate assessment of the property's internal condition and help the client make informed decisions about any necessary repairs or maintenance.

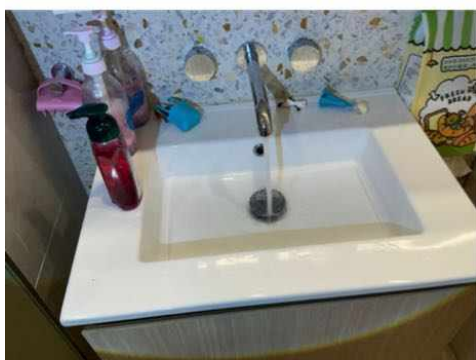
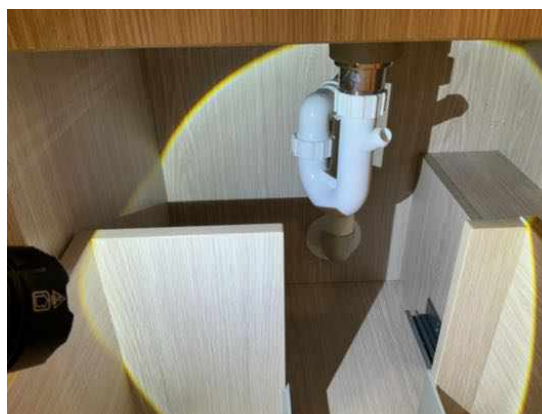
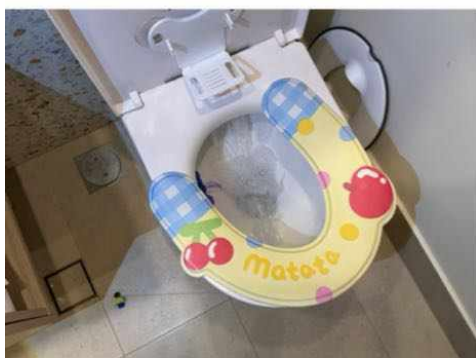
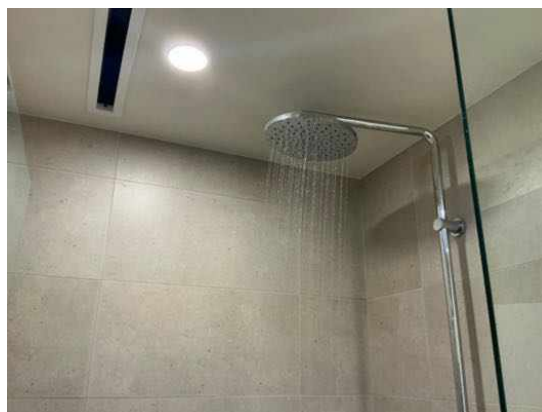
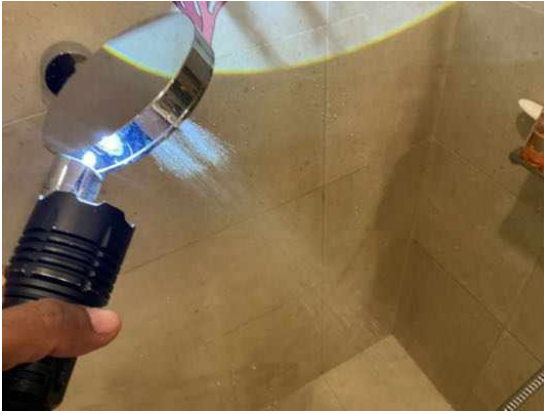
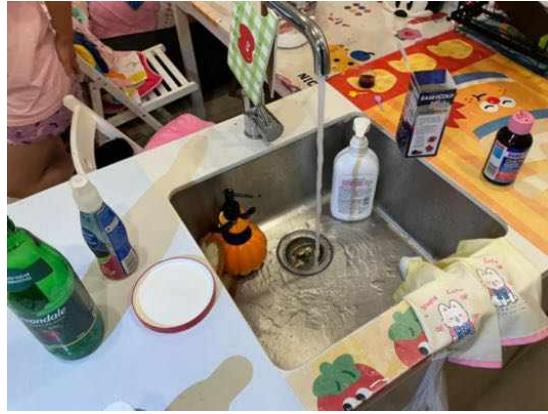
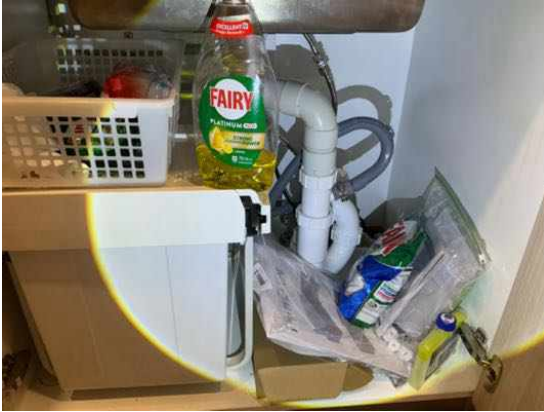
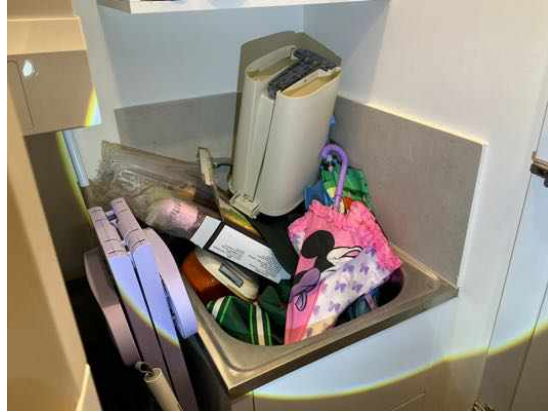
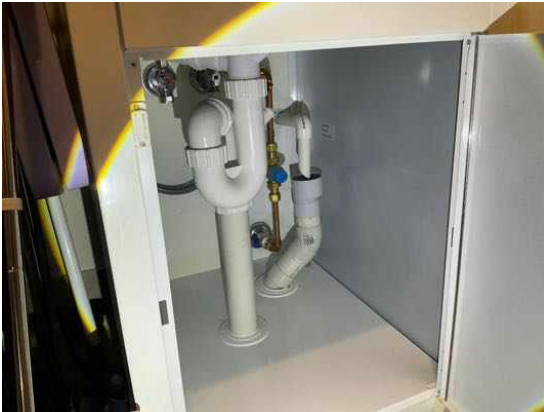
Building: Main Building
Location: All Areas
Finding: FYI - Taps, Drainage & Toilets Tested and Cabinetry Obstructions
Information: During the inspection, all accessible taps, drainage systems, and toilets were tested for water flow and drainage efficiency, and checked for any visible signs of leakage. At the time of the inspection, no issues were noted in these areas. Unless highlighted in a separate defect statement, no immediate remedial work appears necessary. Supporting images may be found in the additional photos section for reference.

It is important to note that while a visual inspection of cupboards and cabinetry beneath sinks and vanities was undertaken, stored personal items and fixtures presented obstructions that limited full visibility of the internal areas. As per standard inspection practices, inspectors are not permitted to move or disturb personal belongings during the inspection process. Therefore, only visible and accessible sections were inspected, and concealed water damage or plumbing defects may not have been detected.

Given this, a re-inspection is recommended after all obstructions have been cleared to allow for a comprehensive assessment of these areas. Regular maintenance and monitoring of plumbing and drainage systems is also advised to ensure ongoing functionality and early detection of potential issues.

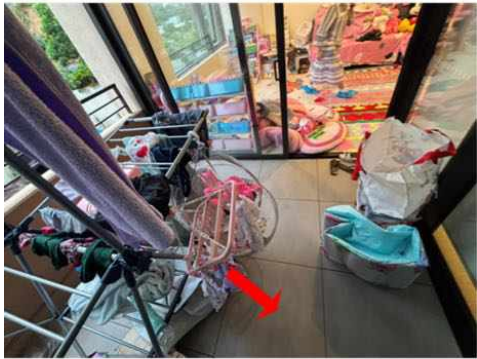
Building: Main Building
Location: Balcony
Finding: FYI - Pedestal Paver System Installed
Information: The exterior tiles on the property appear to be installed using a pedestal paver system, which does not require grout. This system allows water to drain through the gaps between tiles to a waterproof membrane underneath, directing it to designated drainage points. Regular inspection and maintenance of the drainage system are recommended to ensure proper water management and prevent potential issues.
