Building and Timber Pest Inspection Report

Inspection Date: Fri, 27 Feb 2026

Property Address: 72 Sussex St, Cabramatta NSW 2166,
Australia

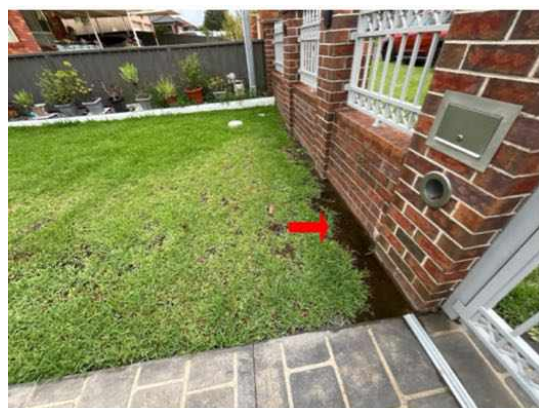
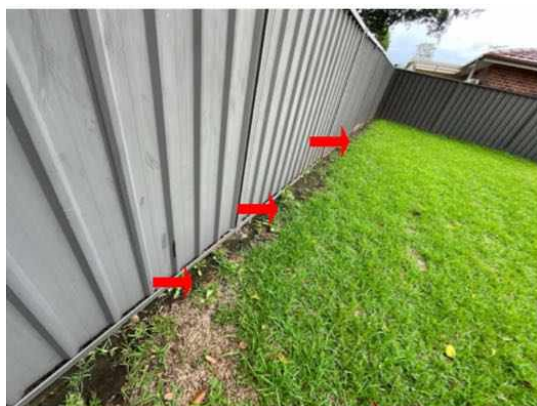
Building: Main Building
Location: Front loan
Finding: Site drainage— Inadequate
Information: The site drainage in this area was found to be inadequate at the time of inspection, creating potential for subsequent water damage to associated building elements. This is additionally conducive to termite activity.

It is important that water does not lie against the base of walls; surrounding paths and ground levels should be sloped to drain water away from walls. Downpipes should not discharge stormwater onto lower walls or plinths. Stormwater should be carried away by large, regularly cleaned drains. Ground levels may need to be lowered to expose a buried DPC.

Where site drainage is inadequate, installation of an Agricultural (Aggie) Drain may be required. A licensed plumber should be appointed to further inspect the property and perform any remedial works as necessary. Water damage and secondary defects are likely to occur if left unmanaged.

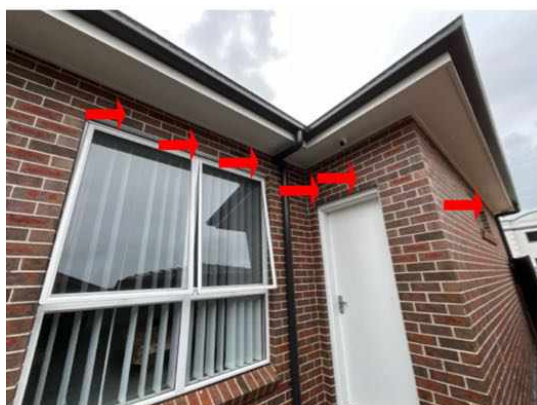
Finding 3.02

Building:	Main Building
Location:	Multiple areas
Finding:	Blockage of weepholes
Information:	Weep holes in the exterior brickwork of the property are designed to allow condensation that may build up between the brickwork and subsequent timber framework to drain from within the wall hence preventing any deterioration of the timber building elements.

Build-up of moisture is likely to occur if weep holes are covered.

It is highly recommended that weep holes are left exposed in all areas throughout the external property. A general handyman must be appointed to ensure all weep hole covers are removed.

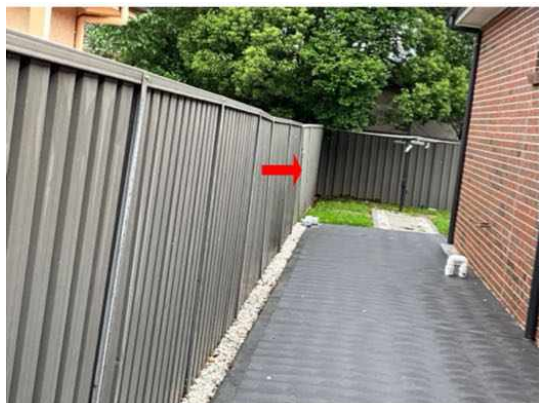
Finding 3.03

Building:	Main Building
Location:	Fencing
Finding:	Fencing - Deteriorated
Information:	It was noted at the time of inspection that sections of the fencing in this area has deteriorated. Typically fencing deteriorates due to age and or wear, rot and or rust

which is generally expected for a structure of this age, due to prolonged exposure to weather conditions. Sometimes inadequate installation or maintenance can be to blame.

If left unattended, it is likely that further damage will occur. It is suspected that repair of several elements of the fencing may be required however replacement may be a consideration of the client also.

A licensed fencing contractor should be appointed to provide further advice and perform rectification works as necessary.

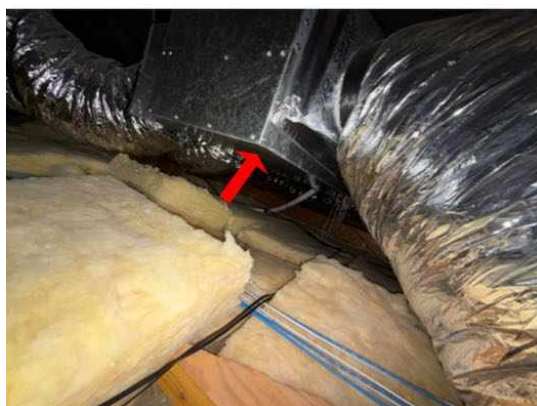
Finding 3.04

Building:	Main Building
Location:	Roof Void
Finding:	Internal air conditioning unit - Missing condensation tray
Information:	The internal air conditioning unit in the roof was found to be missing the condensation tray at the time of inspection.

An internal air conditioning unit inside the roof must have a secondary drip tray with a separate drain line to ensure any condensation is dealt with accordingly to avoid water leaks.

A HVAC specialist must be appointed urgently for consultation and rectification, ensuring the manufacturer guidelines are closely followed.

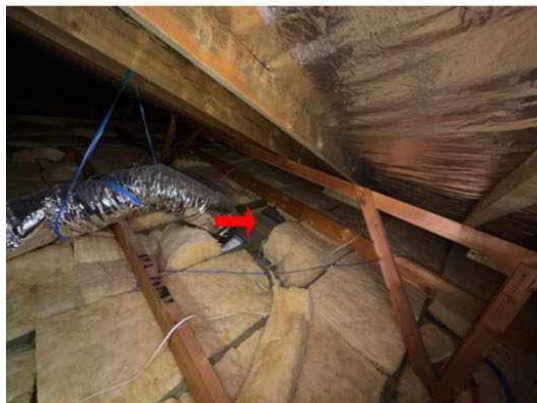
Finding 3.05

Building: Main Building
 Location: Roof Void
 Finding: Insulation - Moved
 Information:

Upon inspection of the roof void it was noted that some insulation is removed and or misplaced.

Installation of adequate insulation is required and should be conducted as soon as possible.

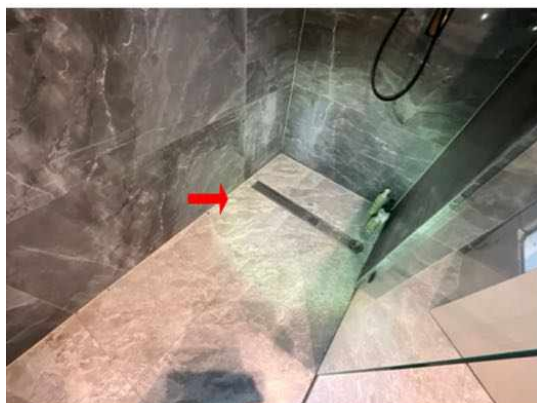
Finding 3.06

Building: Main Building
Location: All Wet Areas
Finding: Sealant and grouting - Missing or damaged
Information:

It was noted on inspection that sealant or grout is degraded to this area.

Different materials and floor areas move at different rates, generally causing cracking to grout or sealant at this point. A flexible sealant is required to allow for expected expansion and contraction, while keeping the joint water tight and protective of all associated building materials.

Flexible and mould resistant materials should be applied to affected areas to prevent any subsequent water damage that is likely to occur. Regular maintenance and replacement of damage or missing or damaged sealant and grout is highly recommended to the wet areas, as this is a regular wear and tear defect. Sealant and grouting in areas that come into regular contact with water should be maintained for the long term care of your property.

A sealant specialist should be appointed to complete these works as soon as possible.

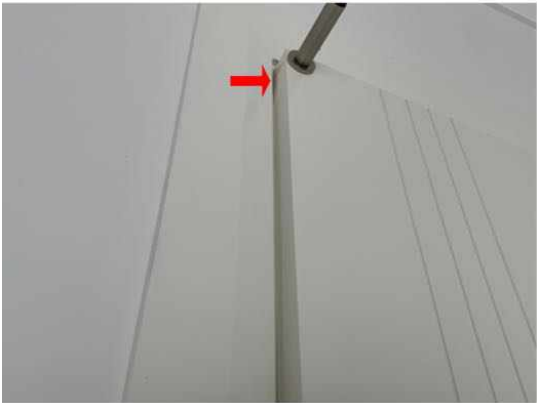
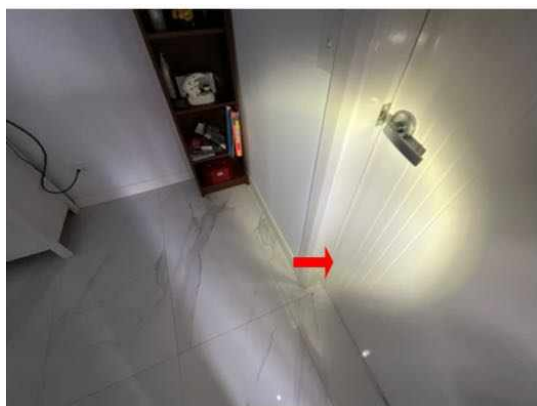
Finding 3.07

Binding and/or jamming of this door is evident during standard operation. This defect inhibits the functionality of the affected door as well as creating potential for secondary defects to associated building elements, such as damage to the floor covering or adjacent frame.

A door that binds to flooring or to the associated door frame may have several causes, ranging from minor defects, such as poor installation of the door or deteriorated hinges.

A licensed carpenter should be appointed to perform minor rectification works at client discretion.

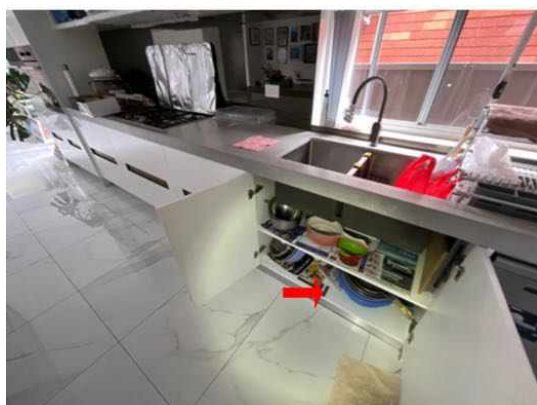
Finding 3.08

Building:	Main Building
Location:	Kitchen
Finding:	Building element - Damaged
Information:	Push to open mechanism to the cupboard door was found to be defective, requiring adjustment.

Repair and/or replacement of damaged elements is advised to ensure that additional secondary defects do not arise as a consequence. Such works are necessary, as all building elements play a key role in the operation and function of the overall structure and its performance.

A general handyman should be appointed to repair or replace the affected building element.

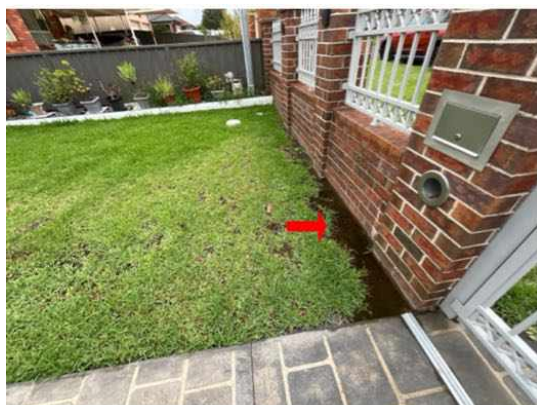
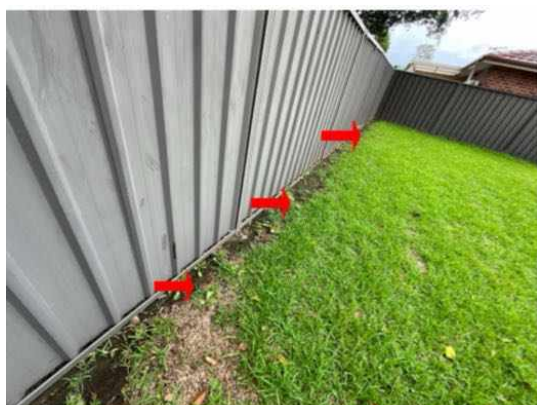
Building: Main Building
 Location: Front loan
 Finding: Site drainage— Inadequate
 Information: The site drainage in this area was found to be inadequate at the time of inspection, creating potential for subsequent water damage to associated building elements. This is additionally conducive to termite activity.

It is important that water does not lie against the base of walls; surrounding paths and ground levels should be sloped to drain water away from walls. Downpipes should not discharge stormwater onto lower walls or plinths. Stormwater should be carried away by large, regularly cleaned drains. Ground levels may need to be lowered to expose a buried DPC.

Where site drainage is inadequate, installation of an Agricultural (Aggie) Drain may be required. A licensed plumber should be appointed to further inspect the property and perform any remedial works as necessary. Water damage and secondary defects are likely to occur if left unmanaged.

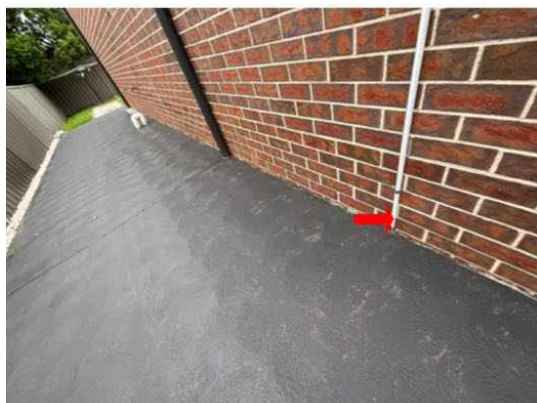
Finding 6.02

Building:	Main Building
Location:	Yard - Side
Finding:	Overflow - Not plumbed for drainage
Information:	The overflow is not plumbed or connected to suitable drainage, which can result in the surrounding area becoming excessively damp.

These damp conditions can lead to secondary defects such as rot, rust or corrosion of associated building elements, the formation of fungal decay, or even the creation of potential slip hazards. When coupled with poor site drainage, pooling of water may also attract termite activity to this area.

It is highly recommended that a licensed plumber be appointed to install adequate drainage to the overflow. These works will ensure that the area remains dry and free of any secondary defects.

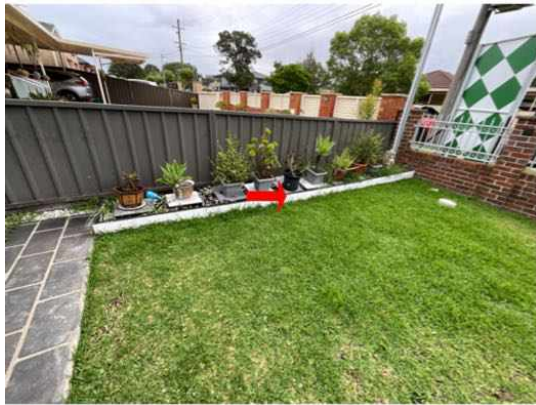
Finding 6.03

Building:	Main Building
Location:	Fencing & Landscaping
Finding:	Building materials in direct ground contact - conducive to termites
Information:	Where timber elements are in direct contact with the ground and consequently moisture or dampness they become conducive to termite activity. Whether timber is used as a building element part of a fencing structure or stored as an unused item they can provide an environment that is attractive to termite infestation.

When met with excessive moisture timber begins to decay and develop wood rot. Any timbers that are in direct contact with external grounds especially if left untreated or non-durable also provide ingress for subterranean termites into that particular element.

The removal of any such materials that may be conducive to termite activity should be removed as soon as possible to minimise the risk of termite attack.

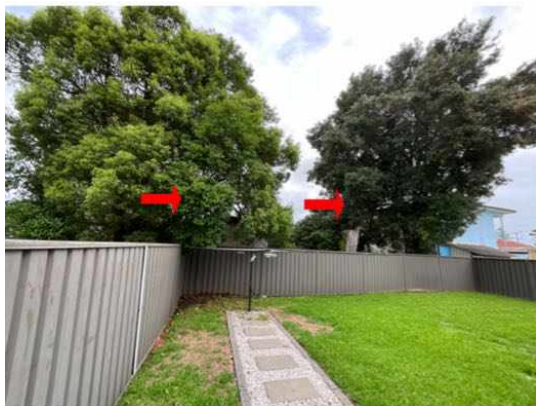
Finding 6.04

Building: Main Building
Location:
Finding: Surrounding bushland - Conductive
Information: Home and or building is situated in a high risk area for termite activity, due to close proximity to surrounding bushland.

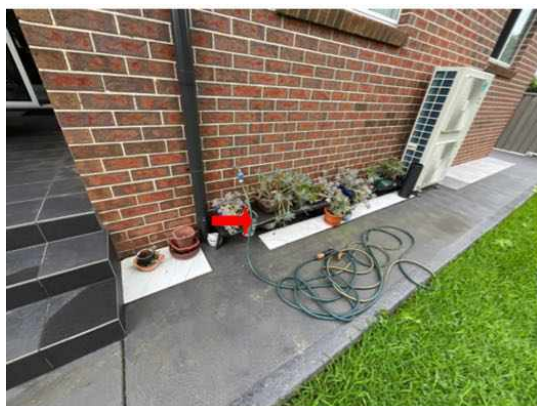
Finding 6.05

Building: Main Building
Location: External tap
Finding: Tap - No drain
Information: The external tap in this area was noted to have no drain at the time of inspection.

This keeps the surrounding surfaces damp while using the tap, which becomes conducive to termite activity.

A licensed plumber must be appointed to ensure an appropriate drain is installed.

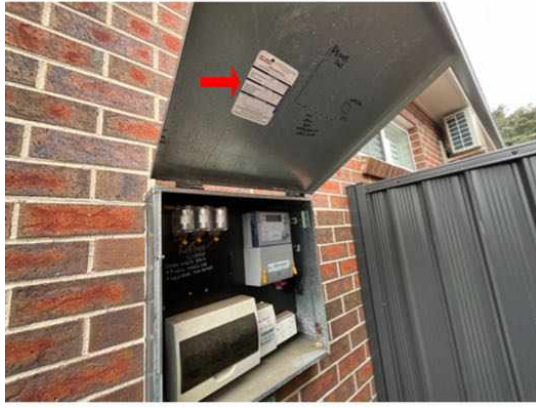
Where a Termite Management System has been identified you should refer to the type of barrier date of installation warranty conditions and any documentation provided by a builder or past owner. Consult the company who installed the barrier to confirm whether the system is still under warranty.

Most chemical termite management systems expire and require replenishment and all physical systems are primarily designed to prevent concealed entry.
