## Building and Timber Pest Inspection Report

Inspection Date: Mon, 12 Jan 2026

Property Address: 12/14 River Esplanade, Mooloolaba QLD  
4557, Australia

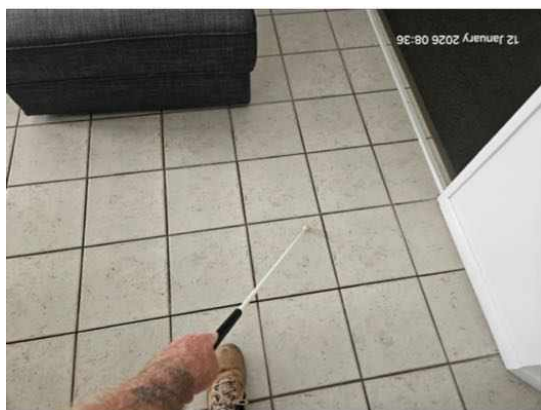
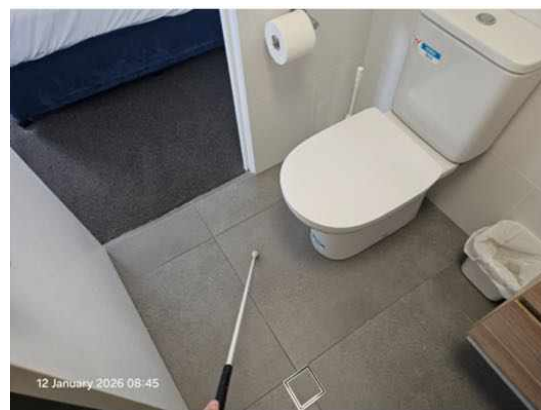
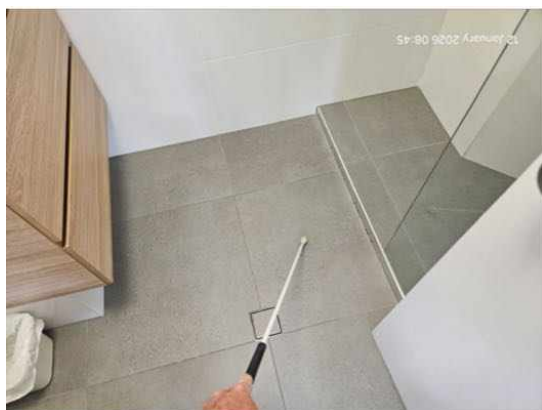
#### Finding 3.01

Building: Main Building  
Location: As shown  
Finding: Tiles - Drummy  
Information: Drummy tiles were identified at the time of inspection. Please see the attached photos for locations.

The term 'drummy' refers to tiles that have become detached from their fixing, despite otherwise being in relatively good condition. Such defects are generally caused by physical or moisture damage to the area. Drummy tiled areas may also be a direct result of poor workmanship during the construction process.

Tiled areas may swell and shrink with changes in air humidity if the area has sustained moisture damage. Any exposure to moisture is capable of causing tiled areas to become drummy and/or cracked over a prolonged period of time. Drummy tiled areas generally require removal and replacement of affected tiles.

Specialist trades are available for these types of services.

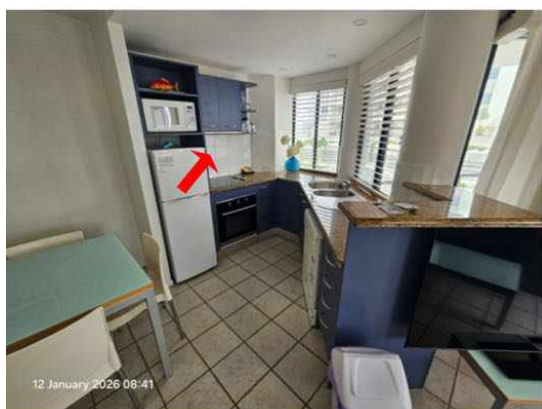
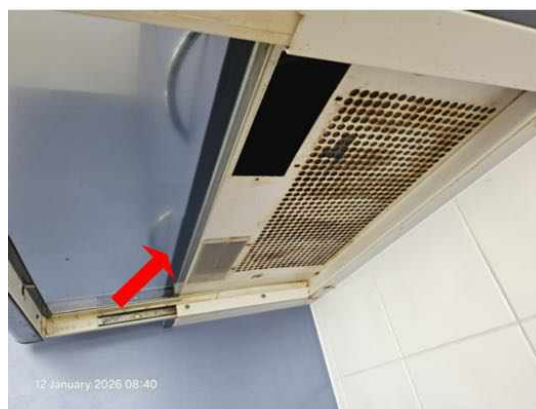
### Finding 3.02

Building: Main Building  
 Location: Kitchen  
 Finding: Rangehood - poor condition  
 Information: While the range hood appears to be working at a satisfactory level; the lights are faulty, one side is missing, and the filter cover is rusted. This may lead to a fault or malfunction of the appliance in the future with regular use.

A licensed electrician or licensed appliance repair technician could be appointed to replace the unit.

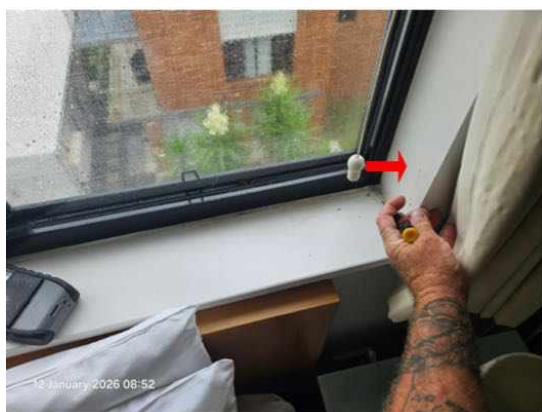
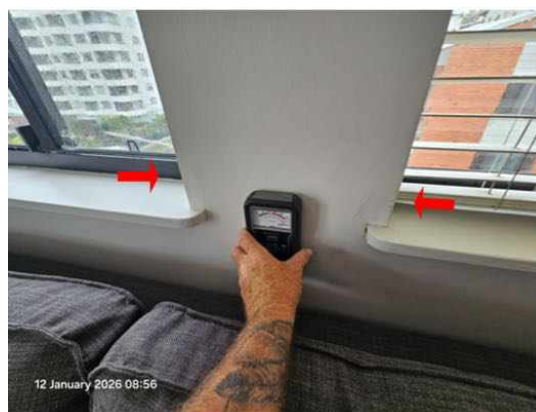
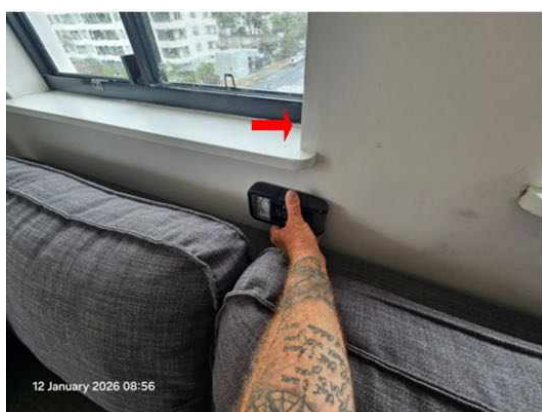
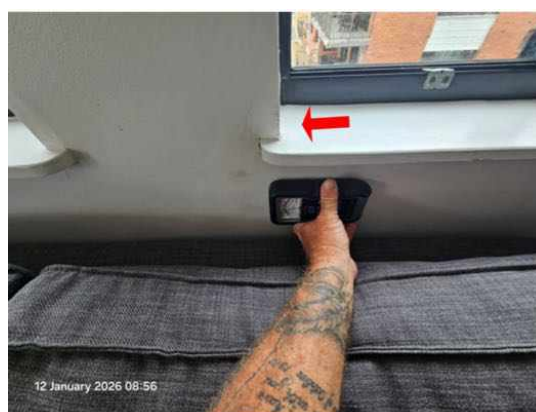
### Finding 3.03

Building: Main Building  
 Location: As shown  
 Finding: Window sill / reveal damage  
 Information: During the inspection moisture damage was noted in the plastered reveal of the windows shown.

Damage is mostly isolated to the lower edges and internal corners, which would indicate that moisture may be entering through the joint between the bottom aluminium profile and the rendered sill. Alternatively, it may be due to the windows

being left open for extended periods and sea air and rain moisture having an effect.

It is not uncommon for this type of finish to be affected in building close to the coast. It was also noticeable that the moisture is affecting the metal external plaster angle.

The moisture readings noted in the window sills and surrounding wall surfaces may be due to open windows during rain events and, as this section of the building faces the prevailing weather, it may be the result of excess exposure. Always monitor these areas for any effects. The plaster reveal sections mentioned should be repaired in the short term.

This should be monitored and there is a change in the reveal appearance, a licensed plasterer or painter should be engaged to carry out the necessary repairs.

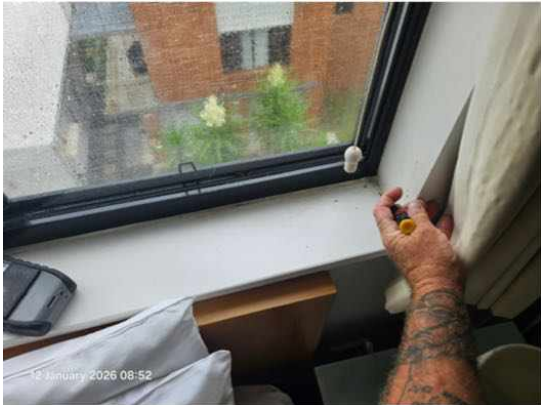
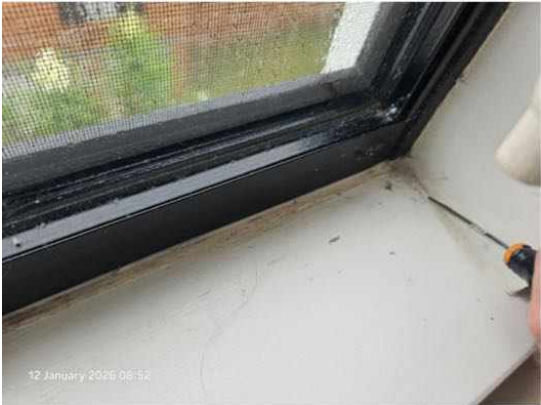
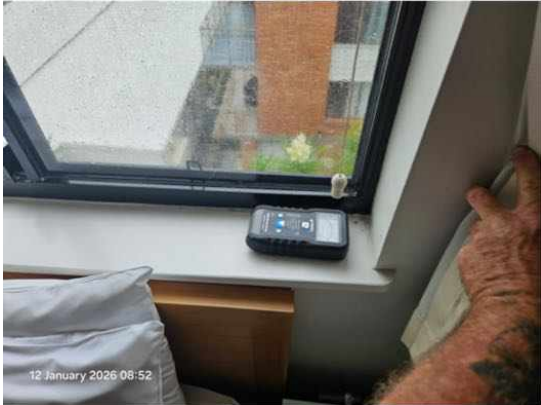
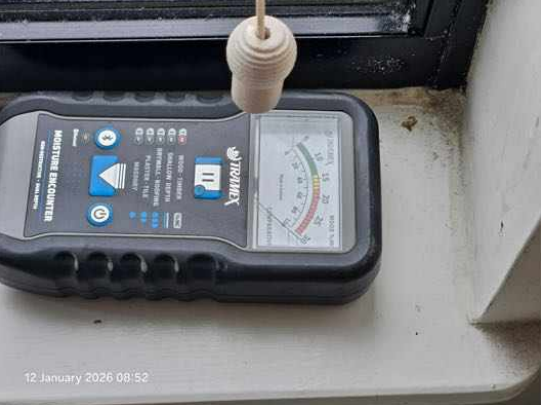
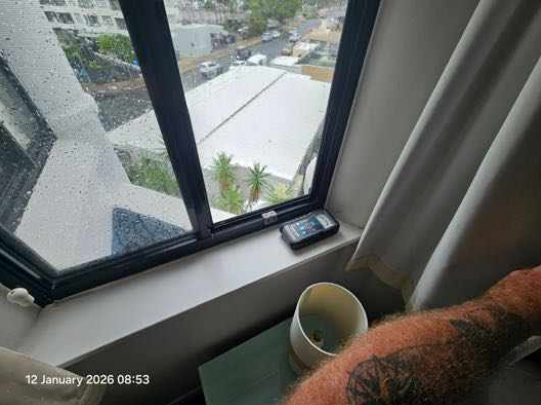
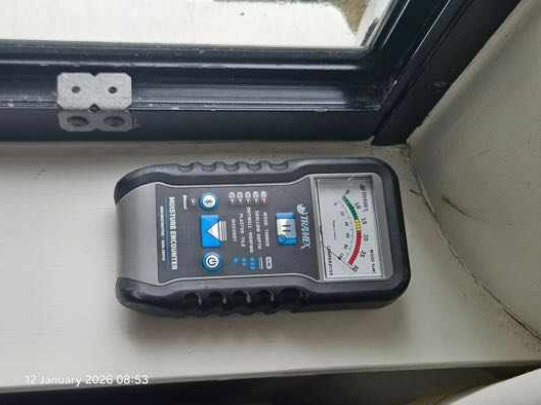
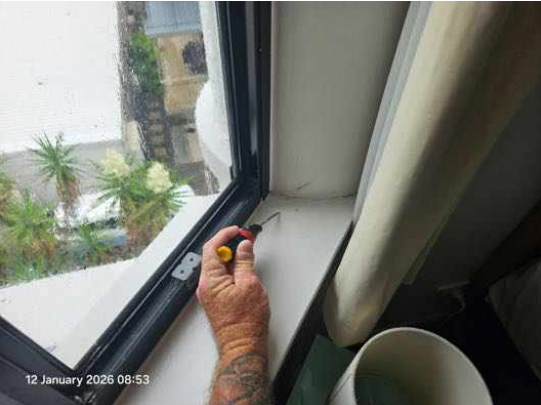
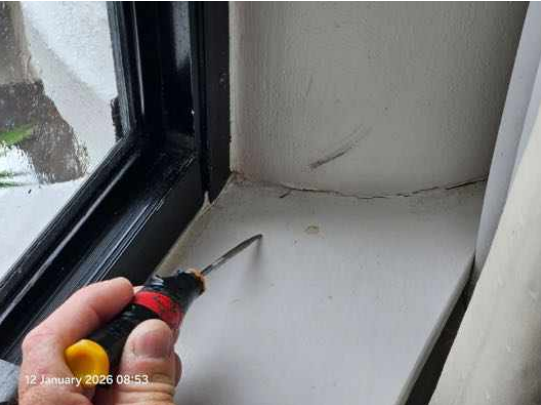
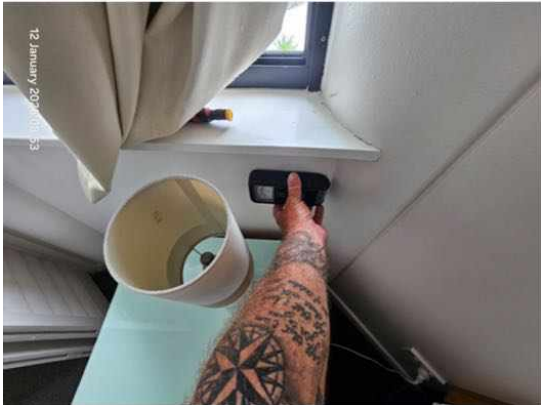
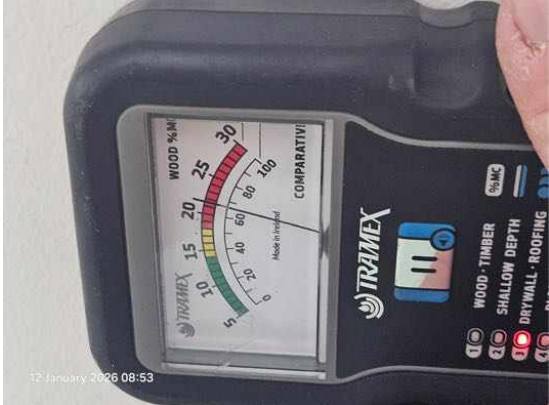
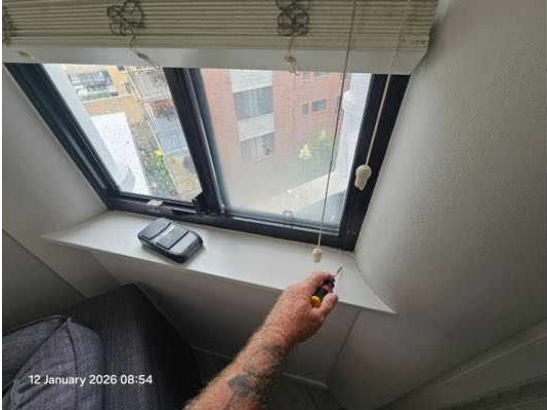
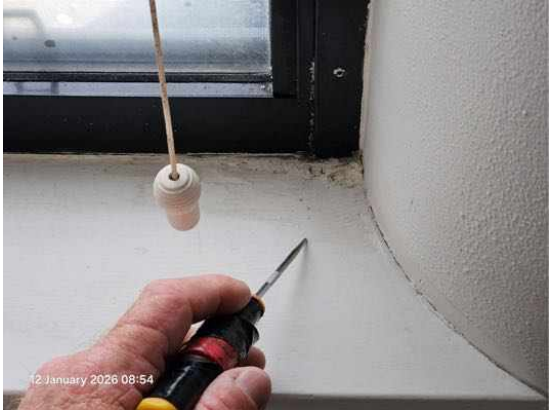
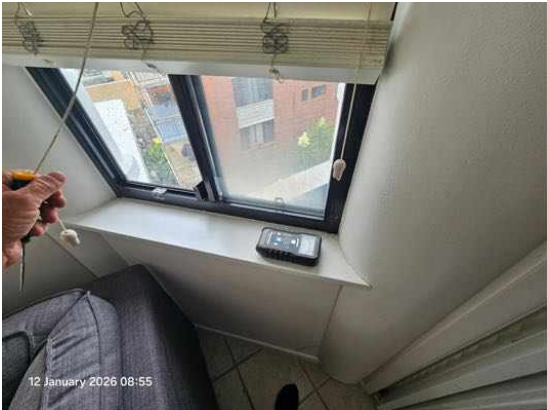
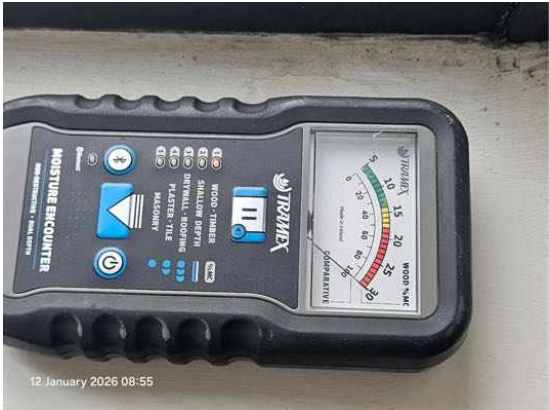
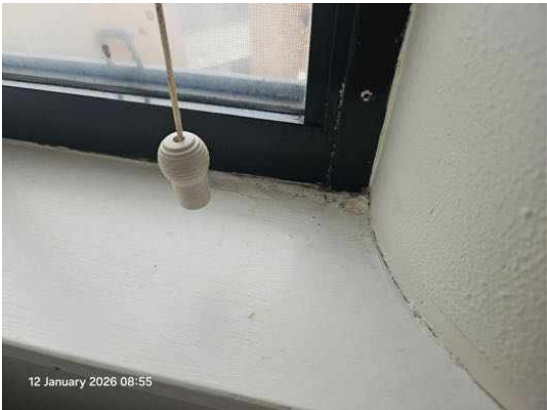
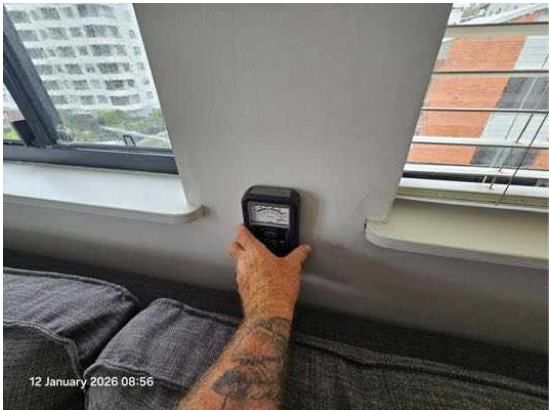
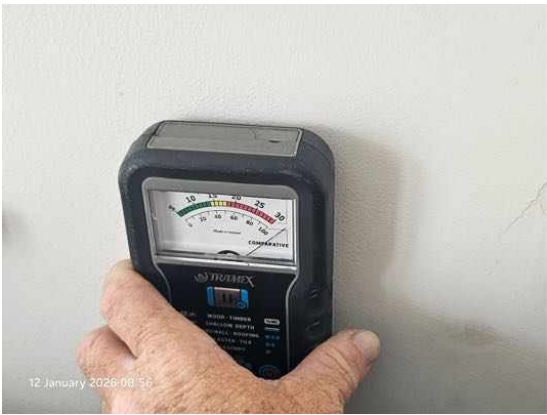
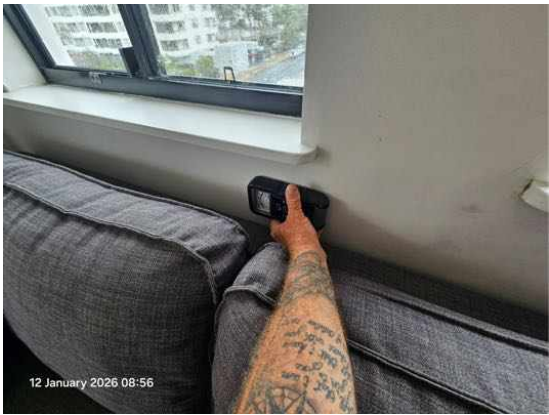
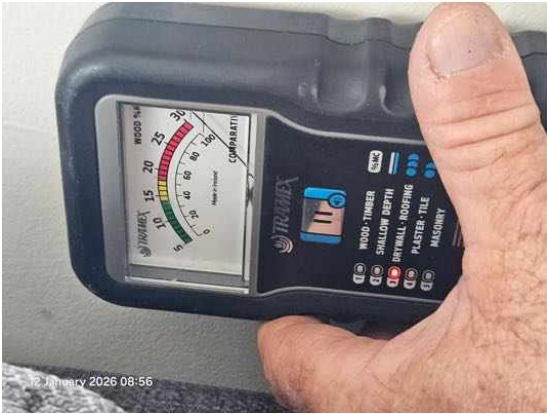
### Finding 3.04

Building:	Main Building
Location:	As shown
Finding:	Window reveal moisture
Information:	During the inspection an elevated moisture reading was noted in the timber reveal of the windows shown. There is minor wood rot forming in the corner. The damage is isolated to the ends at the internal corners of the sills shown, which would indicate that moisture may be entering through the joint between the bottom aluminium profile and the sill. Alternatively, it may be due to moisture entering via the window when left open.

This should be monitored. A licensed painter could be engaged to carry out the necessary repairs to the sill.

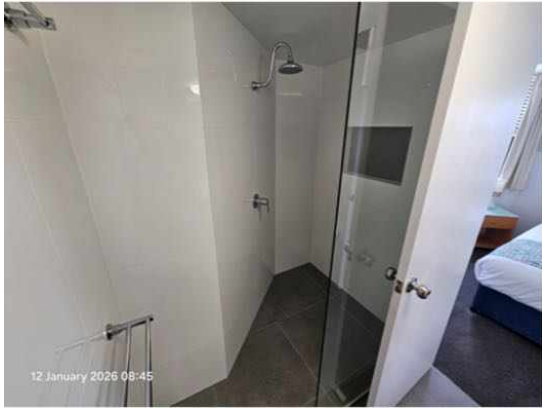
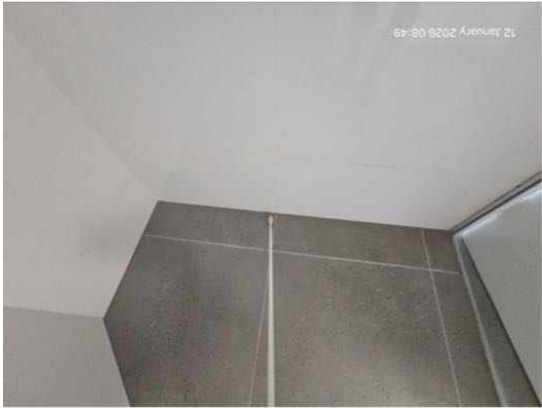
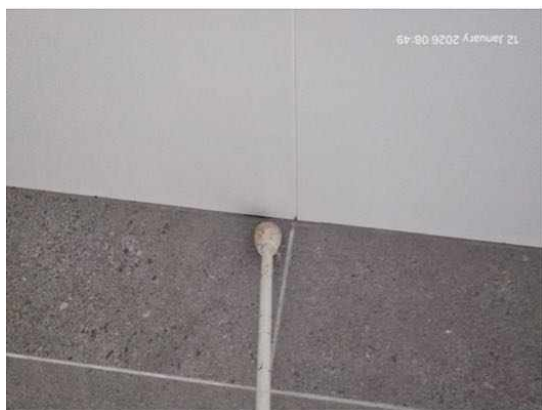
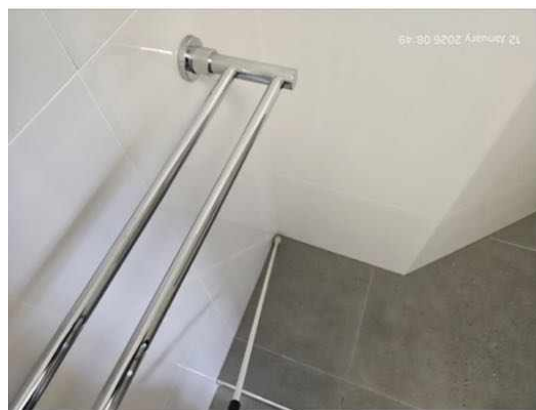
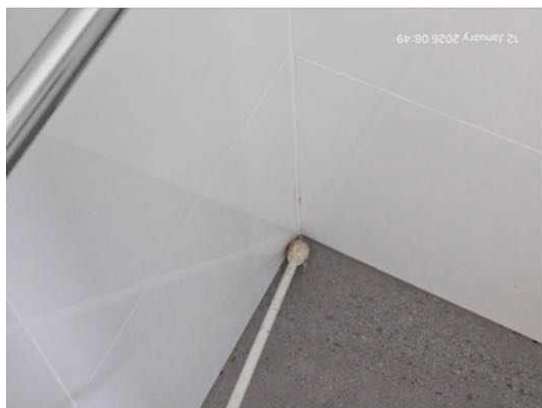
**Finding 3.05**

Building: Main Building  
 Location: Bathroom  
 Finding: Sealant - requires renewal  
 Information: The silicone sealant around the base of the shower requires renewal as it has become delaminated from the floor / wall junction. It is recommended that the existing silicone sealant be removed and new sealant be applied.

A licensed tiler or suitably qualified handy person could be engaged to carry out this work.

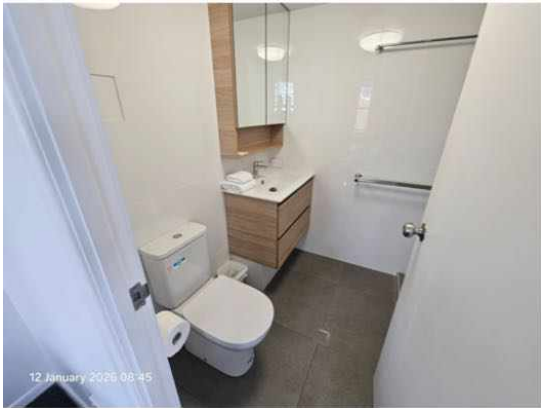
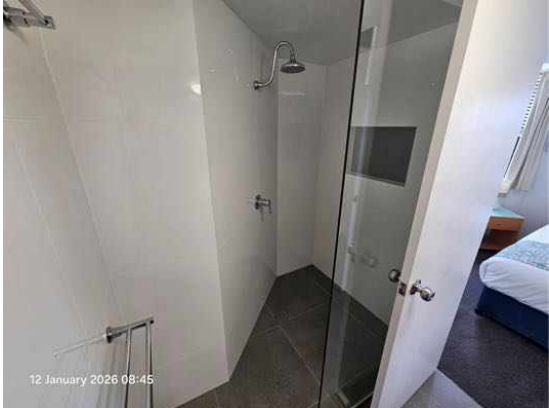
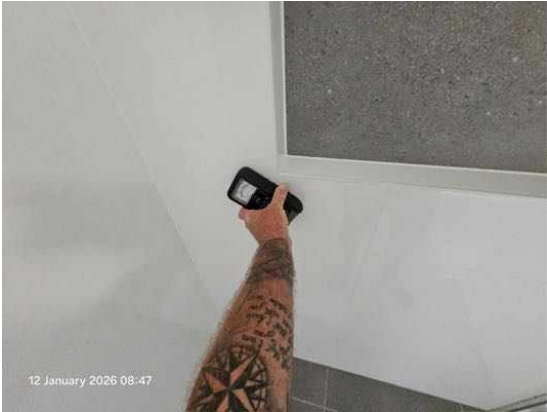
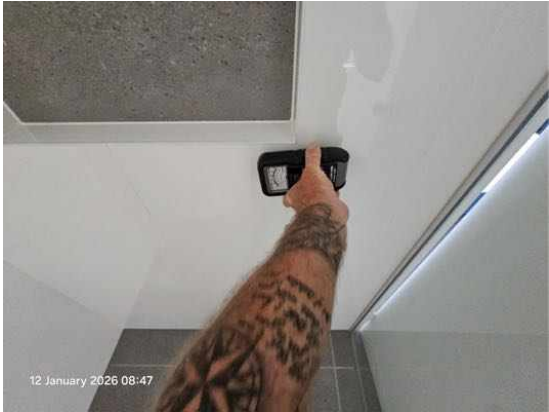
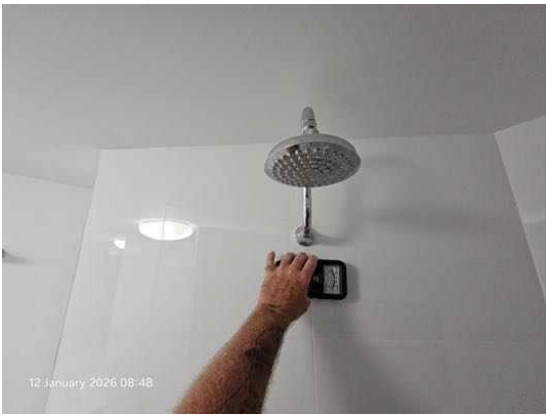
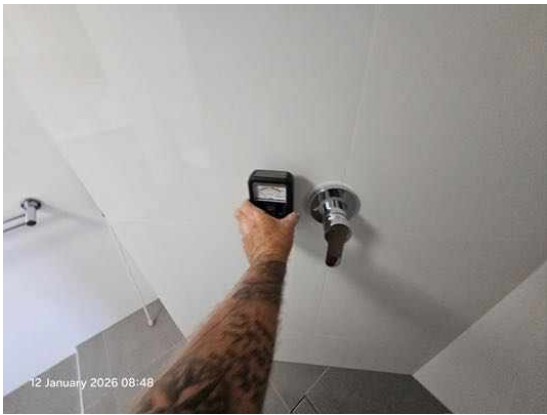
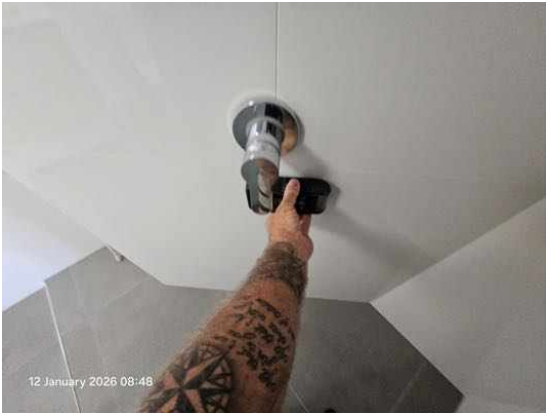
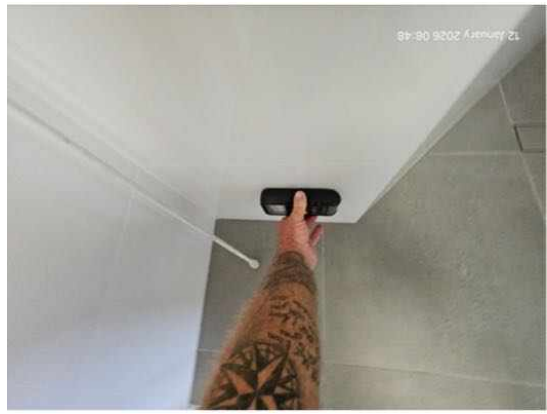
Building: Main Building  
Location: Bathroom  
Finding: No moisture detected in bathroom  
Information: On the day of inspection the shower in the bathroom was measured for moisture using a "Tramex" moisture meter. During this inspection no moisture was detected in these areas and the tiled / sheeted surfaces appear to be in good order.

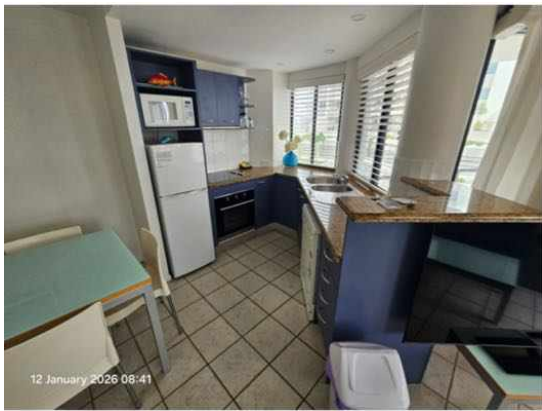
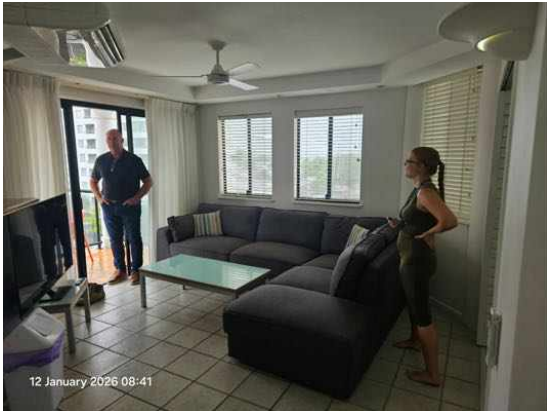
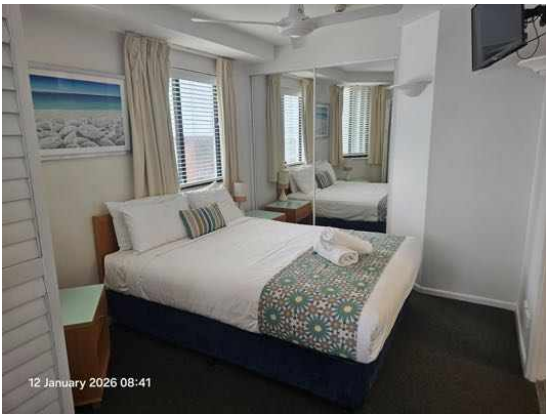
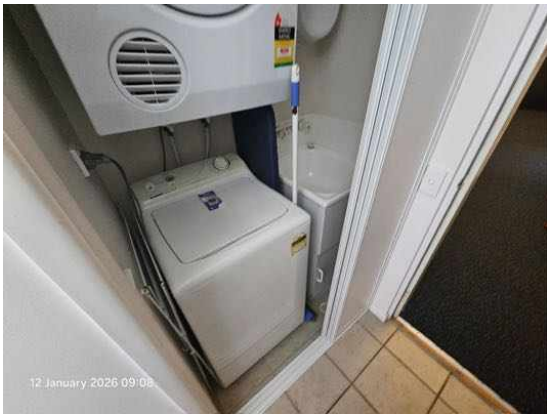
Building: Main Building  
 Location: All Areas  
 Finding: Additional Photos - Obstructions and Limitations  
 Information: These photographs are an indication of the obstructions and limitations which impeded full inspection of the property at the time of inspection. These obstructions can hide an array of defects and should be removed to allow full inspection to be carried out. A re-inspection is recommended once the areas are made accessible.

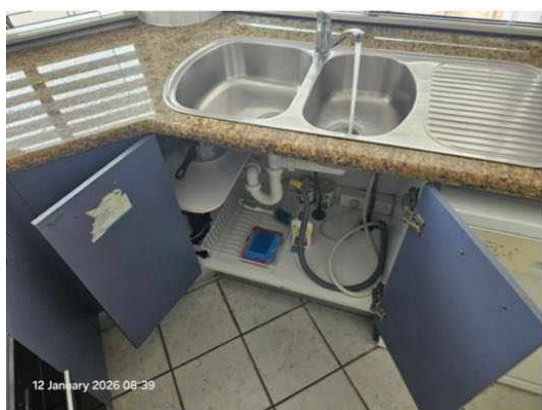
Building: Main Building  
 Location: Kitchen cupboard  
 Finding: Durable timber pest notice - not assessable  
 Information: On the day of inspection it was noted that the durable pest inspection / treatment notice was missing, not visible or out of date. These notices / stickers are to verify the currency and type of timber pest system / barrier in place or being used in and around the property.

It will be assumed that there is no current system in use.

It is recommend that a licensed timber pest controller be contacted to assess the

properties needs and provide costings.
