Building and Timber Pest Inspection Report

Inspection Date: Wed, 4 Mar 2026

Property Address: 9a Bonneville Bvd, Goulburn NSW 2580,
Australia

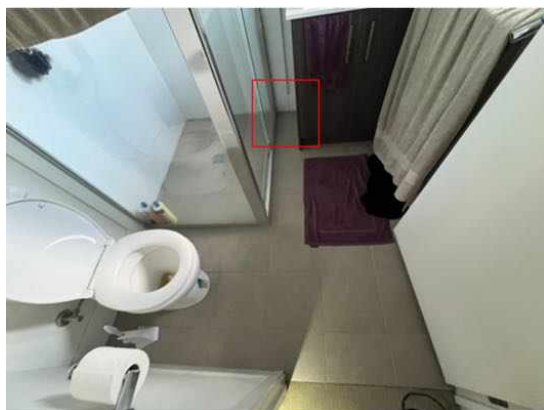
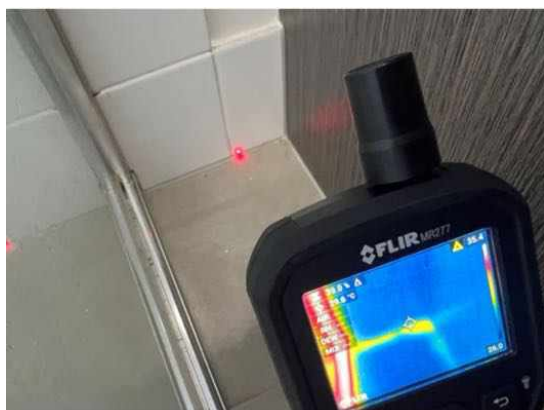
Building: Main Building
Location: Ensuite
Finding: Wet Area - Moisture Tracking
Information: Thermal imaging undertaken during the inspection identified temperature anomalies consistent with moisture tracking from the shower area toward the adjoining vanity section of the bathroom. This pattern is commonly associated with moisture movement across tiled surfaces or through underlying building materials and may indicate deterioration of sealant joints, grout lines, or potential deficiencies within the waterproofing system.

Wet areas are frequently exposed to water, and where moisture is able to migrate beyond the immediate shower enclosure it may penetrate concealed sections of flooring or adjoining wall structures. If left unmanaged, this condition may lead to progressive moisture damage to surrounding building elements.

The adjoining wall area was obstructed at the time of inspection and could not be visually assessed for any associated moisture damage. Thermal imaging identifies temperature variations only and does not confirm the presence or extent of concealed moisture or damage.

A licensed plumber or tiling contractor should be appointed to further assess the shower enclosure, adjoining tile junctions, and waterproofing integrity to ensure the area remains adequately sealed against water penetration and to determine whether remedial works are required.

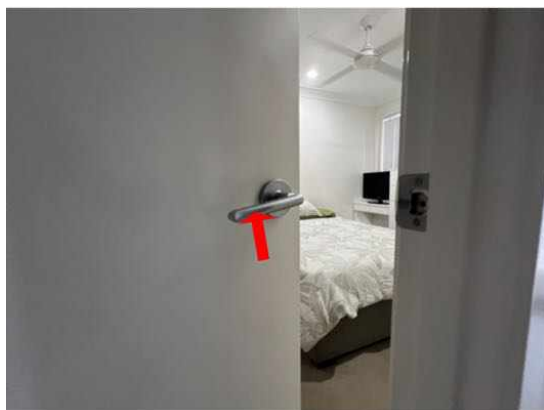
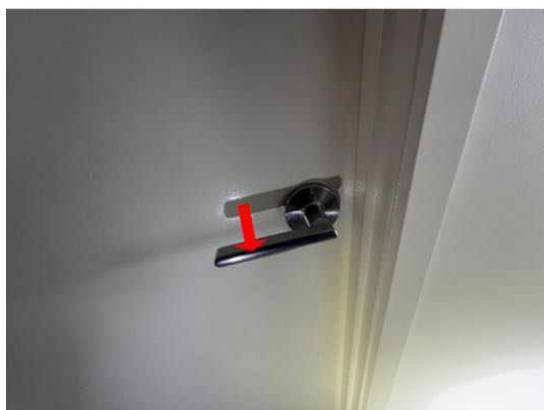
Finding 3.02

Building:	Main Building
Location:	All Internal Areas
Finding:	Door Handle - Loose
Information:	The door handle lever in this area was identified as loose at the time of inspection. A loose door handle can impede the proper operation of the door and, if left unattended, may lead to further deterioration or damage to the associated door structure.

This defect is typically caused by wear and tear, insufficient fixing, or deterioration of the handle's components.

It is recommended that a qualified carpenter or general handyperson be appointed to secure or replace the handle to restore its functionality and ensure proper operation.

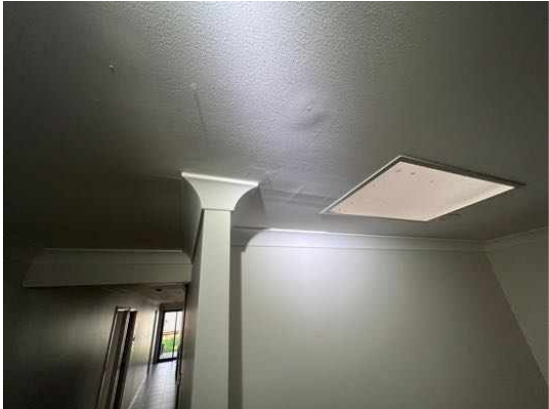
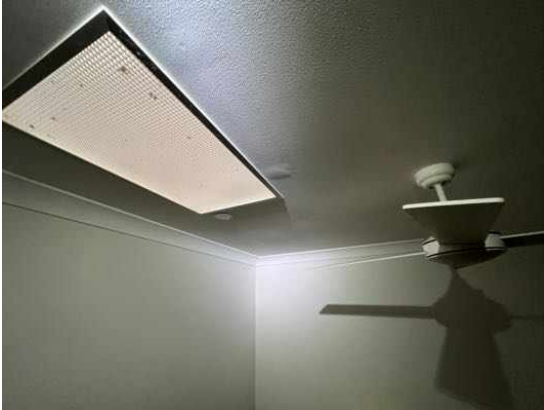
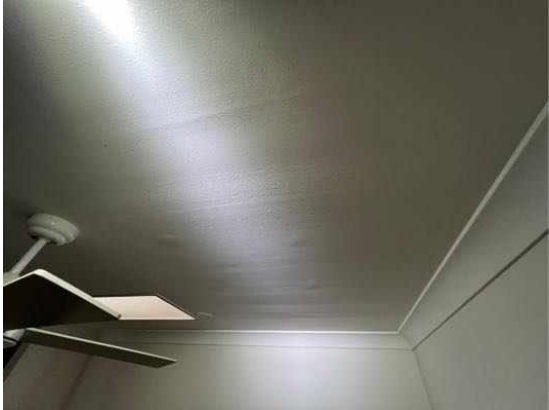
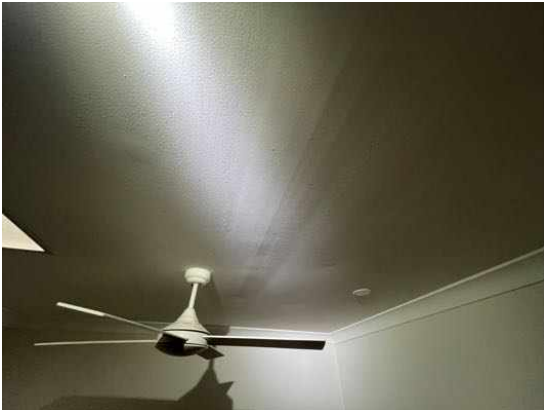
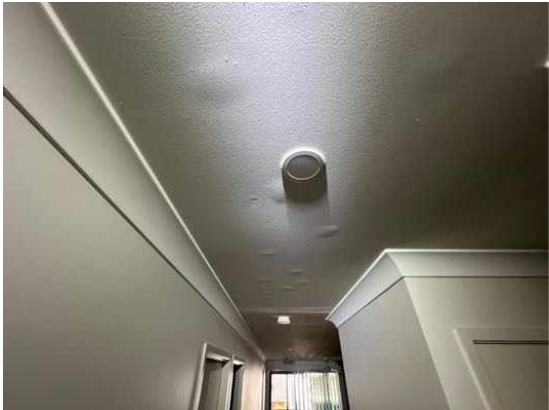
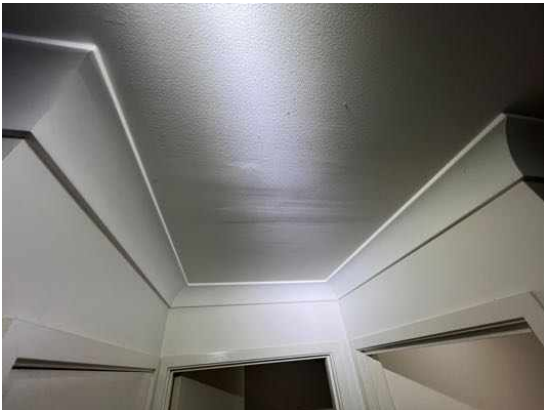
Finding 3.03

Building:	Main Building
Location:	Entry, Hallway, Office, Bathroom, Living, Dining, Bedroom 3, Bedroom 2, Bedroom 1, Ensuite
Finding:	Ceiling linings - Poor workmanship
Information:	Ceiling linings in these areas were observed to display poor finishing and surface irregularities at the time of inspection. Visible screw flushing finishes, inadequate flushing of joints and uneven surface areas were evident across sections of the ceiling lining. These conditions are typically associated inadequate plasterboard finishing or insufficient setting and sanding of joint compound during installation.

While primarily aesthetic in nature, poor finishing of this kind may become more noticeable over time and may require remedial patching and refinishing to achieve an acceptable appearance.

A plastering contractor should be appointed to assess the affected ceiling areas and undertake repairs as required to improve the finish and presentation of the ceiling lining.

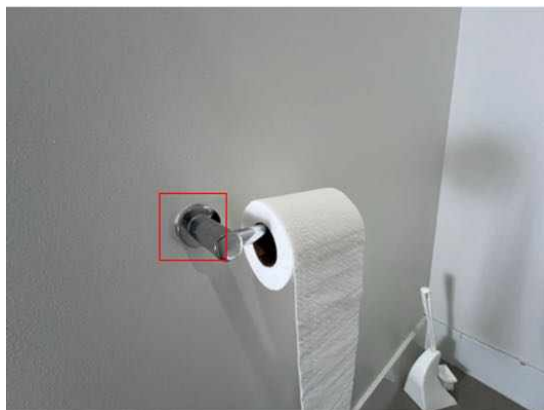
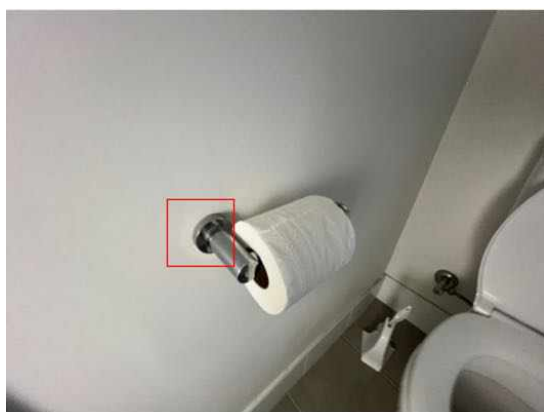
Building:	Main Building
Location:	Toilet (WC), Bathroom, Ensuite
Finding:	Fitting or fixture - Loose
Information:	The fitting in this area is loose and requires adjustment to tighten.

If left unmanaged, the fitting may further deteriorate, causing potential for the

development of other minor secondary defects.

A relevant tradesperson should be appointed to perform these rectification works at discretion of the client.

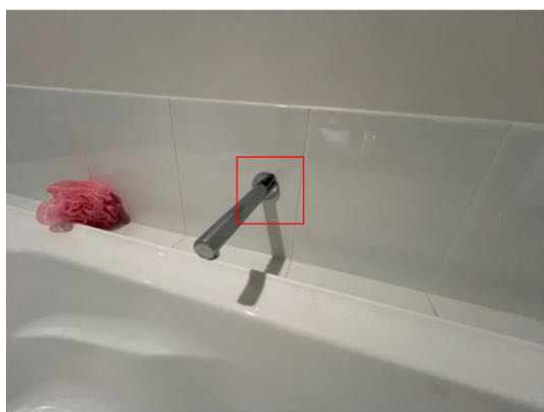
Building:	Main Building
Location:	Bathroom
Finding:	Bath spout - Loose
Information:	The bath spout was observed to be loose at its connection point at the time of

inspection. This condition is commonly caused by poor installation, deterioration of sealant, or movement in the fixture over time.

A bath spout may lead to water leakage behind the wall/floor, potentially causing moisture damage and deterioration of associated building elements if left unmanaged.

It is recommended that a licensed plumber be engaged to assess and properly secure the spout to prevent further movement and potential water ingress.

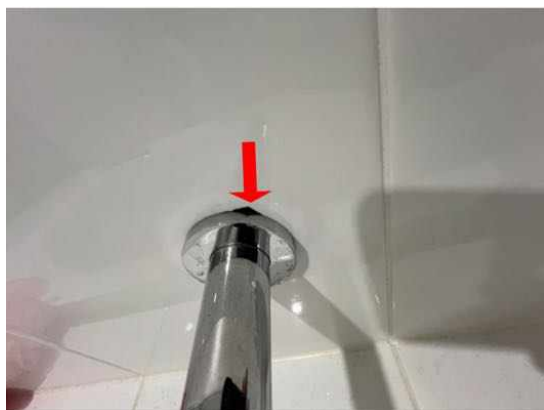
Finding 3.10

Building:	Main Building
Location:	Bathroom
Finding:	Tiles - penetration gaps
Information:	Over sized cutout for pipe penetration was evident to the tiling in this area at the time of inspection. While the opening appears to be minor, this area is frequently exposed to water, allowing potential for water penetration into adjoining sections of walls or flooring.

If left unmanaged, water penetration to these areas may lead to subsequent water damage, which is likely necessitate repair work to affected building elements.

A tiling contractor should be appointed to ensure that no further water damage occurs. The re-application of silicone and grouting throughout remaining tile work is also advised, to further protect the area against water penetration.

Where water penetration has led to water damage, appointment of a relevant tradesperson may be required to repair damaged building elements.

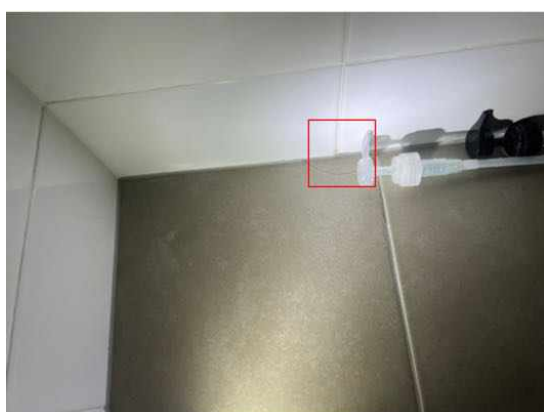
Finding 3.11

Building:	Main Building
Location:	Bathroom
Finding:	Tiles - Cracked or damaged
Information:	Cracking was evident to the tiling in this area at the time of inspection. While the cracking appears to be minor, this area is frequently exposed to water, allowing potential for water penetration into adjoining sections of walls or flooring.

If left unmanaged, water penetration to these areas may lead to subsequent water damage, which is likely necessitate repair work to affected building elements.

A tiling contractor should be appointed to ensure that no further water damage occurs. The re-application of silicone and grouting throughout remaining tile work is also advised, to further protect the area against water penetration.

Where water penetration has led to water damage, appointment of a relevant tradesperson may be required to repair damaged building elements.

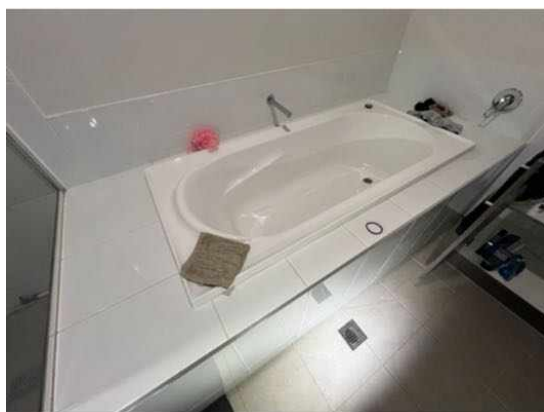
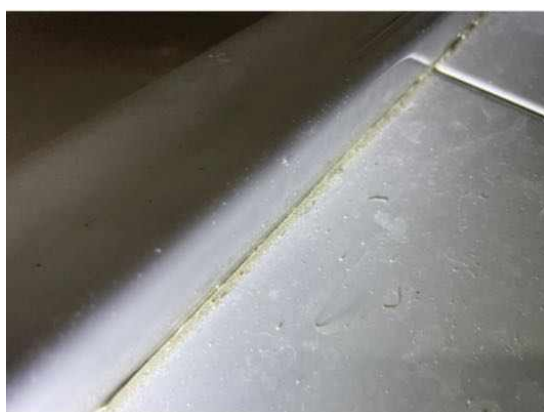
Building: Main Building
Location: Bathroom, Ensuite
Finding: Sealant and grouting - Missing or damaged
Information: It was noted on inspection that sealant or grout is degraded to the tiled shower alcove and or other areas of the bathroom.

Different materials and floor areas move at different rates, generally causing cracking to grout or sealant at this point. A flexible sealant is required to allow for expected expansion and contraction, while keeping the joint water tight and protective of all associated building materials.

There appears to be excessive mould to the sealant and grout which will likely require scraping out and replacement.

Flexible and mould resistant materials should be applied to affected areas to prevent any subsequent water damage that is likely to occur. Regular maintenance and replacement of damage or missing or damaged sealant and grout is highly recommended to the wet areas, as this is a regular wear and tear defect. Sealant and grouting in areas that come into regular contact with water should be maintained for the long term care of your property.

A sealant specialist or tiling contractor should be appointed to complete these works as soon as possible

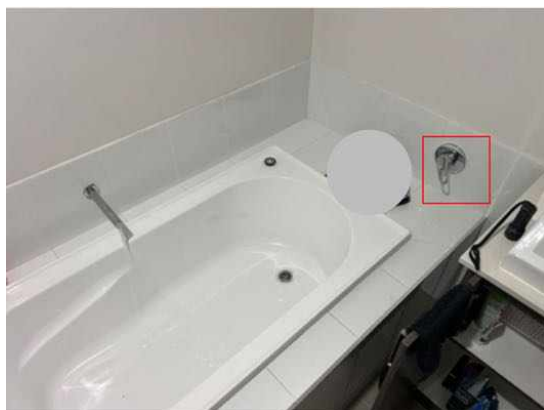
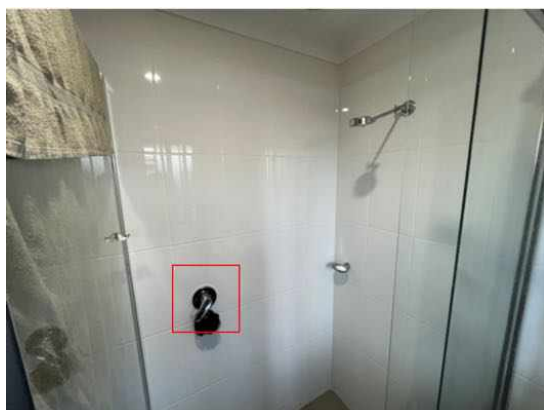
Finding 3.15

Building:	Main Building
Location:	Bathroom, Ensuite
Finding:	Tap - Water hammer
Information:	This tap shows evidence of water hammer being present. Water hammer, a pressure surge resulting when a fluid is forced to suddenly change direction, is a common defect in plumbing fittings, particularly those that are aged and not frequently maintained. Water hammer is generally caused by factors that create high water pressure in the affected plumbing fixture, usually evidenced by a faint banging noise during operation of the affected tap.

Although water hammer is generally considered to be a minor defect, subsequent damage such as erosion of tap hardware and/or water damage to associated building elements is likely to occur if left unmanaged.

A licensed plumber should be appointed as soon as possible to replace any affected tap hardware and perform any remedial works as necessary. Please be advised that the appointment of a cabinet maker or qualified carpenter may be necessary if water damage to associated building elements has occurred.

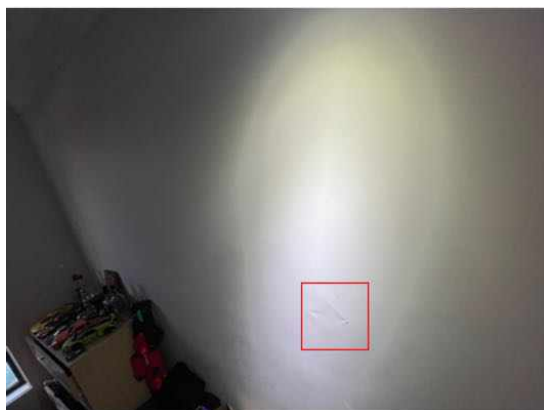
Finding 3.16

Building:	Main Building
Location:	Bedroom 3
Finding:	Wall - Incomplete or substandard works
Information:	The patch to this plasterboard finishing in this area appears to be incomplete or have been completed to a substandard level.

Works that have not been completed to a satisfactory level create potential for the development of building defects and may impede on the safety and integrity of the overall structure.

It is highly recommended that a licensed plasterboard contractor or painter should be appointed to finish the wall.

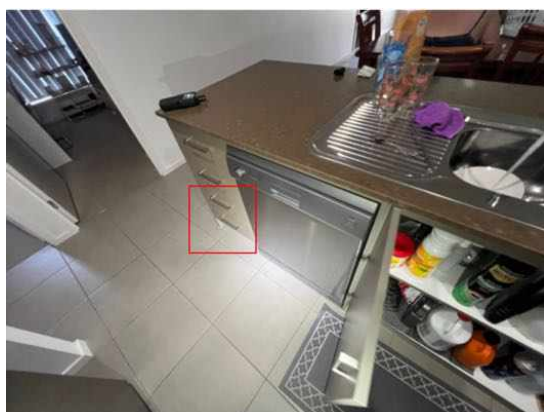
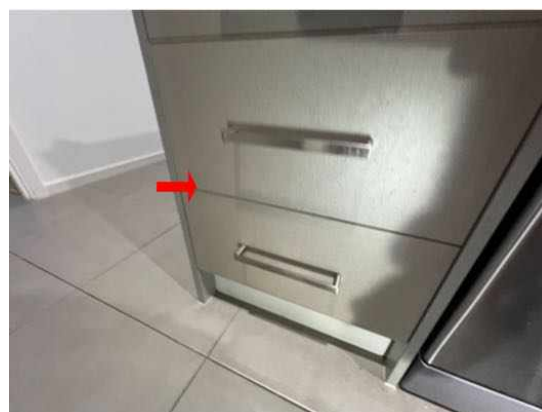
Finding 3.17

Building:	Main Building
Location:	Kitchen
Finding:	Joinery Drawer- Binding
Information:	A joinery drawer was found to be binding during operation, likely due to poor alignment, warping, or obstruction within the drawer track or surrounding structure.

Binding drawers reduce the functionality of cabinetry and may worsen over time if left unmanaged.

A qualified cabinetmaker or handyman should be engaged to assess the joinery and substructure to determine the cause and recommend appropriate remedial action.

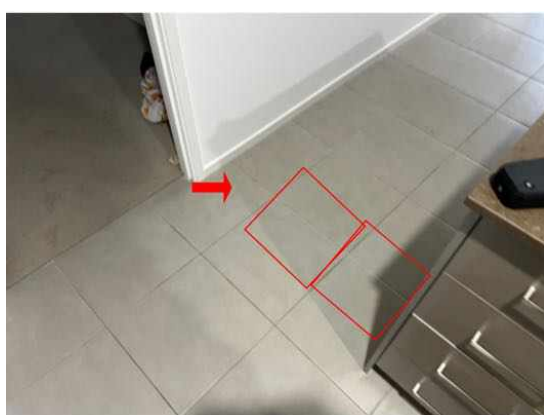
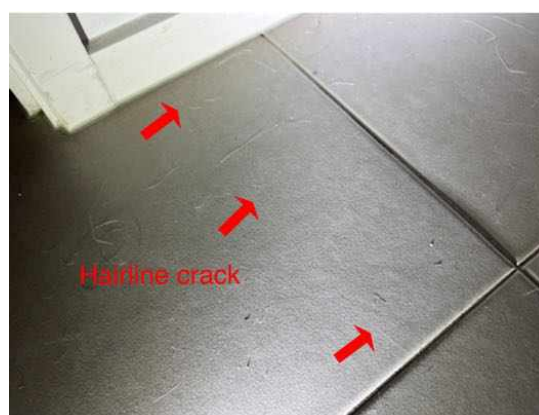
Finding 3.18

Building:	Main Building
Location:	Kitchen
Finding:	Tiles - Drummy
Information:	Drummy tiled areas were identified at the time of inspection. The term 'drummy' refers to tiles that have become detached from their fixing, despite otherwise being in relatively good condition. Such defects are generally caused by physical or moisture damage to the area. Drummy tiled areas may also be a direct result of poor

Tiled areas may swell and shrink with changes in air humidity if the area has sustained moisture damage. Any exposure to moisture is capable of causing tiled areas to become drummy and/or cracked over a prolonged period of time. Drummy tiled areas generally require removal and replacement of affected tiles, with adequate sealant and grouting.

Specialist trades are available for these types of services. A registered builder may be required to undertake works if damage is extensive or if secondary building defects have resulted. Otherwise, it is advised that a tiling contractor be appointed to perform works as necessary. Immediate action is recommended to ensure that no further damage is sustained in the affected area.

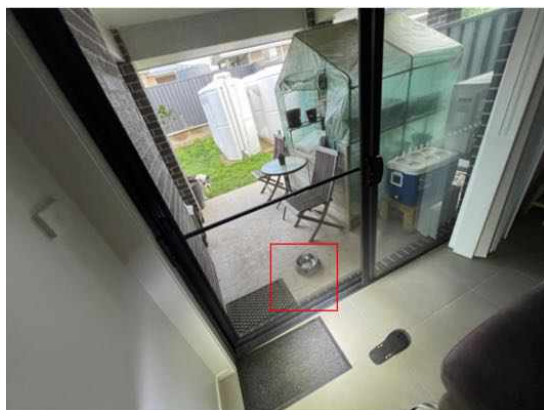
Finding 3.19

Building:	Main Building
Location:	Living Room
Finding:	Flyscreen - Damaged
Information:	The Flyscreen is as a result of damage (accidental or deliberate).The building element detracts from the operational state of the window.

Where not replaced/repared, damaged flyscreens allow pest and insect ingress into the adjoining room/s. Such works are necessary, as all building elements play a key role in the operation and function of the overall structure and its performance.

A general handy person may be appointed to replace/repair Flyscreen at the discretion of the client.

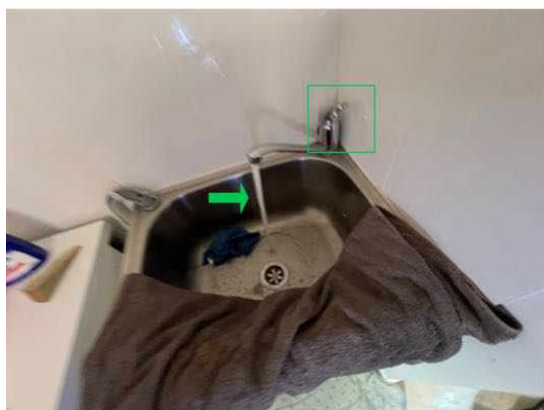
Finding 3.20

Building:	Main Building
Location:	Laundry
Finding:	Laundry Tap - No Water Flow to One Outlet
Information:	One side of the laundry tap assembly was found to have no water flow. This may be due to the washing machine not being connected or the isolation valve being closed. The client should seek advice from a licensed plumber to confirm operation once appliances are installed and connected.

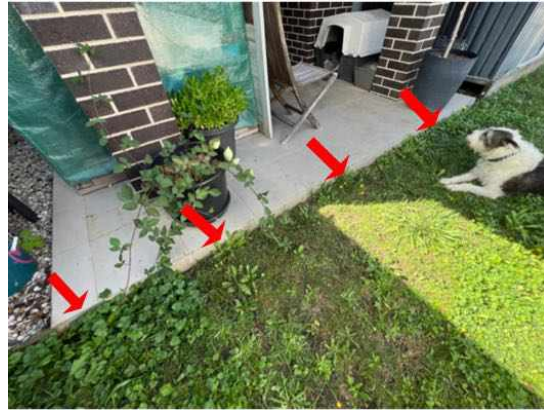
Finding 3.25

Building: Main Building
 Location: Alfresco
 Finding: Tiles - Drummy
 Information: Drummy tiled areas were identified at the time of inspection. The term 'drummy' refers to tiles that have become detached from their fixing, despite otherwise being in relatively good condition. Such defects are generally caused by physical or moisture damage to the area. Drummy tiled areas may also be a direct result of poor workmanship during the construction process.

Specialist trades are available for these types of services. A registered builder may be required to undertake works if damage is extensive or if secondary building defects have resulted. Otherwise, it is advised that a tiling contractor be appointed to perform works as necessary. Immediate action is recommended to ensure that no further damage is sustained in the affected area.

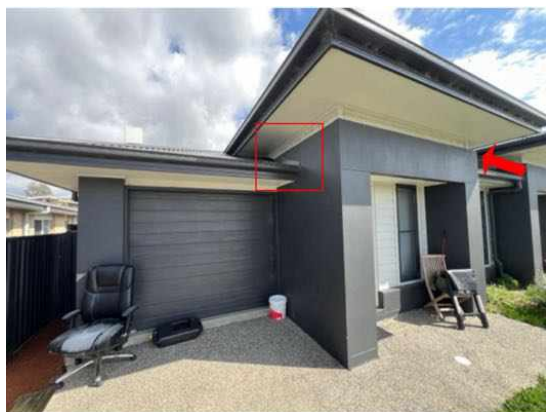
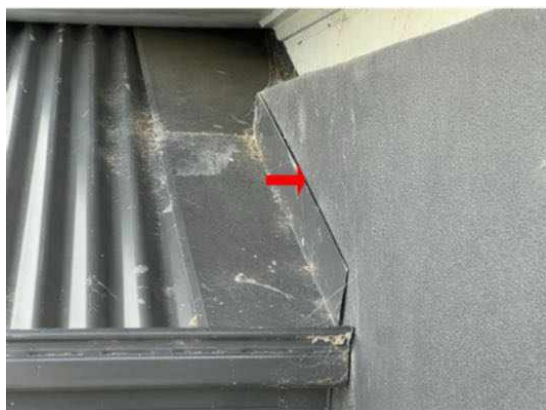
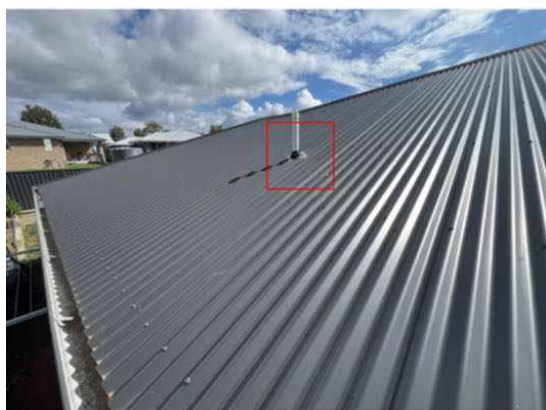
Finding 3.27

Finding: Roof plumbing - Flashing inadequate

A roofing plumber should be appointed as soon as possible to install relevant roof plumbing materials, ensuring that no further damage is sustained.

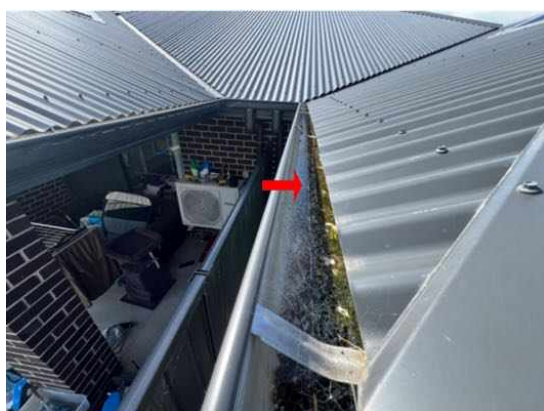
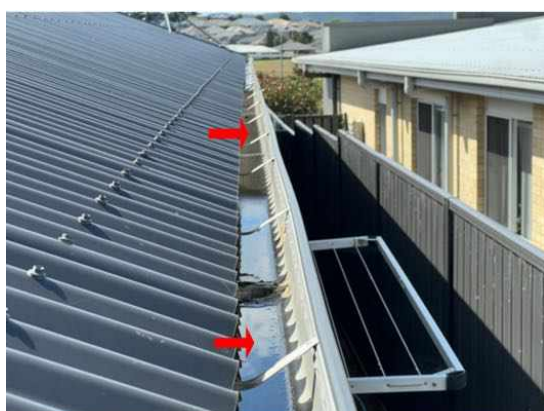
Finding 3.28

Building:	Main Building
Location:	Roof Exterior
Finding:	Gutters - Water pooling
Information:	Water was found to be pooling in sections of the roof guttering. This is generally a secondary defect caused by blocked or partially blocked gutters. Such blockages and subsequent water pooling are likely to lead to rust and water damage to associated structures if left unattended.

A roofing plumber should be appointed as soon as possible to rectify this issue. It is highly advised that all gutters be maintained on a frequent basis to ensure the condition of roof plumbing.

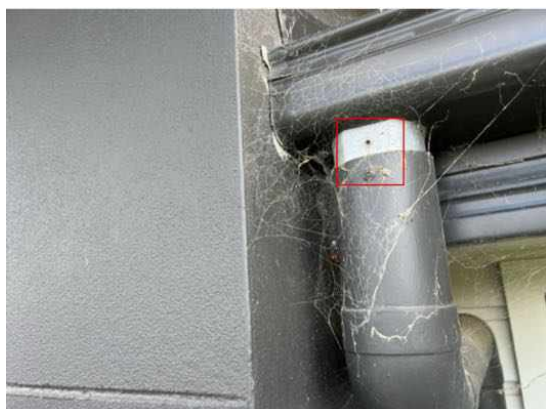
Finding 3.29

Building:	Main Building
Location:	Roof Exterior
Finding:	Downpipe - inadequately secured

Inadequate downpipe connection may result in water discharging near the building foundation, increasing the risk of dampness, erosion, or concealed damage to surrounding elements. A licensed plumber should assess the downpipe and ensure it is properly fixed to maintain effective stormwater drainage from the property.

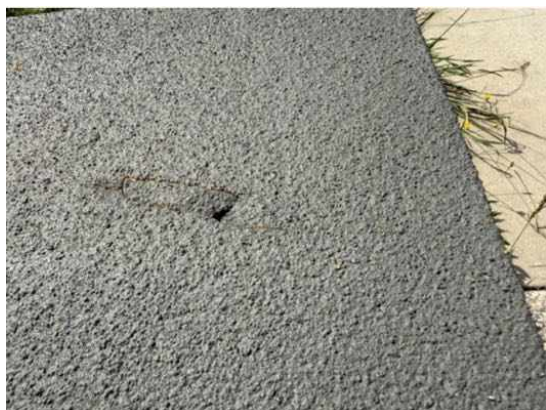
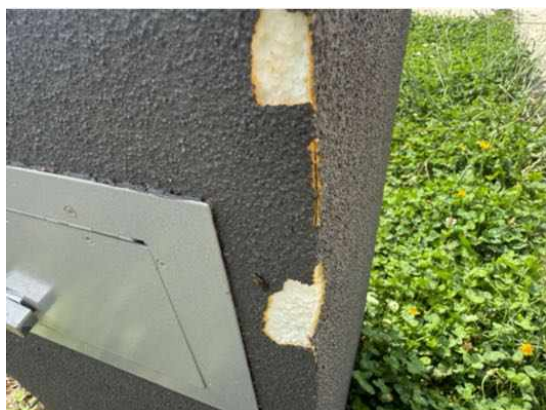
Finding 3.31

Building:	Yard
Location:	Yard - Front
Finding:	Letterbox - EPS Render Damage
Information:	Damage was observed to the rendered finish of the letterbox structure at the time of inspection. Sections of the render coating have broken away, exposing the underlying EPS (expanded polystyrene) core material.

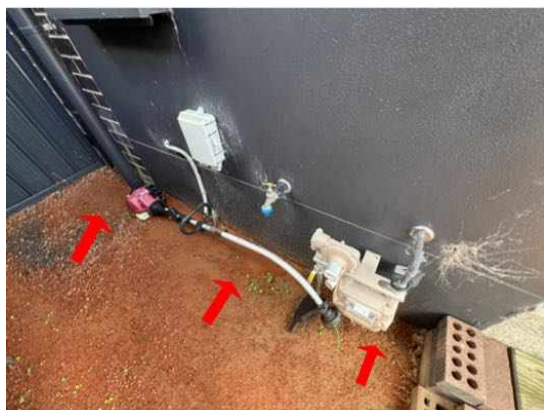
Finding 6.08

Building:	Main Building
Location:	Exterior walls - left side
Finding:	External taps - Not plumbed for drainage
Information:	The External taps is not plumbed or connected to suitable drainage, which has resulted in the surrounding area becoming excessively damp. These damp conditions can lead to secondary defects such as rot, rust or corrosion of associated building elements, the formation of fungal decay, or even the creation of potential slip hazards. When coupled with poor site drainage, pooling of water may also attract termite activity to this area. It is highly recommended that a qualified plumber be appointed to install adequate drainage to the overflow. These works will ensure that the area remains dry and free of any secondary defects.
