## Timber Pest Inspection Report

Inspection Date: Wed, 25 Feb 2026

Property Address: 5 Eltham St, Flemington VIC 3031, Australia

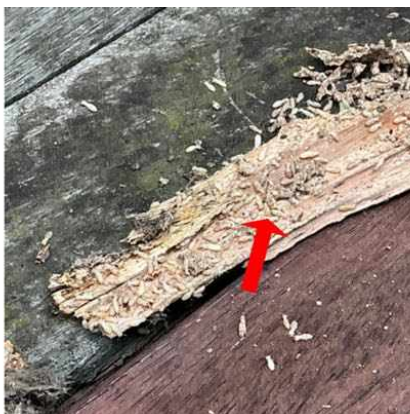
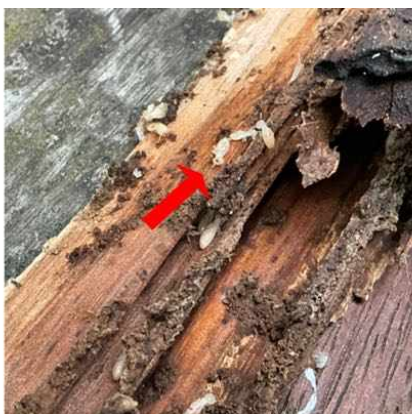
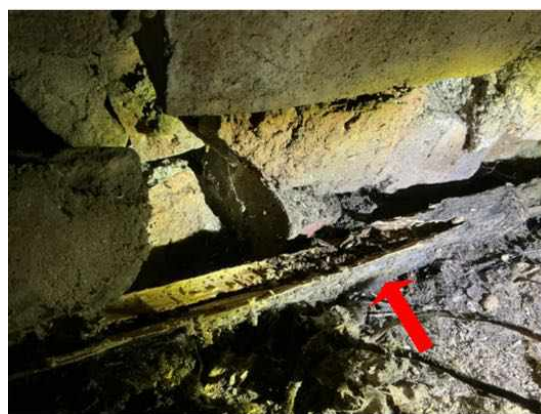
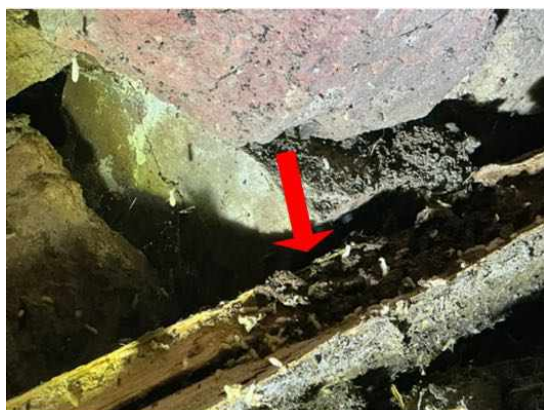
#### Termite and Timber Pest 2.01

Building: Main Building  
 Location: Subfloor  
 Finding: Evidence of live *Coptotermes* Spp termite activity was identified  
 Information: Confirmation of species must be made by a lab. Based on in field observations the species identification is preliminary in nature only. *Coptotermes* Spp are a common termite family that are generally distributed Australia-wide. The presence of these termite species is typically difficult to detect by the untrained eye as nests in domestic households are usually found completely underground or within living/dead vegetation.

*Coptotermes* Spp are known to attack both living and/or dead trees as well as seasoned timber that may be used throughout the external area of a property. The most common form of attack is on sleeper retaining walls that are in direct contact with the ground. If these timbers are non-durable and/or untreated ingress is provided for *coptotermes* or other species of subterranean termites directly from the surrounding grounds and into the timber.

This property is highly susceptible to timber pest activity. LIVE LOCALISED TERMITE ACTIVITY was observed in the sub floor area during the inspection.

This appeared to be limited to timber off cuts in contact with the ground.

If evidence of live *coptotermes* spp activity is found during inspection treatment is required immediately to prevent any further damage that will inevitably ensue if left unattended. Treatment options include the installation of bait stations with the view of directly eradicating the colony or the installation of a post-construction chemical barrier which is designed to prevent the reoccurrence of termite infestation. Remedial works or replacement of affected timber builder elements may also be required.

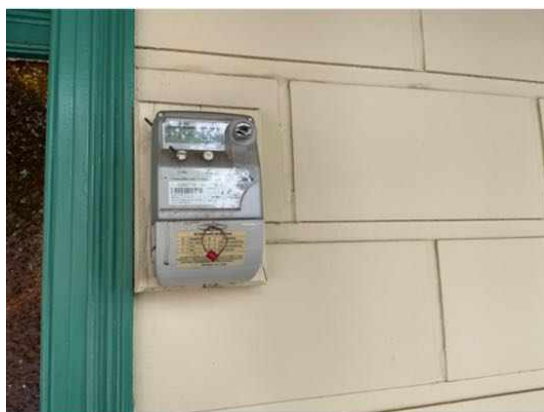
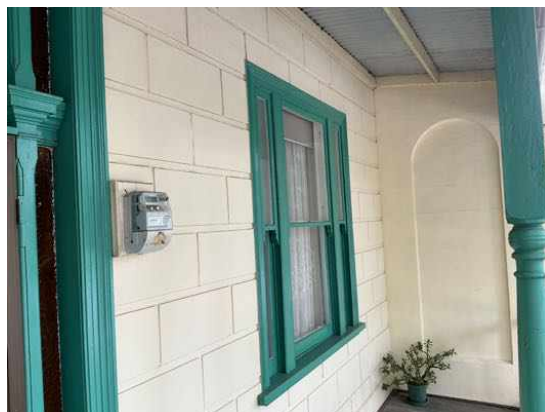
### Termite and Timber Pest 4.01

Building:	Main Building
Location:	Meter Box
Finding:	Termite Management System - no evidence of a chemical installation
Information:	The application of a post-construction chemical termite barrier is highly recommended for all properties, particularly if live termite activity has been found on the site previously. Such barriers are highly effective in preventing termite attack on any timber building elements throughout the property.

A durable notice should be placed in the switchboard unit to indicate current termite barriers. At the time of inspection, it appeared as though no termite management system has been installed, with no evidence to suggest preventative works taking place.

The client may consider gaining further advice from a pest controller as to the costs and procedures involved with this application. It is recommended that obtaining such

advice be a short-term priority.

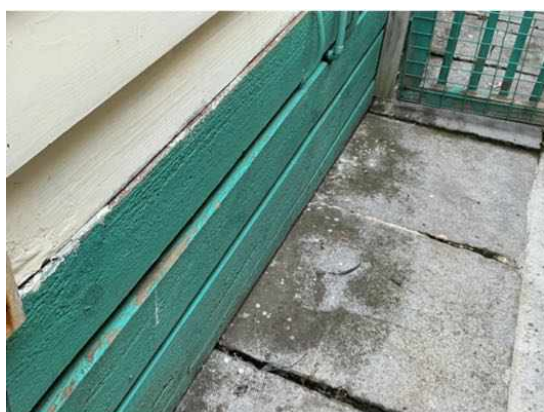
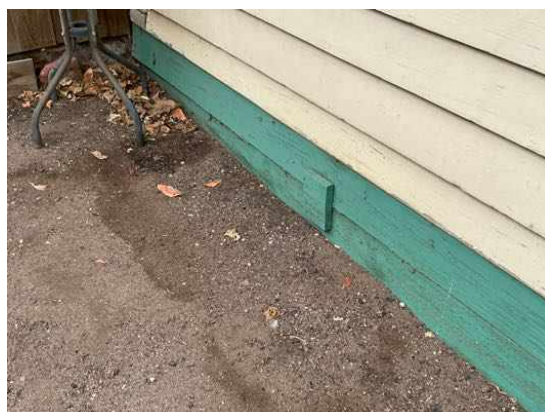
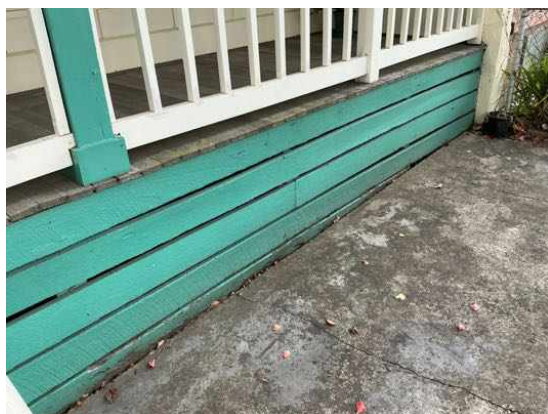
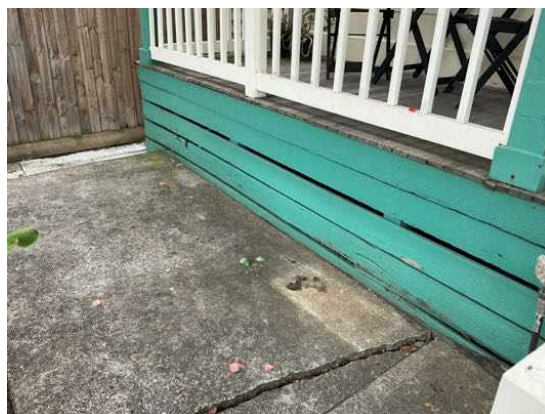
## Termite and Timber Pest 4.02

Building:	Main Building
Location:	All External Areas
Finding:	Untreated or non-durable timbers in a hazardous environment
Information:	To reduce the risk of timber pest attack it is essential that timber used in a hazardous environment (e.g. in direct contact with the ground or frequently exposed to damp conditions) is of sufficient durability and/or is adequately preservative treated.

Untreated timbers in direct contact with the ground are likely to develop severe wood rot and/or fungal decay if left unattended creating attraction for subterranean termites to infest the timbers from surrounding areas.

If untreated or non-durable timbers are found to be in a hazardous environment it is highly advised that replacement of these building elements be performed as soon as possible to aid the protection of the property against termite / timber pest attack.

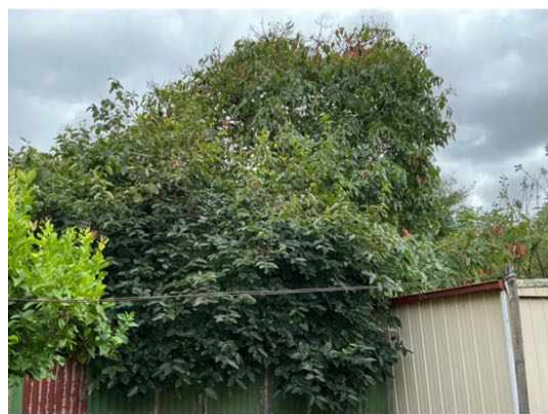
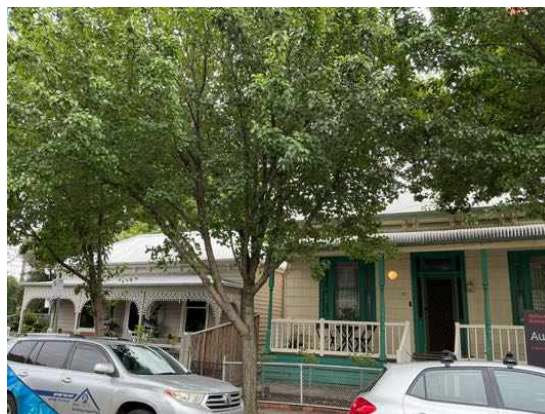
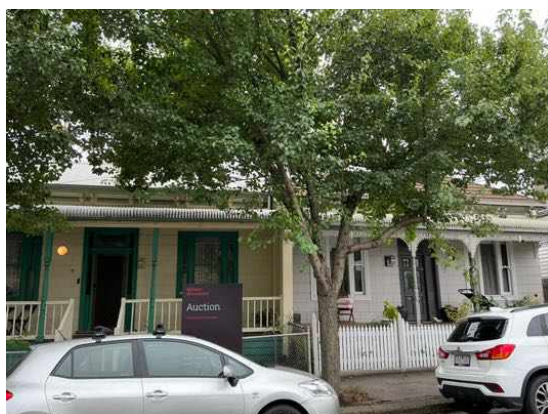
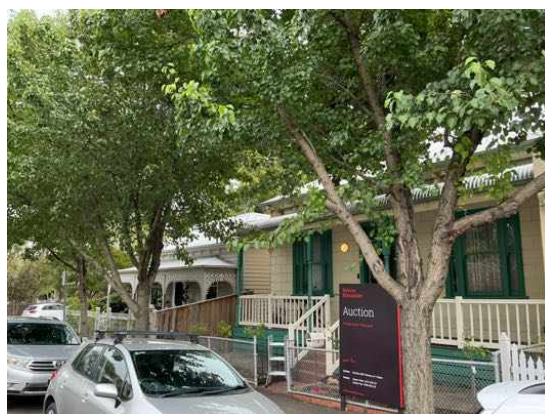
### Termite and Timber Pest 4.03

Building: Main Building  
Location: All External Areas  
Finding: Trees/large/termite  
Information: It was observed that there were several large trees next to or nearby the building.

The trees have the potential to provide conducive conditions for termite infestation

It is recommended that periodic 12 monthly inspections by a registered pest control contractor be undertaken and further reinstatement of outdated termite barriers as soon as possible.

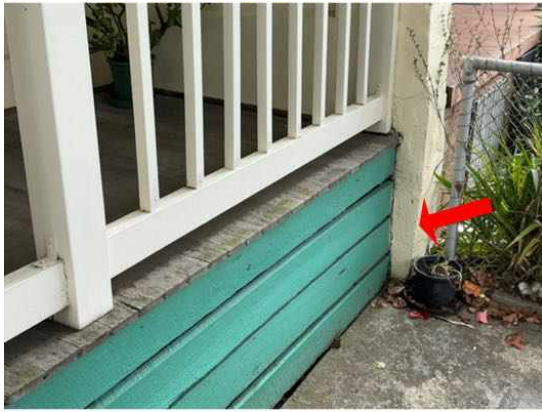
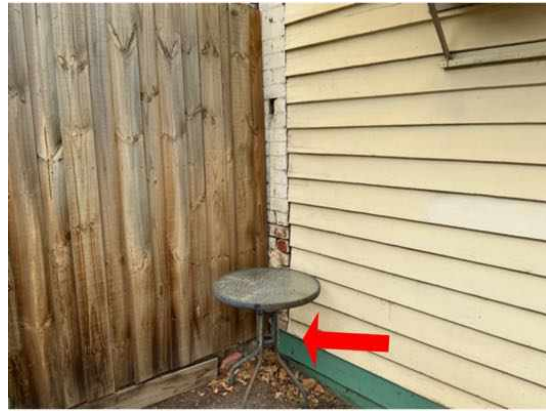
### Termite and Timber Pest 4.04

Building: Main Building  
Location: All External Areas  
Finding: Bridging or breaching of termite barriers - adjacent internal flooring  
Information: Bridging is the spanning of a termite barrier or inspection zone so that subterranean termites are provided with passage over or around that barrier.

Breaching is the making of a hole or gap in a termite barrier so that termites are provided with a passage through that barrier.

It is important for internal flooring to be raised above adjacent external ground levels. Where external ground levels are above internal flooring water pooling and subsequent internal flooding is likely to occur which may attract termite activity to the internal area.

It is highly advised that a landscaper or paver be appointed to lower external grounds that are raised above adjacent internal flooring. Alternatively if external grounds and internal flooring is level installation of a raised door sill may be appropriate in preventing any water pooling in the area.

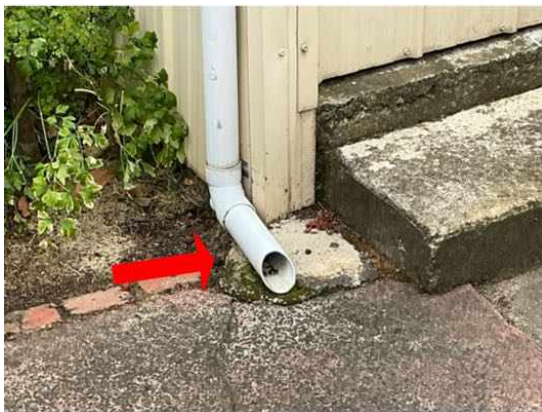
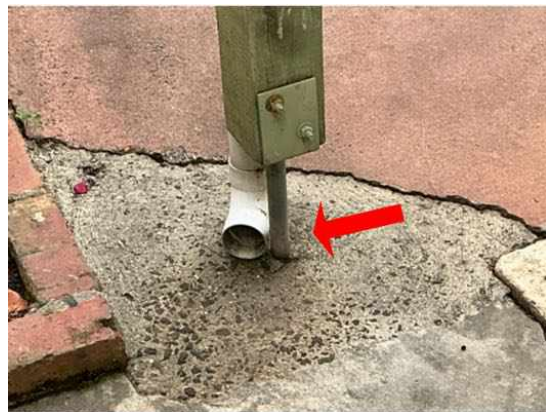
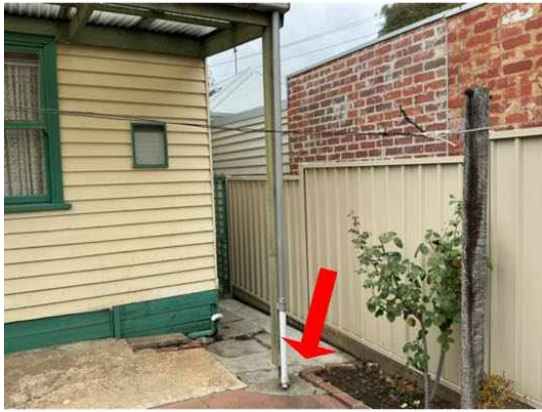
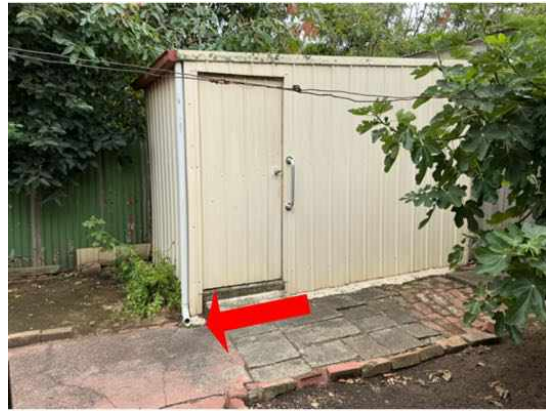
### Termite and Timber Pest 4.05

Building: Main Building  
Location: All External Areas  
Finding: Downpipe disconnected TP  
Information: It was noted that several downpipes are disconnected to the stormwater system.

Downpipes disconnected can cause flooding and over saturation of the surrounding foundation soils,

Moisture ingress to the building and footing movement may occur should the moisture content of the soil be not be kept constant.

Excessive moisture levels in the soil can be conducive to termite infestation

A licensed plumber should review at the owner discretion.

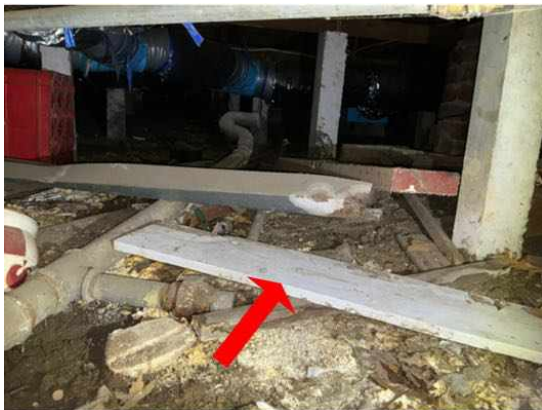
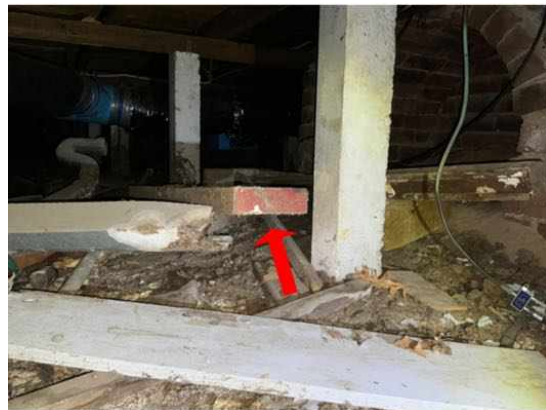
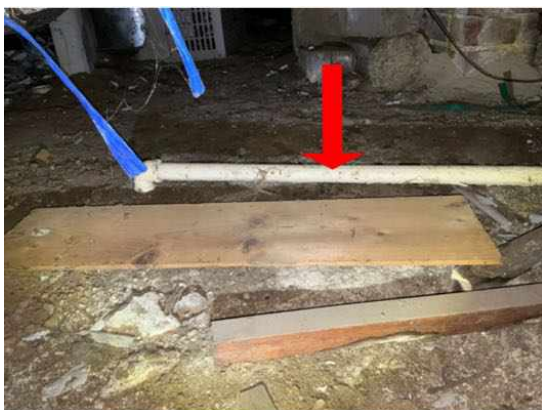
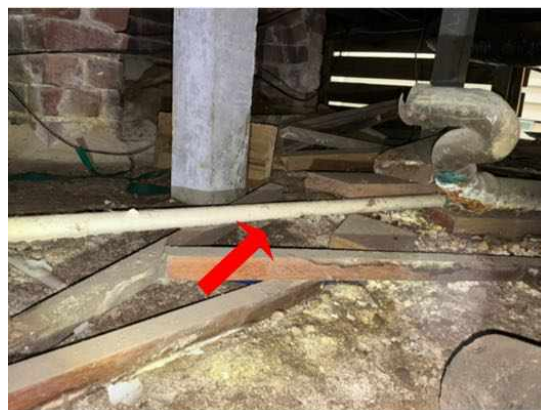
### Termite and Timber Pest 4.06

Building:	Main Building
Location:	Subfloor
Finding:	Stored timbers - subfloor space or external area
Information:	The storing of timbers in the subfloor space or around the external property increases the risk of termite activity being present. As they are likely to come into contact with weather conditions or excessive moisture wood rot is likely to develop on timbers that are not treated.

It is highly recommended that any stored timbers be immediately removed from areas in which they may attract any termite / timber pest attack. Minimisation of risk / prevention of termite attack is far more adequate than dealing with the presence of termite activity.

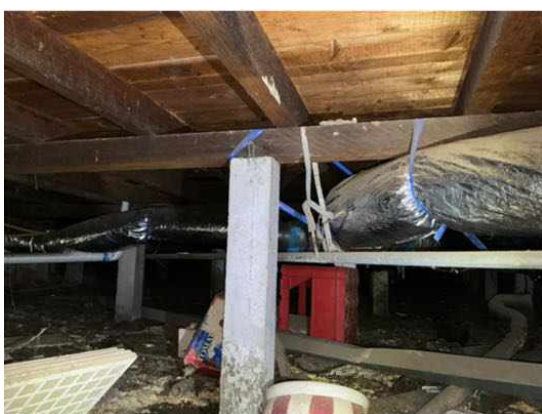
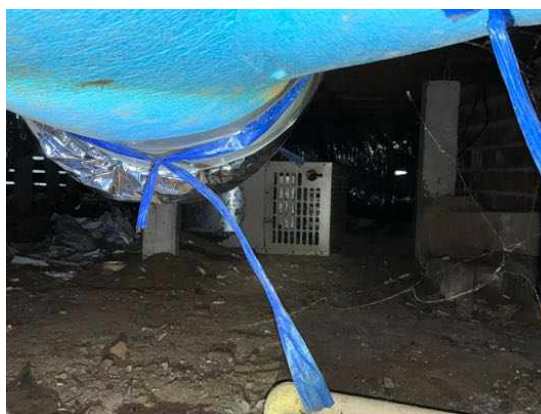
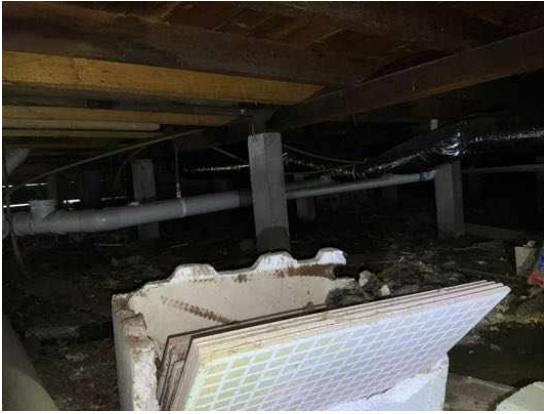
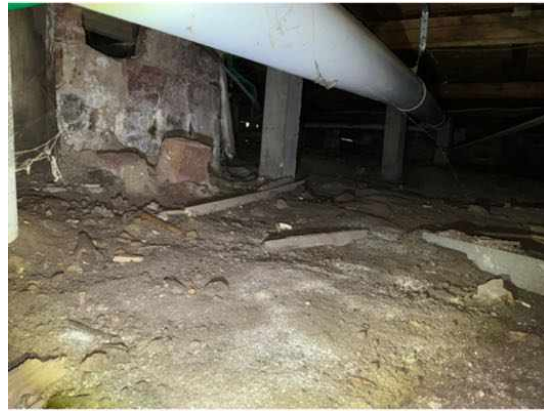
### Termite and Timber Pest 4.07

Building: Main Building

Location: Subfloor

Finding: Subfloor - Debris

Information: An array of debris was found in the subfloor area at the time of inspection. Debris in this area restricts subfloor ventilation and creates potential for concealed pest entry. Stored timbers and other materials may also make the area susceptible to termite activity and wood rot.

A clear and empty subfloor will be better ventilated and easier to maintain in a dry condition. The removal of any timber debris is vital in minimising the risk of termite or wood borer activity.

Debris in the subfloor should be removed as soon as possible. Depending on the location and amount of debris and stored items, the homeowner may elect to undertake this task. Alternatively there are a large number of rubbish removal subcontractors that could undertake these works.

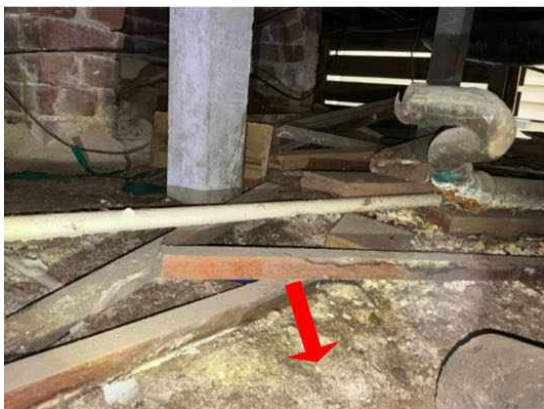
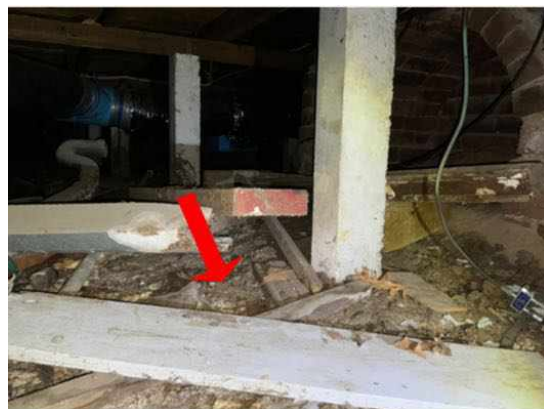
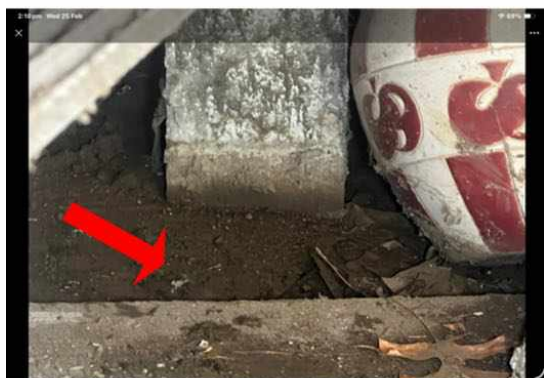
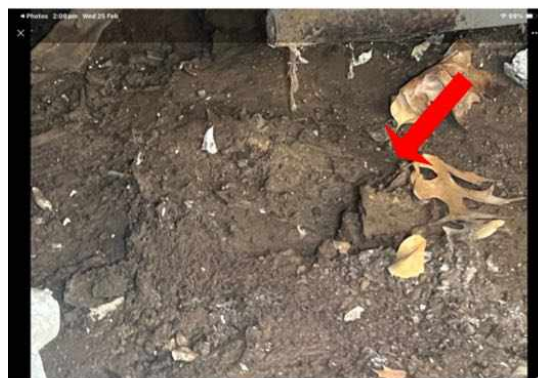
### Termite and Timber Pest 4.08

Building:	Main Building
Location:	Subfloor
Finding:	Site drainage - Inadequate
Information:	The site drainage in this area was found to be inadequate at the time of inspection, creating potential for subsequent water damage to associated building elements. The subfloor area was excessively damp in the subfloor door area. Excessive dampness can be conducive to termite infestation.

It is important that water does not lie against the base of walls; surrounding paths and ground levels should be sloped to drain water away from walls. Downpipes should not discharge stormwater onto lower walls or plinths. Stormwater should be carried away by large, regularly cleaned drains.

Where site drainage is inadequate, installation of an Agricultural (Aggie) Drain may be required. A qualified plumber should be appointed to further inspect the property and perform any remedial works as necessary. Water damage and secondary defects are likely to occur if left unmanaged.

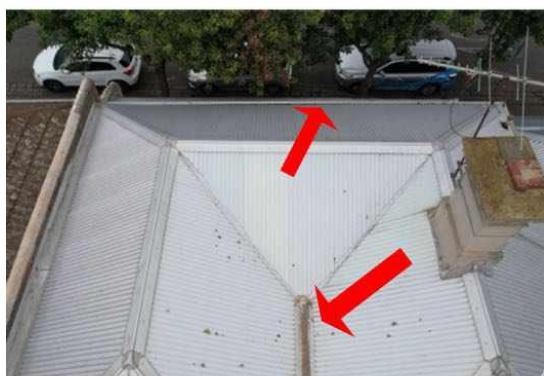
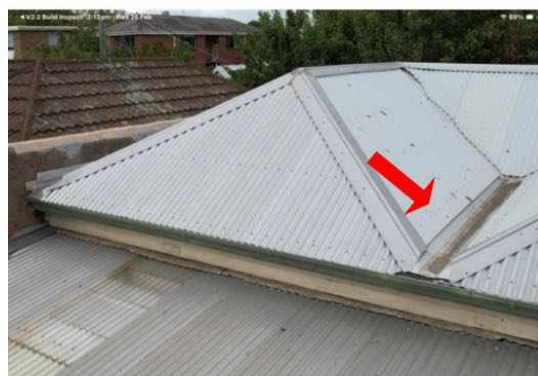
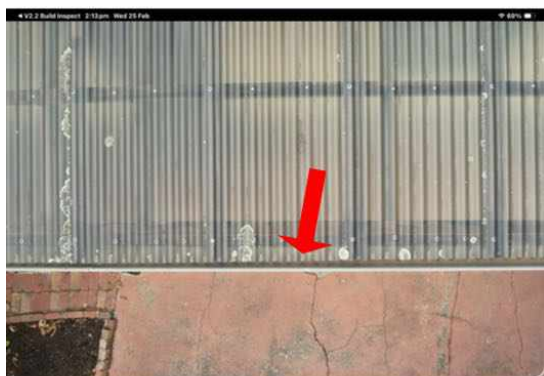
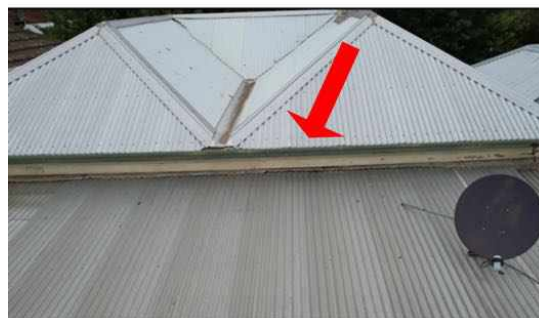
## Termite and Timber Pest 4.09

Building:	Main Building
Location:	Roof Exterior
Finding:	Gutters - Blocked
Information:	Roof plumbing structures, such as guttering and downpipes, should be free of all debris to prevent blockages. Blockages of the guttering and downpipes will lead to pooling and accumulated water overflows, which is likely to subsequently flood eaves and exterior walls.

Blocked gutters are likely to lead to high levels of moisture in the affected areas. Such moisture will not only cause rust and decay of the associated building materials, but can also provide conditions that are conducive to termite and timber pest activity. Blockages in gutters should therefore be removed immediately to ensure dry conditions are maintained.

Where gutter guard is installed regular maintenance should include cleaning out any debris which may rest on top of or filter through the gutter guard.

Consult a Licensed Plumber for further specific advice on remedial works that may be required. In the interim, it is highly advised that blocked gutters be removed by the homeowner or a general handyperson as a matter of urgency.

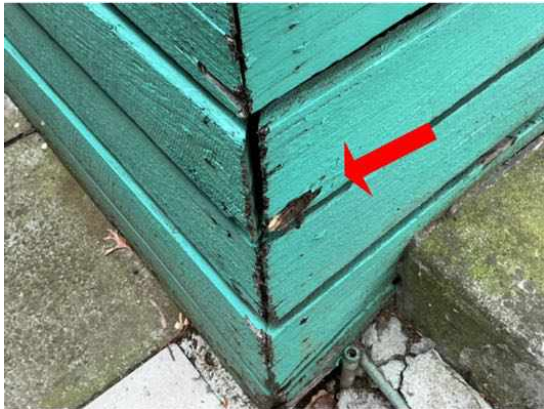
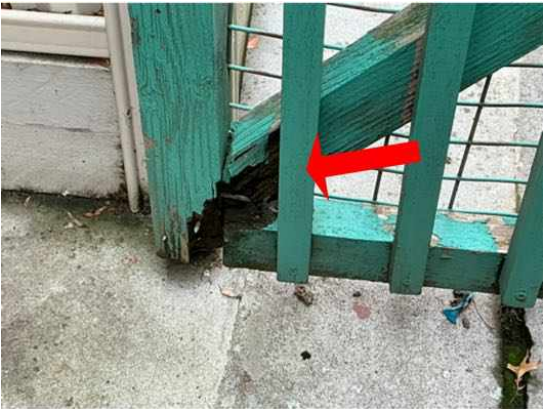
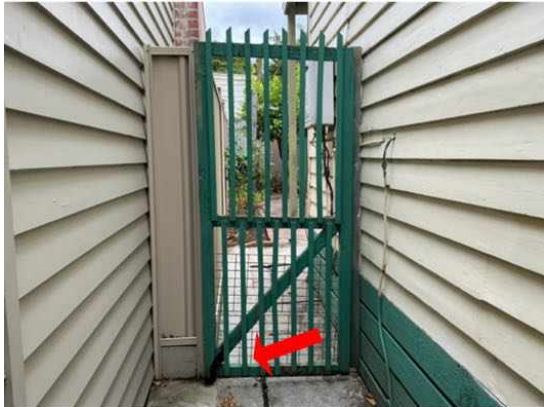
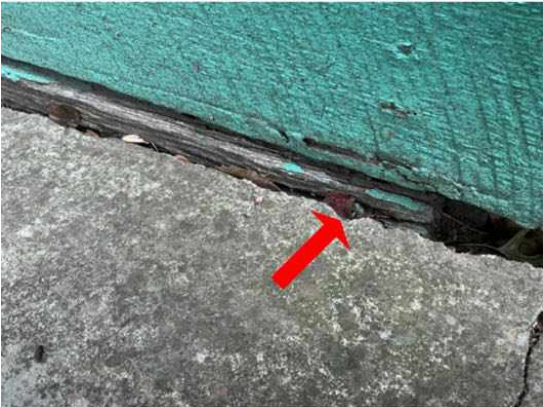
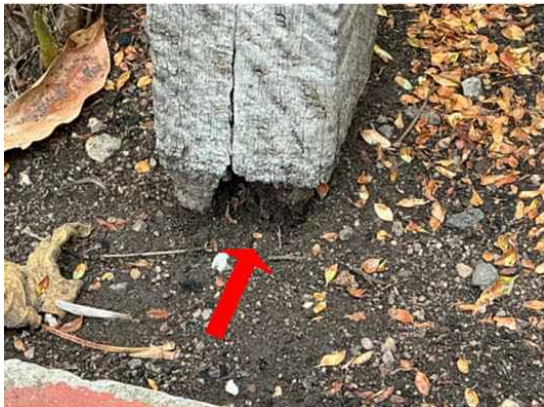
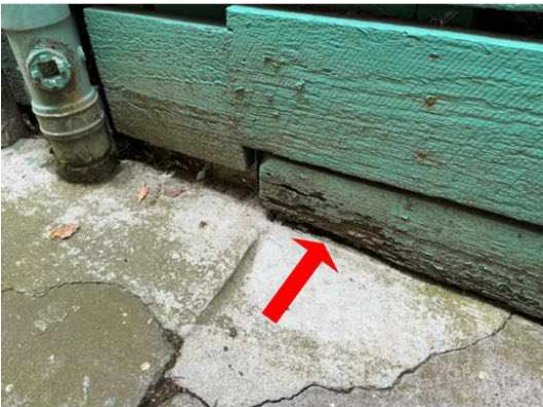
### Termite and Timber Pest 7.01

Building: Main Building

Location: All External Areas

Finding: Wood rot

Information: These timber building elements show evidence of wood rot. Wood rot, also known as Fungal Decay, occurs when timbers and other cellulose building materials are exposed to damp conditions on an ongoing basis. This could be the result of exposure to weathering over a prolonged period of time, or the attraction of excessive moisture from other abutting building materials. Contributing factors also include poor air ventilation in the area.

Wood rot is often associated with general damp problems and is evidenced by a 'musty' smell or mould and mildew occurring on surfaces. If left unmanaged, damp conditions can lead to further health problems and the decay of timbers will continue.

Early intervention and regular maintenance, particularly of exterior timbers, will prolong the useful life of these building elements. Prior to any works being performed, the cause of the moisture that has created the visible wood rot should be identified and addressed in a suitable manner. Replacement of affected timbers may then be a necessary step in protecting surrounding building elements from such deterioration.

A qualified plumber may be appointed to assess the cause of excessive moisture and to provide advice on any remedial works as required. A qualified carpenter or registered builder may also be required to replace affected building materials.

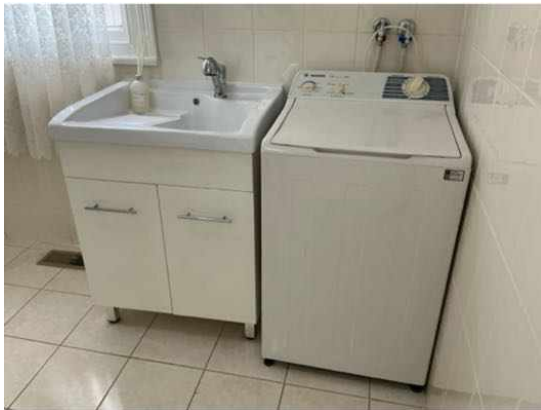
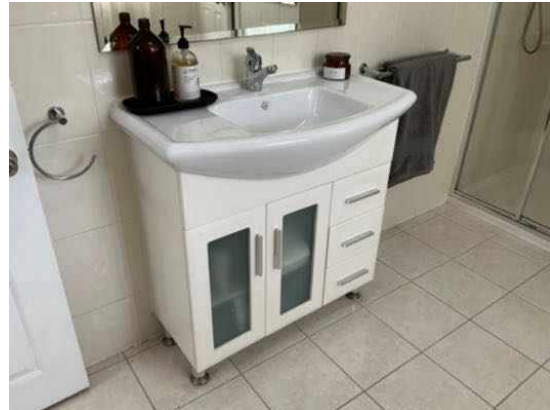
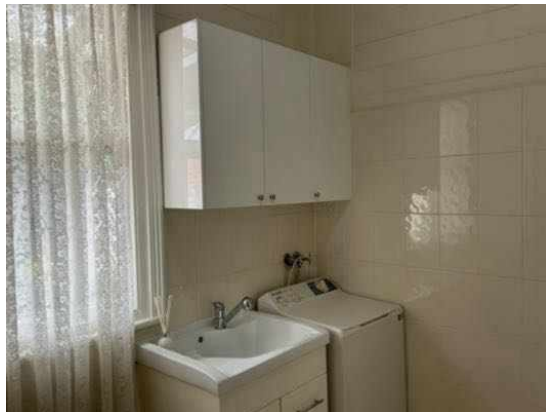
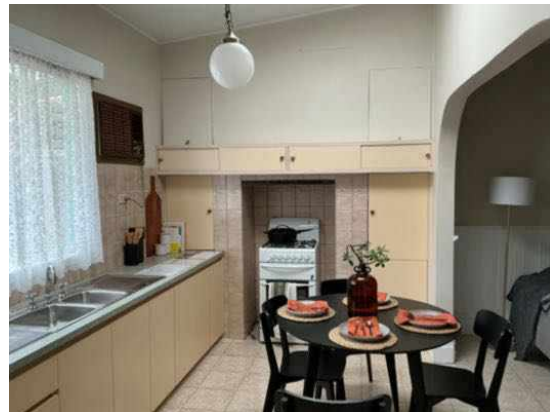
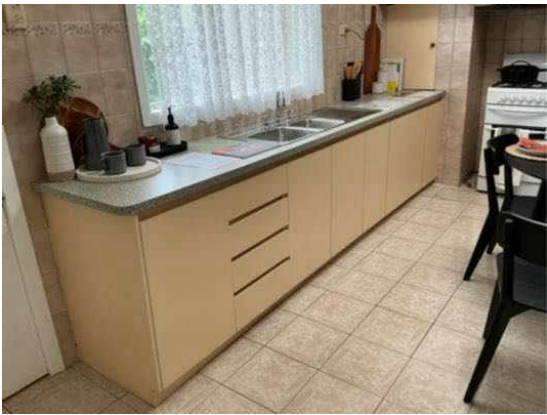
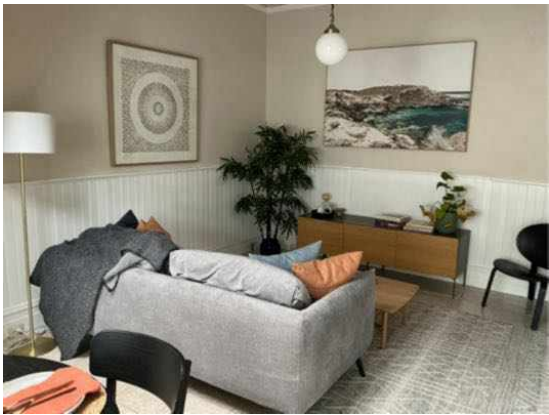
#### Noted Item

Building: Main Building  
Location: All Areas  
Finding: Additional Photos - Obstructions and Limitations  
Information: These photographs are an indication of the obstructions and limitations which impeded full inspection of the property at the time of inspection. These obstructions can hide an array of defects and should be removed to allow full inspection to be carried out. A re-inspection is recommended once the areas are made accessible.
