Building and Timber Pest Inspection Report

Inspection Date: Mon, 23 Feb 2026

Property Address: 2/14 Prospect St, Pascoe Vale VIC 3044,
Australia

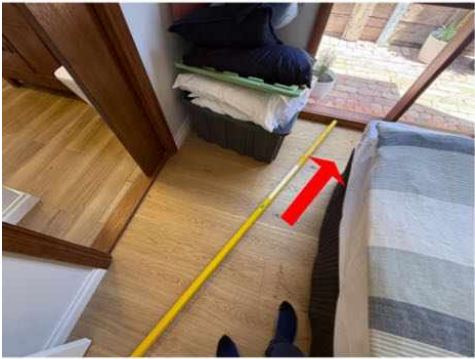
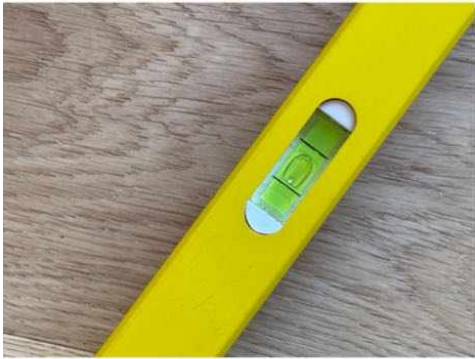
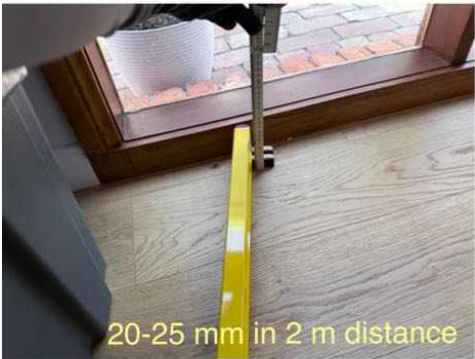
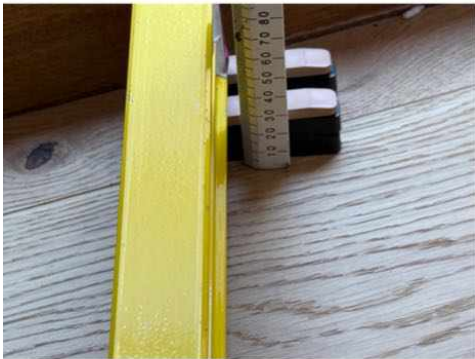
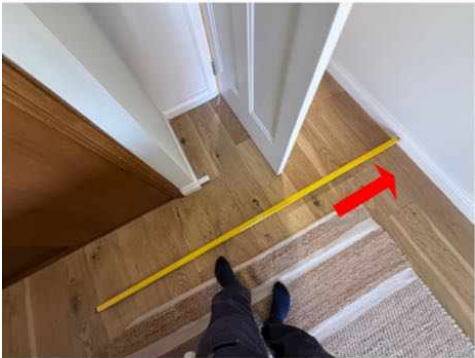
Building:	Main Building
Location:	All Internal Areas
Finding:	Subsidence- minor to moderate
Information:	It appears that the Sub structure has been affected by movement of the foundations, often referred to as sinking or subsidence.

General subsidence is usually initiated by changes in soil moisture content. The most critical factor is identifying the specific causes, and identifying if this is a recurring or ongoing problem, or one that has been resolved by previous works in the past.

The following statement has been referenced from VBA guide to standard & tolerances (part 2.08)- Slab Levelness: Except where documented otherwise, new floors are defective if within the first 24 months of handover they differ in level by more than 10 mm in any room or area, or more than 4 mm in any 2 m length. The overall deviation of floor level to the entire building footprint shall not exceed 20 mm. Our max documented deviation was 20-25 mm in 2 m distance.

If in future secondary defects like door binding, major internal cracking is noticed. It will be advised to begin by consulting a structural engineer to determine the required scope of works. This generally includes some form of underpinning or resin injections, as well as addressing the underlying cause. Consultation with a geotechnical engineer may also be necessary where changes to soil moisture content is apparent.

A Registered Builder specialising would then generally carry out works as advised by an Engineer.

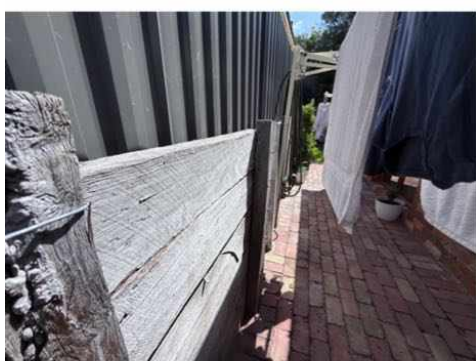
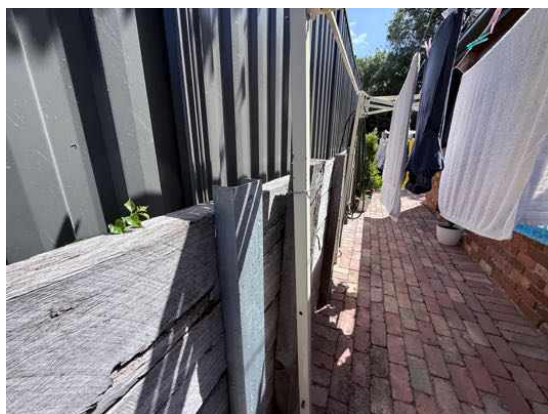
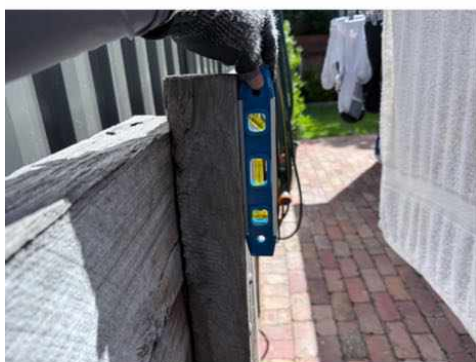
Finding 3.02

Information: The retaining wall in this area was found to be bowing (minor) at the time of inspection. Generally, defective retaining walls are caused by poor original design or material use. However, deteriorated retaining walls may also be a result of general deterioration, poor site drainage or unmanaged stormwater flows.

If left unmanaged, the retaining wall may become a safety hazard if it continues to destabilise (monitoring recommended, new support posts are already installed). Where retaining walls further rot and decay, an environment is created that is conducive to termite and pest infestation. Significant repair and replacement should be expected at that stage.

Where retaining walls are considered structural walls, a structural engineer / surveyor should be consulted regarding required remedial works. Otherwise, a landscaper or retaining wall installer may be appointed to repair or replace the wall, at the discretion of the client.

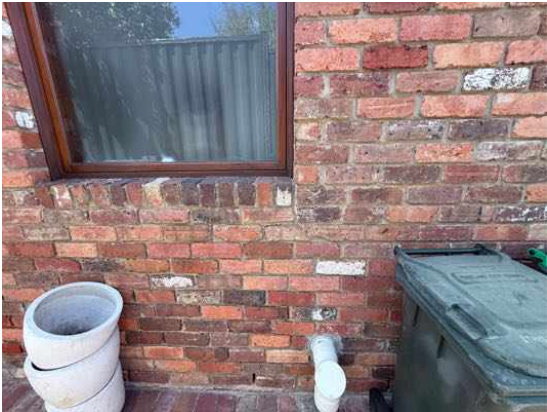
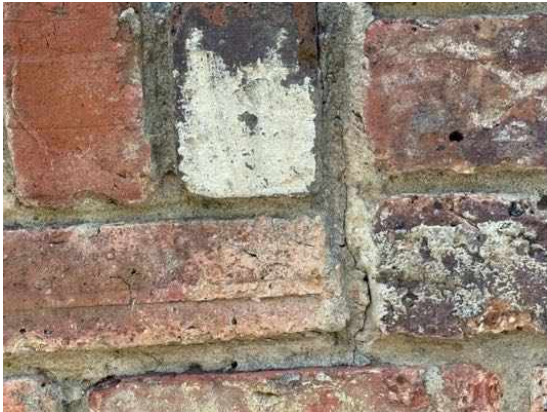
Finding 3.03

Finding: Brickwork - Cracking [Fine]

Information: Although fine cracks are quite noticeable, they are often only considered to be an appearance defect and usually do not indicate any structural damage. Generally, the cause of a fine crack is indicative of a separation between brickwork and mortar throughout the structure, but single bricks may also show cracks of this nature.

Cracking of this nature can generally be repaired with minor filling and should be conducted by a qualified bricklayer.

Always contact a building inspector should cracks widen lengthen or become more numerous.

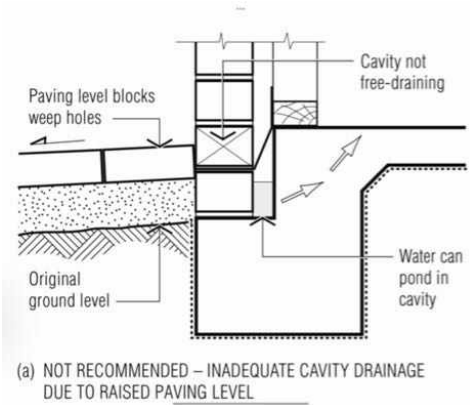
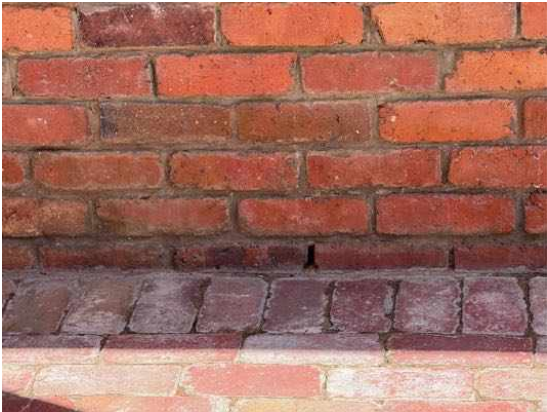
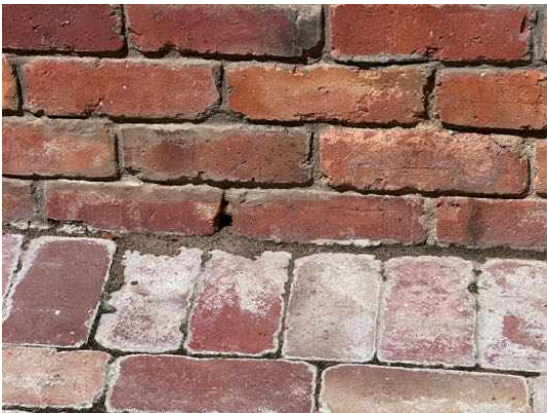
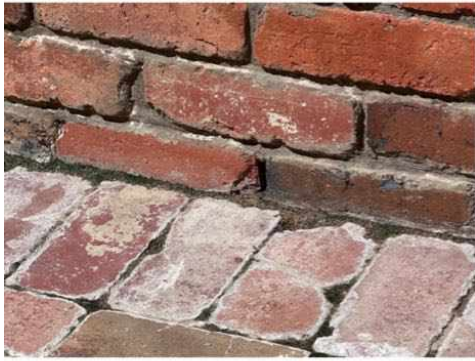
Finding 3.05

Building: Main Building
 Location: Some External Areas
 Finding: Weep holes - Partially Blocked
 Information: It was noted during the time of inspection that some of the weep holes to the brickwork were blocked. Weep holes are designed to allow water from leaks or seepages in brickwork to be directed to the external environment, prior to entering the wall cavity or associated building materials. Weep holes should therefore be kept clean and free of debris or blockages.

Blocked weep holes are likely to result in the presence of excessive moisture within the brickwork and associated structures, creating potential for water damage and moisture problems. Can also allow concealed termite ingress.

Depending on the nature of the blockage, the homeowner may be able to undertake remedial works to remove blockages. Alternatively, appointment of a registered builder may be required to remove blockages. Preventative works are necessary in ensuring the structural integrity of the affected brickwork and should be performed as soon as possible.

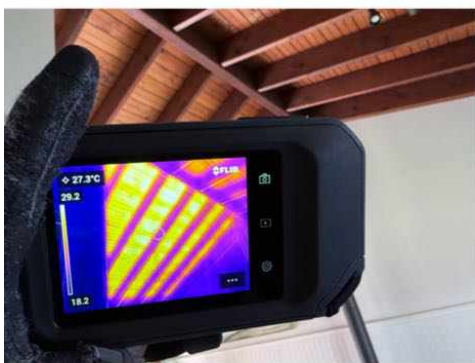
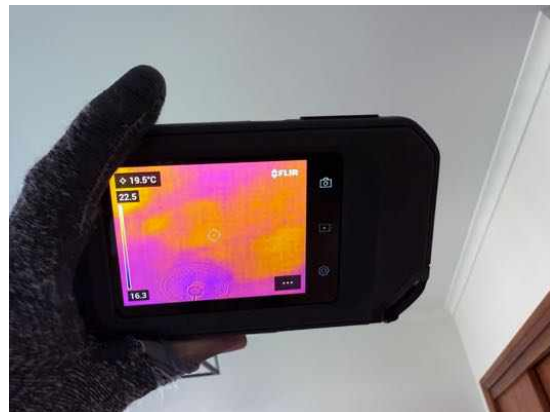
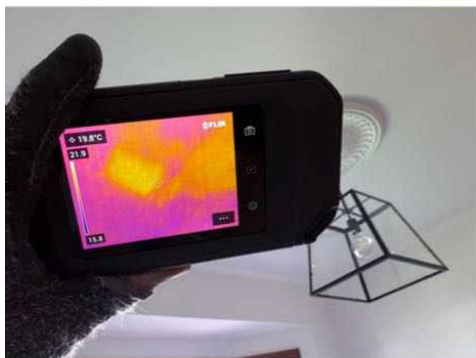
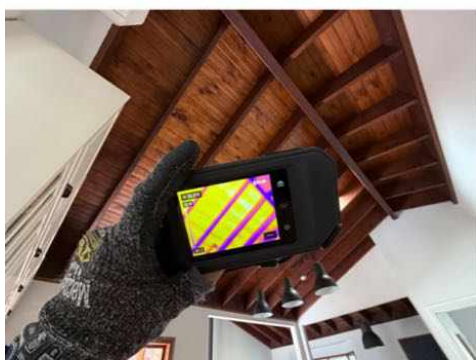
Finding 3.06

Building:	Main Building
Location:	Roof Void
Finding:	Uneven coverage of insulation.
Information:	Upon inspection of the roof void it was noted that there was uneven coverage of insulation. Insufficient or uneven insulation will result in a comparatively higher cost to heat and cool a property, which works as a barrier to heat transfer. This helps to keep out unwanted heat in summer and preserves warmth inside your home in winter. It can also help soundproof your home from unwanted airborne noise transfer. Example - Where there is a gap in coverage totaling 5% there is a potential for up to 50% of the energy efficiency to escape.

Installation of adequate insulation is recommended as soon as possible. Caution should be exercised when accessing the roof void. Do not attempt to stand on the framework to the underside of the trusses and be aware there is a potential for electric shock if contact is made with exposed or faulty electrical wiring.

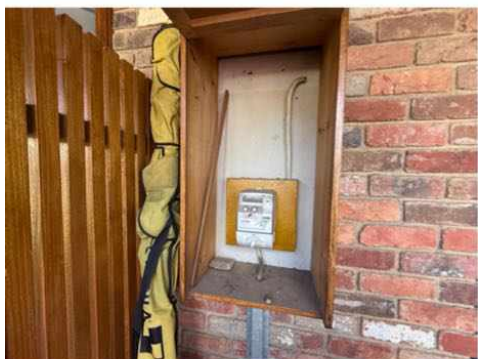
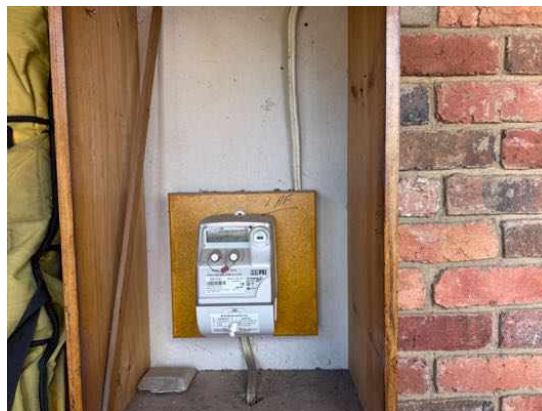
Building:	Main Building
Location:	Meter Box
Finding:	Termite Management System - no evidence of a chemical installation
Information:	The application of a post-construction chemical termite barrier is highly recommended for all properties, particularly if live termite activity has been found on the site previously. Such barriers are highly effective in preventing termite attack on any timber building elements throughout the property.

system has been installed, with no evidence to suggest preventative works taking place.

The client may consider gaining further advice from a pest controller as to the costs and procedures involved with this application. It is recommended that obtaining such advice be a short-term priority.

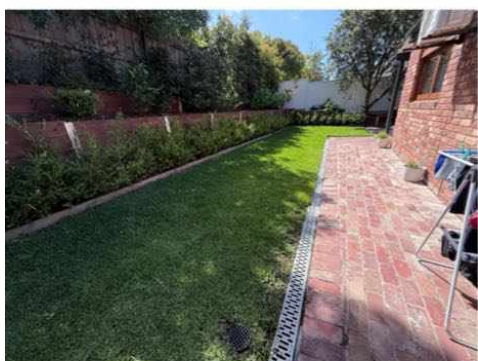
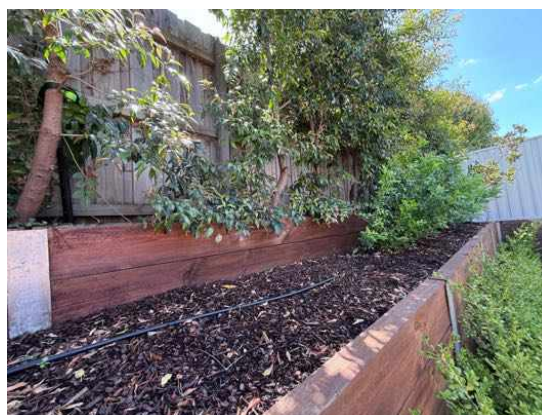
Finding 6.02

Building: Main Building
 Location: All External Areas
 Finding: Garden Bed/ Mulch - Conditions Conducive to Termites
 Information: Mulch were found around the property. These areas can include untreated timber, and with a combination of moisture from watering hosing can make conditions conducive to termite activity and termite ingress.

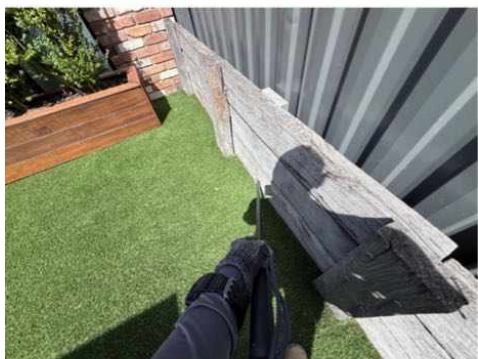
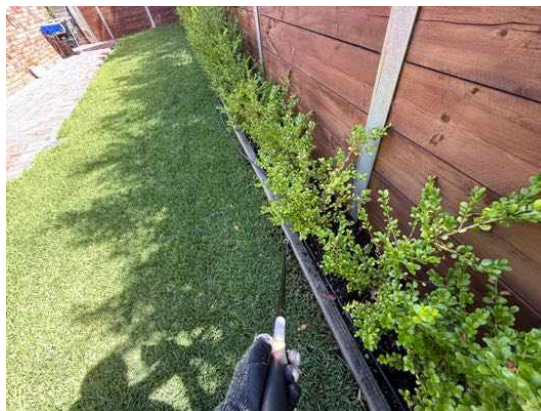
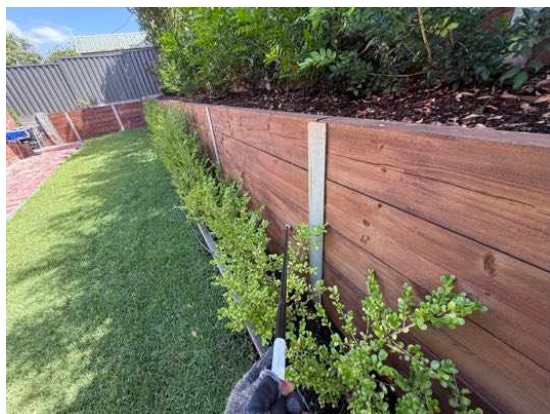
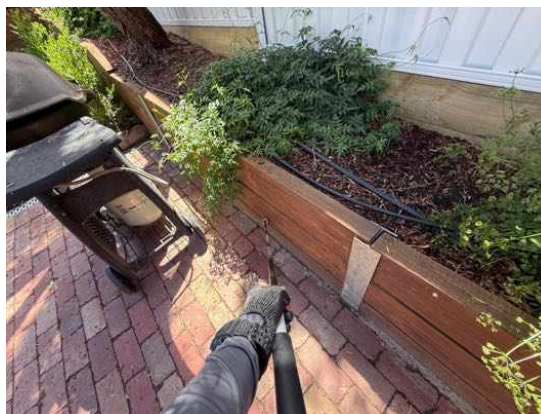
Finding 6.03

Building: Main Building
 Location: All External Areas
 Finding: In ground contact
 Information: Any timbers in direct ground contact provide opportunity for concealed termite entry and are likely to be subject to premature rot and decay as the soil retains moisture or

damp conditions against the timbers.

Remove untreated timber that is in direct contact with external grounds. Consider replacement with more durable materials i.e. treated timber or non timber elements. Frequent pest inspections are advised to readily identify any termite activity in these areas.

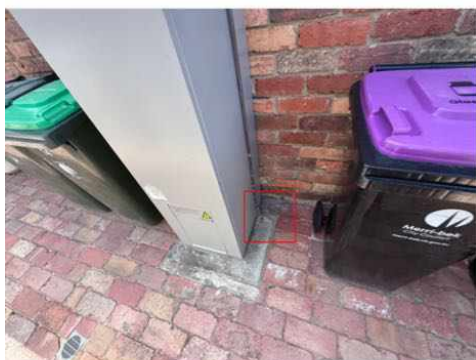
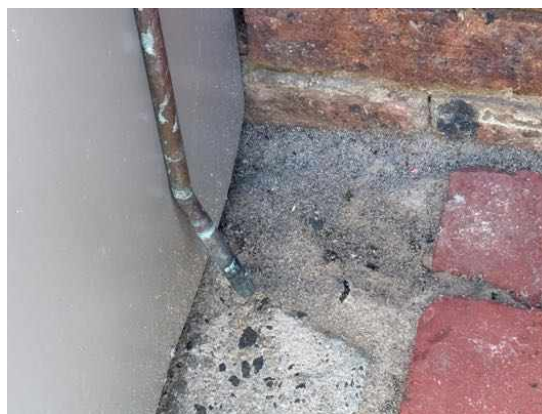
Finding 6.04

Building:	Main Building
Location:	Exterior walls - left side
Finding:	Hot water relief valve not connected to drainage.
Information:	Hot water relief valve is discharged inappropriately. Because of which, base perimeter can become excessively damp, potentially creating an environment that is susceptible to rust and corrosion of surrounding building elements, as well as attracting termites and other pests.

It is highly recommended that a plumber be appointed to install adequate drainage equipment where necessary.

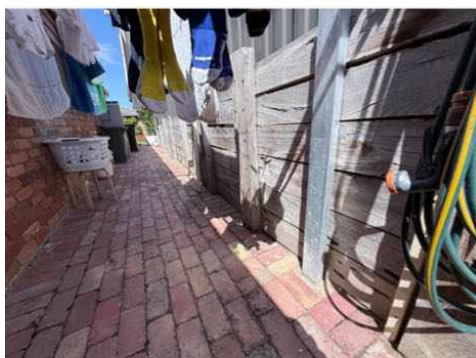
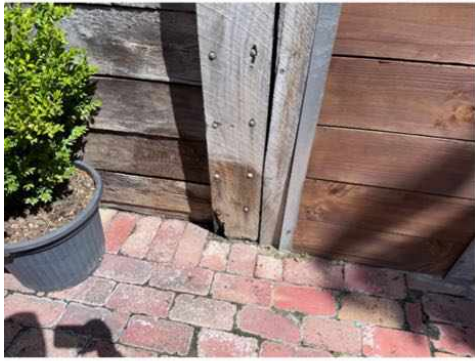
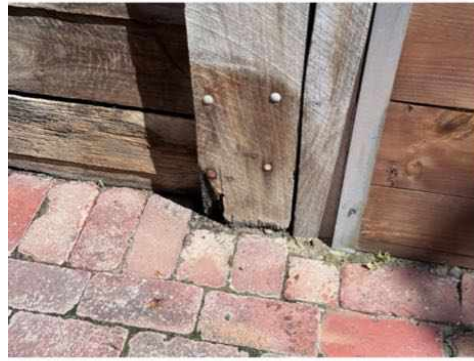
Finding 7.01

Building:	Main Building
Location:	Yard - Side
Finding:	Fungal decay - present (localised)
Information:	Fungal decay also known as wood decay or wood rot generally refers to the deterioration of timber elements when in contact with excessive levels of moisture for a prolonged period of time.

The development of fungal decay is accelerated by temperatures in the range of 5degreeC to 40degreeC as well as the presence of oxygen. Generally fungal decay develops on timber elements that are in use in an external environment which are exposed to rain penetration.

In this case although the affected timber element is in a decaying state the extent of any visible damage appears to be localised to a specific area and is yet to spread to other parts of the building element or affect adjoining structures. The fungal decay is therefore likely to be of a relatively superficial nature with minimal impact on the structural integrity or tensile strength of the timber element.
