# Building and Timber Pest Inspection Report

Inspection Date: Tue, 10 Feb 2026

Property Address: 11 Lois Ct, Trafalgar VIC 3824, Australia

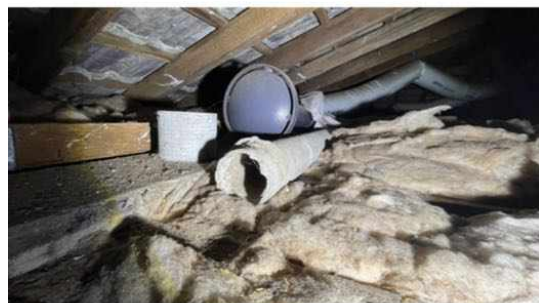
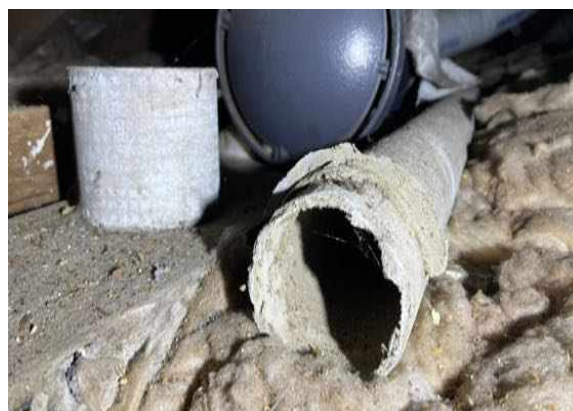
Building:	Main Building
Location:	Roof Void
Finding:	Asbestos - Suspected ACM Identified on Site
Information:	Flue pipe was suspected to contain asbestos at the time of inspection. Reporting on Asbestos is outside the Scope of this Report. This suspected defect is highlighted as a caution only. We suspect, based on our experience in the building industry, that there is a higher risk of the identified building element containing asbestos.

As Asbestos Reporting is outside the scope of this report, we advise that you consider a separate Asbestos Inspection and Condition Audit, which can include the taking of samples for definitive confirmation of the presence of Asbestos.

In the interim, the client is advised to act with caution, especially when considering any damage to building materials general wear and tear renovations extensions demolition and general maintenance activities due to the suspected presence of Asbestos.

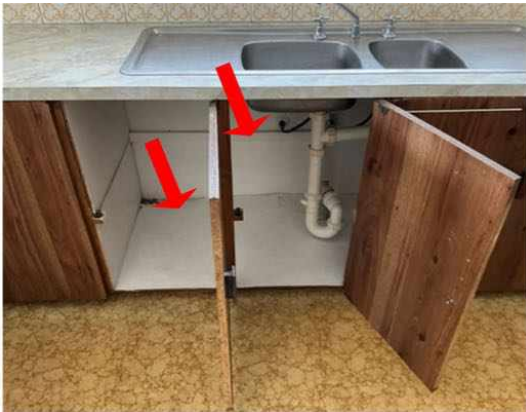
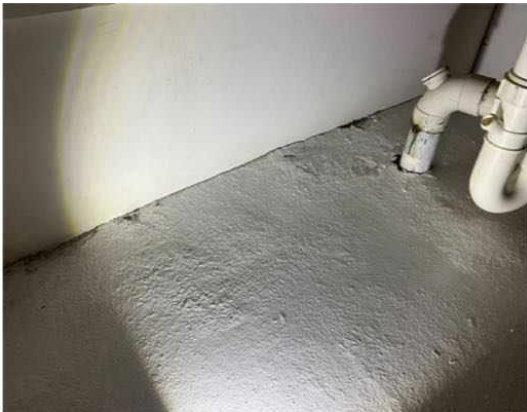
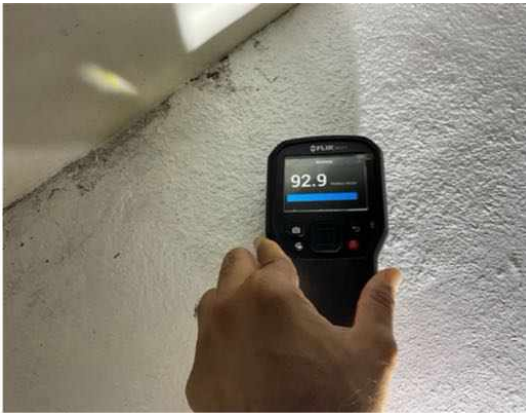
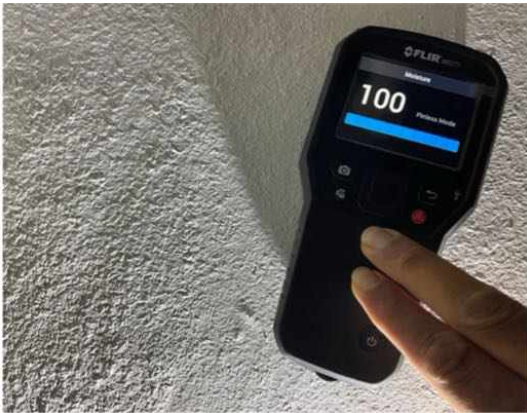
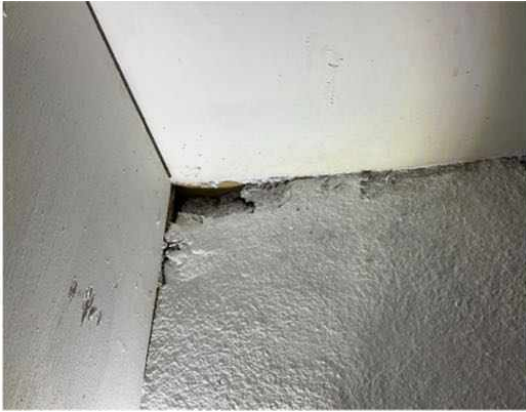
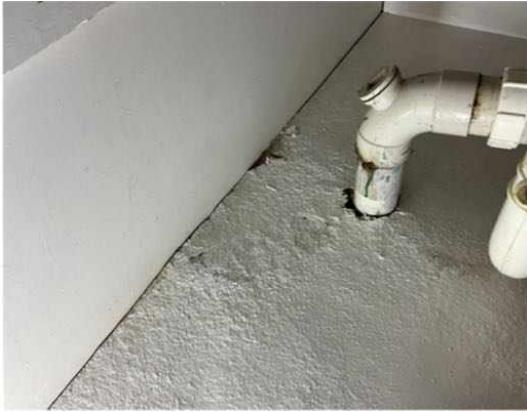
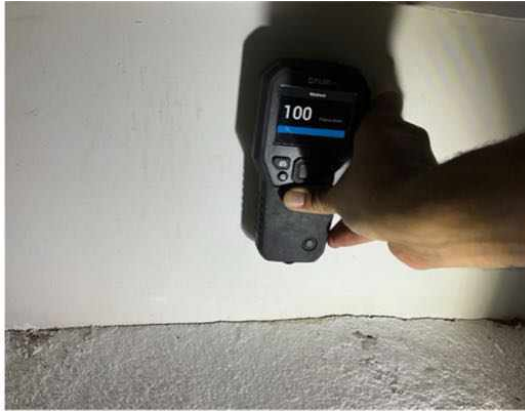
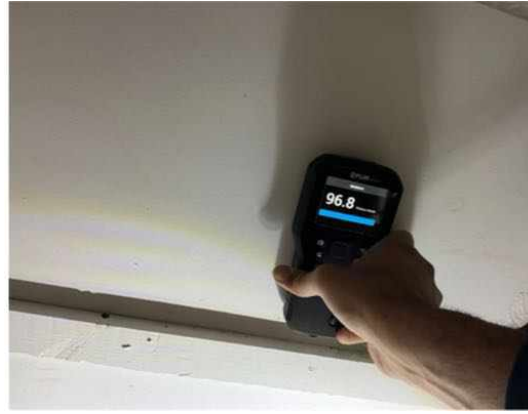
#### Finding 2.01

Building:	Main Building
Location:	Kitchen
Finding:	Swollen Cabinet & Elevated Moisture – Under Kitchen Sink
Information:	Swelling to the kitchen sink cabinet base and surrounding joinery was observed at the time of inspection. Elevated moisture levels were recorded beneath the sink area cabinet and adjacent wall lining, indicating the presence of an active or recent internal plumbing leak. The moisture intrusion has likely resulted from leaking pipework,

Prolonged moisture exposure can cause deterioration of cabinetry substrates, fungal growth, and potential damage to wall linings and flooring materials. Continued leakage may also attract timber pests and lead to further structural deterioration of concealed elements if not promptly addressed.

It is recommended that a licensed plumber be engaged immediately to identify and rectify the source of the leak. Damaged cabinetry and affected wall components should be assessed and repaired or replaced as necessary once the area has been fully dried to prevent ongoing deterioration.

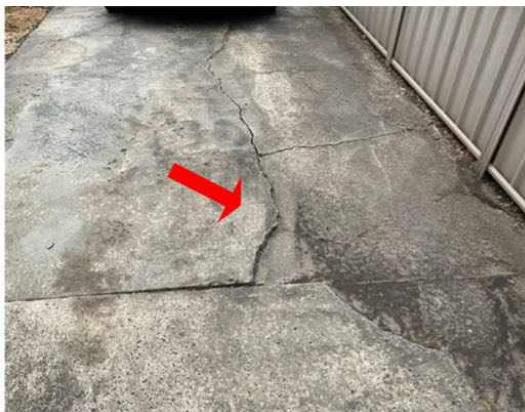
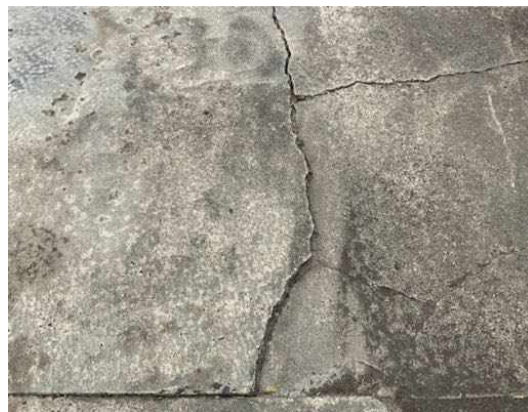
### Finding 3.01

Building:	Main Building
Location:	All Areas
Finding:	Damaged Concrete Paving – Driveway Area
Information:	Concrete paving within the driveway area was observed to be damaged at the time of inspection. The damage appears in the form of cracking and surface deterioration, which may have resulted from vehicle loading, ground movement, shrinkage, or general wear and tear over time.

If left unaddressed, damaged paving may continue to deteriorate, potentially leading to trip hazards, water ponding, and further surface breakdown. Ongoing movement or moisture ingress beneath the slab may accelerate cracking and compromise the serviceability of the driveway surface.

It is recommended that the affected sections be assessed and repaired as necessary to prevent further deterioration. A registered builder or concreting contractor should be consulted to determine whether patch repairs or partial replacement of the paving is required.

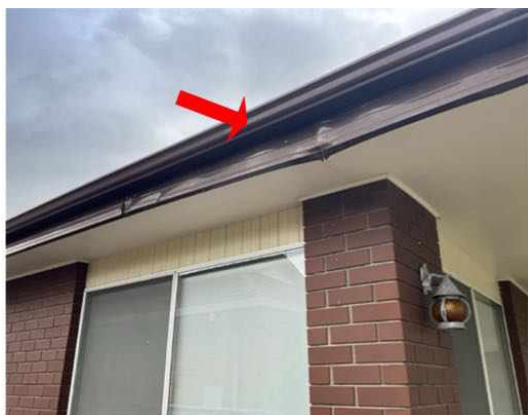
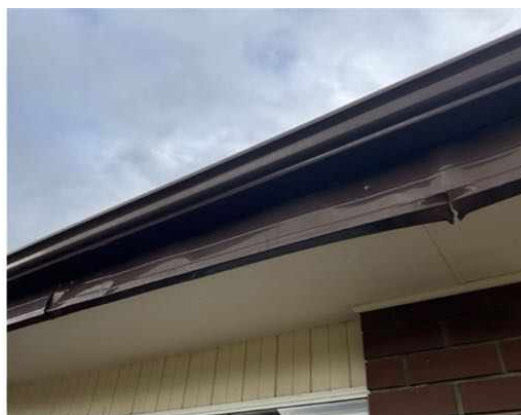
### Finding 3.02

Building: Main Building  
 Location: Roof Exterior  
 Finding: Damaged Metal Fascia – Right Side Elevation  
 Information: Metal fascia was found damaged on the right side of the property at the time of inspection. The damage appears to include deformation and surface deterioration, which may have resulted from impact, weather exposure, or general aging of the material.

Damaged fascia components may compromise the support and alignment of the guttering system and can allow moisture to penetrate behind the fascia, potentially leading to timber decay, corrosion of fixings, or water ingress into the roof space. If left unattended, further deterioration may occur and affect the performance of the roof drainage system.

It is recommended that a licensed roofing contractor assess the extent of the damage and carry out necessary repair or replacement works to ensure the fascia and associated guttering remain secure and weatherproof.

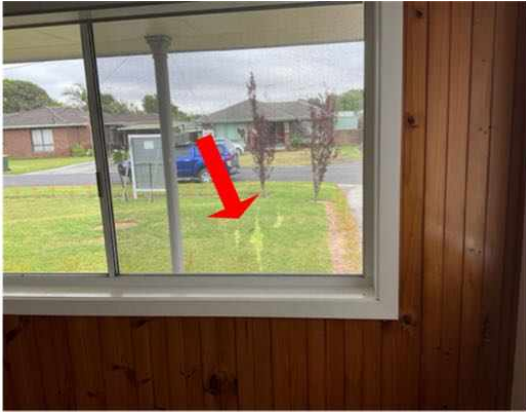
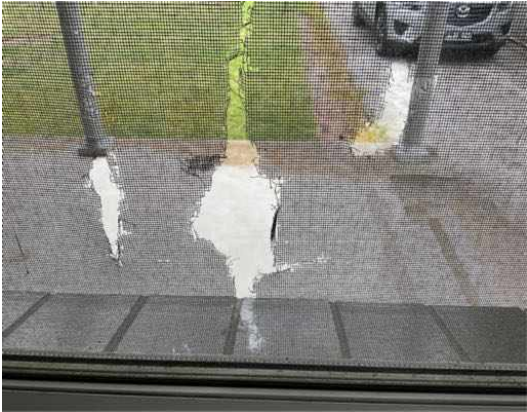
### Finding 3.03

Building: Main Building  
 Location: Dining Room  
 Finding: Flyscreens - Damaged  
 Information: Flyscreens were found to be damaged to the windows at the time of inspection. Whether the flyscreens have not been installed properly or damaged post-installation, it detracts from the complete operational state of the window.

Where not repaired, damaged flyscreens allow pest and insect ingress into the adjoining rooms. It is advised that all damaged building elements be replaced in order to ensure the full function of all building structures.

A general handyperson or a repairer may be appointed to repair flyscreens at the

discretion of the client.

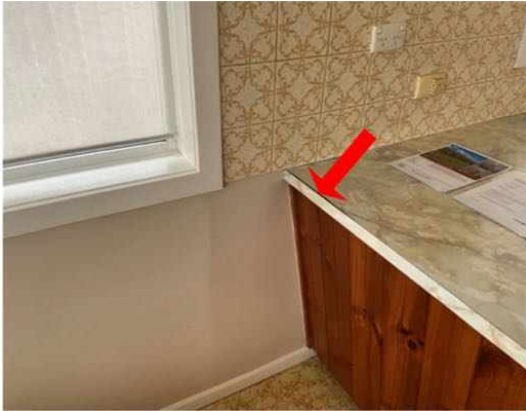
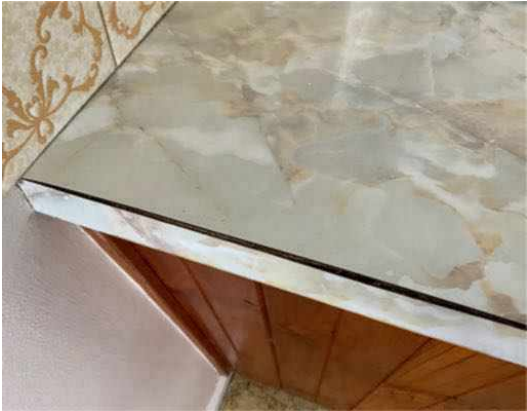
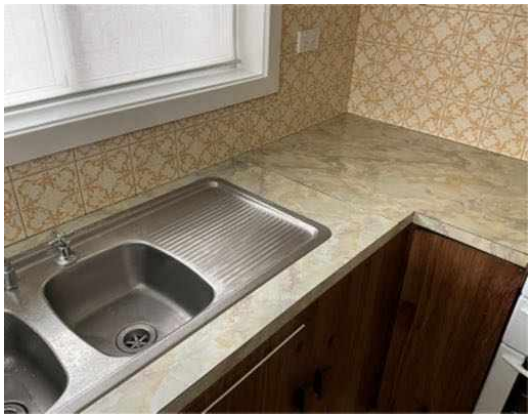
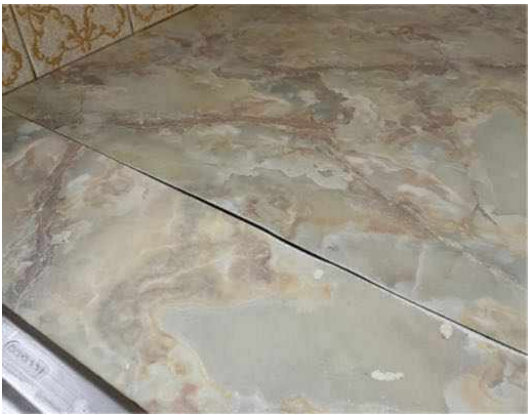
**Finding 3.04**

Building: Main Building  
 Location: Kitchen  
 Finding: Detached Laminate Finish – Kitchen Area  
 Information: Laminate surface finish was found detached in multiple sections within the kitchen area at the time of inspection. The detachment appears to be occurring at the edges and surface areas of cabinetry, which may be due to moisture exposure, adhesive failure, impact damage, or general wear and tear over time.

If left unaddressed, detached laminate may continue to lift or peel, leading to further deterioration of the underlying substrate. Moisture ingress into exposed cabinetry panels can cause swelling, delamination, and structural weakening of the cupboards, potentially requiring more extensive repairs.

It is recommended that the affected cabinetry be assessed and repaired as required. A qualified cabinet maker or handyman should be consulted to re-adhere or replace the damaged laminate sections to prevent further deterioration and maintain the functionality and appearance of the kitchen joinery.

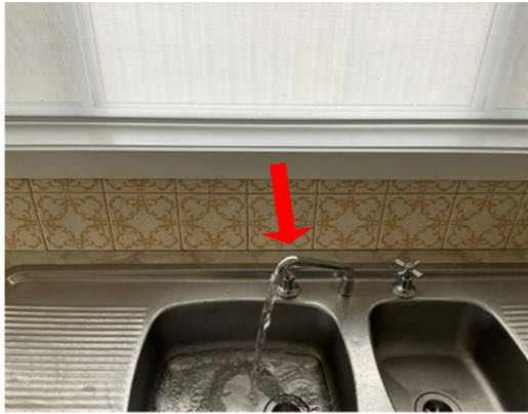
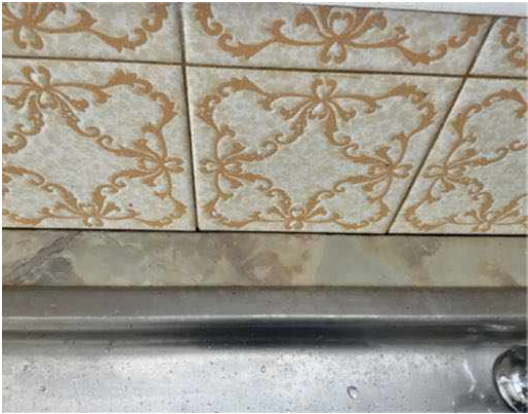
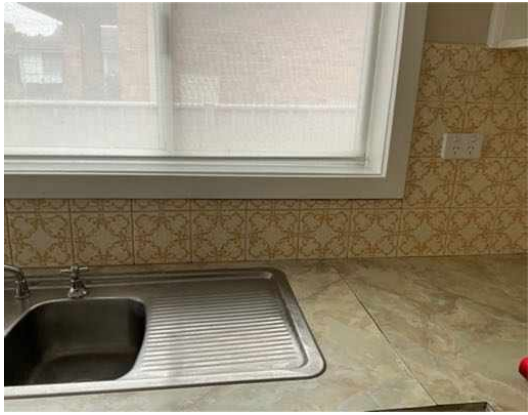
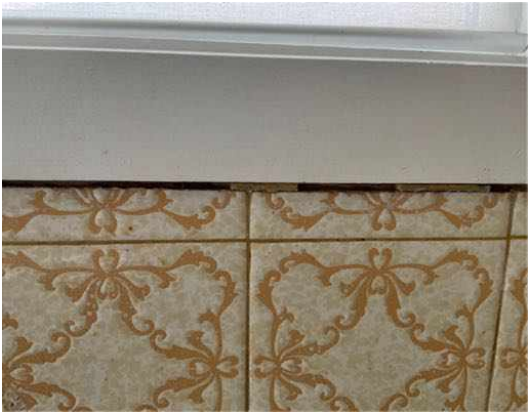
**Finding 3.05**

Building: Main Building  
 Location: Kitchen  
 Finding: Grout - Deteriorated  
 Information: Grout was found deteriorated in this area. Grout is used to protect gaps and crevices in building materials to ensure that they are water-tight and prevent water penetration to the associated structures.

Where grout is missing or deteriorated, a tiling contractor should be appointed immediately to apply grout and re-apply any silicone where necessary. Failure to do so is likely to lead to water damage to the surrounding area.

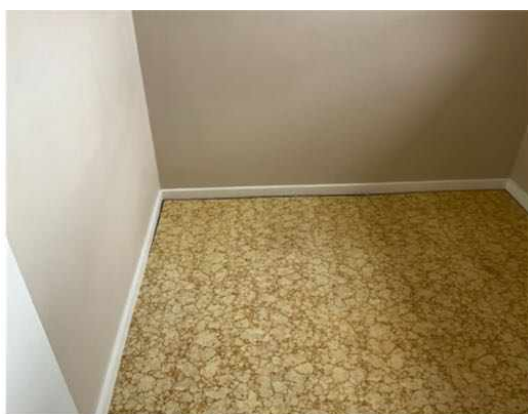
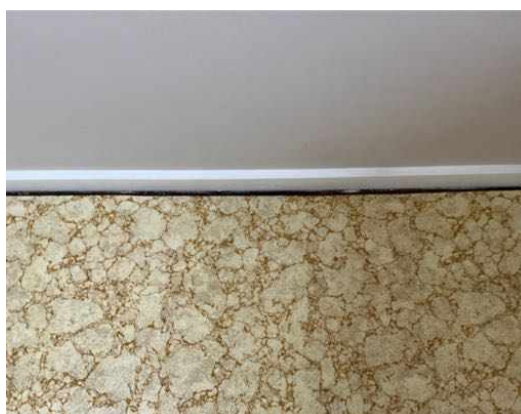
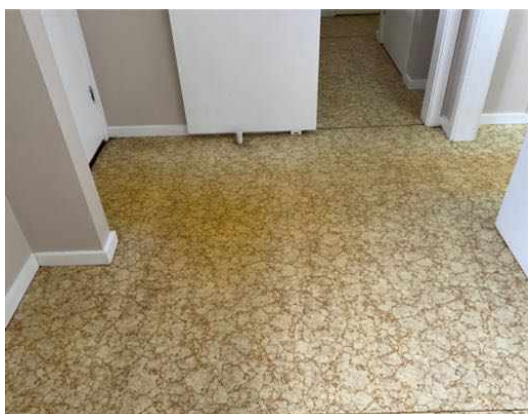
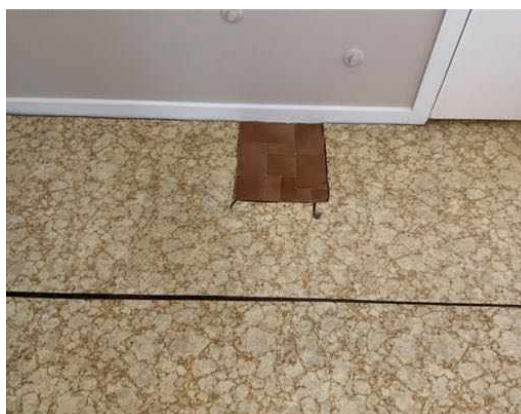
### Finding 3.06

Building:	Main Building
Location:	All Internal Areas
Finding:	Deteriorated & Disjointed Vinyl Flooring
Information:	Vinyl flooring was observed to be deteriorated and disjointed in several sections at the time of inspection, with visible gaps forming between adjoining sheets/planks. This condition may have resulted from age-related wear, adhesive failure, subfloor movement, moisture exposure, or poor installation.

If left unaddressed, the separation and gaps may widen over time, creating trip hazards and allowing moisture or debris to penetrate beneath the flooring. Moisture ingress can potentially affect the underlying substrate, leading to swelling, mould growth, or further floor covering failure.

It is recommended that the affected flooring areas be assessed and repaired or replaced as necessary. A qualified flooring contractor should be consulted to determine whether re-securing, patch repair, or full replacement is required to restore the integrity and safety of the floor surface.

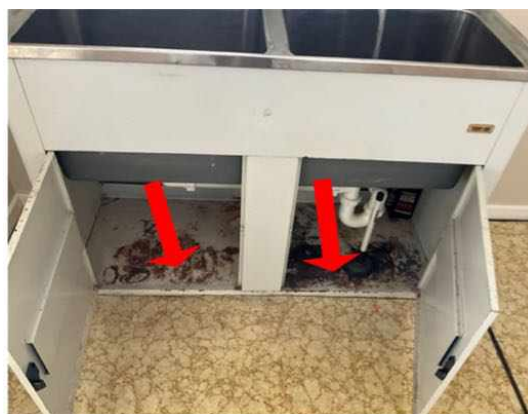
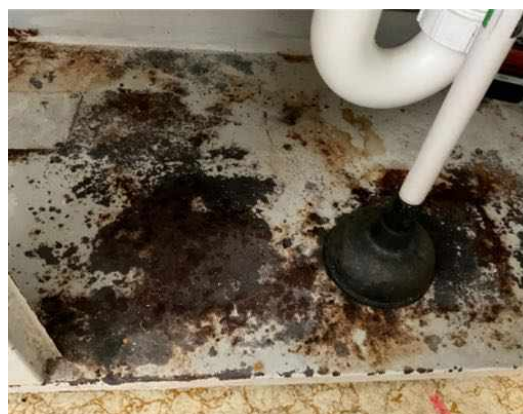
### Finding 3.07

Location: Laundry  
 Finding: Rusted Cabinet – Laundry Sink Area  
 Information: The cabinet beneath the laundry sink was observed to be rusted at the time of inspection. The corrosion appears to have developed due to prolonged exposure to moisture, likely from minor leaks, condensation, or regular water splashing associated with the sink area.

If left unaddressed, ongoing corrosion may weaken the cabinet structure, compromise its load-bearing capacity, and lead to further deterioration of surrounding materials. Persistent moisture in this area may also indicate concealed plumbing issues and can contribute to mould growth or additional damage to adjacent wall and floor finishes.

It is recommended that the area be inspected for any active plumbing leaks and rectified by a licensed plumber if required. The affected cabinet should be repaired or replaced as necessary to prevent further deterioration and to maintain the functionality of the laundry area.

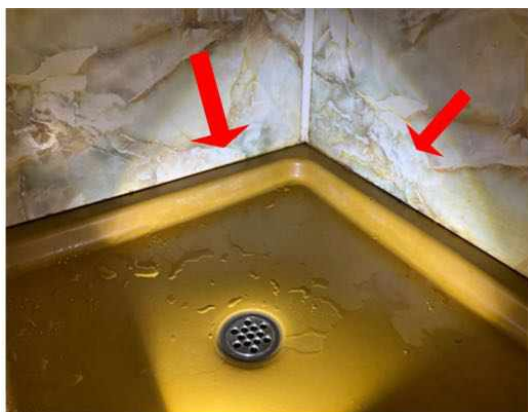
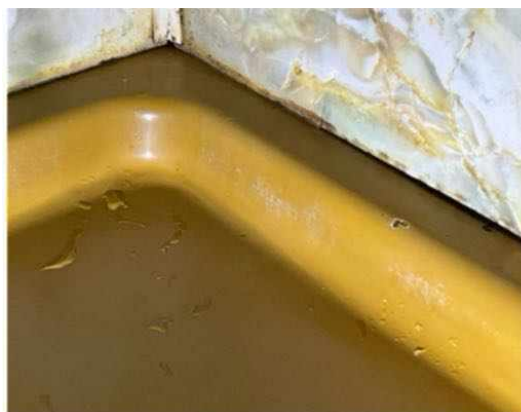
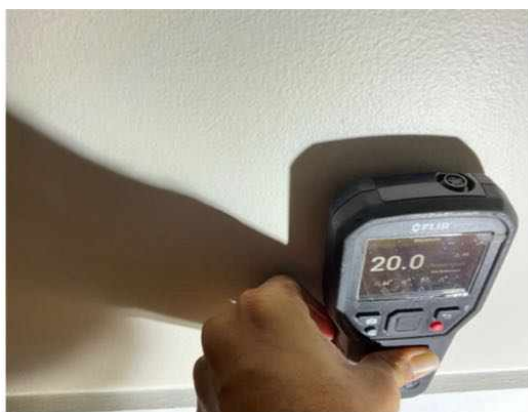
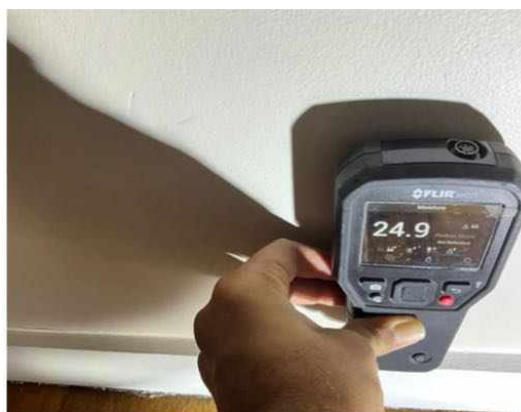
### Finding 3.08

Building: Main Building  
 Location: Bathroom  
 Finding: Deteriorated Shower Grout and Elevated Moisture Readings  
 Information: Deterioration of grout was observed within the shower area at the time of inspection. The grout appears worn and degraded in sections, which may allow water to penetrate behind the tiled surface during normal use. Elevated moisture levels were recorded on the backside of the shower area wall, indicating possible water ingress beyond the tiled finish.

If left unaddressed, continued moisture penetration may result in damage to the wall lining, framing timbers, and adjoining building elements. Prolonged exposure to moisture can also create conditions conducive to timber decay, mould growth, and potential termite activity in concealed areas.

It is recommended that a licensed plumber be engaged to further investigate the source of moisture ingress and assess the condition of the waterproofing system.

Regrouting and/or rectification of the waterproofing membrane may be required, depending on the extent of the issue. Prompt action is advised to prevent further deterioration and concealed damage.

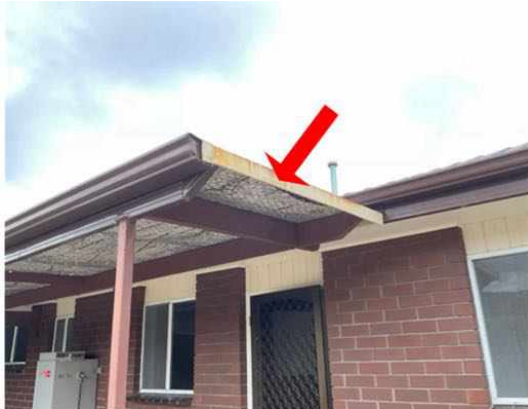
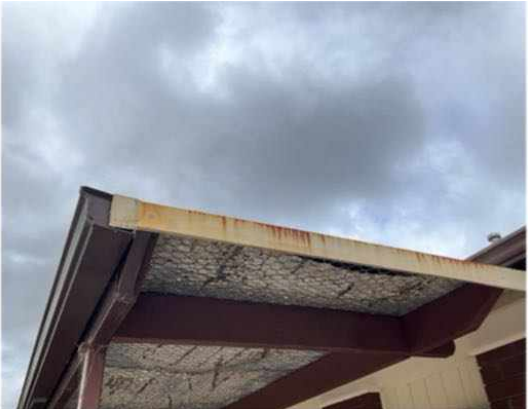
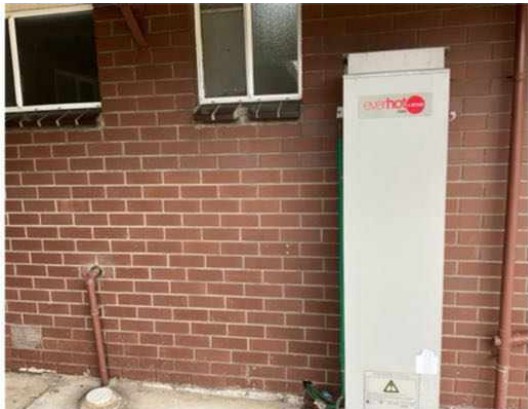
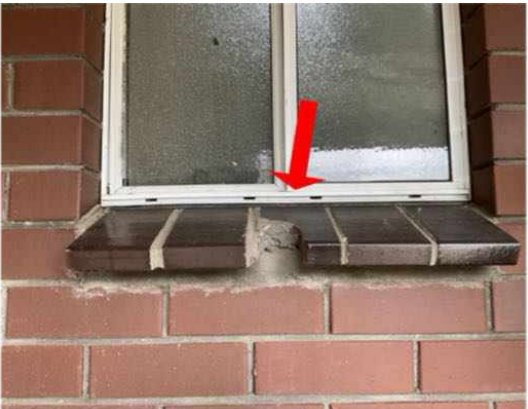
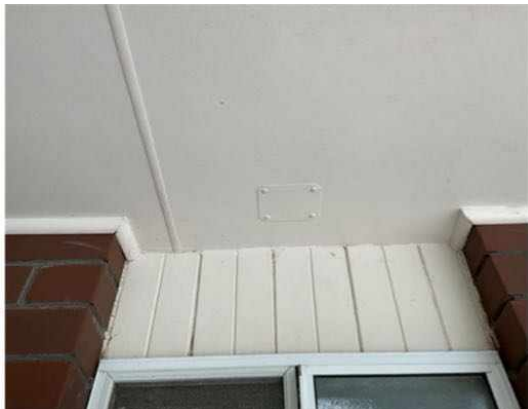
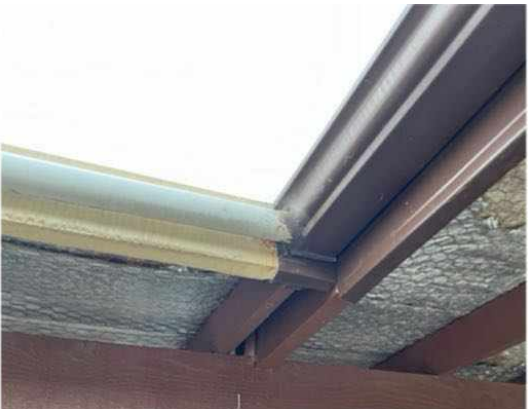
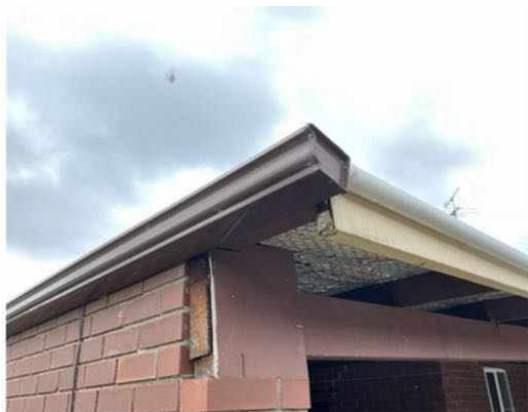
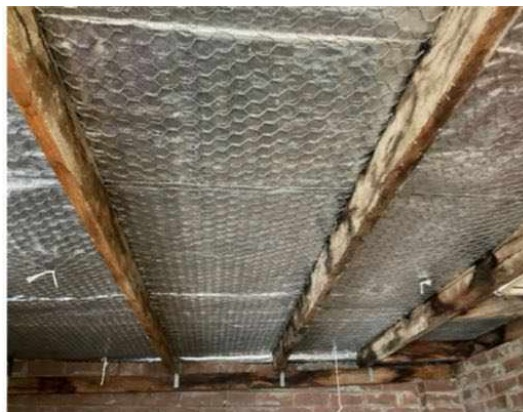
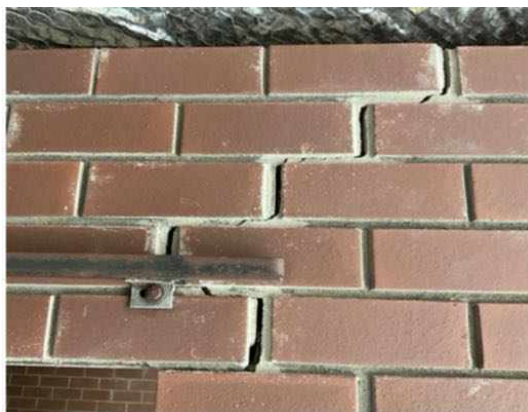
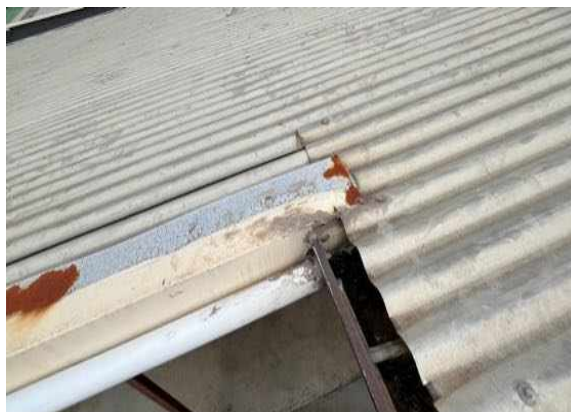
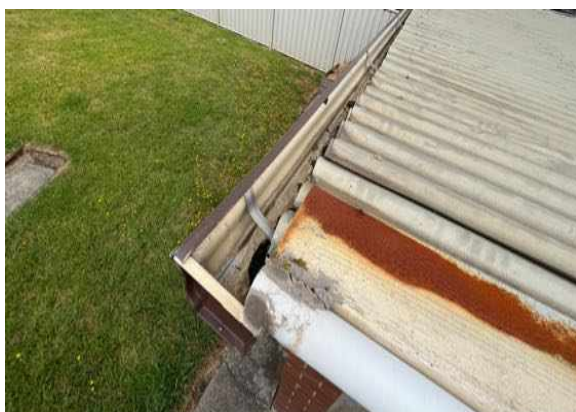
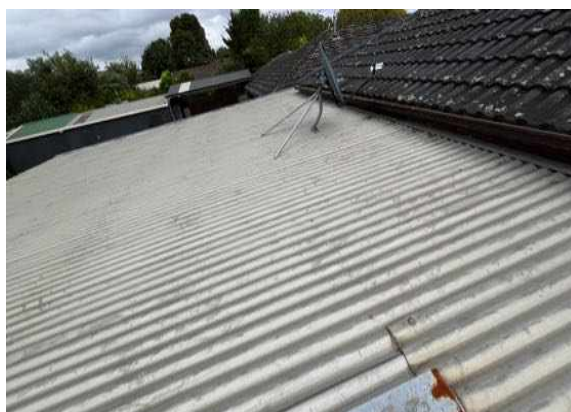
### Finding 3.09

Building:	Main Building
Location:	Garage & Storage
Finding:	Garage and Storage Area – Suspected Non-Professional Construction, Brickwork Cracking and Corrosion
Information:	The garage and adjoining storage area appear to have been constructed or modified in a manner that may not reflect acceptable professional building standards. Certain elements of workmanship suggest informal or non-compliant alterations. Downpipes have been modified from their apparent original configuration. Brickwork deterioration was observed in multiple areas, including mortar decay and surface wear. Step cracking was identified within sections of the brickwork. Additionally, rusting and corrosion were observed to various building elements within the affected areas.

Construction or alterations not carried out to appropriate standards may compromise structural performance, durability, and weather resistance. Modified downpipes can adversely affect stormwater discharge, increasing the risk of water accumulation around footings and walls. Step cracking in brickwork may indicate structural movement such as footing settlement or foundation movement. Corrosion of building

elements can weaken structural components over time and may accelerate deterioration if moisture exposure continues.

It is recommended that a registered builder be engaged to assess the garage and storage area construction and associated defects for compliance and structural adequacy. A structural engineer may be required to further investigate the cause and extent of step cracking if movement is ongoing. A licensed plumber should review the modified downpipes to ensure compliant stormwater management. Corroded components should be repaired or replaced as necessary to maintain structural integrity and prevent further deterioration.

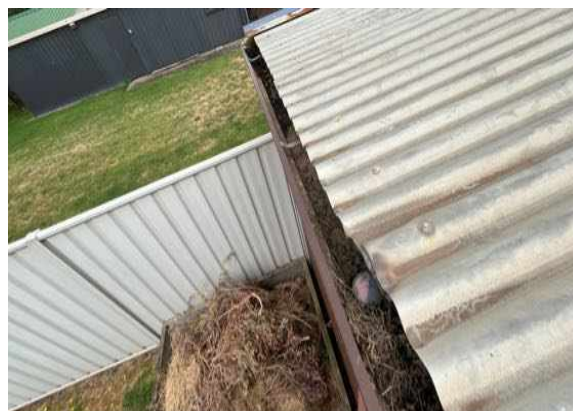
Blocked gutters are likely to lead to high levels of moisture in the affected areas. Such moisture will not only cause rust and decay of the associated building materials, but can also provide conditions that are conducive to termite and timber pest activity. Blockages in gutters should therefore be removed immediately to ensure dry conditions are maintained.

Consult a Licensed Plumber for further specific advice on remedial works that may be required. In the interim, it is highly advised that blocked gutters be removed by the homeowner or a general handyperson as a matter of urgency.

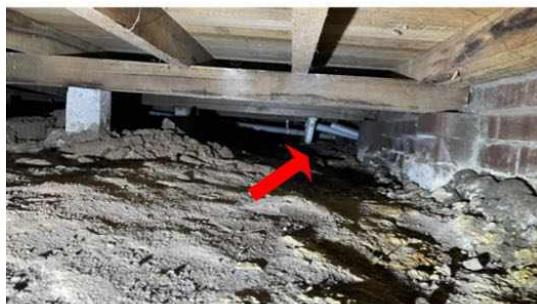
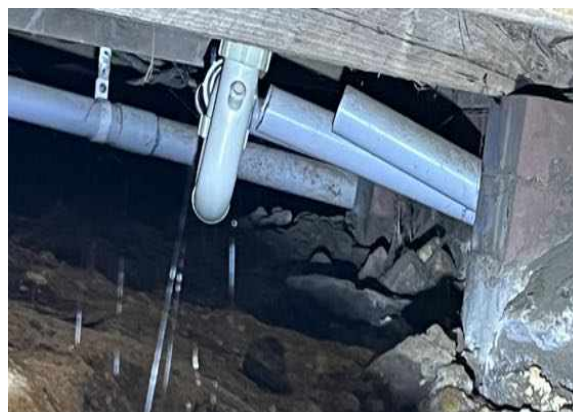
### Finding 3.12

Building:	Main Building
Location:	Subfloor
Finding:	Subfloor – Inappropriate Pipe Discharge and Termite Risk
Information:	Two pipes were observed discharging water directly into the subfloor area at the time of inspection. This arrangement allows water to accumulate beneath the dwelling rather than being directed to an approved stormwater drainage point. The source and function of the discharge pipes could not be fully determined within the scope of this visual, non-invasive inspection.

Ongoing water discharge into the subfloor can result in elevated moisture levels and persistently damp conditions. Such conditions are conducive to timber decay, fungal growth, corrosion of metal components, and structural deterioration. Excess moisture in subfloor areas significantly increases the risk of termite activity, as termites are attracted to damp environments and moisture-compromised timbers. If left unaddressed, this may lead to concealed structural damage.

It is recommended that a licensed plumber be engaged to identify the source of the discharge and redirect the pipes to a compliant stormwater drainage system. The subfloor area should be regularly monitored for signs of excessive moisture, timber decay, and termite activity.

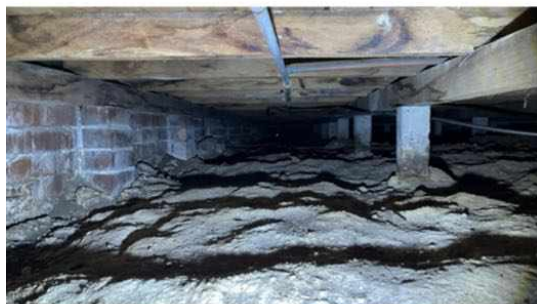
### Finding 3.13

Building:	Main Building
Location:	Subfloor
Finding:	Subfloor – Uneven Ground Surface and Inadequate Ventilation
Information:	Uneven ground surface conditions were observed within the subfloor area at the time of inspection. In addition, subfloor ventilation appeared to be inadequate, with limited airflow provision noted. The assessment was conducted as a visual, non-invasive inspection only, and access restrictions may limit full visibility of all areas.

Uneven ground surfaces can allow water to pond or accumulate beneath the dwelling, contributing to elevated moisture levels. Inadequate subfloor ventilation restricts natural air circulation, preventing effective drying of moisture. These combined conditions create an environment conducive to timber decay, mould growth, corrosion of metal components, and increased termite risk, as termites are attracted to damp and poorly ventilated areas. Prolonged exposure to such conditions may adversely affect the durability and structural integrity of subfloor timbers.

It is recommended that a registered builder assess the subfloor area and implement measures to improve drainage and ground grading to prevent water accumulation. Additional compliant subfloor ventilation should be installed as required to promote adequate airflow in accordance with current standards. Ongoing monitoring of the subfloor environment is advised to ensure moisture levels remain within acceptable limits.

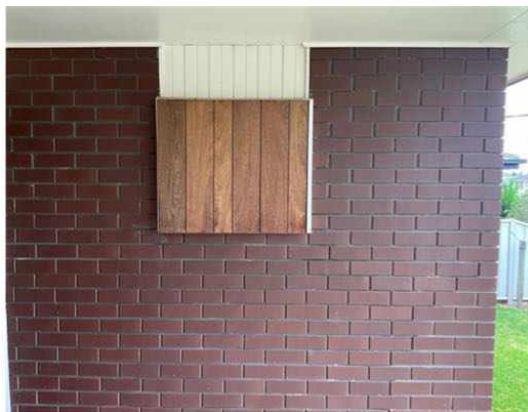
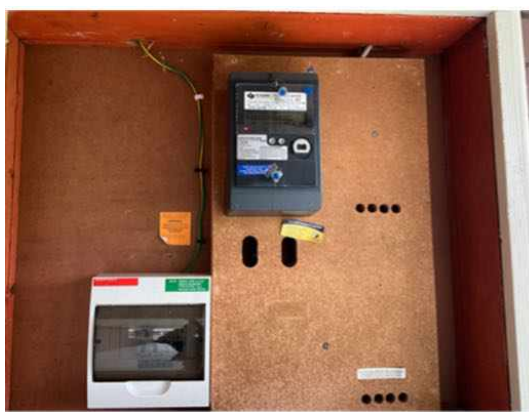
Building:	Main Building
Location:	Meter Box
Finding:	Termite Management System - no evidence of a chemical installation
Information:	The application of a post-construction chemical termite barrier is highly recommended for all properties, particularly if live termite activity has been found on the site previously. Such barriers are highly effective in preventing termite attack on any timber building elements throughout the property.

A durable notice should be placed in the switchboard unit to indicate current termite barriers. At the time of inspection, it appeared as though no termite management system has been installed, with no evidence to suggest preventative works taking place.

The client may consider gaining further advice from a pest controller as to the costs and procedures involved with this application. It is recommended that obtaining such advice be a short-term priority.

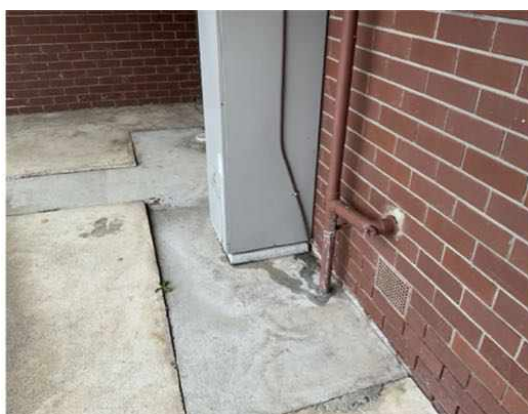
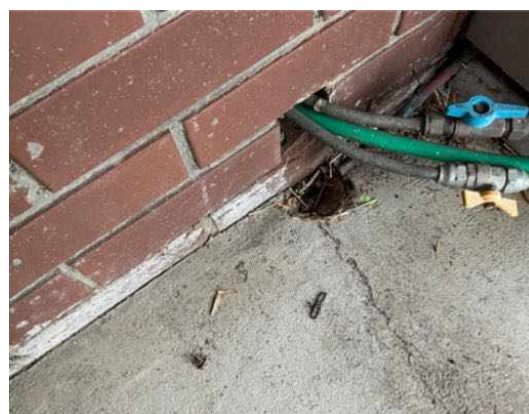
### Finding 6.02

Building:	Main Building
Location:	All External Areas
Finding:	HWS Overflow - Not Connected
Information:	The Hot Water System (HWS) overflow was found to be disconnected from storm water drainage and is creating excessive moisture in the surrounding area.

These damp conditions can lead to secondary defects such as rot, rust or corrosion of associated building elements, the formation of fungal decay, or even the creation of potential slip hazards. When coupled with poor site drainage, pooling of water may also attract termite activity to this area.

It is highly recommended that a licensed plumber be appointed to connect the HWS overflow in order to prevent such an environment from being created. These minor works should be carried out as soon as possible.

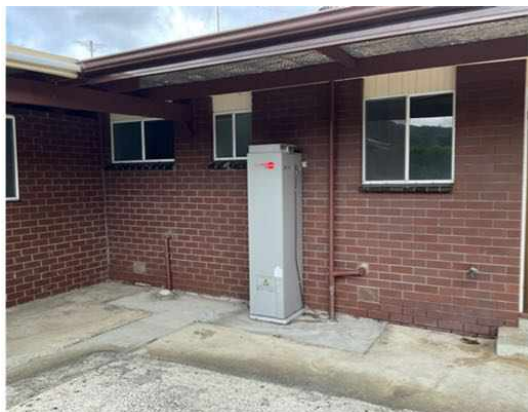
### Finding 6.03

Building:	Main Building
Location:	All External Areas
Finding:	Bridging - Attachments to Buildings
Information:	Bridging occurs when items against a building provide a concealed entry point for

Building attachments of this nature need to be frequently inspected for termite activity by a qualified inspector.

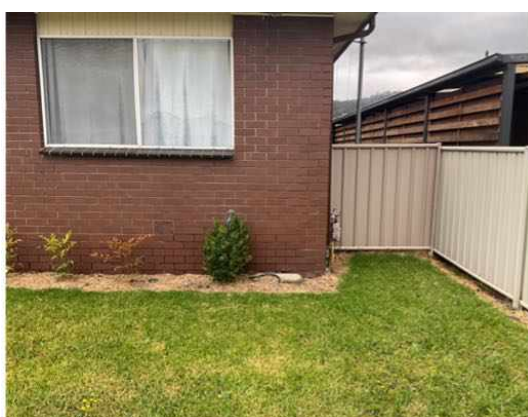
#### Finding 6.04

Building:	Main Building
Location:	All External Areas
Finding:	Garden Beds - Conditions Conducive to Termites
Information:	Garden beds were found to be evident in the garden area. These garden beds can include untreated timber, and with a combination of moisture from watering hosing can make conditions conducive to termite activity and termite ingress.

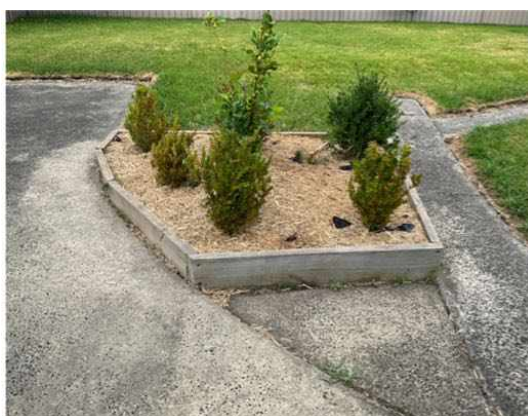
#### Finding 6.05

**Information:** Where timber elements are in direct contact with the ground and consequently moisture or dampness they become conducive to termite activity. Whether timber is used as a building element part of a fencing structure or stored as an unused item they can provide an environment that is attractive to termite infestation.

When met with excessive moisture timber begins to decay and develop wood rot. Any timbers that are in direct contact with external grounds especially if left untreated or non-durable also provide ingress for subterranean termites into that particular element.

The removal of any such materials that may be conducive to termite activity should be removed as soon as possible to minimise the risk of termite attack.

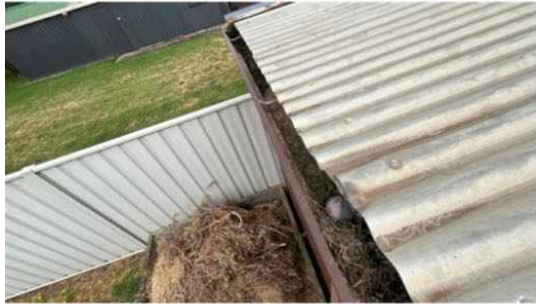
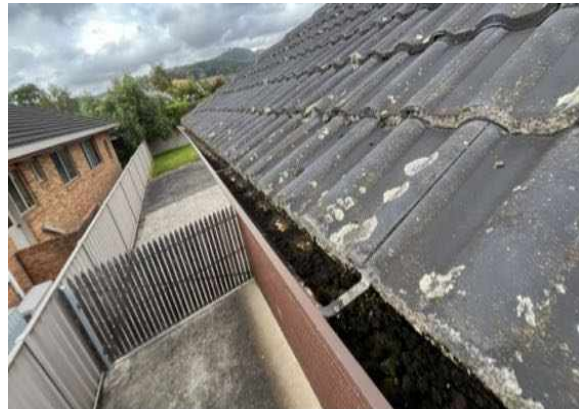
## Finding 6.06

**Information:** During the inspection, debris accumulation was noted in the guttering and downpipes. Blocked gutters can cause water to pool and overflow, leading to excessive moisture around eaves, fascia boards, and exterior walls. Where gutter guards are installed, regular maintenance is essential to remove any debris that may settle on top or filter through. Prolonged exposure to moisture in these areas creates conditions conducive to timber decay and potential termite or timber pest activity.

Excess moisture resulting from blocked gutters can accelerate timber deterioration, increasing the risk of fungal decay and attracting timber pests such as termites. Moisture-damaged timber is highly susceptible to infestation, as pests are drawn to damp and softened wood. If left unaddressed, this issue can lead to structural weakening and costly remediation work.

It is strongly recommended that all blockages in the gutters and downpipes be cleared immediately to maintain dry conditions and reduce the risk of timber pest activity. Homeowners or a general handyperson can perform routine cleaning; however, a licensed plumber should be consulted for further assessment and any necessary

remedial work. Ongoing gutter maintenance is crucial in preventing future moisture-related timber issues.
