Building and Timber Pest Inspection Report VR

Inspection Date: Thu, 11 Dec 2025

Property Address: 20 Hakea Ave, Frenchs Forest NSW 2086,
Australia

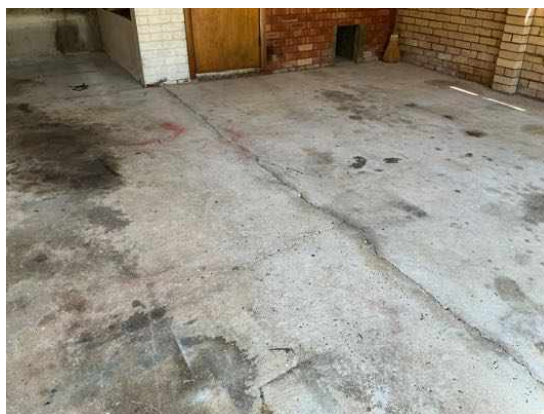
Building: Main Building
Location: Garage, Driveway
Finding: Crack in concrete slab - Category 2
Information: A crack coded as Category 2 was identified in the slab. A Category 2 crack is described as a distinct crack, with the slab being noticeably curved or changed in level.

To be considered Category 2, the approximate width of the crack is less than 2.0mm, or a change in offset of less than 15mm when a 3m straight edge is placed over the defect.

Category 2 cracks to slabs should be monitored for a period of 12 months. At the end of the monitoring period, cracks rated greater than Category 2 are considered defects that require rectification.

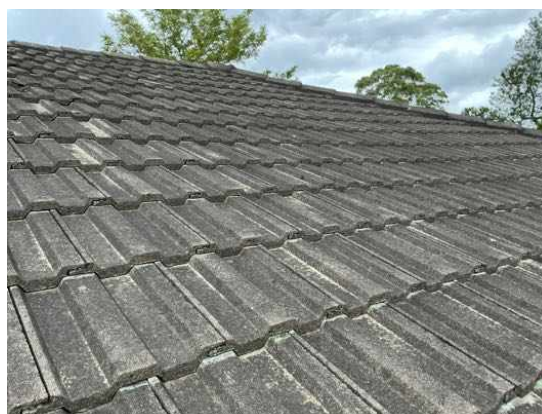
Finding 3.05

Building:	Main Building
Location:	Roof Exterior
Finding:	Roof Tiles - Weathered (VR)
Information:	At the time of inspection, the roof tiles were noted to be weathered, which is consistent with age and normal exposure to the elements. While no immediate concerns were observed, it is recommended that the roof tiles be monitored and maintained as required to help ensure ongoing weather protection.

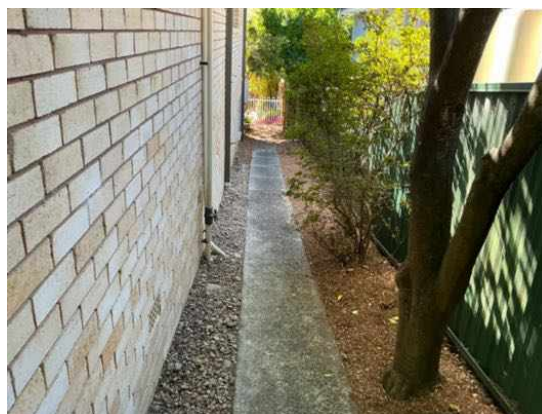
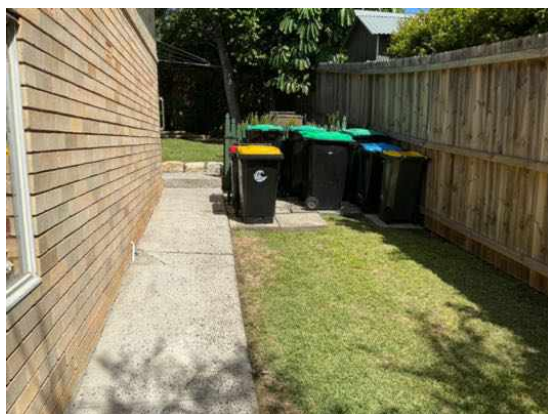
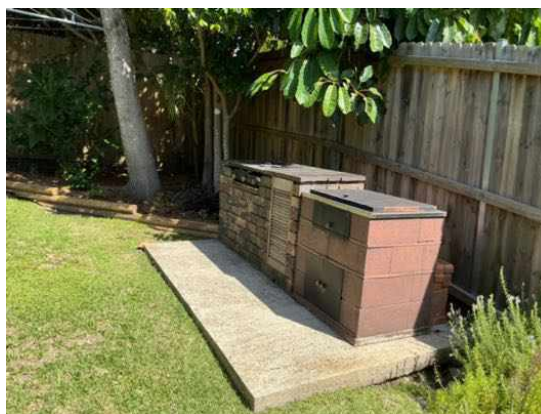
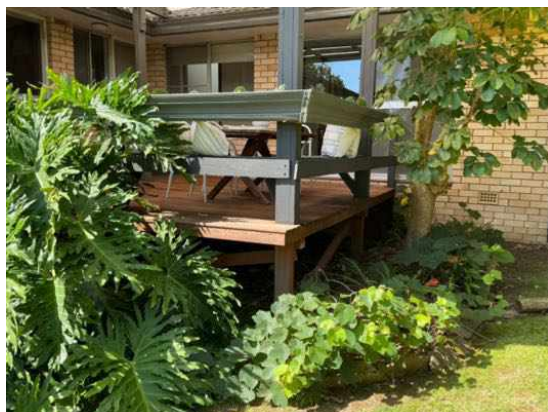
Building: Main Building
Location: All External Areas
Finding: Obstructions and Limitations - External Areas
Information: The attached photographs provide a visual representation of the obstructions and limitations that impeded a full inspection of the external areas of the property at the time of assessment. These obstructions, which may include vegetation, stored items, debris, or other physical barriers, can obscure potential defects and prevent a thorough evaluation of the property's condition. Obstructions of this nature can conceal a wide range of issues, such as structural damage, water ingress, pest infestations, or deteriorating building materials, which may not be visible during the initial inspection.

It is essential that these obstructions be cleared to allow for a comprehensive inspection of the external areas. Removing these barriers will enable a more accurate assessment of the property's condition and allow any hidden defects to be identified and addressed promptly. Failure to do so could result in undetected issues worsening over time, potentially leading to more costly repairs in the future.

Therefore, it is strongly recommended that the obstructions be removed and a re-inspection be scheduled once the affected areas are made fully accessible. This will ensure a complete evaluation of the property's exterior and provide the client with a clear understanding of any potential issues that may have been concealed during the initial inspection.

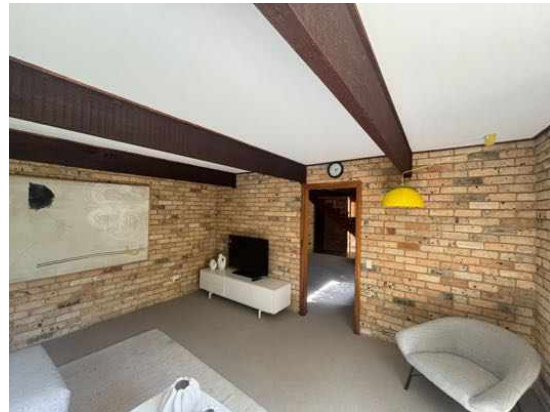
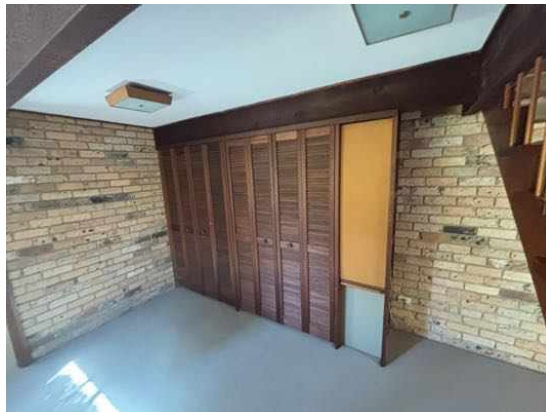
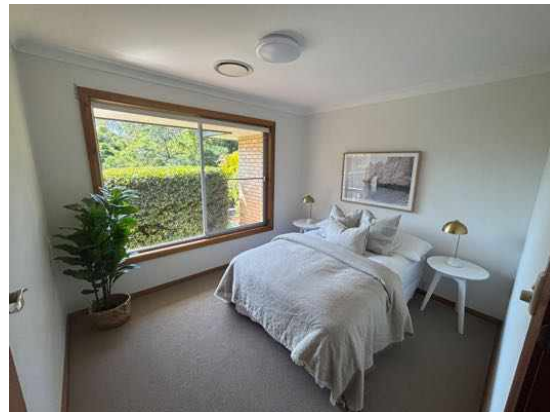
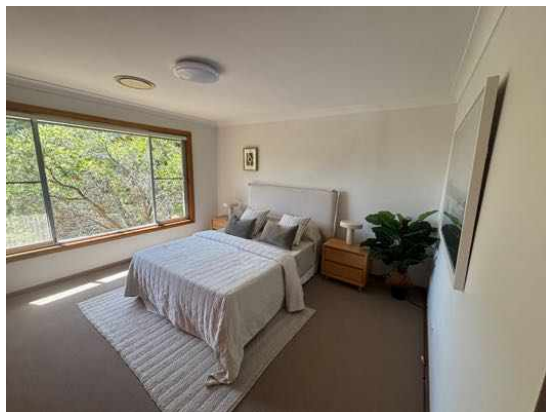
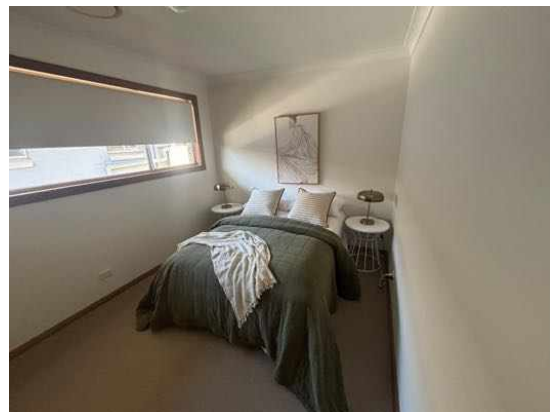
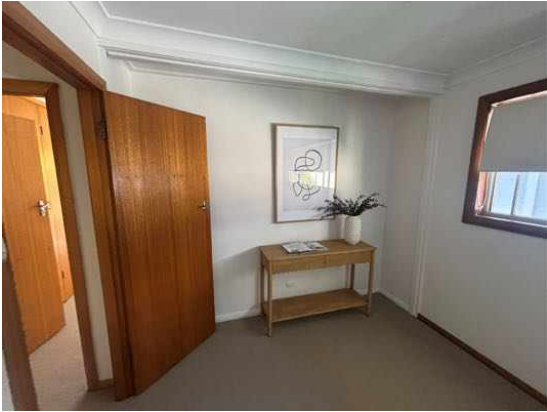
Information: The accompanying photographs provide clear evidence of the obstructions and limitations that restricted a comprehensive inspection of the internal areas of the property at the time of assessment. These obstructions, which may include furniture, personal belongings, stored items, or structural elements such as wall coverings and built-ins, significantly hindered the ability to thoroughly evaluate these areas. It is important to note that such obstructions can potentially conceal a wide array of defects, ranging from hidden structural damage, water leaks, pest infestations, or electrical issues, to deteriorating materials that may not be visible during the initial inspection.

The presence of these impediments means that critical areas of the property were not accessible, and therefore, any underlying defects that may affect the integrity and safety of the property could remain undetected. These hidden defects, if left unaddressed, could worsen over time and may result in costly repairs or pose potential safety hazards to the occupants.

It is highly recommended that all obstructions be cleared to facilitate a complete and thorough inspection of the internal areas. Once the obstructions have been removed and full access is available, a re-inspection should be carried out to ensure that any

previously concealed issues can be properly identified and rectified. This follow-up inspection will provide a more accurate assessment of the property's internal condition and help the client make informed decisions about any necessary repairs or maintenance.

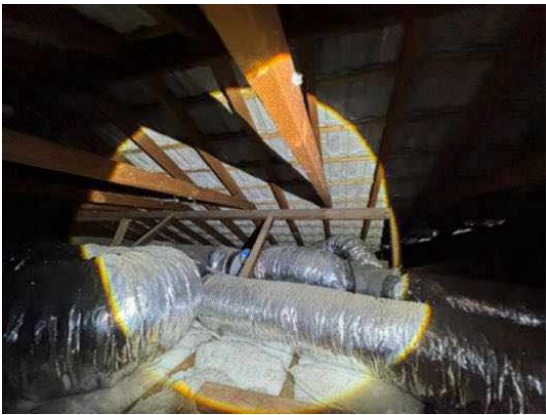
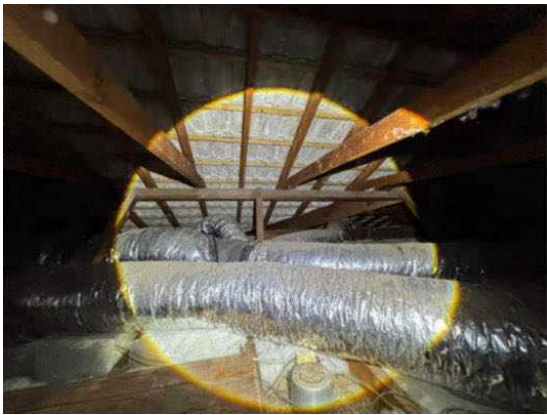
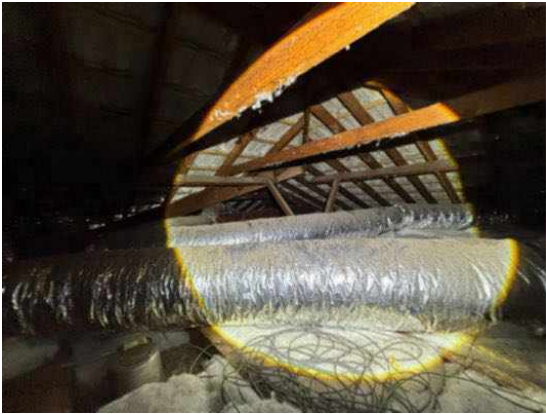
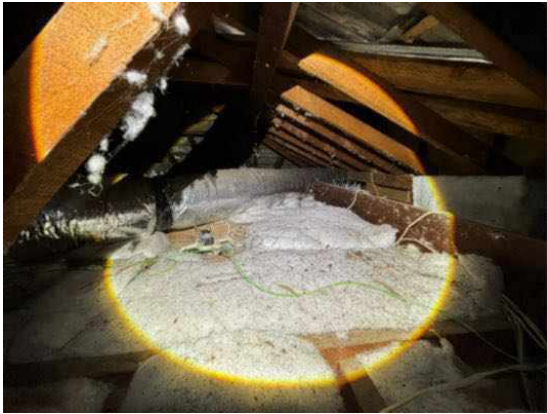
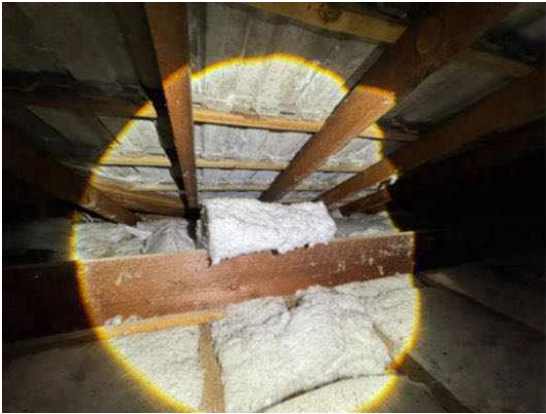
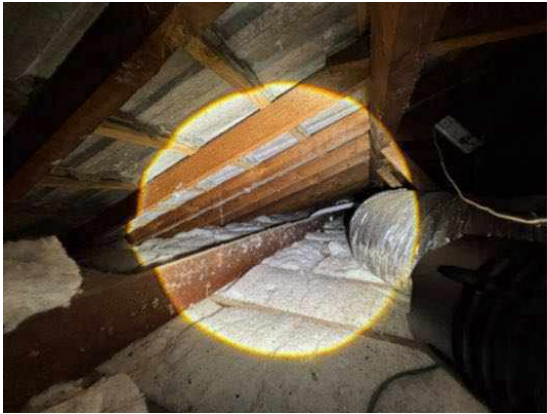
Building:	Main Building
Location:	Roof Void
Finding:	Obstructions, Limitations, and General Roof Space Condition
Information:	The photographs provided document both the general condition and the obstructions and limitations that were present in the roof cavity of the main building at the time of inspection. These obstructions—such as insulation materials, stored items, structural elements, or electrical wiring—restricted safe and adequate access to key areas within the roof space. As a result, a comprehensive inspection of all components could not be completed.

Obstructions of this nature may conceal a variety of potential defects, including damaged framing, compromised insulation, evidence of moisture ingress, pest activity, or electrical hazards. While no major issues were observed in the visible areas, the presence of these limitations means that some defects may remain undetected.

It is recommended that these barriers be removed or repositioned to facilitate full and safe access to the roof space. Once clear, a follow-up inspection should be conducted to allow for a thorough assessment of all concealed areas. This will help ensure that the condition of the roof cavity is accurately evaluated and any hidden issues are appropriately identified and addressed.

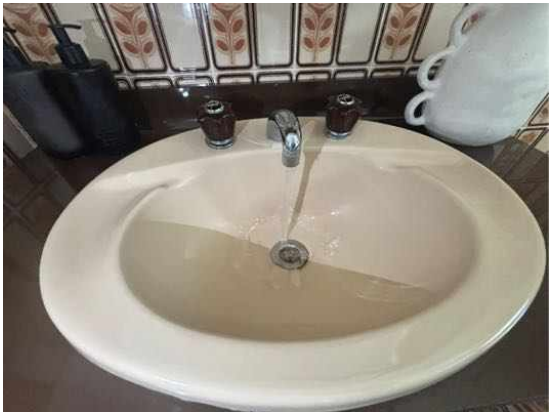
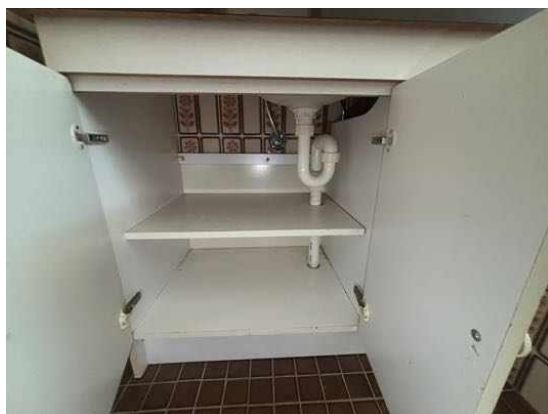
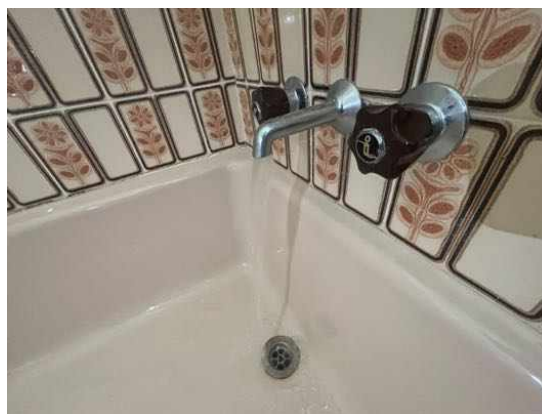
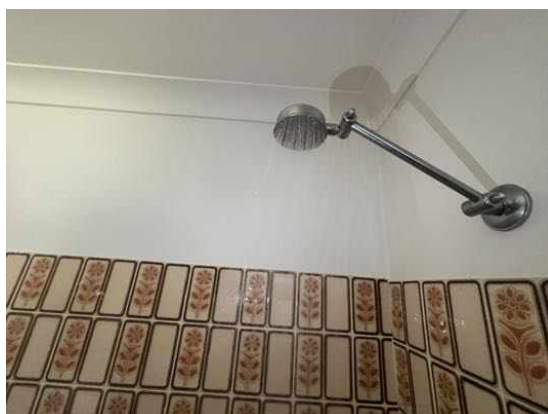
Building:	Main Building
Location:	All Areas
Finding:	FYI - Taps, Drainage & Toilets Tested and Cabinetry Obstructions
Information:	During the inspection, all accessible taps, drainage systems, and toilets were tested for water flow and drainage efficiency, and checked for any visible signs of leakage. At the time of the inspection, no issues were noted in these areas. Unless highlighted in a separate defect statement, no immediate remedial work appears necessary. Supporting images may be found in the additional photos section for reference.

It is important to note that while a visual inspection of cupboards and cabinetry beneath sinks and vanities was undertaken, stored personal items and fixtures presented obstructions that limited full visibility of the internal areas. As per standard inspection practices, inspectors are not permitted to move or disturb personal belongings during the inspection process. Therefore, only visible and accessible sections were inspected, and concealed water damage or plumbing defects may not have been detected.

Given this, a re-inspection is recommended after all obstructions have been cleared to allow for a comprehensive assessment of these areas. Regular maintenance and monitoring of plumbing and drainage systems is also advised to ensure ongoing functionality and early detection of potential issues.

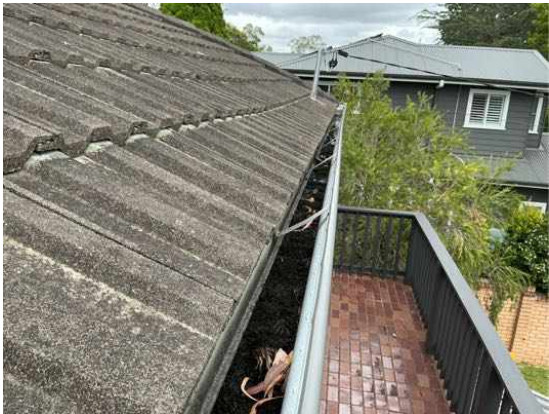
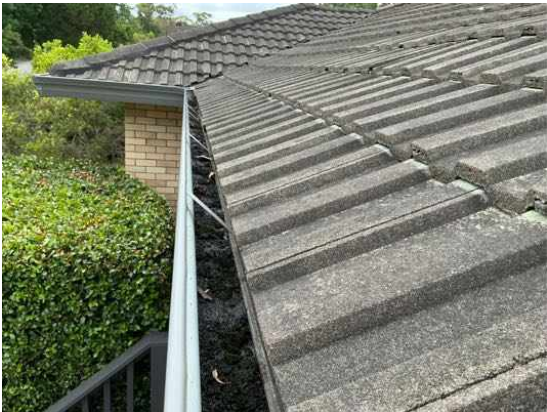
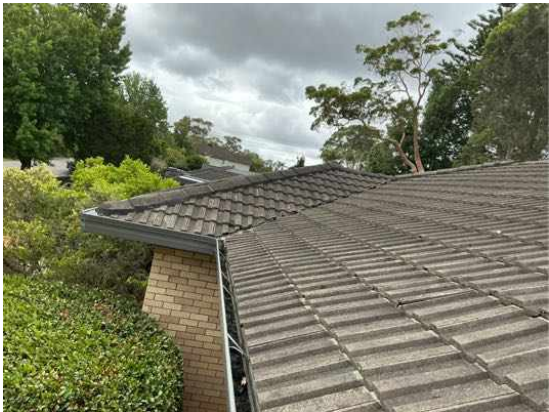
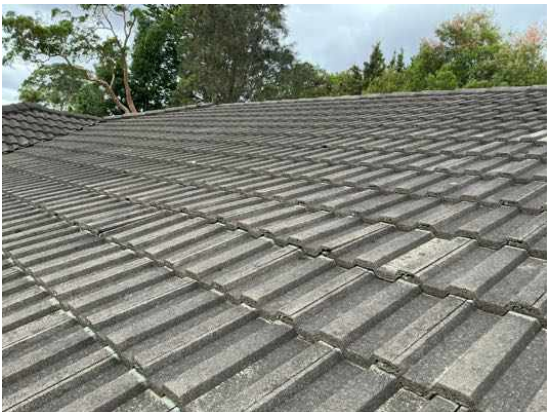
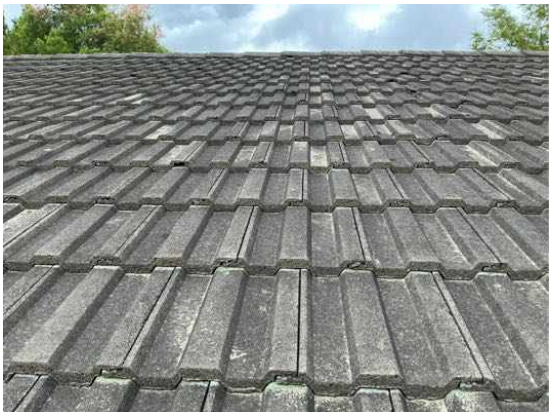
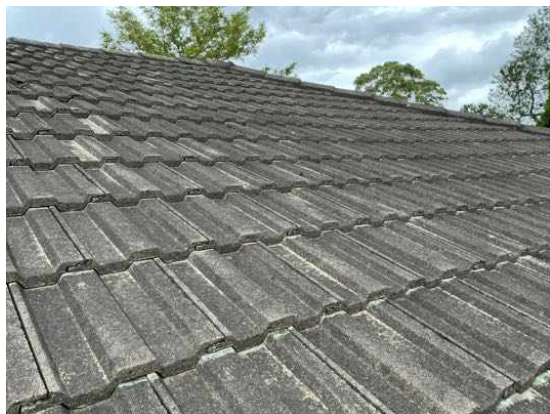
Information: As part of the information provided, please note that the attached roof photos represent the condition of the roof at the time of inspection. These photos are for visual reference only and do not constitute a detailed roofing assessment. Any defects or issues identified with the roof are mentioned separately in the defect statements. It is strongly recommended that the client engage a qualified roofer to conduct a thorough inspection of the roof, ensuring that any potential issues, such as leaks, structural integrity, or wear and tear, are properly identified and addressed.

Additionally, the condition of the roof may change over time due to weather, natural wear, or other unforeseen factors. Regular maintenance and inspections by a licensed professional are advised to ensure the roof remains in good condition and to avoid costly repairs in the future. The information provided in these photos should be considered a snapshot of the roof's condition during the time of inspection and not a guarantee of its future performance.

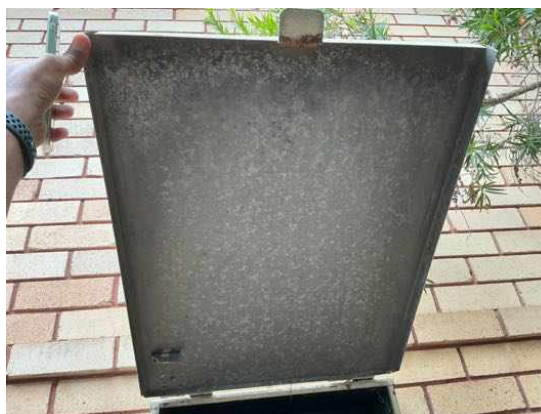
Building: Main Building
 Location: Meter Box
 Finding: Termite Management Recommendation – No Evidence of Chemical Installation (VR)
 Information: At the time of inspection, there was no visible evidence of a chemical termite management system installed around the property. Chemical barriers are a key component of termite protection and are particularly important in preventing concealed termite entry into timber elements of the structure.

In accordance with standard requirements, a durable notice should be located within the electrical switchboard to detail any termite protection systems applied, including chemical treatments. No such notice was observed during the inspection.

It is recommended that the client engage a licensed pest controller to carry out chemical termite treatment.
