Building and Timber Pest Inspection Report

Inspection Date: Tue, 10 Mar 2026

Property Address: 10 Crabapple Cl, Bowral NSW 2576,
Australia

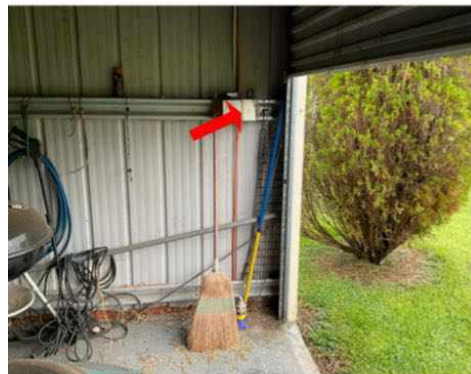
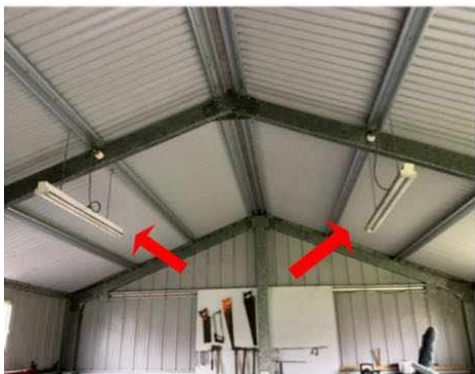
Finding 1.01

Building: Building 1
Location: Garage
Finding: Light switch faulty - requires electrician
Information: The light switch in the garage emitted sounds making it unsafe to use. The lights did not work on turning this on.

This damaged fitting may be a safety hazard if there is potential contact with persons in the area.

A Licensed electrician should be appointed to rectify these areas immediately.

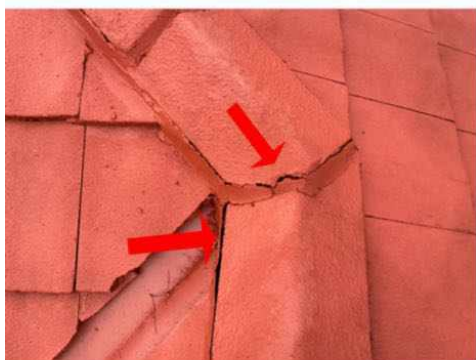
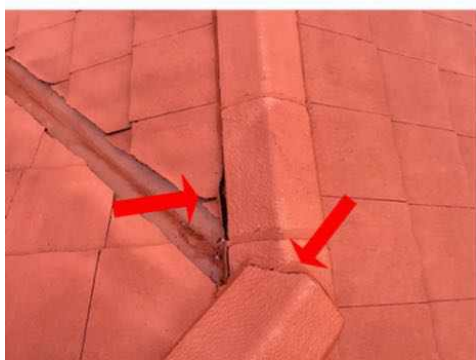
Building: Building 1
Location: Roof Exterior
Finding: Roofing areas - Weathered
Information: Upon inspection of the exterior roofing, the majority of the roof tiles were considered to be in a good condition, with the roof mortar in fair condition.

Where left unmanaged, deteriorating roofing materials are likely to lead to a number of secondary defects, including minor water leaks and weather exposure to internal roofing structures.

Re-sealing and replacing many small areas of gaps and damage must be undertaken by the client to help preserve and extend the life span of these roofing areas.

Remedial works are likely to increase the longevity of the exterior roofing structure.

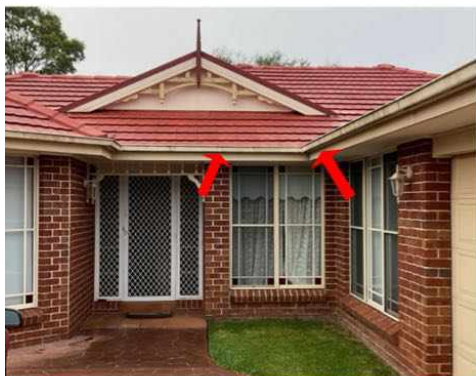
Finding 3.02

Building:	Building 1
Location:	Roof exterior
Finding:	Roof plumbing - Insufficient fall
Information:	There is an insufficient fall in the roof drainage, which means that the angle is inadequate to facilitate movement of rainwater. This is probably a result of lack of gutter maintenance. This is resulting in pooling of water in the area, creating the potential for water damage to associated building elements.

Without adequate roof drainage, premature rust and decay of the roof plumbing structures is imminent. The development of such deterioration is likely to lead to the formation of secondary defects to adjoining wall sections and roofing elements.

Adjustment by a roofing plumber is required as soon as possible to prevent any further damage to the area.

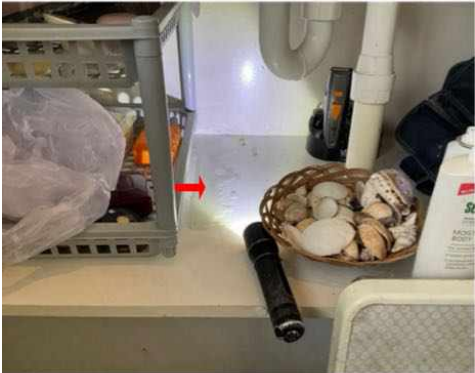
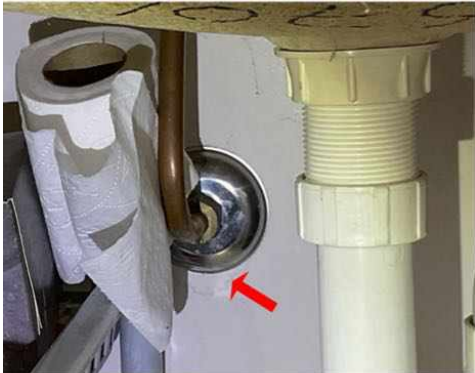
Finding 3.03

Building:	Building 1
Location:	Bathroom
Finding:	Shower screen leaking and water found
Information:	Leaking was evident to the shower screening at the time of inspection. It is suspected that the leaking has occurred as a result missing sealant. Leaking from the shower , where left unattended, is likely to lead to water damage to adjoining flooring and walls. Such damage can lead to water damage and necessitate extensive remedial works being required.

Water was found under the vanity and rear staining was observed however the taps were run for 5 minutes and no leaks were found.

This may be old staining or something spilt in this cupboard. Active water leaks may also create an environment that is susceptible to the formation and development of mould.

Appointment of a sealant expert is required to repair or replace this missing sealant. Such works should be performed as soon as possible to ensure that no further damage occurs.

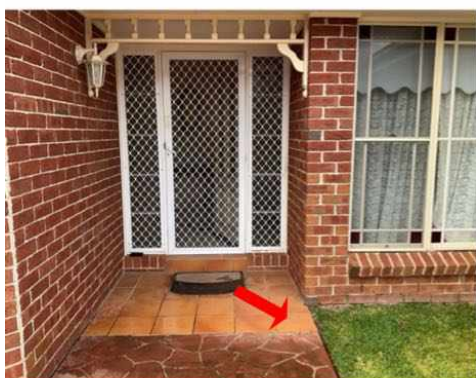
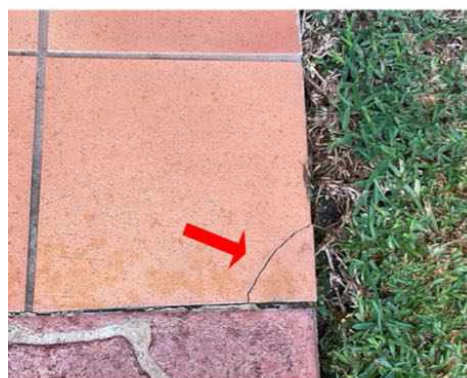
Building:	Building 1
Location:	Porch
Finding:	Tile cracked
Information:	A cracked tile was evident on the balcony at the time of inspection. It is suspected that this cracking has occurred as a result of impact damage.

Cracked tiles throughout the household detract from the overall appearance of the affected areas. In wet areas of kitchens and bathrooms, it can lead to water damage of adjoining walls and floors.

Replacement of cracked tiles is recommended as soon as possible. A tiling contractor may be appointed to perform these works. Where cracks become more numerous, contact a licensed building inspector for further investigation.

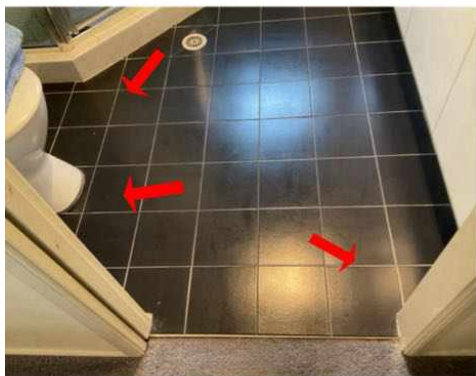
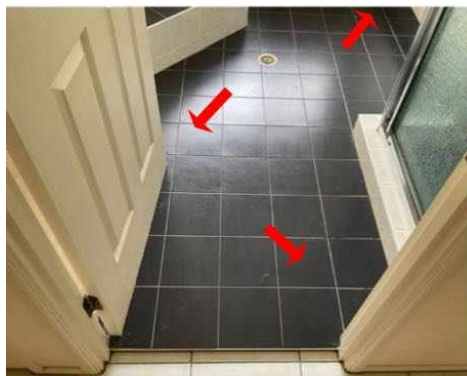
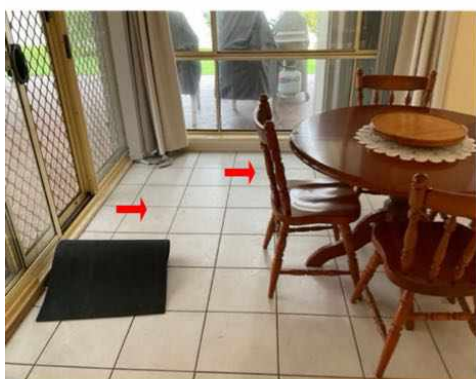
Finding 3.06

Building:	Building 1
Location:	Pictured areas
Finding:	Tiles - Drummy
Information:	Drummy tiles were identified in these 3 areas at the time of inspection. The term 'drummy' refers to tiles that have become detached from their fixing, despite otherwise

being in relatively good condition. Such defects are generally caused by physical or moisture damage to the area. Drummy tiled areas may also be a direct result of poor workmanship during the construction process.

Tiled areas may swell and shrink with changes in air humidity if the area has sustained moisture damage. Any exposure to moisture is capable of causing tiled areas to become drummy and/or cracked over a prolonged period of time. Drummy tiled areas can require removal and replacement of affected tiles, with adequate sealant and grouting. A tiling contractor can be appointed to perform works as necessary.

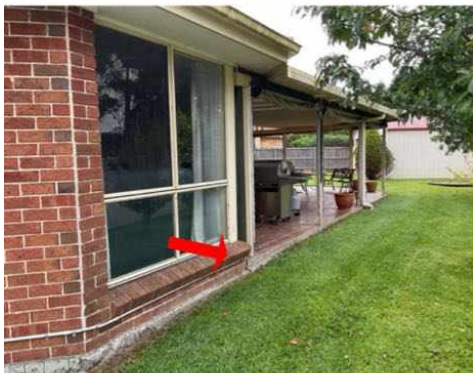
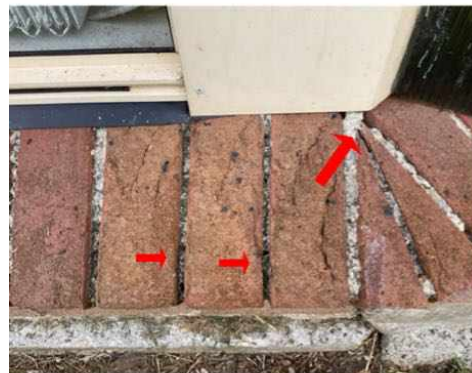
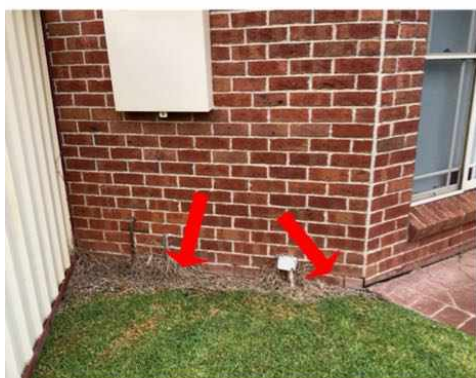
Building:	Building 1
Location:	Exterior walls
Finding:	Brickwork - Deteriorated mortar
Information:	Mortar, or 'bedding', is the material which fills joints and intersections between bricks in masonry walls and structures. Sections of mortar in this brickwork were identified as having deteriorated, which is generally expected for a property of this age and condition.

Mortar may deteriorate as a result of age of building materials, minor movement of bricks, or frequent exposure to weathering. Mortar should be replaced to ensure that bricks remain in their intended location and to prevent gaps, which would allow water or moisture ingress and secondary damage as a result.

Mortar deterioration can be addressed by a bricklayer where areas of deterioration are localised and easily accessible. Alternatively, appointment of a registered builder is advised, to repoint large areas of decaying mortar. Where secondary structural defects have become evident, consultation with a structural engineer may be required.

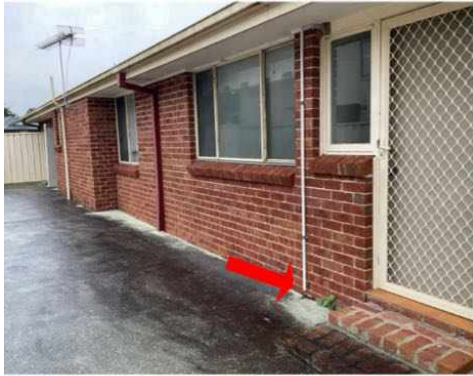
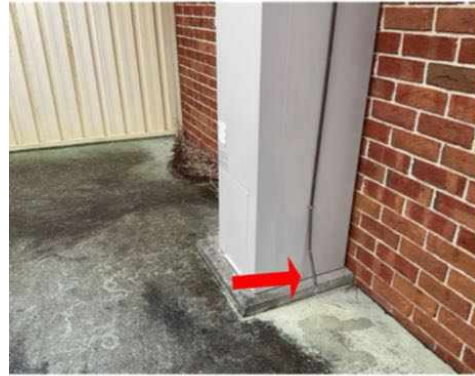
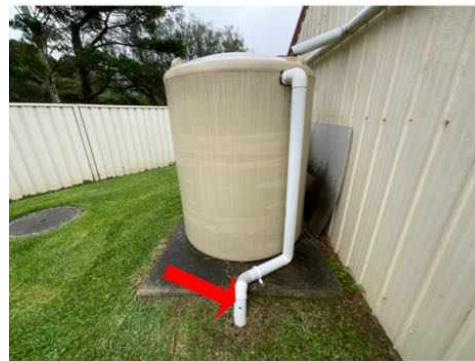
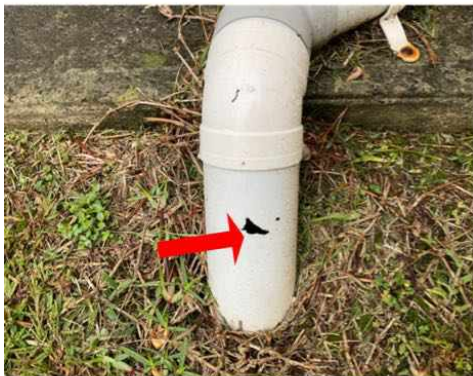
Finding 3.09

Building:	Building 1
Location:	Right wall
Finding:	Site drainage - Inadequate
Information:	The site drainage in this areas was found to be inadequate at the time of inspection, creating potential for subsequent water damage to associated building elements.

The air conditioners and hot water system overflow run against the house walls. The water tank overflow has a small crack.

It is important that water does not lie against the base of walls; surrounding paths and ground levels should be sloped to drain water away from walls. Downpipes should not discharge stormwater onto lower walls or plinths. Stormwater should be carried away by large, regularly cleaned drains. Ground levels may need to be lowered to expose a buried DPC.

Where site drainage is inadequate, installation of an Agricultural (Aggie) Drain may be required. A qualified plumber should be appointed to further inspect the property and perform any remedial works as necessary. Secondary defects are likely to occur if left unmanaged.

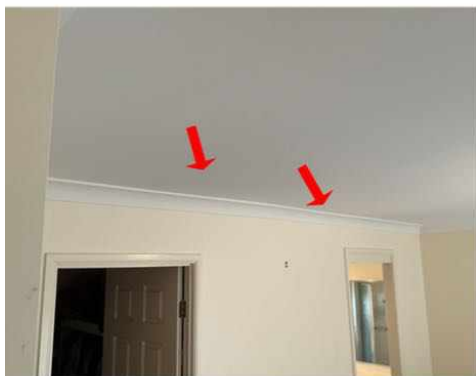
Finding 3.10

Building:	Building 1
Location:	Pictured areas
Finding:	Ceiling - out of level
Information:	The ceiling in the master bedroom was out of level at the time of inspection. This does not appear to have sagged, as no cracking or moisture was evident. It is thought this ceiling was constructed this way. An inspection of the above roof void and removing all insulation to check this area is highly recommended.

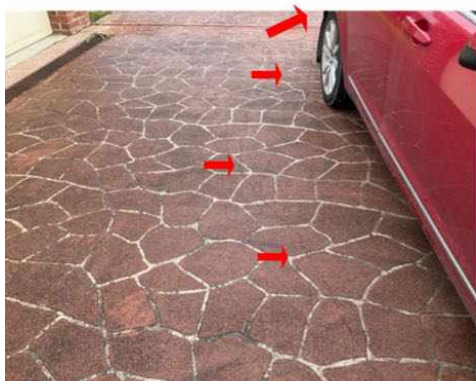
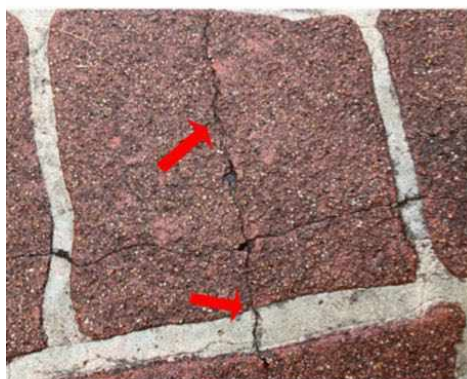
Finding 3.11

Building:	Building 1
Location:	Yard - front
Finding:	Crack in concrete slabs - Category 1
Information:	Cracks coded as Category 1 was identified in these pictured slabs. A Category 1 crack is described as a fine but noticeable crack, with the slab at an otherwise reasonable level. To be considered Category 1, the approximate width of the crack is less than 1.0mm, or a less than 10mm change in offset when a 3m straight edge is placed over the defect.

Category 1 cracks should be monitored for a period of 12 months. At the end of the monitoring period, identified cracks that are rated greater than Category 2 are considered defects, and require rectification.

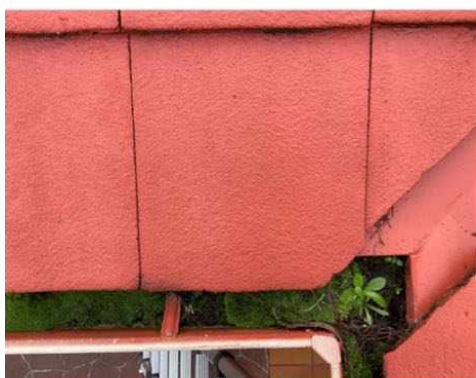
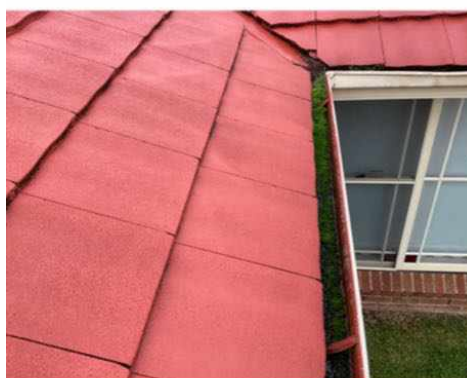
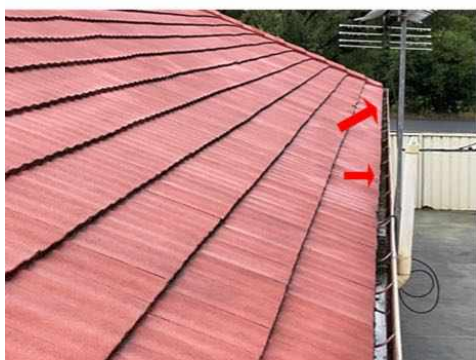
Finding 3.12

Building:	Building 1
Location:	Roof exterior
Finding:	Gutters - Full and blocked
Information:	The guttering on around the roof was found to be blocked at the time of the inspection. Roof plumbing structures, such as guttering and downpipes, should be free of all debris to prevent blockages. Blockages of the guttering and downpipes will

Blocked gutters are likely to lead to high levels of moisture in the affected areas which can cause rust and decay of the gutters and downpipes and wood rot to adjoining timber areas. Blockages in gutters should therefore be removed immediately to ensure dry conditions are maintained.

It is highly advised that gutters be cleaned by the homeowner or a general handyperson as a matter of urgency.

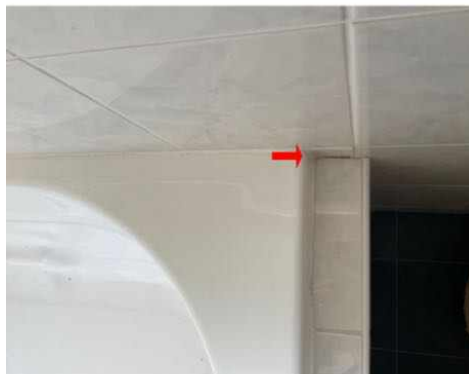
Finding 3.13

Building:	Building 1
Location:	Kitchen and bathrooms
Finding:	Sealant and grouting - Missing or damaged
Information:	It was noted on inspection that small areas of sealant or grout is degraded to these pictured wet areas.

Different materials and floor areas move at different rates, generally causing cracking to grout or sealant at this point. A flexible sealant is required to allow for expected expansion and contraction, while keeping the joint water tight and protective of all associated building materials.

Flexible and mould resistant materials should be applied to affected areas to prevent any subsequent water damage that is likely to occur. Regular maintenance and replacement of damage or missing or damaged sealant and grout is highly recommended to the wet areas, as this is a regular wear and tear defect. Sealant and grouting in areas that come into regular contact with water should be maintained for the long term care of your property.

A sealant specialist or tiling contractor should be appointed to complete these works as soon as possible

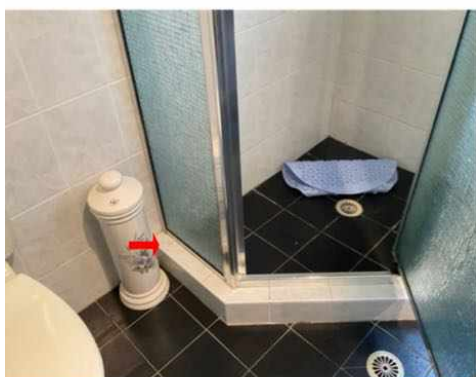
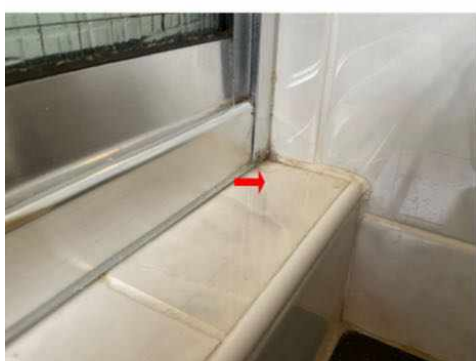
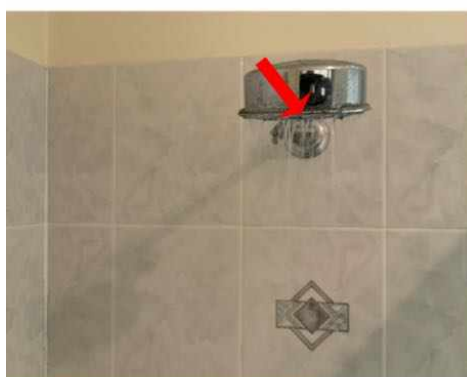
Finding 3.14

Building:	Building 1
Location:	Bathrooms
Finding:	Shower screens - Leaking and poor ensuite shower flow
Information:	Leaking was evident to the shower screening at the time of inspection. It is suspected that the leaking has occurred as a result missing sealant. Leaking from the shower , where left unattended, is likely to lead to water damage to adjoining flooring and walls. Such damage can lead to water damage and necessitate extensive remedial works being required. Active water leaks may also create an environment that is susceptible to the formation and development of mould. The ensuite shower also had poor water flow and it is suspected the ageing shower head is blocked.

Appointment of a sealant expert is required to repair or replace this missing sealant. Such works should be performed as soon as possible to ensure that no further damage occurs.

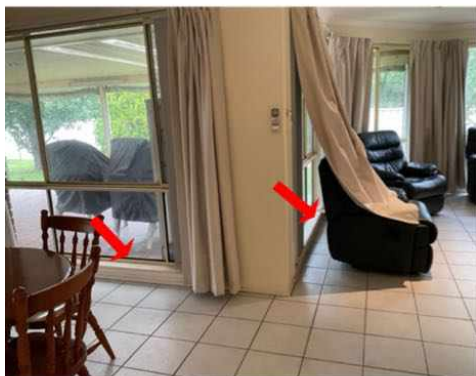
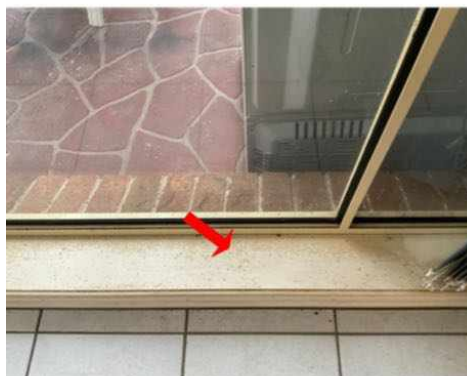
Finding 3.15

Building:	Building 1
Location:	Pictured areas
Finding:	Mould - Present
Information:	Where evidence of mould growth was noted, there may be environmental, biological or health issues associated with the report. A specialist inspection by a suitably qualified environmental health inspector is warranted, where mould is extensive or where any queries regarding air quality spores or other related issues apply.

Generally, the client is advised to ensure that the general environment is free of moisture and humidity to aid in the prevention of mould formation and development. Any mould found during the inspection should be cleaned immediately by a cleaning contractor or the homeowner as applicable. Additional brick vents, mechanical ventilation and removal of all subfloor debris will all assist in keeping this subfloor mould free.

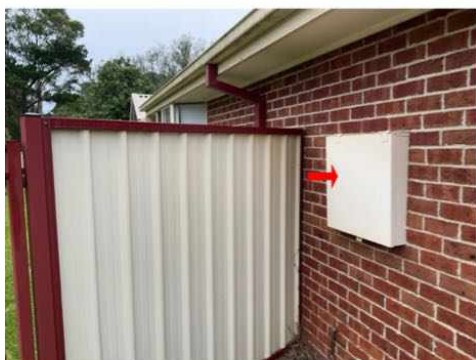
Building:	Building 1
Location:	Meter Box
Finding:	Termite Management System - no evidence of a chemical installation
Information:	The application of a post-construction chemical termite barrier is highly recommended for all properties. Such barriers are highly effective in preventing termite attack on any timber building elements throughout the property.

A durable notice should be placed in the switchboard unit to indicate current termite barriers. At the time of inspection, the durable notice was evident and it appeared as though no chemical termite management system has been installed, with no evidence to suggest preventative works taking place since the property was built in 1997.

The client may consider gaining further advice from a pest controller as to the costs and procedures involved with a 'chemical' application. It is recommended that obtaining such advice be a short-term priority.

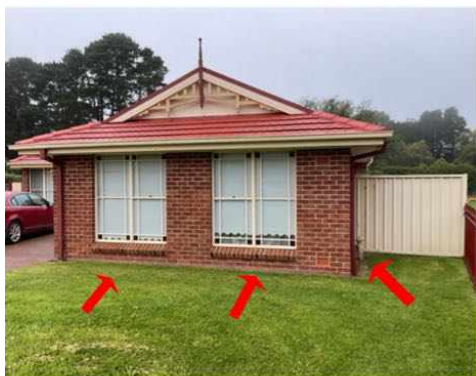
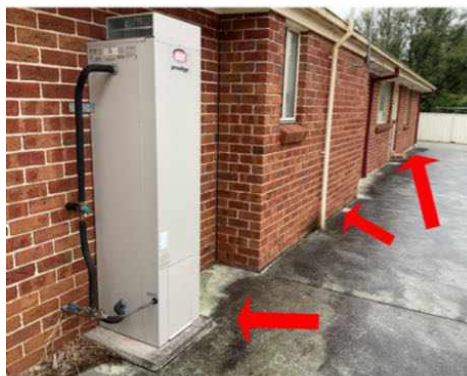
Finding 6.02

Building:	Building 1
Location:	Exterior walls
Finding:	Slab Edge - Exposure
Information:	An inspection zone of at least 75mm in relation to the exposed slab edge, between the bottom brick and the perimeter pavement, is required. This inspection zone should be maintained in order to force termites into the open where they can be detected more readily during regular inspections. The slab edge should not be concealed by anything that may prevent inspection of the area, including render, landscaping, soil, turf, paving, concrete cladding or other structures.

If the slab edge is not properly exposed there is a high risk of termite attack. Sometimes, in order to determine the type of slab, a suitably qualified person such as an architect or builder may be required to consult the construction plans.

Where the slab edge cannot be properly inspected, it is highly recommended that termite or timber pest inspections be carried out every 6-12 months to aid protection of the property against infestation.
