# Building Inspection Report

Inspection Date: Mon, 23 Feb 2026

Property Address: 22 Pybus St, Snug TAS 7054, Australia

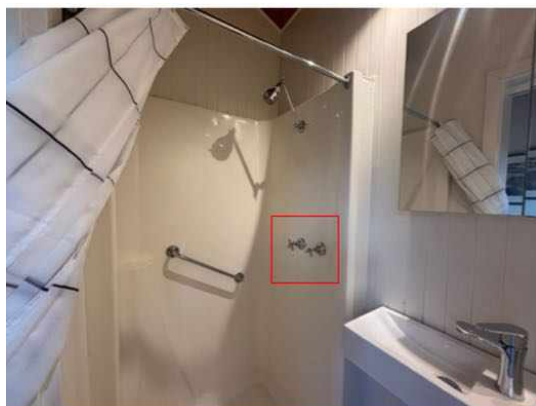
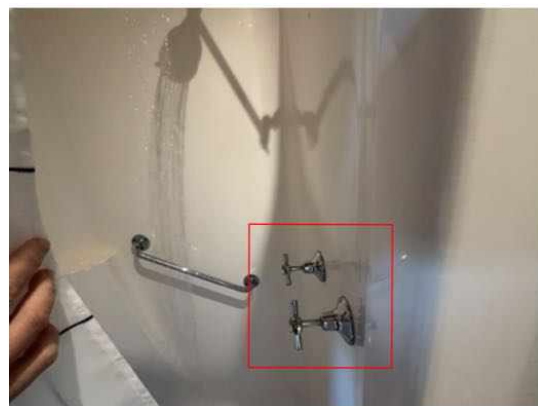
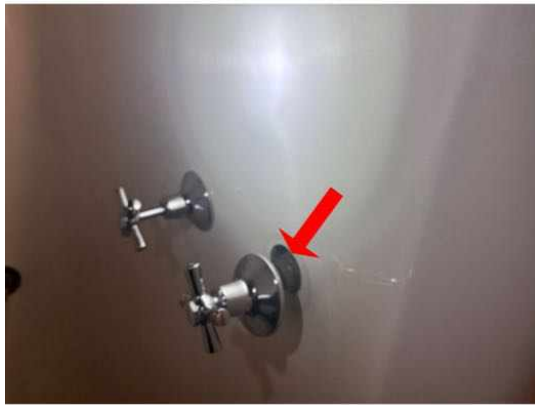
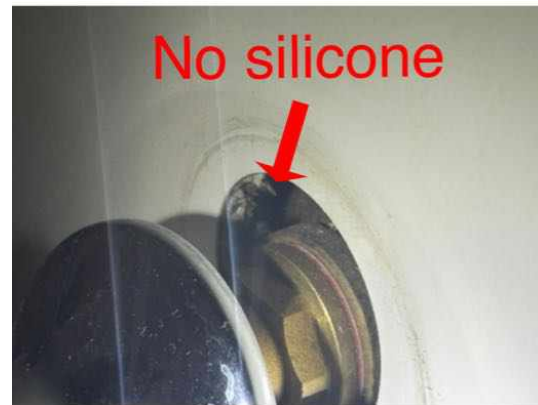
#### Defects 3.01

Location: Ensuite

Finding: Ensuite silicone to tap penetrations

Information: In the ensuite the silicone to the tap penetrations appears to be missing. The tap penetrations are the most likely area for water ingress. I could not access this area in the subfloor, the access was too small and a plumbing pipes running across the entry.

Regular maintenance and replacement of damage or missing or damaged sealant and grout is highly recommended to the wet areas, as this is a regular wear and tear defect. Sealant and grouting in areas that come into regular contact with water should be maintained for the long term care of your property.

Failure to remedy could result in damage to surrounding building elements.

Recommend client engage a Lic Plumber to rectify as soon as possible.

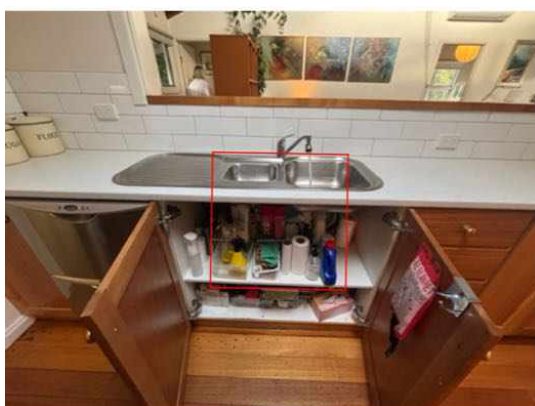
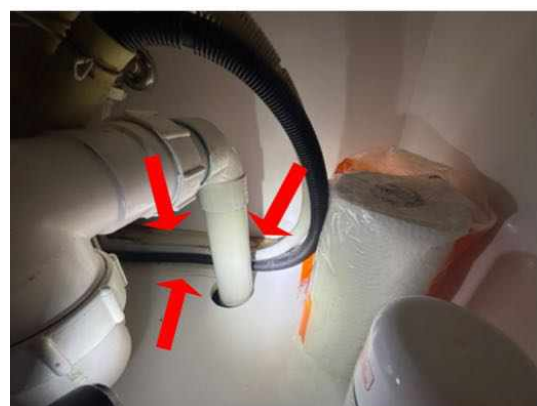
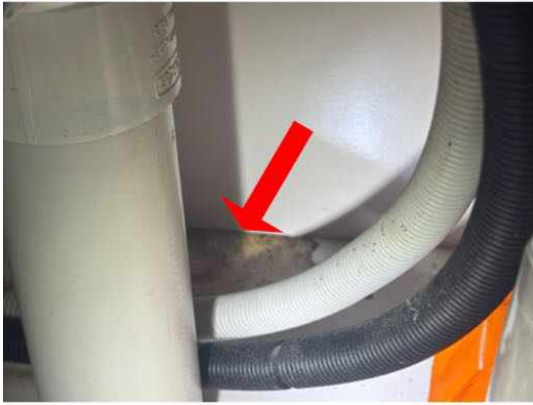
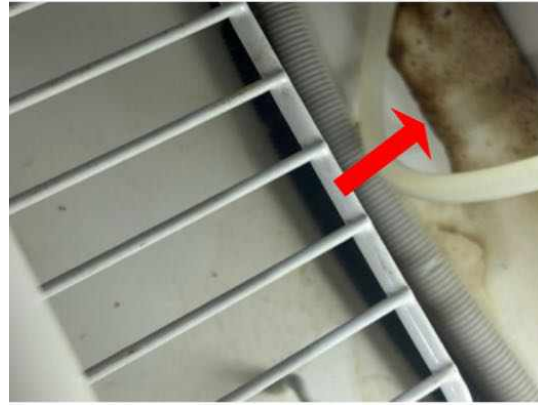
### Defects 3.02

Location: Kitchen

Finding: Water staining under kitchen sink

Information: In the kitchen under the sink cabinet, there is some water staining. It was dry at the time of the inspection.

Water staining was evident in this area at the time of inspection. Water staining indicates that surfaces have been exposed to excessive moisture over time. The minerals and other elements in the water lead to staining, which may graduate to corrosion and deterioration if left unmanaged.

While mostly an appearance defect, water staining can be indicative of more serious defects, which may be currently concealed by other building elements.

Recommend client engage a Lic Plumber as soon as possible to inspect and rectify (if required).

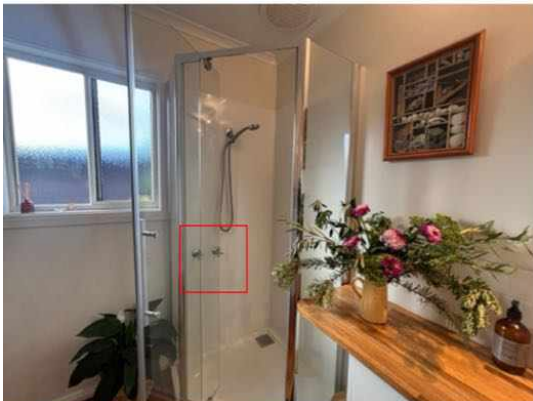
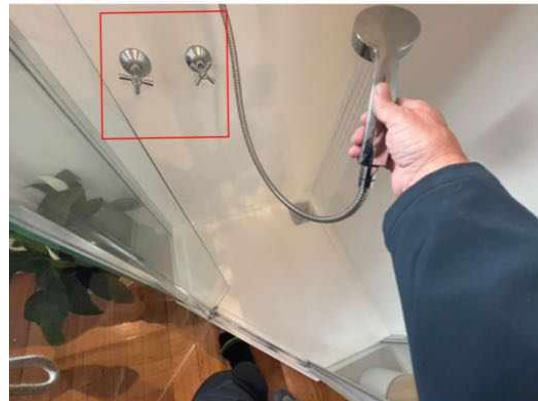
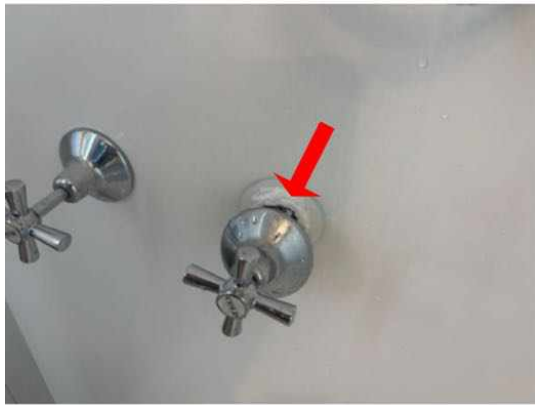
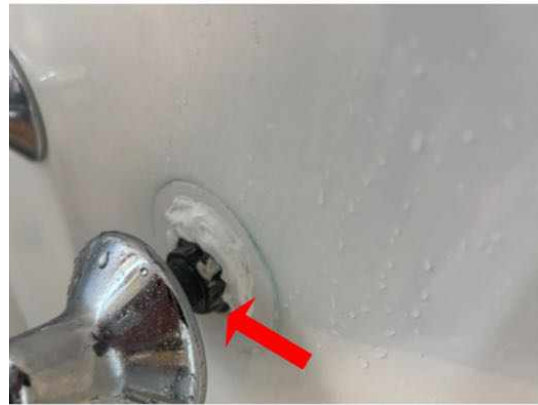
### Defects 3.03

Building: Main Building  
 Location: Bathroom  
 Finding: Silicone to tap penetrations deteriorated  
 Information: In the bathroom the silicone to the tap penetrations appears to be incomplete.

Regular maintenance and replacement of damage or missing or damaged sealant and grout is highly recommended to the wet areas, as this is a regular wear and tear defect. Sealant and grouting in areas that come into regular contact with water should be maintained for the long term care of your property.

Failure to remedy could result in damage to surrounding building elements.

Recommend client engage a Lic Plumber to inspect and rectify as soon as possible.

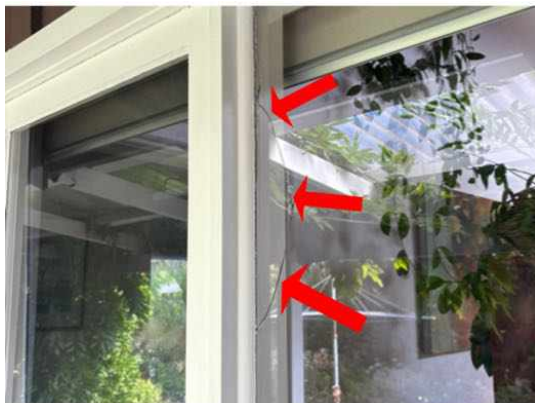
### Defects 3.04

Building: Main Building  
Location: Butlers pantry  
Finding: Glass broken to window  
Information: The glass is broken to the butlers party window pane.

Recommend client engage a Glazier to rectify at clients convenience, to prevent further deterioration.

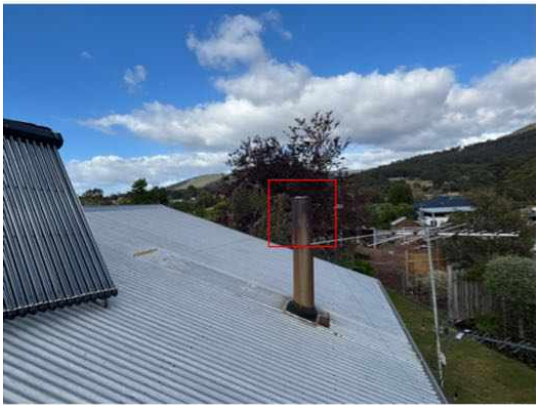
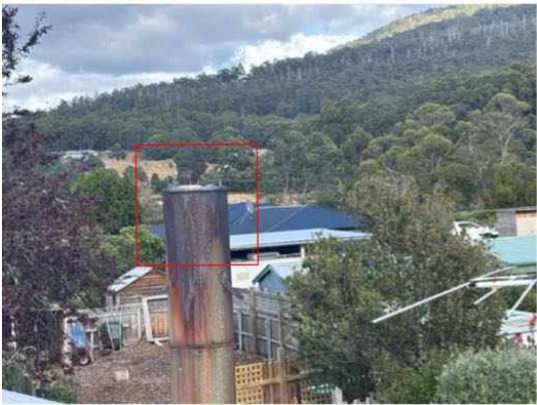
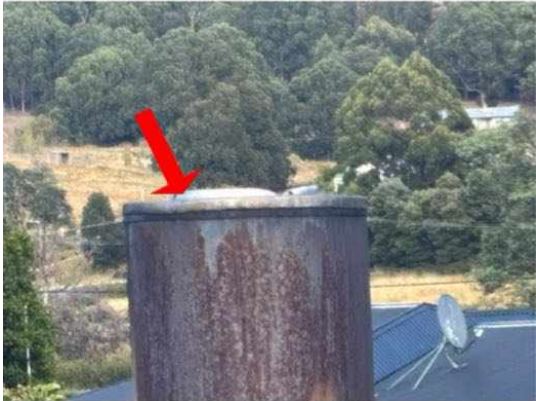
### Defects 3.05

Building: Main Building  
Location: Roof  
Finding: Wood heater flue not capped  
Information: On the roof the wood heater flue has not been capped.

Failure to rectify could allow water and vermin ingress to the interior of the property.

Recommend client engage a Handy Person to rectify as soon as possible.

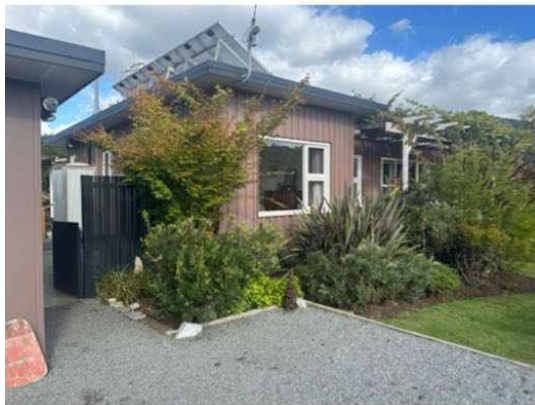
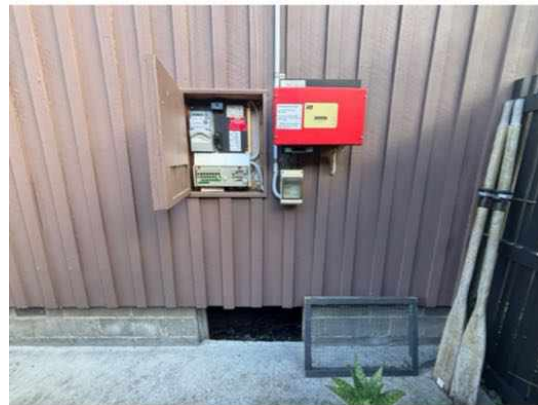
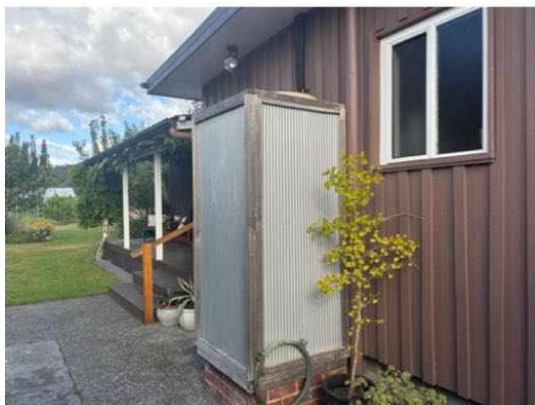
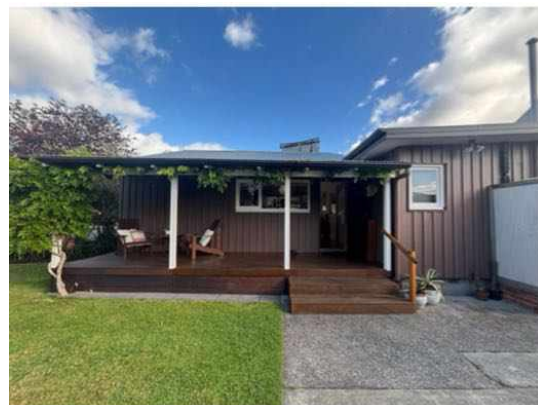
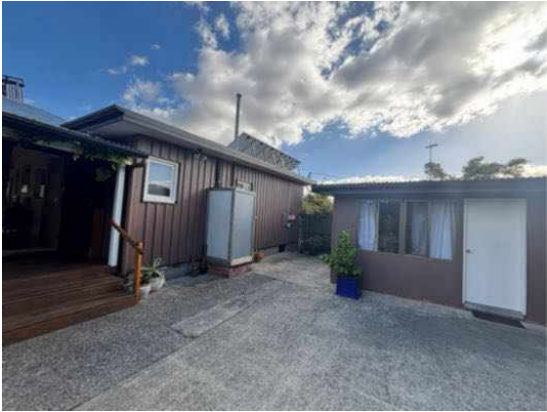
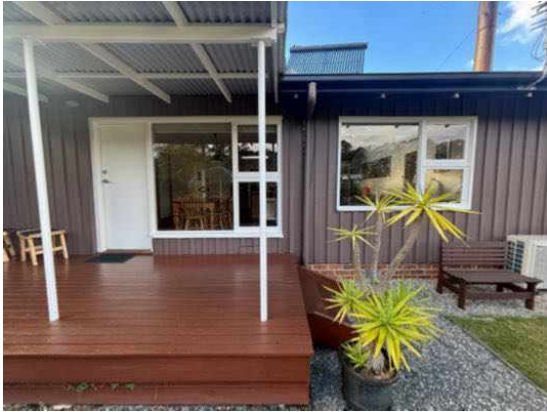
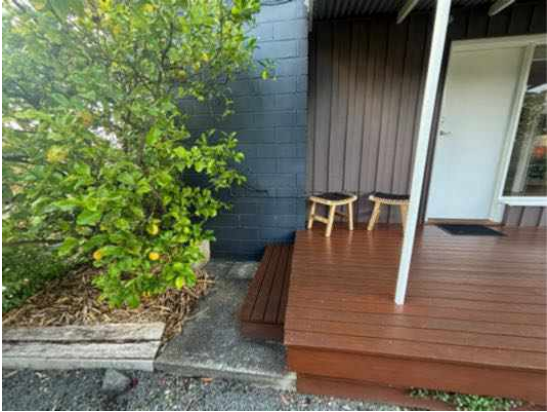
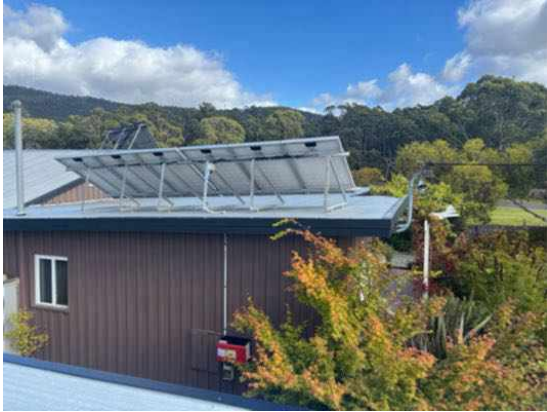
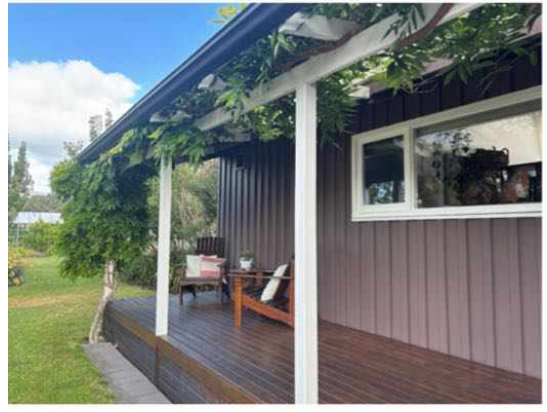
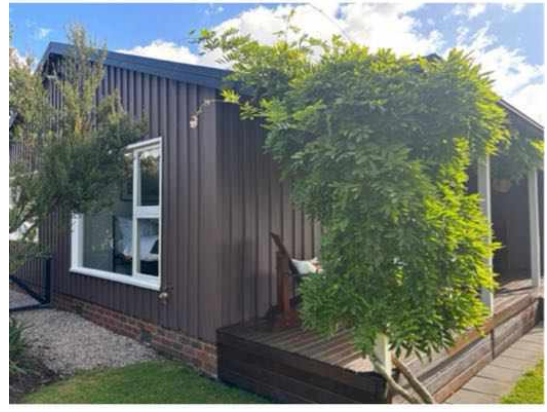
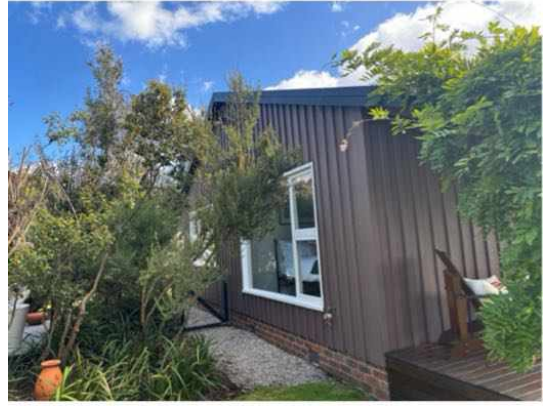
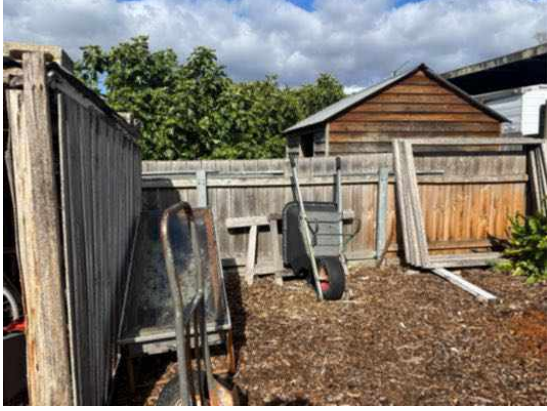
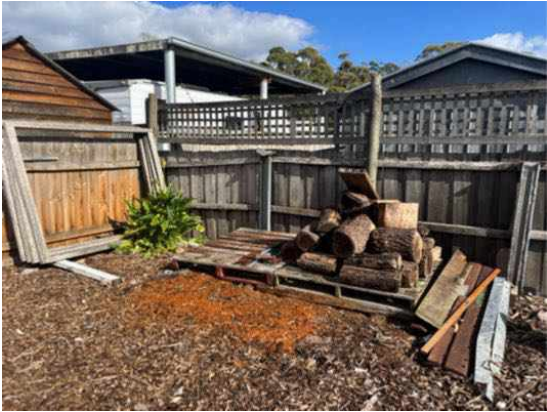
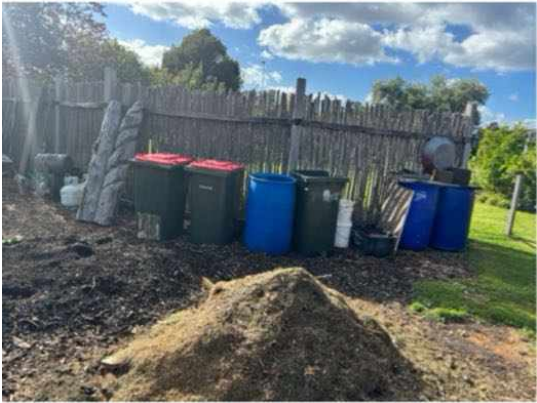
Finding: Additional Photos - Obstructions and Limitations

Information: These photographs are an indication of the obstructions and limitations which impeded full inspection of the property at the time of inspection. These obstructions can hide an array of defects and should be removed to allow full inspection to be carried out. A re-inspection is recommended once the areas are made accessible.

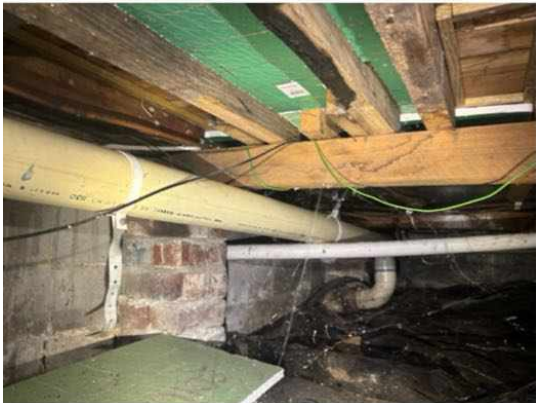
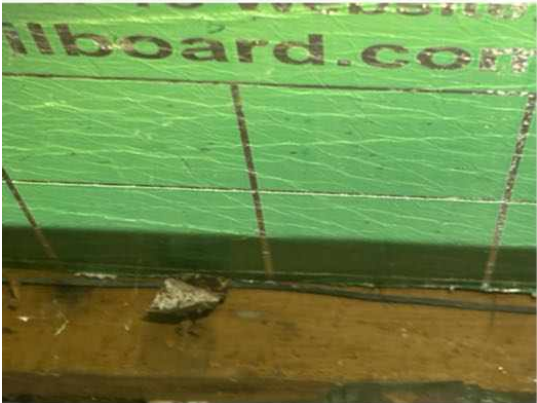
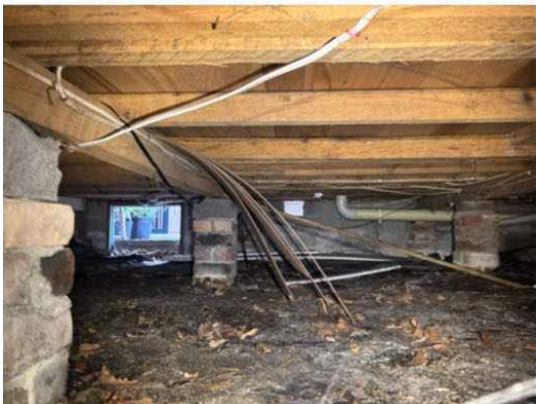
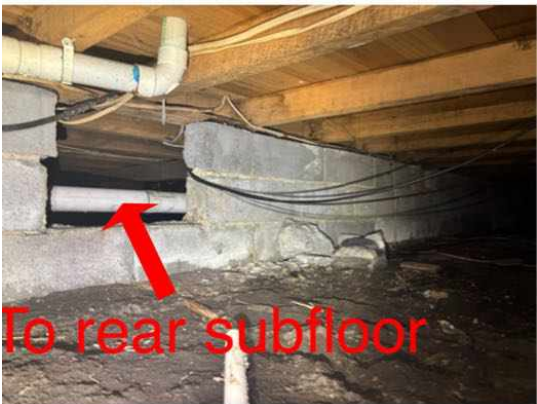
Finding: Additional Photos - Obstructions and Limitations

Information: These photographs are an indication of the obstructions and limitations which impeded full inspection of the property at the time of inspection. These obstructions can hide an array of defects and should be removed to allow full inspection to be carried out. A re-inspection is recommended once the areas are made accessible.

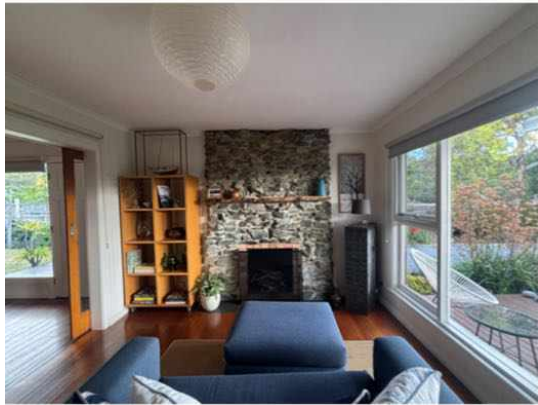
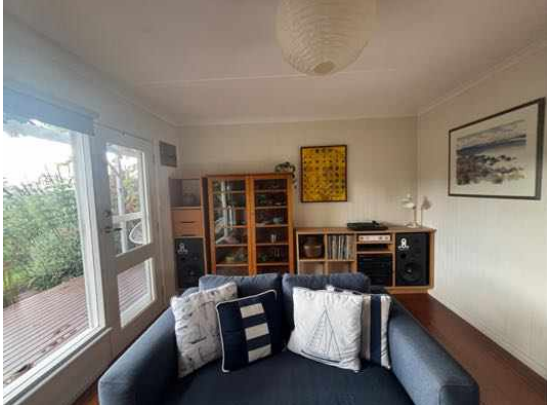
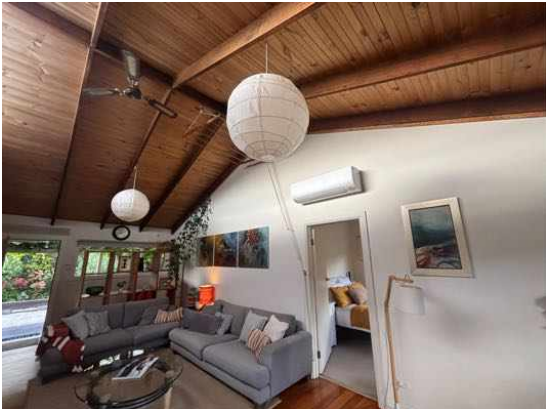
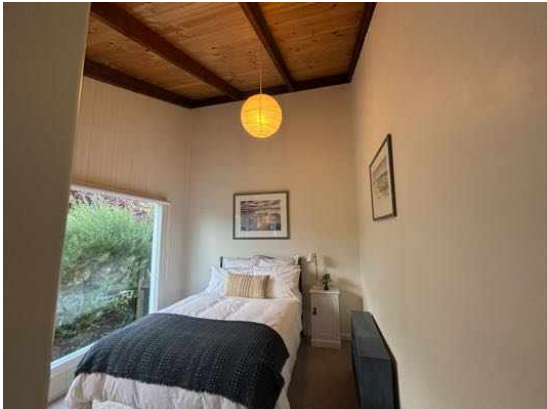
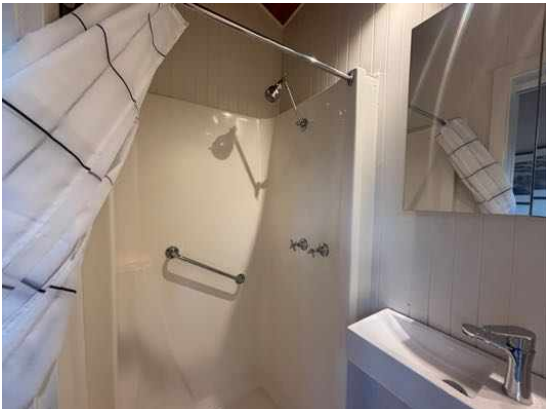
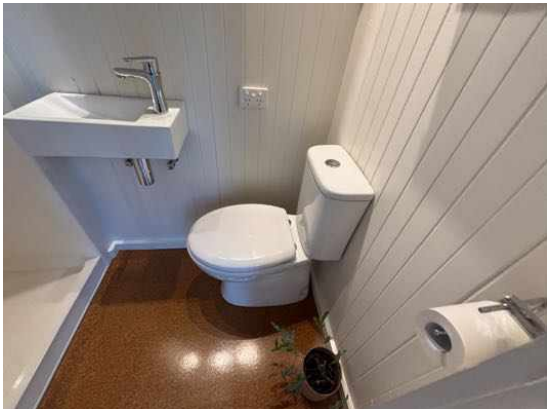
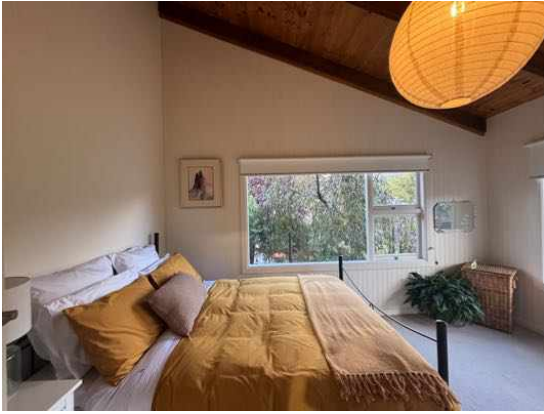
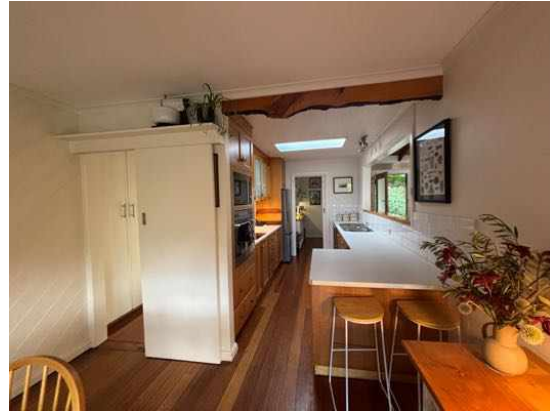
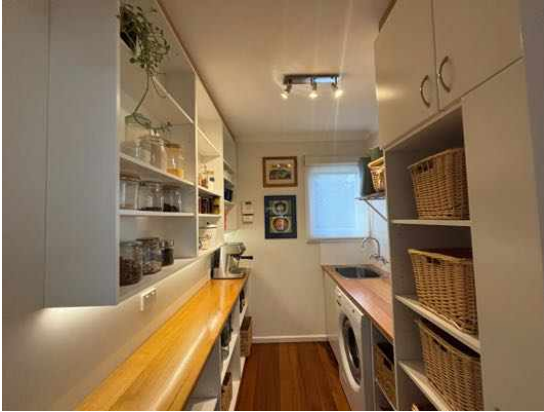
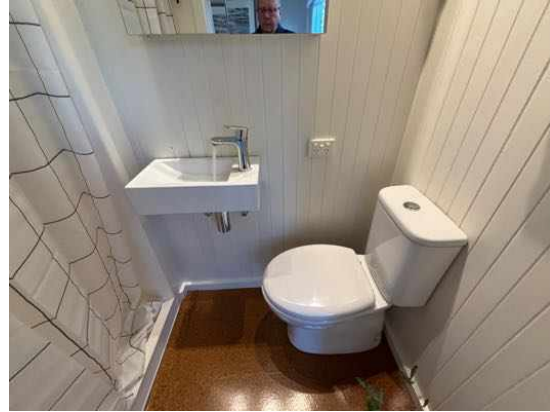
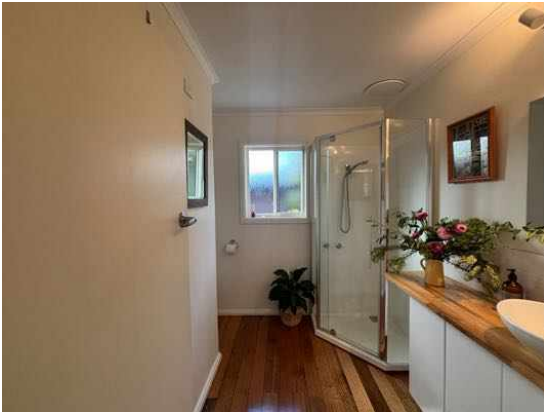
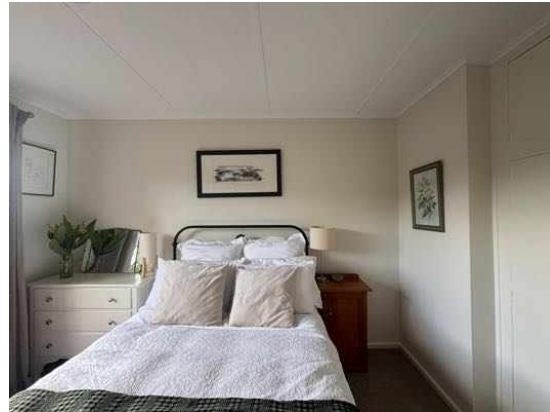
Finding: Additional Photos - Obstructions and Limitations

Information: These photographs are an indication of the obstructions and limitations which impeded full inspection of the property at the time of inspection. These obstructions can hide an array of defects and should be removed to allow full inspection to be carried out. A re-inspection is recommended once the areas are made accessible.

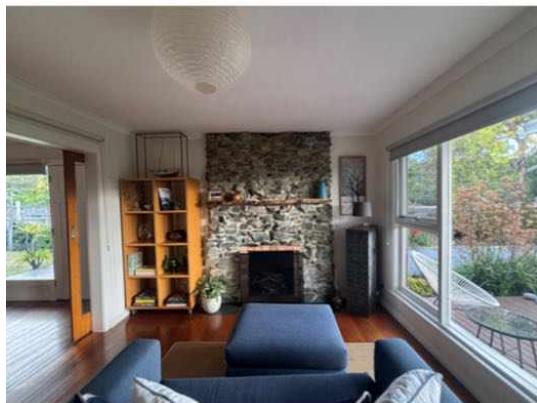
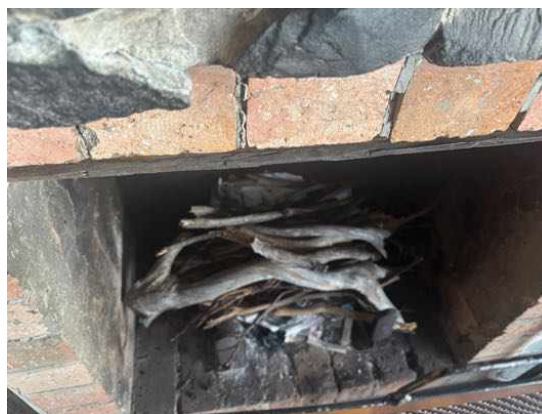
Building: Main Building  
 Location: Lounge  
 Finding: Open Fire Place  
 Information: FYI in the living room there is an open fire place. Inspection of the open fire place is outside the scope of this report. Recommend that the client engage a Wood Heater & Flue Specialist to check the condition of the chimney and to ensure safety before the fire place is used. Open fire places and flues can cause health and fire risks.

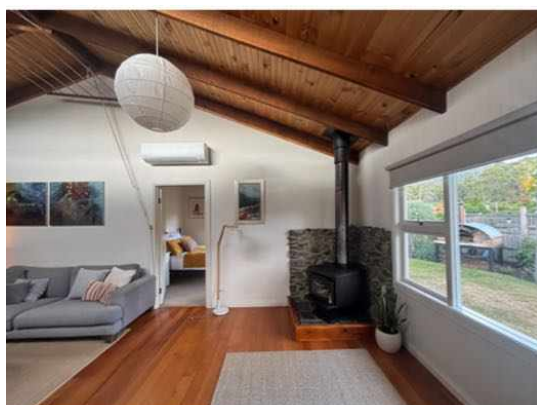
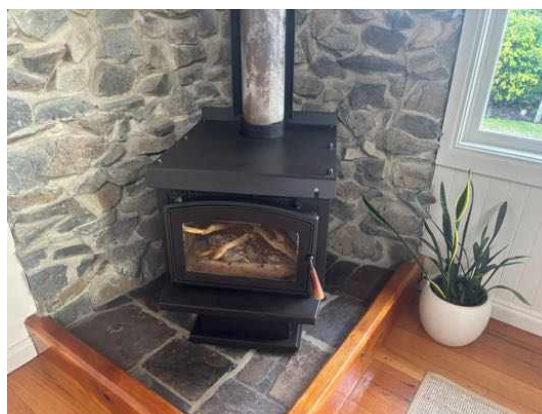
Building: Main Building  
 Location: Living  
 Finding: Wood Heater  
 Information: FYI in the living room there is a wood heater fitted. Inspection of the wood heater is outside the scope of this report. Recommend that the client engage a Wood Heater and Flue Specialist to check the condition of the fire box and flue, to ensure safety before the wood heater is used. Faulty wood heaters and flues can cause health and fire risks.

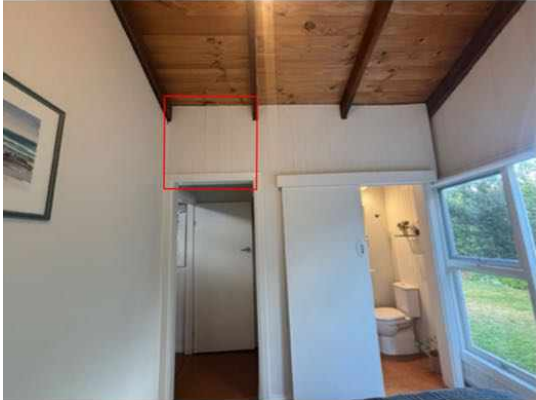
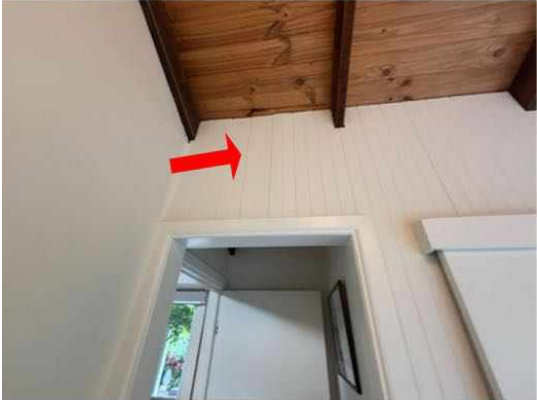
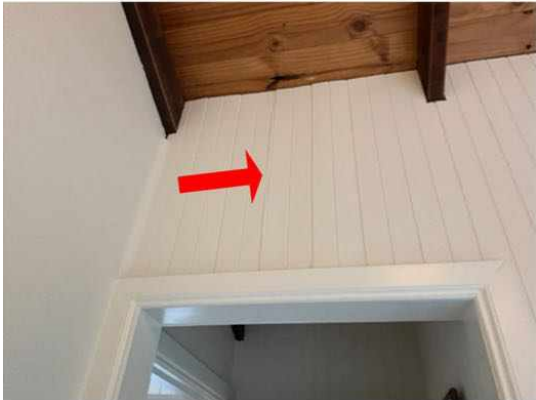
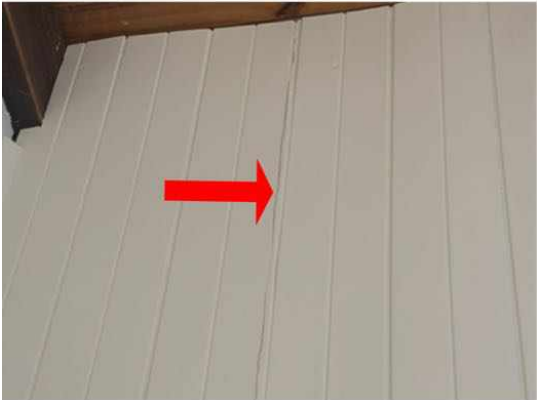
Building: Main Building  
 Location: Back bedroom  
 Finding: Minor cracking  
 Information: FYI There is minor cracking to the cladding in the back bedroom;

These small cracks are cosmetic and likely as a result of shrinkage.

Client could choose to engage Handy Person or painter to prep, paint and repair as clients discretion. Always contact your building inspector as soon as possible, should cracks widen, lengthen, or become more numerous.

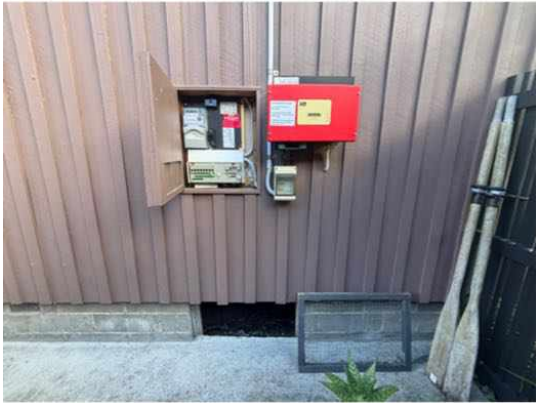
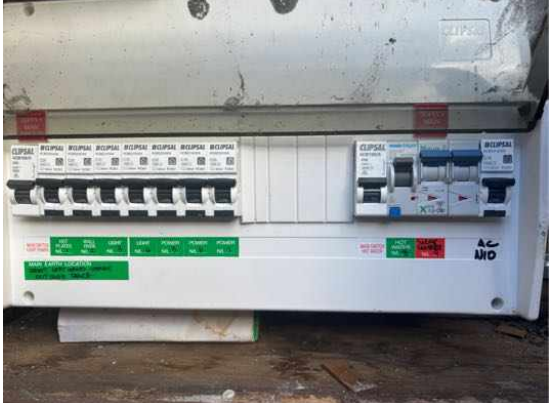
Building: Main Building  
 Location: Switchboard  
 Finding: FYI switchboard  
 Information: FYI the switchboard is updated and has protected circuits.

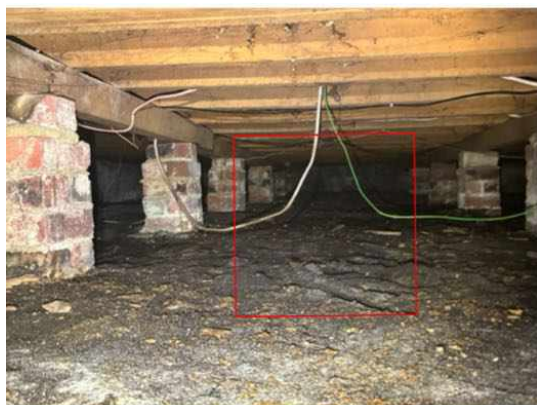
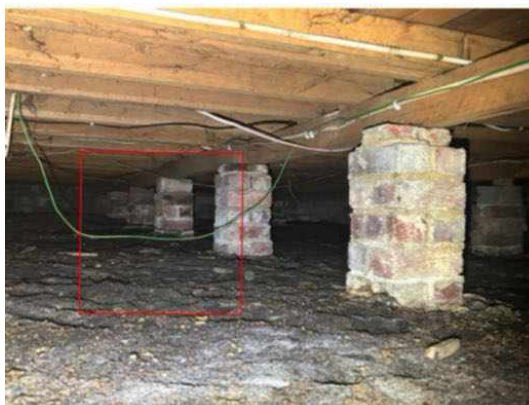
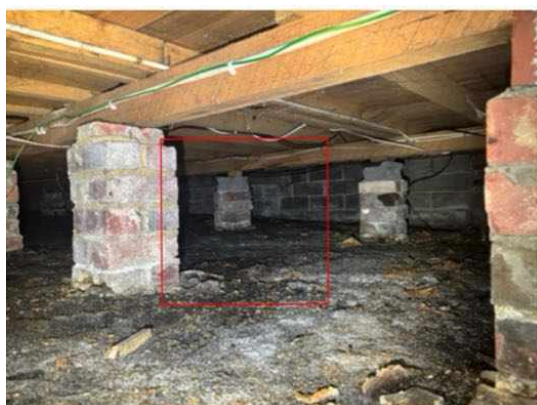
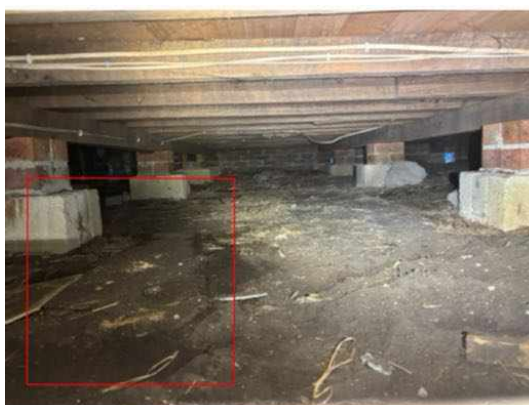
Building: Main Building  
 Location: Subfloor

Finding: FYI dampness  
 Information: FYI there was some minor dampness in some parts of the subfloor. This is most likely due to the subfloor being below the external ground area. However the soil was sandy and it should drain quickly.

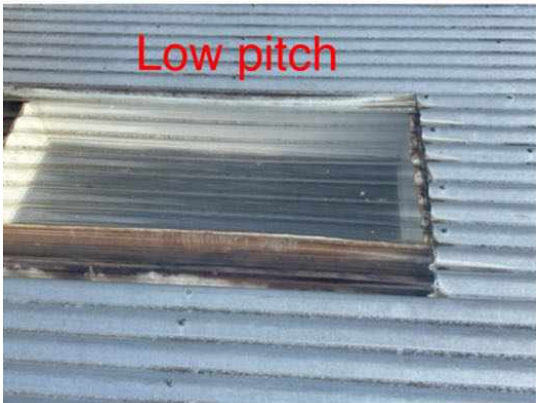
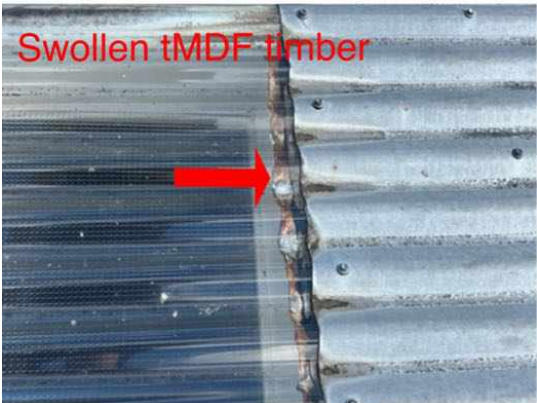
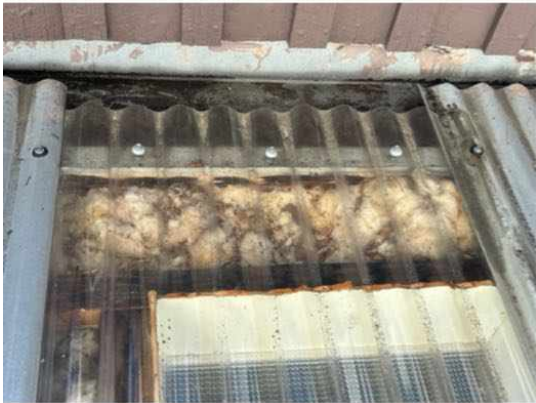
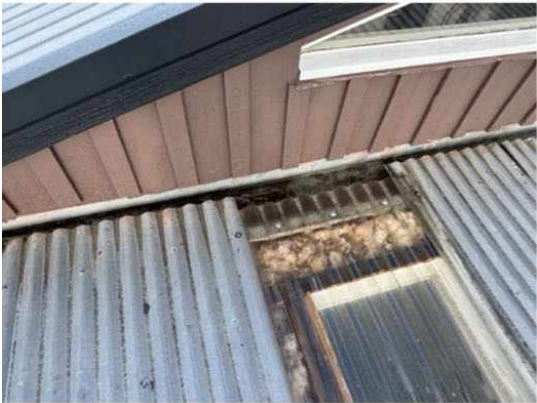
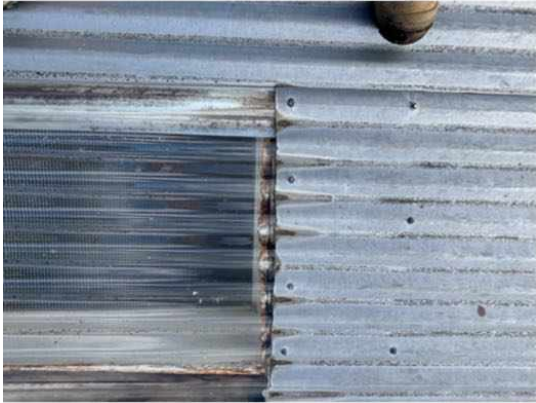
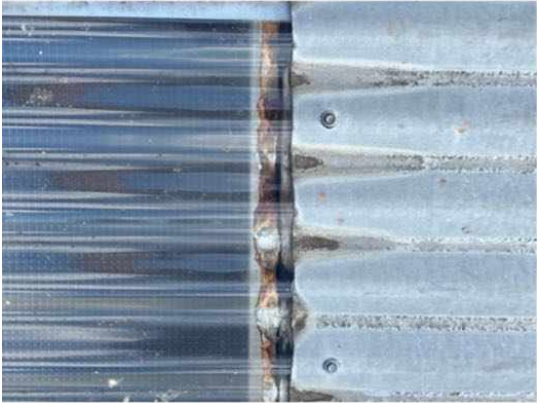
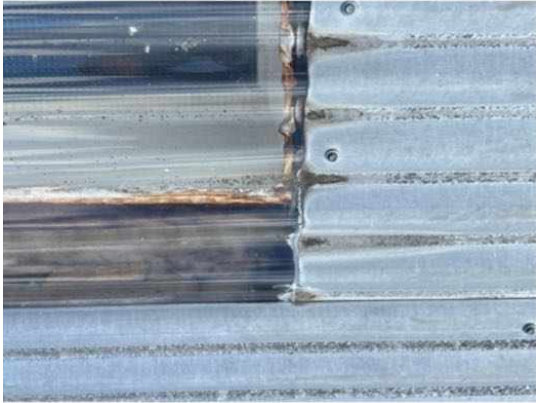
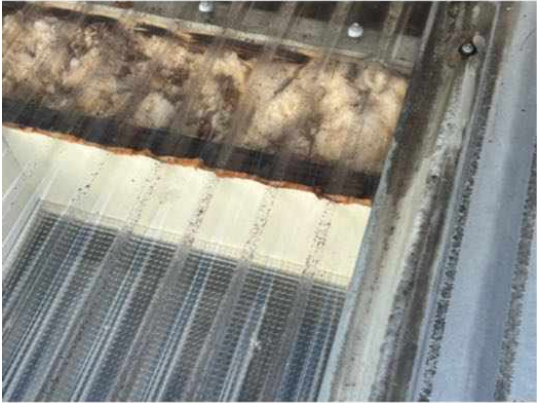
Building: Main Building  
 Location: Roof  
 Finding: Skylight to kitchen  
 Information: FYI the skylight to the kitchen is home made and not a professionally supplied and installed skylight. MDF has been used for the skylight surround and under the laser light, however the MDF material used is not ideal for this purpose. There is some minor water damage/swelling to the timber, most likely from condensation. The pitch of the roof is less than 5 degrees, therefore the skylight is more prone to water leaking and pooling.

Recommend client engage a Lic Plumber/Handy Person to check the skylight on a regular basis to ensure there are no leaks or further deterioration.

If the skylight starts to leak recommend client engage a Lic Roof Plumber or Skylight Contractor to rectify, as soon as possible. They will probably recommend this skylight be replaced, with a professionally constructed skylight with roof flashings to prevent

water ingress.

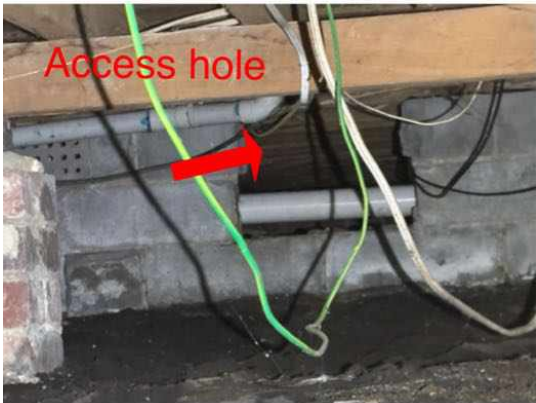
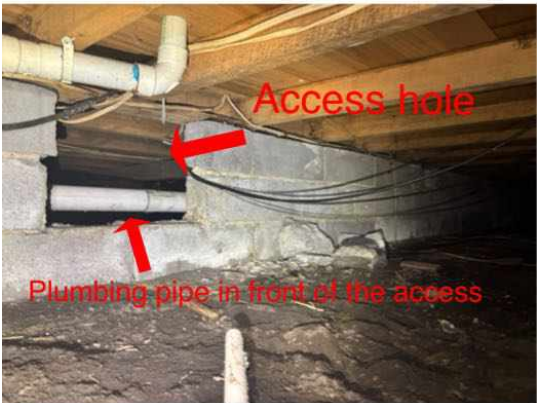
Building: Main Building  
Location: Subfloor  
Finding: FYI subfloor access  
Information: FYI the access to the subfloor at the rear of the house was not accessible. There was a small opening in the brick wall and plumbing pipes running across the area close to the opening.
