Building and Timber Pest Inspection Report VR

Inspection Date: Sat, 21 Mar 2026

Property Address: 8 Jamison St, Maclean NSW 2463, Australia

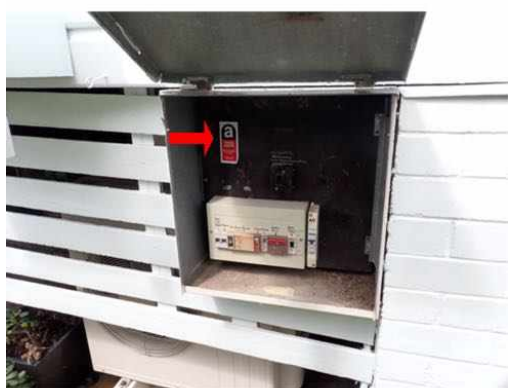
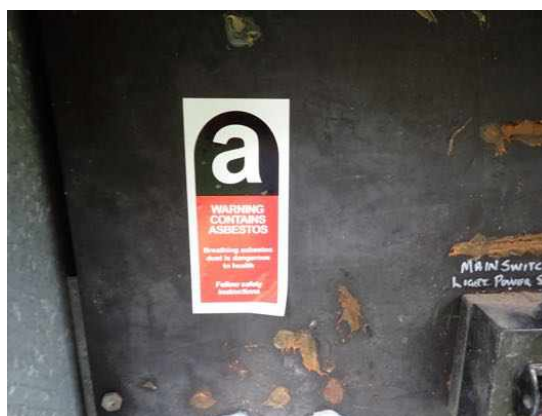
Finding 1.01

Building:	Main Building
Location:	Electrical meter box
Finding:	Asbestos Warning Sticker Identified
Information:	An asbestos warning sticker was identified on site, indicating the possible presence of asbestos-containing materials. No invasive inspection was carried out to confirm the presence or condition of such materials at the time of inspection. If disturbed, asbestos materials can pose a health risk. Further assessment by a licensed asbestos assessor is recommended if works are planned or materials are to be disturbed. No immediate action is required unless disturbance is proposed.

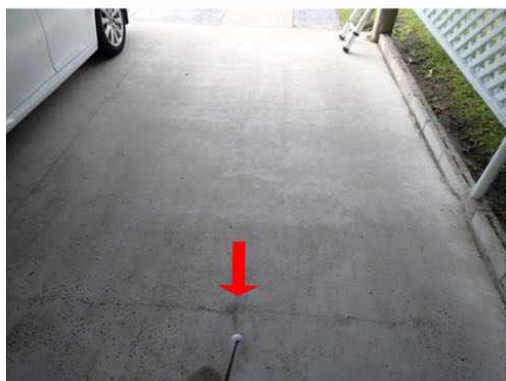
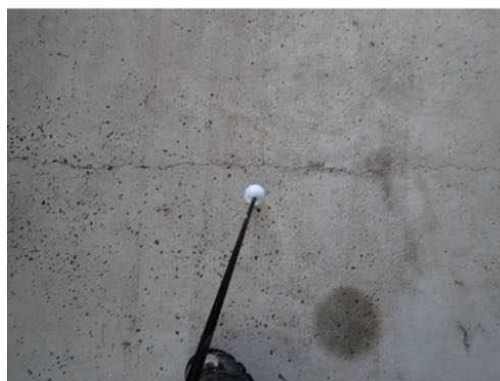
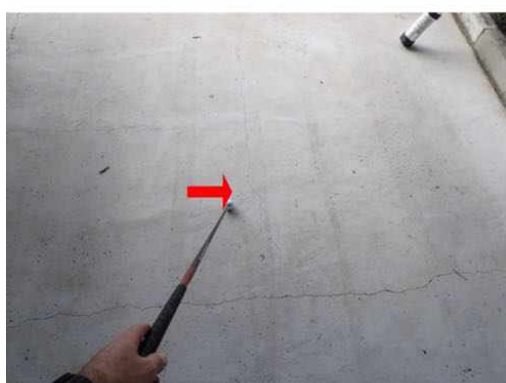
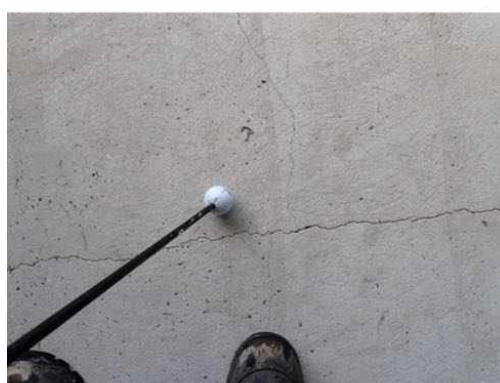
Finding 3.01

Building:	Carport
Location:	Concrete floor
Finding:	Minor Cracks To Carport Concrete Floor
Information:	Minor cracking was identified to the carport concrete floor, likely due to normal shrinkage, settlement, or age-related movement. This is a common condition; however, continued movement or moisture ingress may lead to further deterioration over time. Repairs should be carried out by a suitably qualified concreter if required, including sealing of affected areas. Monitoring and maintenance are recommended as

part of general upkeep.

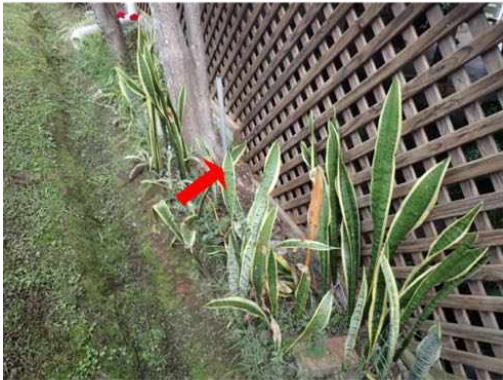
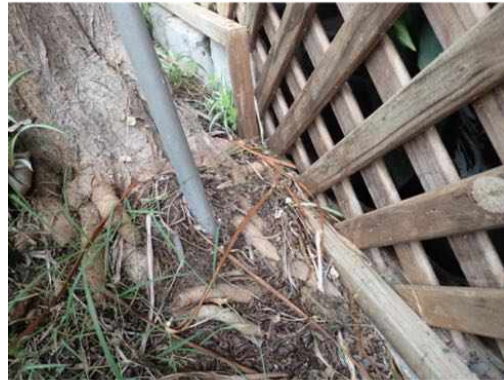
Finding 6.01

Building:	Main Building
Location:	Timber screening right hand side of building
Finding:	Timber Screening In Contact With Ground Conducive To Termite Attack
Information:	Timber screening to the right-hand side of the building was identified in contact with the ground, which is conducive to termite activity by providing direct access and a potential food source. This increases the risk of concealed termite infestation to the structure. Rectification should be carried out by a suitably qualified tradesperson, including separating the timber from ground contact or replacing with appropriate

materials. A licensed pest controller should be engaged to assess and implement termite management measures if required. Repairs and preventative measures are recommended to reduce the risk of termite attack.

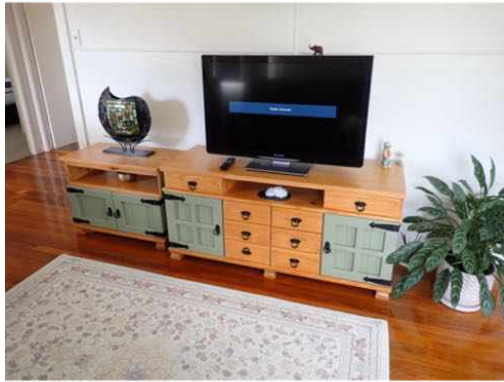
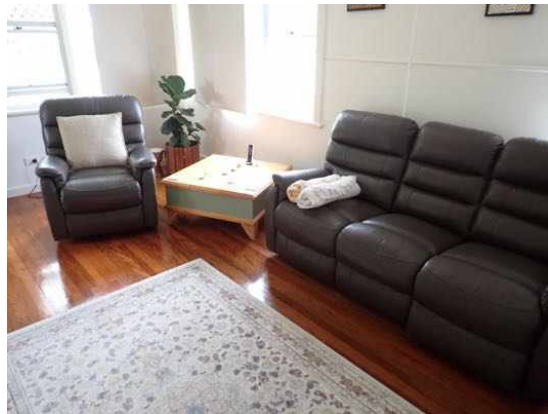
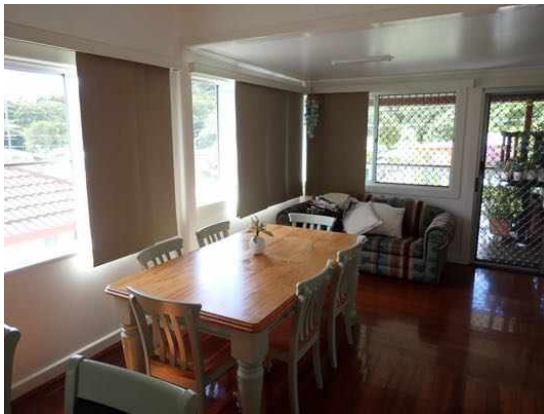
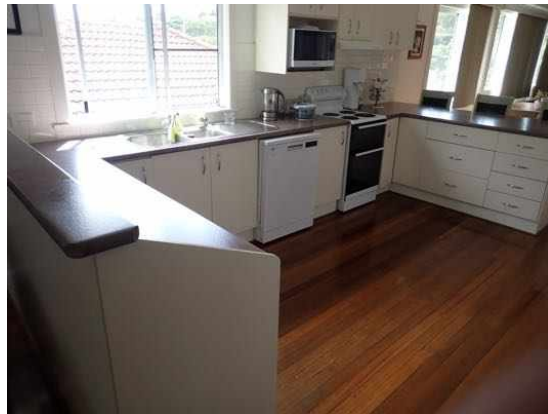
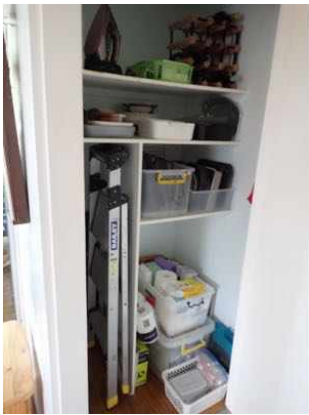
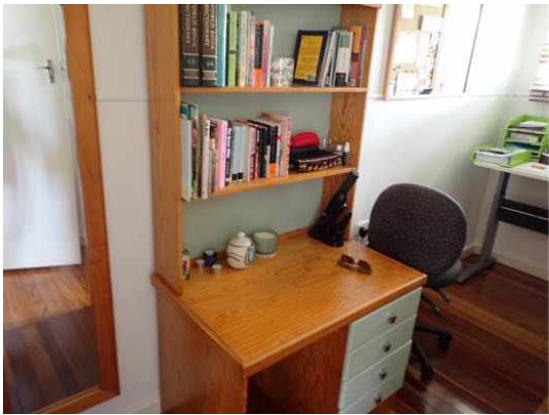
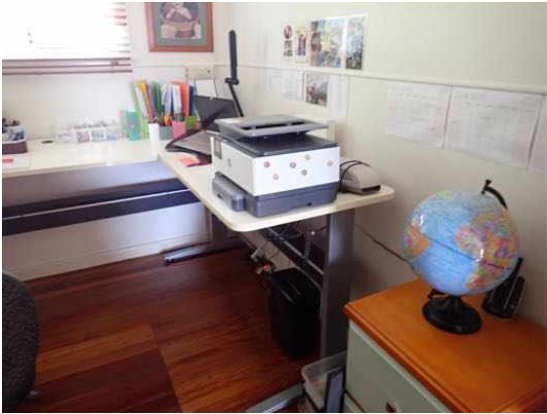
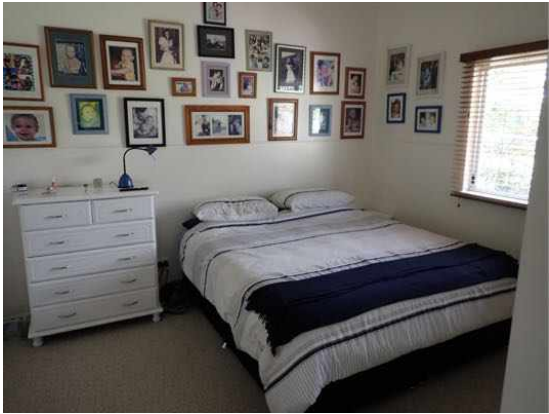
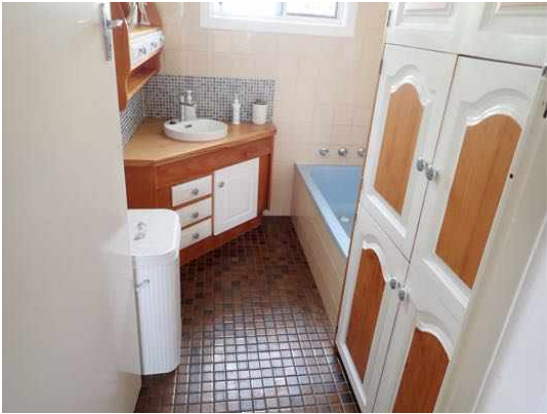
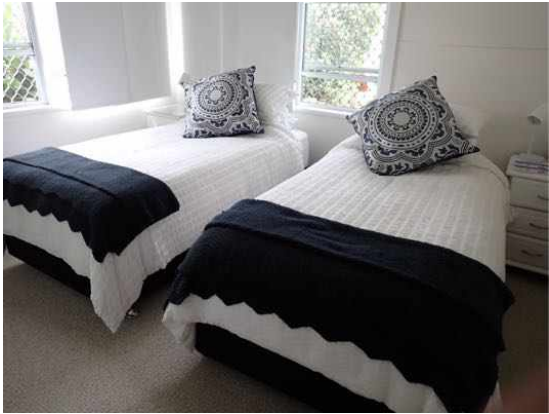
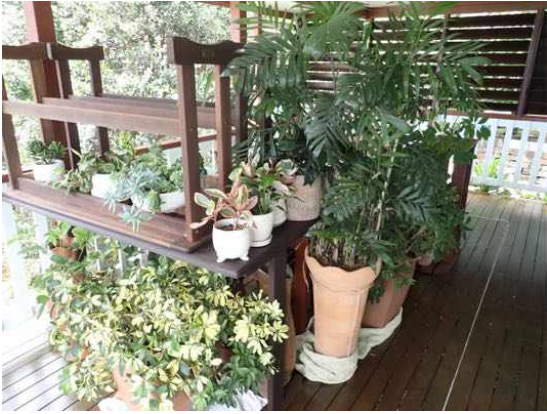
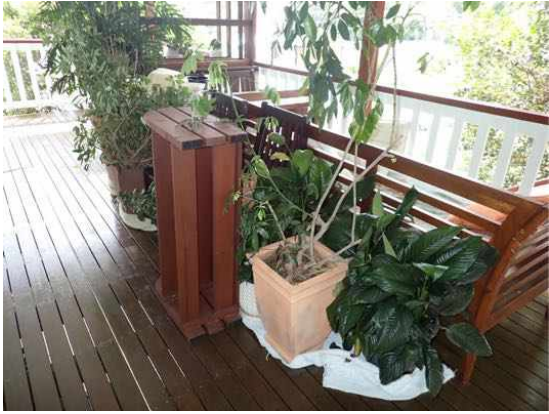
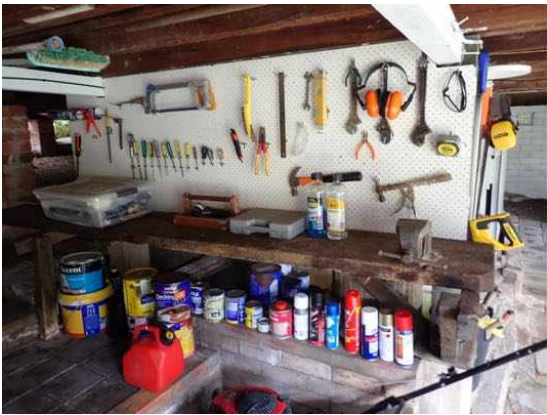
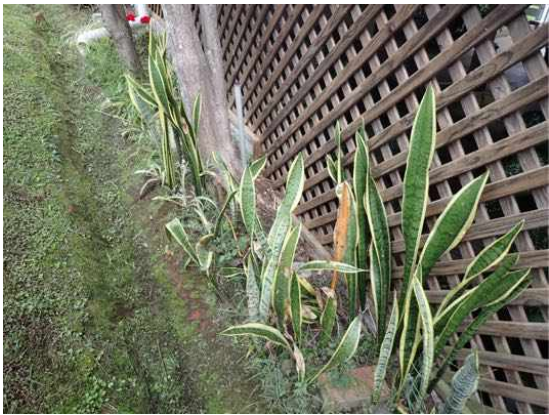
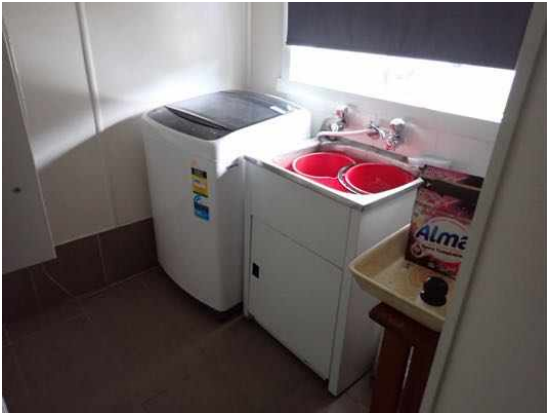
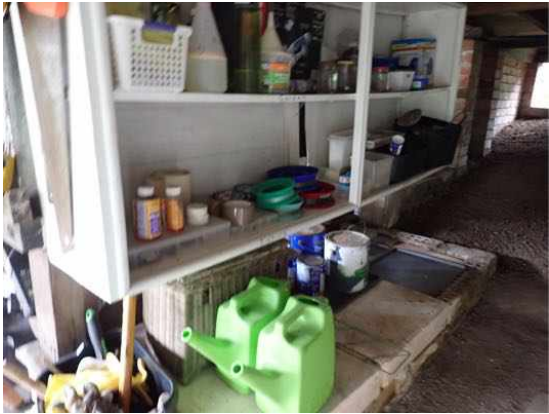
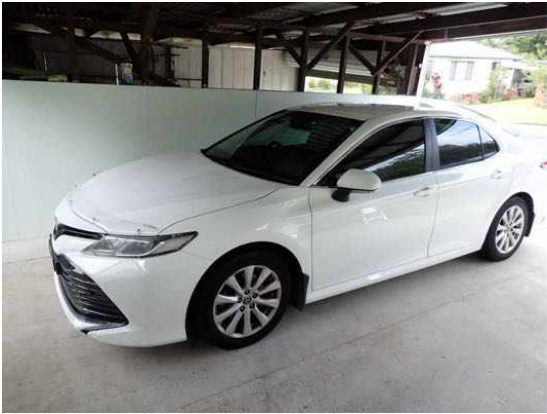
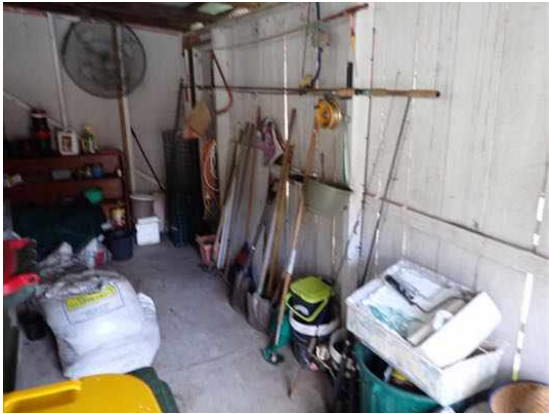
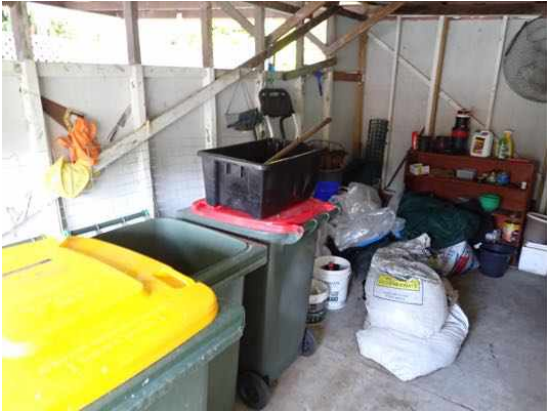
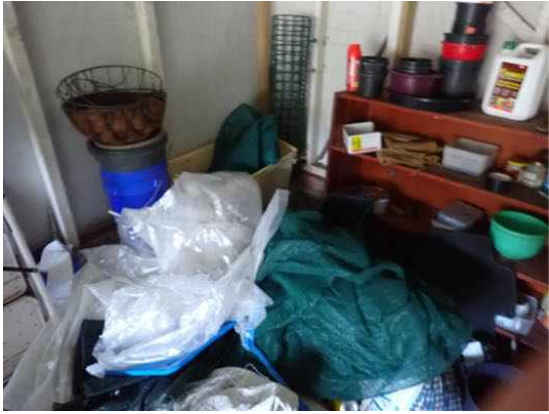
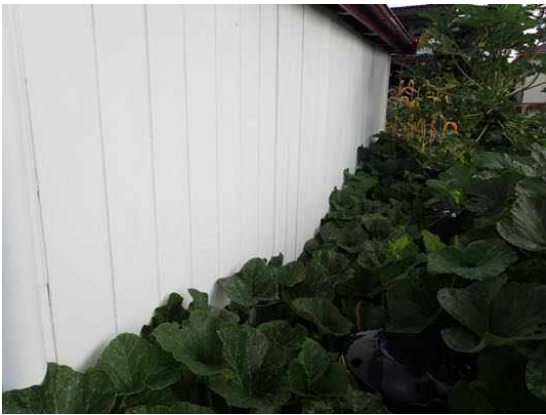
Noted Item

Building: Main Building
Location: All Areas
Finding: Additional Photos - Obstructions and Limitations
Information: These photographs are an indication of the obstructions and limitations which impeded full inspection of the area at the time of inspection. These obstructions can hide an array of defects and should be removed to allow full inspection to be carried out. A re-inspection is recommended once the areas are made accessible.
