# Building and Timber Pest Inspection Report

Inspection Date: Tue, 27 Jan 2026

Property Address: 3 Brushbox Cl, Glenwood NSW 2768,  
Australia

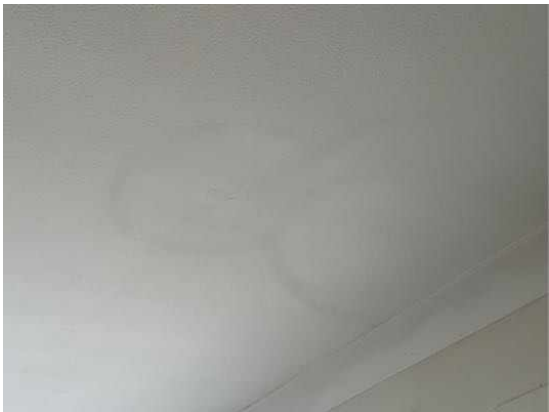
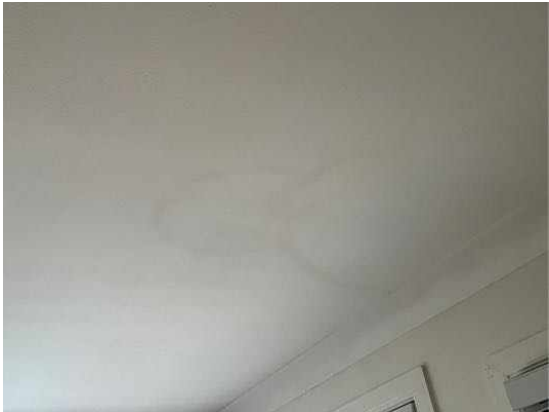
Finding: Water staining

Information: Water staining was evident in this area at the time of inspection. Water staining indicates that surfaces have been exposed to excessive moisture over time. The minerals and other elements in the water lead to staining, which may graduate to corrosion and deterioration if left unmanaged.

water staining can be indicative of more serious defects, which may be currently concealed by other building elements.

Where water staining is active, a licensed plumber must be consulted to identify the cause of the staining and to provide advice on any repair work that may be required. Replacement of any broken or damaged structures is advised.

Conversely, where water staining is old and inactive, affected building materials may be repaired or replaced at client discretion. A qualified carpenter or registered builder may be appointed to perform these works.

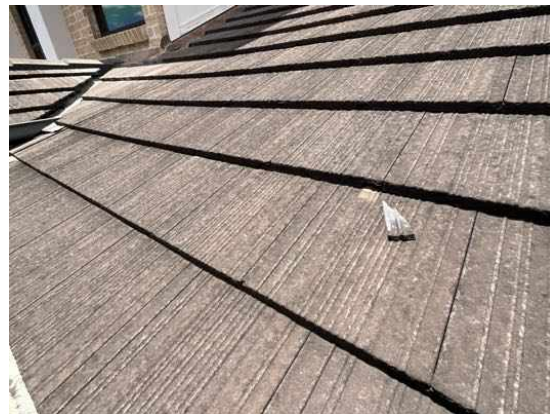
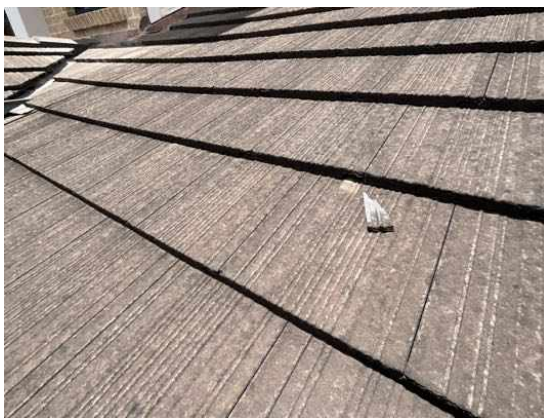
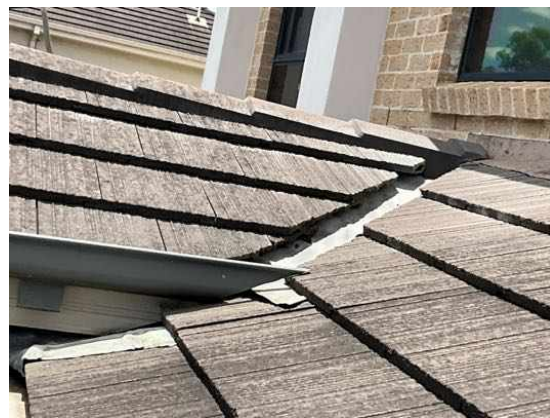
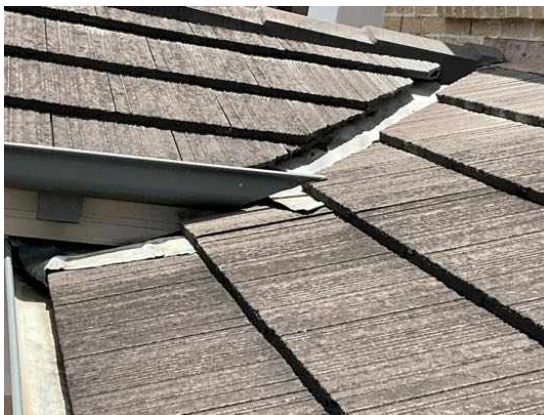
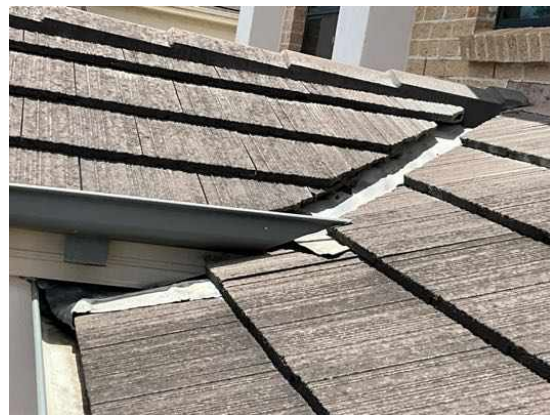
**Finding 3.01**

Building: Main Building  
Location: All Areas  
Finding: Roof Weathered  
Information: Upon inspection of the exterior roofing, the majority of roof was not in a fair condition. While weathering of the roof is consistent with the age of the property, maintenance works are required.

Isolated areas of mortar have come loose in the valleys and minor cracking is also present. Re-pointing and re-sealing the may be considered as an interim solution by the client to help preserve and extend the life span of the tiles.

Where left unmanaged, deteriorating roof are likely to lead to a number of secondary defects, including minor water leaks and weather exposure to internal roofing structures.

Consultation with a roofing contractor is highly advised to gain advice on cost of remedial works that may be required in the short to medium term. Remedial works are likely to increase the longevity of the exterior roofing structure.

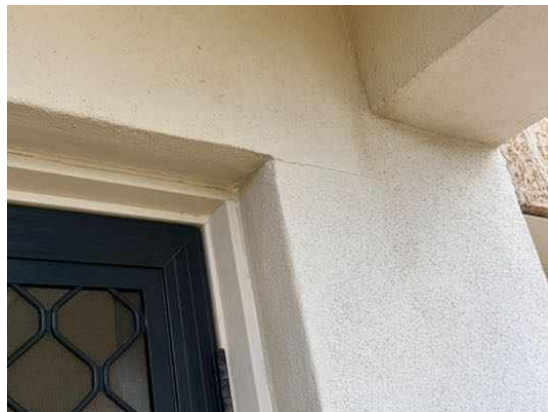
Finding: Brickwork - Cracking [Fine]

Information: Although fine cracks are quite noticeable, they are often only considered to be an appearance defect and usually do not indicate any structural damage. Generally, the cause of a fine crack is indicative of a separation between brickwork and mortar throughout the structure, but single bricks may also show cracks of this nature.

Cracking of this nature can generally be repaired with minor filling and should be conducted by a qualified bricklayer.

Always contact a building inspector should cracks widen lengthen or become more numerous.

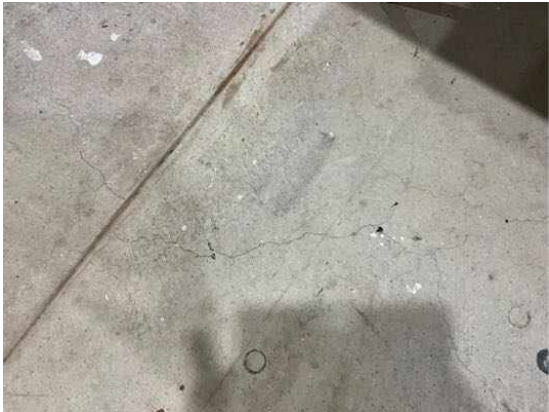
Finding: Crack in concrete slab - Category 0

Information: A crack coded as Category 0 was identified in the slab. A Category 0 crack is described as a hairline crack, representing insignificant movement of slab from level.

The approximate width of the crack to be considered Category 0 is 0.3mm, or change in offset of less than 8mm when a 3m straight edge is placed over the defect.

No rectification is required at this time. However, all cracking should be monitored over a 12 month period to identify any further damage in the area.

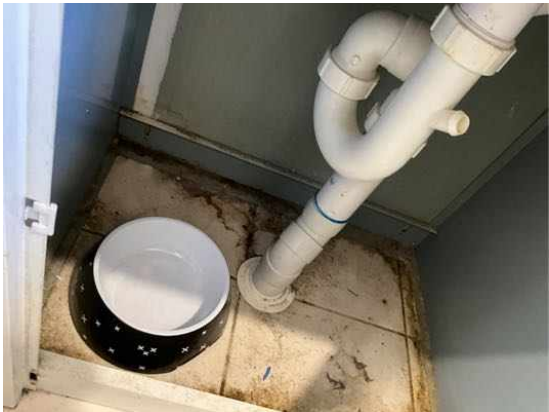
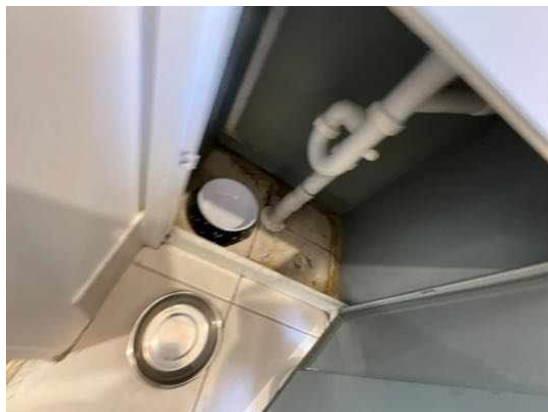
**Finding 3.09**

Building: Main Building  
Location: Laundry  
Finding: Water Stains in Vanity  
Information: "Water stains observed in the vanity area, compromising its appearance and potentially causing damage."

Continued water exposure may lead to material damage, mold growth, and diminished aesthetic appeal.

A licensed plumber or maintenance professional should assess and fix any leaks contributing to the water stains, while a cleaning or restoration service may be needed to address the visible stains and prevent further damage.

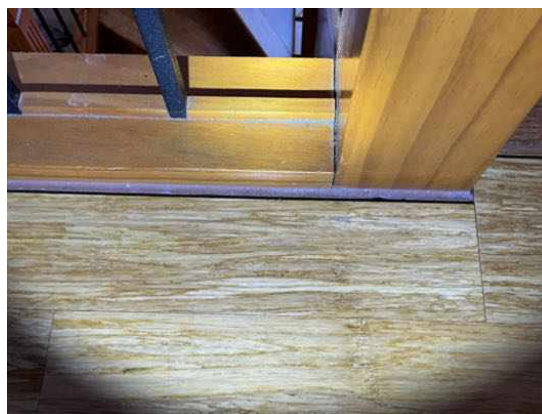
### Finding 3.10

Building: Main Building  
 Location: Upstairs  
 Finding: Timber flooring - Gaps  
 Information: Gaps have developed in the timber flooring, creating spaces between the individual floorboards.

The gaps pose a tripping hazard and can accumulate dirt and debris, affecting the aesthetic appeal of the flooring. Additionally, exposure to moisture or changes in humidity may exacerbate the issue, potentially leading to long-term damage.

A flooring specialist should inspect and address the gaps in the timber flooring. The professional can employ appropriate techniques, such as filling, sealing, or adjusting the floorboards to ensure a safe and aesthetically pleasing floor surface.

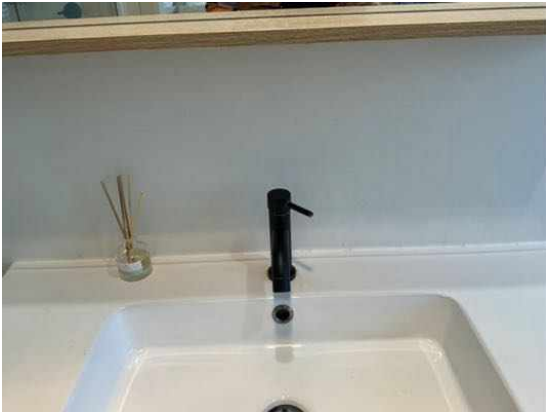
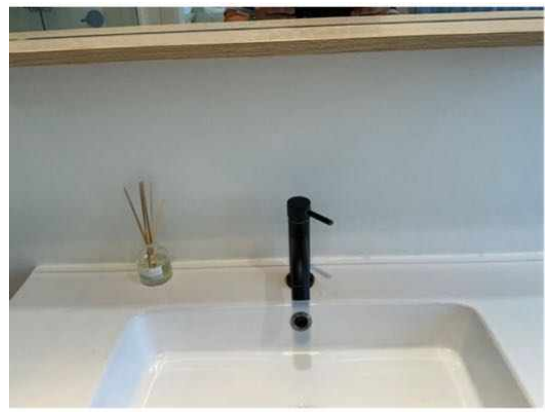
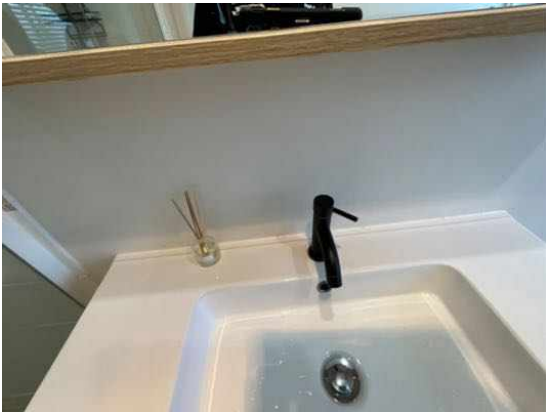
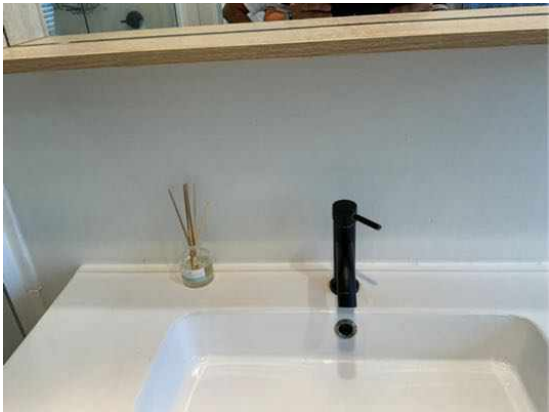
Building:	Main Building
Location:	Bathroom & en-suite
Finding:	Splashback Missing- Washbasin / Vanity
Information:	No splashback was installed behind the washbasin/vanity. The wall-bench junction is exposed, with painted wall lining (gyprock) directly behind the basin.

Water splash may directly affect the wall lining, leading to moisture penetration, damage to gyprock, deterioration of finishes, and potential mould growth over time.

A suitable splashback and waterproof sealant should be installed by a licensed plumber or bathroom contractor to protect the wall lining from water exposure.

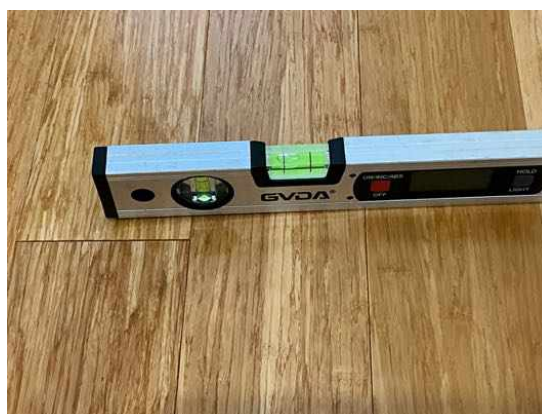
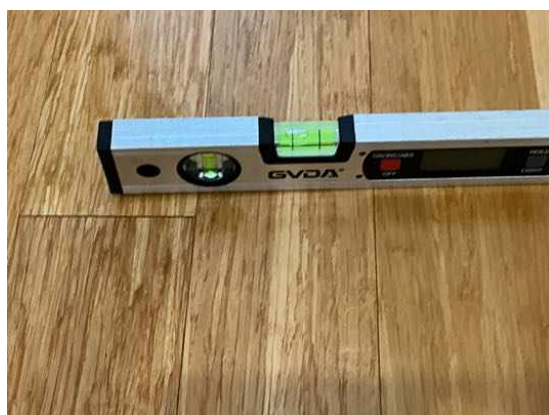
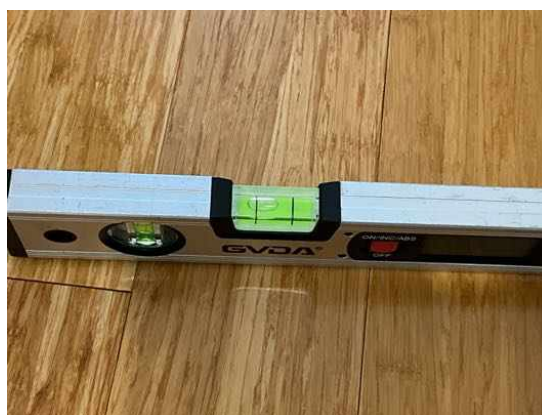
Finding 3.14

Building: Main Building  
 Location: Upstairs  
 Finding: Timber Flooring - Uneven  
 Information: The internal flooring in this area is out of level and uneven. Uneven flooring is likely to indicate minor defects may be caused by friction or impact.

It is advised that the flooring be closely monitored to identify any further movement or changes. If the flooring remains relatively unchanged for an extended period (i.e. several months), the current minor defects can be addressed through surface repair. Should the unevenness worsen, further assessment and corrective actions on the flooring will be necessary to prevent continued damage.

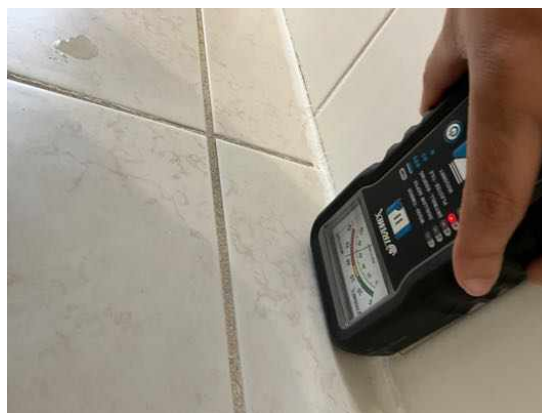
Building:	Main Building
Location:	Ensuite
Finding:	Shower - Damp
Information:	Damp is evident to the lower 300mm of wall to the shower alcove. This defect is quite common, and is suspected to have been caused by moisture permeating through the grouting in this area, which shows evidence of deterioration. Leaking pipes within the adjoining wall is also a possible cause.

Damp (or structural damp) refers to the presence of unwanted moisture in the structure of a building, either as the result of intrusion from outside, or condensation from within the structure. In the shower area, internal water leaks or other sources of excessive moisture are generally the cause of damp.

Unmanaged damp in the shower recess is likely to facilitate the formation and development of mould and fungi growth, decaying associated building materials and compromising their structural integrity. It is important to address damp conditions, as the World Health Organisation notes that excess moisture leads - on almost all indoor materials - to growth of microbes such as moulds, fungi and bacteria, which subsequently emit spores and other matter into the indoor air. Exposure to these contaminants is associated with a wide range of respiratory and other health-related problems.

Consultation with a qualified plumber or bathroom specialist is advised immediately to identify the cause of damp and to perform remedial works as required. Where excessive mould growth is present, further inspection by a specialist environmental

health inspector should also be considered.

Always ensure that sealant and grout is in good condition to prevent any moisture issues occurring in the future.

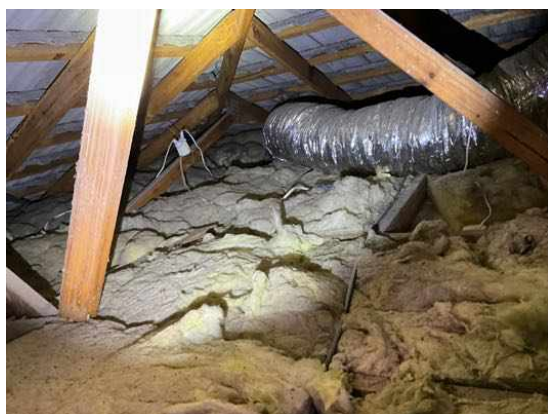
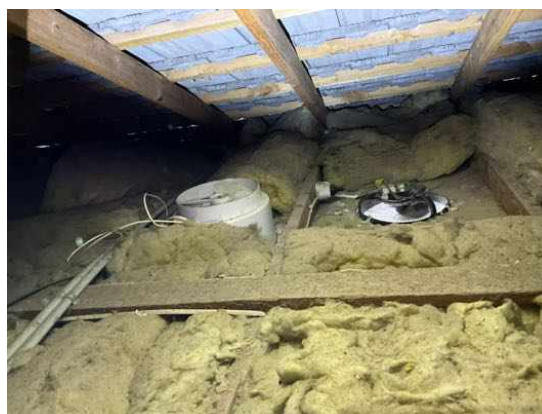
### Finding 3.17

Building:	Main Building
Location:	Roof Void
Finding:	Insulation - Covering downlights
Information:	Sections of insulation in the roof void have been poorly installed or moved from their original position and are covering down light fittings. While the down lights have been fitted with appropriate protective covers, the presence of this insulation creates a potential fire hazard.

Any insulation within the vicinity of down light fixtures should be moved and re-applied to more appropriate sections of the roof void, thus ensuring the area is fire-safe. An insulation contractor should be appointed as soon as possible to perform any necessary works as required.

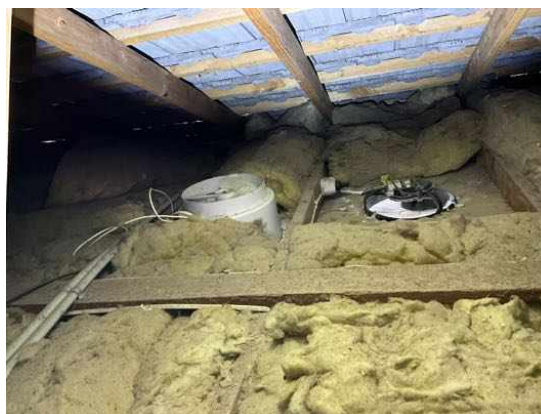
### Finding 3.18

Building:	Main Building
Location:	Roof Void
Finding:	Exhaust fan not vented out
Information:	The exhaust fan located within the roof void is not appropriately ducted to the external atmosphere and is currently discharging moist air directly into the roof space. This is considered a defect under AS 4349.1, as it does not meet the minimum standard of residential building performance expected under normal residential building practices.

This condition may lead to excessive condensation within the roof void, increasing the risk of mould growth, deterioration of insulation, timber decay, and overall reduced durability of building elements. It may also result in poor indoor air quality, potentially affecting occupant health.

It is recommended that the exhaust fan be modified by a licensed HVAC contractor or qualified builder, ensuring it is properly ducted to discharge externally in accordance with manufacturer specifications, the National Construction Code (NCC), and applicable Australian Standards.

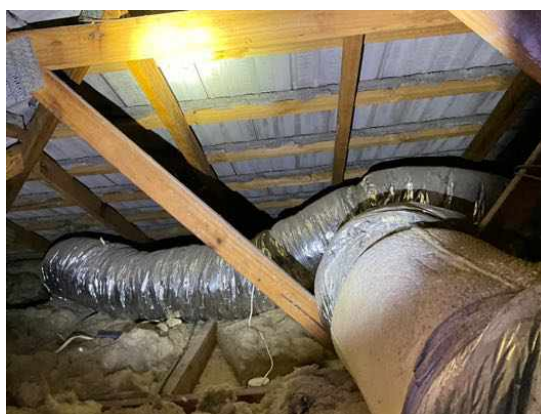
### Finding 3.19

Building:	Main Building
Location:	Roof Void
Finding:	Sarking - Missing
Information:	Sarking is missing under the roof sheeting. Sarking acts as an insulator that helps with noise reduction and protects against water penetration. Sarking plays a key role in the operation and function of the overall roofing structure and its performance.

Although not a requirement at the time of construction, replacement of any missing building element is advisable (although this can be quite expensive to do after the time of construction). Where sarking is missing, regular inspections of the roof tiles for cracking and potential moisture penetration is required.

Sarking may be retrospectively fitted by a registered builder at the discretion of the client.

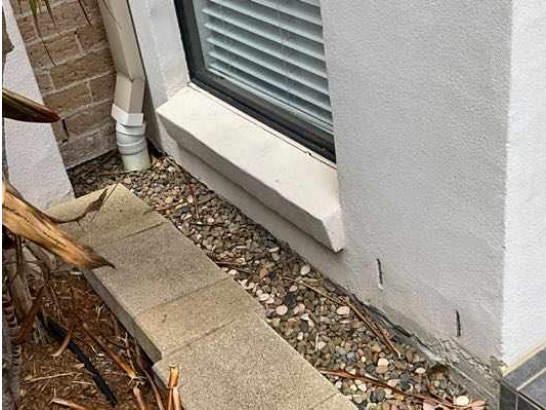
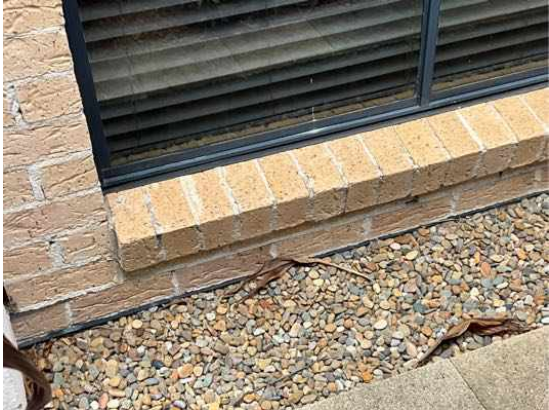
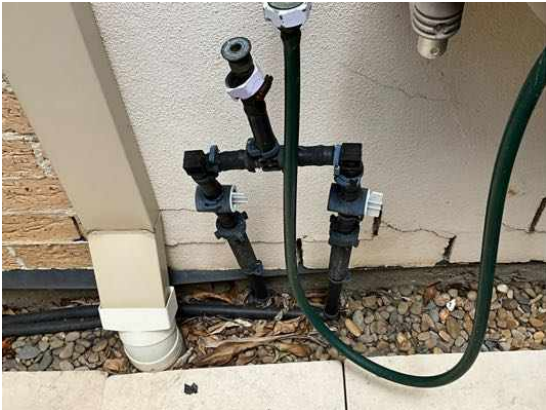
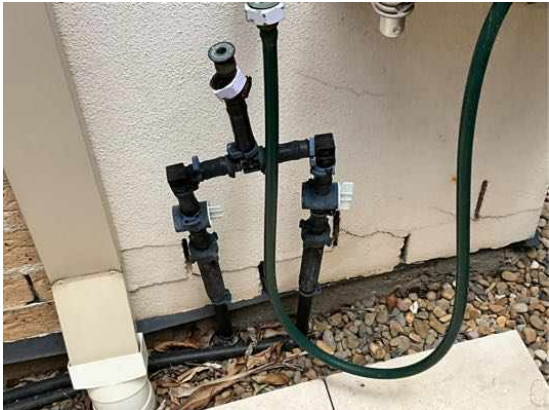
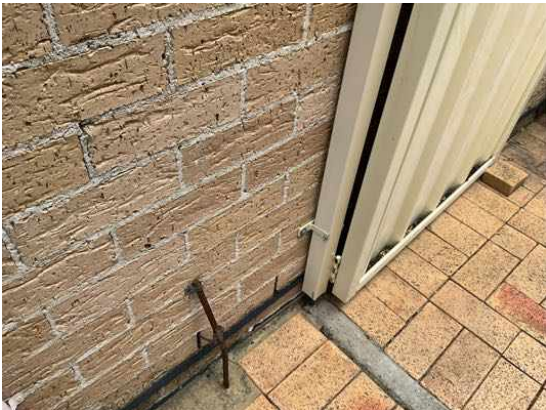
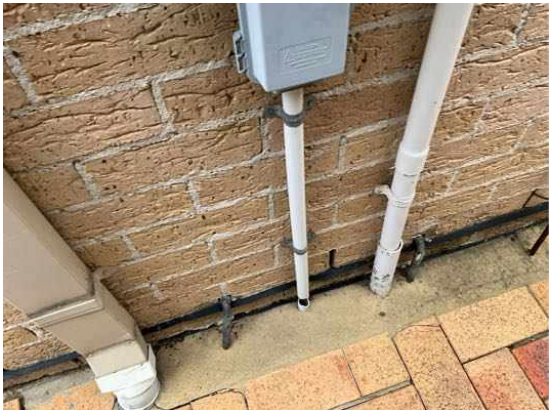
If the slab edge is not properly exposed there is a high risk of termite attack. Sometimes, in order to determine the type of slab, a suitably qualified person such as an architect or builder may be required to consult the construction plans.

Where the slab edge cannot be properly inspected, it is highly recommended that termite or timber pest inspections be carried out every 6-12 months to aid protection of the property against infestation.

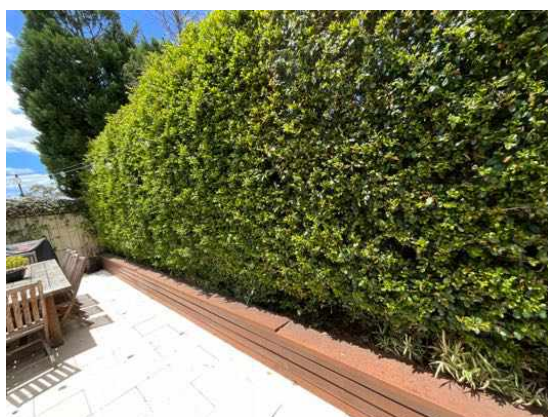
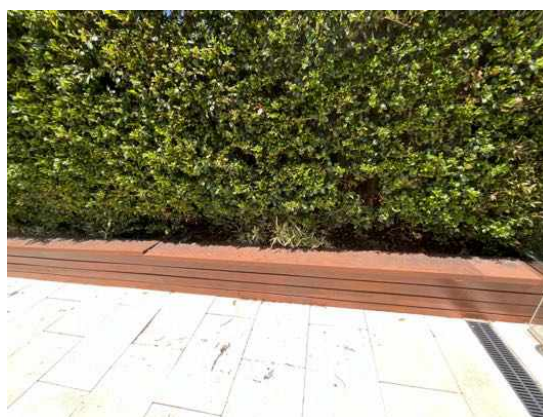
Building:	Main Building
Location:	All Areas
Finding:	Timber on ground / conducive conditions to termite damage

Information: Timber on the ground is indeed conducive to termite damage. Termites are known to thrive in moist environments, and wood in contact with soil or moisture is more susceptible to infestation.

To prevent this, it's important to keep timber elevated and away from direct ground contact. Regular inspections and proper termite control measures are also essential to protect your wooden structures from termite damage.
