Building and Timber Pest Inspection Report

Inspection Date: Tue, 3 Feb 2026

Property Address: 551 Fox St, Lavington NSW 2641, Australia

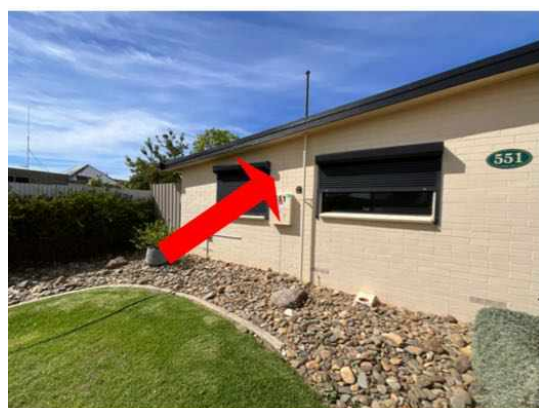
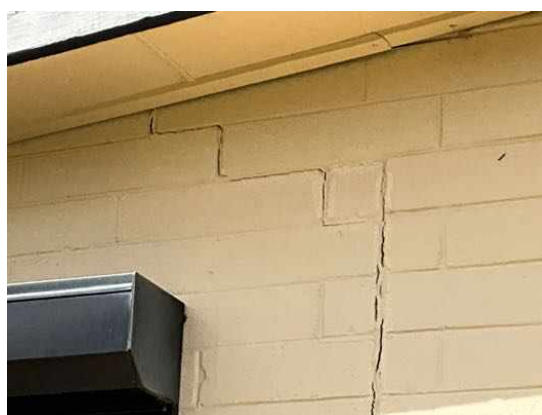
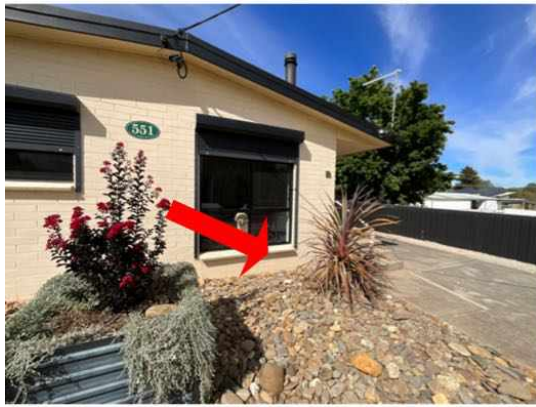
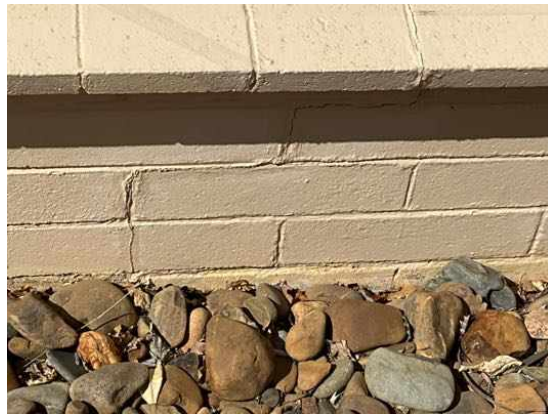
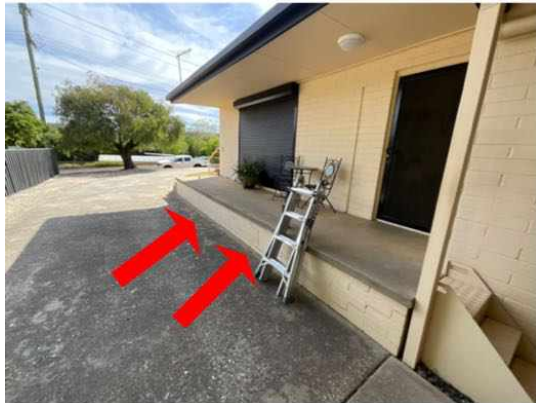
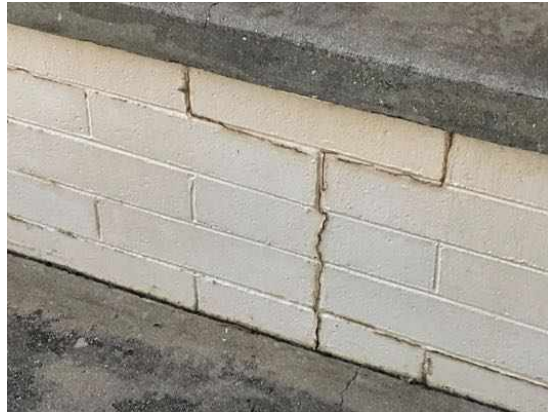
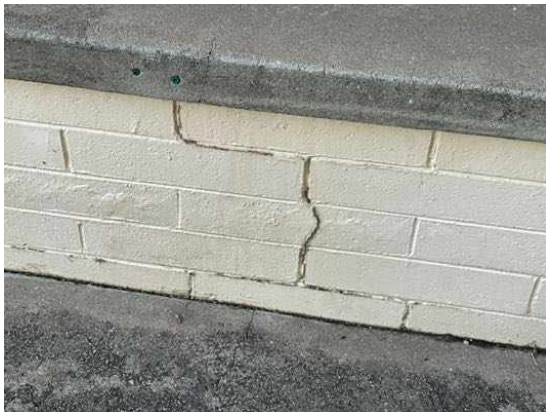
Finding 3.01

Building: Building 1
Location: Front wall area
Finding: Brickwork- Step cracking
Information: Step cracking was identified to the brickwork in this area at the time of inspection. Step cracking, which is similar to other forms of cracking, has a variety of possible causes. However, the most common is the subsidence of adjacent footings.

Step cracking is a relatively common defect, and is most likely to occur adjacent to windows, doors and other openings. Mortar failure in the gaps between affected bricks indicates the stresses and tensions affecting the wall.

Minor step cracking can be used as a warning sign to address factors causing stress to the wall, which can include the effect of surrounding trees, water leaks, soil erosion, or even the presence of reactive soils in the surrounding area.

If cracks increase in size or number contact a Licensed builder immediately to make all needed repairs.

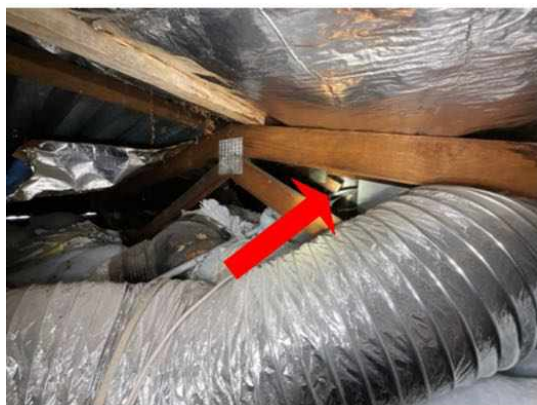
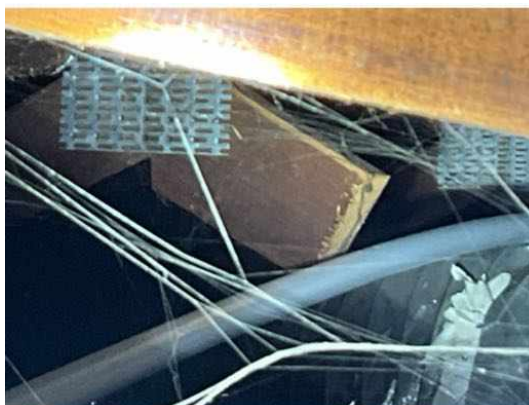
Finding 3.02

Building:	Building 1
Location:	Roof Void
Finding:	Poor installation
Information:	The roof void shows signs of supporting framing being cut to accommodate HVAC (air conditioning unit). This framing should be supported with extra timber to replace the function of the removed framing.

No sagging or damage to the roof can be seen at the time of inspection.

Monitoring is recommended in the first instance. If any movement or sagging of the roof occurs, a carpenter or builder should be contacted immediately to improve the

framing and prevent further deterioration.

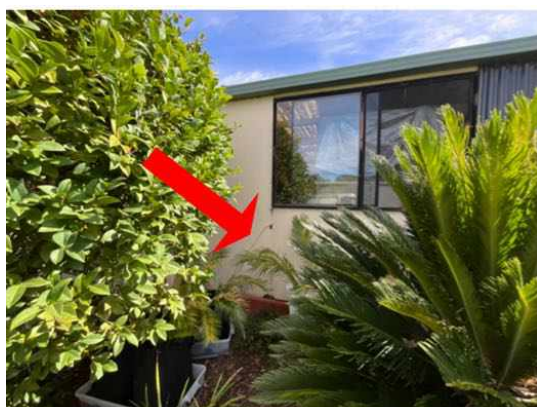
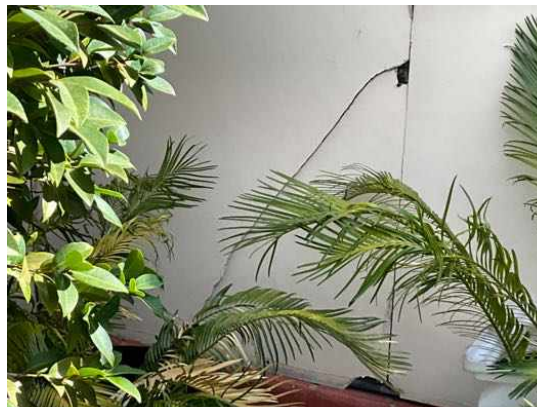
Finding 3.03

Building:	Building 1
Location:	Alfresco
Finding:	Cladding- deteriorated
Information:	The external cladding shows signs of damage in several areas. Although not serious at this point, monitoring should be undertaken at intervals to ensure no further damage occurs.

A cladding specialist or handyman could be contacted as needed to patch any damage to prevent further deterioration.

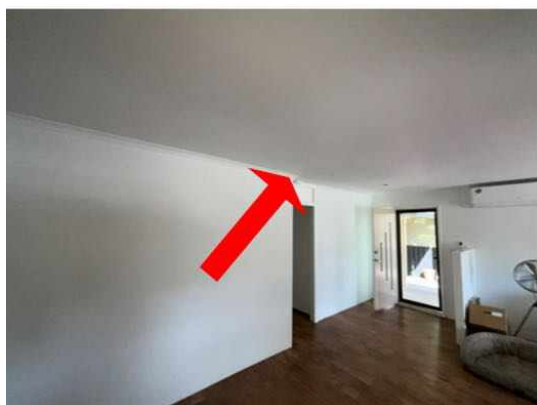
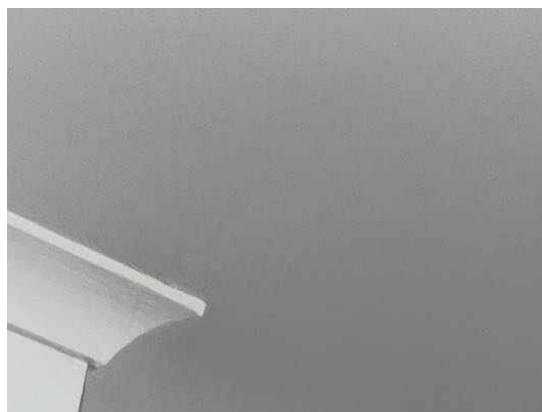
Finding 3.04

Building:	Building 1
Location:	Living Room
Finding:	Cracking - Damage Category 1 - Fine (up to 1mm)
Information:	Although fine cracks are quite noticeable, they are often only considered to be an appearance defect, and usually do not indicate any structural damage. Generally, the cause of a fine crack is indicative of a separation between building materials and finishes (e.g. paint, plaster, etc.) along joins.

Cracking of this nature can generally be repaired with minor sanding, filling and/or repainting. Such works should be performed by a qualified painter or a general handyman.

Monitoring of all cracking should be conducted frequently. Always contact a building inspector should cracks widen, lengthen, or become more numerous.

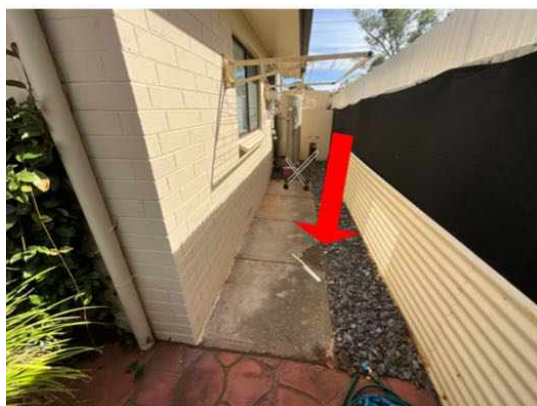
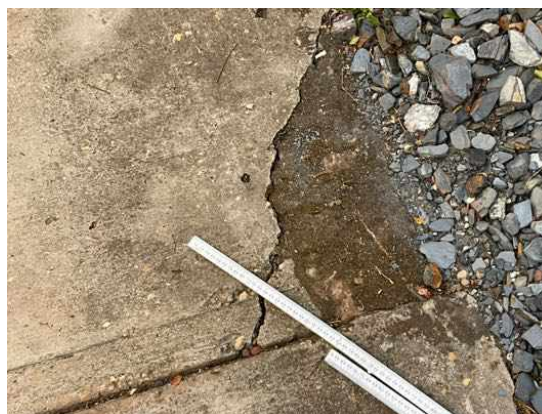
Finding 3.05

Building:	Building 1
Location:	Yard - Side
Finding:	Cracking - External Concrete Paving Damage Category 4 - Gaps in Slab (4mm - 10mm +)
Information:	Gaps in the slab were identified in external concrete paving. Gaps in the slab are significant and are likely to lead to the development of safety hazards and secondary defects if left unmanaged, such as the creation of a trip hazard.

General age and expected deterioration of the paved areas is a common cause of this type of cracking. However, expansion and contraction of the slab may also have occurred due to environmental factors. Such factors include variable moisture and weather conditions, the presence of trees and their roots having a settling or lifting affect on the soil, or the effect of load bearing, e.g. heavy vehicles over a sustained period of time.

Cracking to this degree may also be due to poor original installation of the concrete. Factors such as poor compaction of the sub surface and/or inadequate reinforcing of the slab may create cracking and other secondary defects. Gaps in the concrete paving may also have a more significant structural cause, such as subsidence of soils.

Where gaps in the concrete paving are adjacent to structural elements of the building, the advice of a Structural Engineer is advisable before undertaking repairs. Significant repair and likely replacement of the concrete paving is probable.

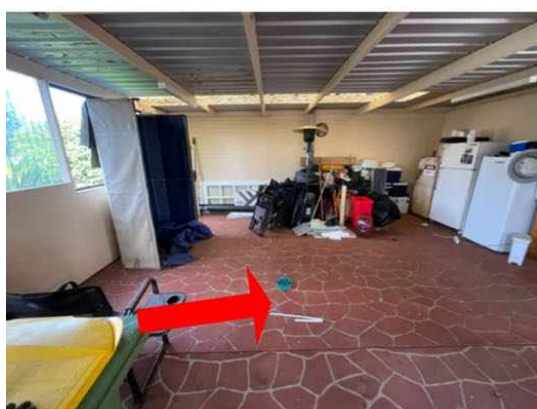
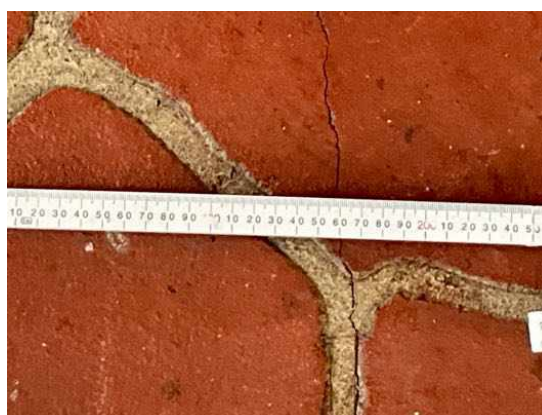
Finding 3.06

Building:	Building 1
Location:	Alfresco
Finding:	Cracking - External Concrete Paving Damage Category 1 - Fine (less than 2mm)
Information:	Fine cracks were identified in external concrete paving. Although fine cracks are quite noticeable, they are often only considered to be an appearance defect, and usually do not indicate any structural damage. To be considered a Category 1 or fine crack, the crack is found to be less than 2mm in width.

Generally the cause of a hairline crack in existing concrete paving such as driveways and pathways is indicative of the expansion and contraction of the concrete. Such causes are generally due to environmental factors, such as moisture levels, weather conditions, root systems of nearby trees or the soil types on which they are laid.

Fine cracks may also be due to poor original installation of the concrete. Factors such as poor compaction of the sub surface and/or inadequate reinforcing of the slab may create cracking and other secondary defects.

Monitoring of all cracking should be conducted frequently. Always contact a building inspector should cracks widen, lengthen, or become more numerous.

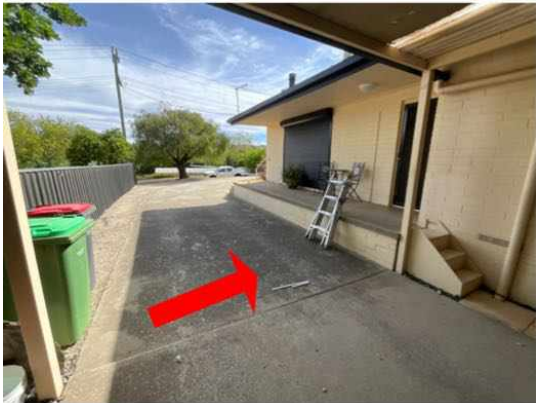
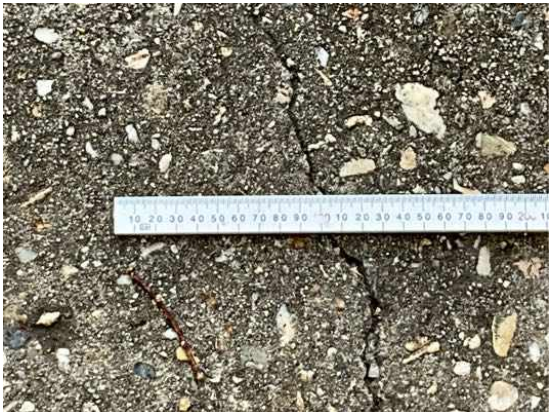
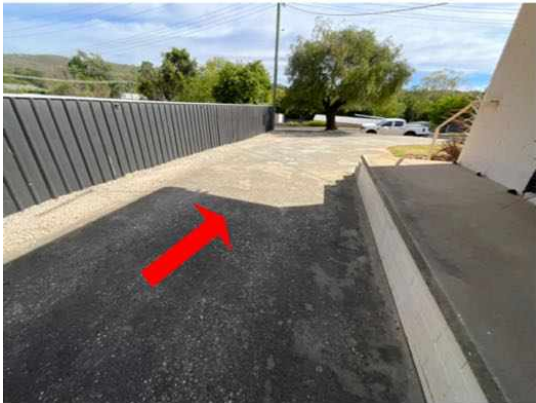
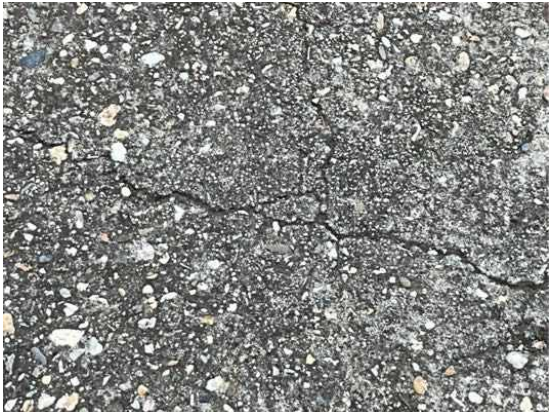
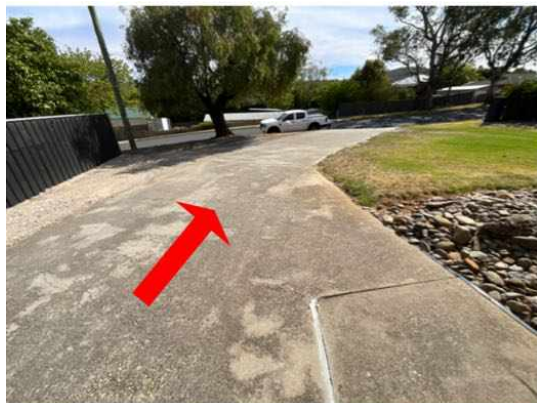
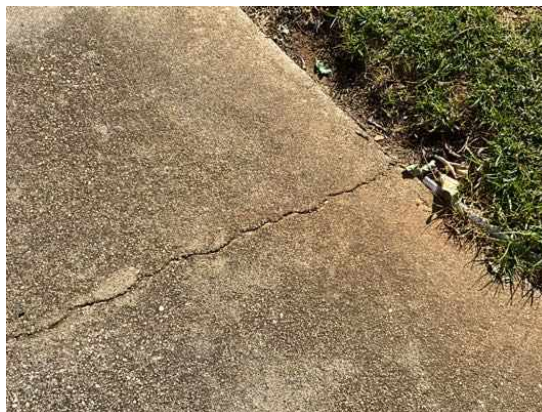
Finding 3.07

Building: Building 1
Location: Driveway
Finding: Cracking - External Concrete Paving Damage Category 1 - Fine (less than 2mm)
Information: Fine cracks were identified in external concrete paving. Although fine cracks are quite noticeable, they are often only considered to be an appearance defect, and usually do not indicate any structural damage. To be considered a Category 1 or fine crack, the crack is found to be less than 2mm in width.

Generally the cause of a hairline crack in existing concrete paving such as driveways and pathways is indicative of the expansion and contraction of the concrete. Such causes are generally due to environmental factors, such as moisture levels, weather conditions, root systems of nearby trees or the soil types on which they are laid.

Fine cracks may also be due to poor original installation of the concrete. Factors such as poor compaction of the sub surface and/or inadequate reinforcing of the slab may create cracking and other secondary defects.

Monitoring of all cracking should be conducted frequently. Always contact a building inspector should cracks widen, lengthen, or become more numerous.

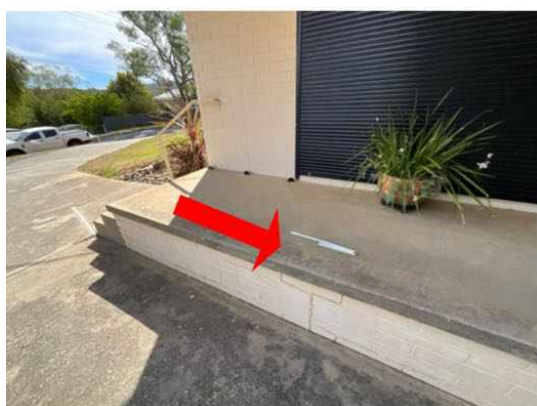
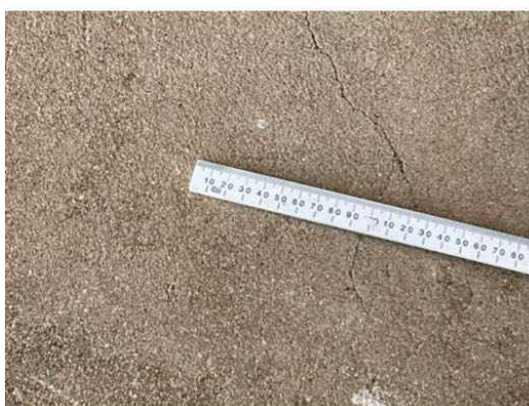
Finding 3.08

Building:	Building 1
Location:	Entry
Finding:	Cracking - External Concrete Paving Damage Category 1 - Fine (less than 2mm)
Information:	Fine cracks were identified in external concrete paving. Although fine cracks are quite noticeable, they are often only considered to be an appearance defect, and usually do not indicate any structural damage. To be considered a Category 1 or fine crack, the crack is found to be less than 2mm in width.

The cracking in the block work has been repaired. No action is needed.

Fine cracks may also be due to poor original installation of the concrete. Factors such as poor compaction of the sub surface and/or inadequate reinforcing of the slab may create cracking and other secondary defects.

Monitoring of all cracking should be conducted frequently. Always contact a building inspector should cracks widen, lengthen, or become more numerous.

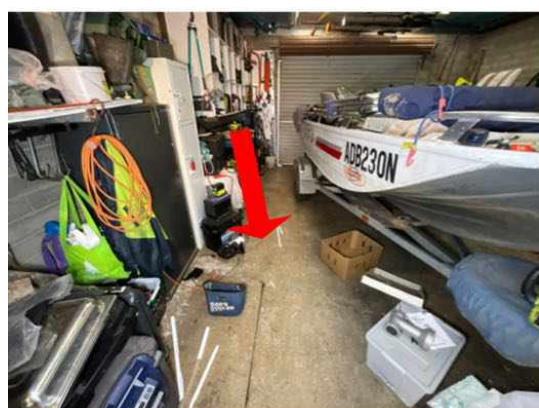
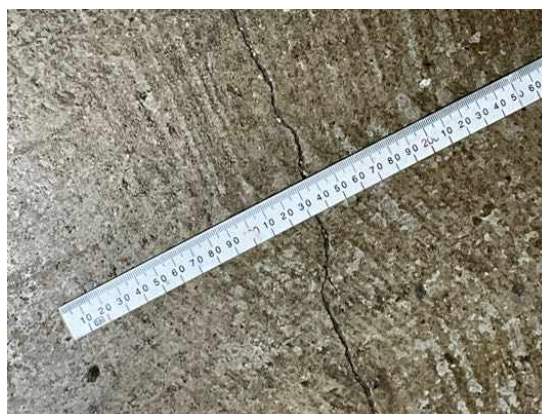
Finding 3.09

Building:	Building 1
Location:	Garage
Finding:	Crack in concrete slab - Category 1

Information: A crack coded as Category 1 was identified in the slab. A Category 1 crack is described as a fine but noticeable crack, with the slab at an otherwise reasonable level.

To be considered Category 1, the approximate width of the crack is less than 1.0mm, or a less than 10mm change in offset when a 3m straight edge is placed over the defect.

Category 1 cracks should be monitored for a period of 12 months. At the end of the monitoring period, identified cracks that are rated greater than Category 2 are considered defects, and require rectification.

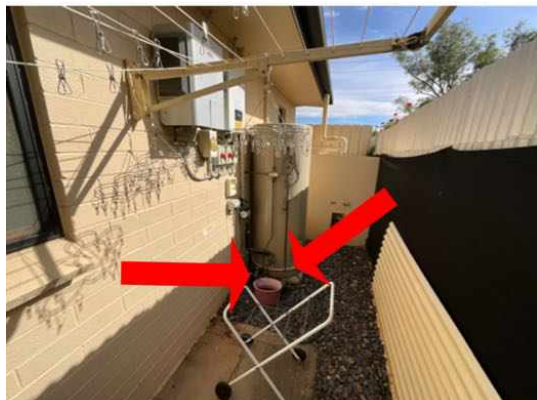
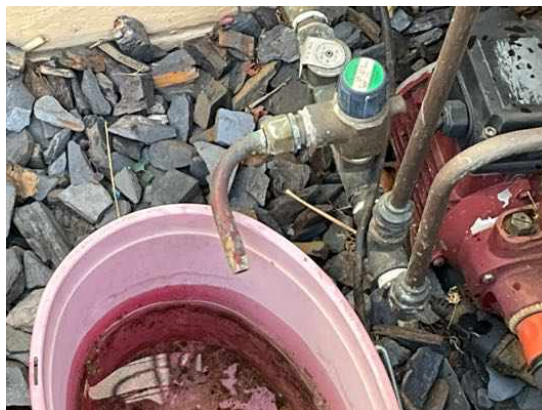
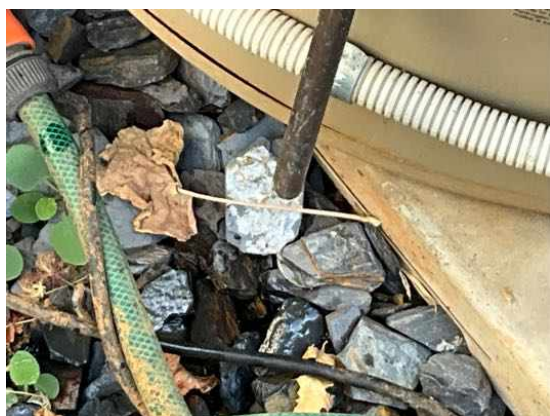
Finding 6.01

Building: Building 1
 Location: Yard - Side
 Finding: HWS Overflow - Not Connected
 Information: The Hot Water System (HWS) overflow was found to be disconnected from storm water drainage and is creating excessive moisture in the surrounding area.

These damp conditions can lead to secondary defects such as rot, rust or corrosion of associated building elements, the formation of fungal decay, or even the creation of potential slip hazards. When coupled with poor site drainage, pooling of water may

also attract termite activity to this area.

It is highly recommended that a licensed plumber be appointed to connect the HWS overflow in order to prevent such an environment from being created. These minor works should be carried out as soon as possible.

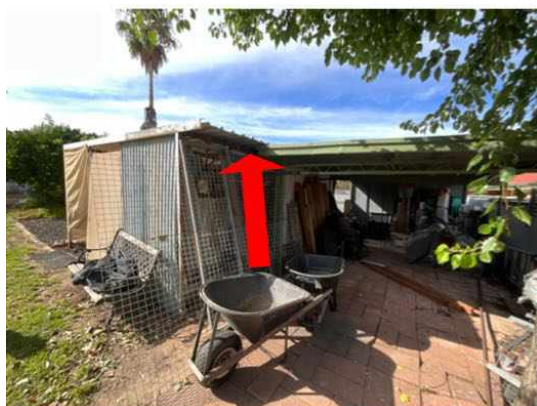
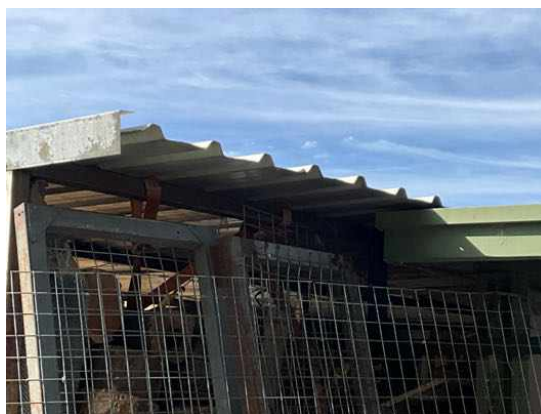
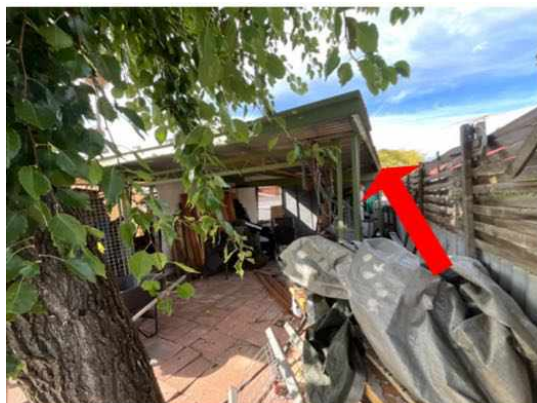
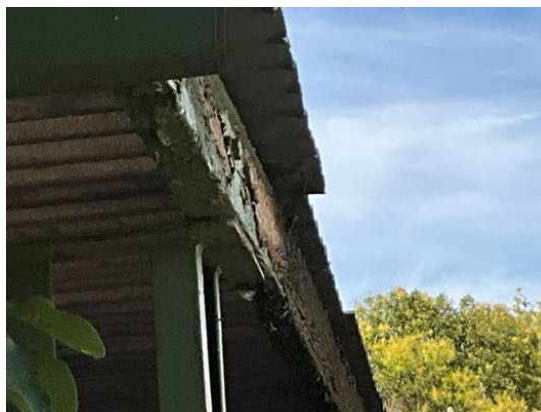
Finding 6.02

Building:	Building 1
Location:	Shed
Finding:	Guttering Missing
Information:	The Guttering in this area was missing at the time of inspection. Guttering, Downpipes and Stormwater drainage are vital to protect the integrity of the structure and to prevent an environment conducive to Timber Pest attack.

A Plumber should be contacted as soon as possible to replace and connect to drainage the missing Guttering.

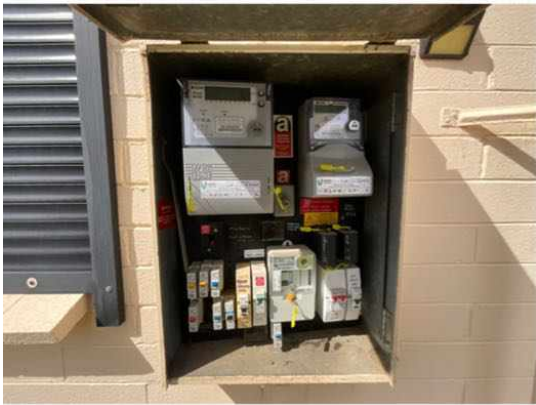
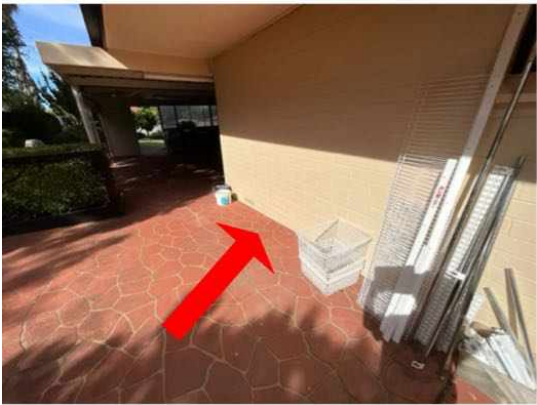
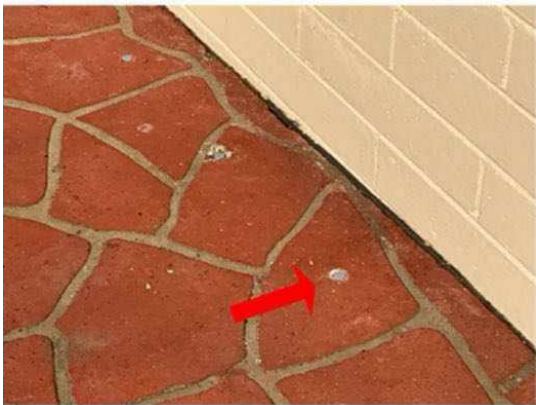
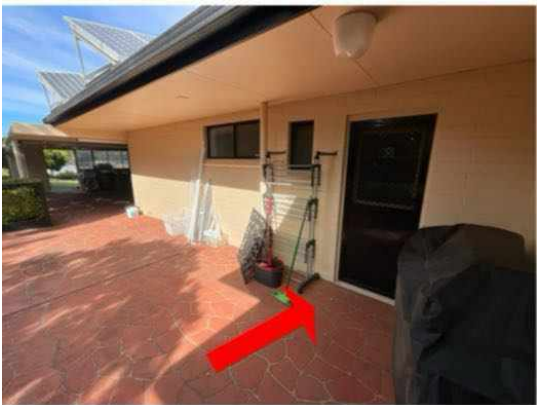
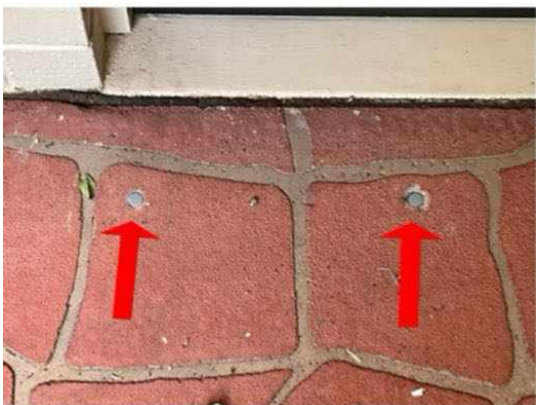
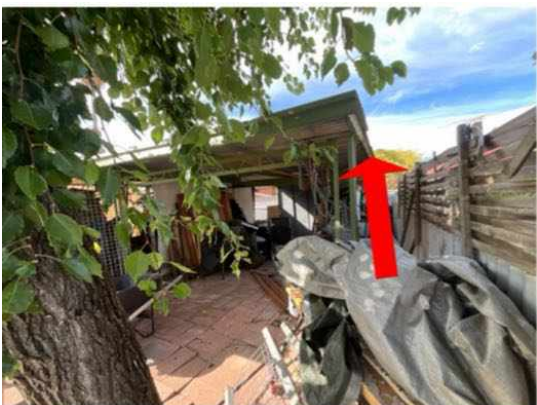
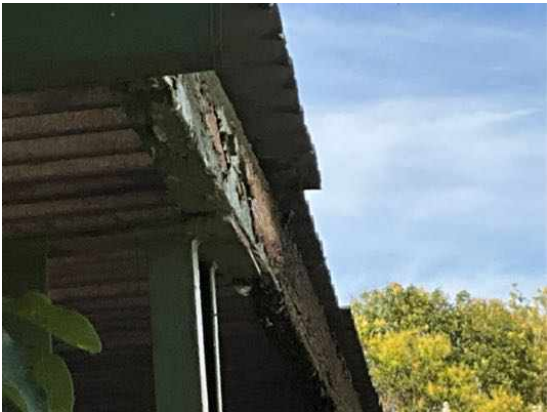
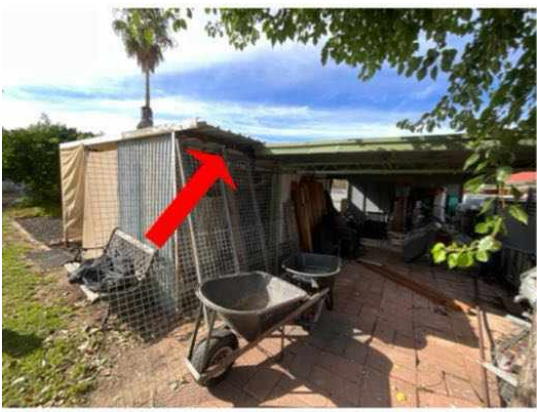
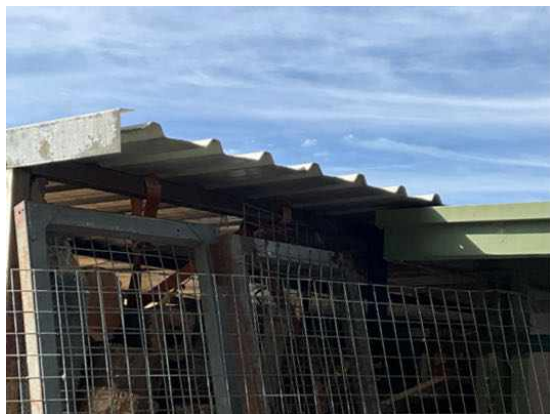
Finding 6.03

Building:	Building 1
Location:	All External Areas
Finding:	Termite Management System- evidence of a chemical installation
Information:	The application of a post-construction chemical termite barrier is highly recommended for all properties, particularly if live termite activity has been found on the site previously. Such barriers are highly effective in preventing termite attack on any timber building elements throughout the property.

A durable notice has been placed in the switchboard unit to indicate current termite barriers. At the time of inspection, it appeared as though a termite management system has been installed. The recency of any treatment cannot be determined.

The client may consider gaining further advice from a pest controller as to the costs and procedures involved with this application. It is recommended that obtaining such advice be a short-term priority.

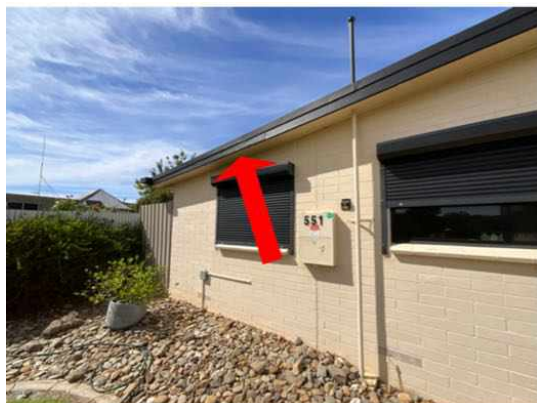
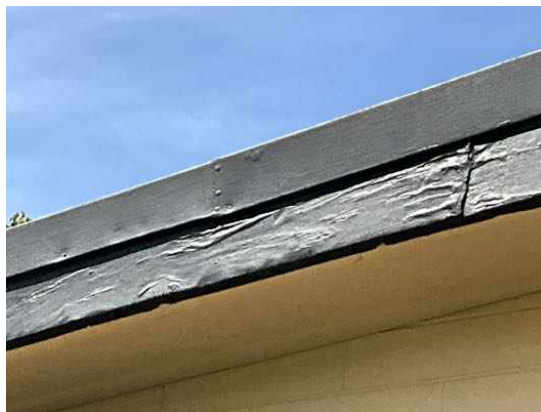
Finding 7.01

Building:	Building 1
Location:	Eaves
Finding:	Fungal decay - present (localised)
Information:	Fungal decay also known as wood decay or wood rot generally refers to the deterioration of timber elements when in contact with excessive levels of moisture for a prolonged period of time.

The development of fungal decay is accelerated by temperatures in the range of 5degreeC to 40degreeC as well as the presence of oxygen. Generally fungal decay develops on timber elements that are in use in an external environment which are exposed to rain penetration.

In this case although the affected timber element is in a decaying state the extent of any visible damage appears to be localised to a specific area and is yet to spread to other parts of the building element or affect adjoining structures. The fungal decay is therefore likely to be of a relatively superficial nature with minimal impact on the structural integrity or tensile strength of the timber element.

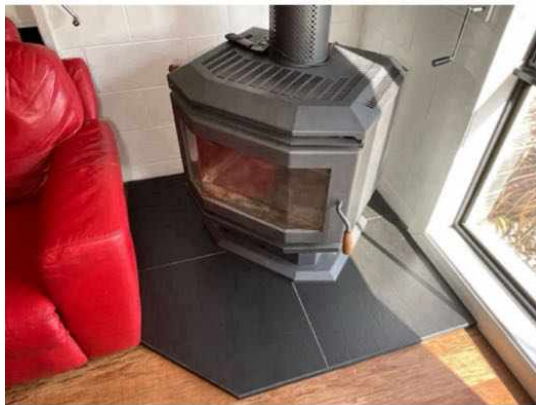
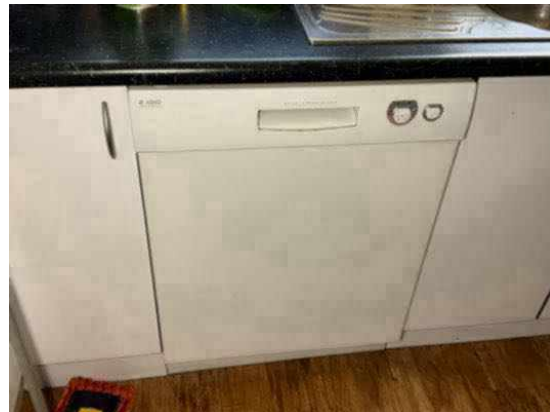
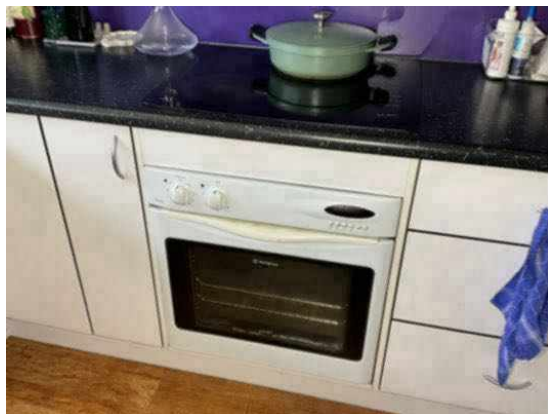
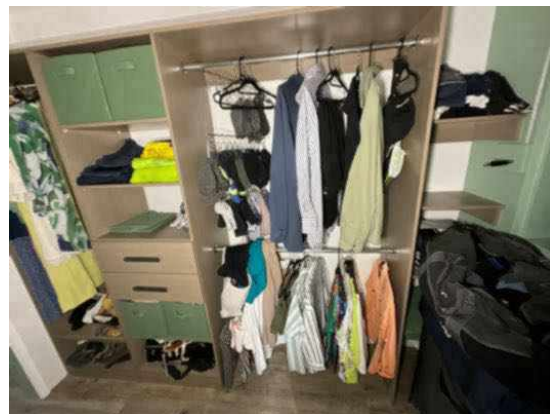
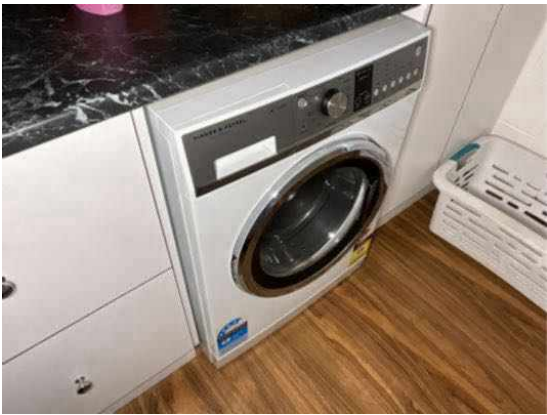
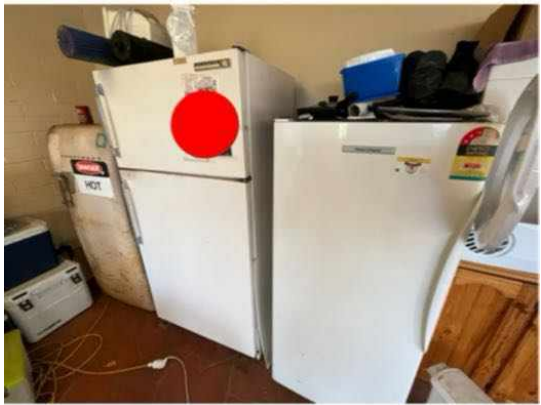
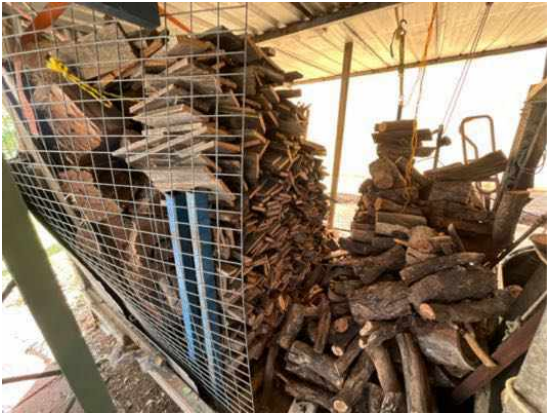
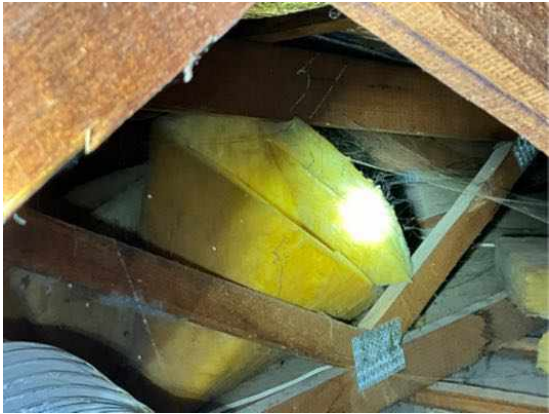
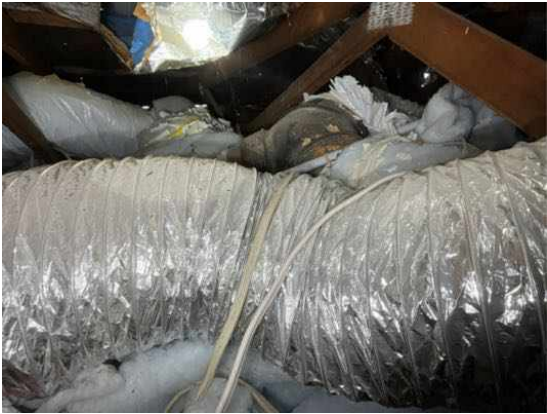
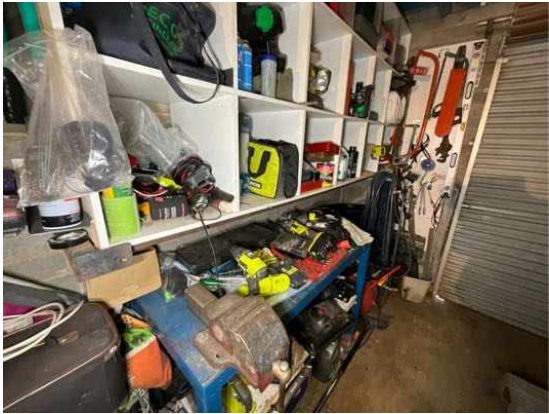
Noted Item

Building: Building 1
Location: All Areas
Finding: Additional Photos - Obstructions and Limitations
Information: These photographs are an indication of the obstructions and limitations which impeded full inspection of the property at the time of inspection. These obstructions can hide an array of defects and should be removed to allow full inspection to be carried out. A re-inspection is recommended once the areas are made accessible.
