# Building and Timber Pest Inspection Report

Inspection Date: Tue, 24 Mar 2026

Property Address: 240 Rivergum Dr, East Albury NSW 2640, Australia

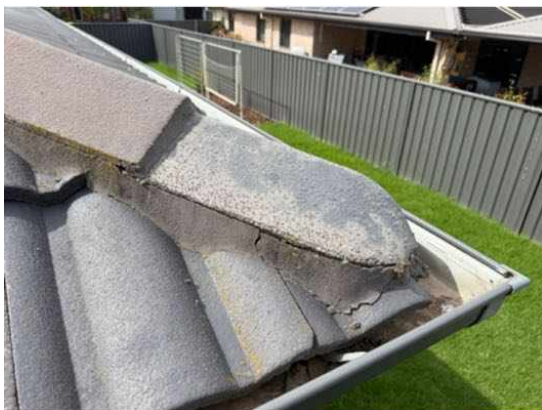
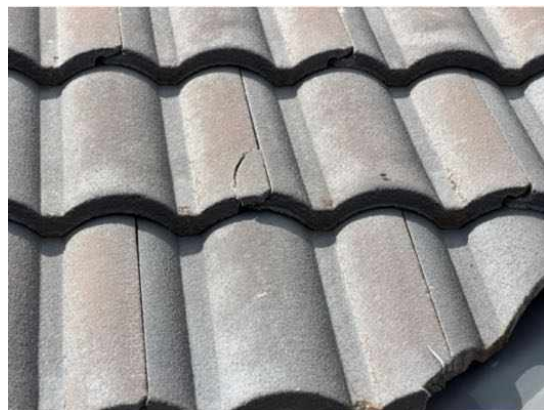
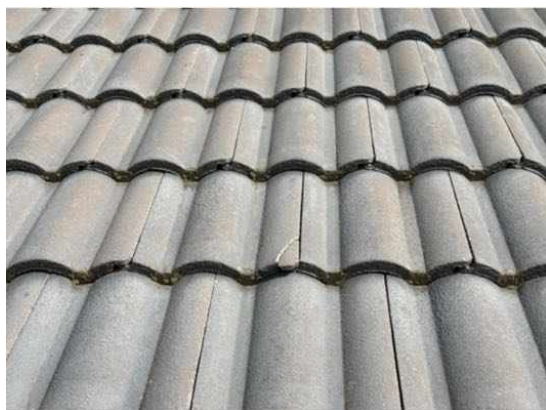
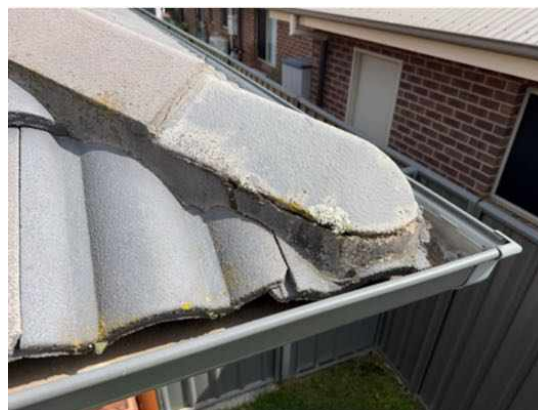
#### Finding 3.01

Building: Main Building  
Location: Roof Exterior  
Finding: Roof Exterior - Minor Cracking  
Information: Areas of cracked tiles and cracking in the tile pointing were identified to the roof exterior. While weathering of the tiles is consistent with the age of the property, maintenance works are advised, to avoid the development of secondary building defects.

Areas of minor weathering and cracked tiles were identified to the roof exterior. Recommend consulting with a licensed roofing contractor to provide further advice regarding future maintenance works needed.

Recommend consulting with a licensed roofing contractor in the short term, to provide further advice on future maintenance works needed.

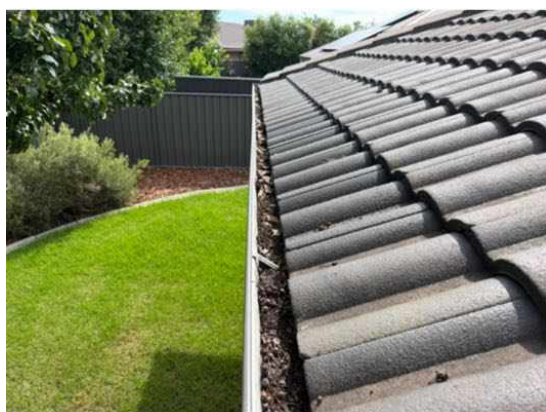
### Finding 3.02

Building:	Main Building
Location:	Guttering
Finding:	Debris in Gutters
Information:	It appears that there is some debris in the gutters. Accumulation of debris can lead to blockages of the gutters & water overflows, if neglected.

Recommend engaging a general handyman to remove debris from the gutters to prevent overflows & blockages.

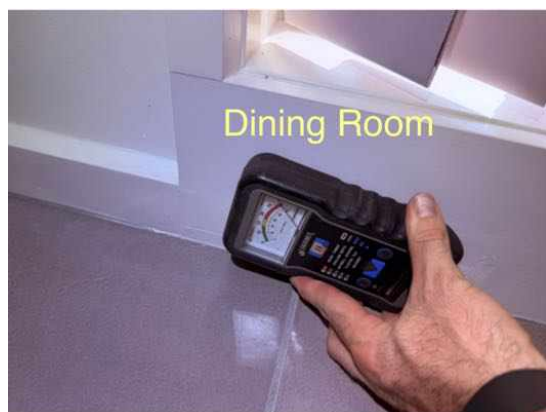
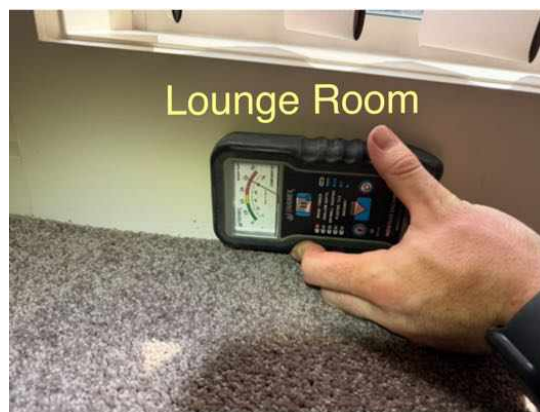
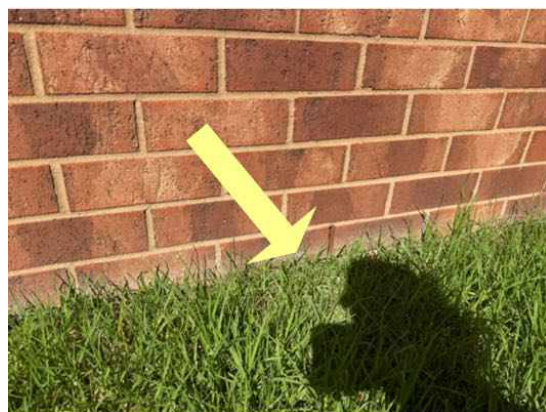
### Finding 6.01

Building: Main Building  
 Location: Dining Room, Lounge Room  
 Finding: High Moisture - Skirting Boards  
 Information: It appears high moisture was present at, but not limited to the skirting boards of the dining room and lounge room. It is suspected this has been caused by the external ground levels being higher than the damp-proof course (DPC), & water pooling against the building. Areas of high moisture create an environment conducive to termite activity.

It appears high moisture was present at, but not limited to the skirting boards of the dining room and lounge room. Recommend engaging a landscaping contractor and dampproofing specialist in the short term to provide remedial works where necessary.

Recommend engaging a landscaping contractor and dampproofing specialist in the short term to provide remedial works where necessary.

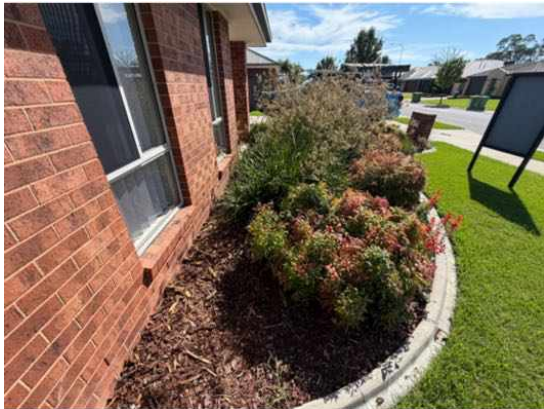
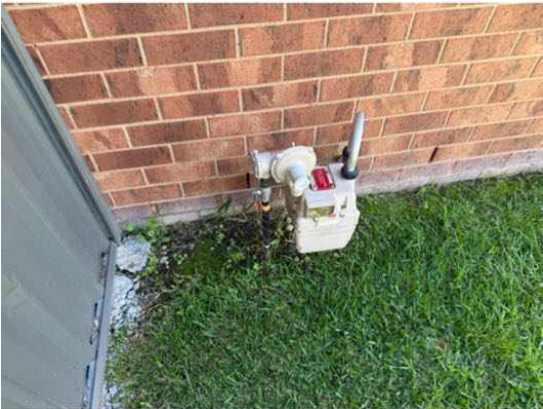
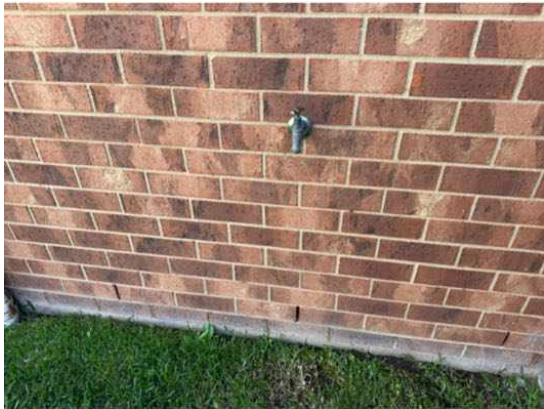
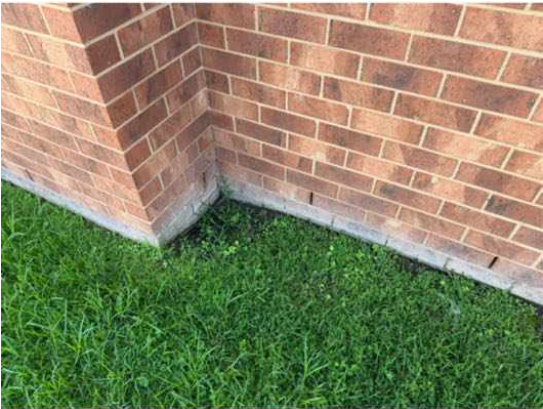
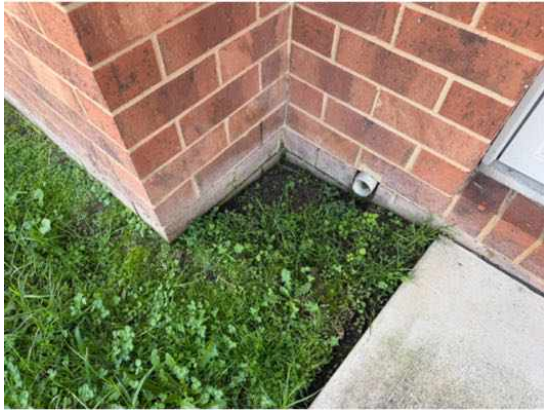
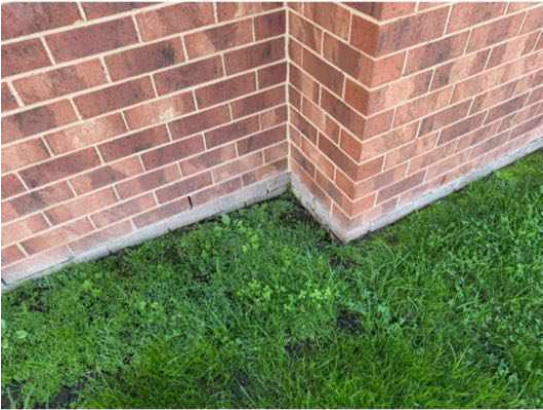
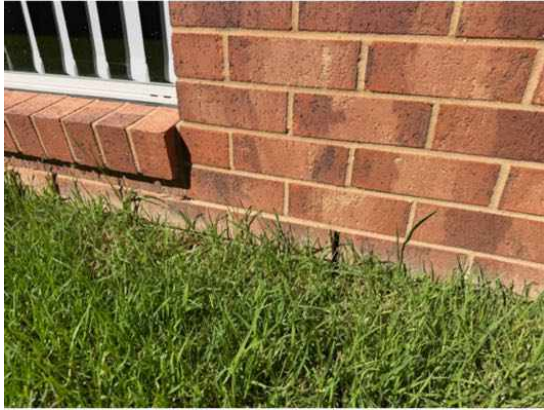
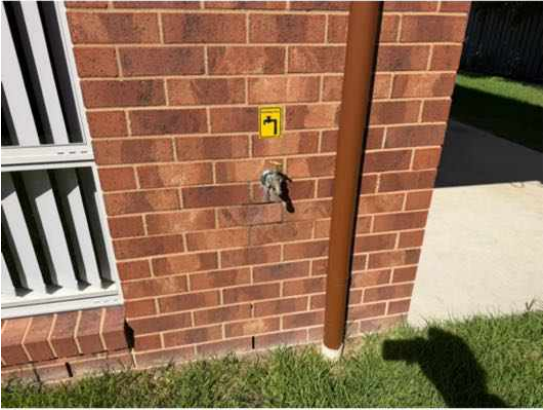
### Finding 6.02

Building: Main Building  
 Location: All external areas  
 Finding: Potential Water pooling - against property  
 Information: Potential areas of water pooling around the perimeter of the property were identified. Where insufficient drainage of taps, and poor site drainage is present, water pooling is likely to occur, and can create areas conducive to timber pests. Recommend consulting with a licensed plumber and/or landscaping contractor to provide further advice.

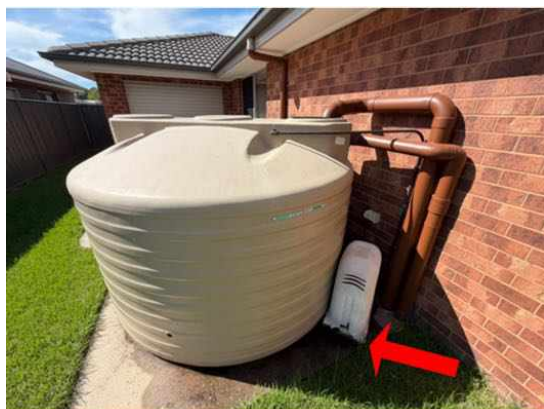
Finding 6.03

Building:	Main Building
Location:	Water Pump / Tank
Finding:	Water Tank / Pump - Leaking
Information:	It appears that the rainwater pump and/or water tank was leaking. Leaking water tanks can create water pooling at the base, creating areas conducive to timber pest activity. Recommend engaging a licensed plumber in the short term, to provide remedial works where necessary.

Areas of potential water pooling were identified to the perimeter of the building. It appears the rainwater pump and/or water tank was leaking. Recommend consulting with a licensed plumber to provide remedial works.

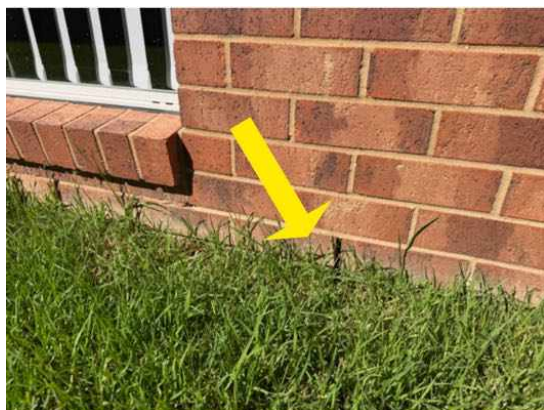
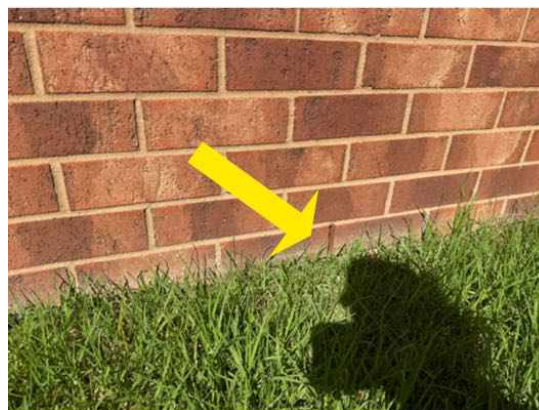
### Finding 6.04

Building:	Main Building
Location:	Right Side House
Finding:	Weep holes - Blocked & Bridging
Information:	It appears some weep holes of the brickwork are blocked by the external finished ground level. This can restrict moisture escape and can create conducive conditions to termite activity. This also creates a bridge point, allowing termites to bypass the physical termite barrier & allows for concealed entry into the building.  Recommend engaging a licensed landscaping contractor in the short term to lower external ground levels where feasible and restore adequate weep hole drainage and inspection zones.

Areas of the external ground level at, but not limited to the right side of the building appeared to be higher than the base of the weep holes. Recommend engaging a landscaping contractor to lower external ground levels, where feasible, to allow for sufficient drainage and inspection zone.

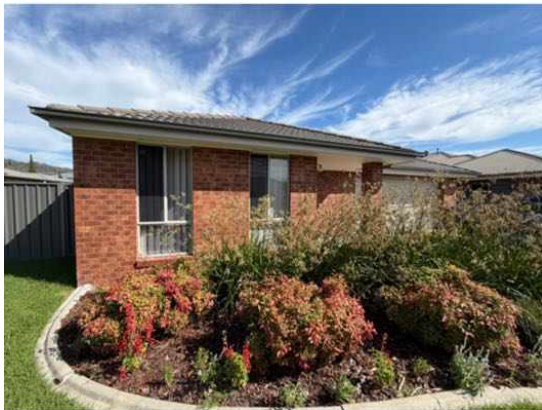
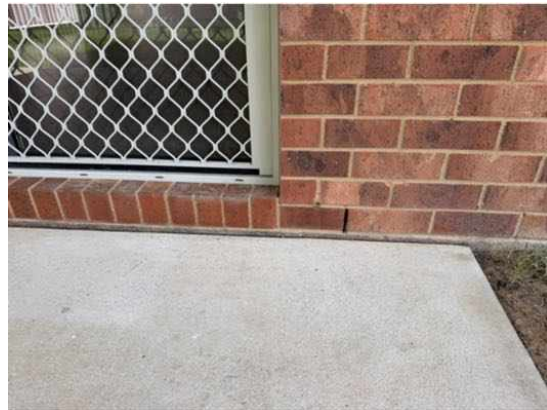
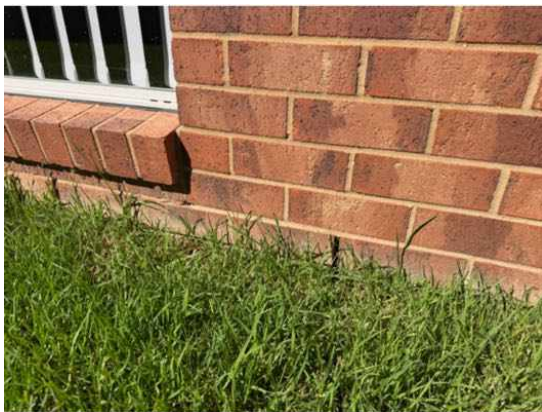
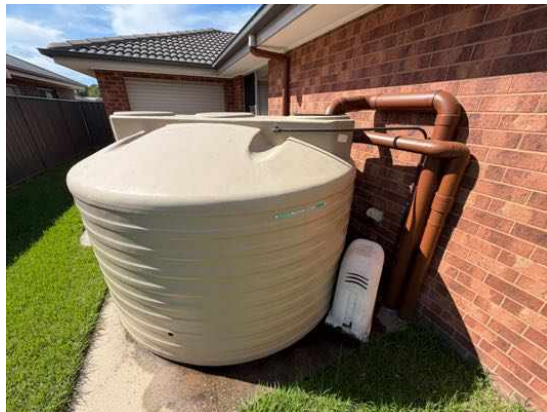
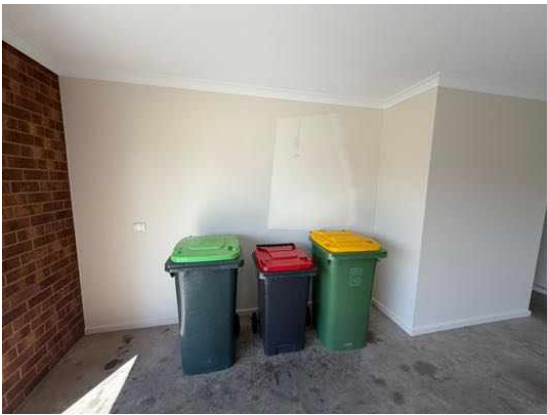
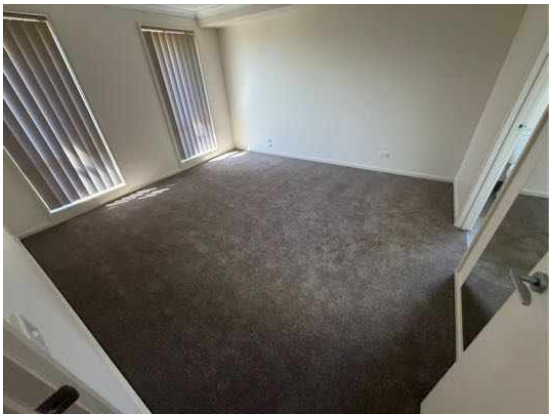
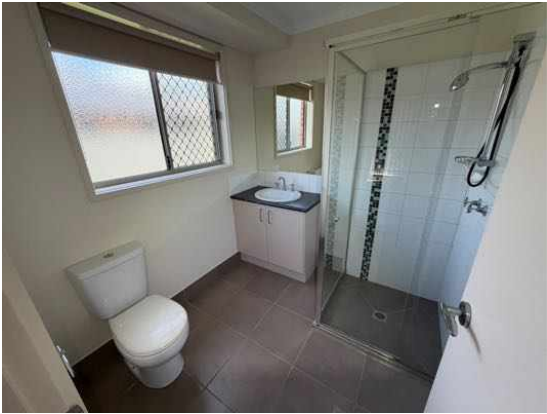
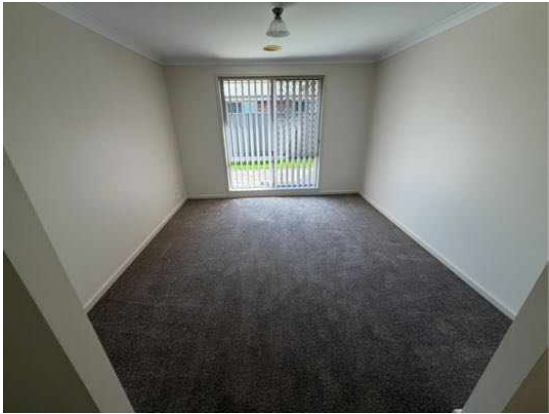
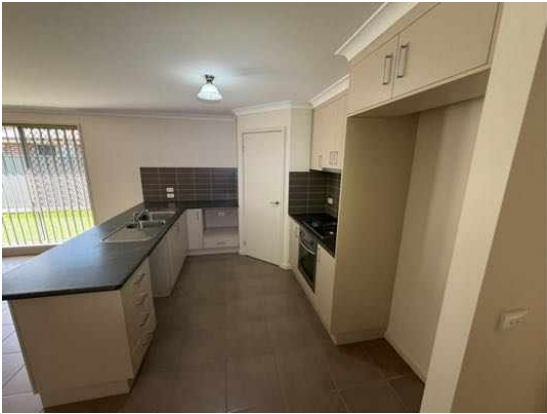
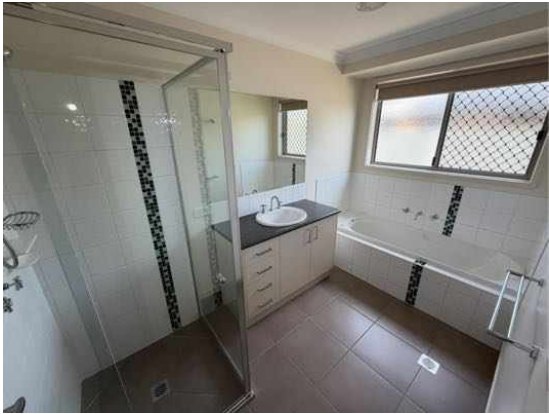
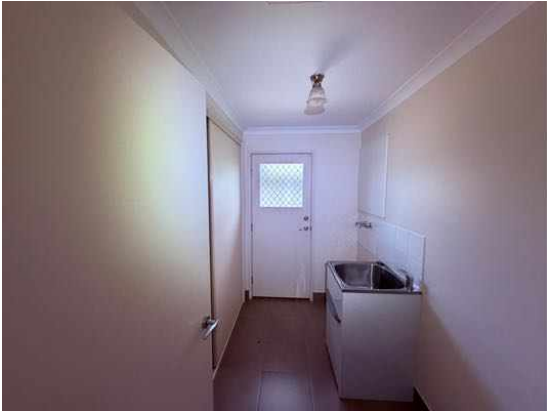
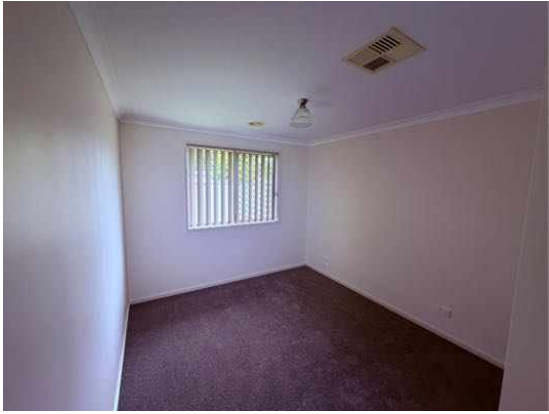
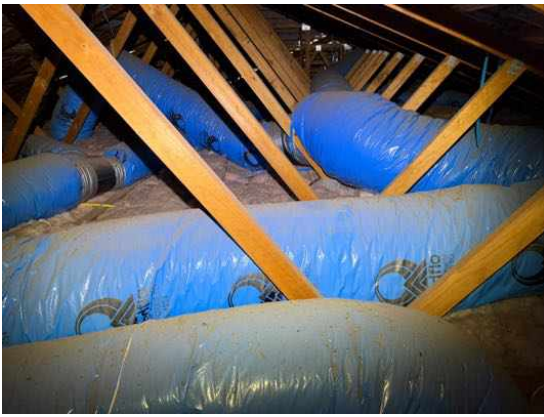
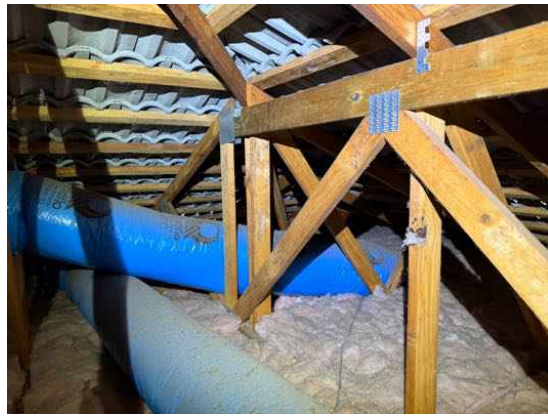
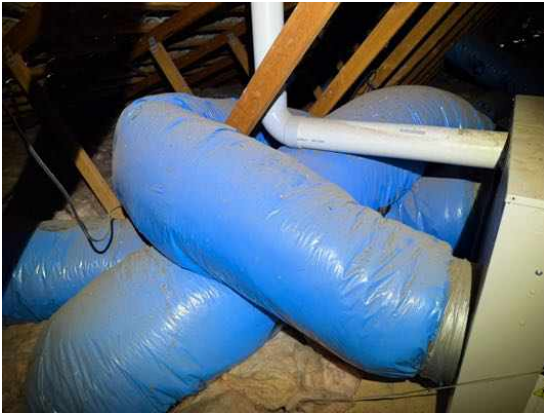
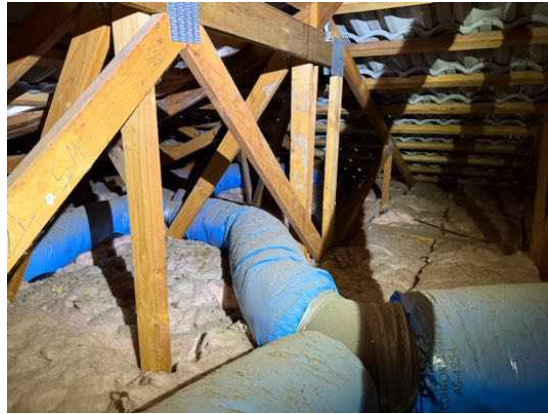
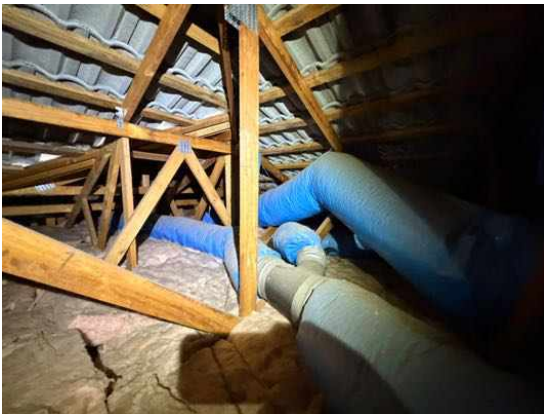
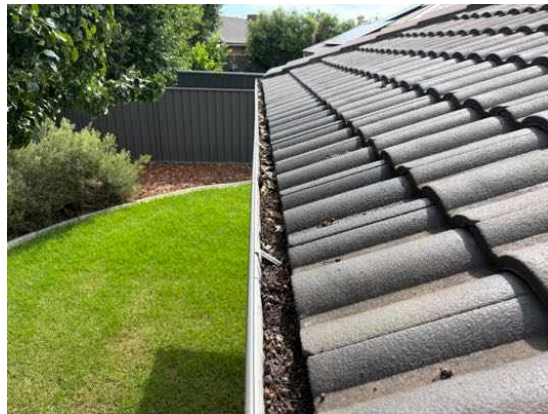
Building: Main Building  
Location: All Areas  
Finding: Additional Photos - Obstructions and Limitations  
Information: These photographs are an indication of the obstructions and limitations which impeded full inspection of the property at the time of inspection. These obstructions can hide an array of defects and should be removed to allow full inspection to be carried out. A re-inspection is recommended once the areas are made accessible.

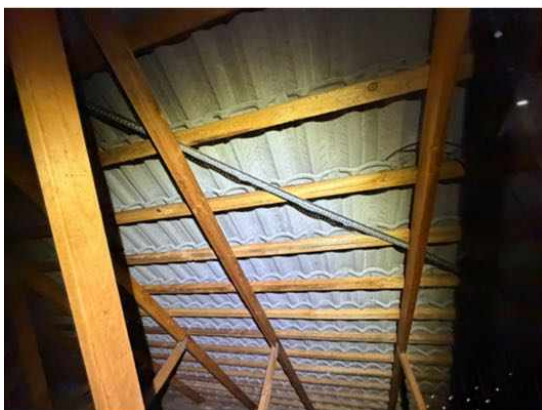
Building: Main Building  
 Location: Roof Void  
 Finding: Sarking - Not Present  
 Information: It is noted for your information that sarking has not been installed on the roof. Sarking is a laminated aluminium foil applied to the interior of the roof covering, assists in insulating the property and acting as a vapour-barrier to the roof void.

The client can consult with a licensed roofing contractor at their discretion, to provide further advice.

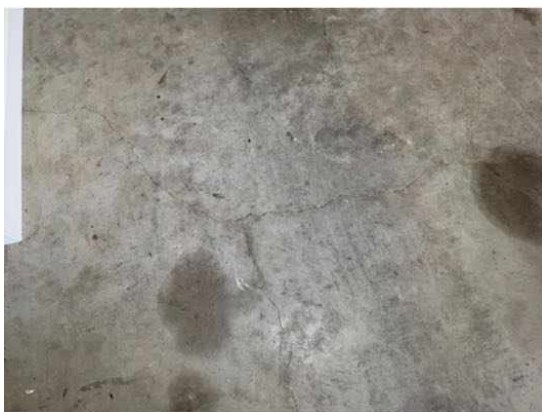
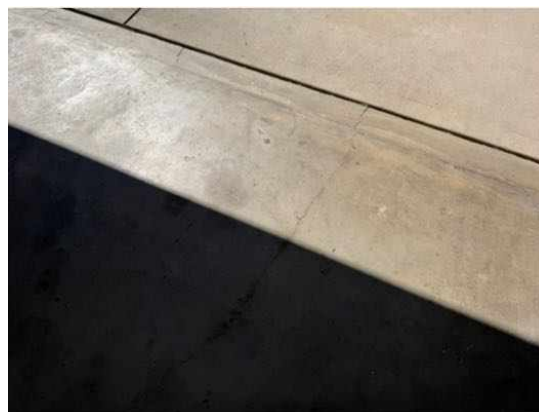
Building: Main Building  
 Location: Garage  
 Finding: Cracking - Garage Slab  
 Information: Minor cracking was identified in the garage slab. Cracking in concrete slabs is common, and can be caused by general movement of the footings over time or "settling" of the building after construction.

The client should monitor the cracking. Should the cracking of the garage slab widen, lengthen or become more numerous, a structural engineer should be engaged for further evaluation.

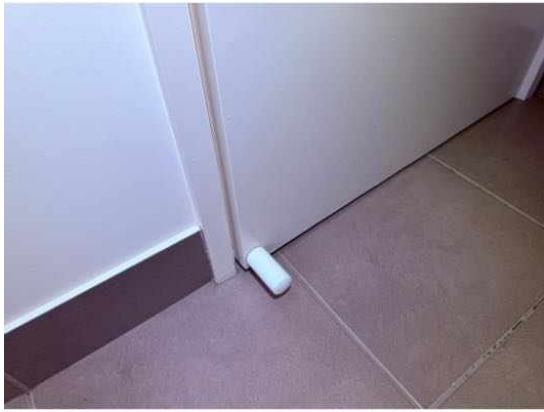
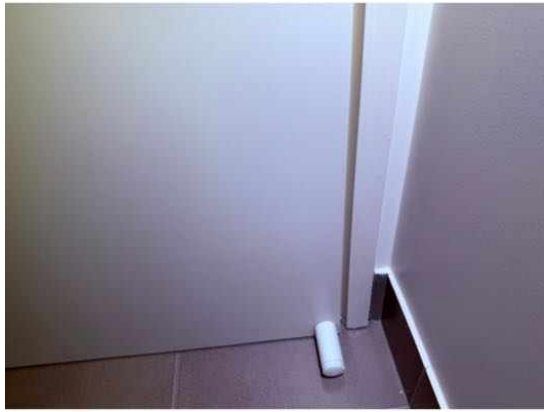
Building: Main Building  
 Location: Internal Doors  
 Finding: Doors - Binding/jamming  
 Information: It was noted at the time of inspection that some internal doors, were binding against the door jambs. A qualified carpenter or general handyman can be appointed to perform minor rectification works at the clients discretion.

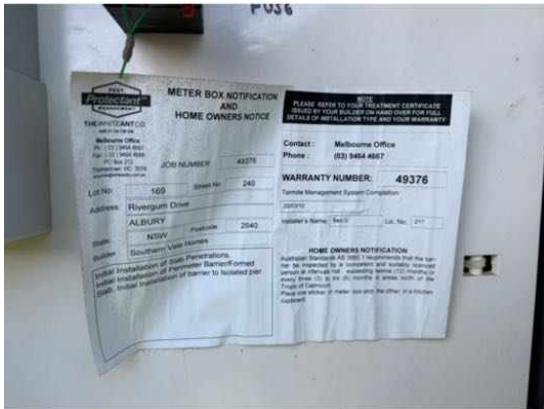
A durable notice was identified in the switchboard, indicating that a physical termite barrier is in place. Regular 12 monthly inspections should be conducted by a qualified termite inspector, to identify any early signs of timber-pest activity. Recommend consulting with the pest control company that installed the barrier, to provide further advice regarding the system and future management plan.

Building: Main Building  
 Location: Switchboard  
 Finding: Evidence of a previous termite management system  
 Information: A durable notice has been installed in the meter box, indicating that a previous termite management system has been installed. The type of termite system that has been installed is a physical polymer barrier which prevents concealed termite entry into the building and forces termites out into the open.

Recommend consulting with the pest control company that installed the barrier to provide further advice regarding the system and future termite management plan. Regular 12 monthly inspections should be conducted by a qualified termite inspector, to identify any timber-pest activity.
