Building Inspection Report

Inspection Date: Tue, 24 Mar 2026

Property Address: 28 Mountain Rd, Laidley QLD 4341,
Australia

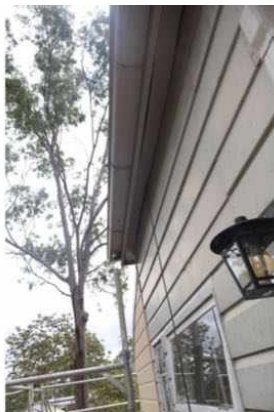
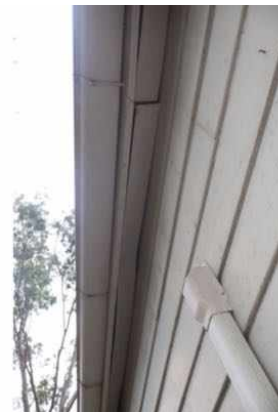
Defects 1.01

Building: Main Building
 Location: Eaves > Rear
 Finding: Eaves - Damaged
 Information: The eaves around the external property were found to be in a visibly poor condition. The damage may have been sustained as a result of a number of possible causes, including poor roof drainage, leaking roof plumbing or minor impact damage.

The damage to the eave sheeting in this area detracts from the appearance of the structure, as well as potentially compromising the structural integrity of the roofing area.

Where eaves show moderate to severe damage, remedial works may be required. Where water damage is suspected as being the underlying cause, appointment of a licensed plumber is advised as a matter of urgency to identify the source of the water leak.

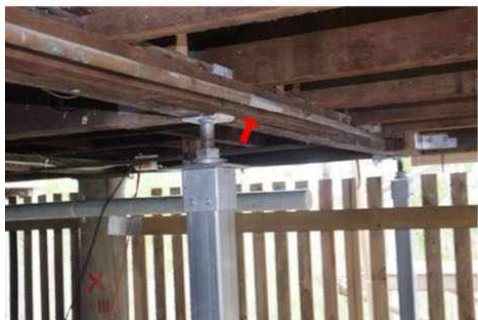
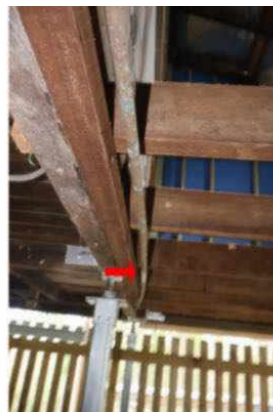
Defects 3.01

Building: Main Building
 Location: Subfloor > Rear
 Finding: Plumbing fixing not connected.

Information: At time of inspection it was noted that the plumbing not fixed.
This could cause plumbing connection to fail if not fixed off correctly.
A plumber maybe required to rectify this issue.

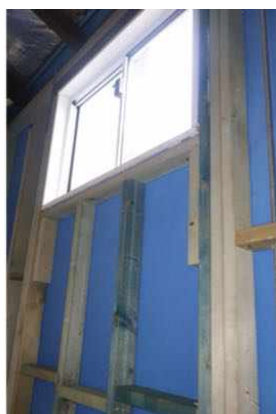
Building: Main Building
 Location: Bathroom > Rear Left
 Finding: Glass - windows compliance
 Information: New glass window has no visible compliance acoustic rating.

News glass windows do not display the required compliance marking in accordance with AS 1288:2021 glass in buildings selections and installation.

Lack of compliance marking means the glazing cannot be confirmed as meeting Australian safety and performance requirements.

This may pose safety risk and result in non-compliance with the national construction code. NCC.

Confirm certification of the installed glass through manufacturer documentation or replace glazing with glass clearly marked as compliant to AS.1288 and AS/NZS 2208

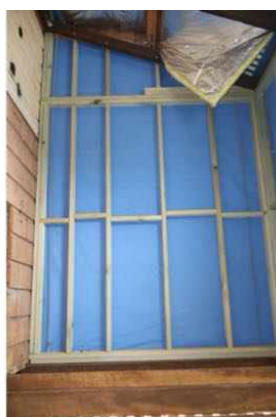
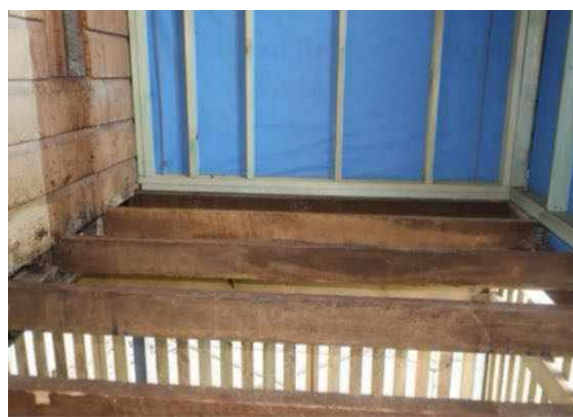
Building: Main Building
 Location: Bathroom > Existing
 Finding: Frame reconstruction - No engineering plans
 Information: For structural works like framing (walls, roof, load bearing elements),

A licensed structural engineer is usually required to; verify the design meets building code NCC (National Construction Code)

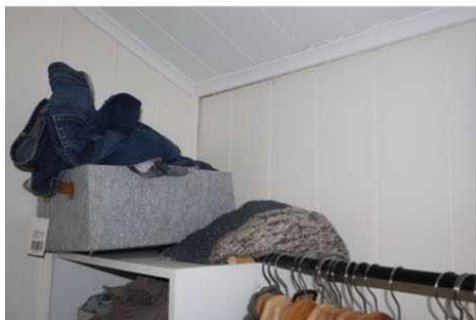
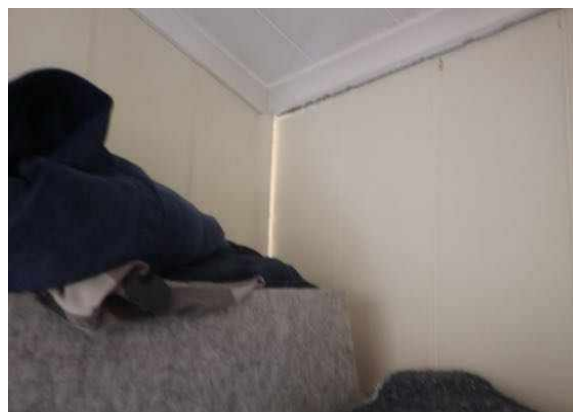
Building:	Main Building
Location:	Walk-In Robe - Master > Rear Right
Finding:	Wall cladding- open joints
Information:	Open joints in the wall cladding were identified, this is considered to be a defect under standard and tolerances.

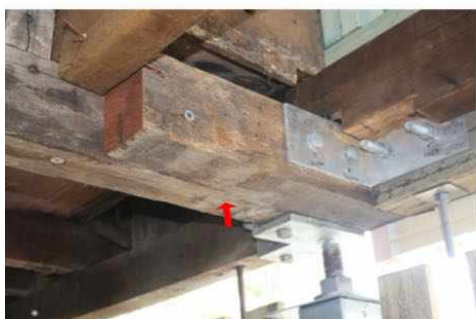
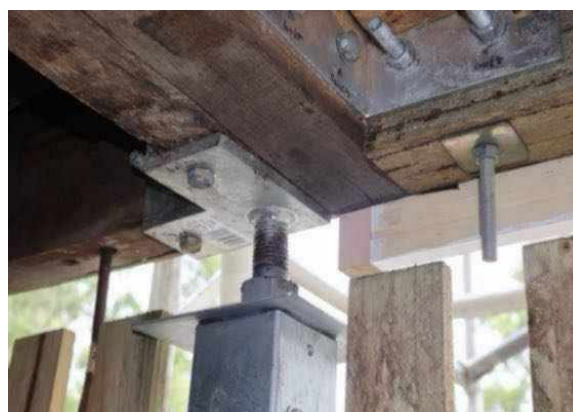
Building: Main Building
 Location: Subfloor > Rear
 Finding: Subfloor - bearer not adequately supported
 Information: The subfloor structure does not have sufficient to adequately carry imposed loads.

This may include missing or inadequate supports.

Confirmation may be required by a structural engineer to determine if bracing is adequate or requires further attention.

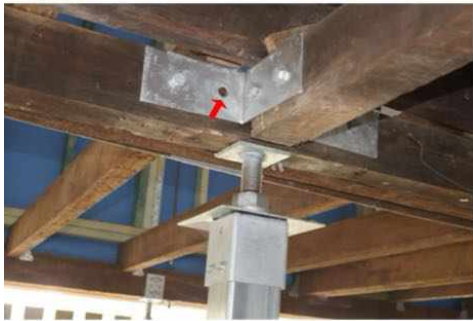
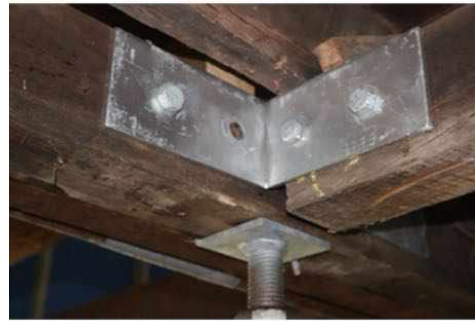
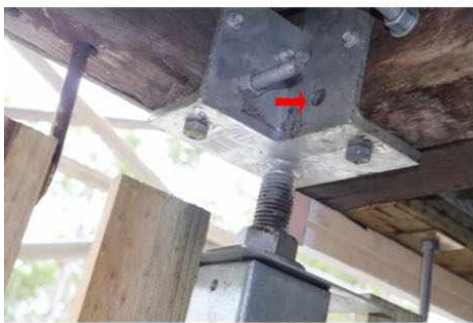
Building: Main Building
 Location: Subfloor > Rear Right
 Finding: Frame anchor - bolts missing
 Information: Anchor bolts securing the subfloor frame to bearers are missing.

Anchor bolts are critical to transfer vertical loads to footing, provide resistance to wind uplift.

Missing anchor bolts significantly compromise structural stability and wind resistance.

Anchor bolts should be installed as soon as possible.

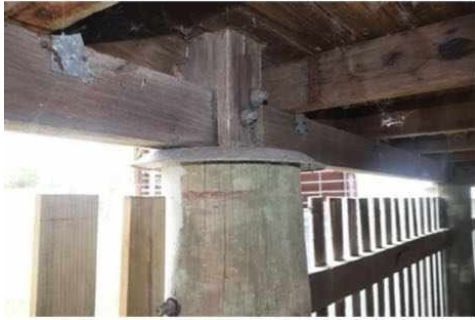
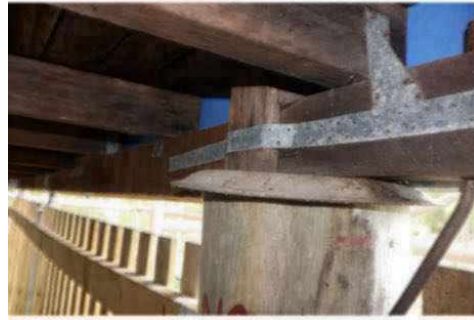
Building: Main Building
Location: Subfloor > Rear Right
Finding: Subfloor - bracing inadequate
Information: Subfloor bracing lacks sufficient bracing to adequately support and stabilise the flooring system.

Existing bracing elements have been installed which is not consistent with original bracing and may require certification.

Bracing should be confirmed by a structural engineer or building certifier.

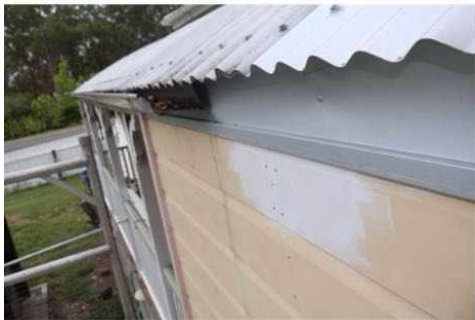
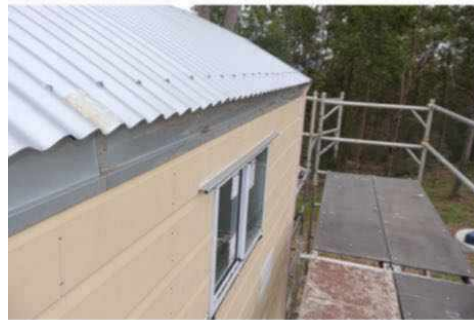
Building: Main Building
 Location: Roof Exterior > Rear Right
 Finding: Roof gutters - missing
 Information:

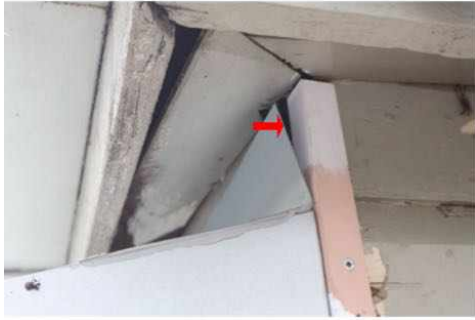
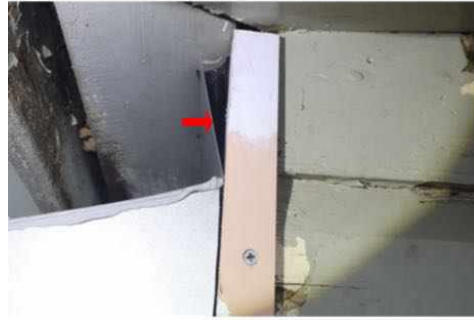
Building: Main Building
 Location: Roof Exterior > Rear
 Finding: Roof plumbing - Loose flashing
 Information: Metal and other material flashings are applied to seals and intersections between roof coverings and building elements. They are designed to aid in weatherproofing of roof joins, and require regular inspection and maintenance as they are more subject to rust-related deterioration.

The flashing in this section of the exterior roofing appears to have come loose from its original fixing. It is suspected that this minor defect has occurred as a result of general deterioration over time.

Re-fixing and potential replacement of certain areas of flashing is advised to promote adequate roof drainage and protection from water penetration. Failure to perform

these works may result in water damage and accelerated deterioration of associated building elements.

A roofing contractor or roofing plumber should be appointed as soon as possible to restore the flashing to a fully operational state.
