Building and Timber Pest Inspection Report

Inspection Date: Mon, 5 Jan 2026

Property Address: Villa 5 South Shores, Normanville SA 5204,
Australia

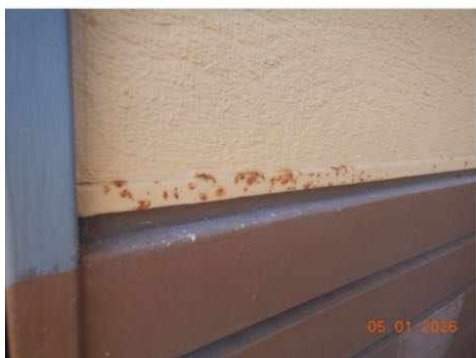
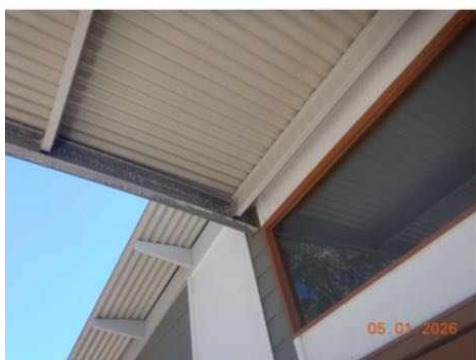
Building: Building 1
Location: Deck
Finding: Building element - Rusted or corroded
Information: Minor surface rust and corrosion appears to be evident to still work around the decking/ veranda and also elements of the exterior cladding, which is likely to have developed as a result of excessive exposure to moisture and the proximity to the ocean.

As surface rust provides no protection to the underlying iron, the deteriorating condition is likely to worsen if not addressed in the short-term future.

Where possible, the use of galvanized (treated) metals or aluminium coated metals aid in rust prevention, as does regular general maintenance. Rust formation can be controlled with coatings, such as paint, that isolate the iron from the environment.

Rusting and corrosion should be managed by ideally removing or limiting the affected surface from exposure to moisture, then treating the rust to slow the deterioration and could be carried out by a licensed painting contractor.

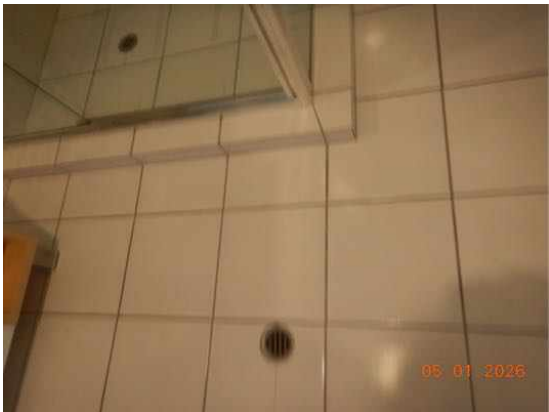
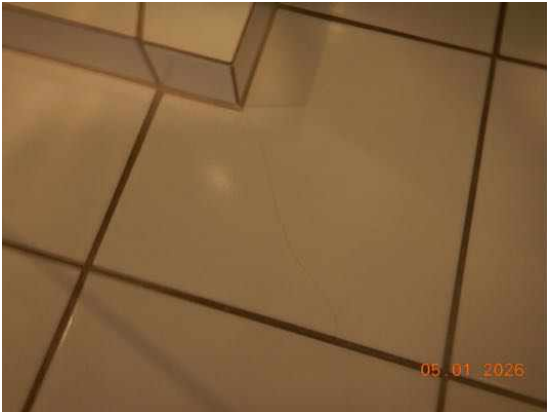
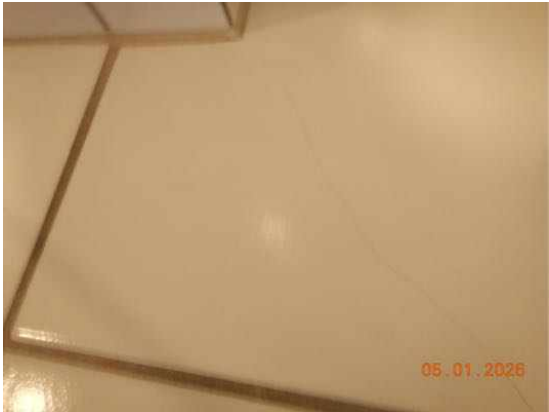
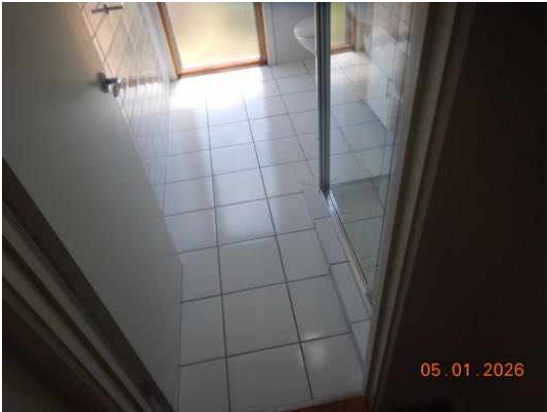
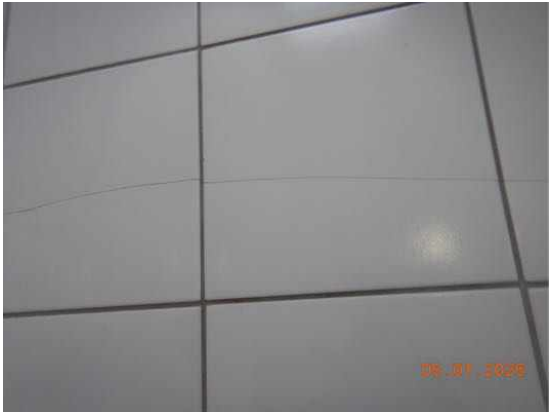
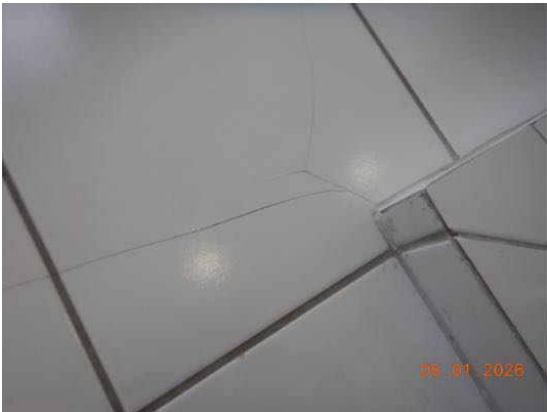
Finding 3.02

Building:	Building 1
Location:	Bathroom
Finding:	Tiles - Cracked or damaged minor
Information:	Cracking was evident to approximately 10 tiles to the bathrooms, in the general floor areas of the home at the time of inspection.

The cracking appears to be minor and is likely due to general movement, settlement of the building.

As the area should not be submerged in water, no secondary defects are likely to be created and as such repairs left to the discretion of the client.

A tiling contractor could be appointed to make repairs to return the ascetics of the property.

Always contact Jims Building Inspections if cracking becomes more extensive.

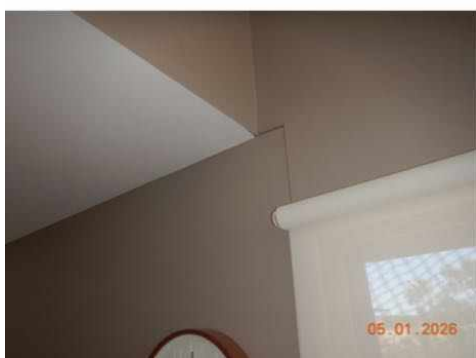
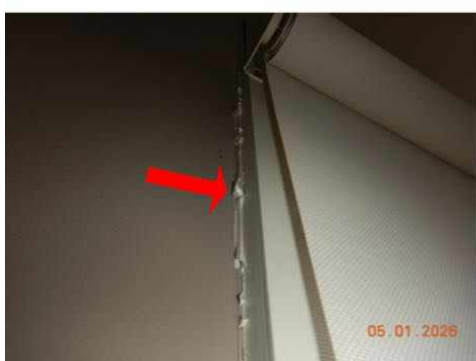
Finding 3.03

Building: Building 1
Location: All Internal Areas
Finding: Cracking - Damage Category 1 - Fine (up to 1mm)
Information: There were fine cracks evident to the walls and ceilings throughout the dwelling at the time of inspection.

Although fine cracks are quite noticeable, they are often only considered to be an appearance defect, and usually do not indicate any structural damage. Generally, the cause of a fine crack is indicative of a separation between building materials and finishes (e.g. paint, plaster, etc.) along joins.

Cracking of this nature can generally be repaired with minor sanding, filling and/or repainting. Such works should be performed by a qualified painter or a general handyman.

Monitoring of all cracking should be conducted frequently. Always contact a building inspector should cracks widen, lengthen, or become more numerous.

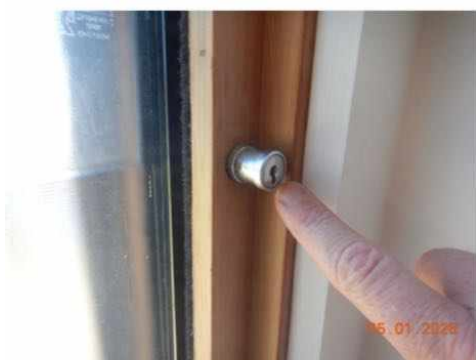
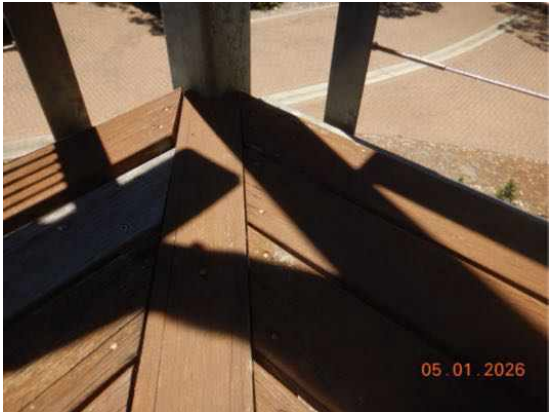
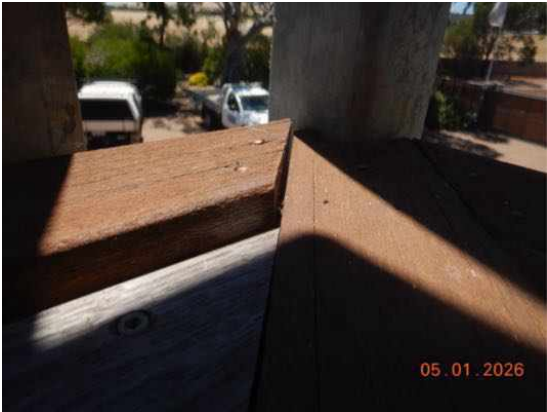
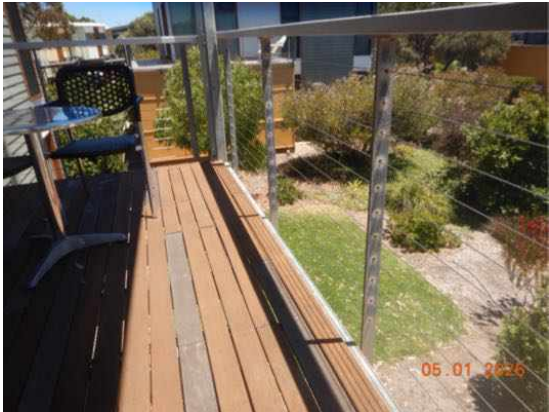
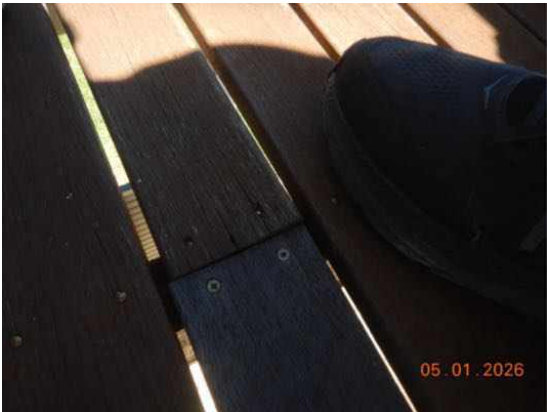
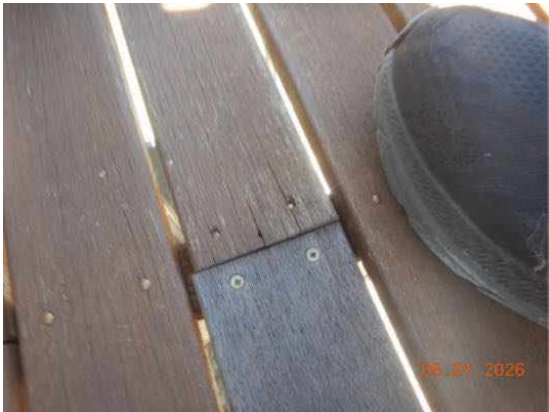
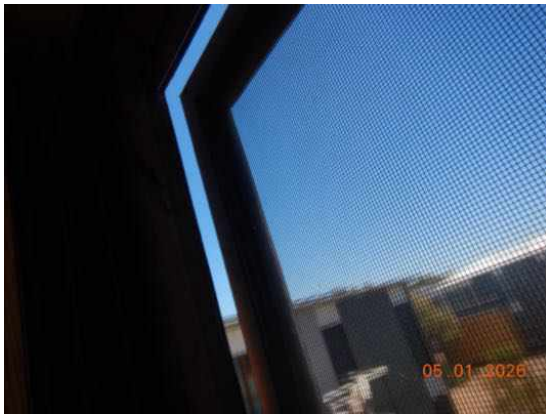
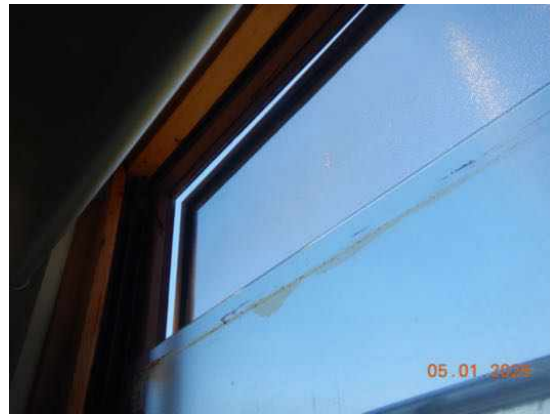
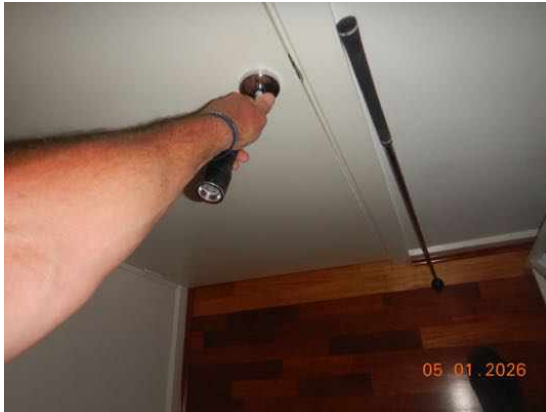
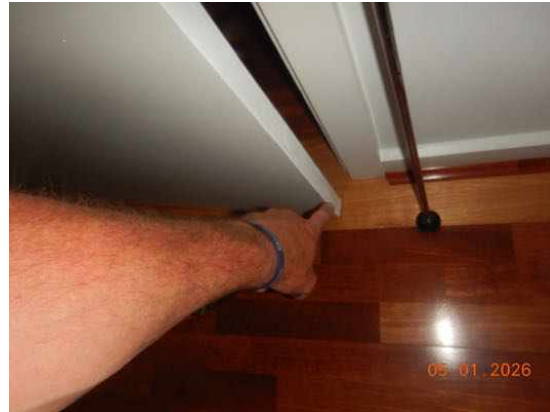
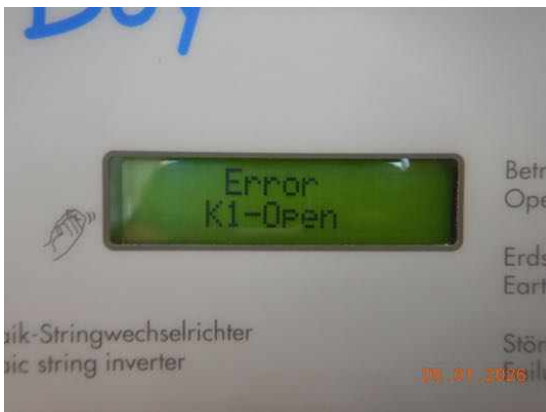
Finding 3.04

Building: Building 1
 Location: All Areas
 Finding: Minor defects present
 Information: There were several age and maintenance related defects evident to the dwelling at the time of inspection. These defects include but are not limited to

- Some window locks difficult to operate, lubricant
- Minor damage to several window stiles
- Several loose deck boards, refix
- Loose flyscreen upstairs.
- Door rubbing on frame
- Solar potentially not operating

Appropriate licensed trades people could be appointed to make repairs at the discretion of the client.

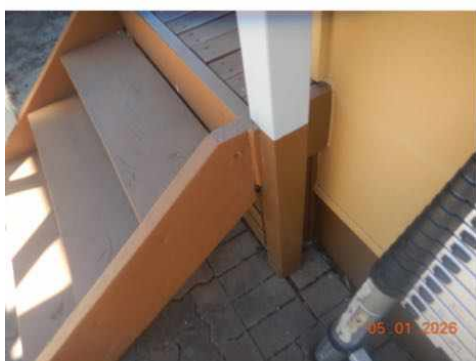
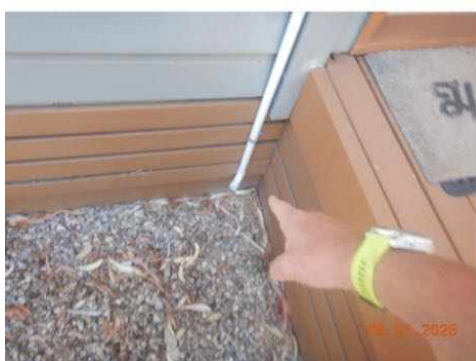
Building: Building 1
 Location: All External Areas
 Finding: Untreated or non-durable timbers in a hazardous environment
 Information: To reduce the risk of timber pest attack it is essential that timber used in a hazardous environment (e.g. in direct contact with the ground or frequently exposed to damp conditions) is of sufficient durability and/or is adequately preservative treated. Additionally any timber lying around or timber stumps should be removed.

Untreated timbers in direct contact with the ground are likely to develop severe wood rot and/or fungal decay if left unattended creating attraction for subterranean termites to infest the timbers from surrounding areas.

If untreated or non-durable timbers are found to be in a hazardous environment it is highly advised that replacement of these building elements be performed as soon as possible to aid the protection of the property against termite / timber pest attack. Failing this close monitoring is recommended in an attempt to identify termite infestation at an early stage.

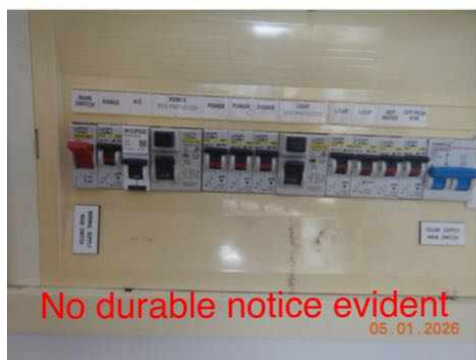
Finding 6.02

Building: Building 1
 Location: All Areas
 Finding: Termite Management System - no evidence of a chemical installation

At the time of inspection, it appeared as though no termite management system has been installed, with no evidence to suggest preventative works taking place.

The client may consider gaining further advice from a pest controller as to the costs and procedures involved with this application. It is recommended that obtaining such advice be a short-term priority.

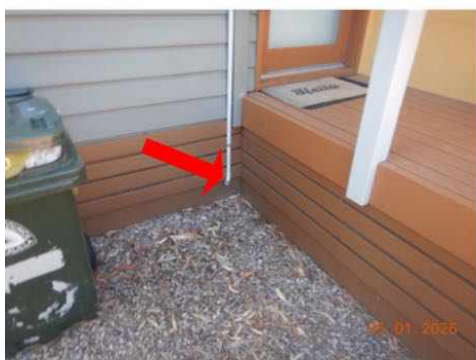
Finding 6.03

Building: Building 1
Location: All External Areas
Finding: Air conditioner and or external tap - No drainage
Information: Moisture around the perimeter of the building should be minimised to ensure that the area is kept dry and stable which in turn reduces the risk of water damage and termite infestation.

There appears to be no drainage points set up to the air conditioning unit, and or the external tap/ stormwater overflows. While this is not a legal requirement it is recommended to reduce the risk of moisture related issues and the creation of an environment conducive to termite activity.

It is recommended that a licensed plumber be appointed to set up drainage in order to prevent such an environment from being created.

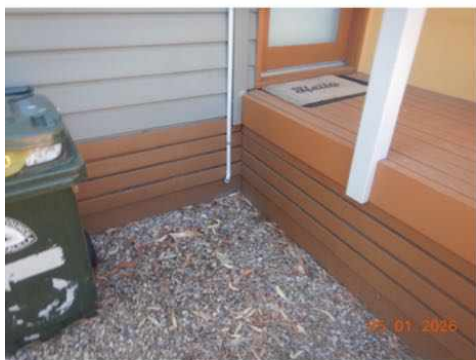
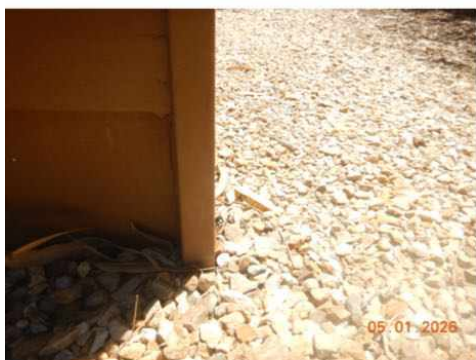
Finding 6.04

Building:	Building 1
Location:	All External Areas
Finding:	Perimeter Paving - Missing/ Insufficient Fall
Information:	The perimeter ground levels around the dwelling, were found to have an inadequate slope away from the adjoining building structure, creating potential for water pooling in this area and allowing moisture to enter the wall.

Not only that but soil has been placed against the wall with no protection to the brickwork to prevent moisture ingress. No high moisture was evident to the brickwork at the time of inspection.

Perimeter paving is required to fall from the building by a minimum of 25mm in the first metre and bare ground should fall away from the house by 50mm in the first meter. This standard ensures that excessive moisture does not pool around the base of building structures, which creates potential for water and structural damage, as well as making the area susceptible to termite and timber pest activity.

Where paving or ground levels do not have adequate fall, a licensed paving contractor should be appointed to install perimeter pavement to ensure a dry environment beneath the house. It is recommended that these works are carried out in the short-term.

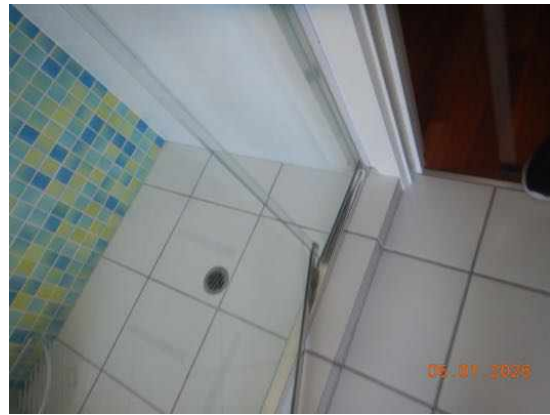
Finding 6.05

Building:	Building 1
Location:	Ensuite - Master
Finding:	Sealant - maintenance required
Information:	It was noted on inspection that sealant is showing signs of deterioration to the main bathroom. There were no abnormally high readings for moisture in the area.

Secondary defects can occur if maintenance is not carried out ranging from moisture in walls to deterioration of adjacent building elements

Flexible and materials should be applied to affected areas to prevent any subsequent water damage that can occur. Regular maintenance and replacement of damaged/ deteriorated sealant and grout is highly recommended as this is a regular wear and tear defect.

Repairs are required and should be carried out by a licensed bathroom sealant specialist immediately.

Silicone and grout generally need repair at least every 5 years and as such close monitoring should be carried out in the future after repairs are carried out.

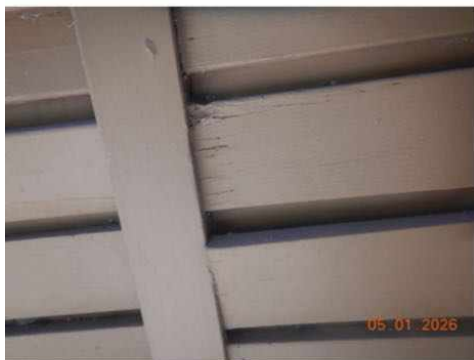
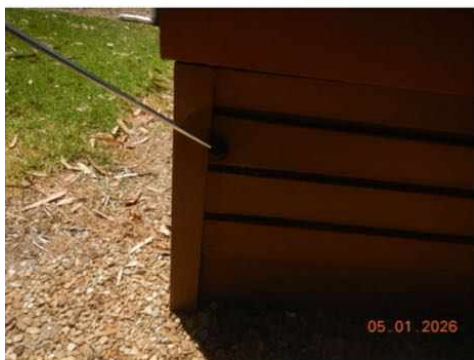
Finding 7.01

Building: Building 1
Location: All External Areas
Finding: Several elements - Wood rot
Information: Wood rot was found to be affecting several elements including small sections of the external cladding and trims at the time of inspection.

It is likely that this wood rot has developed as a result of frequent exposure to rain and other weather conditions however deteriorated guttering or building elements can be a contributing factor also.

It is also suspected that failure to maintain these elements over a prolonged period has resulted in them deteriorating at an accelerated rate, increasing their susceptibility to the development of wood rot.

Early intervention and regular maintenance will prolong the useful life of these building elements.

Repair and/or replacement of affected areas may be a necessary step in protecting surrounding building elements from such deterioration. Remedial works should be performed by a registered builder at the discretion of the client to prevent any further damage.

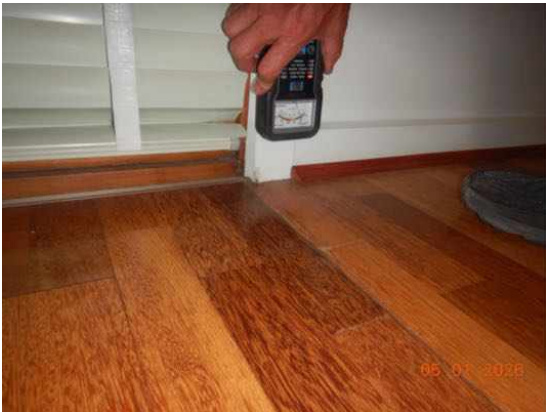
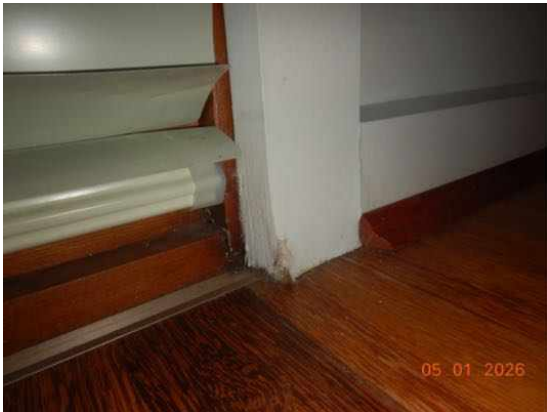
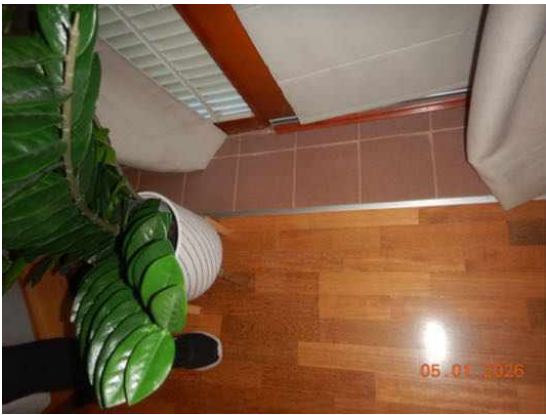
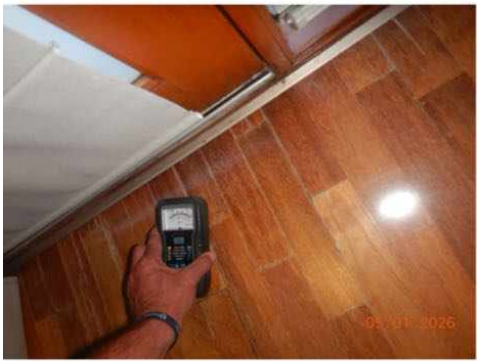
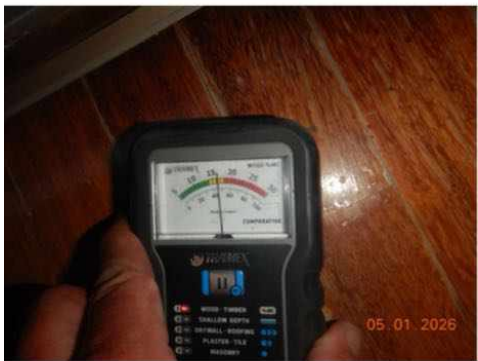
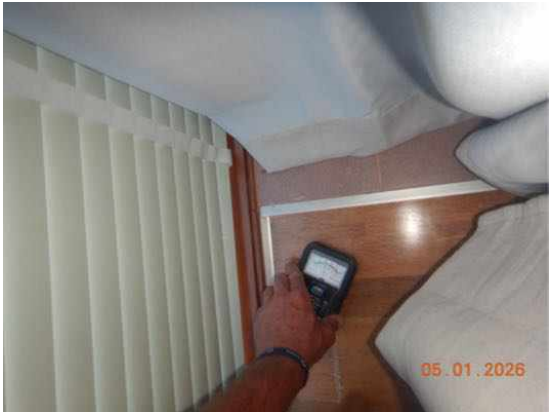
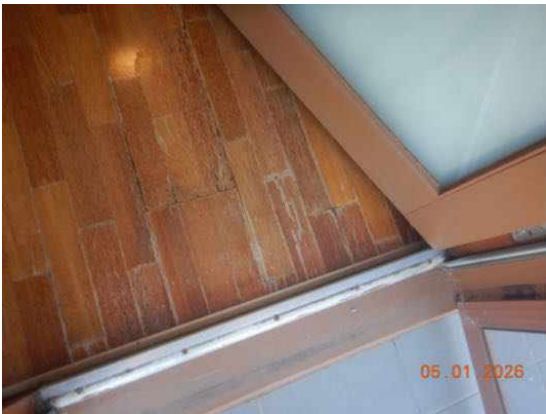
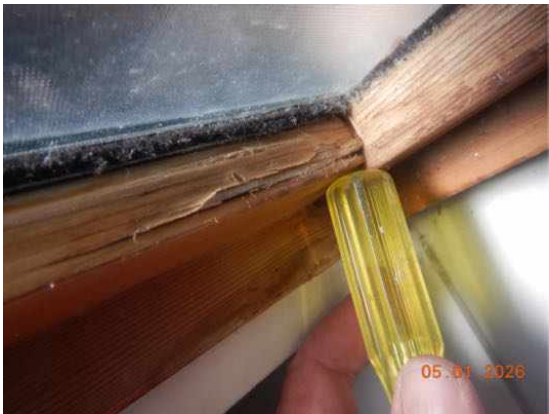
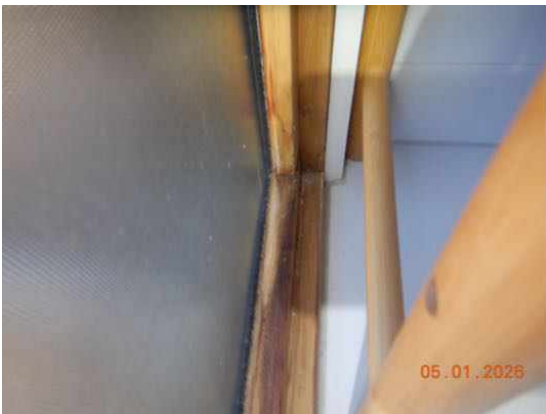
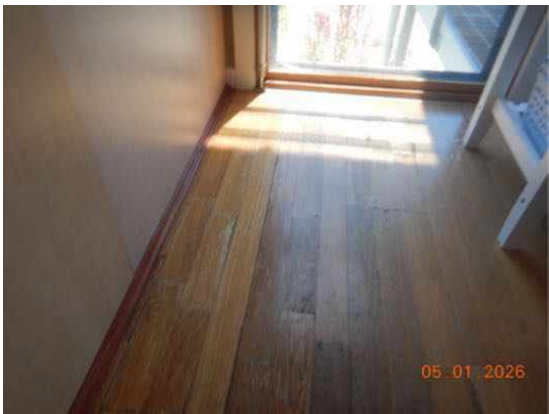
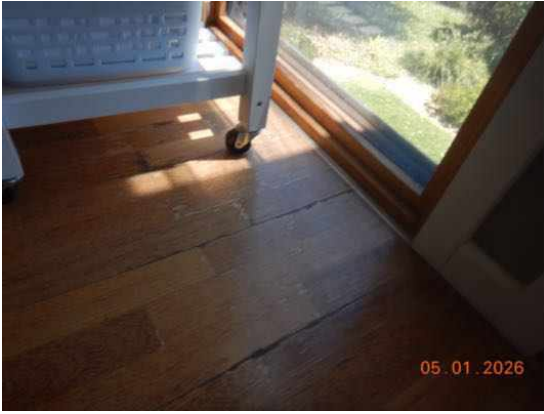
Finding 7.02

Building: Building 1
Location: All Areas
Finding: Building element - Swollen/ leak
Information: There is swelling evident to several internal window/ door frames, architraves and also damage to adjacent flooring evident. Moisture to these areas generally occurs when windows, balconies or other exterior elements leak which is not uncommon where buildings are subject to excessive wind and rain pressures often found in coastal areas.

There were no high readings for moisture to these areas indicating that issues regarding moisture ingress may have been managed and should be monitored closely.

Swollen building elements generally indicate that the building materials have been affected by excessive moisture over a prolonged period of time, and have swollen as a result. The formation and development of mould/fungi or mildew is also a likely consequence of excessive moisture.

Excessive moisture is likely to lead to the development of secondary damage to any associated building elements, which may necessitate major reparation works if prolonged.

Rectification of the cause of the water leak should be addressed prior to any remedial works to the swollen building elements. A licensed plumber should be appointed immediately to identify the cause of the leak and provide advice on remedial works as necessary, Repair and/or replacement of swollen building elements should be conducted as a matter of maintenance by a registered builder or qualified carpenter.
