## Building Inspection Report

Inspection Date: Mon, 23 Feb 2026

Property Address: 35 Prince Charles St, Morphett Vale SA  
5162, Australia

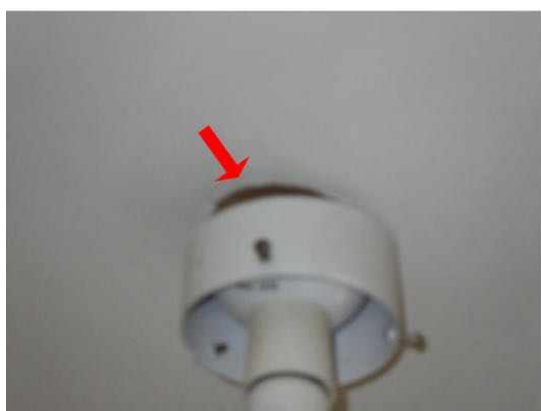
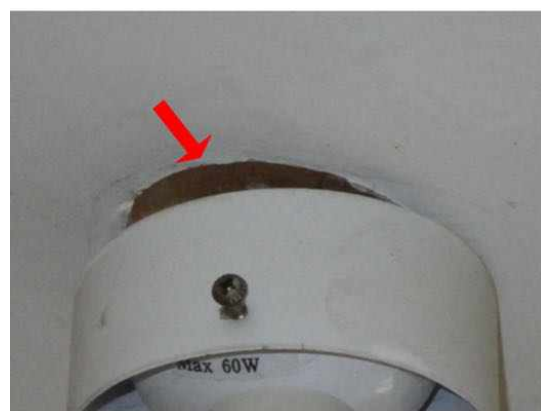
#### Defects 1.01

Building:	Building 1
Location:	All Internal Areas
Finding:	Electrical fitting - Broken/ Loose from its original fixing
Information:	The electrical fitting in this laundry area was found to be broken/ loose from its original fixing at the time of inspection. Breakage occurs generally when the building materials have aged and decayed, but may also be indicative of impact damage to the building element (accidental or deliberate).

Left unmanaged, the fitting is unlikely to cause further damage to surrounding building elements. However, the broken fitting does expose electrical works, and may create a safety hazard if there is potential contact with persons in the area.

Repair and/or replacement of the broken fitting is advised. A Licensed electrician should be appointed to repair/replace the fitting immediately.

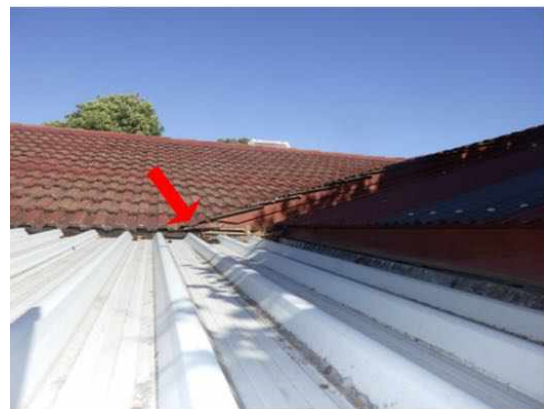
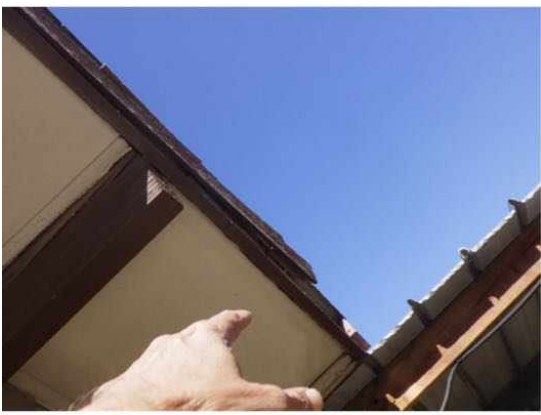
### Defects 2.01

Building:	Building 1
Location:	All External Areas
Finding:	Roof plumbing - Flashing inadequate
Information:	At the time of inspection it was noticed some sections of the roof are missing or have inadequate roof flashings. Flashings are metal and other materials which are applied to seals and intersections between roof coverings and building elements. They are designed to aid in weatherproofing of roof joins.

Flashings that are not installed adequately or are missing are likely to result in water penetration to the interior of the property, as well as creating excessively damp conditions against the exterior surfaces and around the base perimeter of the building.

Premature ageing and secondary building defects are imminent where roof plumbing is missing or inadequately installed. Additionally, water pooling also creates an environment that is susceptible to termite and pest infestation.

A roofing plumber should be appointed as soon as possible to install relevant roof plumbing materials, ensuring that no further damage is sustained.

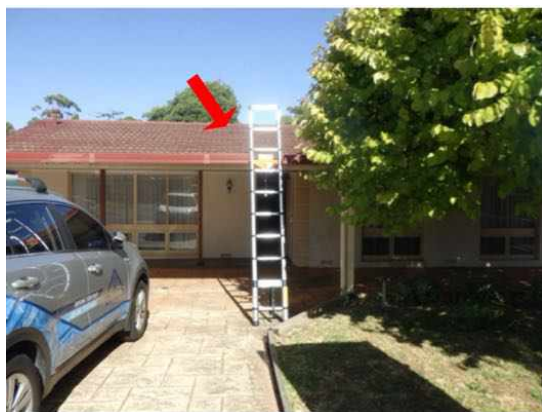
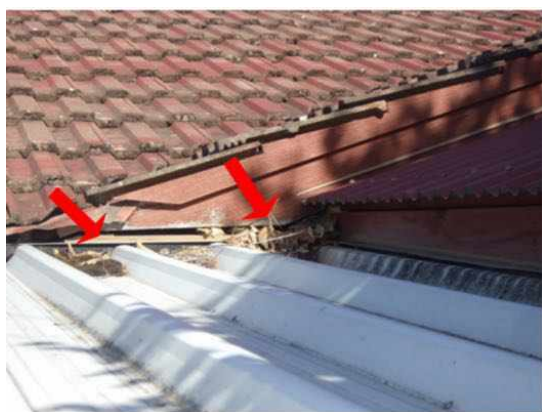
Defects 2.02

Building: Building 1  
Location: All External Areas  
Finding: Gutters - Blocked  
Information: At the time of inspection it was noticed that gutters were blocked in few sections around the property. Gutters have to be cleaned in regular intervals

Blocked gutters are likely to lead to high levels of moisture in the affected areas. Such moisture will not only cause rust and decay of the associated building materials, but can also provide conditions that are conducive to termite and timber pest activity. Blockages in gutters should therefore be removed immediately to ensure dry conditions are maintained.

Consult a Licensed Plumber for further specific advice on remedial works that may be required. In the interim, it is highly advised that blocked gutters be removed by the homeowner or a general handyperson as a matter of urgency.

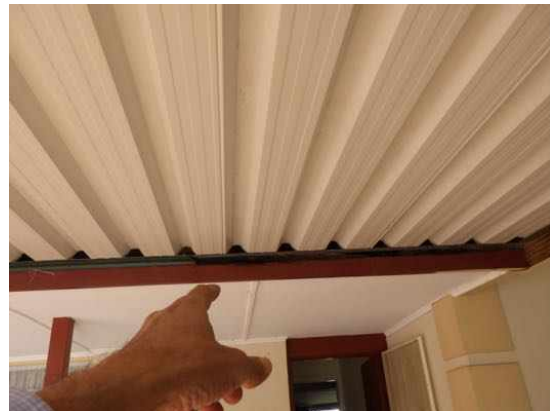
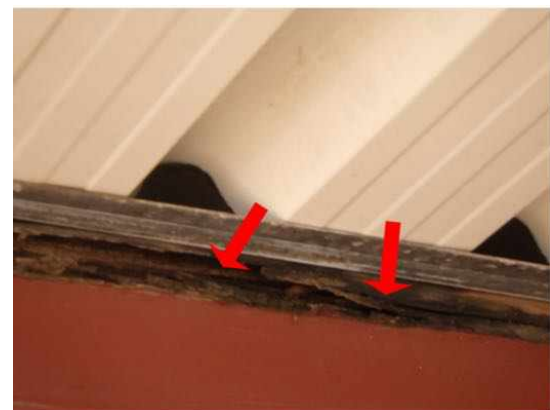
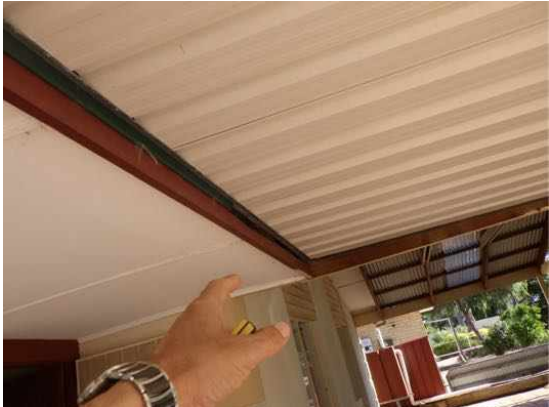
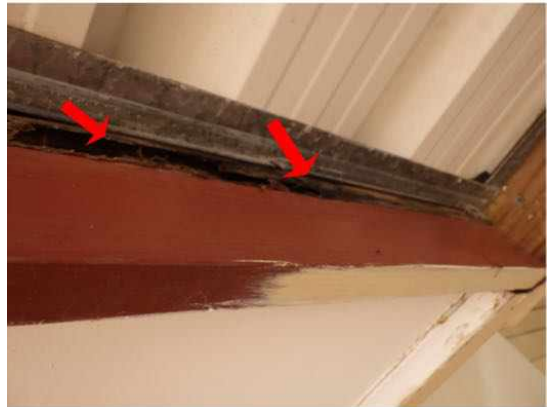
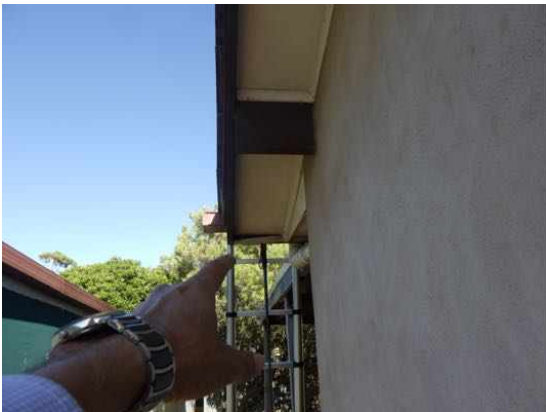
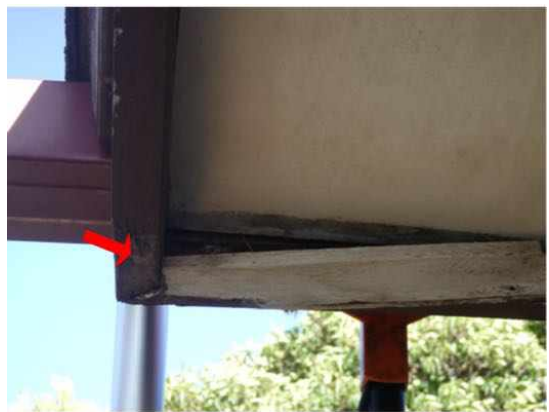
**Defects 2.03**

Building: Building 1  
Location: All External Areas  
Finding: Wood rot  
Information: This building element shows evidence of wood rot. Wood rot, also known as Fungal Decay, occurs when timbers and other cellulose building materials are exposed to damp conditions on an ongoing basis. This could be the result of exposure to weathering over a prolonged period of time, or the attraction of excessive moisture from other abutting building materials. Contributing factors also include poor air ventilation in the area.

Wood rot is often associated with general damp problems and is evidenced by a 'musty' smell or mould and mildew occurring on surfaces. If left unmanaged, damp conditions can lead to further health problems and the decay of timbers will continue.

Early intervention and regular maintenance, particularly of exterior timbers, will prolong the useful life of these building elements. Prior to any works being performed, the cause of the moisture that has created the visible wood rot should be identified and addressed in a suitable manner. Replacement of affected timbers may then be a necessary step in protecting surrounding building elements from such deterioration.

A qualified plumber may be appointed to assess the cause of excessive moisture and to provide advice on any remedial works as required. A qualified carpenter or registered builder may also be required to replace affected building materials.

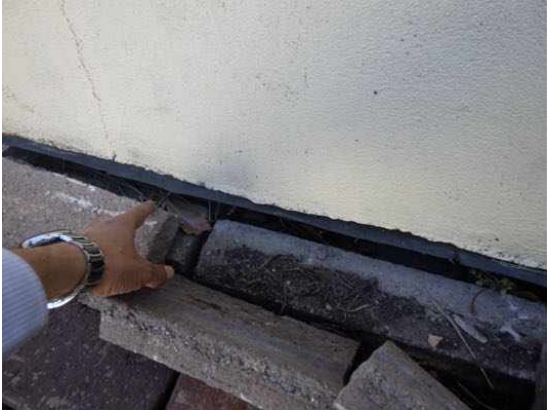
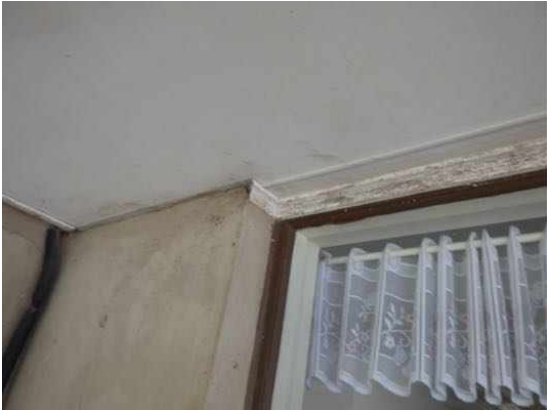
## Defects 2.04

Building:	Building 1
Location:	All External Areas
Finding:	Living area - External walls - Damaged
Information:	At the time of inspection it was noticed that sections of living area external walls were damaged.

Apart from that it was also noticed that paving were loose from its original fixing in this living area external walls.

Breakage occurs generally when the building materials have either aged and decayed, or as a result of damage (accidental or deliberate).

Repair and/or replacement of broken elements is advised to ensure that additional secondary defects do not arise as a consequence. Such works are necessary, as all building elements play a key role in the operation and function of the overall structure and its performance.

A relevant tradesperson should be appointed as soon as possible to repair or replace the affected building element prior to any subsequent damage being caused.

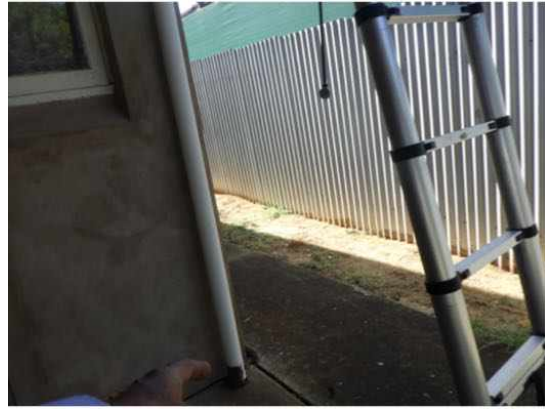
Defects 2.05

Building: Building 1  
Location: All External Areas  
Finding: Site drainage - Inadequate  
Information: The site drainage in this area was found to be inadequate at the time of inspection, creating potential for subsequent water damage to associated building elements.

Where site drainage is inadequate, installation of an Agricultural (Aggie) Drain may be required. A qualified plumber should be appointed to further inspect the property and perform any remedial works as necessary. Water damage and secondary defects are likely to occur if left unmanaged.

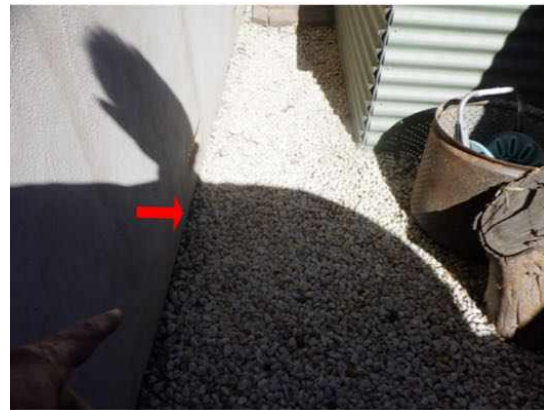
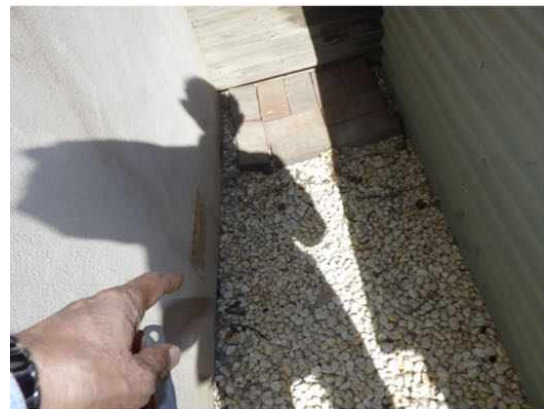
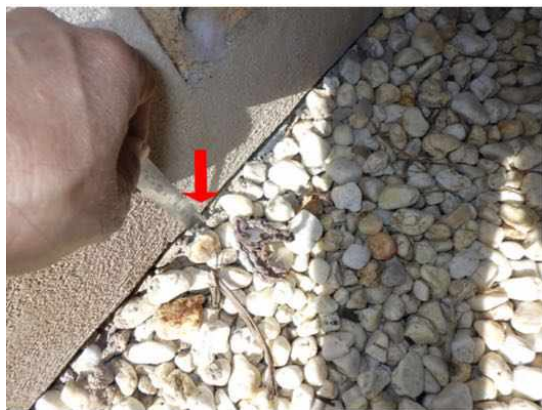
### Defects 3.01

If the slab edge is not properly exposed there is a high risk of termite attack. Sometimes, in order to determine the type of slab, a suitably qualified person such as an architect or builder may be required to consult the construction plans.

Where the slab edge cannot be properly inspected, it is highly recommended that termite or timber pest inspections be carried out every 6-12 months to aid protection of the property against infestation.

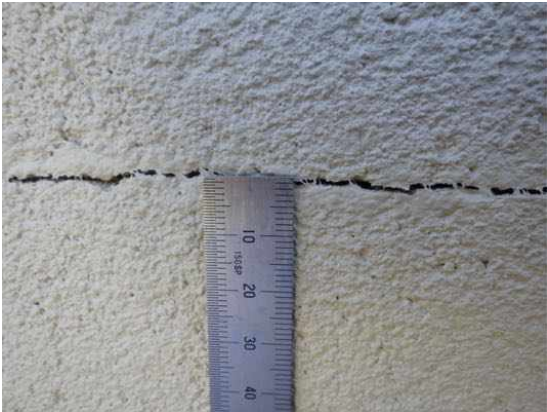
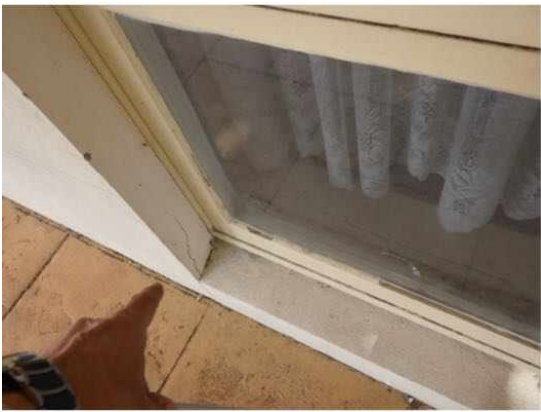
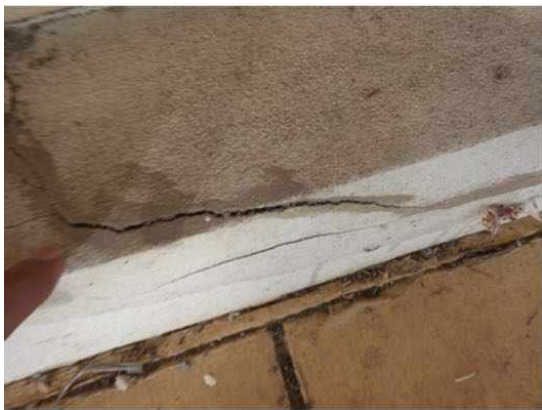
### Defects 3.04

Building:	Building 1
Location:	All External Areas
Finding:	Damage to Masonry Walls (Cracks)- Category 2
Information:	It has been observed that damage to masonry walls caused by movement of slabs, footings, or other causes, has occurred. The degree of damage falls within Category 2, described as noticeable cracks which are easily filled. Such cracking may cause doors and/or windows to stick slightly, and are generally less than 5mm in width.

Damage of this category is required to be monitored for a period of 12 months, after which time a crack rated at Category 2 or above is considered a defect requiring rectification, such as minor repairs and repointing. Always contact your building

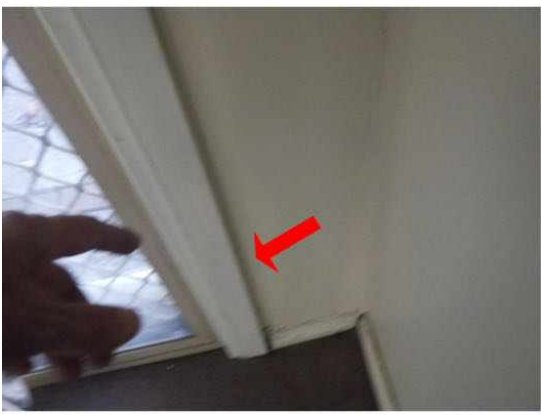
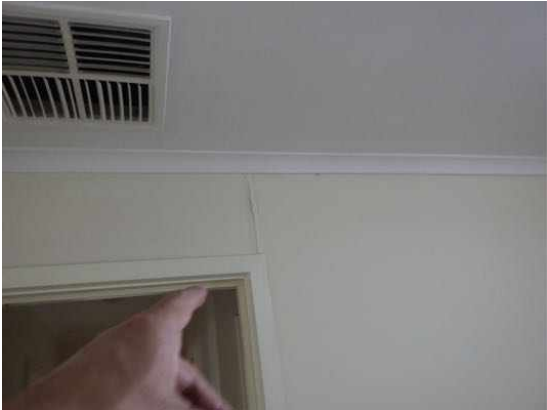
Defects 3.05

Building: Building 1  
Location: All Internal Areas  
Finding: Internal walls & Ceilings - Damaged/ Cracked  
Information: At the time of inspection it was noticed that few sections of internal walls and ceilings were damaged / cracked around the property.

Breakage occurs generally when the building materials have either aged and decayed, or as a result of damage (accidental or deliberate).

Repair and/or replacement of broken elements is advised to ensure that additional secondary defects do not arise as a consequence. Such works are necessary, as all building elements play a key role in the operation and function of the overall structure and its performance.

A relevant tradesperson should be appointed to repair or replace the affected building element prior to any subsequent damage being caused.

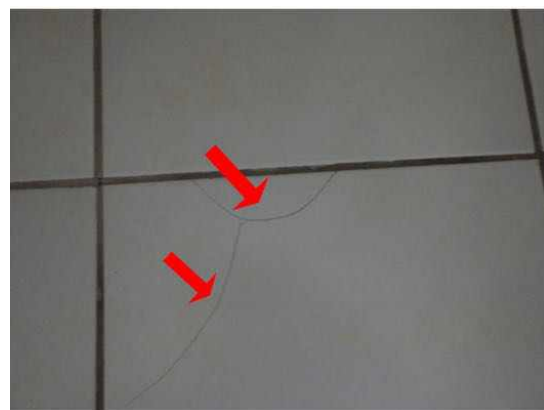
### Defects 3.06

Building:	Building 1
Location:	All Internal Areas
Finding:	Tiles - Cracked or damaged
Information:	Cracking was evident to the tiling in this area at the time of inspection. While the cracking appears to be minor, this area is frequently exposed to water, allowing potential for water penetration into adjoining sections of walls or flooring.

If left unmanaged, water penetration to these areas may lead to subsequent water damage, which is likely necessitate repair work to affected building elements.

A tiling contractor should be appointed to ensure that no further water damage occurs. The re-application of silicone and grouting throughout remaining tile work is also advised, to further protect the area against water penetration.

Where water penetration has led to water damage, appointment of a relevant tradesperson may be required to repair damaged building elements.

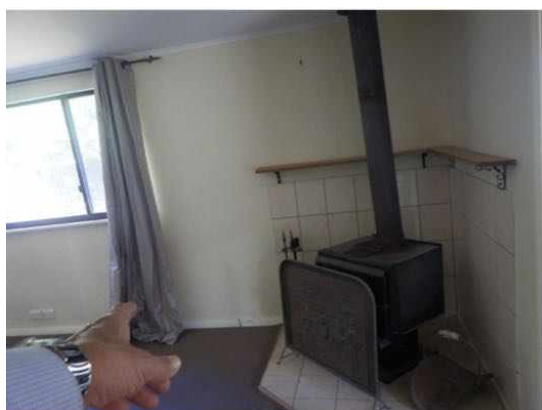
### Defects 3.08

Building:	Building 1
Location:	All Internal Areas
Finding:	Building element - Swollen
Information:	Swollen building elements generally indicate that the building materials have been affected by excessive moisture over a prolonged period of time, and have swollen as a result. The formation and development of mould/fungi or mildew is also a likely consequence of excessive moisture, which may pose major respiratory issues for occupants, particularly the elderly, the very young and those with existing illnesses and could be potential health safety hazards. In these cases an appropriately qualified inspector/tester should also be contacted for advice and/or technical assistance.

The structural integrity of swollen building elements can not be guaranteed, and further damage is likely to develop if left unmanaged. Excessive moisture is likely to lead to the development of secondary damage to any associated building elements, which may necessitate major reparation works if prolonged.

Rectification of the cause of the water leak should be addressed prior to any remedial works to the swollen building elements. A licensed plumber should be appointed immediately to identify the cause of the leak and provide advice on remedial works as necessary, Repair and/or replacement of swollen building elements should be conducted as a matter of urgency by a registered builder or qualified carpenter.

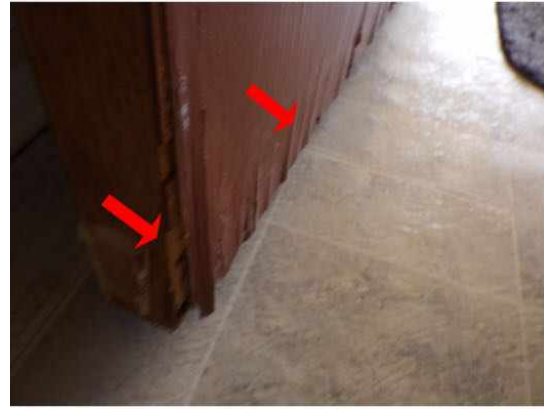
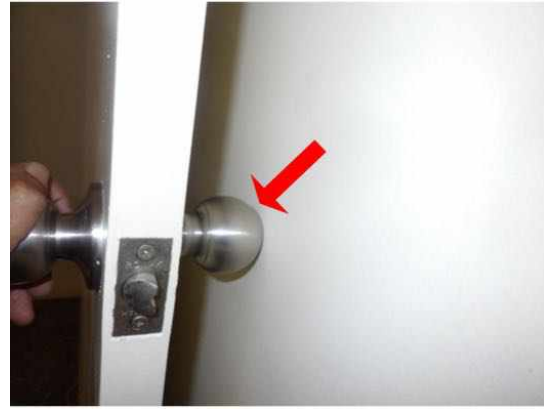
### Defects 3.09

Building:	Building 1
Location:	All Internal Areas
Finding:	Door stop - Missing
Information:	The door stop is missing or is inadequate to stop the door handle from damaging the wall. Although some building elements may seem irrelevant or unnecessary, all building elements play a key role in the operation and function of the overall structure and its performance.

Re-installation or replacement of the door stop is advised as soon as possible to prevent any subsequent damage to the door or associated structures. A general handyman may be appointed to perform these works at client discretion.

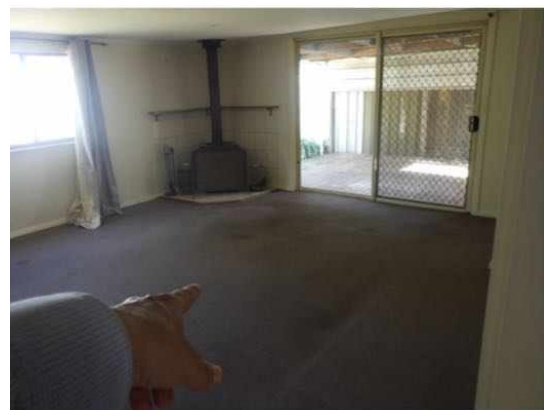
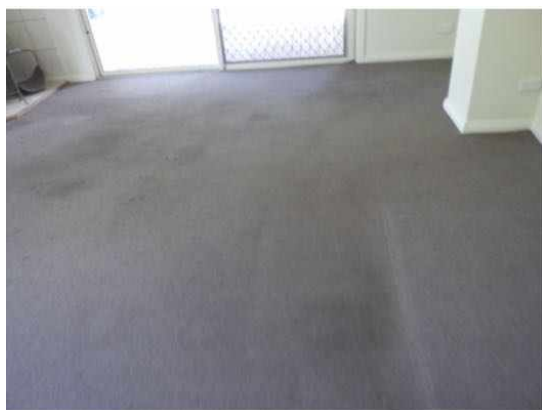
### Defects 3.10

Building:	Building 1
Location:	All Internal Areas
Finding:	Carpet - Deteriorated
Information:	Sections of the carpet floor covering in this area appeared to be mouldy. It is suspected that the presence of excessive moisture, possibly due to an internal water leak, has created an environment conducive to mould/fungi growth.

Mould presents as a health hazard and may create potential for respiratory difficulties.

Prior to any remedial works being completed, it is essential that a licensed plumber further inspect the area and identify the cause of the excessive moisture, as well as identifying any underlying issues that may be associated.

Replacement of the affected carpet is required as a matter of urgency to ensure the safety of the area. Where required, remedial works should be undertaken to any associated walls and flooring showing evidence of mould.

Where mould is excessive, further inspection by an Environmental Health inspector is advisable.

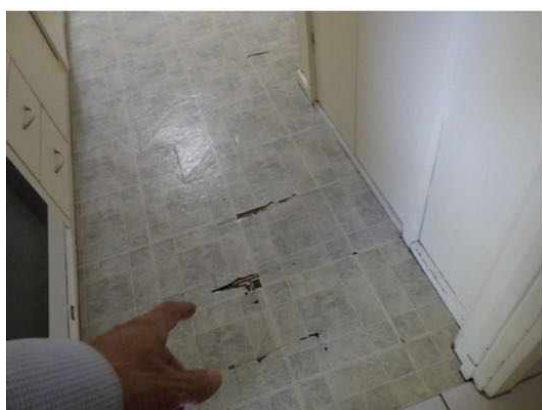
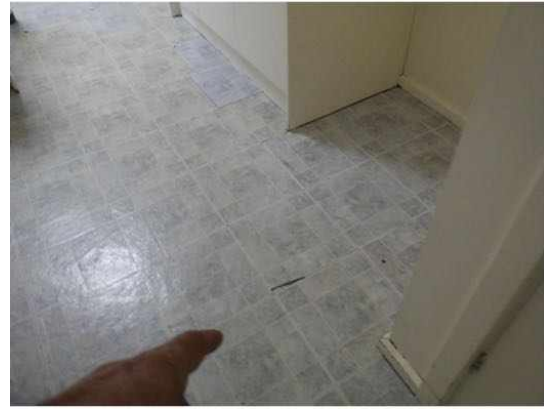
### Defects 3.11

Building:	Building 1
Location:	All Internal Areas
Finding:	Flooring - Damaged
Information:	At the time of inspection it was noticed that few sections of flooring was damaged / deteriorated around the property .

Breakage occurs generally when the building materials have either aged and decayed, or as a result of damage (accidental or deliberate).

Repair and/or replacement of broken elements is advised to ensure that additional secondary defects do not arise as a consequence. Such works are necessary, as all building elements play a key role in the operation and function of the overall structure and its performance.

A relevant tradesperson should be appointed to repair or replace the affected building element prior to any subsequent damage being caused.

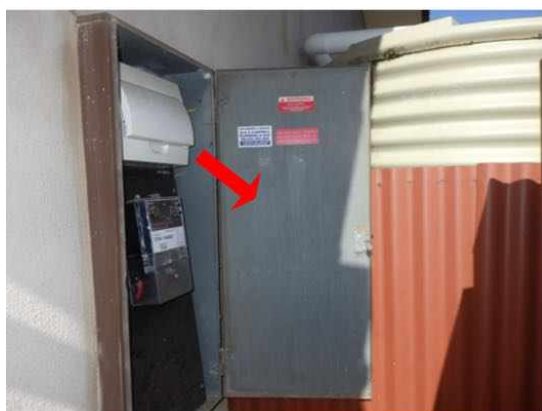
#### Noted Item

Building: Building 1  
 Location: All External Areas >  
 Finding: Termite Management System - No evidence of a chemical installation  
 Information: The application of a post-construction chemical termite barrier is highly recommended for all properties, particularly if live termite activity has been found on the site previously. Such barriers are highly effective in preventing termite attack on any timber building elements throughout the property.

A durable notice should be placed in the switchboard unit to indicate current termite barriers. At the time of inspection, it appeared as though no termite management system has been installed, with no evidence to suggest preventative works taking place.

The client may consider gaining further advice from a pest controller as to the costs and procedures involved with this application. It is recommended that obtaining such advice be a short-term priority.

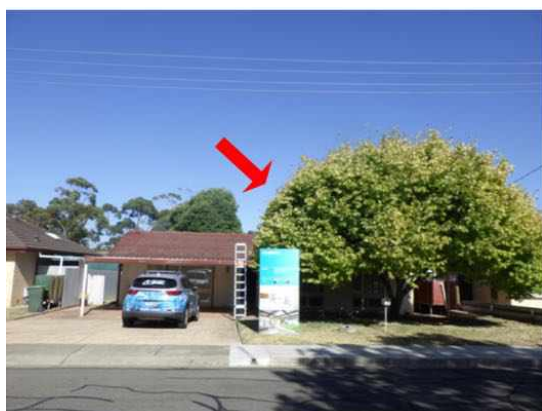
### Noted Item

Gutters are a critical part of the building's management of storm water and rain. It is therefore important that they be kept clear to prevent secondary damage to associated building elements, including exterior and interior walls, ceiling linings and any adjoining building elements. Where gutters are blocked, pooling of rainwater is likely to occur, fast-tracking rust and corrosion of the roof plumbing elements.

It is highly advised that all overhanging tree branches be removed as soon as possible to prevent any further damage. Repair and/or replacement of sections of damaged guttering may also be required where the extent of the damage necessitates.

Such works should be performed by the homeowner; however, appointment of a landscape contractor or an arborist may be required. Consultation with a licensed roof plumber is required where guttering has been damaged.
