Building and Timber Pest Inspection Report

Inspection Date: Mon, 16 Mar 2026

Property Address: 614/2 Studio Dr, Eastgardens NSW 2036,
Australia

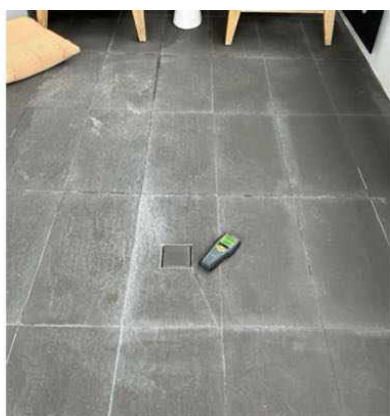
Building: Main Building
Location: Balcony bedroom , Lounge Balcony
Finding: Balcony Elevated Moisture - Strata - Further investigation recommended
Information: Elevated moisture was recorded at the base of the balcony wall and tiles, with associated staining consistent with water exposure including deteriorated grout and efflorescence . While no internal damage was visible at the time of inspection, balconies in multi-unit dwellings are high-risk areas for waterproofing failure, which can lead to leaks into adjoining units and significant rectification costs. Further investigation by a licensed waterproofing contractor is strongly recommended.

Depending on the strata plan, this area may form part of the common property, in which case remedial responsibility may rest with the owners corporation (strata). Purchasers should seek clarification from the strata manager and legal adviser prior to purchase.

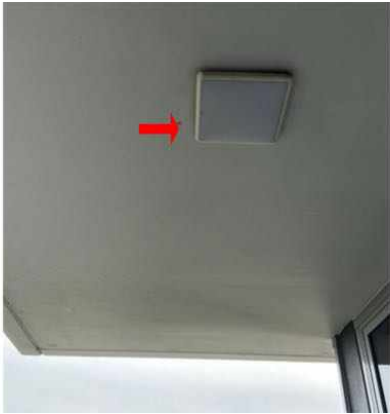
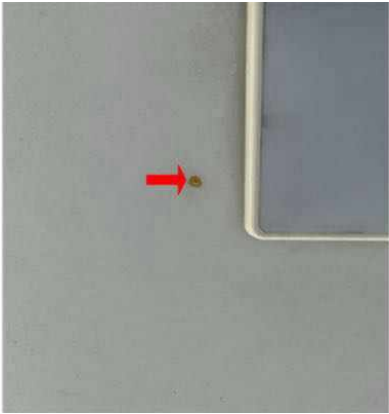
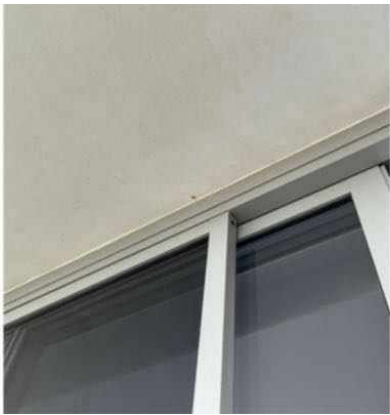
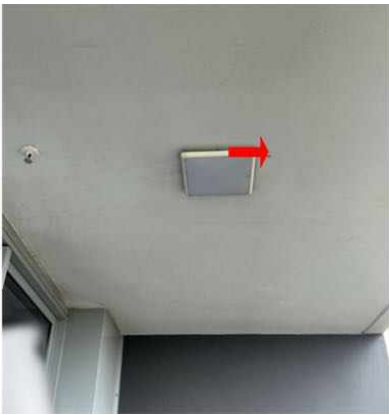
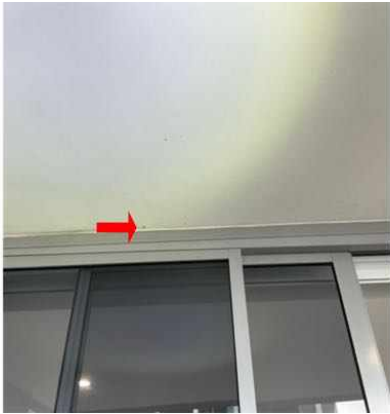
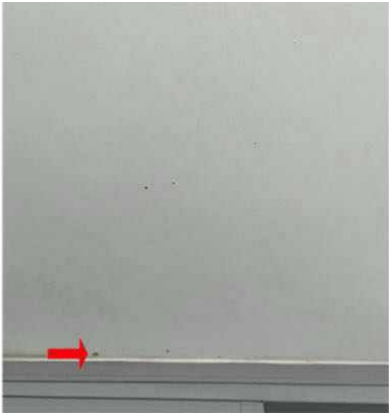
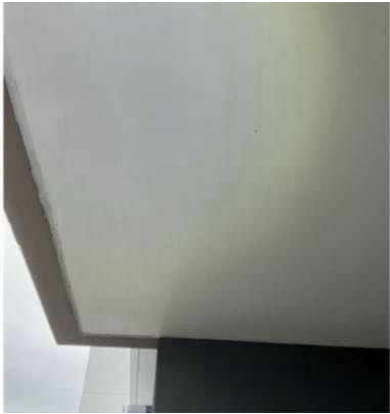
Building: Main Building
Location: Balcony x 2
Finding: Rust Staining & Elevated moisture - Requires further investigation
Information: Elevated moisture , minor staining and marks appearing consistent with possible screw penetrations with rust staining through paint was noted at the time of inspection. No symptoms of concrete spalling was observed. Recommend the Owners Corporation engage a painter or remedial contractor to seal any exposed steel and apply an appropriate external-grade coating during routine maintenance.

Further investigation by a remedial engineer or licensed waterproofing contractor is recommended to understand cause of elevated moisture.

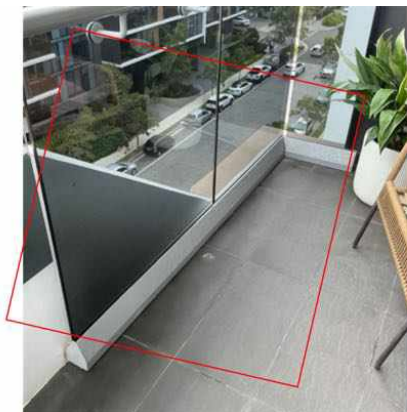
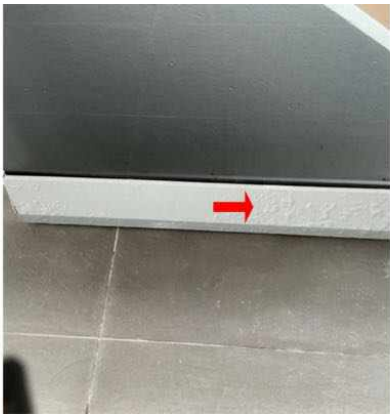
Finding 3.03

Building:	Main Building
Location:	Balcony
Finding:	Painted surface - Bubbling and possible rusting
Information:	Sections of paint in this area was found to have bubbled and deteriorated. Paint bubbling is generally an indication of excessive moisture in the area, that is currently hidden by the painted surface.

The presence of excessive moisture can have major implications on associated building elements if left unattended. While only seemingly minor at this stage, the damage cannot be determined due to the paint obstructing any further inspection of the damage.

It is highly advised that the affected paint be cleaned to allow a further, more invasive inspection by a licensed plumber. Failure to act on this defect may necessitate major works in the future.

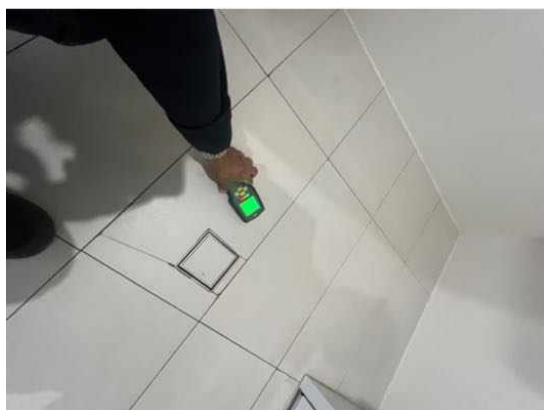
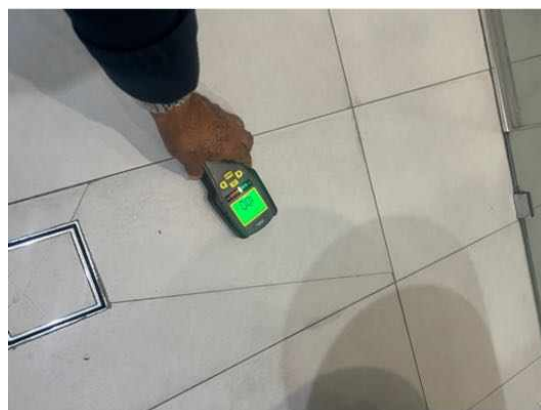
Building:	Main Building
Location:	Bathrooms, Laundry
Finding:	Elevated Moisture Bathroom (No visible deterioration noted)
Information:	Elevated moisture levels were detected to tiled surfaces in bathroom/shower areas. Persistent moisture ingress can lead to concealed damage, including timber rot and mould growth.

Elevated moisture readings in tiled wet areas can occur from normal shower use, age/deterioration of waterproofing membranes, plumbing leaks or moisture absorption through grout lines. While no damage was visible, elevated readings may indicate moisture retention behind tiles, which can be a conducive condition for future deterioration if not monitored.

Monitor the area over time for signs of drumming, efflorescence, tile movement, or grout deterioration. A licensed waterproofing specialist can perform further investigation (e.g., pressure testing, membrane assessment) to understand the cause of elevated moisture.

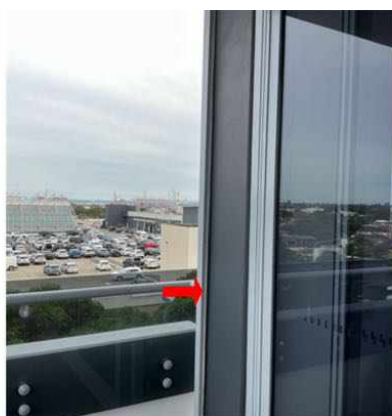
Finding 3.06

Building:	Main Building
Location:	Balcony
Finding:	Building element - Damaged - Gap between window and wall possible moisture ingress
Information:	Breakage occurs generally when the building materials have either aged and decayed, or as a result of damage (accidental or deliberate).

Repair and/or replacement of broken elements is advised to ensure that additional secondary defects do not arise as a consequence. Such works are necessary, as all building elements play a key role in the operation and function of the overall structure and its performance.

A relevant tradesperson should be appointed to repair or replace the affected building element prior to any subsequent damage being caused.

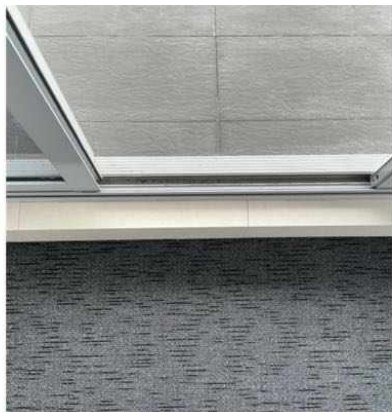
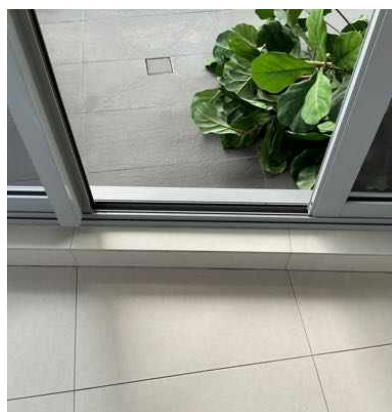
Finding 3.07

Building:	Main Building
Location:	Balcony bedroom & Lounge
Finding:	Balcony Floor Level Differential
Information:	The balcony finished surface appears to be close to, or at the same level as, the

internal floor. Standard construction practice requires a step-down of approximately 50 mm unless a fully engineered threshold drainage system is provided. No such drainage features were visible during inspection. This configuration increases the risk of water ingress, and confirmation of the balcony waterproofing detail through strata/building management is recommended.

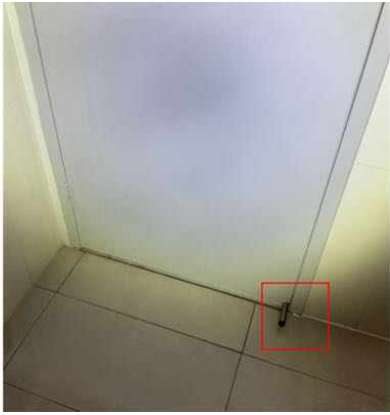
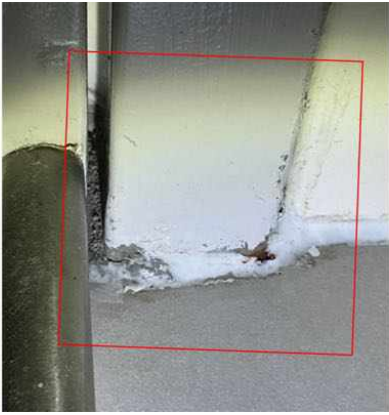
Building: Main Building
Location: All Internal Areas - Bathrooms
Finding: Wet-Area Door Jambs – Moisture Staining
Information: moisture staining and deterioration were observed at the base of the wet-area door jamb and architraves. This is commonly due to water splashing or moisture tracking from the bathroom floor into adjacent joinery or inadequate waterproof transition at the bathroom threshold.

Further inspection by a licensed waterproofing contractor is recommended to verify exact cause and remedial measures

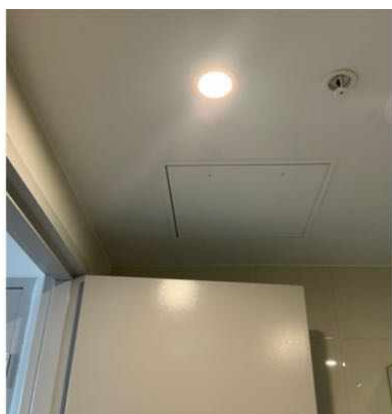
Finding 3.10

Building:	Main Building
Location:	Ensuite
Finding:	Painted surface - Bubbling
Information:	Sections of paint in this area was found to have bubbled and deteriorated. Paint bubbling is generally an indication of excessive moisture in the area, that is currently hidden by the painted surface.

Paint bubbling typically occurs due to poor adhesion, inadequate surface preparation, or minor humidity exposure during painting. No visible signs of moisture ingress or structural movement were observed at the time of inspection.

The presence of excessive moisture can have major implications on associated building elements if left unattended. While only seemingly minor at this stage, the damage cannot be determined due to the paint obstructing any further inspection of the damage.

It is highly advised that the affected paint be cleaned to allow a further, more invasive inspection by a licensed plumber. Failure to act on this defect may necessitate major works in the future.

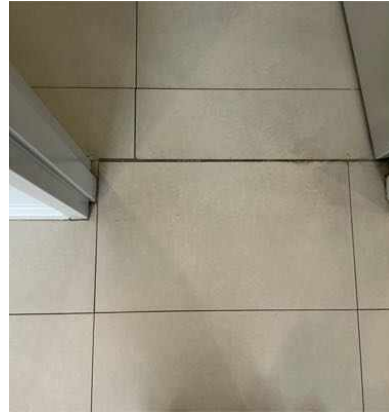
Finding 3.11

Building:	Main Building
Location:	Bathroom
Finding:	Bathroom & external floor threshold
Information:	The bathroom floor is at the same level as the adjoining timber flooring. This configuration is typical in modern apartments and is permitted where compliant waterproofing and floor falls are provided. No evidence of moisture damage was observed at the time of inspection; however, waterproofing performance cannot be confirmed without invasive inspection.

Care should be taken to avoid excessive water migration beyond the bathroom during

use.

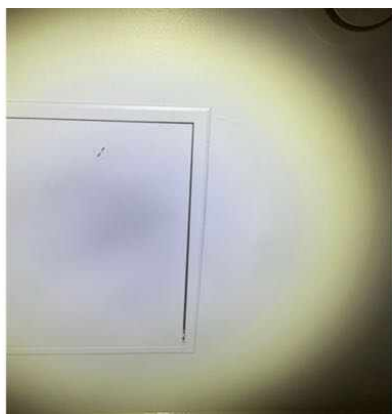
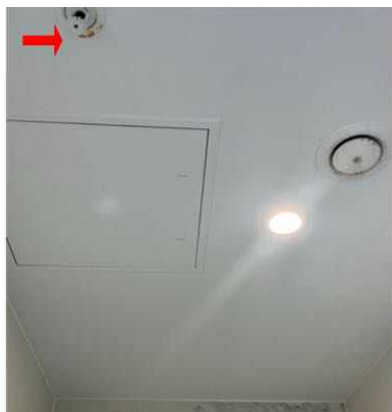
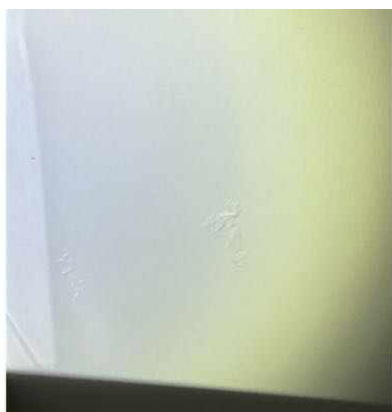
Finding 3.12

Building:	Main Building
Location:	Laundry ,bathroom, ensuite ,
Finding:	Water Staining - Humidity or Ventilation
Information:	The ceiling surface shows peeling paint and water staining on the walls faint commonly consistent with humidity-related staining, often found in bathroom or wet areas with insufficient ventilation. While there is no visible sagging or major water damage, the pattern suggests prolonged moisture exposure, possibly due to steam accumulation or minor condensation issues. According to AS 4349.1–2007 (Appendix C), this would be classified as a minor defect unless further deterioration or active leaks are found. Recommend improving mechanical or natural ventilation, cleaning the surface with mould treatment, and monitoring for recurrence.

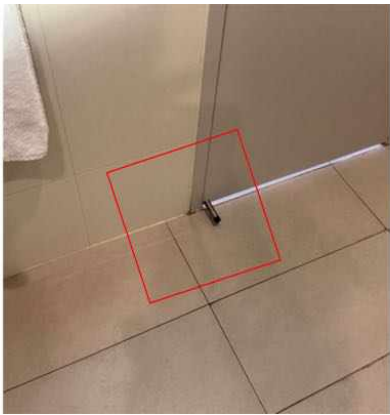
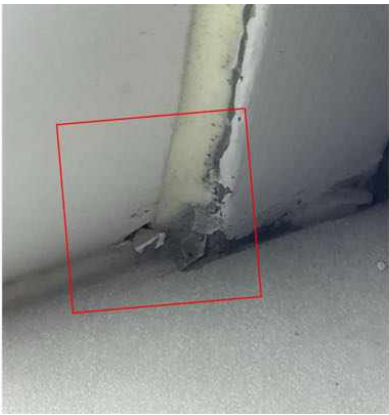
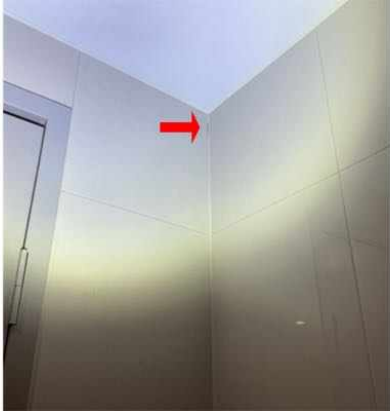
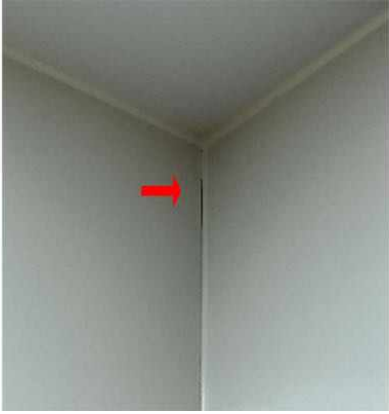
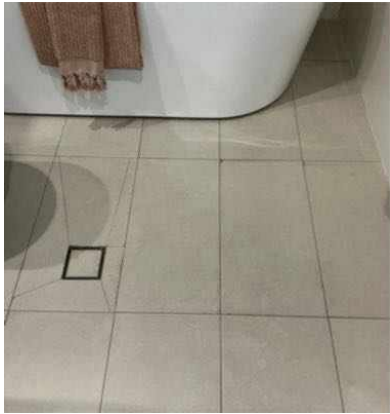
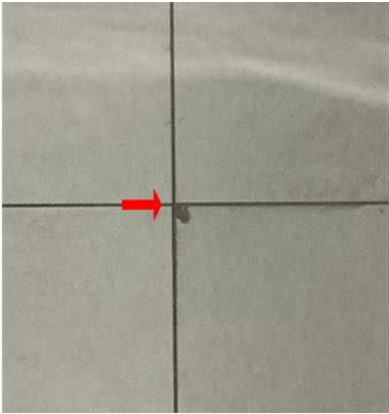
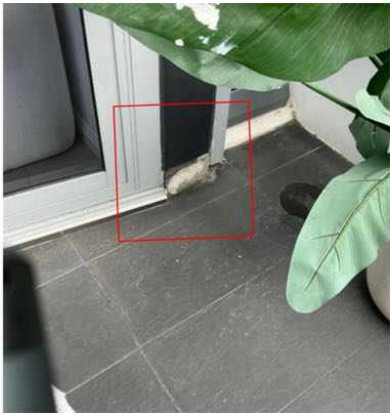
Finding 3.13

Building: Main Building
 Location: All Internal Areas - Laundry, bathroom ,ensuite, balcony front
 Finding: Tiles - Cracked or damaged
 Information: Cracking was evident to the tiling in this area at the time of inspection. While the cracking appears to be minor, this area is frequently exposed to water, allowing potential for water penetration into adjoining sections of walls or flooring.

If left unmanaged, water penetration to these areas may lead to subsequent water damage, which is likely necessitate repair work to affected building elements.

A tiling contractor should be appointed to ensure that no further water damage

Where water penetration has led to water damage, appointment of a relevant tradesperson may be required to repair damaged building elements.

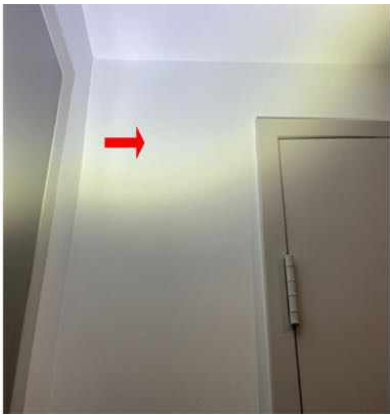
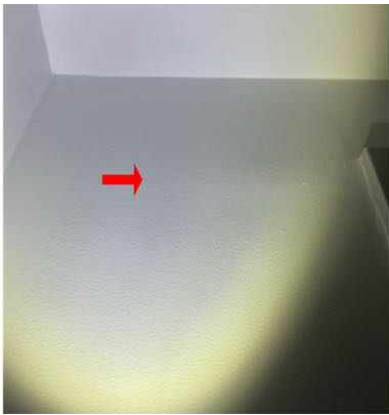
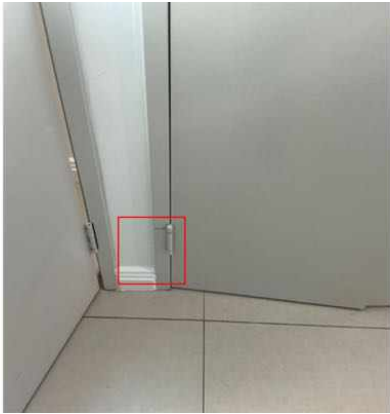
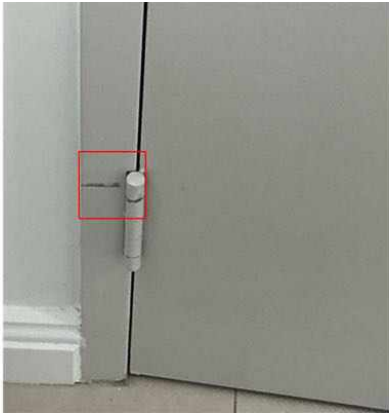
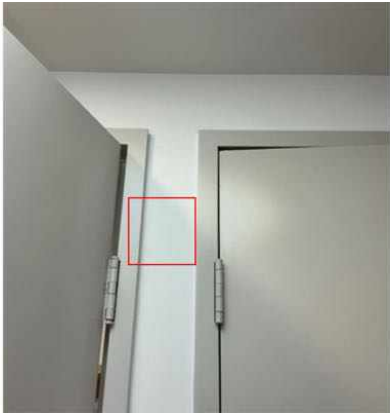
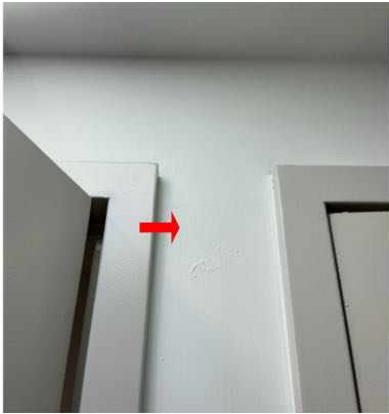
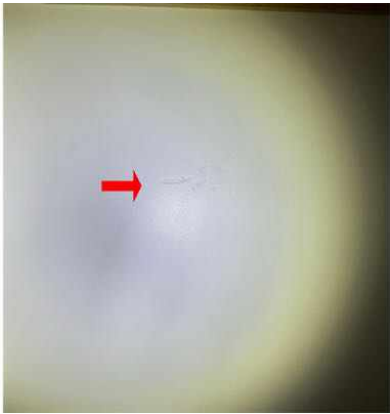
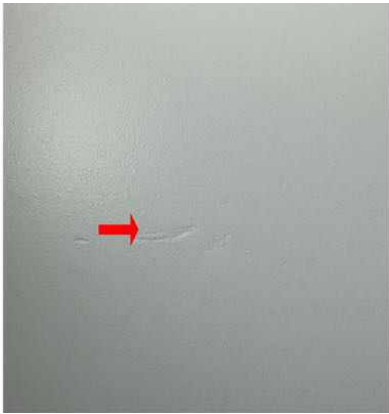
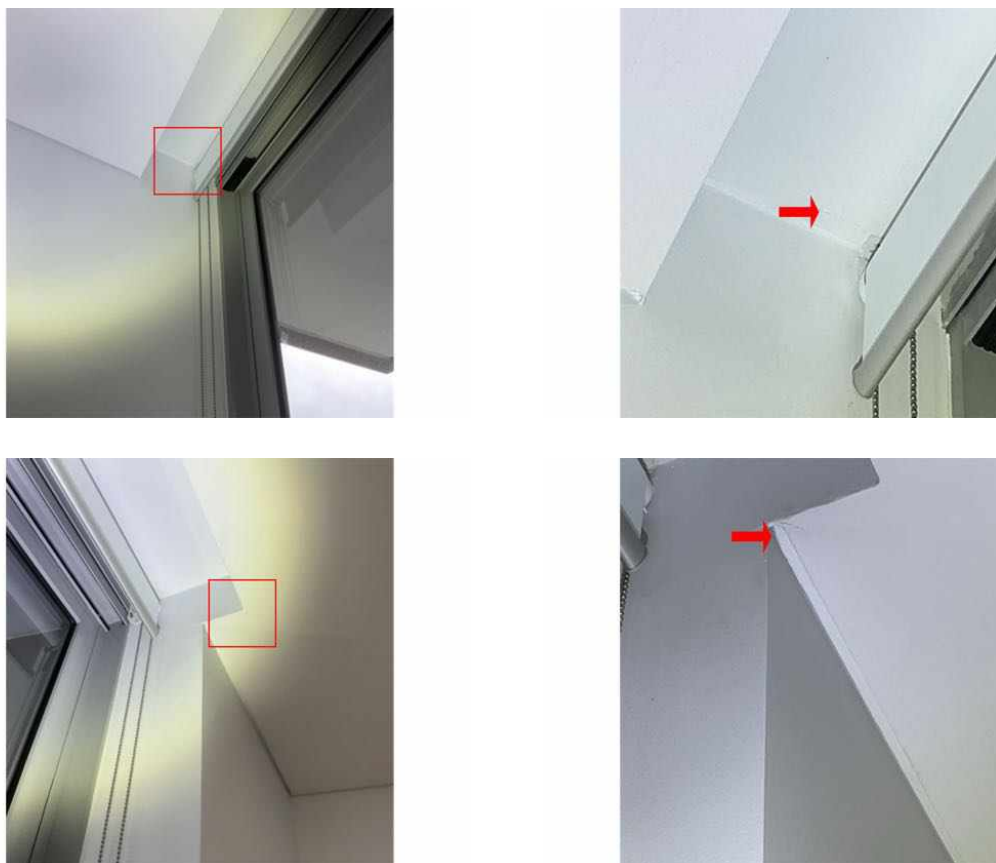
Finding 3.14

Building:	Main Building
Location:	All Internal Areas
Finding:	Paint finish and hairline cracking
Information:	The paint finish in this area was identified as being incomplete at the time of inspection including some hairline minor cracking.

Whilst incomplete or missing paint finish is generally an appearance defect, it can also lead to the development of secondary building defects over time. Incomplete areas of paint finish expose the area to moisture, potentially accelerating the deterioration of underlying building materials.

Incomplete paint finishes should be sanded back, filled, leveled and painted, as applicable. Where inadequate or missing paint protection has led to the deterioration of the associated building element, repair and/or replacement of this building element may be required.

A painting contractor should be appointed as soon as possible to perform necessary works to aid the appearance of the affected area and to ensure the area is protected against further deterioration. Alternatively, the homeowner following manufacturer instructions may perform these works.

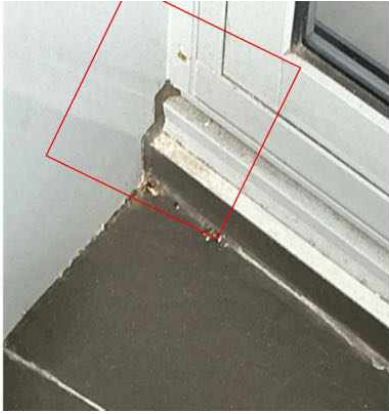
Finding 3.15

Building:	Main Building
Location:	All Internal Areas
Finding:	Sealant and grouting - Missing or degraded
Information:	It was noted on inspection that sealant or grout is degraded. There is also evidence of poor workmanship and excessive use of sealant. Silicone should never be used as a first line of defence against waterproofing. Further inspection by a licensed waterproofing contractor is highly recommended.

Different materials and floor areas move at different rates, generally causing cracking to grout or sealant at this point. A flexible sealant is required to allow for expected expansion and contraction, while keeping the joint water tight and protective of all associated building materials.

There appears to be excessive mould to the sealant and grout which will likely require scraping out and replacement.

Flexible and mould resistant materials should be applied to affected areas to prevent any subsequent water damage that is likely to occur. Regular maintenance and replacement of damage or missing or damaged sealant and grout is highly recommended to the wet areas, as this is a regular wear and tear defect. Sealant and grouting in areas that come into regular contact with water should be maintained for the long term care of your property.

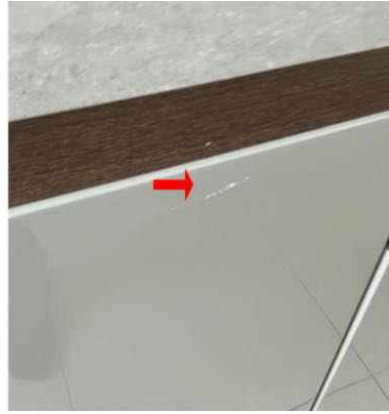
Finding 3.16

Building:	Main Building
Location:	All Internal Areas
Finding:	Building element - Damaged - Laundry no water on tap , minor scratches on kitchen cupboard to some areas , built in seal separation to some areas bedrooms
Information:	Breakage occurs generally when the building materials have either aged and decayed, or as a result of damage (accidental or deliberate).

Repair and/or replacement of broken elements is advised to ensure that additional secondary defects do not arise as a consequence. Such works are necessary, as all building elements play a key role in the operation and function of the overall structure and its performance.

A relevant tradesperson should be appointed to repair or replace the affected building element prior to any subsequent damage being caused.

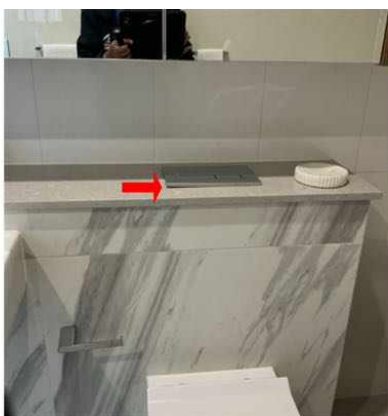
Information: The installation of this building element appears to have been completed to a substandard level of workmanship or is incomplete. Generally substandard repairs or installation are related to poor workmanship, the use of inappropriate materials, or a failure to complete installation to a suitable standard.

Where installation is substandard and/or incomplete, the client should contact the responsible trade to undertake rectification. Unfinished and substandard building works are likely to degrade more quickly and may create potential for secondary defects to associated building elements.
