Building and Timber Pest Inspection Report

Inspection Date: Mon, 23 Feb 2026

Property Address: 18 Tanglewood Place, Glenmore Park NSW
2745

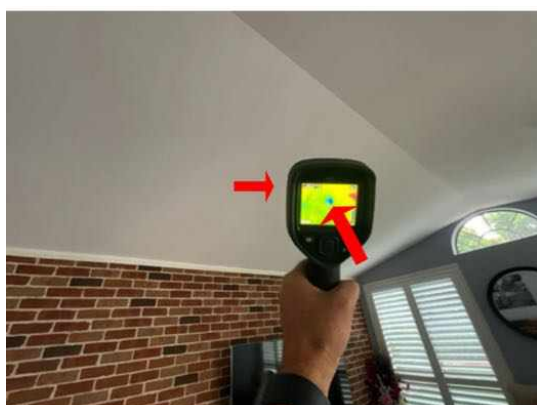
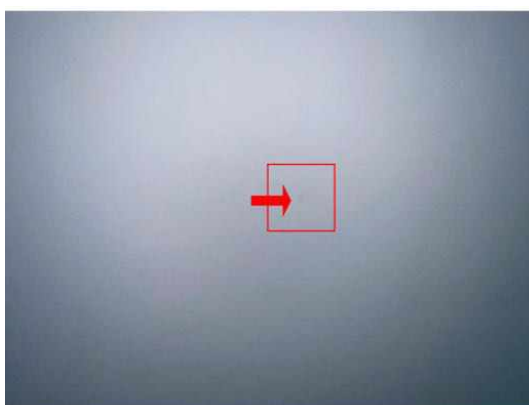
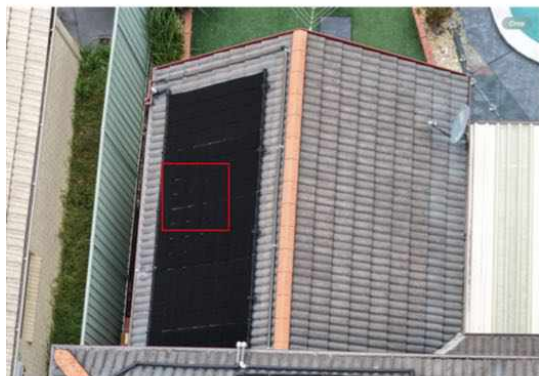
Building: Main Building
 Location: Rumpus Room
 Finding: Minor Defect – Minor Ceiling Water Staining (Skillion / Raked Roof Section)
 Information: Location:

Minor water staining was identified to the ceiling lining in this area at the time of inspection. The staining was faint and not readily visible under normal lighting conditions; however, it was detected with the assistance of a thermal imaging camera. The affected area appears isolated and limited in extent.

Water staining indicates that the ceiling lining has been exposed to moisture at some stage. Even minor or historical moisture entry can result in cosmetic staining due to mineral deposits contained within rainwater.

At the time of inspection, no active dripping or saturation was observed. Due to the faint nature of the staining and limitations of a single-point-in-time inspection, it could not be determined whether the staining is historical and inactive or indicative of intermittent moisture entry occurring during specific weather conditions.

It is recommended that a licensed roof tiling specialist be engaged to assess the tiled roof covering, flashings, and penetrations above the affected area. This may require temporary lifting or adjustment of the pool heating tubing to allow adequate inspection of the roof surface beneath.

Any identified defects should be rectified to prevent further moisture ingress.

If specialist assessment determines the staining to be historical and no active leak is present, cosmetic repair, sealing, or replacement of the affected ceiling lining may be undertaken at the client's discretion.

Monitoring of the area during and after periods of heavy or wind-driven rainfall is advised to confirm whether moisture ingress is ongoing.

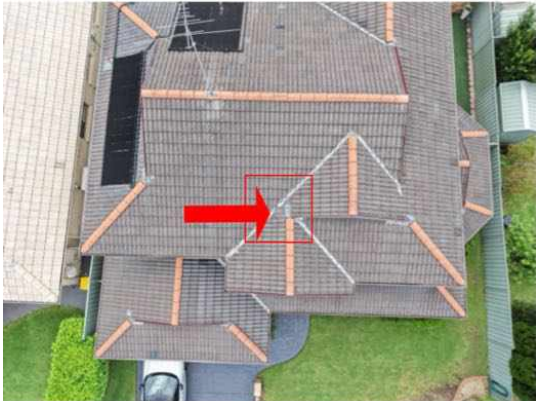
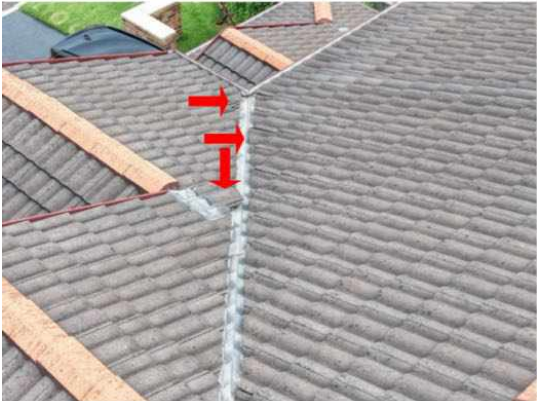
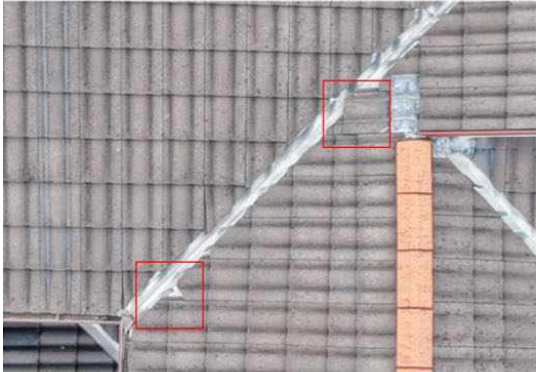
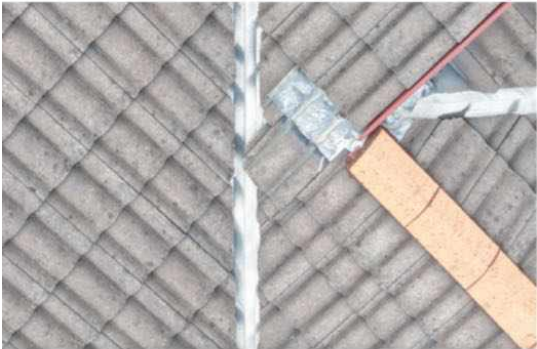
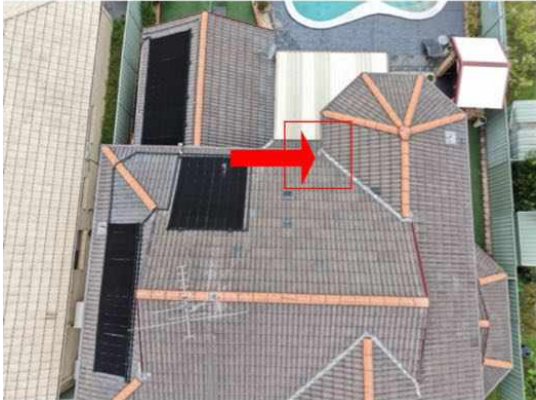
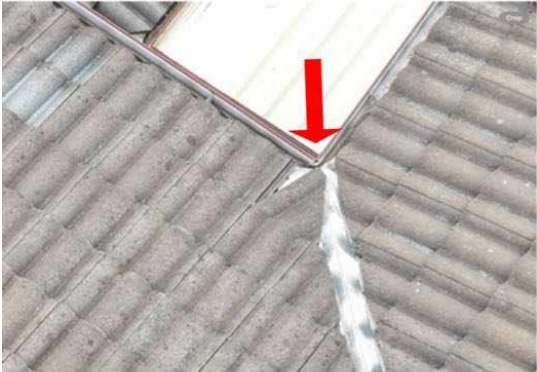
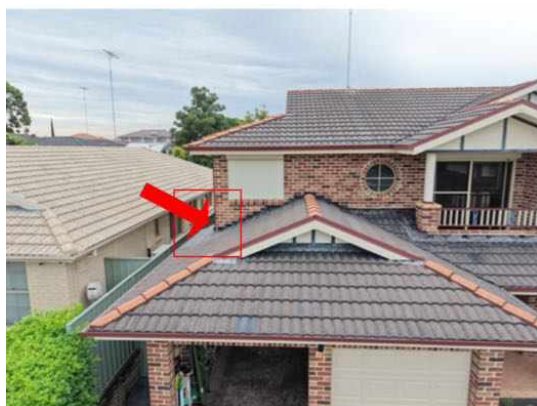
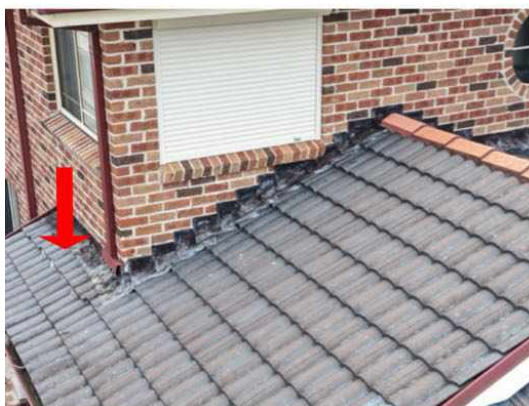
Finding 3.02

Building:	Main Building
Location:	Roof Exterior
Finding:	Roof tiles - Slipped or Dislodged Tiles.
Information:	Observation:

During the external inspection of the roof covering, it was noted that some roof tiles have slipped or moved from their original position.

Tile movement can occur due to minor causes such as:

- Broken or cracked tiles,
- Failed or deteriorated fixings,
- Movement or degradation of supporting battens.

Immediate rectification is recommended. A licensed roofing contractor should be engaged to:

- Replace or refix any loose or missing tiles, and

- Inspect the roof for any related or underlying issues that may require further attention.

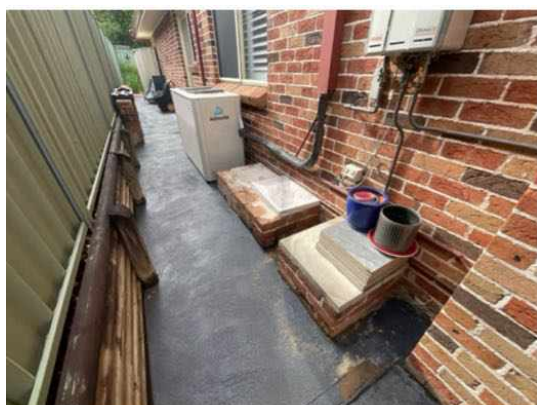
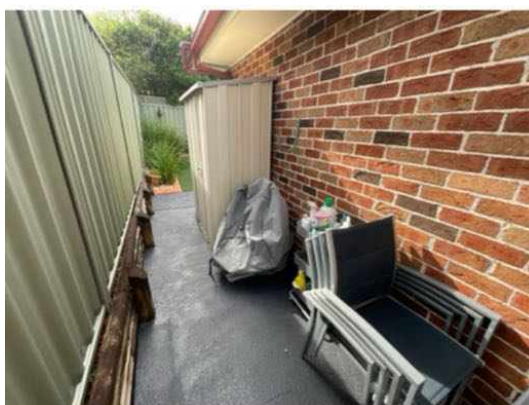
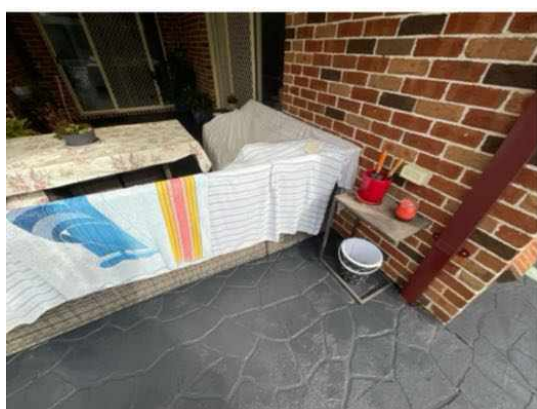
At the time of inspection, it was noted that the weep holes in the external brickwork of the property are concealed by further, stored items and/or building materials. This creates a bridging point for termites, allowing undetected access over or around the termite barrier system and into the structure. As a result, a full inspection of this area could not be achieved.

- These obstructions also provide moist, shaded environments that are attractive to termite activity.
- Moisture build-up due to covered weep holes further increases the risk of timber pest infestation and wood decay.

- All weep holes should remain exposed and unobstructed across the entire property to allow for effective drainage and visual termite inspections.
- It is strongly advised that any material or structure covering weep holes be removed promptly, and a re-inspection carried out to ensure termite entry is not occurring undetected.
- Where removal of obstructions is not feasible, it is recommended that the area be inspected regularly, ideally every 3 to 6 months, to monitor for signs of termite activity or moisture-related damage.

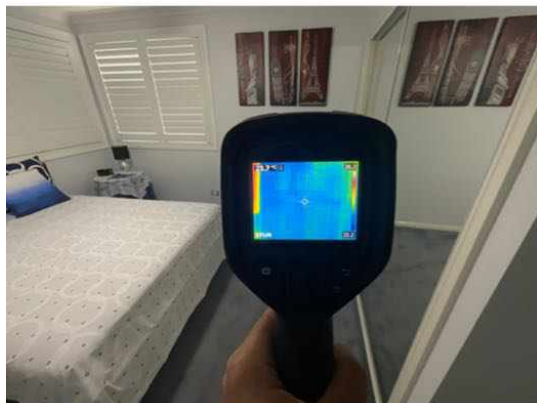
Termites release heat in the form of carbon dioxide and build mud tubes with high moisture content, which can create irregular heat patterns on surfaces such as walls, ceilings, and floors.

At the time of the inspection, no abnormalities indicating live termite activity were observed. However, it's important to note that various factors—such as obstructions, ambient temperature, and wall material/thickness—can impact the accuracy of thermal readings. In cases where surfaces are visually restricted or obstructed, a comprehensive thermal scan may not always be feasible.

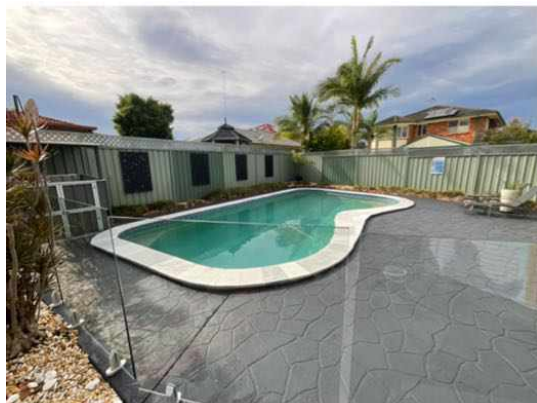
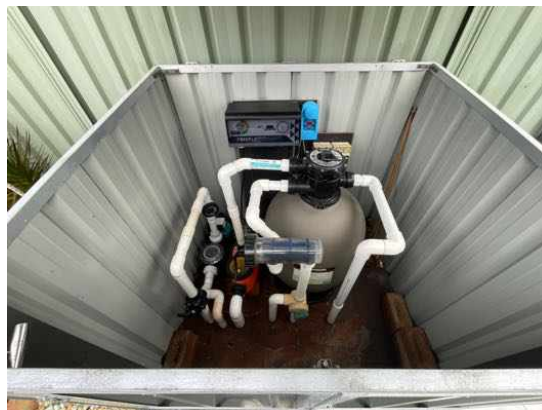
Building: Yard
 Location: Pool Area
 Finding: Swimming Pool – Excluded from Standard Building Inspection.
 Information: Observation:

- The structural condition and interior finish of the pool
- Fencing and safety barriers (including compliance with local council and legislative requirements)
- The operation and condition of pool equipment, including pumps, filters, and heating systems
- The condition of pool surrounds, paving, and drainage systems

Undertaking this inspection will help ensure that any safety, compliance, or maintenance issues are properly identified and addressed prior to finalising the property purchase.

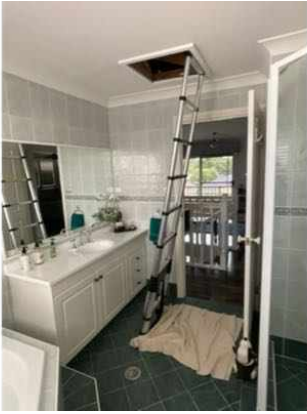
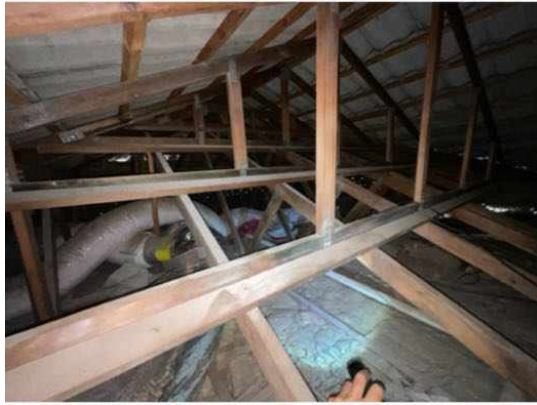
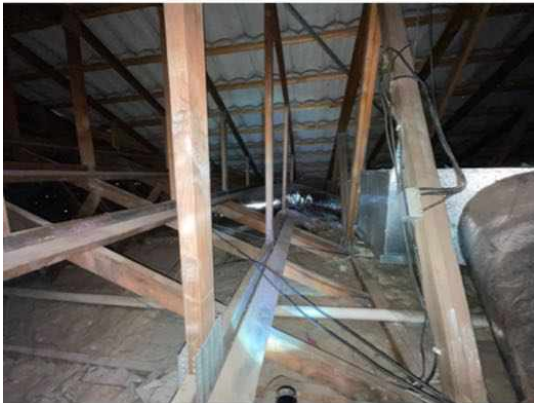
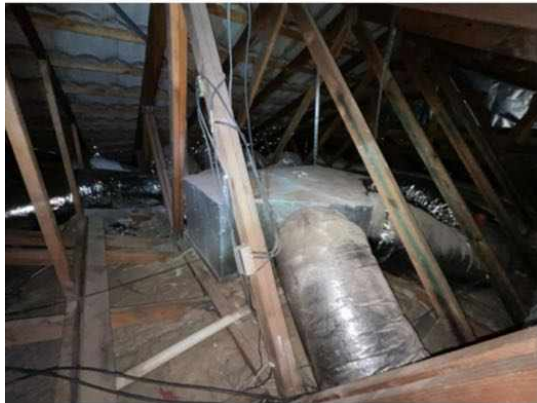
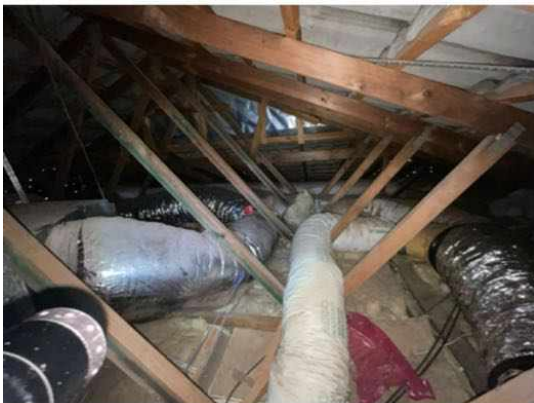
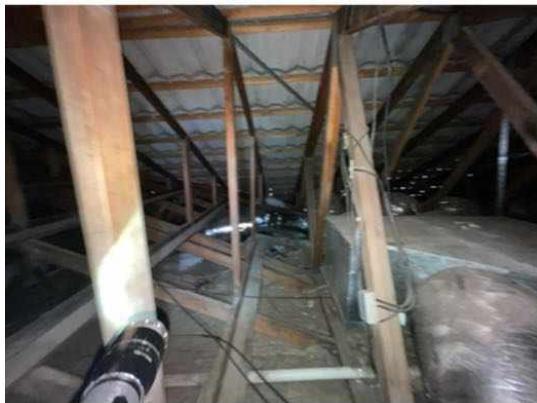
Building: Main Building
 Location: Roof Exterior
 Finding: Roof Covering Assessment
 Information: Roof Covering Type

Installation of an additional manhole is recommended to facilitate a re-inspection and enable a more thorough assessment of the roof void in the future. This will help ensure that all structural elements and concealed areas are properly evaluated.

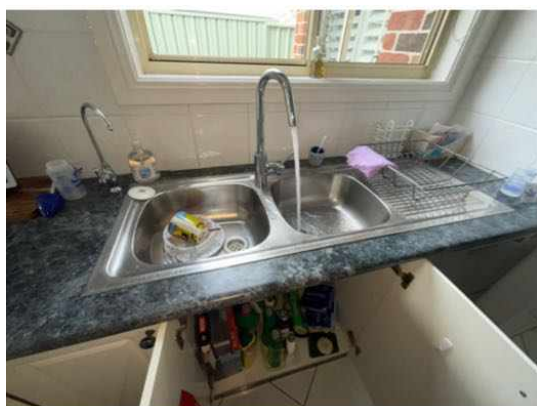
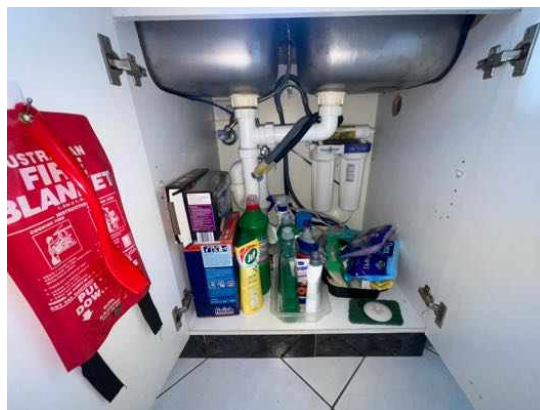
Building: Main Building
Location: Kitchen
Finding: Kitchen Sink – Overall Condition & Recommendations.
Information: Observations:

- Further monitoring and testing are recommended once the tap(s) are in constant use, to identify any drainage issues or signs of slow leaks not evident during the limited inspection.
- For long-term property care, it is advised that sealant and grouting in water-exposed areas be regularly inspected and maintained. A sealant specialist or tiling contractor may be engaged to carry out these works where necessary.
- It is recommended that the stored items beneath the sink be removed to allow for a full re-inspection of the plumbing and cabinetry, ensuring no concealed defects are present.

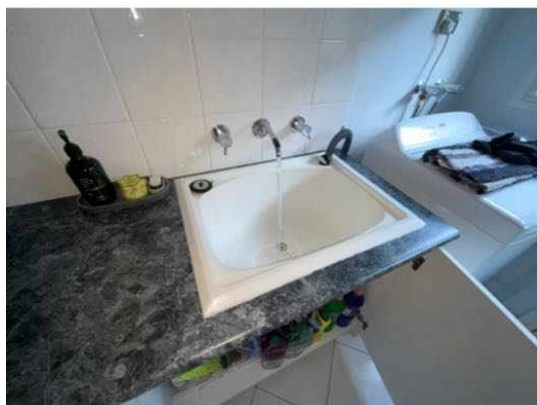
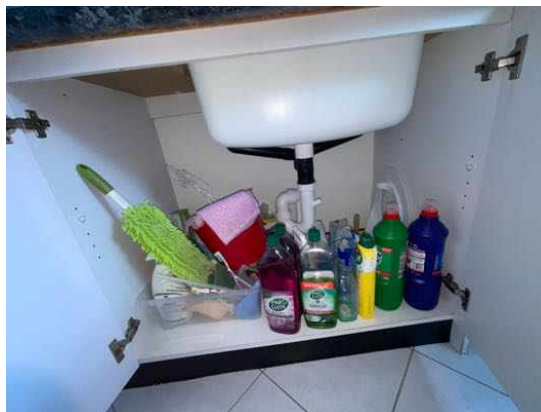
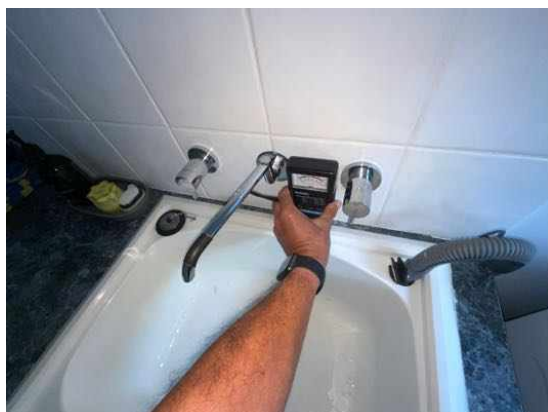
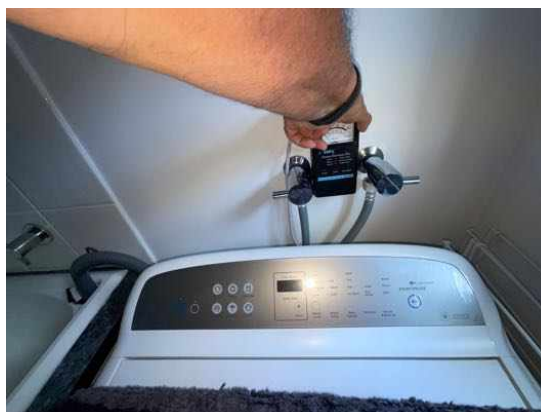
Building: Main Building
 Location: Laundry
 Finding: Laundry - Taps/Plumbing/Drainage.
 Information: Observation: Laundry Tub – Taps, Plumbing, and Cabinetry

- Regular maintenance and prompt replacement of missing or deteriorated sealant is highly recommended, as this is a common wear-and-tear issue.
- Sealant and grouting in wet areas should be maintained as part of the long-term care and upkeep of the property.

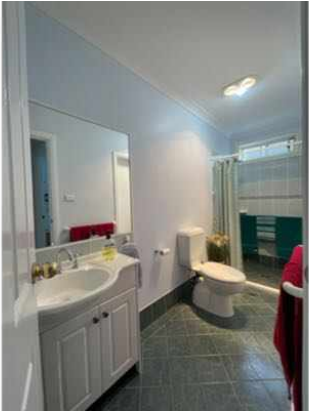
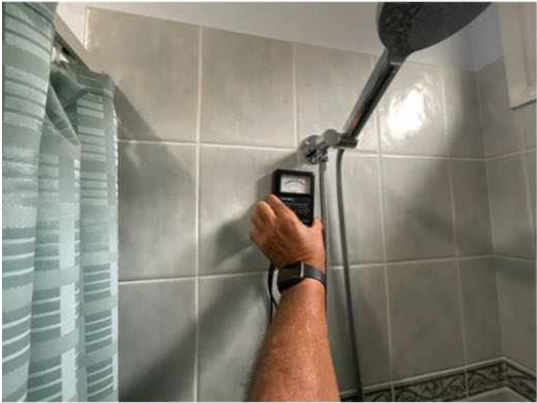
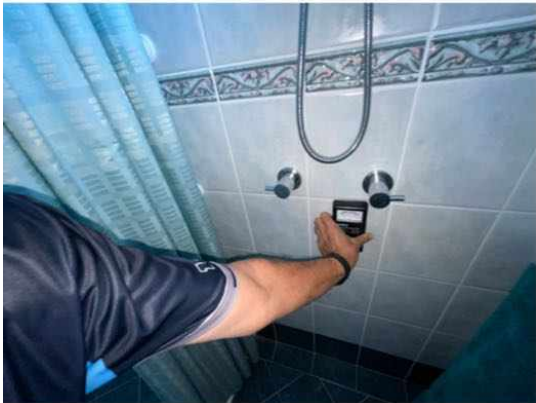
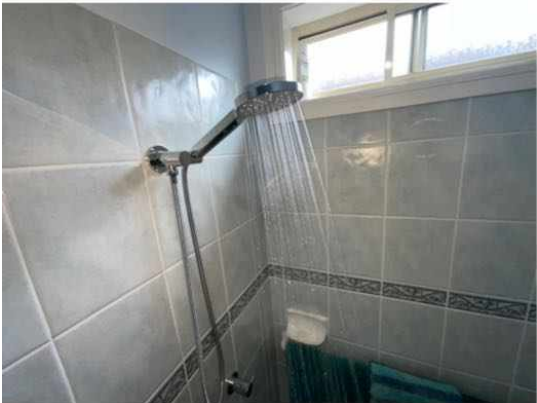
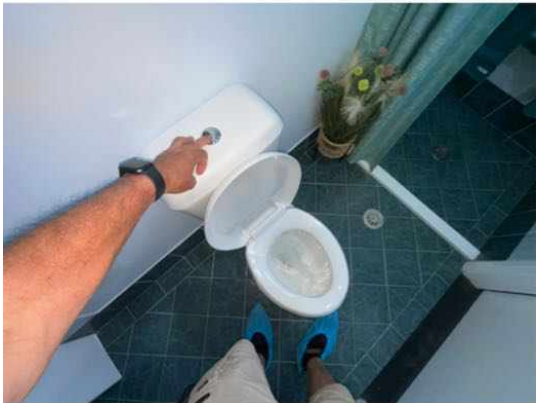
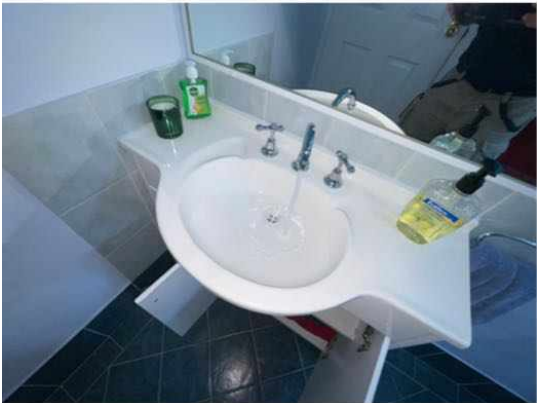
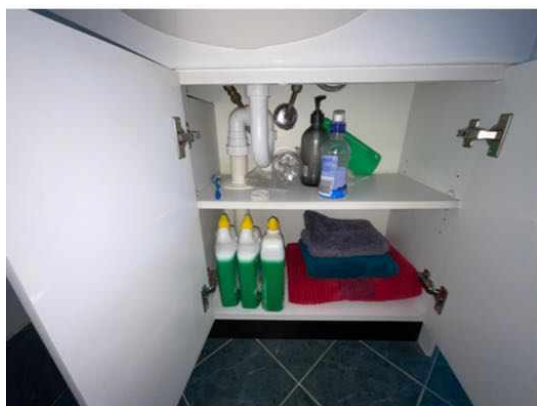
Building: Main Building
 Location: Powder Room
 Finding: Wet Areas - Bathroom(s) - Overall Condition & Recommendations.
 Information: Overall Condition & Recommendations

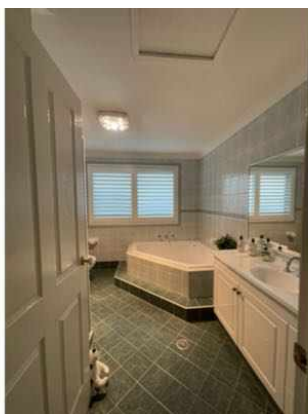
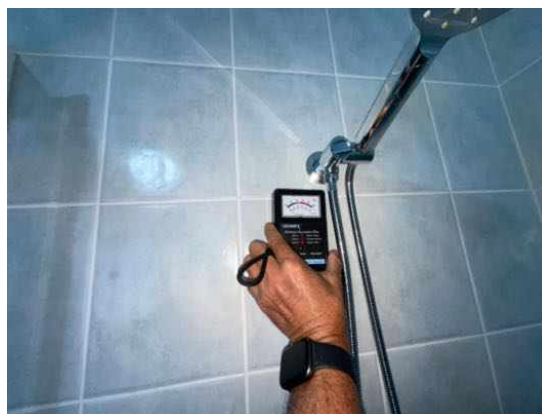
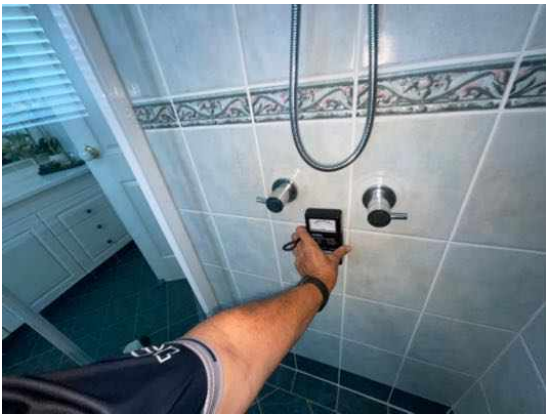
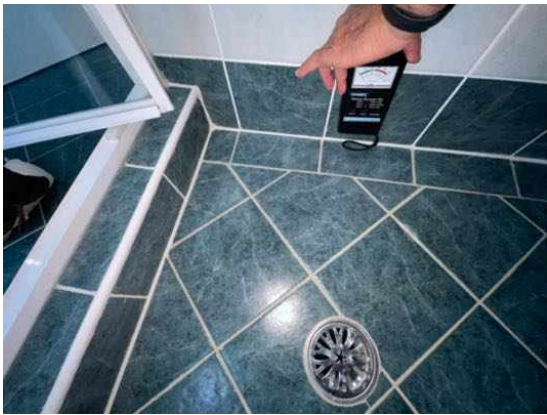
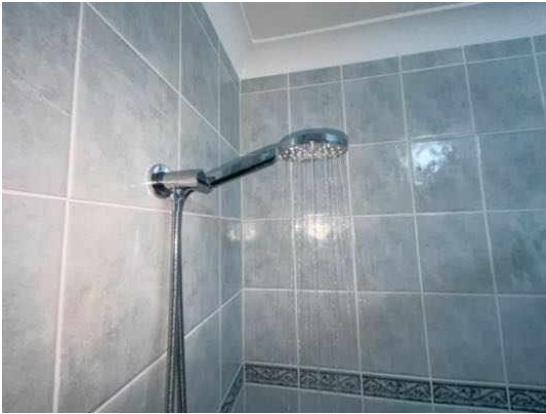
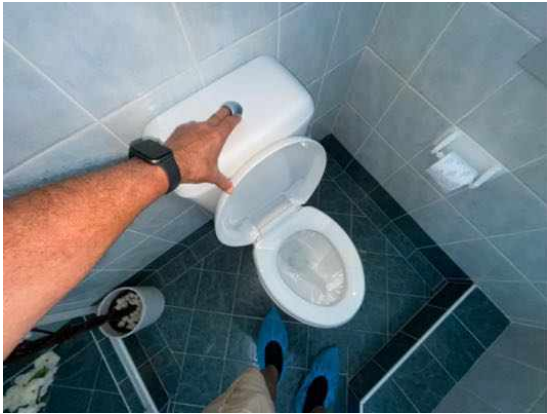
Building: Main Building
 Location: Bathroom
 Finding: Wet Areas - Bathroom(s) - Overall Condition & Recommendations.
 Information: Overall Condition & Recommendations

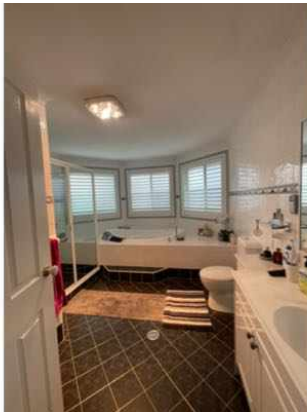
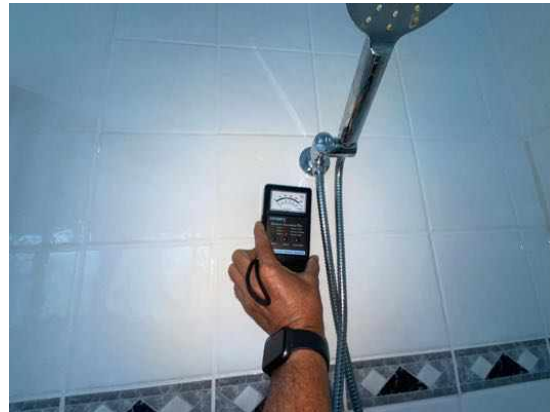
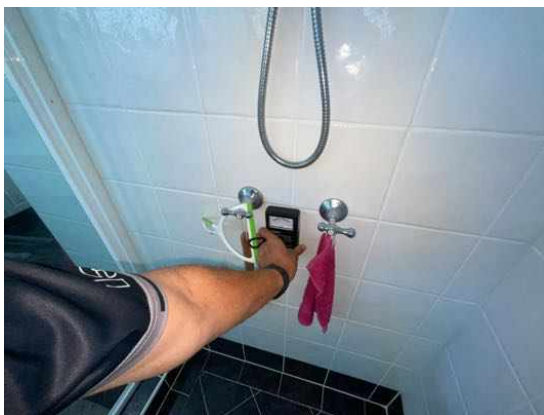
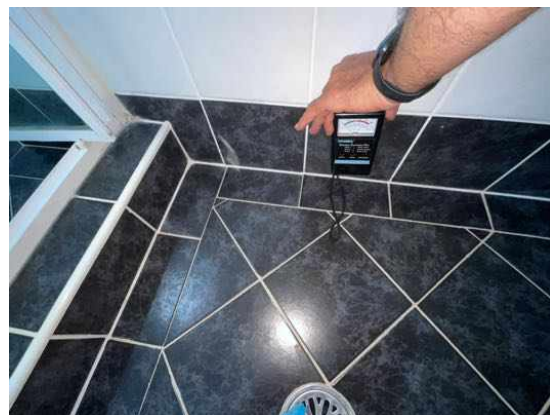
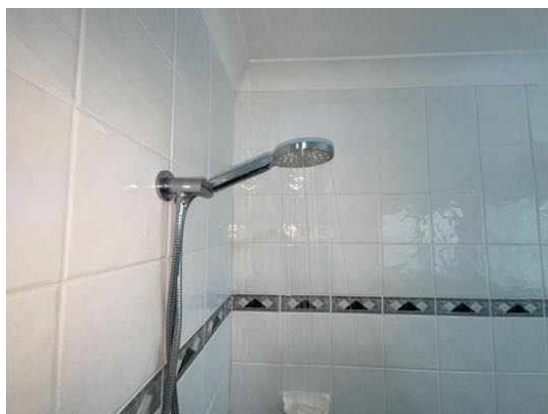
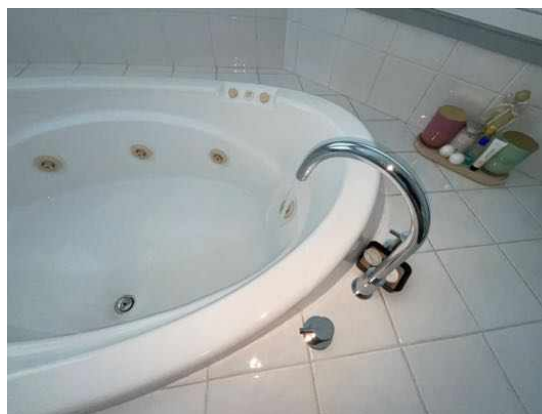
Building: Main Building
Location: Ensuite
Finding: Wet Areas - Bathroom(s) - Overall Condition & Recommendations.
Information: Overall Condition & Recommendations

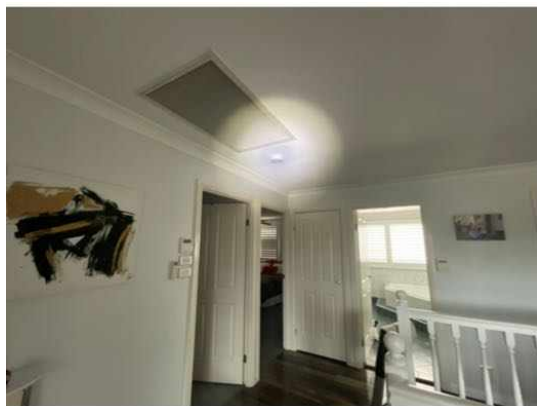
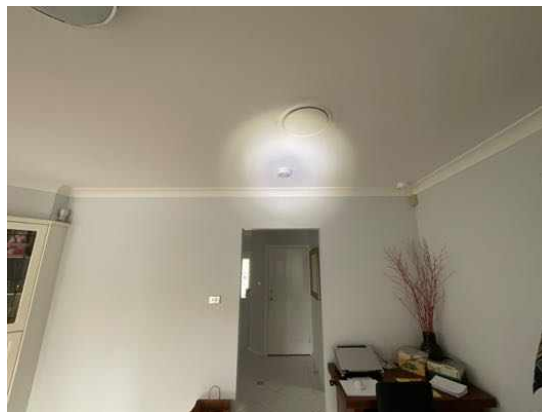
Building:	Main Building
Location:	All Areas
Finding:	Smoke Detectors / Alarms.
Information:	Reporting on the presence, type, location, or compliance of smoke detectors or alarms, including hard-wired smoke detection systems and their legislative requirements, is outside the scope of this inspection report.

- All smoke detectors be tested monthly by the homeowner.
- All systems comply with the requirements of AS 3786 and any applicable state-based legislation.
