Building and Timber Pest Inspection Report

Inspection Date: Thu, 26 Feb 2026

Property Address: 713 Canterbury Rd, Surrey Hills VIC 3127,
Australia

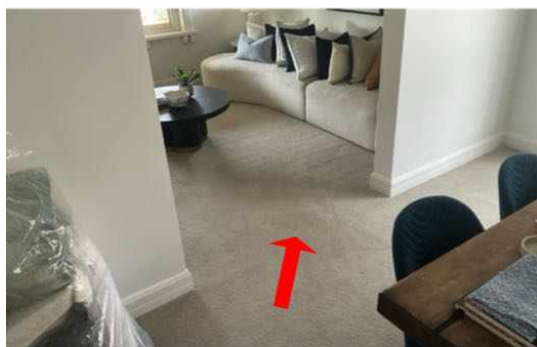
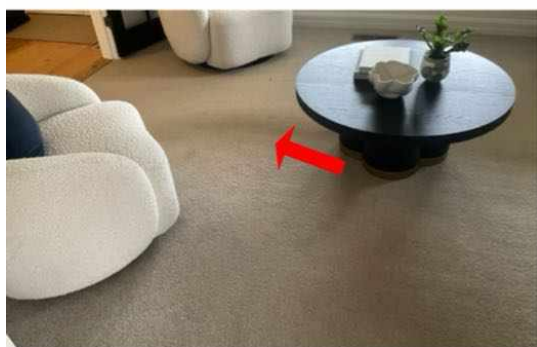
Information: The internal flooring in this area is out of level and uneven. Uneven flooring is likely to indicate minor defects such as expected movement of the foundations of the property, but may also indicate subsidence of the associated subfloor stumps.

It is advised that the flooring be closely monitored to identify any further movement. Where flooring remains relatively unchanged for an extended period of time (i.e. several months), it is likely that this defect has been caused by expected movement of the foundations of the property.

However, where flooring is uneven further, potentially invasive inspection of the subfloor structures and stumps in this area is required. In this case, works to repair are likely to be required, and would be carried out by a registered builder specialising in re-stumping.

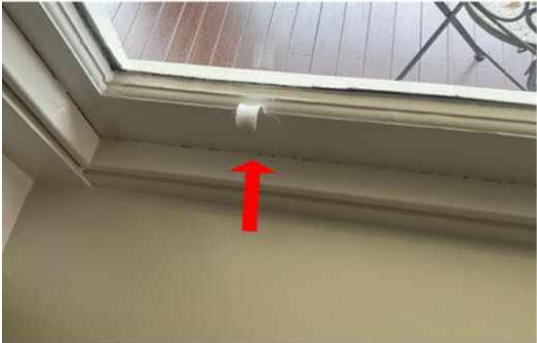
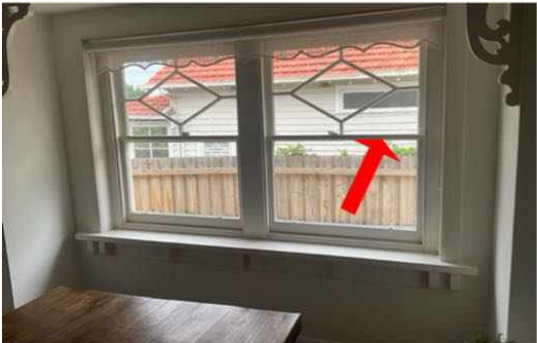
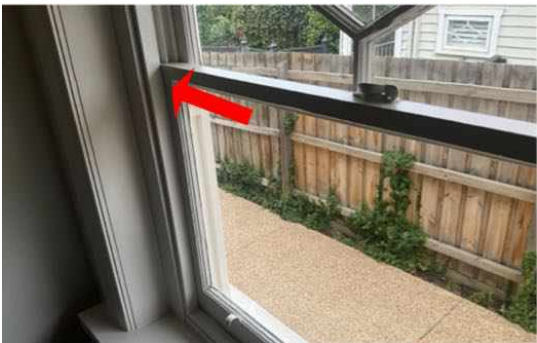
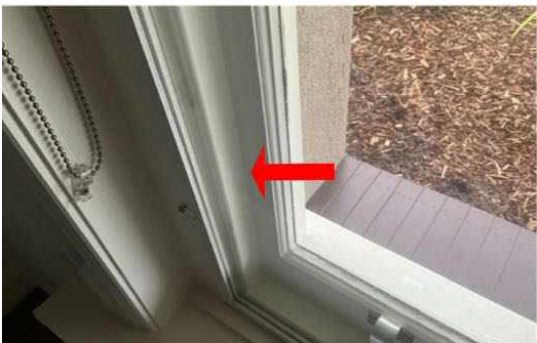
Finding 3.02

Windows provide ventilation to the adjoining area and should be at a fully operational level to ensure user comfort. Restricted function of the window may also pose as a potential safety hazard if required for emergency egress from the building.

Where windows have been painted shut the seal of the paint needs to be broken. This is generally done by breaking the seal of the paint and then maintaining the sash tracks, clearing and lubricating them with silicone. Remedial paint work will likely be required and can be completed along with the rest of the remedial works necessary by a general handyman.

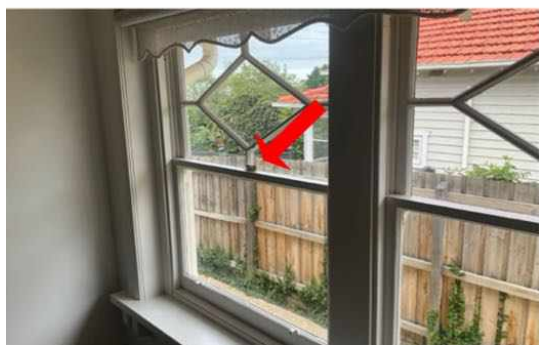
Finding 3.03

Building:
 Location: Dining Room
 Finding: Window missing latches/locks
 Information: At the time of inspection the windows in these areas were missing their latches and were unable to be locked.

This has the potential to pose as a potential safety/security risk .

It is recommended the windows have latches installed as a matter of urgency by a licensed carpenter or suitably competent handyman.

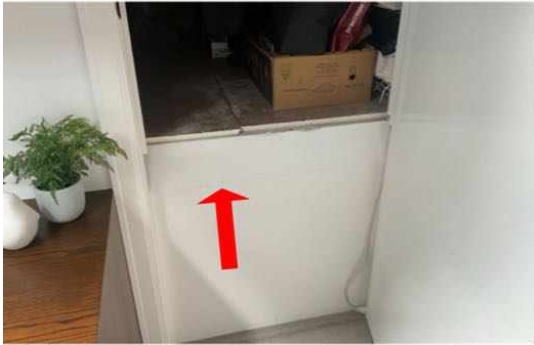
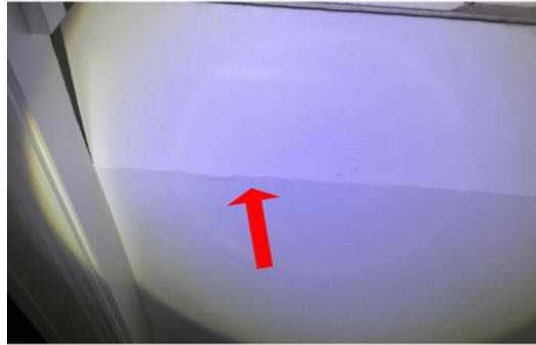
Finding 3.04

Building:
 Location: Bedroom 4
 Finding: Cracking - fine
 Information: Some fine cracking was noted throughout the property.

Although fine cracks are quite noticeable, they are often only considered to be an appearance defect, and usually do not indicate any structural damage. Generally, the cause of a fine crack is indicative of a separation between building materials and finishes (e.g. paint, plaster, etc.) along joints.

Note: photos included are indicative of fine cracking noted at the the time of inspection. Other fine cracks may be present but not recorded here.

Cracking of this nature can generally be repaired with minor sanding, filling and/or repainting. Such works should be performed by a qualified painter or a general handyman.

Monitoring of all cracking should be conducted frequently. Always contact a building inspector should cracks widen, lengthen, or become more numerous.

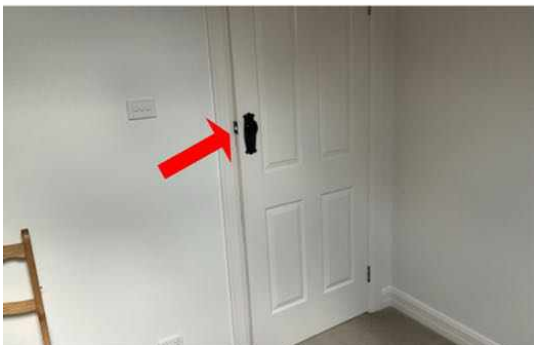
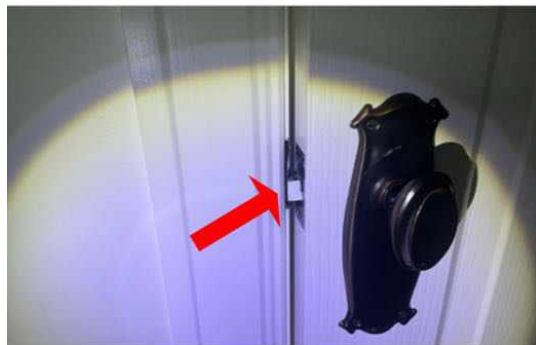
Finding 3.05

This is a common defect and is expected in a property of this age, whether being due to substandard installation or general deterioration of the door hardware.

Readjustment of the striker plate is recommended at client discretion. Works such as these can be completed by a general handyman or qualified carpenter.

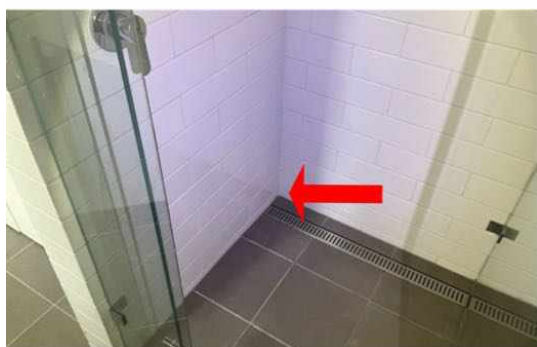
Building:
 Location: Bathroom
 Finding: Grout and sealant - Missing or degraded within the bathroom area
 Information: It was noted on inspection that grout or sealant is degraded to areas within the bathroom.

Different materials move at different rates, generally causing cracking to grout at this point. Build up of moisture in the bathroom can also cause grout and sealants to degrade and become mouldy.

Any damaged or degraded materials should be scraped out and flexible and mould resistant materials should be applied to affected areas to prevent any subsequent water damage that may occur. Regular maintenance and replacement of damaged or missing grout/ sealant is highly recommended to the wet areas, as this is a regular wear and tear defect. Both grout and sealant in areas that come into regular contact with water should be maintained for the long term care of your property.

A bathroom specialist or tiling contractor should be appointed to complete these works as soon as possible.

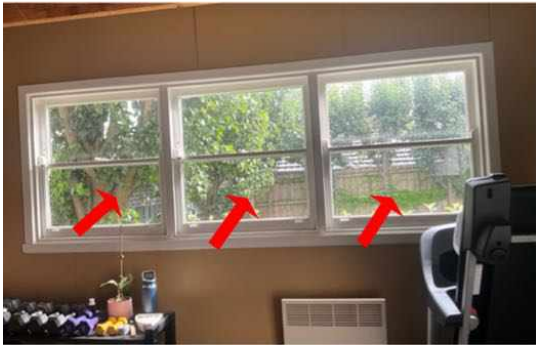
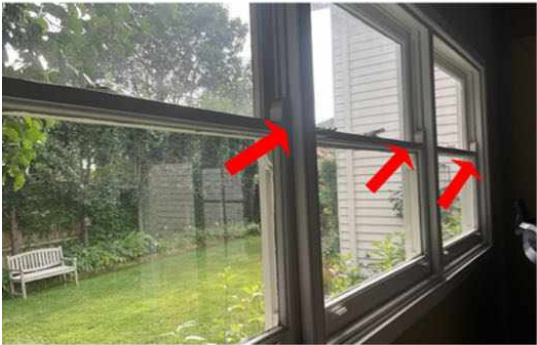
Finding 3.09

Building:
 Location: Garage
 Finding: Windows - Sticking
 Information: The windows to various areas were sticking and slightly difficult to operate at the time of the inspection. Windows provide ventilation to the adjoining area and should be at a fully operational level to ensure user comfort.

Restricted function of the window may also create potential for secondary defects to the associated building elements, such as damage to the window frames as well as a potential safety hazard if required for emergency egress from the building.

The most usual causes are swelling of timbers due to moisture, bulging or bowing of frames, or general material degeneration. Lack of maintenance can also contribute to the windows sticking.

Easement may be required, which may involve some sanding and repainting. It will almost always include ensuring the areas are cleaned and free of any debris that may be detrimental to their operational state

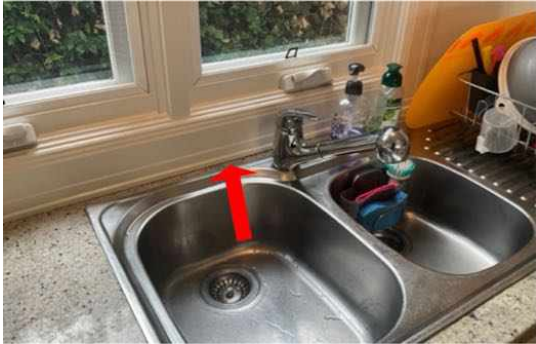
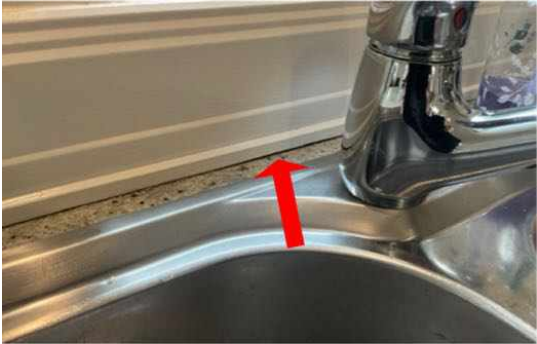
Finding 3.10

Building: Kitchen
Location: Kitchen
Finding: Sealant - Missing or degraded
Information: Sealant is missing or degraded in this area. Sealant is used to protect gaps and crevices in building materials to ensure that they are water-tight and prevent water penetration to the associated structures.

Where sealant is missing or degraded , a tiling contractor should be appointed immediately to re-apply any silicone where necessary. Failure to do so may lead to water damage to the surrounding area.

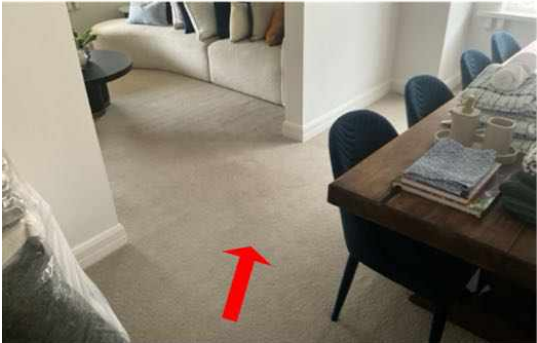
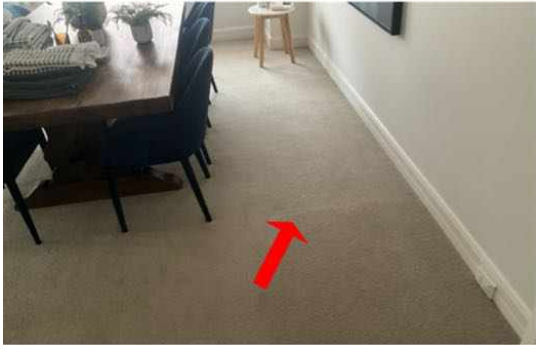
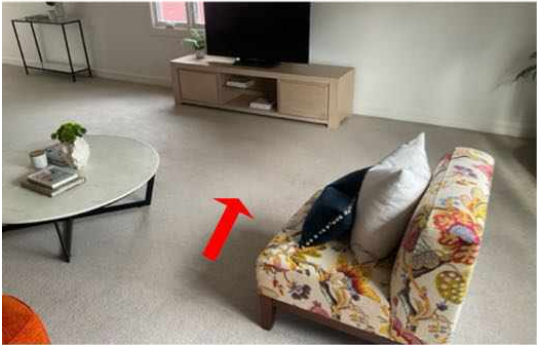
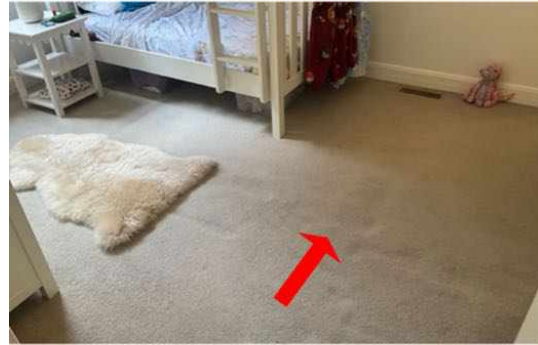
Finding 3.11

Building:
Location: All Areas
Finding: Floor - creaking slightly in some areas
Information: The internal flooring in these areas were creaking slightly when walked upon at the time of inspection.

Creaking floors generally indicate that the floorboards or the subfloor structures are coming loose from the supporting structure that they are installed on.

The areas should be monitored for any changes or unevenness. Should this occur, consultation with a registered builder should be undertaken to determine the cause . The potential resolution may involve regluing and screwing the floor down through to replacement of subfloor support structures.

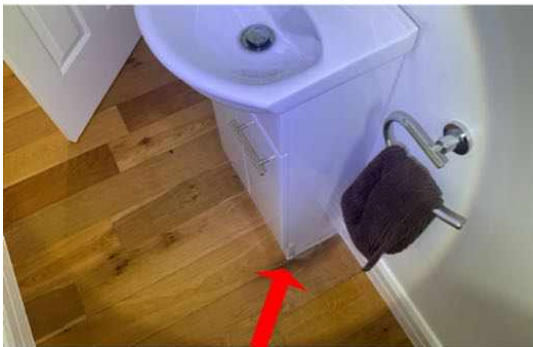
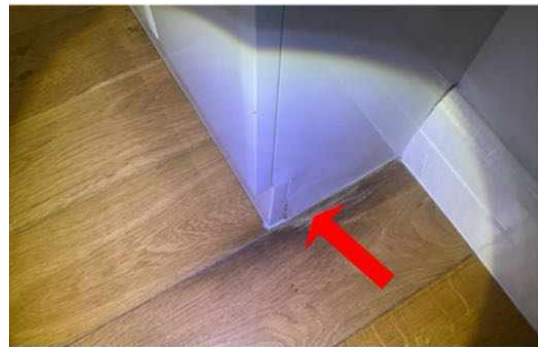
Finding 3.12

Finding: Moisture damage to the base of the toilet vanity

Information: Evidence of moisture damage was identified to the base of the toilet vanity .

It is suspected that this has occurred as a result of excess moisture from internal spills.

A licenced carpenter or competent handyman should be engaged to inspect the moisture damaged area and repair or replace any items where necessary.

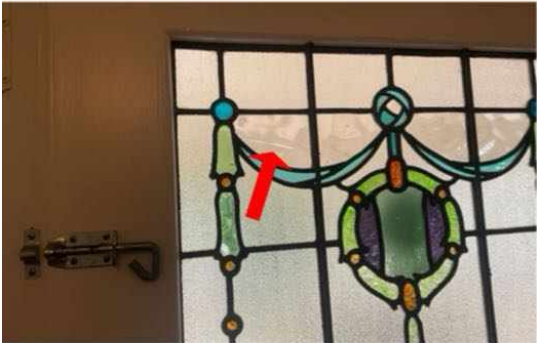
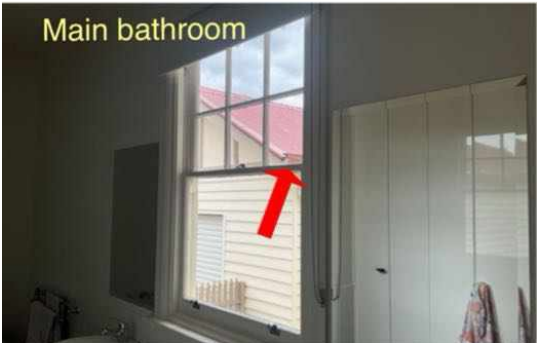
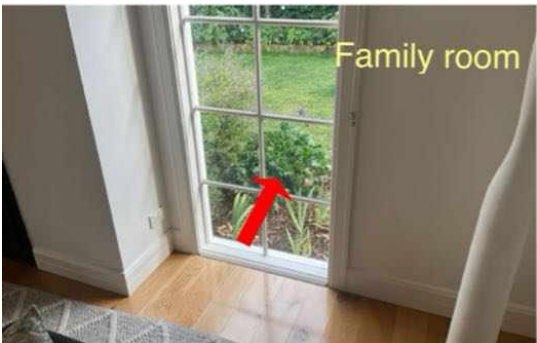
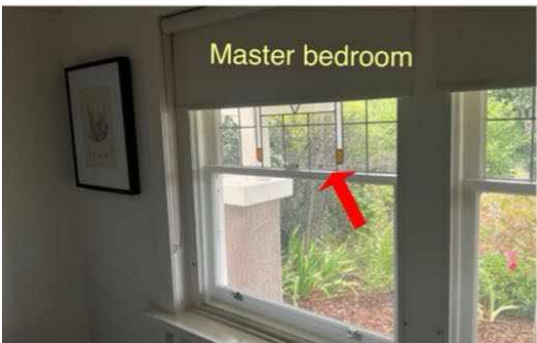
Finding 3.13

Finding: Window cracked

Information: At the time of inspection the window in this area had some significant cracking. This defect is generally the result of impact damage but may be due to other factors. Refer to photos for further information. Care should be taken in this area. The area should be monitored for further dilapidation.

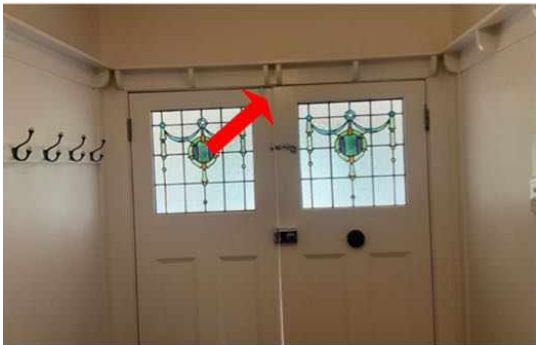
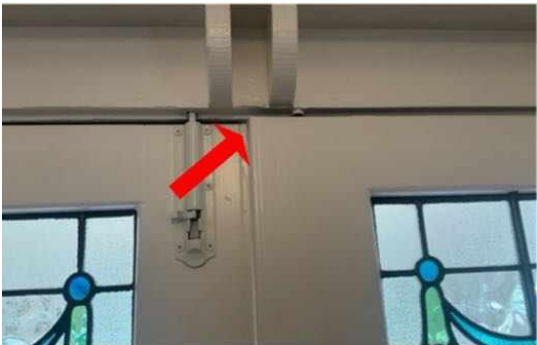
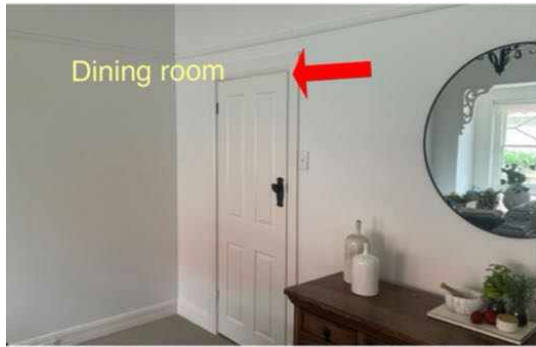
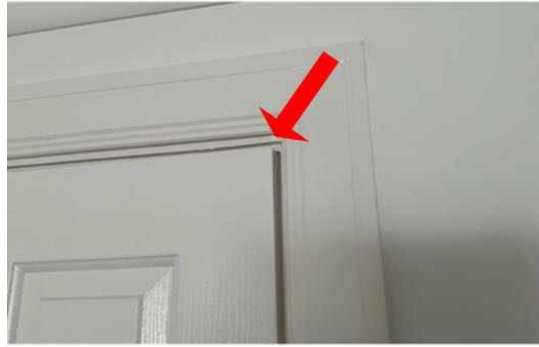
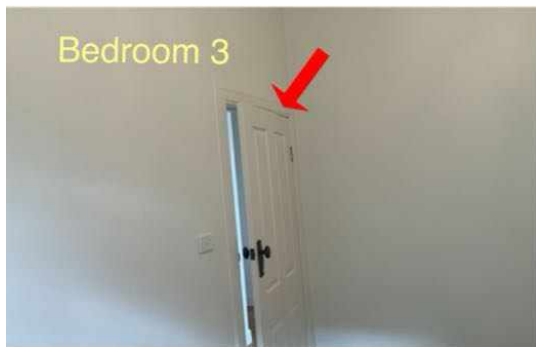
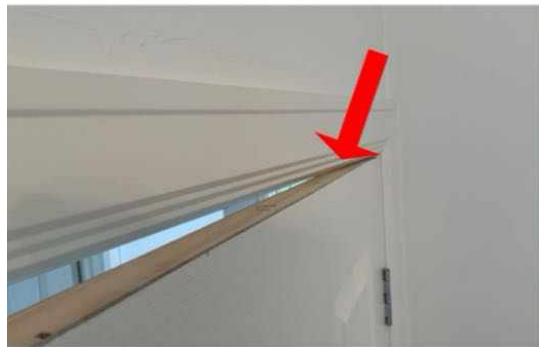
Finding 3.14

Building:
Location: All Areas
Finding: Door - Binding/jamming
Information: Binding and/or jamming of this door is evident during standard operation. This defect inhibits the functionality of the affected door as well as creating potential for secondary defects to associated building elements, such as damage to the floor covering.

A door that binds to flooring or to the associated door frame may have several causes, ranging from minor defects, such as poor installation of the door or deteriorated hinges, through to major structural issues, such as damage to subfloor structures.

Where door binding/jamming appears to indicate major structural issues (not suspected in this instance) , a registered builder specialising in re-stumping should be appointed to provide an estimate on the cost of rectification.

For minor causes, a qualified carpenter or general handyperson should be appointed to perform minor rectification works at client discretion.

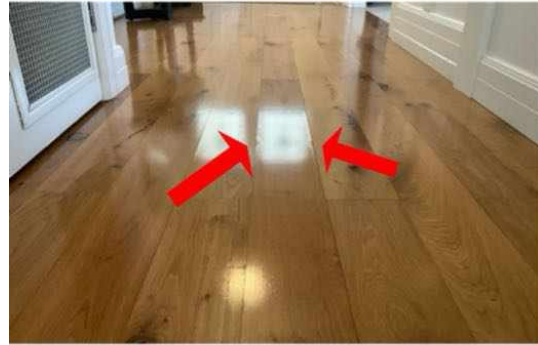
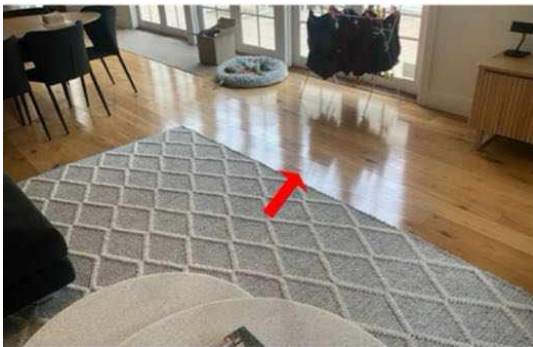
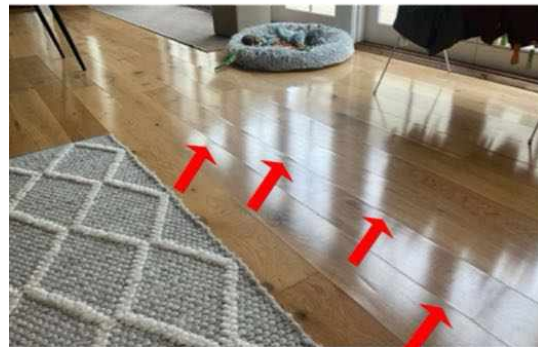
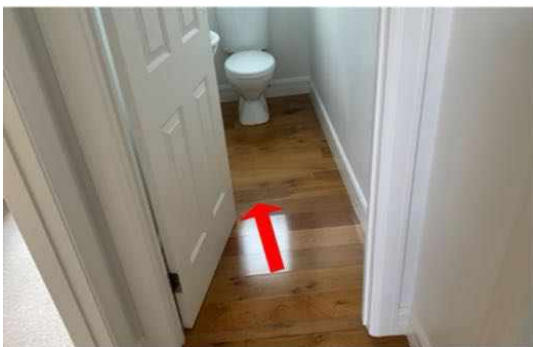
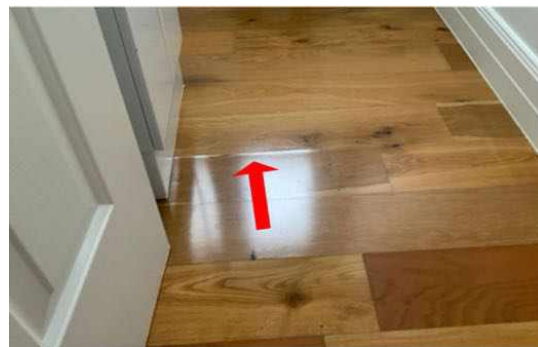
Finding 3.15

Finding: Floating floorboards - slight lifting and damage to the flooring in this area.

Information: At the time of inspection, there was some evidence of suspected moisture damage to the flooring, as noted where the floor boards were lifted slightly.

It is suspected this has occurred due to moisture possibly from mopping the floor.

The flooring should be monitored for any further damage or changes and should that occur, consultation with a flooring specialist should be sought.

This may require the flooring to be lifted and replaced in severely damaged areas.

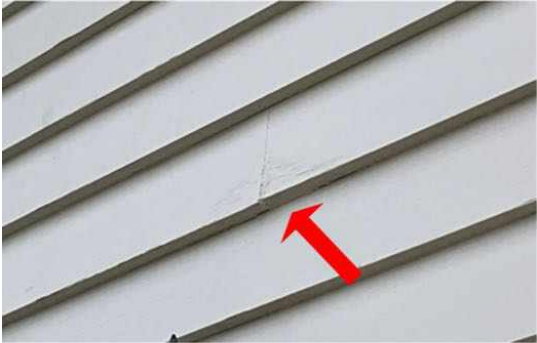
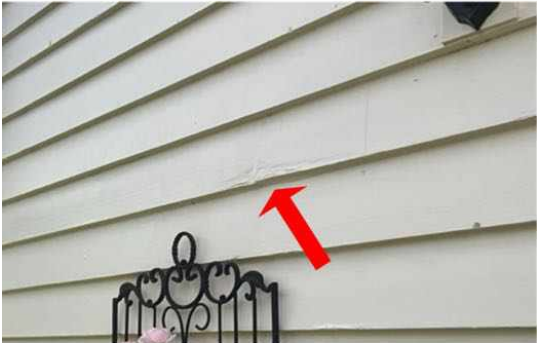
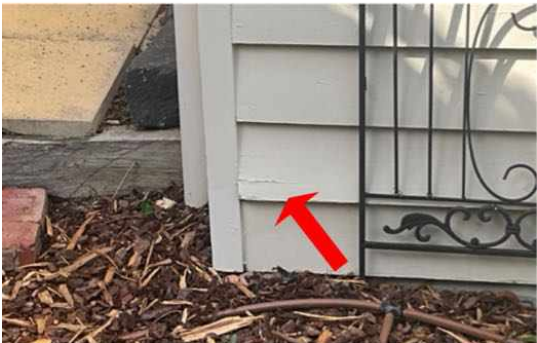
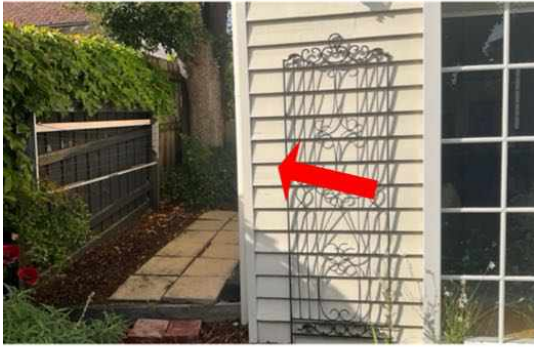
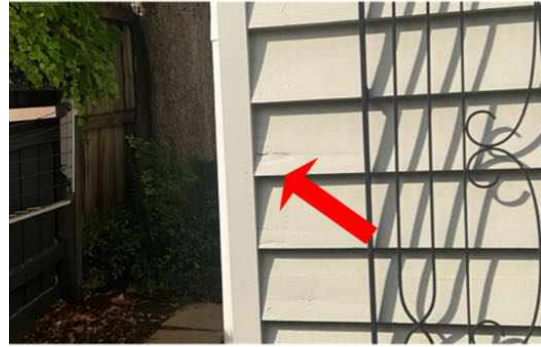
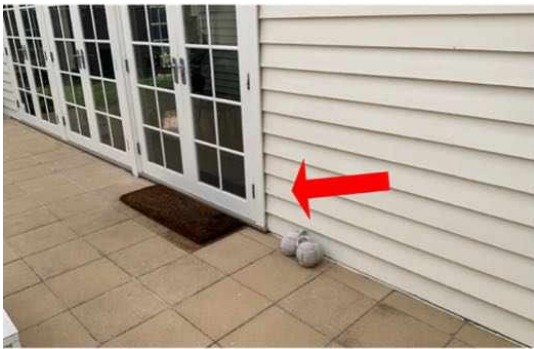
Finding 3.16

Information: Some of the external weatherboards show signs of fungal decay (wood rot) in several sections. This wood rot is suspected to have developed over a prolonged period of time due to frequent weather exposure, which is expected in a property of this age and condition

Weatherboards are sealed and protected by paint and other sealants. When these sealants deteriorate over time, they allow water penetration to the weatherboards, causing wood rot. If left unmanaged, the wood rot is likely to develop further, possibly

necessitating major repair or replacement works in the long-term future.

To maintain the condition of the external wall cladding, any severely affected weatherboards should be substituted as soon as possible with pre-treated replacements. Where weatherboards have rotted due to excessive moisture other than rain penetration, the cause of the moisture should be identified immediately by a licensed plumber. A qualified carpenter should be appointed to repair and replace rotting weatherboards.

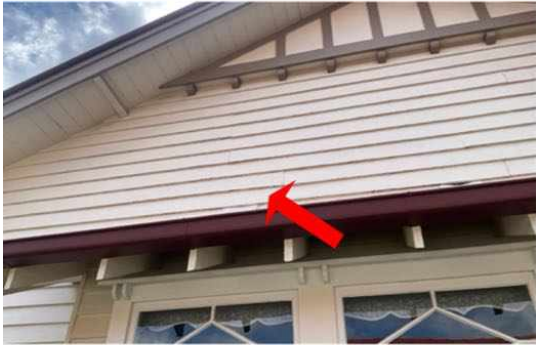
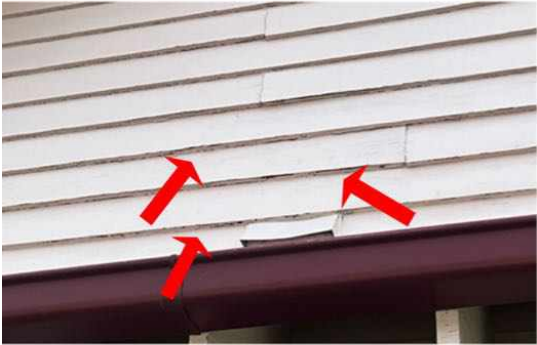
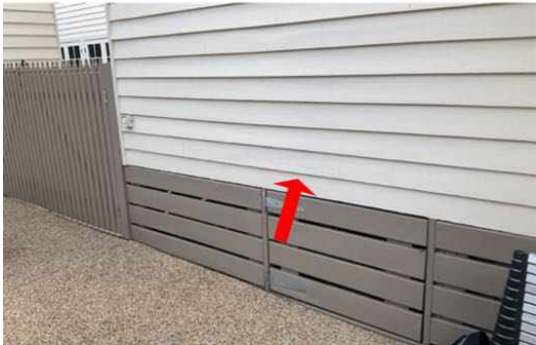
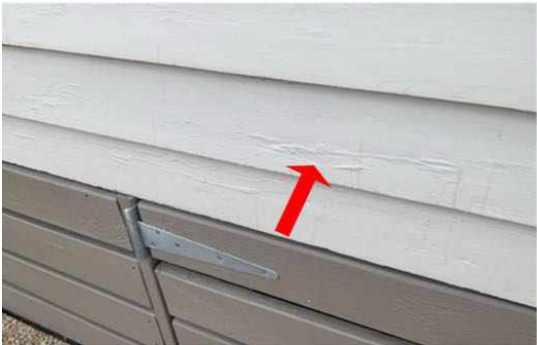
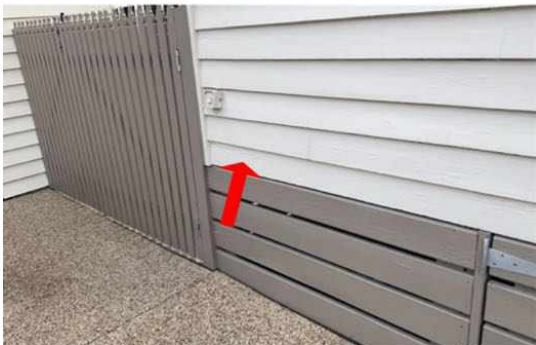
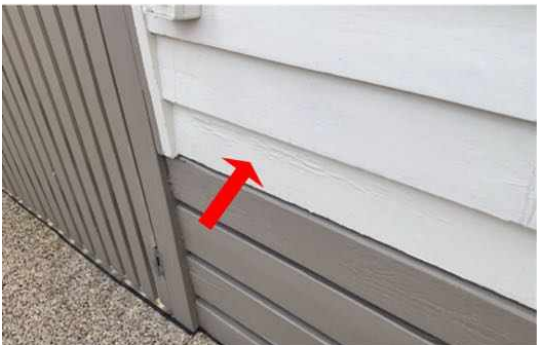
Finding 3.17

Information: External timbers that are frequently exposed to harsh weather conditions require adequate protection in order to maintain their condition. Where timbers have not been painted or treated adequately, general deterioration is likely to occur at an accelerated rate.

If left unattended, replacement of these timbers is likely to be necessary in the short-term future.

Please note: other timbers around the property may be weathering slightly but not showing here

Adequate treatment of these timbers is required as soon as possible by a painting contractor or general handyman.

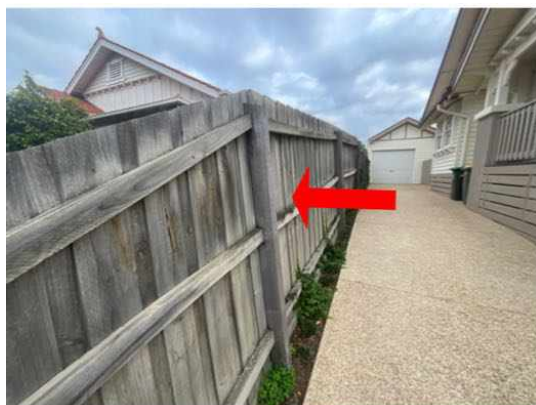
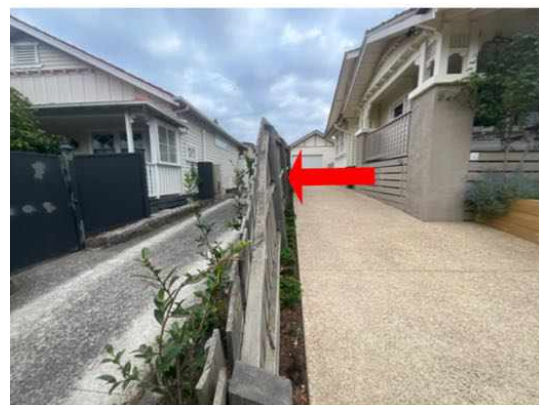
Finding: Fencing - leaning with some areas of deterioration

Information: It was noted at the time of inspection that sections of the side fencing either side of the property were leaning slightly. Some areas of deterioration were also noted.

Typically fencing deteriorates due to age and or wear, rot and or rust which is generally expected for a structure of this age, due to prolonged exposure to weather conditions. Sometimes inadequate installation or maintenance can be to blame.

Should further damage occur, repair of several elements of the fencing may be required. Replacement may also be a consideration.

A licensed fencing contractor should be appointed to provide further advice and perform rectification works as necessary.

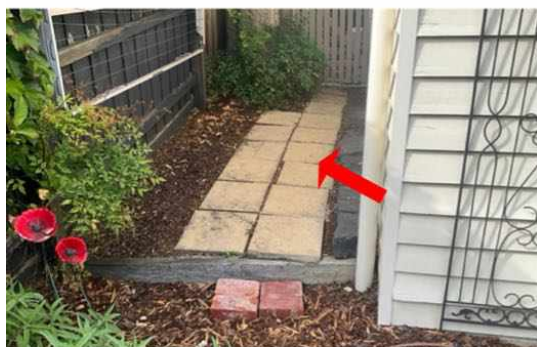
Finding 3.20

Finding: Paving - Uneven with some lifting and subsidence noted in some areas

Information: Sections of the external paved area on the right hand side of the property are uneven with some lifting and subsidence noted in some areas. It appears as though the area may have been subject to poor installation, or that paving sections have shifted due to movements in the foundation of the property.

Where paving becomes very uneven it may create a trip hazard.

Monitoring of the area is recommended . Should pavers become further uneven, re-paving of the area would be required to remedy this situation.

Further consultation with a specialist landscaper would then be advised.

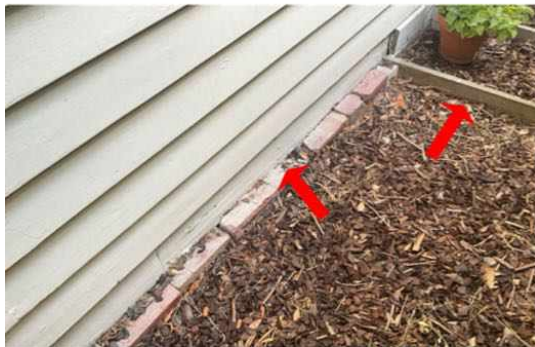
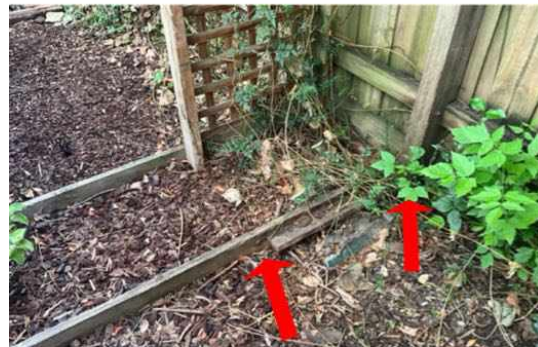
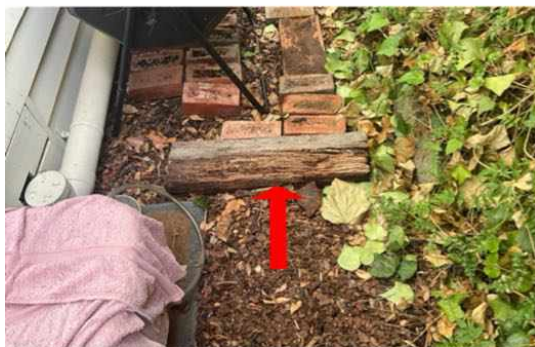
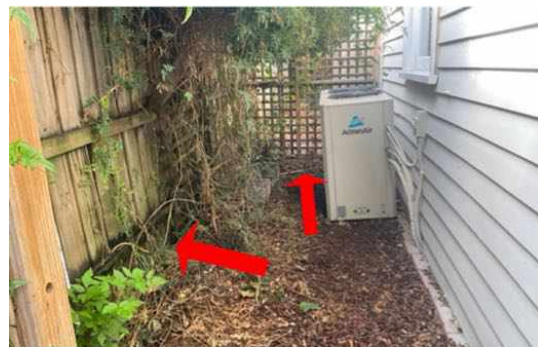
Building:
 Location: All External Areas
 Finding: Building materials in direct ground contact - conducive to termites
 Information: Where timber elements are in direct contact with the ground and consequently moisture or dampness, they become conducive to termite activity. Whether timber is used as a building element, part of a fencing structure or stored as an unused item, they can provide an environment that is attractive to termite infestation.

When met with excessive moisture, timber begins to decay and develop wood rot. Any timbers that are in direct contact with external grounds especially if left untreated or non-durable also provide ingress for subterranean termites into that particular element.

Where possible, the removal of any such materials that may be conducive to termite activity should be carried out as soon as possible to minimise the risk of termite attack. Where not possible or practical, regular monitoring of timber elements is recommended. Replacement of any damaged materials should be carried out where necessary.

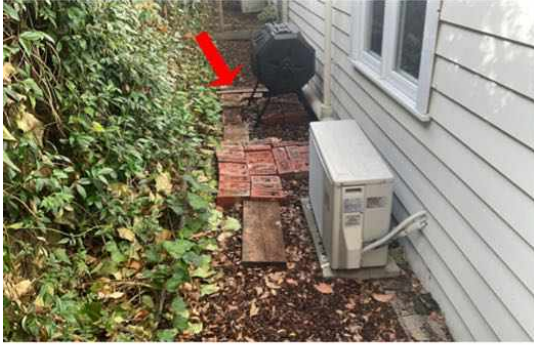
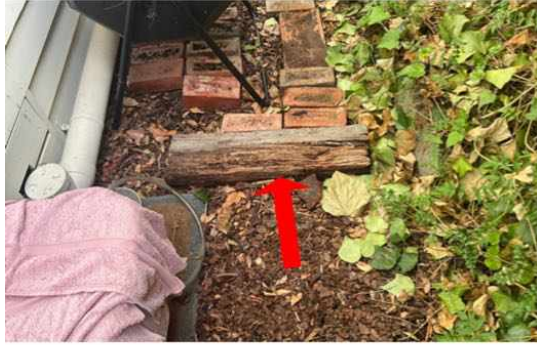
Generally fungal decay develops on timber elements that are in use in an external environment which are exposed to rain penetration.

Decaying timbers can create an environment conducive to timber pest attack. It is recommended that the decaying timbers be repaired / replaced to lessen the risk of timber pests.
