Building and Timber Pest Inspection Report

Inspection Date: Fri, 6 Mar 2026

Property Address: 100 Albury St, Tumbarumba NSW 2653,
Australia

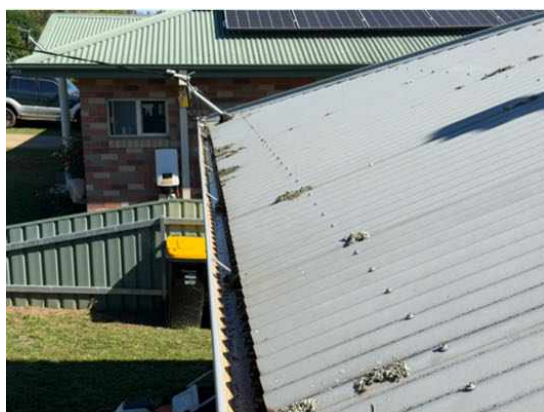
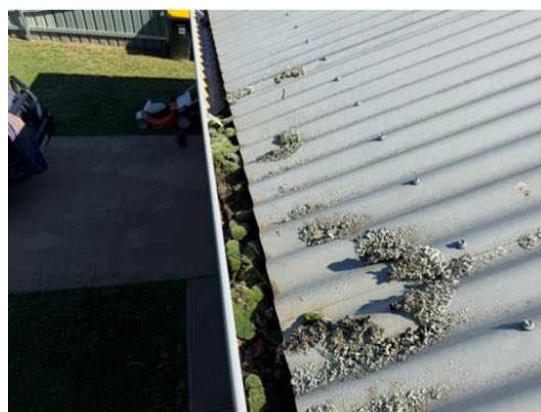
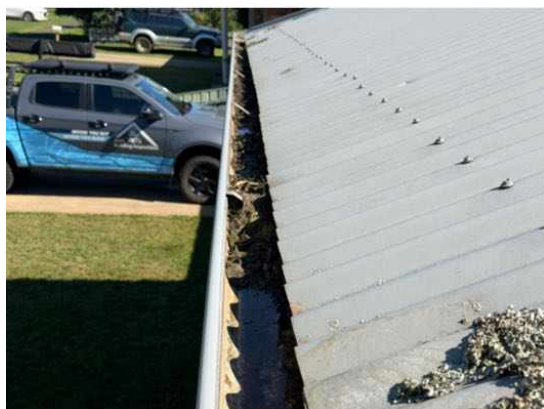
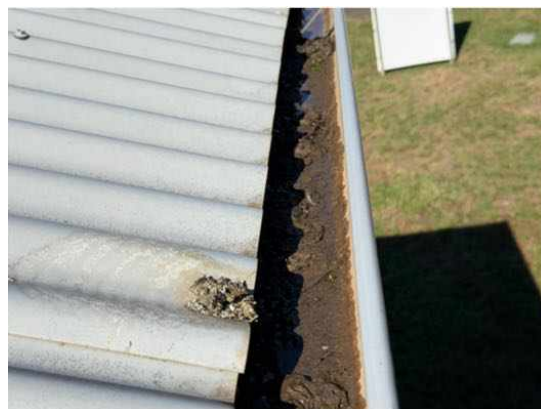
Finding 3.01

Building: Main Building
Location: Guttering
Finding: Gutters - Debris & Water pooling
Information: Water pooling and debris were noted in sections of the gutters. Recommend engaging a licensed roof plumber in the short term, to provide further advice & maintenance works to ensure adequate roof drainage is achieved. All debris should be cleared to ensure proper drainage.

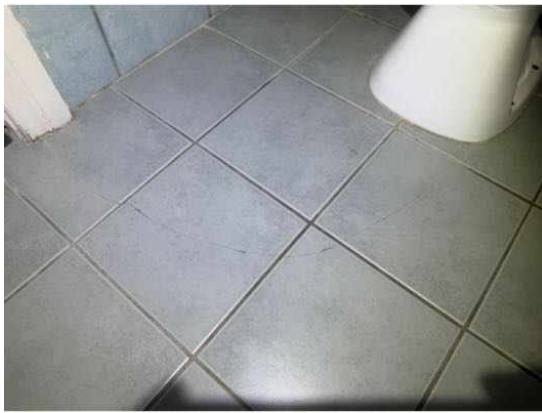
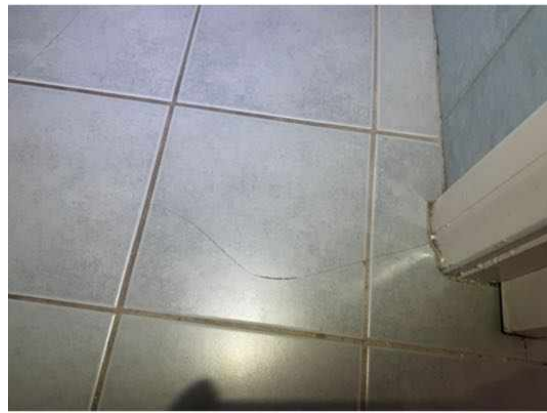
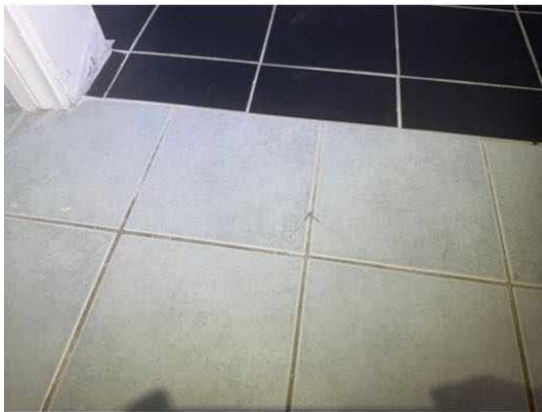
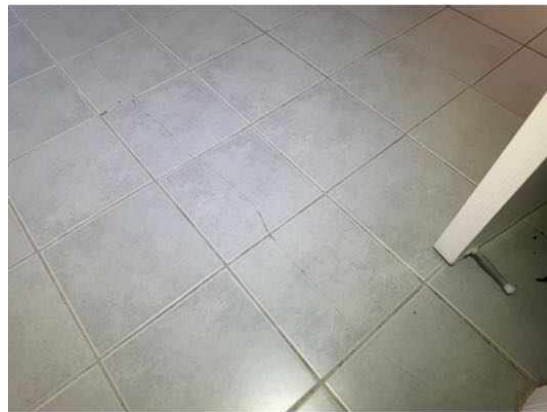
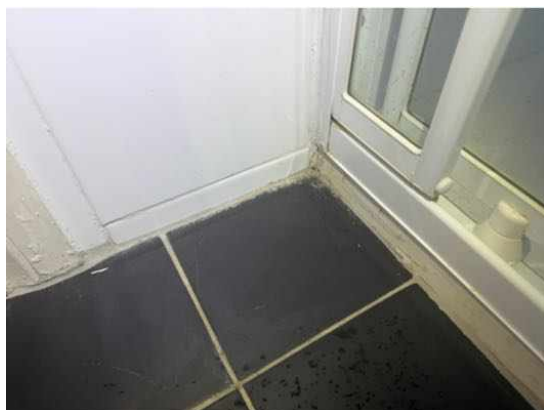
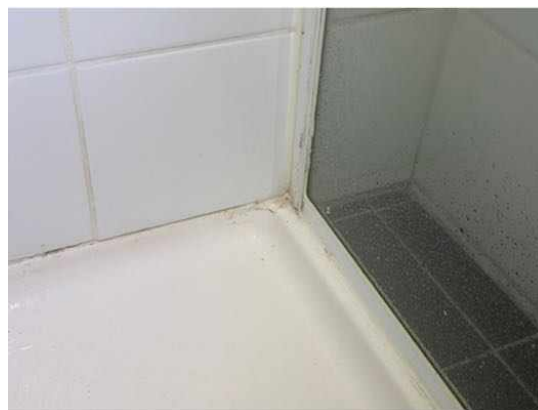
Finding 3.02

Building: Main Building
Location: Tiled Areas
Finding: Sealant / grouting - deteriorated or missing & Cracked Tiles
Information: It appears that the sealant and grout has deteriorated / weathered in some tiled areas, a common defect in buildings of a similar age. Areas of cracked tiles were also noted.

Sealant and grouting in areas that come into regular contact with water should be maintained for the long term care of your property.

Recommend engaging a licensed tiling contractor in the short term, to provide maintenance works where necessary.

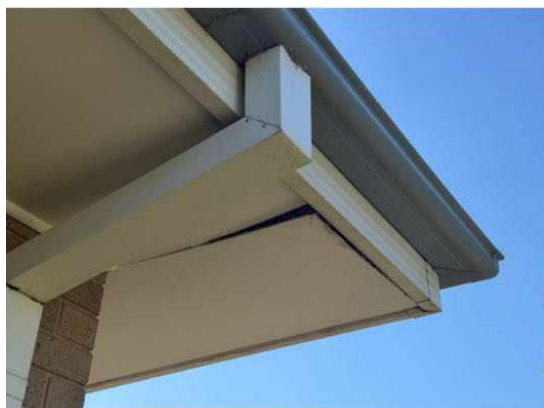
Finding 3.03

Building:	Main Building
Location:	Front eave
Finding:	Eave - Minor Sagging
Information:	It appears that the front eave was sagging, and has popped out of the fascia. Recommend engaging a licensed carpenter at clients discretion, to provide minor maintenance works.

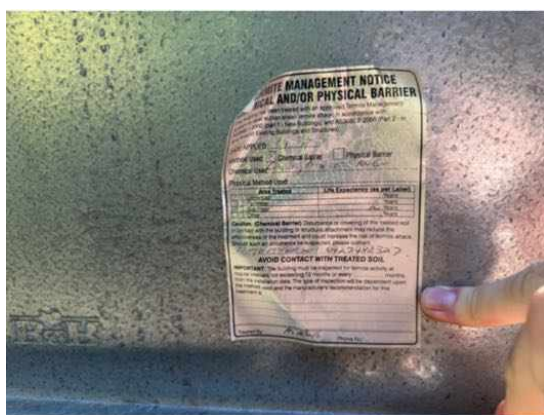
Finding 6.01

Location: Switchboard
 Finding: Expired Termite Treatment
 Information: A durable notice has been installed in the meter box, indicating that a previous termite management system has been installed.

The sticker indicates that the year of installation was 2004, meaning the chemical barrier has now expired.

Such barriers are highly effective in preventing termite attack on the building and therefore should be installed. The client should engage a licensed pest controller to provide further advice regarding application of a termite treatment.

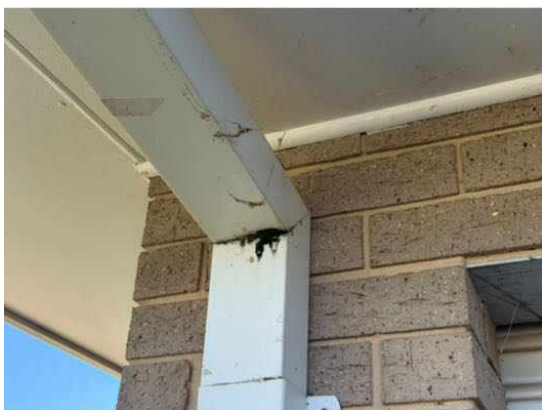
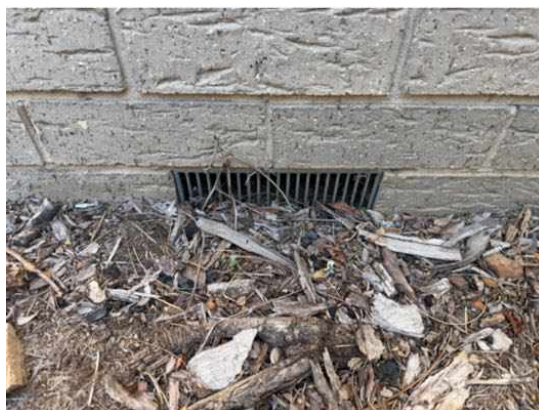
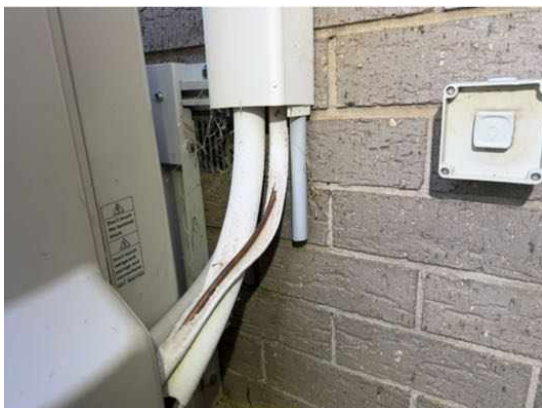
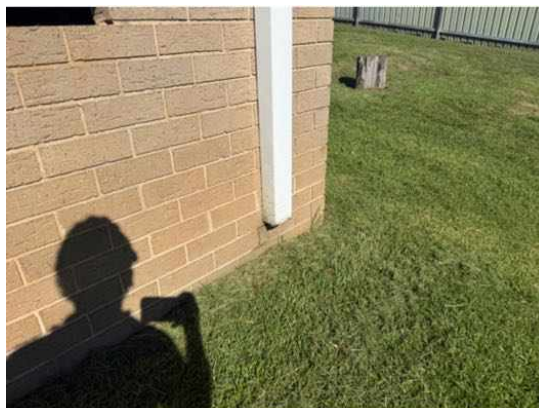
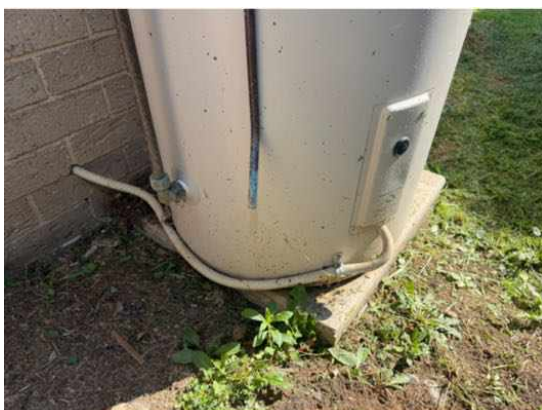
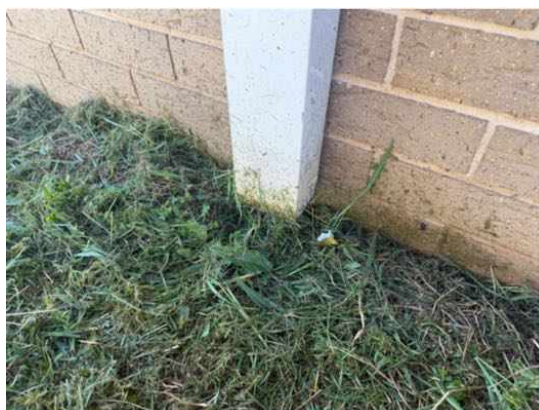
Finding 6.02

Building: Main Building
 Location: All external areas
 Finding: Potential Water pooling - against property & leaking Down-pipes
 Information: It appears that there are potential areas around the perimeter of the property that could be susceptible to water pooling. Where areas of disconnected down-pipes and insufficient drainage of hot water systems, and aircons are present, water pooling is likely to occur, and can create areas conducive to timber pests and moist conditions in the subfloor.

The external ground level also appeared to be higher than the subfloor vents to the right of the building, and should be lowered by the client or general handyman, to avoid water pooling. Recommend consulting with a licensed plumber in the short term to further assess and provide remedial works.

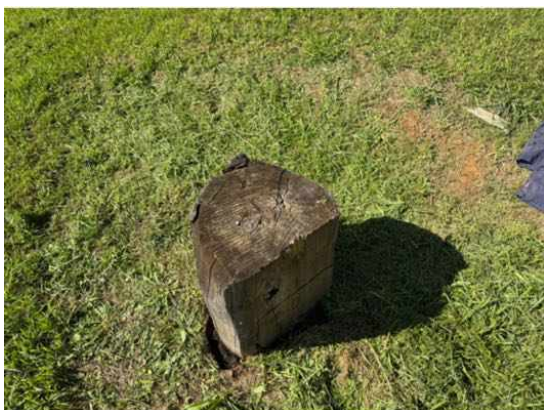
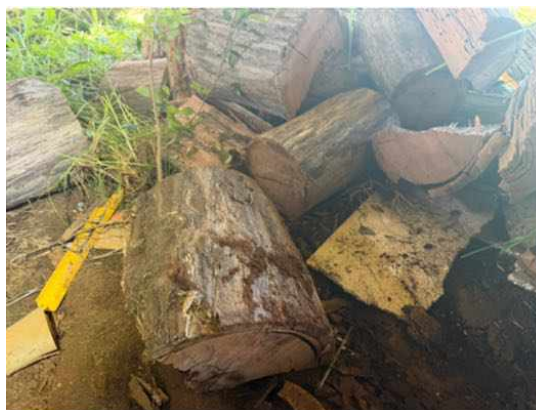
Finding 6.03

Building:	Main Building
Location:	All External Areas
Finding:	Timber in direct ground contact - conducive to termites
Information:	Where timber materials are in direct contact with the ground and consequently moisture, they become conducive to termite activity. The landscaping timbers and firewood beneath the deck create an environment conducive to termite activity.
	Where feasible, any timbers in direct contact with the ground should be removed, to reduce the risk of termite activity.

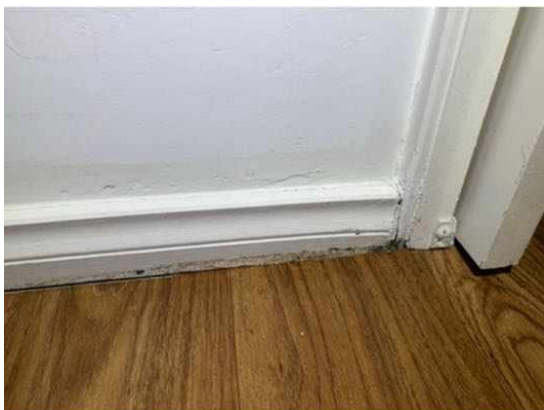
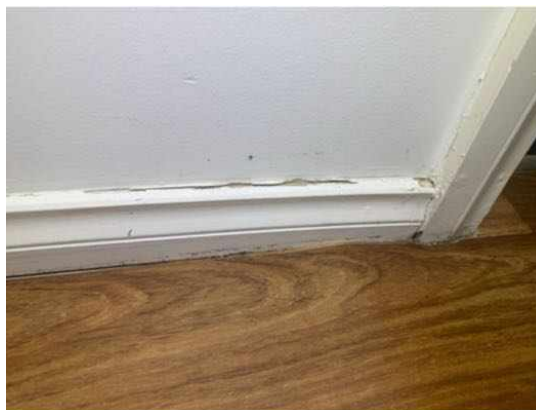
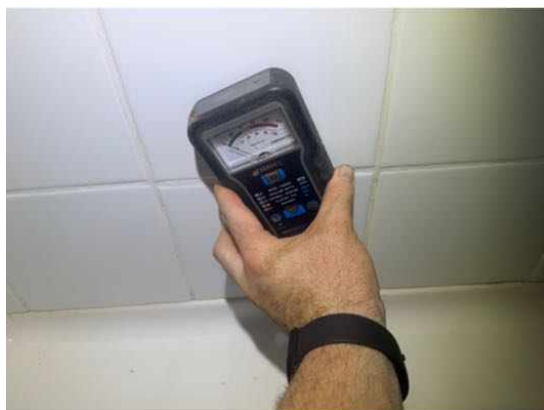
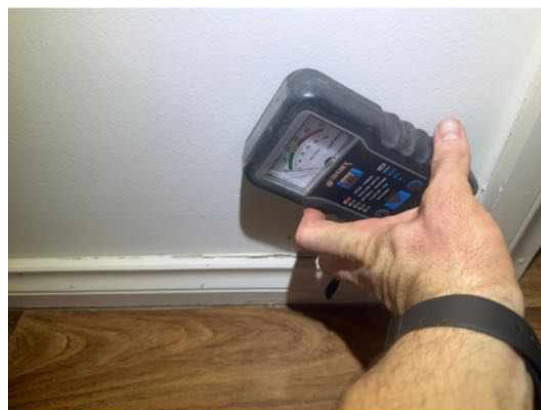
Finding 7.01

Building:	Main Building
Location:	Bedroom, Hallway Skirting
Finding:	Fungal decay & weathering
Information:	It appears fungal decay (wood rot) is present at, but not limited to the skirting of the rear bedroom and hallway walls, adjacent to the shower, indicating previous leaking. No high moisture was evident in this area at the time of inspection.

The client can engage a licensed carpenter and/or painter at their discretion to provide maintenance works where necessary.

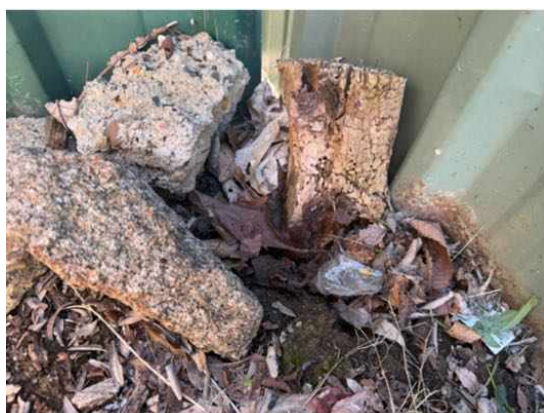
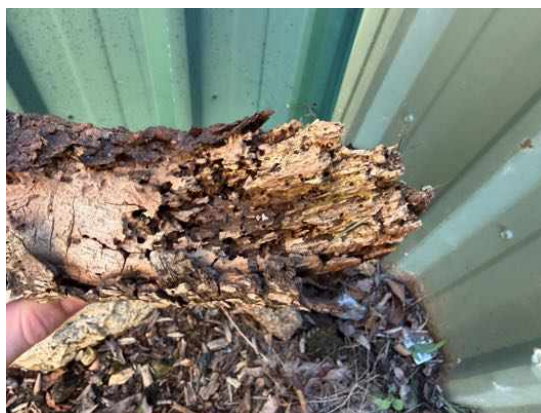
Finding 8.01

Building:	Main Building
Location:	Stump
Finding:	Evidence of wood borer damage identified (powder-post)
Information:	Evidence of previous Lyctus Borer (powder-post beetle) damage was identified to a tree stump. Wood borer damage is generally considered superficial damage to the affected timber. As no live wood borer activity was identified treatment is not required.

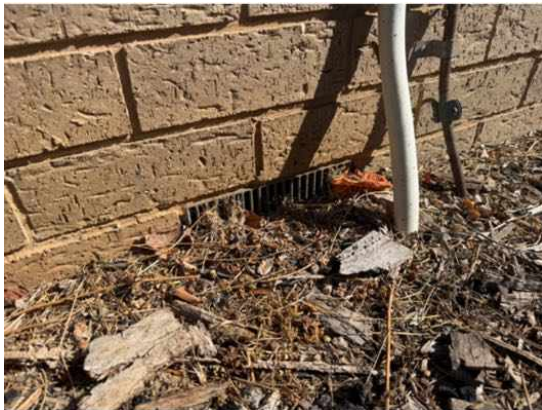
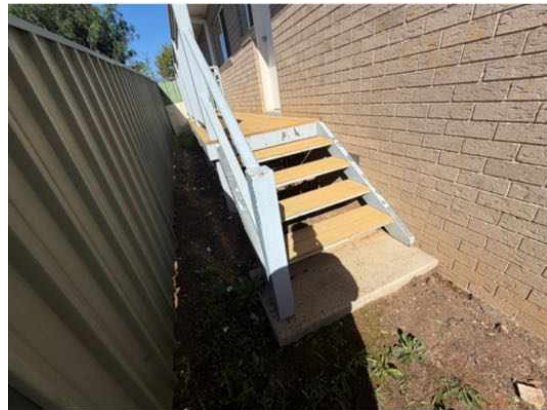
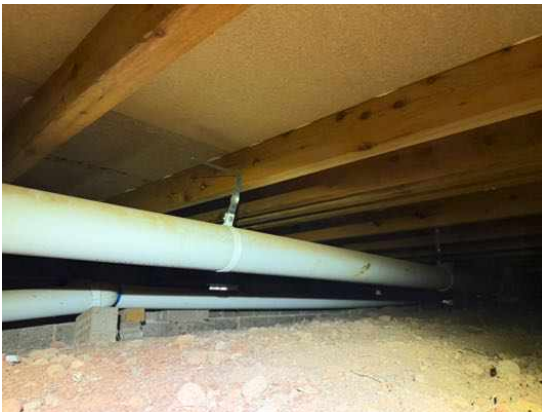
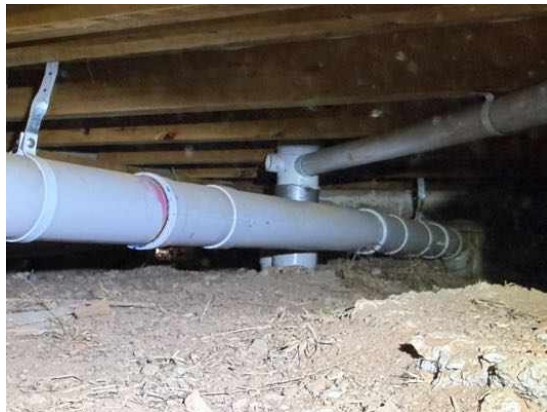
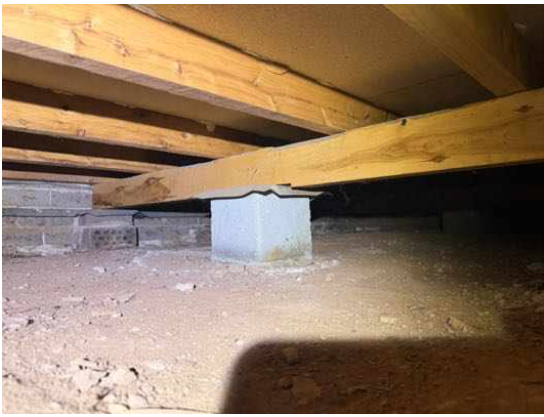
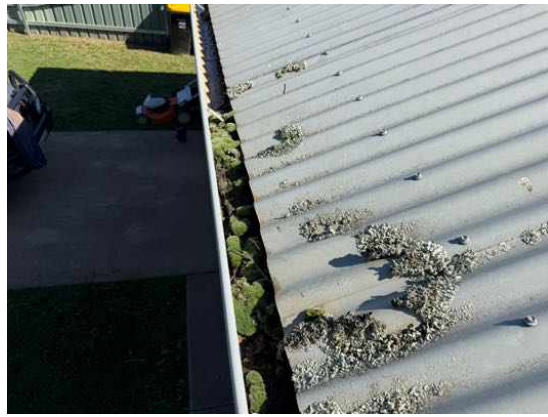
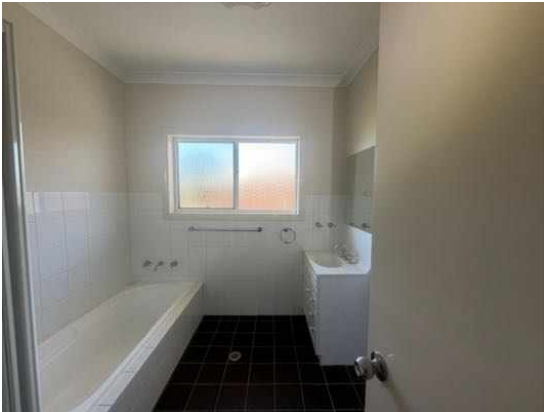
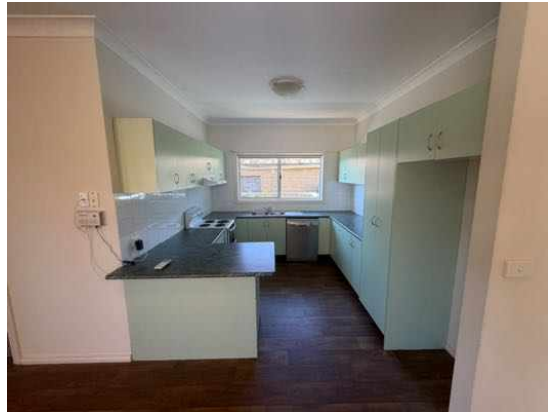
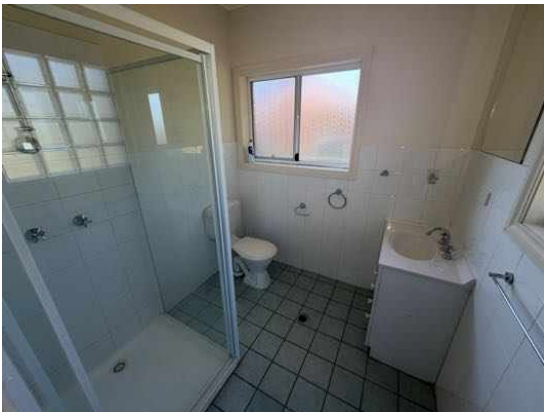
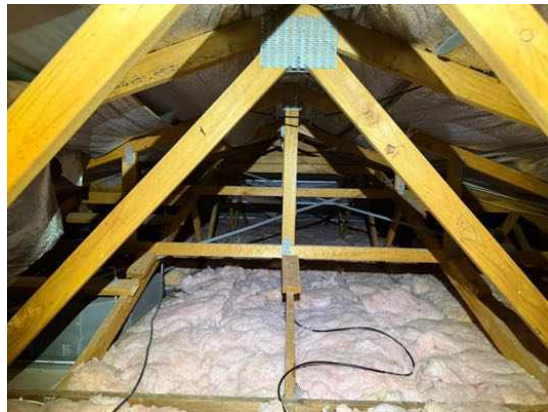
Building: Main Building
Location: All Areas
Finding: Additional Photos - Obstructions and Limitations
Information: These photographs are an indication of the obstructions and limitations which impeded full inspection of the property at the time of inspection. These obstructions can hide an array of defects and should be removed to allow full inspection to be carried out. A re-inspection is recommended once the areas are made accessible.

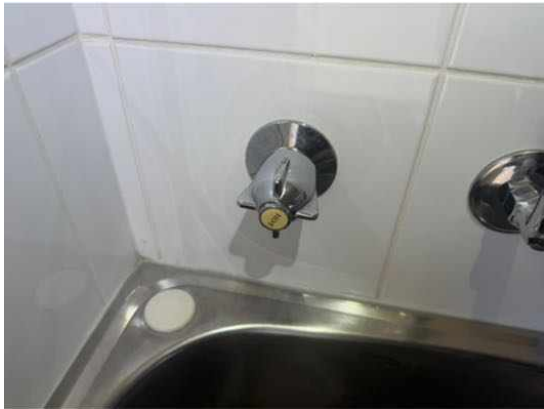
Building: Main Building
Location: Laundry
Finding: Laundry Tap - Not Operational
Information: It appears that the laundry hot water tap was not operational at the time of inspection. Recommend engaging a licensed plumber, at clients discretion to provide maintenance works.

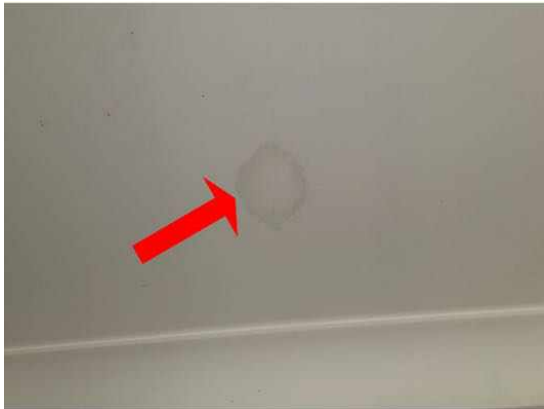
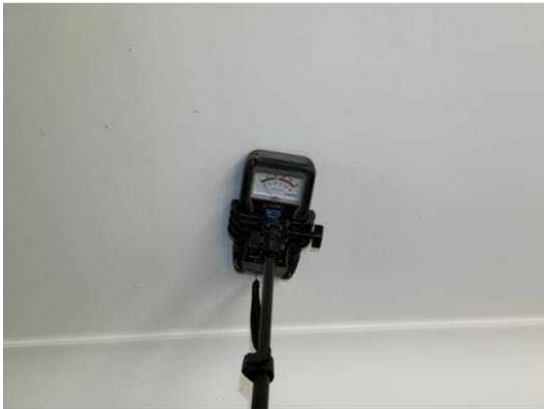
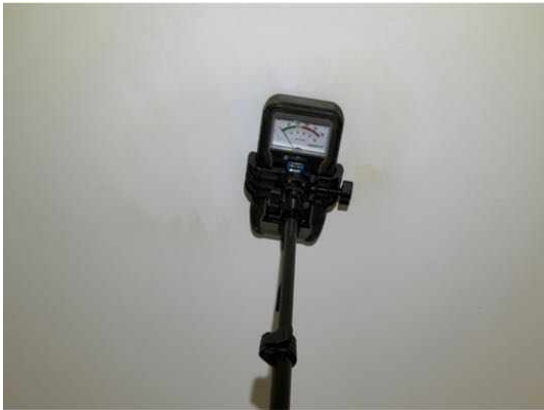
Building: Main Building
Location: Garage & bedroom ceiling
Finding: Staining Present
Information: It appears that staining was present at, but not limited to the garage & front bedroom ceiling. No high moisture was evident in the area at the time of inspection. It is recommended that the client monitor the area.

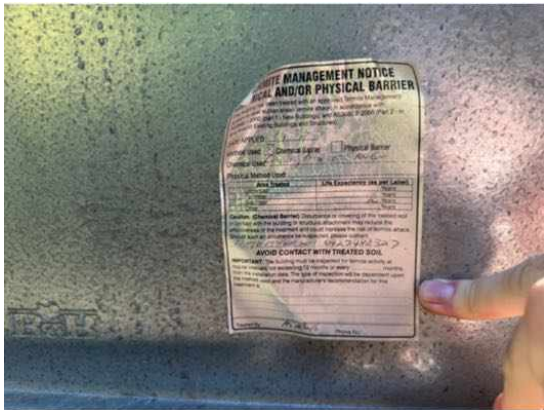
Building: Main Building
Location: Switchboard
Finding: Evidence of a previous termite management system
Information: A durable notice has been installed in the meter box, indicating that a previous termite management system has been installed.

The sticker indicates that the year of installation was 2004, meaning the chemical barrier has expired. Therefore, a termite treatment is strongly recommended. The client should engage a licensed pest controller to provide further advice regarding application of a termite treatment.
