Building and Timber Pest Inspection Report

Inspection Date: Mon, 26 Jan 2026

Property Address: 82 Kirkland Ave, Euroa VIC 3666, Australia

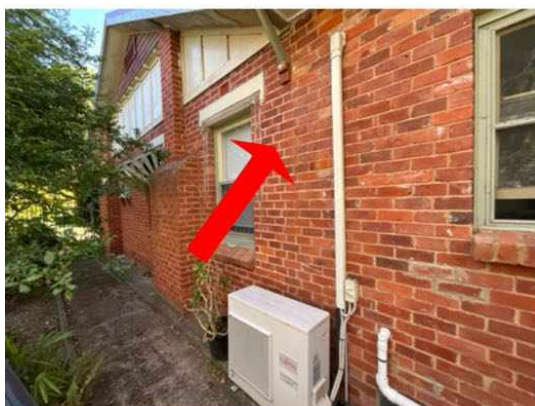
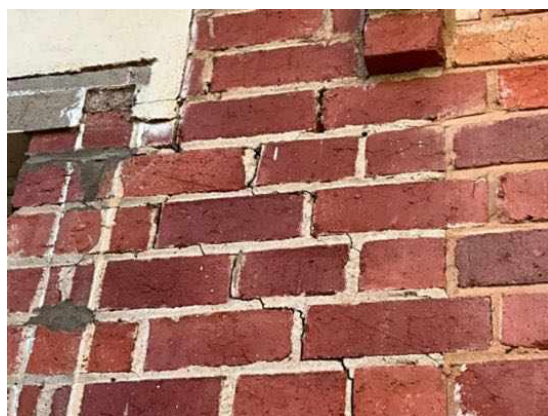
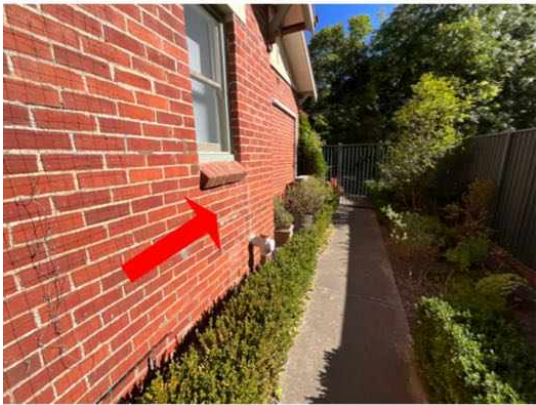
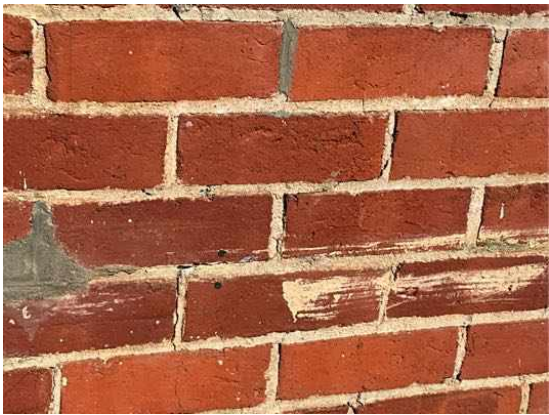
Finding 3.01

Building: Building 1
Location: Yard - Side
Finding: Brickwork- Step cracking
Information: Step cracking was identified to the brickwork in this area at the time of inspection. Step cracking, which is similar to other forms of cracking, has a variety of possible causes. However, the most common is the subsidence of adjacent footings.

Step cracking is a relatively common defect, and is most likely to occur adjacent to windows, doors and other openings. Mortar failure in the gaps between affected bricks indicates the stresses and tensions affecting the wall.

Minor step cracking can be used as a warning sign to address factors causing stress to the wall, which can include the effect of surrounding trees, water leaks, soil erosion, or even the presence of reactive soils in the surrounding area.

If cracks increase in size or number contact a Licensed builder immediately to make all needed repairs.

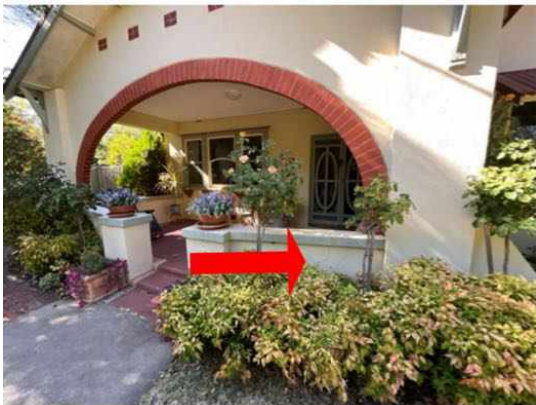
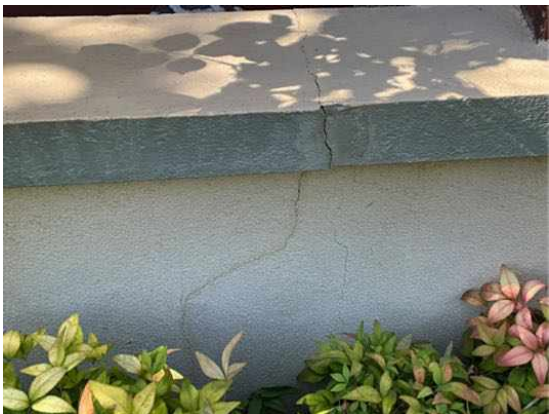
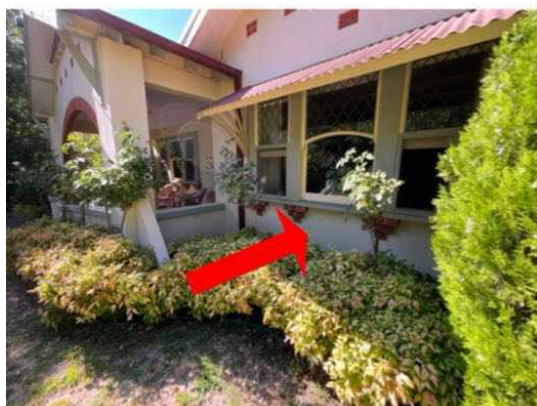
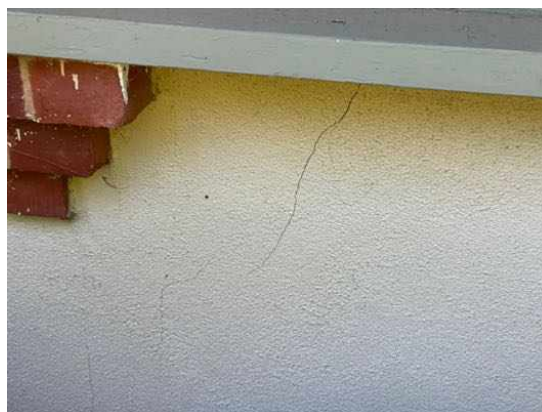
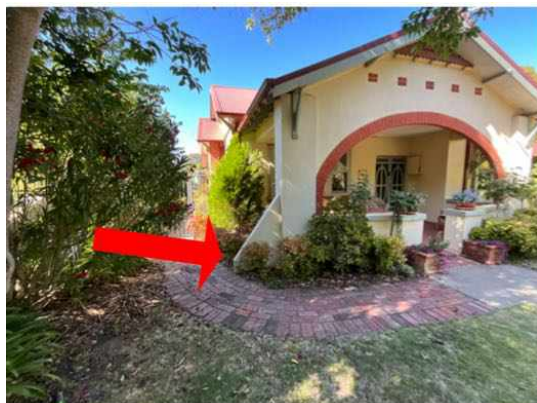
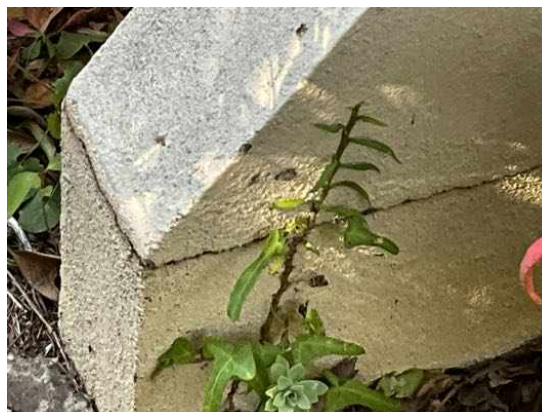
Finding 3.02

Building: Building 1
Location: Front wall
Finding: Brickwork - Cracking [Fine]
Information: Although fine cracks are quite noticeable, they are often only considered to be an appearance defect and usually do not indicate any structural damage. Generally, the cause of a fine crack is indicative of a separation between brickwork and mortar throughout the structure, but single bricks may also show cracks of this nature.

Cracking of this nature can generally be repaired with minor filling and should be conducted by a qualified bricklayer.

Always contact a building inspector should cracks widen lengthen or become more numerous.

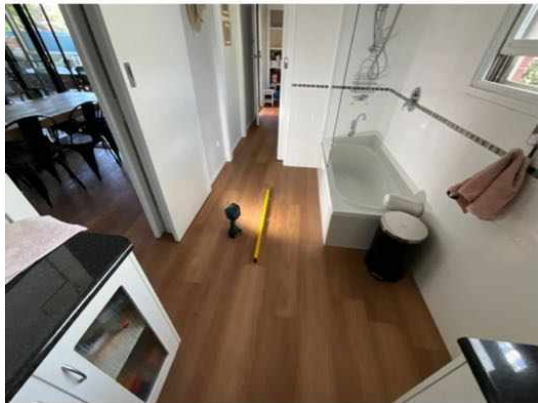
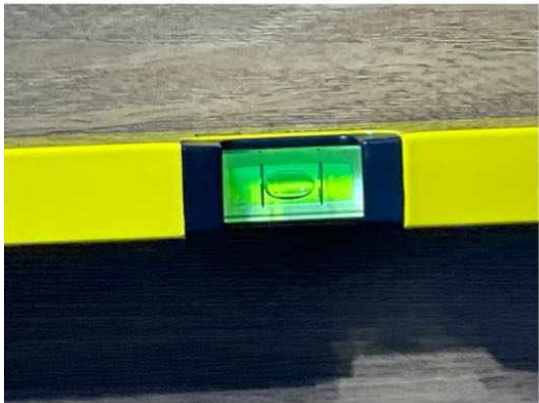
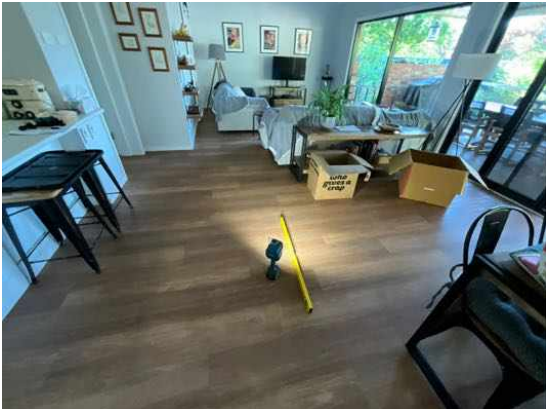
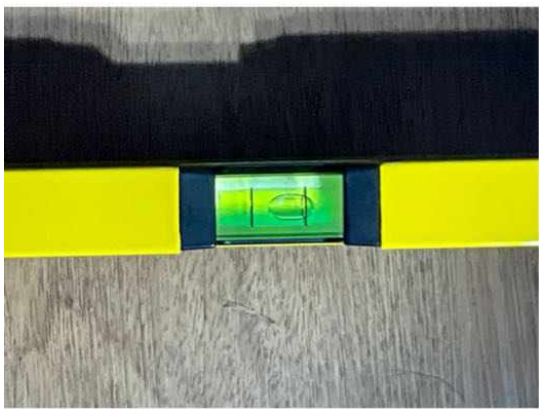
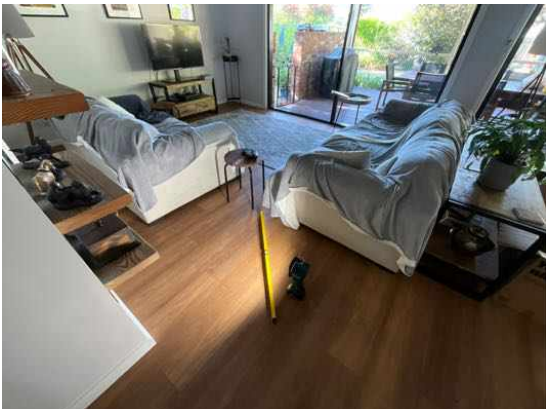
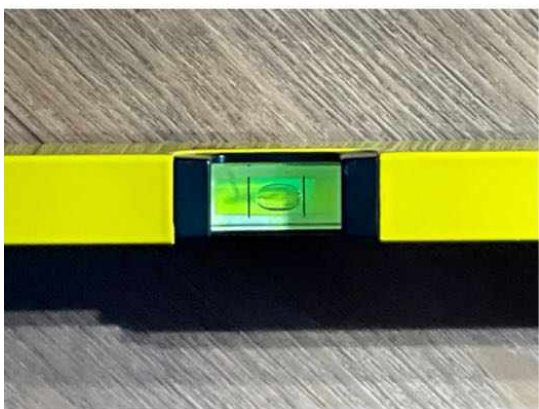
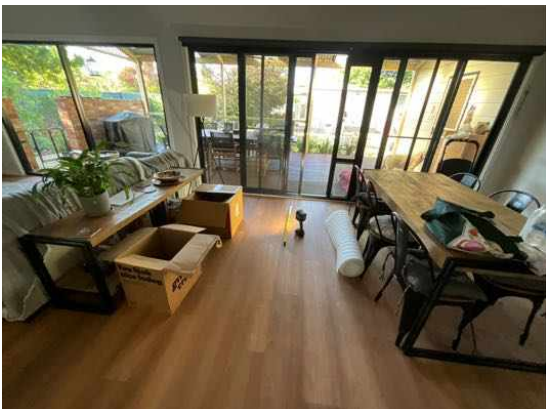
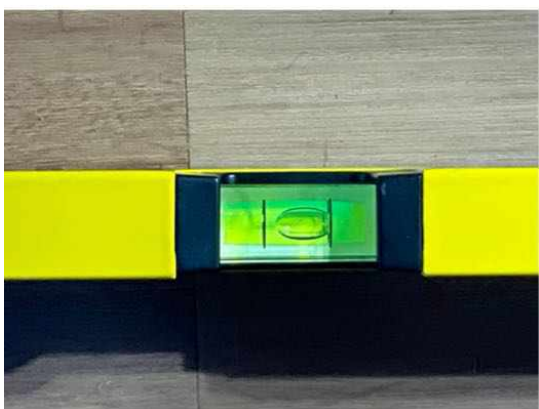
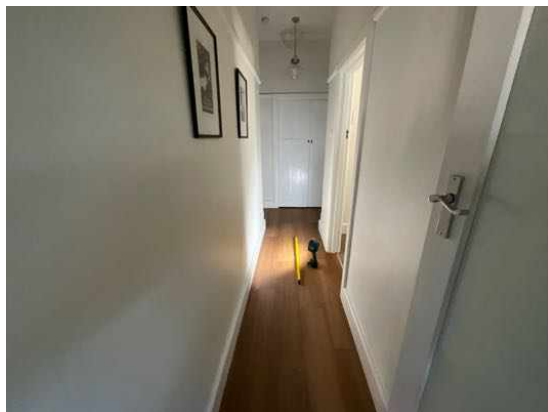
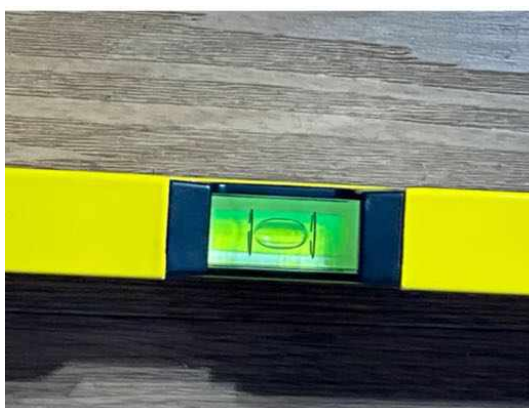
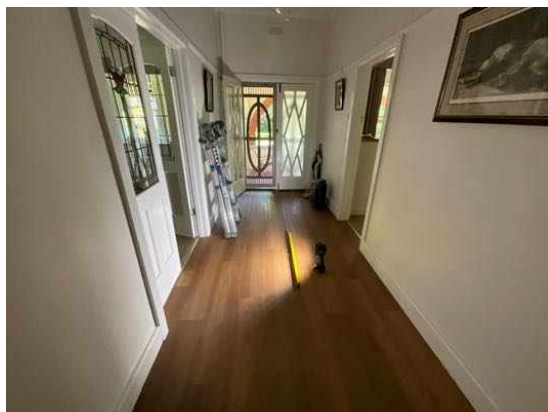
Finding 3.03

Building:	Building 1
Location:	All Internal Areas
Finding:	Flooring - Uneven
Information:	The internal flooring in this area is out of level and uneven. Uneven flooring is likely to indicate minor defects such as expected movement of the foundations of the property, but may also indicate subsidence of the associated subfloor stumps.

It is advised that the flooring be closely monitored to identify any further movement. Where flooring remains relatively unchanged for an extended period of time (i.e. several months), it is likely that this defect has been caused by expected movement of the foundations of the property.

However, where flooring is uneven further, potentially invasive inspection of the subfloor structures and stumps in this area is required. In this case, works to repair are likely to be required, and would be carried out by a registered builder specialising in re-stumping.

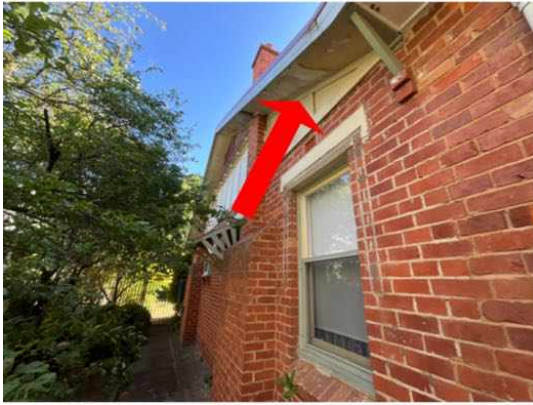
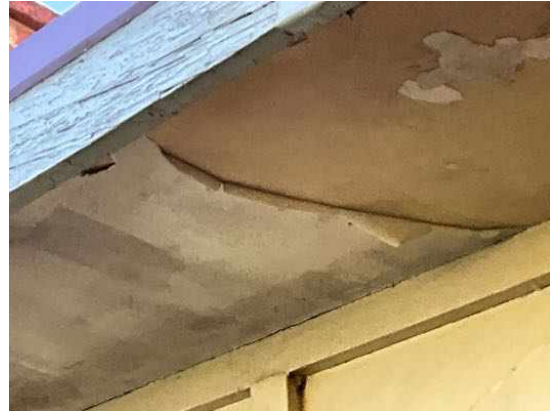
Finding 3.04

Building:	Building 1
Location:	Eaves
Finding:	Paint- Flaking
Information:	Sections of paint in this area was found to have deteriorated. Paint flaking is generally an indication of excessive moisture in the area, that is currently hidden by the painted surface.

The presence of excessive moisture can have major implications on associated building elements if left unattended. While only seemingly minor at this stage, the damage cannot be determined due to the paint obstructing any further inspection of the damage.

A qualified Painter should be contacted at the Owner's discretion to re-paint the area.

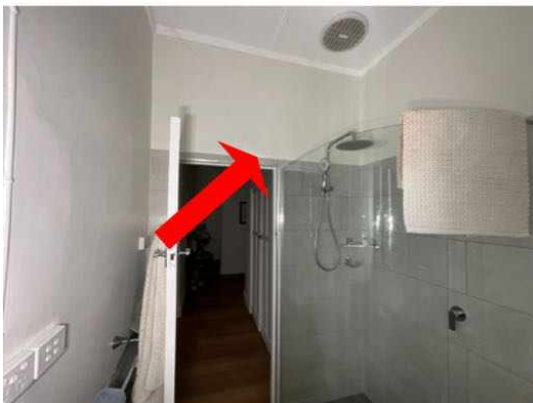
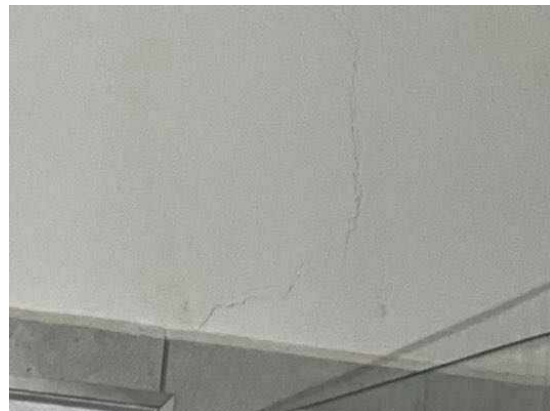
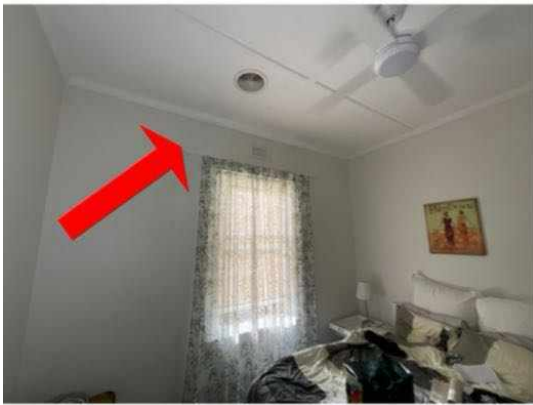
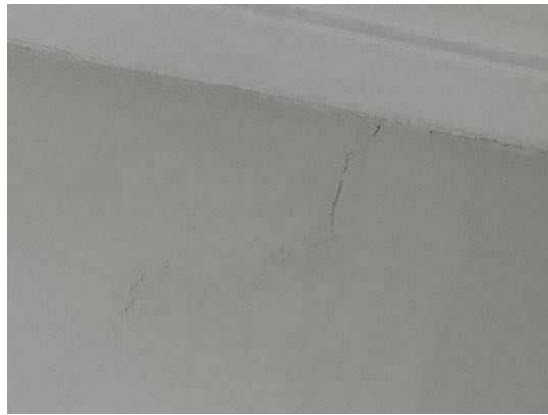
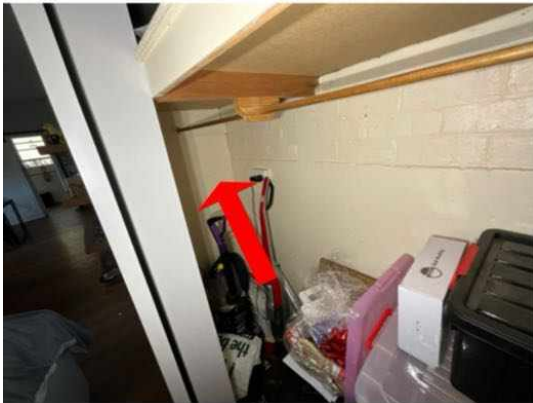
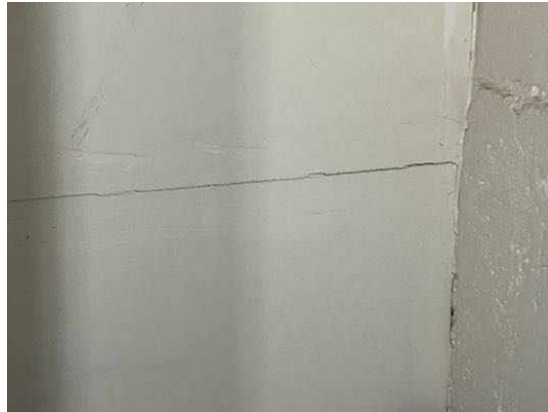
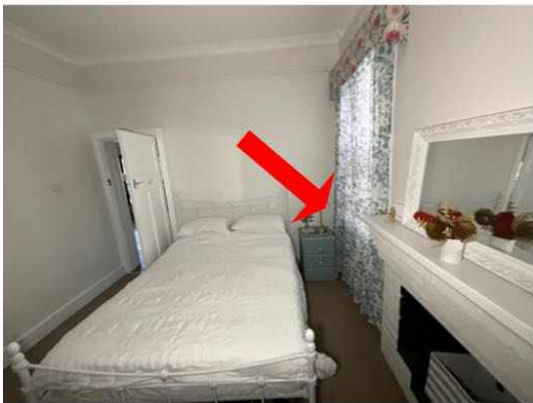
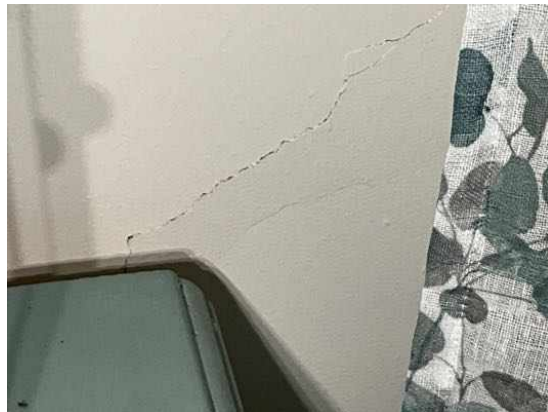
Finding 3.05

Building:	Building 1
Location:	Bathroom, bed 2,3, store
Finding:	Cracking - Damage Category 1 - Fine (up to 1mm)
Information:	Although fine cracks are quite noticeable, they are often only considered to be an appearance defect, and usually do not indicate any structural damage. Generally, the cause of a fine crack is indicative of a separation between building materials and finishes (e.g. paint, plaster, etc.) along joints.

Cracking of this nature can generally be repaired with minor sanding, filling and/or repainting. Such works should be performed by a qualified painter or a general handyman.

Monitoring of all cracking should be conducted frequently. Always contact a building inspector should cracks widen, lengthen, or become more numerous.

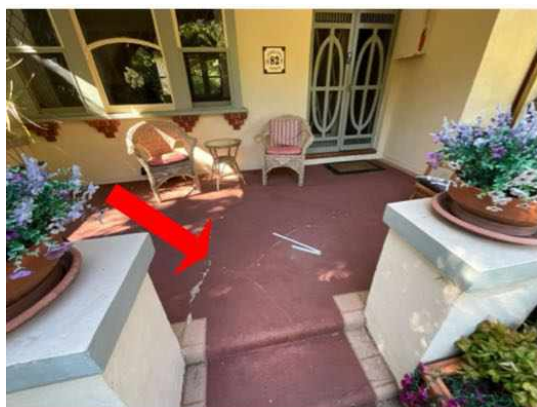
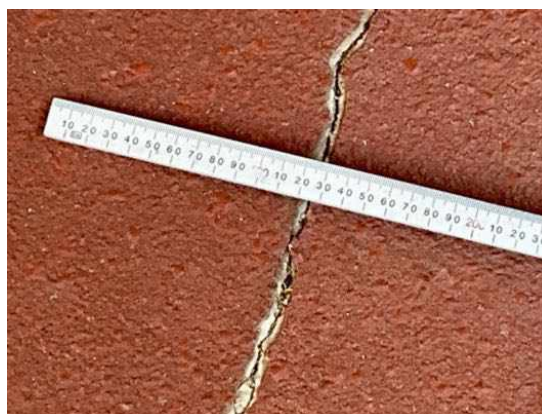
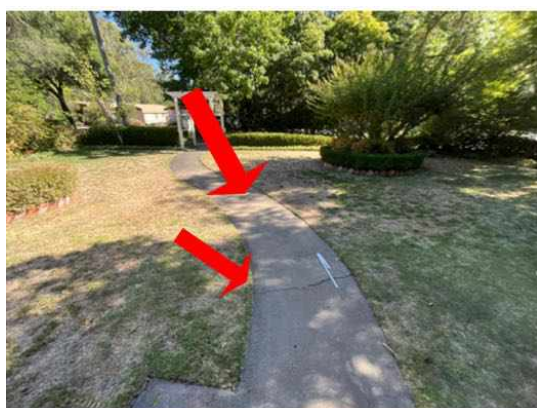
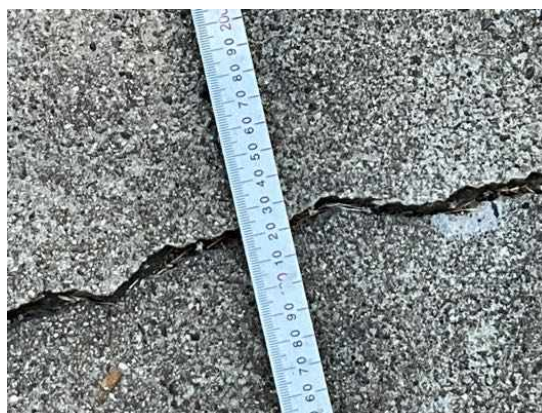
Finding 3.06

Building:	Building 1
Location:	Verandah, path
Finding:	Cracking - External Concrete Paving Damage Category 3 - Wide Cracks (2mm - 4mm)
Information:	Wide cracks were identified in external concrete paving. Wide cracks are significant and are likely to lead to the development of safety hazards and secondary defects if left unmanaged.

General age and expected deterioration of the paved areas is a common cause of this type of cracking. However, expansion and contraction of the slab may also have occurred due to environmental factors. Such factors include variable moisture and weather conditions, the presence of trees and their roots having a settling or lifting

affect on the soil, or the effect of load bearing, e.g. heavy vehicles over a sustained period of time.

Cracking to this degree may also be due to poor original installation of the concrete. Factors such as poor compaction of the sub surface and/or inadequate reinforcing of the slab may create cracking and other secondary defects. Wide cracks may also have a more significant structural cause, such as subsidence of soils.

Where the crack is located adjacent to structural elements of the building, the advice of a Structural Engineer is advisable before undertaking repairs. Significant repair and likely replacement of the concrete paving is probable.

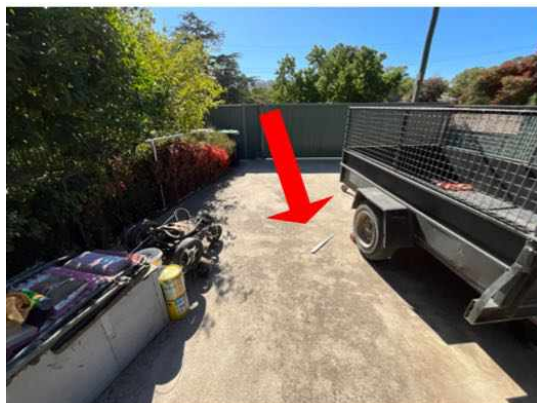
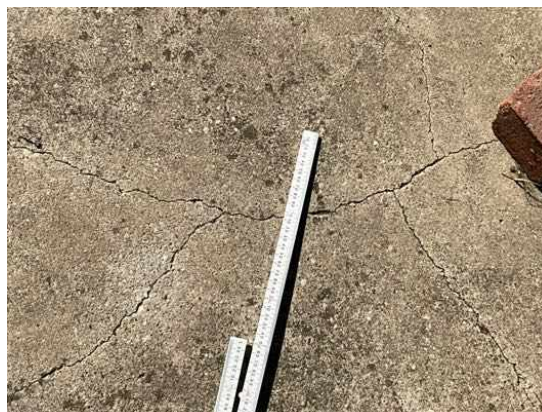
Finding 3.07

Building:	Building 1
Location:	Driveway
Finding:	Cracking - External Concrete Paving Damage Category 1 - Fine (less than 2mm)
Information:	Fine cracks were identified in external concrete paving. Although fine cracks are quite noticeable, they are often only considered to be an appearance defect, and usually do not indicate any structural damage. To be considered a Category 1 or fine crack, the crack is found to be less than 2mm in width.

Generally the cause of a hairline crack in existing concrete paving such as driveways

and pathways is indicative of the expansion and contraction of the concrete. Such causes are generally due to environmental factors, such as moisture levels, weather conditions, root systems of nearby trees or the soil types on which they are laid.

Fine cracks may also be due to poor original installation of the concrete. Factors such as poor compaction of the sub surface and/or inadequate reinforcing of the slab may create cracking and other secondary defects.

Monitoring of all cracking should be conducted frequently. Always contact a building inspector should cracks widen, lengthen, or become more numerous.

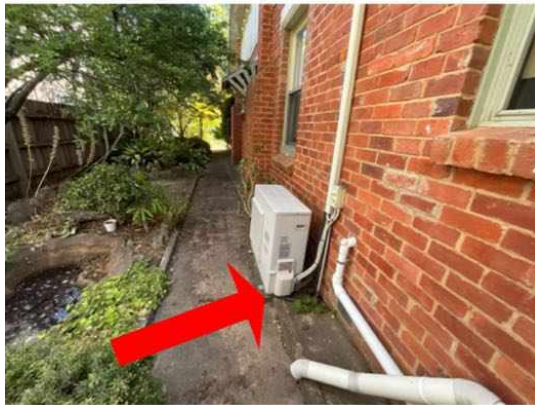
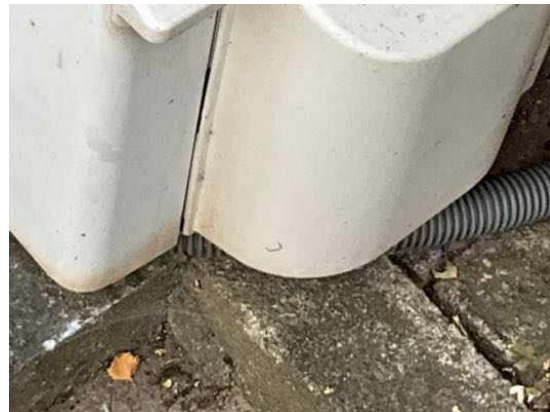
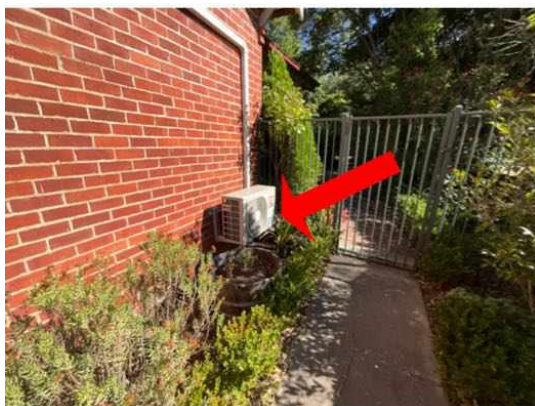
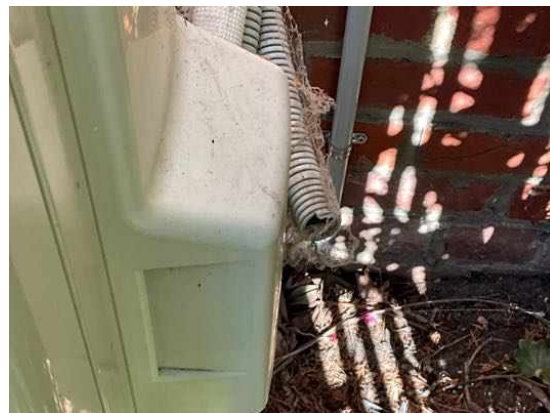
Finding 6.01

Building:	Building 1
Location:	Yard - Side
Finding:	Air conditioner - Disconnected overflow
Information:	The Air Conditioner (A/C) overflow was found to be disconnected from storm water drainage and is creating excessive moisture in the surrounding area.

Such leaking creates an environment which is conducive to an array of defects, including water damage to associated building elements and the attraction of termite or timber pest infestation.

It is highly recommended that a licensed plumber be appointed to connect the A/C

overflow in order to prevent such an environment from being created. These minor works should be carried out as soon as possible.

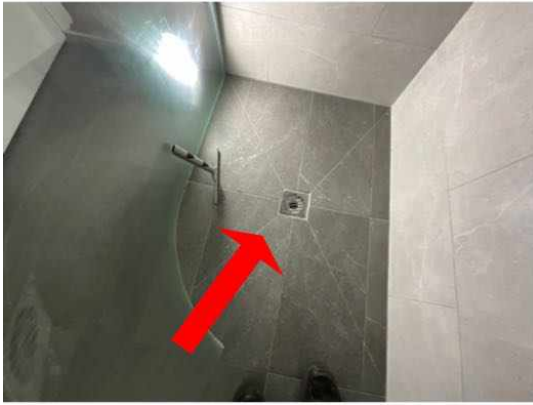
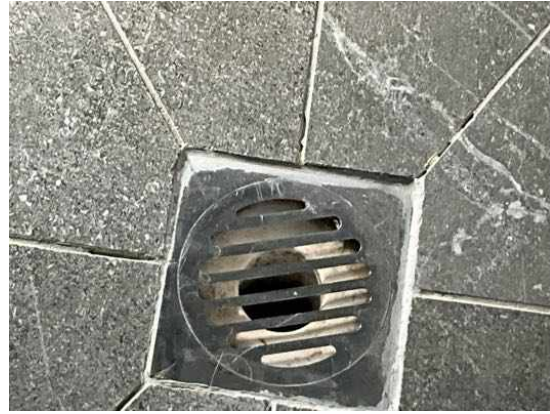
Finding 6.02

Building:	Building 1
Location:	Bathroom
Finding:	Inadequate sealant or Grout
Information:	This area has a lack of effective Sealant or Grout. This is allowing the ingress of water to the structure inside the wall.

The presence of water encourages Termite attack, Mould and Fungal Decay.

A Tiler or General Handy person must be contacted as soon as possible to effect repairs and prevent further deterioration.

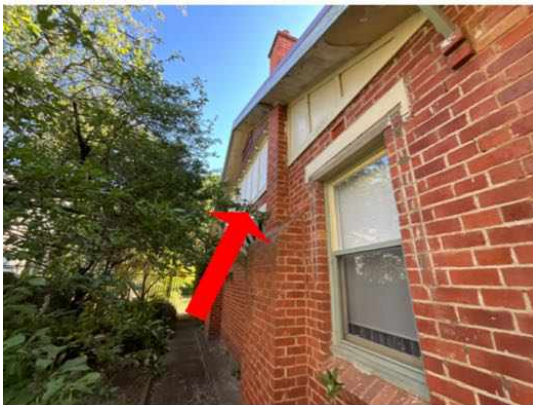
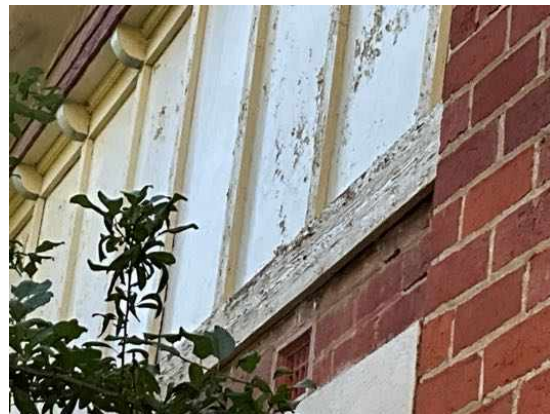
Finding 6.03

Building:	Building 1
Location:	External timber
Finding:	Timber - exposed to weather
Information:	External timbers that are frequently exposed to harsh weather conditions require adequate protection in order to maintain their condition. Where timbers have not been painted or treated adequately, general deterioration is likely to occur at an accelerated rate.

If left unattended, replacement of these timbers is likely to be necessary in the short-term future. Adequate treatment of these timbers is required as soon as possible by a painting contractor or general handyman.

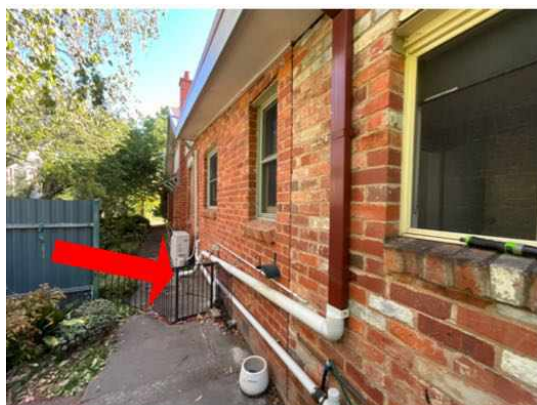
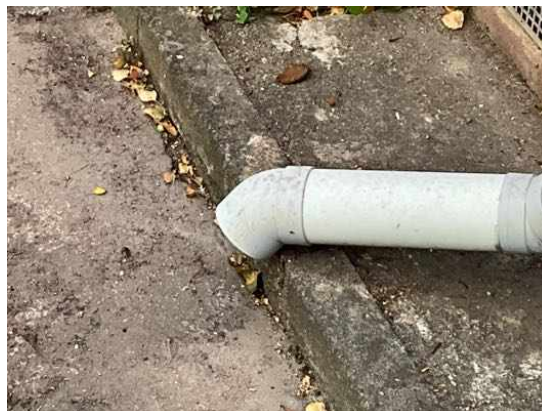
Finding 6.04

Building:	Building 1
Location:	Yard - Side
Finding:	Stormwater drain - Not connected
Information:	The roof plumbing is not adequately connected to stormwater drainage on the site. This disconnection negatively impacts the functional capacity of the roof plumbing.

Where roof plumbing doesn't drain adequately, the area at the base perimeter can

become excessively damp, potentially creating an environment that is susceptible to rust and corrosion of surrounding building elements, as well as attracting termites and other pests.

It is highly recommended that a plumber be appointed to further inspect the area and to install adequate drainage equipment where necessary.

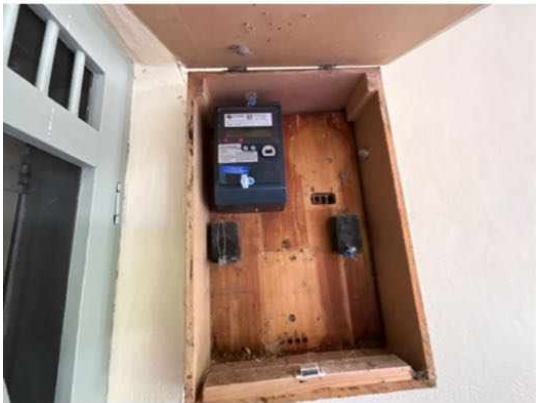
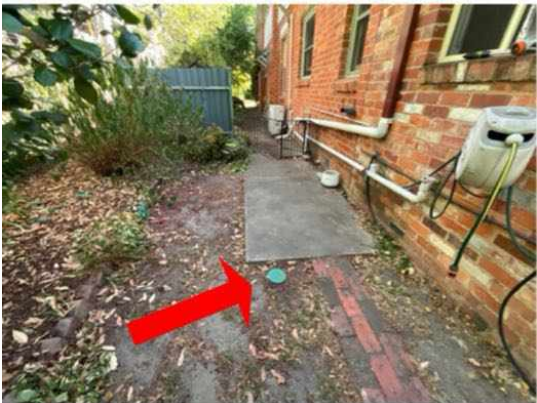
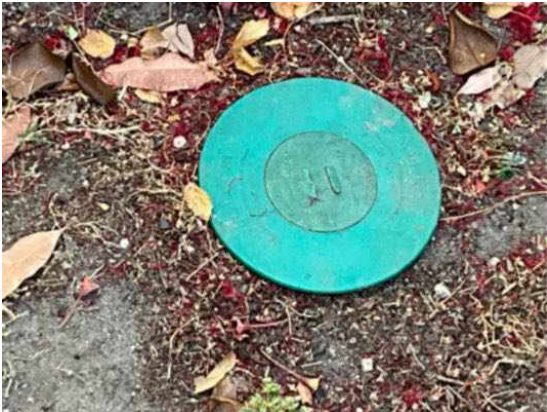
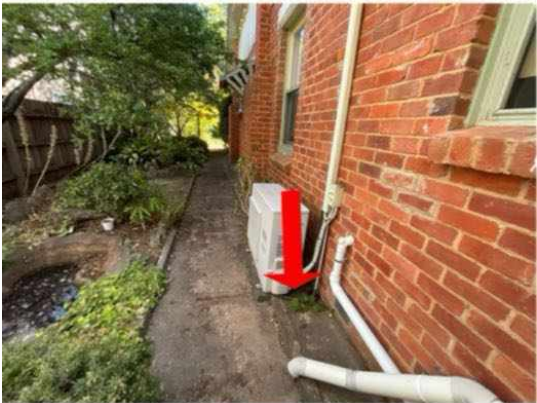
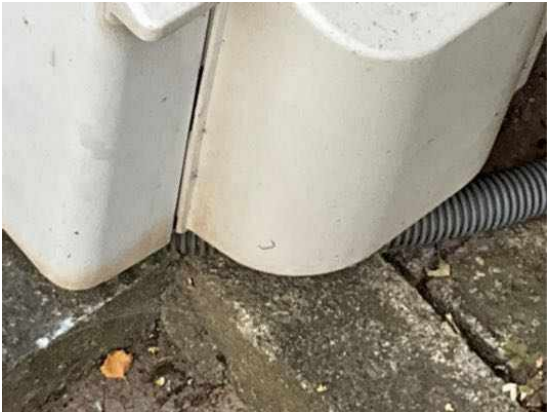
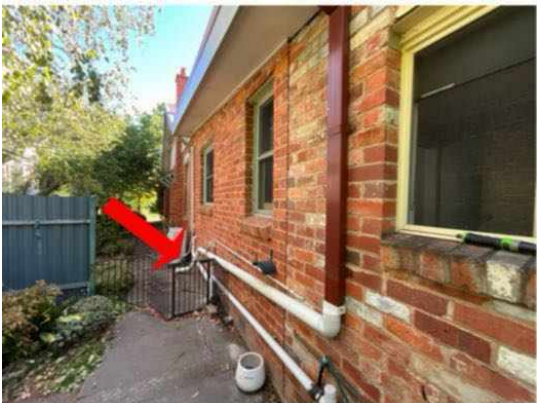
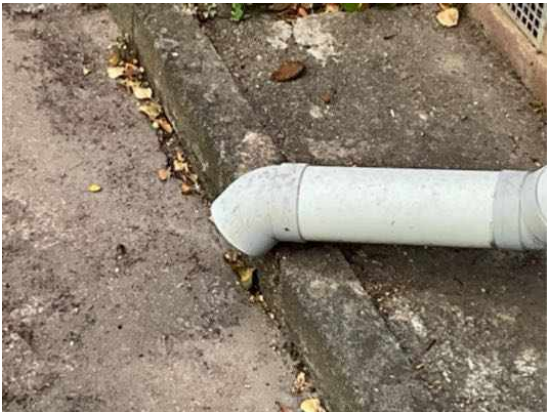
Finding 6.05

Building:	Building 1
Location:	All External Areas
Finding:	Termite Management System- evidence of a chemical installation
Information:	The application of a post-construction chemical termite barrier is highly recommended for all properties, particularly if live termite activity has been found on the site previously. Such barriers are highly effective in preventing termite attack on any timber building elements throughout the property.

A durable notice has been placed in the switchboard unit to indicate current termite barriers. At the time of inspection, it appeared as though a termite management system has been installed. The recency of any treatment cannot be determined.

The client may consider gaining further advice from a pest controller as to the costs and procedures involved with this application. It is recommended that obtaining such advice be a short-term priority.

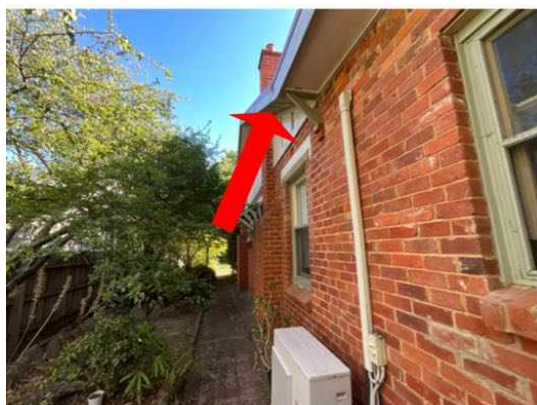
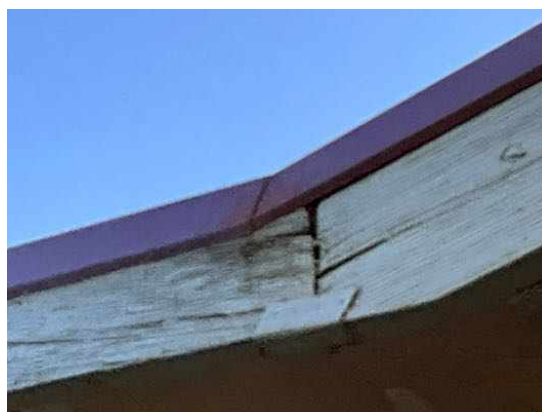
Finding 7.01

Building:	Building 1
Location:	Eaves
Finding:	Fungal decay - present (localised)
Information:	Fungal decay also known as wood decay or wood rot generally refers to the deterioration of timber elements when in contact with excessive levels of moisture for a prolonged period of time.

The development of fungal decay is accelerated by temperatures in the range of 5degreeC to 40degreeC as well as the presence of oxygen. Generally fungal decay develops on timber elements that are in use in an external environment which are exposed to rain penetration.

In this case although the affected timber element is in a decaying state the extent of any visible damage appears to be localised to a specific area and is yet to spread to other parts of the building element or affect adjoining structures. The fungal decay is therefore likely to be of a relatively superficial nature with minimal impact on the structural integrity or tensile strength of the timber element.

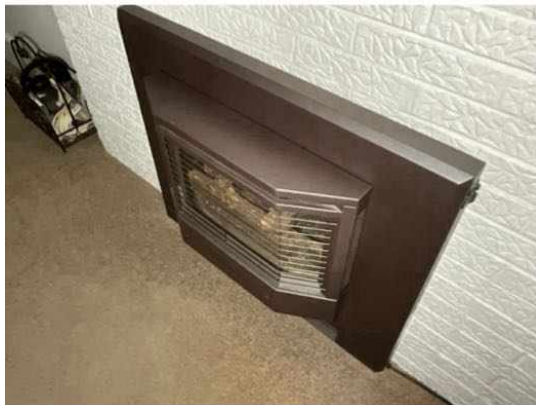
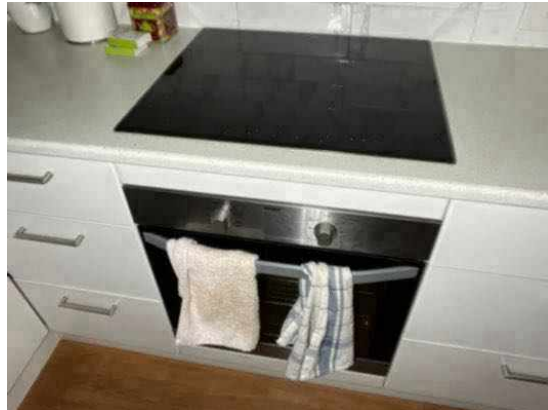
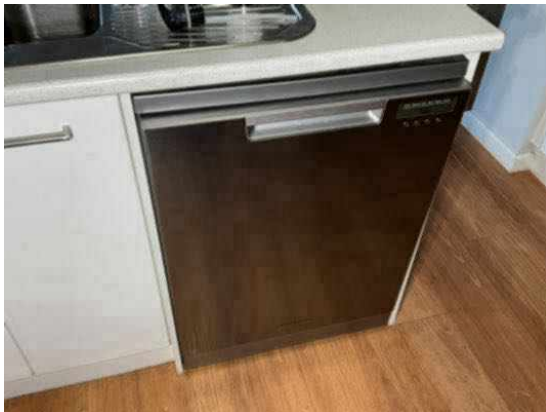
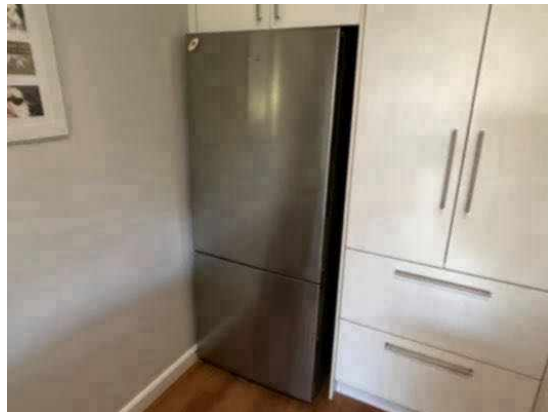
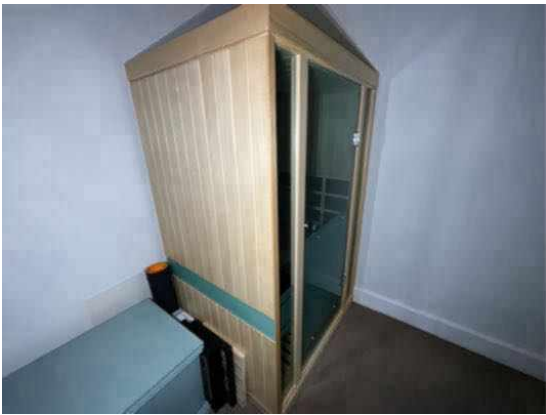
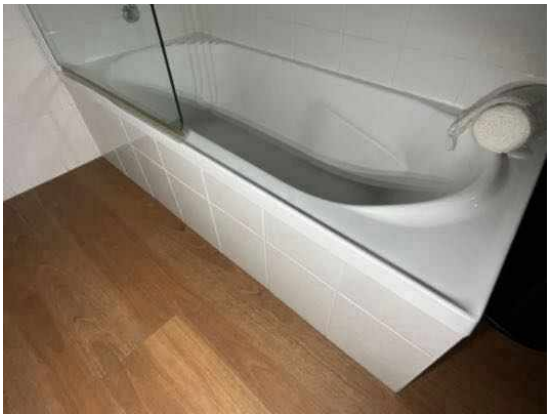
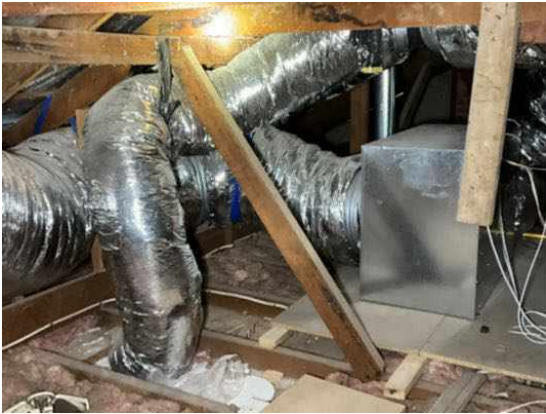
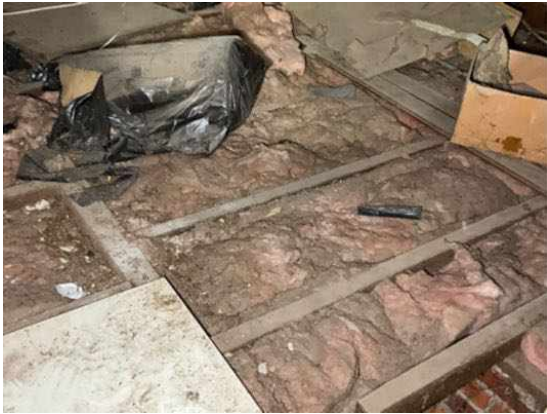
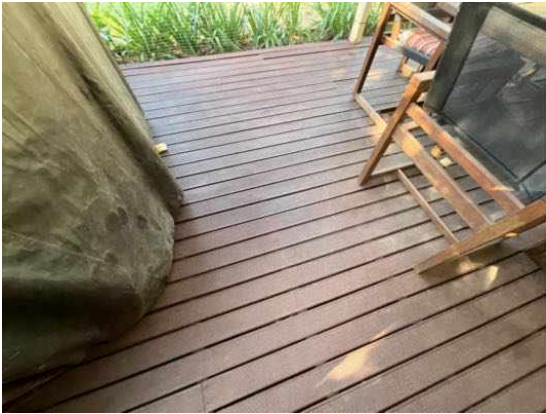
Noted Item

Building: Building 1
Location: All Areas
Finding: Additional Photos - Obstructions and Limitations
Information: These photographs are an indication of the obstructions and limitations which impeded full inspection of the property at the time of inspection. These obstructions can hide an array of defects and should be removed to allow full inspection to be carried out. A re-inspection is recommended once the areas are made accessible.
