Building and Timber Pest Inspection Report

Inspection Date: Fri, 13 Feb 2026

Property Address: 12/12-14 Barker St, St Marys NSW 2760,
Australia

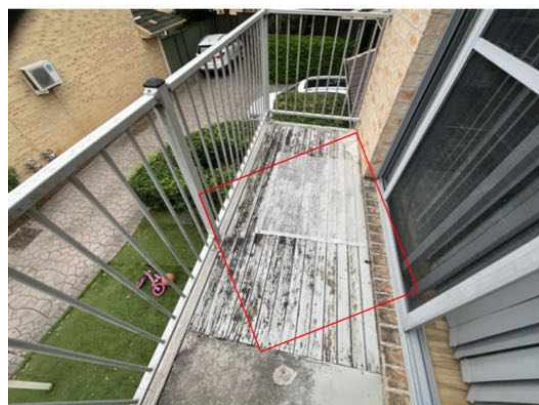
Building:	Main Building
Location:	Balcony
Finding:	Wood rot/decay
Information:	This building element shows evidence of severe wood rot. Wood rot, also known as Fungal Decay, occurs when timbers and other cellulose building materials are exposed to damp conditions on an ongoing basis. This could be the result of exposure to weathering over a prolonged period of time. If left unmanaged, damp conditions can lead to further health problems and the decay of timbers will continue.

The balcony flooring was found to have a severe level of timber rot, requiring urgent replacement by a licensed carpenter/builder.

Early intervention and regular maintenance, particularly of exterior timbers, will prolong the useful life of these building elements. Replacement of affected timbers is a necessary step in protecting surrounding building elements from such deterioration.

A licensed carpenter must be required urgently to replace affected building materials.

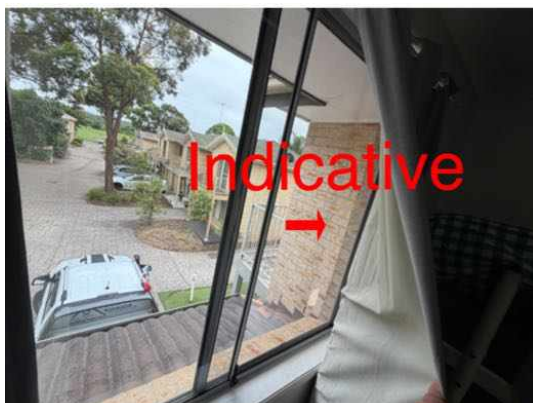
Building:	Main Building
Location:	Upstairs Windows
Finding:	Window restrictors - Missing
Information:	Window restrictors were found to be missing.

The National Construction Code (NCC) requirements apply to all openable bedroom windows in residential buildings, including hotels, motels and for all windows in early childhood centres.

Windows need to be locked at 12.5cm when the devices are engaged. The safety devices must be robust and child proof. The alternative is security screens such as bars or grills on the windows so long as they have gaps no bigger than 12.5cm. Flyscreens do not comply unless they are the reinforced security type and capable of resisting the very strong outward pressure which would prevent a child falling through. The laws apply to openable windows in a building within 1700mm of the internal floor and if the internal floor is more than 2m above the ground floor outside.

Windows upstairs lack appropriate child locks, creating a safety hazard. Window restrictors must be installed on these Windows immediately for added safety.

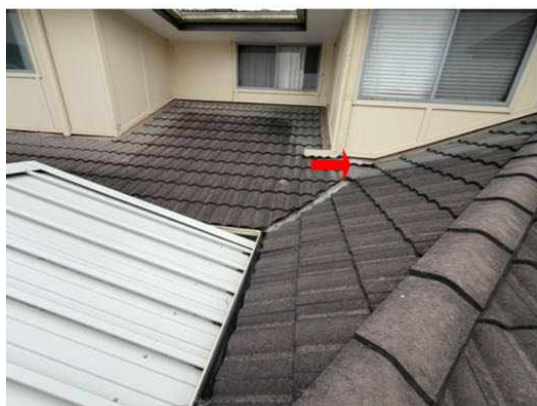
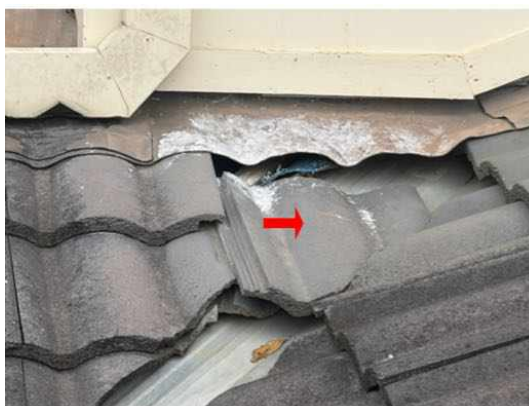
Finding 2.01

Building:	Main Building
Location:	Alfresco
Finding:	Roof tiles - Slippage
Information:	Upon inspection of the exterior roof covering, it was noted that numerous tiles have slipped from their original fixing. Tiles may slip over time due to a number of minor causes, including breakage of tiles, failings in the adjoining battens, or fixings that may have failed.

Roof tiles that have moved from their original position are very likely to allow water penetration into the roof void, exposing roofing structures to excessive moisture. This creates an environment that is conducive to water damage and accelerated deterioration of all associated building elements.

Replacement of loose or missing roofing tiles is recommended immediately to prevent the development of any secondary defects. A roofing restoration specialist should be appointed to complete such works as necessary.

Replace slipped roof tiles urgently.

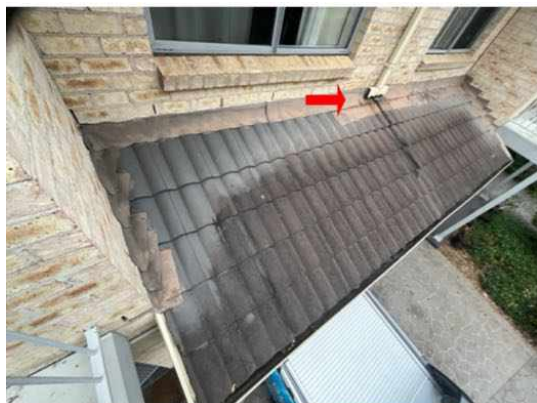
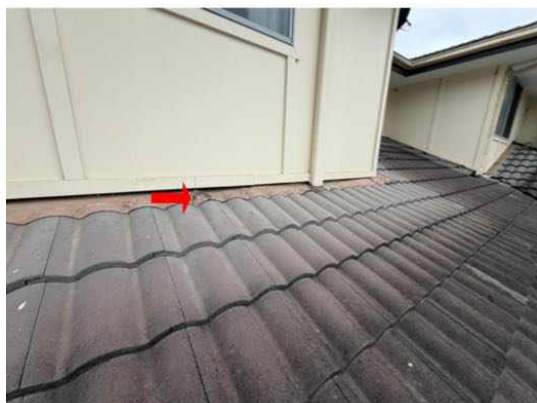
Finding 3.01

Building:	Main Building
Location:	Flashing
Finding:	Roof plumbing - Flashing cracked
Information:	Water leaks generally occur when a particular area of the property is not weather or water tight. Cracks were evident to the roof flashing in this area at the time of inspection.

Regardless of the location, if left unmanaged, even minor leaks can lead to serious

damage of associated building elements, potentially resulting in the need for replacement of building materials. Damage to ceilings, wood rot, mould and other hazards, such as electrical hazards, may also arise if left unmanaged.

Further inspection and repair by a roof specialist or a licensed roof plumber is advised to adequately rectify the potential leak.

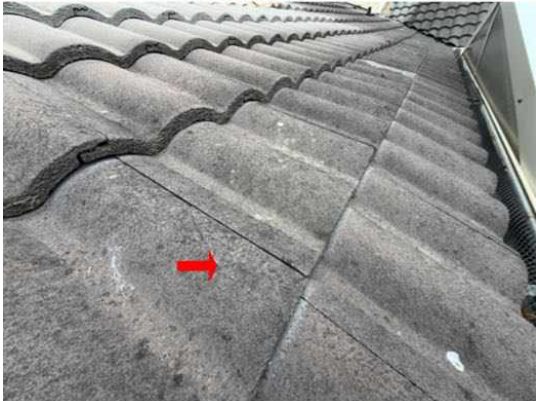
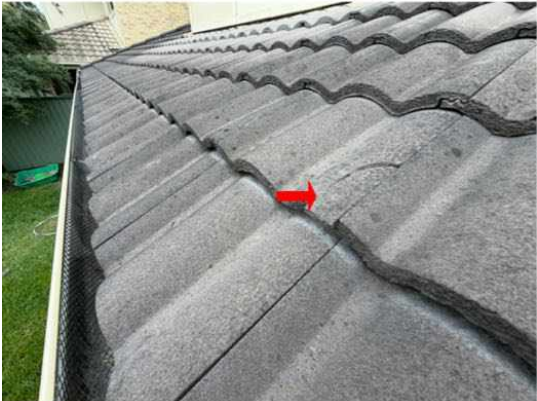
Finding 3.02

Building:	Main Building
Location:	Rear Elevation
Finding:	Roof tiles - Broken
Information:	Upon inspection of the exterior roof covering, broken roofing tiles were identified. Broken and friable roof tiles are generally the result of ageing and weathering of what is essentially a porous material.

If left to further deteriorate, broken and brittle roof tiles are likely to lead to water penetration via the roof into the ceiling space, causing secondary damage to ceiling linings, insulation and roof structures. Broken roof tiles are also likely to detract from the effectiveness of the roof drainage system, creating potential for secondary damage to the exterior roof covering and roof plumbing.

Replacement of broken tiles is required and should be performed by a roofing contractor as soon as possible.

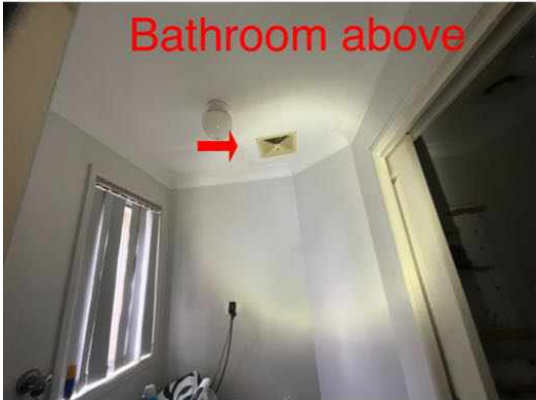
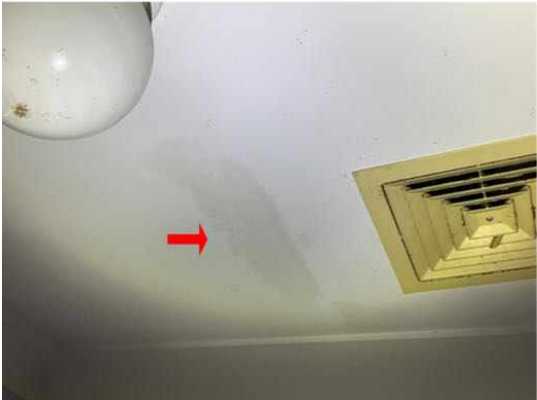
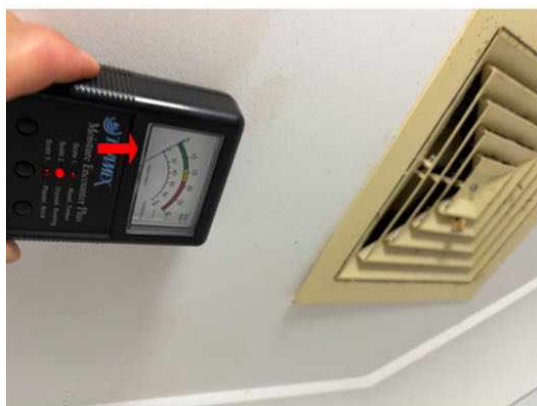
Finding 3.03

Building: Main Building
Location: Kitchen
Finding: Water leak - Inactive
Information: Water leaks generally occur when a particular area of the property is not weather- or water-tight. While the damage in this area appears to be from an old inactive water leak, the area should be monitored frequently for the recurrence of any dampness.

Repair and / or replacement of previously affected building elements is at client discretion. Consider a further invasive inspection: removal of obstructions around the damaged area may reveal further damage which has been concealed. A more significant or major defect may be identified at this time.

Where recurrence of an active water leak is identified, a qualified plumber should be appointed immediately to rectify the leak and advise on any further preventative works as necessary.

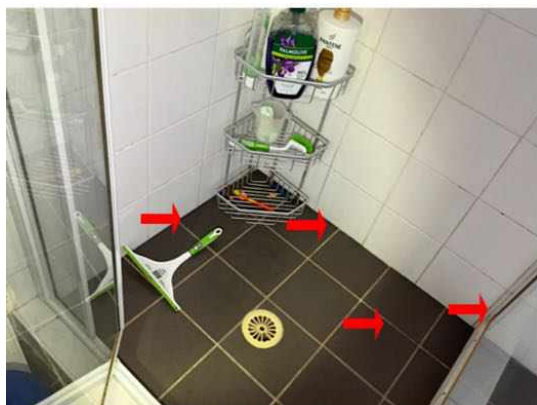
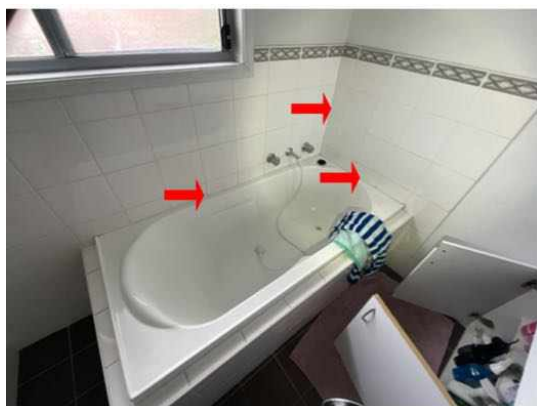
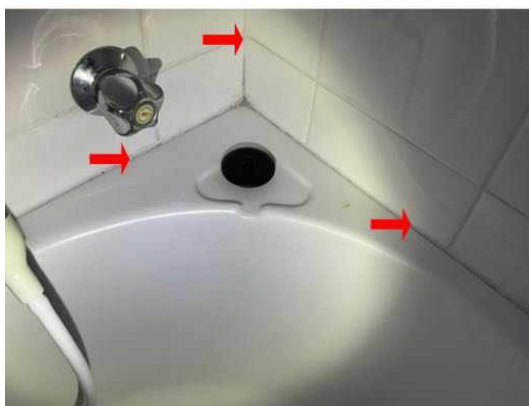
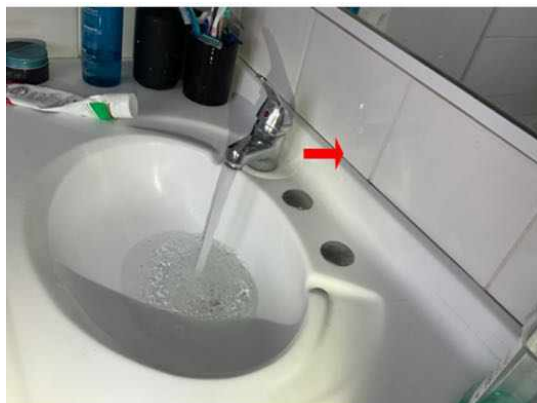
Finding 3.04

Building: Main Building
 Location: All Wet Areas
 Finding: Sealant and grouting - Missing or damaged
 Information:

It was noted on inspection that sealant or grout is degraded to this area.

Different materials and floor areas move at different rates, generally causing cracking to grout or sealant at this point. A flexible sealant is required to allow for expected expansion and contraction, while keeping the joint water tight and protective of all associated building materials.

Flexible and mould resistant materials should be applied to affected areas to prevent any subsequent water damage that is likely to occur. Regular maintenance and replacement of damage or missing or damaged sealant and grout is highly recommended to the wet areas, as this is a regular wear and tear defect. Sealant and grouting in areas that come into regular contact with water should be maintained for the long term care of your property.

A sealant specialist should be appointed to complete these works as soon as possible.

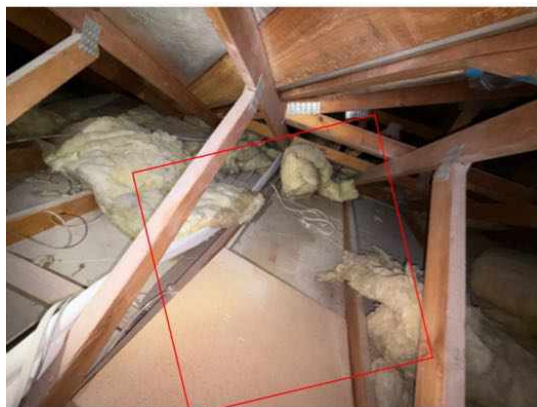
Finding 3.05

Building:	Main Building
Location:	Roof Void
Finding:	Insulation - Inadequate
Information:	Upon inspection of the roof void it was noted that there is a lack of adequate insulation.

The level of insulation in the property does not meet current Australian Standards. Installation of adequate insulation is required and should be conducted as soon as possible.

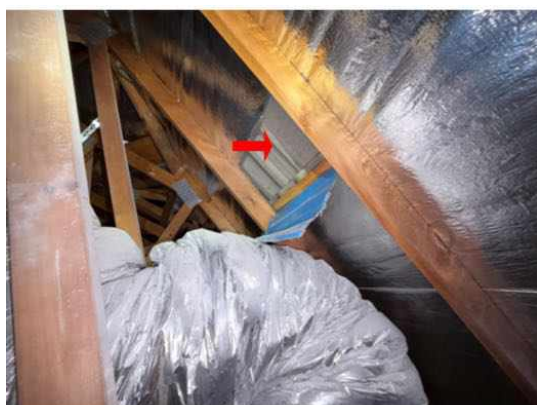
Finding 3.06

Building:	Main Building
Location:	Roof Void
Finding:	Sarking - Damaged
Information:	Sarking, a laminated aluminium foil applied to the interior of the roof covering, assists in insulating the property and acting as a vapour-barrier to the roof void and, subsequently, to the household.

Where sarking is damaged, both insulation and moisture protection of the property are inhibited. This creates a loss of energy and thus negatively impacts the energy efficiency of the property, allowing potential for moisture ingress from condensation or leaking roof tiles.

It is important to repair any holes or damaged sections of sarking to ensure that the building material is fully functional. A registered builder or qualified carpenter should be consulted to provide further advice on this defect and to perform rectification works at client discretion.

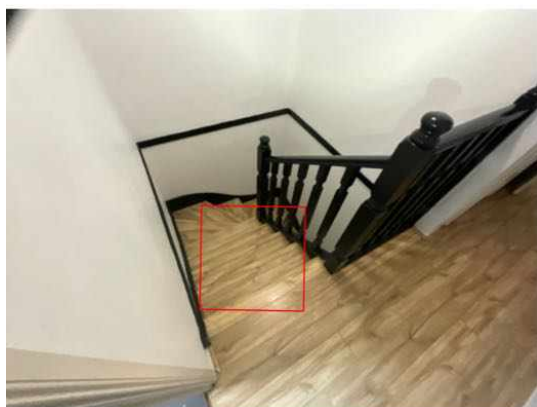
Finding 3.07

Although structural defects such as settlement could also be possible, however squeaky floors generally indicate that nails are coming loose from the joists that they are installed on, which is generally cosmetic rather than structural.

The client should appoint a licensed carpenter to undertake repairs.

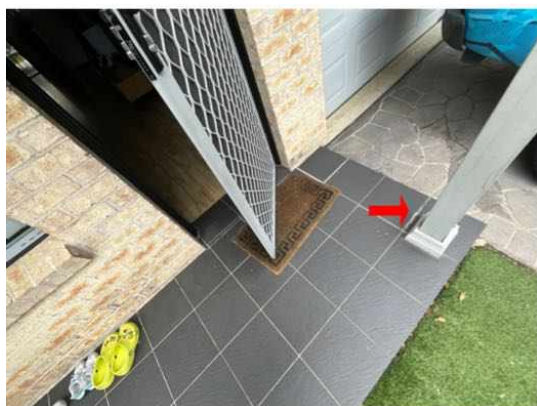
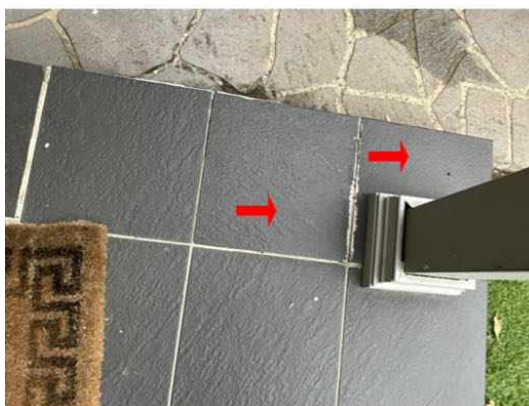
Finding 3.08

Building: Main Building
 Location: Porch
 Finding: Tiles - Drummy
 Information: Drummy tiled areas were identified at the time of inspection. The term 'drummy' refers to tiles that have become detached from their fixing, despite otherwise being in relatively good condition. Such defects are generally caused by physical or moisture damage to the area. Drummy tiled areas may also be a direct result of poor workmanship during the construction process.

Tiled areas may swell and shrink with changes in air humidity if the area has sustained moisture damage. Any exposure to moisture is capable of causing tiled areas to become drummy and/or cracked over a prolonged period of time. Drummy tiled areas generally require removal and replacement of affected tiles, with adequate sealant and grouting.

Specialist trades are available for these types of services. A licensed tiling contractor may be appointed to perform works as necessary.

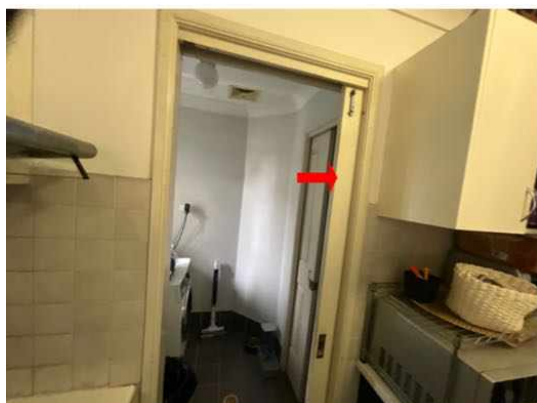
Finding 3.09

Building: Main Building
 Location: Laundry
 Finding: Door - Stiff to slide
 Information:

The door in this area was jammed and difficult to slide along the associated tracks at the time of the inspection. Restricted function of the affected door may pose as a potential safety hazard if required for emergency egress from the building.

Generally, factors such as general age of the building element and a lack of maintenance are the usual causes for this type of defect.

Replacement of door hardware or tracks may be required, as well as minor repairs and cleaning. A registered builder will be required to repair the affected doors.

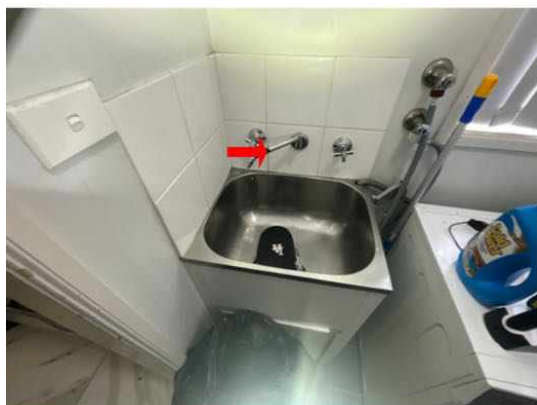
Finding 3.10

Building: Main Building
 Location: Laundry
 Finding: Washers - Degraded
 Information:

The washers on the taps in this area appear to have degraded as a result of general ageing. Degraded washers generally result in slow, persistent leakage from taps and plumbing hardware.

Replacement of washers will ensure that water wastage does not occur and that the persistent water leak does not result in secondary damage to surrounding structures. Such damage may range from rust and corrosion to damage of surfaces, e.g. bench tops, etc.

A qualified plumber should be appointed to replace degraded washers and to further inspect associated plumbing fixtures and fittings. Where water damage has occurred, a carpenter or cabinet maker may be appointed to replace affected building elements.

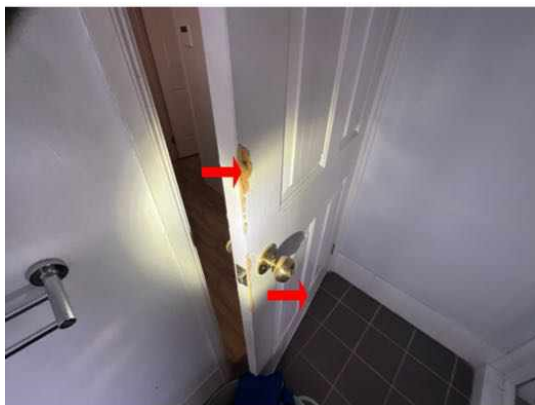
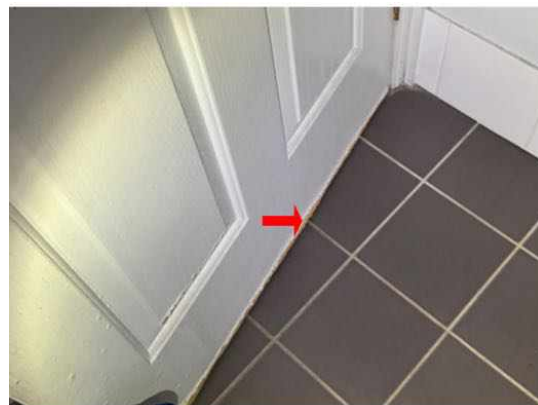
Information: Swollen building elements generally indicate that the building materials have been affected by excessive moisture over a prolonged period of time, and have swollen as a result. Further damage is likely to develop if left unmanaged. Excessive moisture is likely to lead to the development of secondary damage to any associated building elements, which may necessitate major reparation works if prolonged.

Repair and/or replacement of swollen building elements should be conducted by a general handyman or a licensed carpenter.

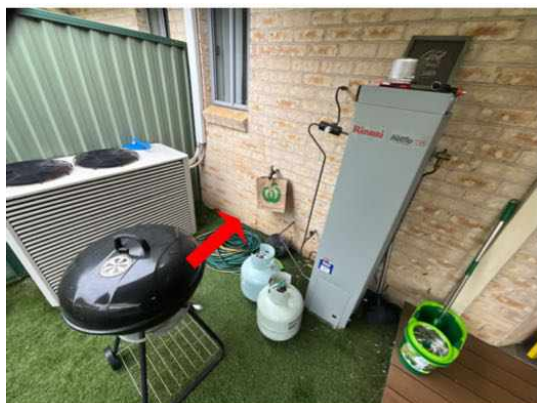
Not able to comment. A very high proportion of termite attacks are over the edge of both Infill and other concrete slabs types. Covering the edge of a concrete slab makes concealed termite entry easy. Infill slab type construction has an even higher risk of concealed termite ingress as the slab edge is concealed due to the construction design and cannot be exposed. The type of slab may only be determined by assessment of the construction plans by a qualified person e.g. Builder, Architect. Construction Plans may be obtainable by your local Council or Builder. Termite activity and or damage may be present in concealed timbers of the building. We strongly recommend frequent regular inspections in accordance with AS 3660.2. Where the

slab edge is not fully exposed or the slab is an infill slab or the slab type cannot be determined then we strongly recommend inspections every 3 to 6 months in accordance with AS 3660.2 or AS 4349.3.

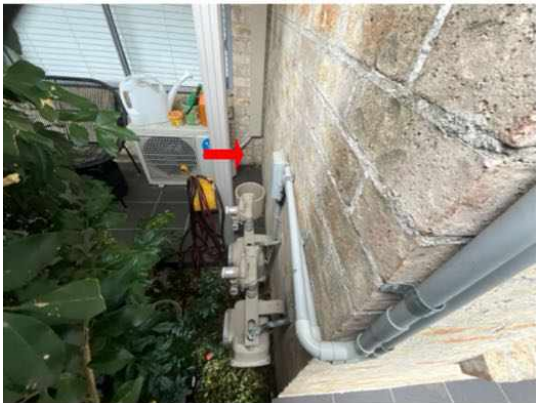
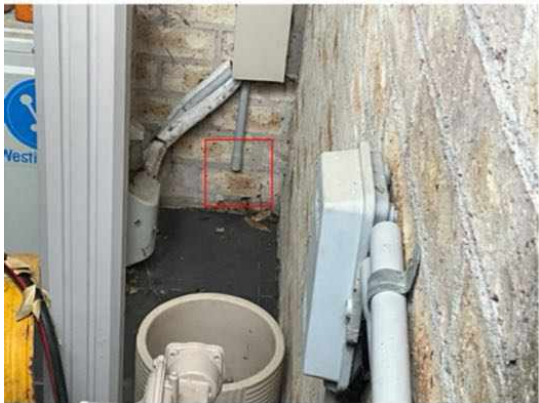
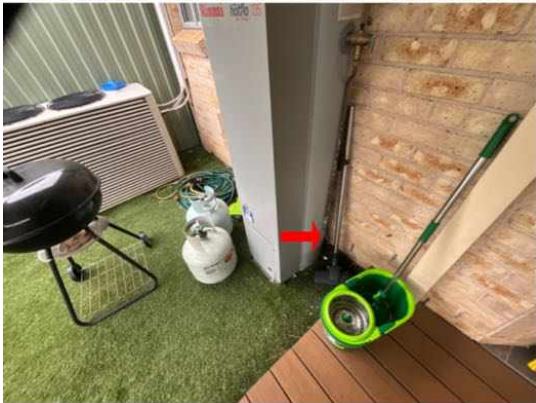
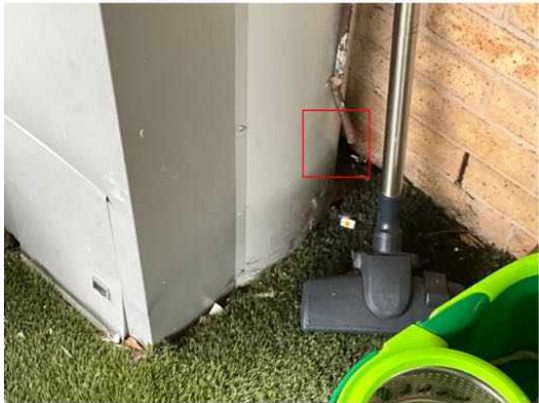
These damp conditions can lead to secondary defects such as rot, rust or corrosion of associated building elements, the formation of fungal decay, or even the creation of potential slip hazards. When coupled with poor site drainage, pooling of water may also attract termite activity to this area.

It is highly recommended that a licensed plumber be appointed to install adequate drainage to the overflow. These works will ensure that the area remains dry and free of any secondary defects.

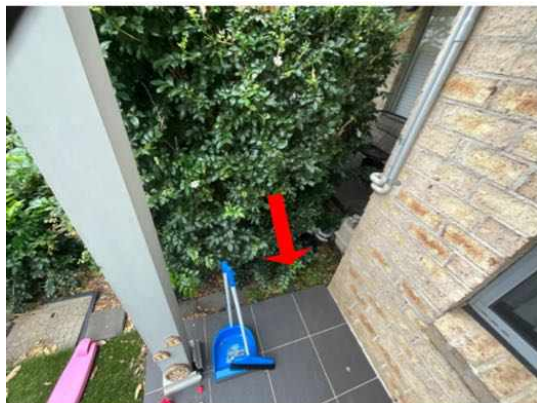
Building: Main Building
 Location: Garden beds

Finding: Garden Beds
 Information: Garden beds were found to be evident in the garden area. These garden beds can include untreated timber, and with a combination of moisture from watering hosing can make conditions conducive to termite activity and termite ingress.

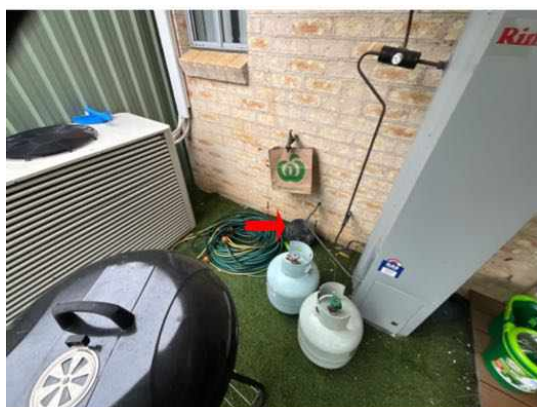
Finding 6.07

Building: Main Building
 Location: External tap
 Finding: Tap - No drain
 Information: The external tap in this area was noted to have no drain at the time of inspection.

A licensed plumber must be appointed to ensure an appropriate drain is installed.

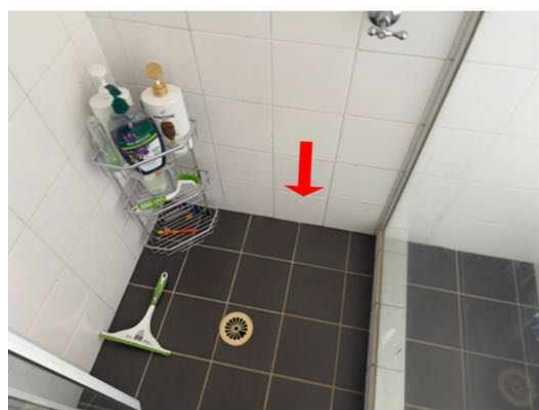
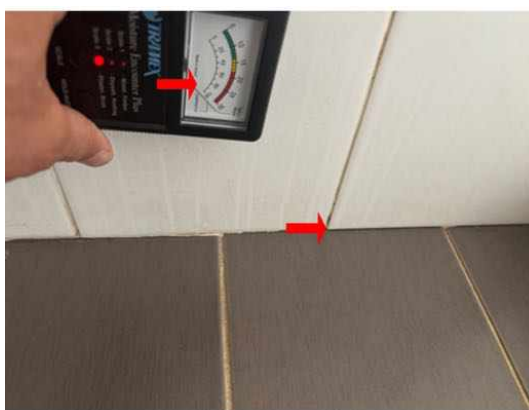
Finding 6.08

Building: Main Building
 Location: Bathroom
 Finding: Shower damp - Sealant and grout
 Information: Damp is evident to the lower 400mm of wall to the shower alcove. This defect is quite

common, and is suspected to have been caused by moisture permeating or leaching through the grouting and sealant in this area, which shows evidence of deterioration. Leaking pipes within the wall is also a possible cause however this seems unlikely in this instance as there is no moisture build up around the taps or transferring to the other side of the wall. There appears to be no sealant around the tap spindles which may be a small contributing factor.

Damp (or structural damp) refers to the presence of unwanted moisture in the structure of a building, either as the result of intrusion from outside, or condensation from within the structure. In the shower area, internal water leaks, degraded materials or other sources of excessive moisture are generally the cause of damp.

Unmanaged damp in the shower recess is likely to facilitate the formation and development of mould and fungi growth, decaying associated building materials and compromising their structural integrity of associated elements. It is important to address damp conditions, as the World Health Organisation notes that excess moisture leads - on almost all indoor materials - to growth of microbes such as moulds, fungi and bacteria, which subsequently emit spores and other matter into the indoor air. Exposure to these contaminants is associated with a wide range of respiratory and other health-related problems. Damp conditions also create a conducive environment for termite infestation.

Consultation with a bathroom sealant specialist is advised immediately to identify the cause of damp and to perform remedial works as required.

Always ensure that sealant and grout is in good condition to prevent any moisture issues occurring in the future.

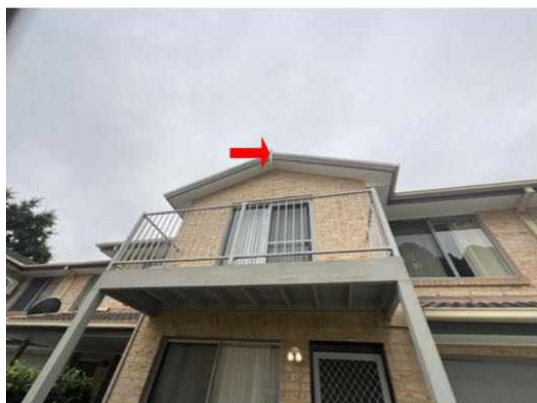
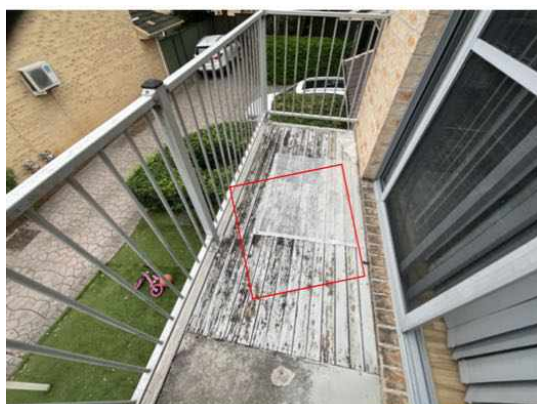
Finding 7.01

Finding: Wood rot/decay
Information: This building element shows evidence of wood rot. Wood rot, also known as Fungal Decay, occurs when timbers and other cellulose building materials are exposed to damp conditions on an ongoing basis. This could be the result of exposure to weathering over a prolonged period of time, or the attraction of excessive moisture from other abutting building materials. Contributing factors also include poor air ventilation in the area.

Wood rot is often associated with general damp problems and is evidenced by a `musty` smell or mould and mildew occurring on surfaces. If left unmanaged, damp conditions can lead to further health problems and the decay of timbers will continue.

Early intervention and regular maintenance, particularly of exterior timbers, will prolong the useful life of these building elements. Prior to any works being performed, the cause of the moisture that has created the visible wood rot should be identified and addressed in a suitable manner. Replacement of affected timbers may then be a necessary step in protecting surrounding building elements from such deterioration.

A licensed plumber may be appointed to assess the cause of excessive moisture and to provide advice on any remedial works as required. A licensed carpenter may also be required to replace affected building materials.
