Building Inspection Report

Inspection Date: Thu, 12 Feb 2026

Property Address: 9 Temple-Wood Ct, Berwick VIC 3806,
Australia

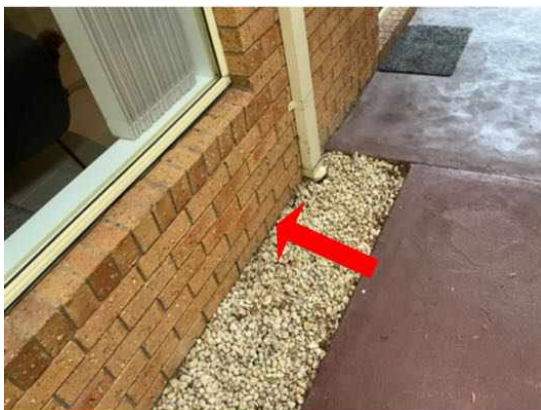
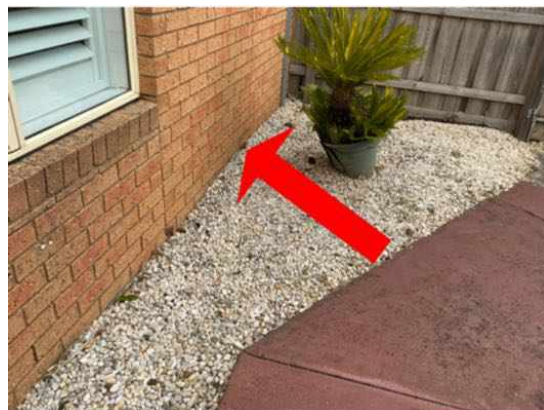
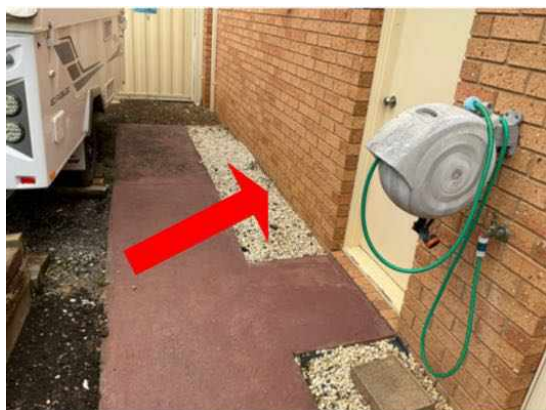
Defects 3.01

Building: Main Building
Location: All External Areas
Finding: Site drainage - Inadequate
Information: The site drainage in sections of the side yards and backyard was found to be inadequate at the time of inspection, creating potential for subsequent water damage to associated building elements.

It is important that water does not lie against the base of walls; surrounding paths and ground levels should be sloped to drain water away from walls. Downpipes should not discharge stormwater onto lower walls or plinths. Stormwater should be carried away by large, regularly cleaned drains. Ground levels may need to be lowered to expose a buried DPC.

Where site drainage is inadequate, installation of an Agricultural (Aggie) Drain may be required. A qualified plumber should be appointed to further inspect the property and perform any remedial works as necessary. Water damage and secondary defects are likely to occur if left unmanaged.

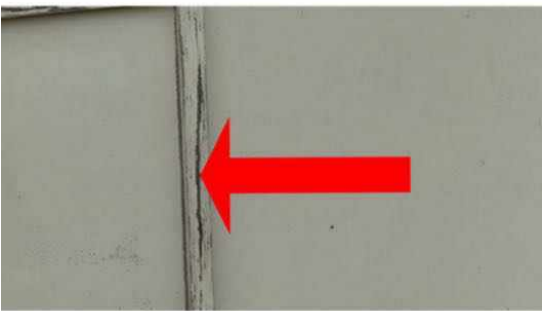
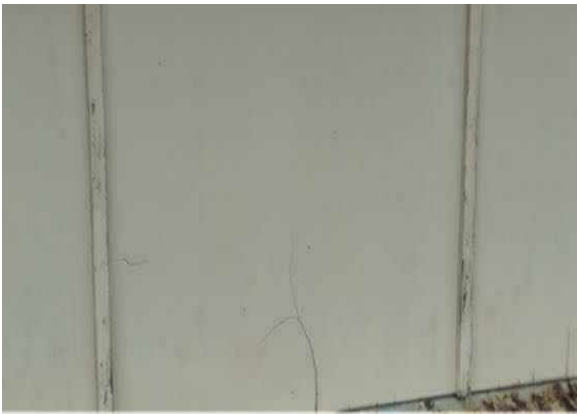
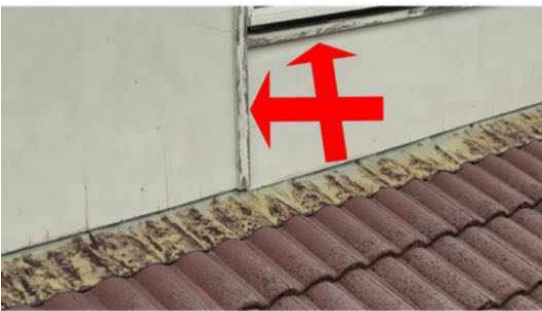
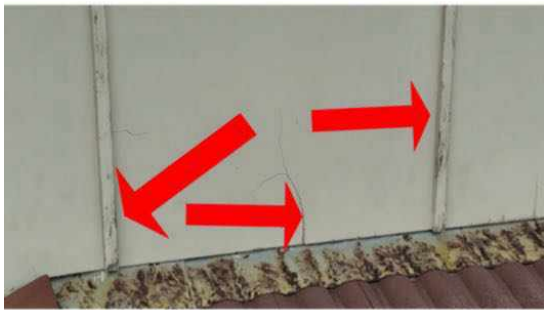
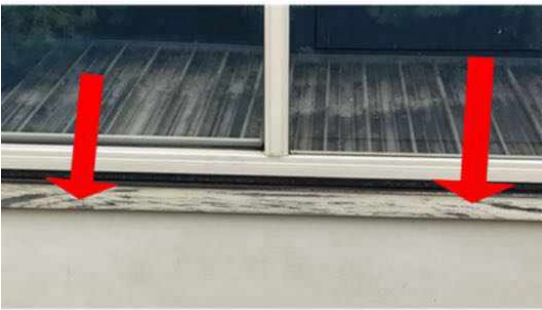
Defects 3.02

Building:	Main Building
Location:	Exterior walls - rear
Finding:	Deterioration and Cracking to External Cladding – Rear Elevation
Information:

The rear elevation of the dwelling incorporates a section of lightweight external cladding, while the remainder of the dwelling is constructed of brickwork. The cladded section was observed to exhibit multiple defects, including vertical and irregular cracking to the sheet joints, localised timber deterioration, and areas of paint breakdown. The lower flashing adjacent to the tiled roof surface shows significant surface corrosion and staining. In addition, sections of timber trim and window framing display advanced paint failure and early-stage decay, particularly at joints and exposed edges.

Cracking to cladding sheets may be associated with differential movement, inadequate joint detailing, moisture exposure, or ageing of the material. The presence of timber deterioration suggests prolonged exposure to moisture, likely due to weathering, inadequate sealing, or flashing performance. Corroded flashings may reduce effective weatherproofing and can contribute to moisture ingress behind the cladding system. If left unaddressed, continued deterioration may lead to progressive timber decay, potential water penetration into the wall cavity, and structural damage to framing elements.

A registered builder should be engaged to further assess the condition of the cladding system, including removal of affected sections if required to inspect the underlying framing. Damaged or deteriorated cladding sheets and timber components should be replaced as necessary, corroded flashings renewed with appropriate corrosion-resistant materials, and all joints properly sealed. All exposed timber should be repaired or replaced, primed, and repainted using suitable external-grade coatings to restore weather resistance and durability.

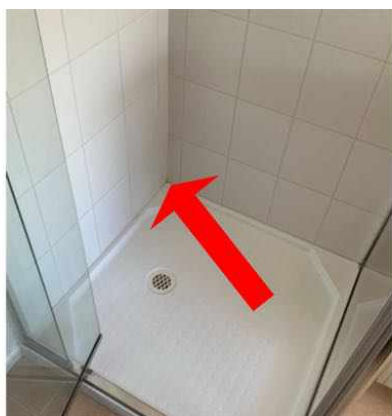
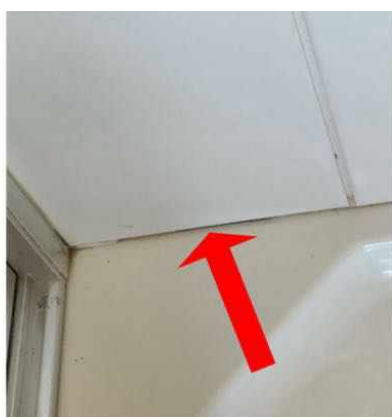
Defects 3.03

Building: Main Building
Location: Bathroom 2
Finding: Sealant and grouting - deteriorated
Information: It was noted on inspection that sealant or grout is degraded to the tiled shower alcove and or other areas of the bathroom.

Different materials and floor areas move at different rates, generally causing cracking to grout or sealant at this point. A flexible sealant is required to allow for expected expansion and contraction, while keeping the joint water tight and protective of all associated building materials.

Flexible and mould resistant materials should be applied to affected areas to prevent any subsequent water damage that is likely to occur. Regular maintenance and replacement of damage or missing or damaged sealant and grout is highly recommended to the wet areas, as this is a regular wear and tear defect. Sealant and grouting in areas that come into regular contact with water should be maintained for the long term care of your property.

A sealant specialist or tiling contractor should be appointed to complete these works as soon as possible

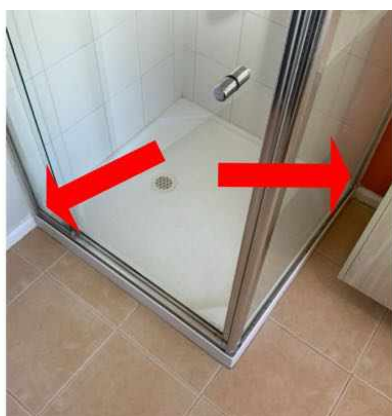
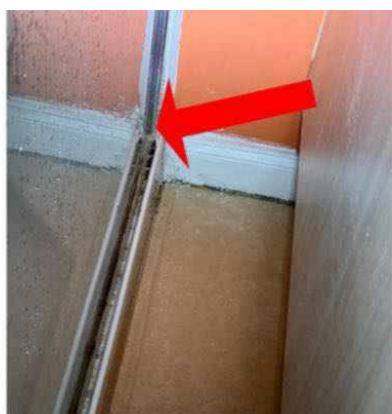
Defects 3.04

Building: Main Building
 Location: Bathroom 2
 Finding: Shower screen - Leaking
 Information: Leaking was evident to the 2nd bathroom's shower screen at the time of inspection. It is suspected that the leaking has occurred as a result of deteriorated or missing caulking to the shower or general ageing of the building elements.

Leaking from the shower where left unattended, is likely to lead to water damage to adjoining flooring and walls. Such damage can lead to water damage and necessitate extensive remedial works being required. Active water leaks may also create an environment that is susceptible to the formation and development of mould.

Appointment of a caulking contractor is required to repair or replace the caulking to the shower area. Such works should be performed as soon as possible to ensure that no further damage occurs.

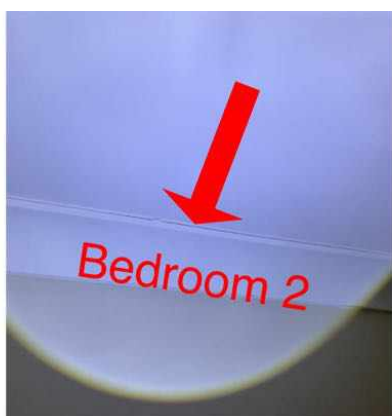
Defects 3.06

Separation gaps were observed between the plaster cornices and the ceiling lining at multiple locations throughout the upper level, including bedrooms and wet areas (ensuite and bathroom). The gaps appear as linear cracking and joint separation along the cornice-to-ceiling junction, with localised areas of visible movement. The condition appears widespread to Level 1, while the ground floor ceilings were noted to be unaffected at the time of inspection.

Moisture testing to the affected areas returned readings within normal ambient ranges, and thermal imaging did not indicate active moisture ingress. A visual inspection within the accessible roof space did not identify obvious structural displacement or significant fixing failure to the ceiling framing. Based on the observations, the condition is more consistent with differential movement, minor structural settlement, seasonal timber shrinkage/expansion, or inadequate original fixing of ceiling sheets and/or cornices, rather than active water penetration.

Although this does not presently appear to be a major structural defect, ongoing movement may result in progressive cracking and aesthetic deterioration. A qualified plasterer should be engaged to assess the extent of movement and determine whether additional mechanical fixing of ceiling sheets is required prior to repairs. Subject to confirmation that no structural or moisture-related cause exists, rectification would typically involve re-securing any loose sections, applying flexible joint compound or sealant to accommodate minor movement, followed by preparation and repainting to restore a uniform finish. Continuous monitoring is recommended to ensure the separation does not worsen over time.

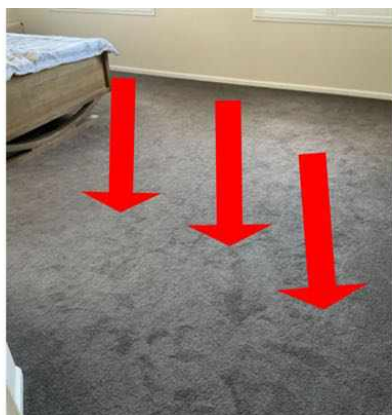
Defects 3.08

Building:	Main Building
Location:	Bedroom - Master
Finding:	Squeaking Subfloor Beneath Carpet – Master Bedroom (Upper Level)
Information:	The floor to the master bedroom at the upper level, which is finished with carpet, was observed to produce noticeable squeaking sounds under normal foot traffic in multiple areas, particularly upon entry to the room. Although the visible surface finish is carpet, the noise is originating from movement within the underlying structural floor system (timber floor sheeting fixed to timber joists).

Squeaking typically occurs where the floor substrate (such as particleboard or plywood sheeting) has loosened from the supporting joists, where fixings have withdrawn over time, or where inadequate fixing was provided at the time of construction. This results in minor vertical movement and friction between components when load is applied. While this condition does not necessarily indicate structural failure, continued movement may lead to further loosening of fixings and ongoing nuisance noise, affecting occupant comfort and amenity.

If the client finds the condition unacceptable, a qualified carpenter should be engaged to investigate and rectify. Rectification generally involves carefully lifting the carpet and underlay in the affected areas, re-securing the floor substrate to the supporting joists using appropriate screws (rather than nails) to minimise future movement, and then reinstating the carpet finish. Works should be carried out using proper carpentry

methods to ensure long-term stability of the floor system.

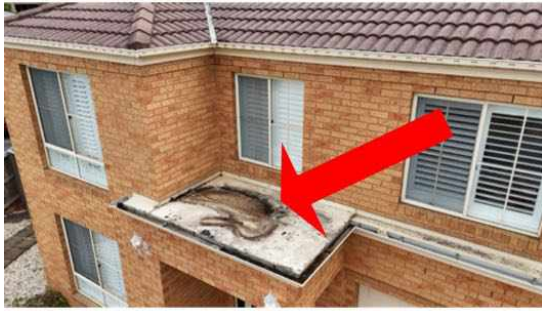
Defects 3.09

Building: Main Building
 Location: Roof Exterior
 Finding: Inadequate Falls and Ponding to Porch Roof Surface
 Information:

The flat roof surface located above the porch entrance was observed to be holding significant ponded water and accumulated debris staining. Visual evidence indicates inadequate falls towards the perimeter gutter, resulting in water pooling across the membrane surface rather than discharging efficiently into the gutter system. The extent and pattern of staining suggest this is an ongoing condition rather than a temporary occurrence.

Persistent ponding on low-slope roofing surfaces can accelerate membrane deterioration, increase the risk of water ingress, and place unnecessary dead load on the roof structure. Over time, this may lead to membrane failure, joint breakdown, internal moisture ingress, ceiling damage to the porch area below, and potential concealed structural decay. Inadequate drainage also promotes debris accumulation, which can further obstruct water flow and exacerbate the issue.

A qualified roofing contractor should be engaged to assess the roof falls and drainage configuration without delay. Rectification may involve regrading the substrate to provide compliant falls towards the gutter, installation of a tapered screed system, or modification of drainage outlets to ensure effective discharge of stormwater. All works should be carried out in accordance with the NCC and relevant Australian Standards to ensure proper long-term performance.

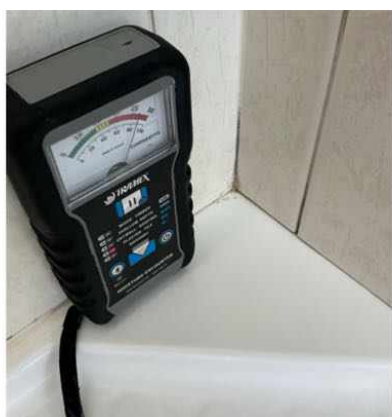
Defects 3.14

Building:	Main Building
Location:	Ensuite
Finding:	Shower - Damp
Information:	Damp is evident to the lower 300mm of wall to the shower alcove. This defect is quite common, and is suspected to have been caused by moisture permeating through the grouting in this area, which shows evidence of deterioration. Leaking pipes within the adjoining wall is also a possible cause.

Always ensure that sealant and grout is in good condition to prevent any moisture issues occurring in the future.

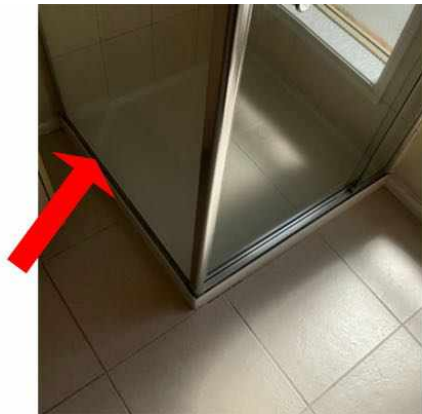
Defects 3.15

Building:	Main Building
Location:	Bedroom - Master
Finding:	Shower screen - Leaking
Information:	Leaking was evident to the master ensuite's shower screen at the time of inspection. It is suspected that the leaking has occurred as a result of deteriorated or missing caulking to the shower or general ageing of the building elements.

Appointment of a caulking contractor is required to repair or replace the caulking to

the shower area. Such works should be performed as soon as possible to ensure that no further damage occurs.

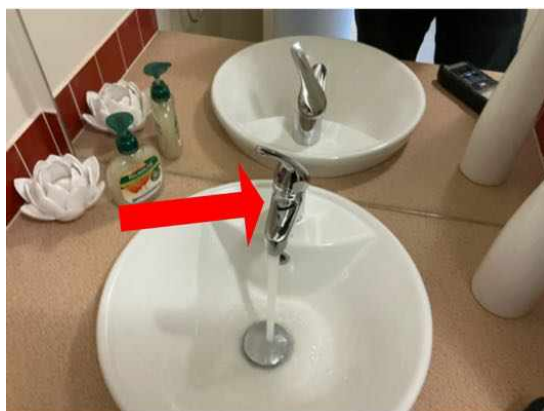
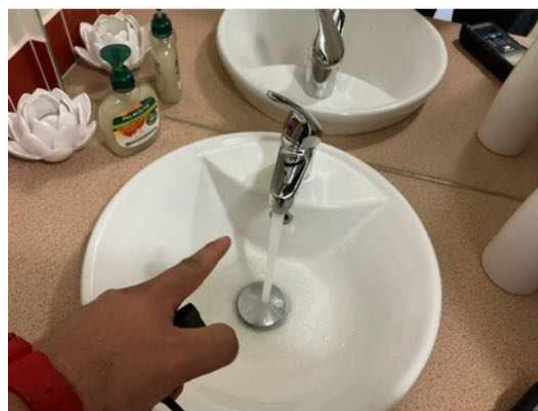
Defects 3.18

Building:	Main Building
Location:	Powder Room
Finding:	Tap - Water hammer
Information:	The powder room sink tap shows evidence of water hammer being present. Water hammer, a pressure surge resulting when a fluid is forced to suddenly change direction, is a common defect in plumbing fittings, particularly those that are aged and not frequently maintained. Water hammer is generally caused by factors that create high water pressure in the affected plumbing fixture, usually evidenced by a faint banging noise during operation of the affected tap.

A licensed plumber should be appointed as soon as possible to replace any affected tap hardware and perform any remedial works as necessary. Please be advised that the appointment of a cabinet maker or qualified carpenter may be necessary if water damage to associated building elements has occurred.

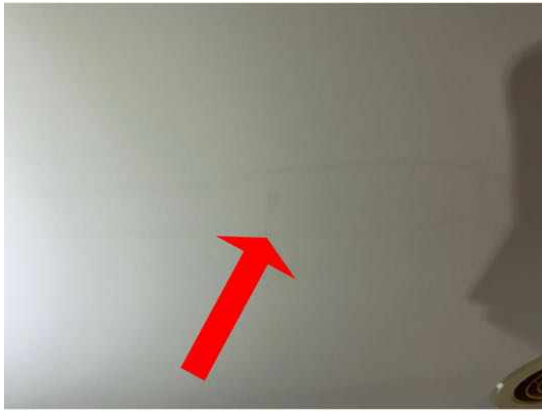
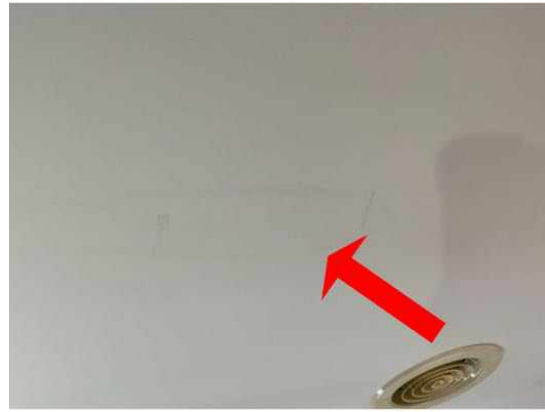
Defects 3.19

Building:	Main Building
Location:	Upstairs living area and downstairs living area
Finding:	Ceiling - Water stained
Information:	Water staining to ceiling linings in both the upstairs living area and the downstairs living area was evident at the time of inspection. Water staining indicates that surfaces have been exposed to excessive moisture over time. The minerals and other elements in the water lead to staining, which may graduate to corrosion and deterioration if left unmanaged.

Conversely, where water staining is old and inactive, affected building materials may be repaired or replaced at client discretion.

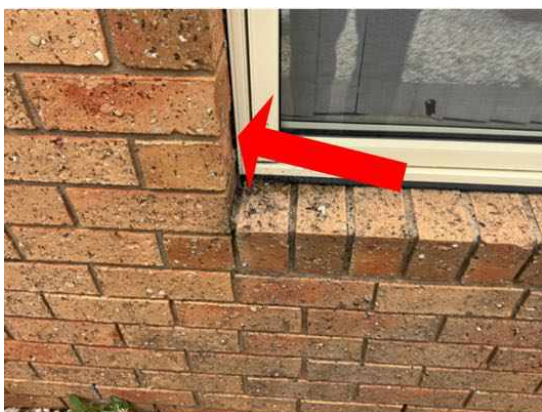
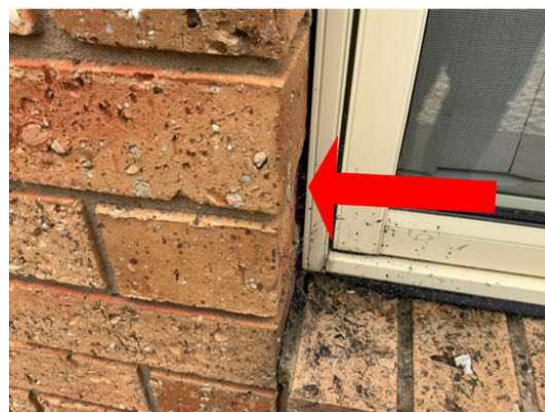
Defects 3.20

Building:	Main Building
Location:	LHS elevation
Finding:	Gaps Around External Window Frames
Information:	Multiple gaps were identified between the external window frames and the adjoining brickwork across the LHS elevation. These gaps appear to be the result of either poor or inconsistent sealant application during installation, or deterioration of the original sealant over time.

A qualified handyman or registered builder should apply a consistent, waterproof, flexible exterior-grade sealant around all affected windows to ensure adequate weatherproofing and protection against moisture and pest entry.

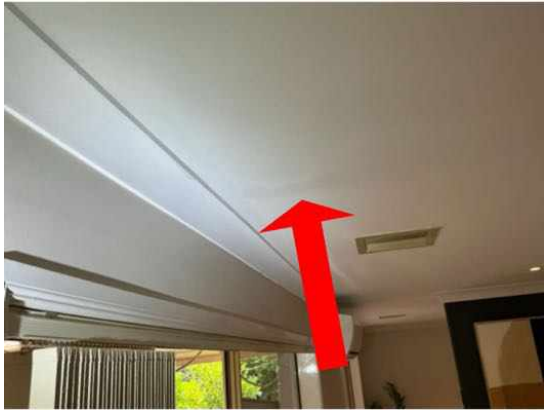
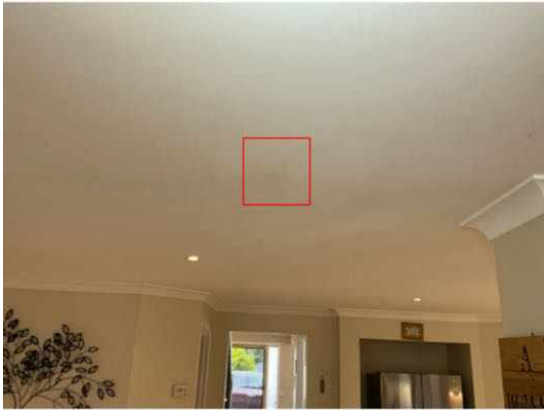
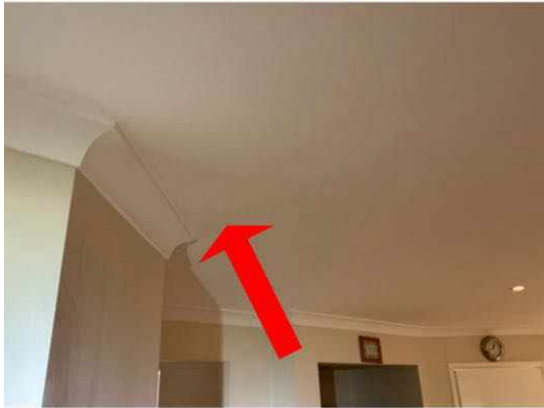
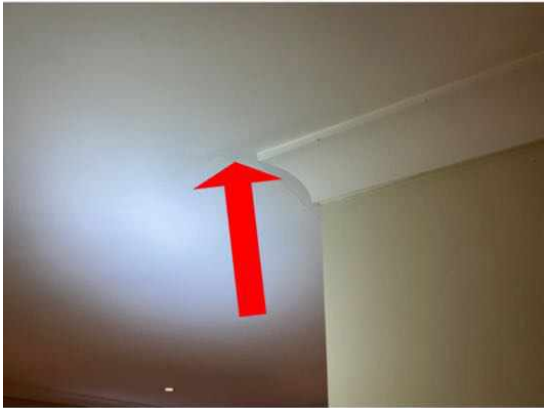
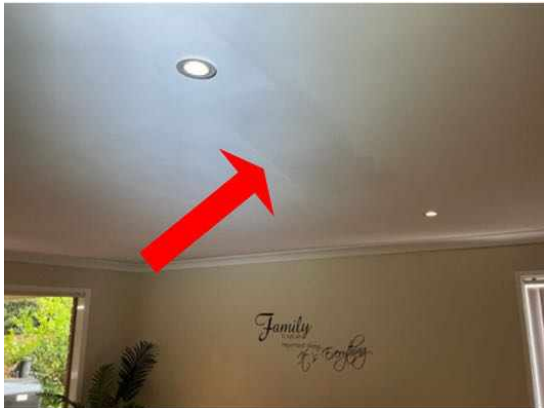
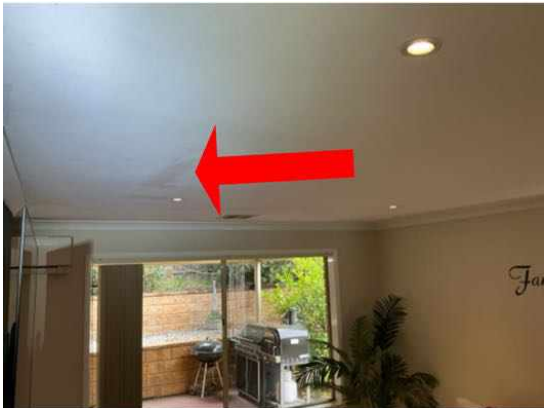
Defects 3.22

Building: Main Building
 Location: All Internal Areas
 Finding: Minor Cosmetic Paint Patching – Ceilings
 Information:

If improved aesthetic presentation is desired, preparation and repainting of the affected ceiling areas by a qualified painter would provide a more uniform finish. This item is considered minor and maintenance-related.

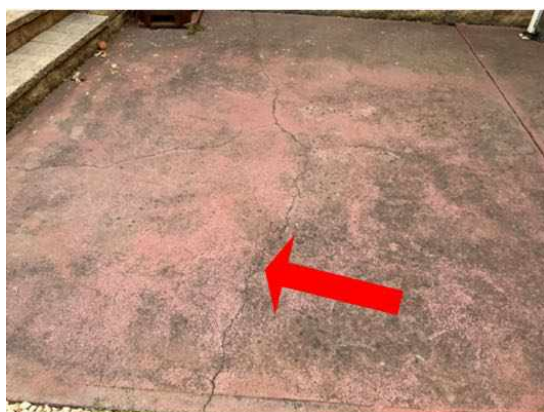
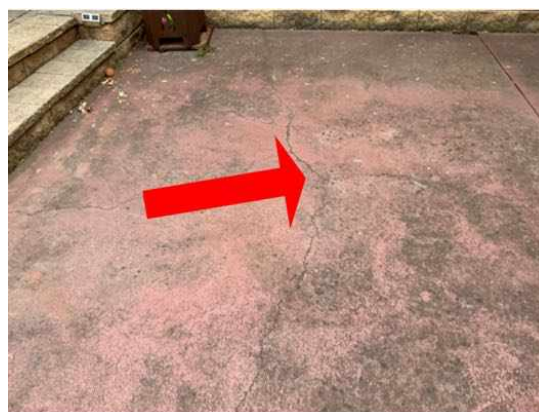
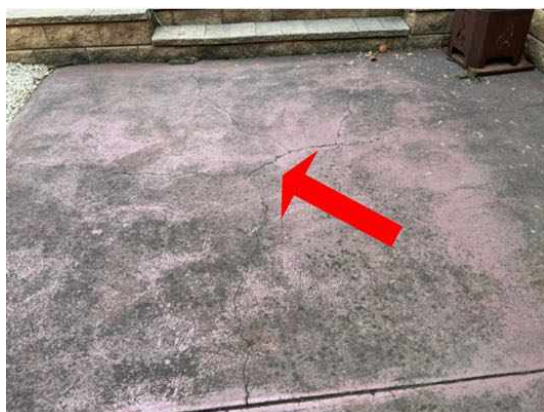
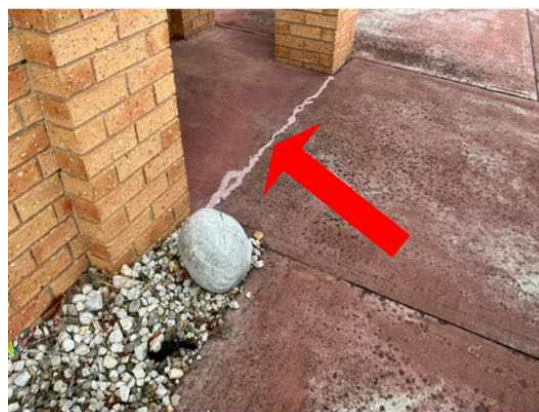
Defects 3.23

Building: Main Building
Location: All External Areas
Finding: Cracking - External Concrete Paving Damage Category 2 - Distinct (less than 3mm)
Information: Distinct cracks were identified in external concrete paving. Distinct cracks are generally found in older concrete paving, and may also present as a trip hazard as consequence of an uneven or curved surface.

Repairs are likely to be required to prevent further cracking and to reduce hazards associated with cracking, such as tripping. Monitoring of all cracking should be conducted frequently. Always contact a building inspector should cracks widen, lengthen, or become more numerous.

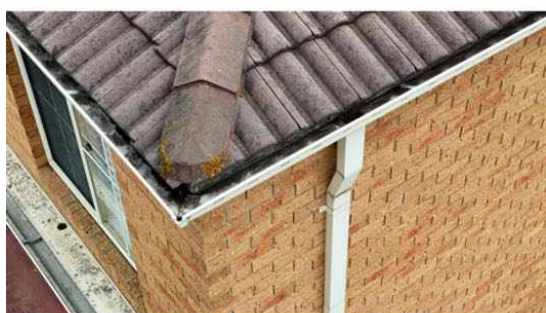
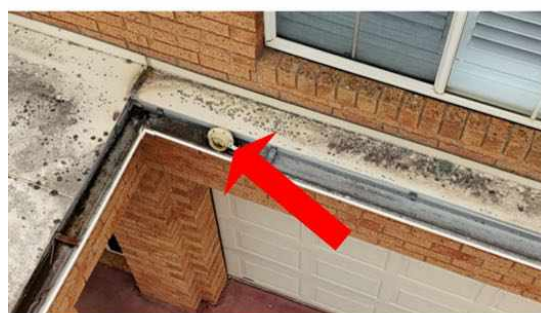
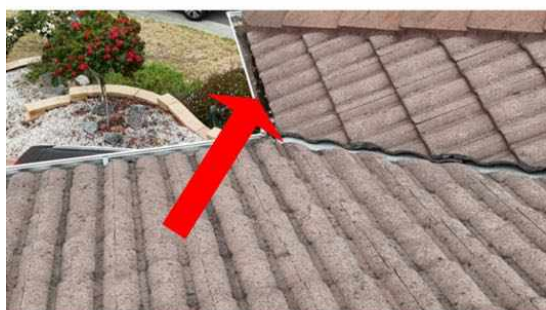
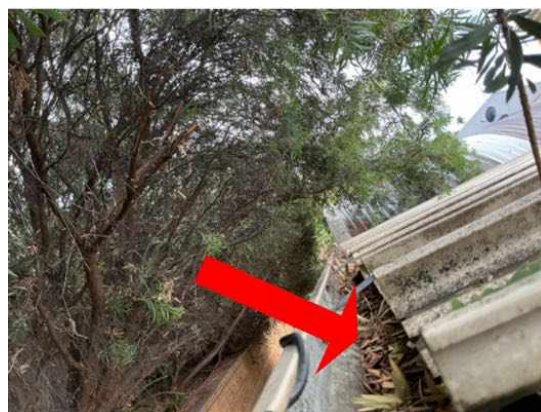
Defects 3.24

Building:	Main Building
Location:	Gutters
Finding:	Gutters - Partially Blocked
Information:	Sections of the external gutters were partially blocked with debris, soil and leaves. Roof plumbing structures, such as guttering and downpipes, should be free of all debris to prevent blockages. Blockages of the guttering and downpipes will lead to pooling and accumulated water overflows, which is likely to subsequently flood eaves and exterior walls.

Consult a Licensed Plumber for further specific advice on remedial works that may be required. In the interim, it is highly advised that blocked gutters be removed by the homeowner or a general handyperson as a matter of urgency.

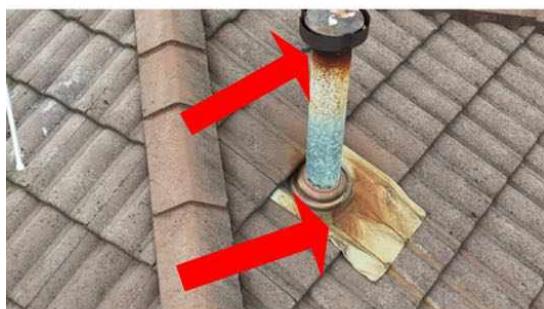
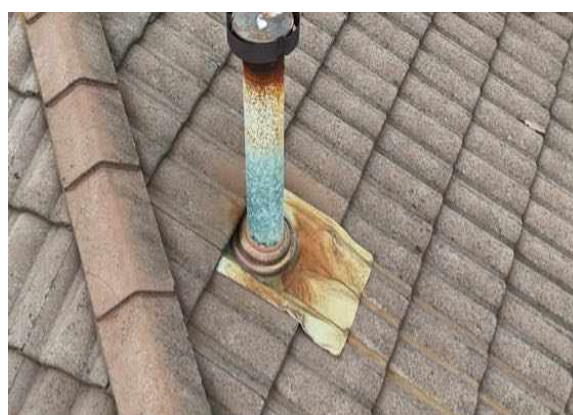
Defects 3.25

Building: Main Building
 Location: Roof Exterior
 Finding: Corroded Roof Penetration Flashing and Deteriorated Vent Pipe
 Information:

flashing appears distorted and unevenly dressed over the roof tiles, with visible rust tracking across the metal surface.

A licensed roof plumber should be engaged to assess the condition of the vent pipe and flashing assembly. Rectification may include replacement of the corroded flashing with a new appropriately dressed and sealed flashing (preferably corrosion-resistant material such as Colorbond or lead-free alternative), and replacement or treatment of the vent pipe as required to ensure proper weatherproofing and durability in accordance with relevant roofing standards.

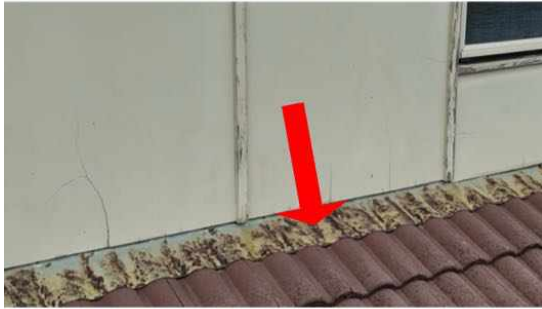
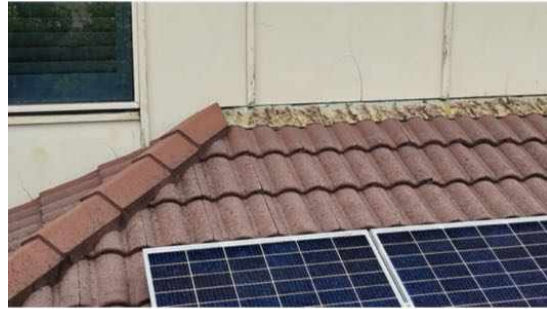
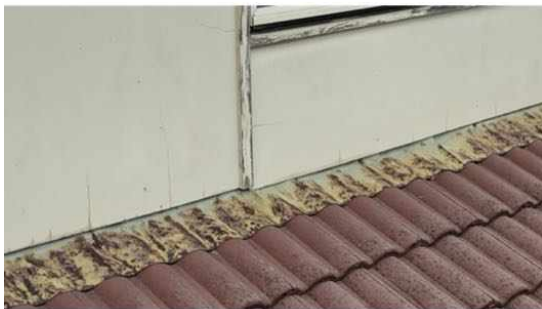
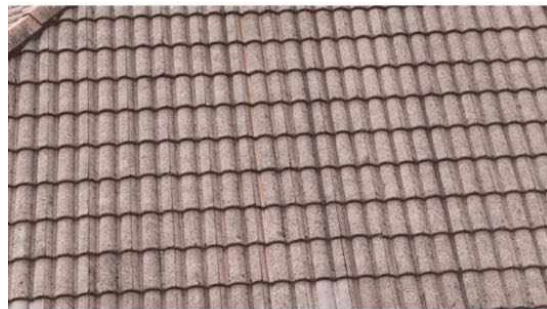
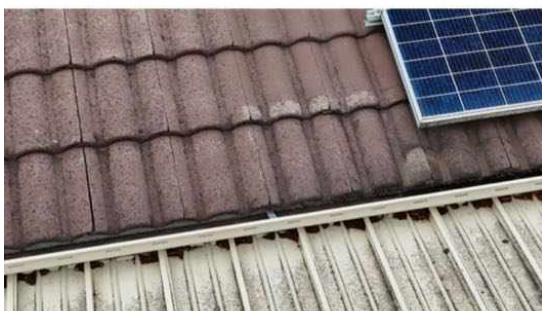
Defects 3.26

Building: Main Building
 Location: Roof Exterior
 Finding: General Weathering to Roof Covering and Flashings
 Information:

recommended that a licensed roof plumber assess the roof and flashing condition, undertake re-sealing where required, treat or replace corroded flashings as necessary, and consider roof restoration works (including cleaning, repointing, and resealing) to maintain long-term performance and weather resistance. Regular roof maintenance is advised.

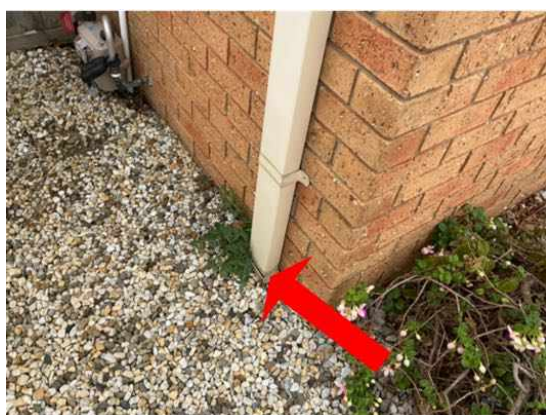
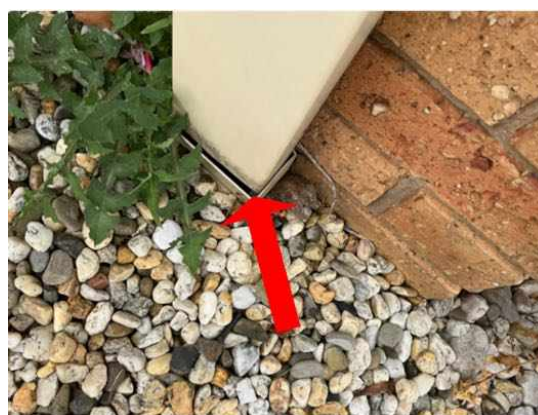
Defects 3.27

Building:	Main Building
Location:	Exterior walls - left side
Finding:	Partially Detached Downpipe
Information:	One of the downpipes are on the left-hand side exterior walls of the property was

A licensed plumber should be engaged to properly reconnect and secure the affected downpipe to ensure effective stormwater drainage.

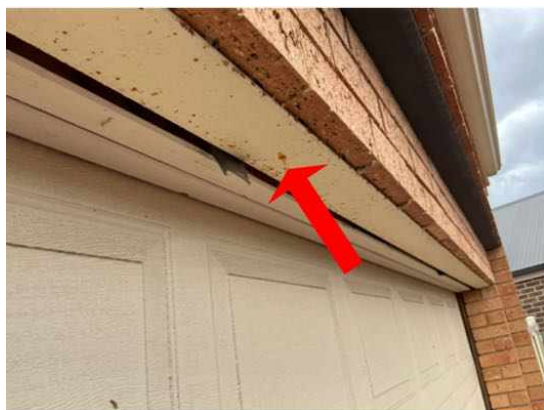
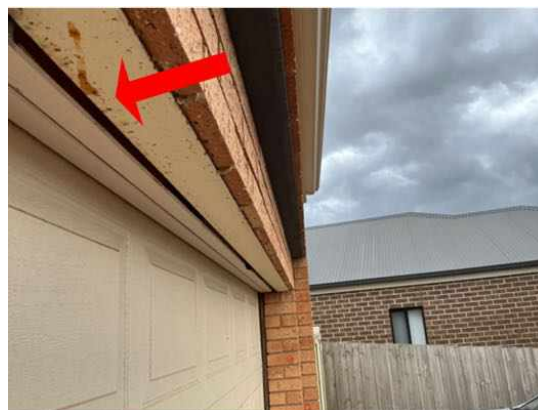
Defects 3.28

Building: Main Building
 Location: Garage
 Finding: Minor Surface Corrosion to Steel Lintel – Garage Opening
 Information:

It is recommended that the affected area be mechanically cleaned to remove surface rust, treated with an appropriate rust-inhibiting primer, and repainted using a suitable exterior-grade protective coating. Early maintenance intervention will assist in preventing further corrosion and extending the service life of the lintel.

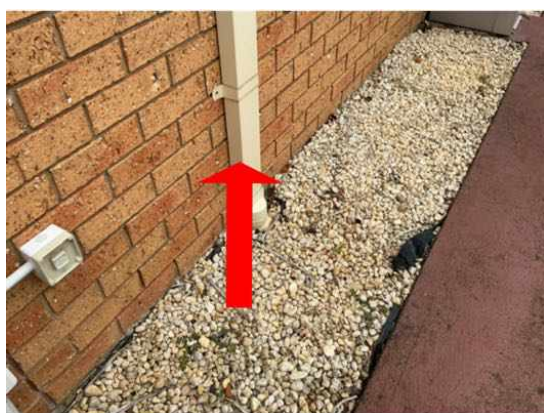
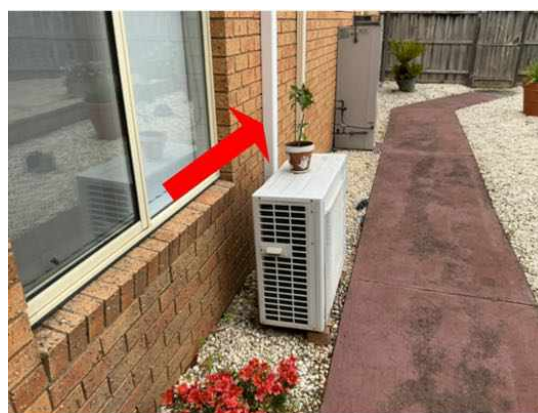
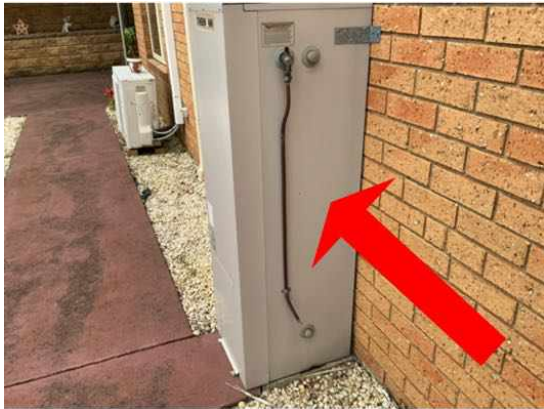
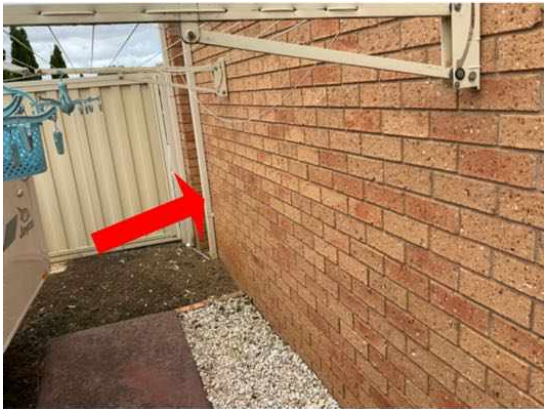
Defects 3.29

Building:	Main Building
Location:	All External Areas
Finding:	Bridging Attachments to the Building - conducive conditions to timber pest activity
Information:	Bridging occurs when items fixed or placed against a building create concealed pathways for termites to bypass any existing termite management system and gain access to the structure undetected. Typical bridging elements include attachments such as hot water services, downpipes, verandahs, decks, steps, fences, and service conduits, where insufficient clearance exists between these elements and the building structure.

It is recommended that these areas be regularly inspected by a licensed and qualified pest inspector. Where bridging is identified, modifications should be made to restore adequate clearance or install appropriate barriers to mitigate the risk of concealed termite ingress.

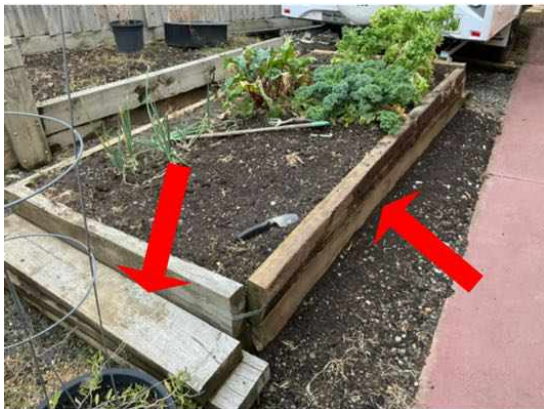
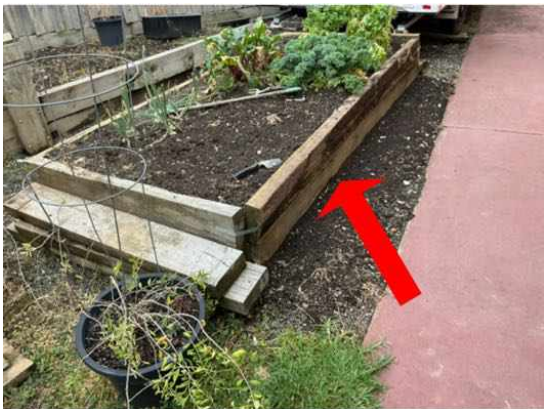
Defects 3.30

Building: Main Building
Location: All External Areas
Finding: In Ground Contact - conducive conditions to timber pest activity
Information: Any timbers in direct ground contact provide an opportunity for concealed termite entry and are likely to be subject to premature rot and decay due to soil retaining moisture or creating damp conditions against the timber surfaces.

Frequent pest inspections by a licensed pest control technician are recommended to readily identify any termite activity in these areas and ensure early intervention if required.
