Building and Timber Pest Inspection Report

Inspection Date: Tue, 20 Jan 2026

Property Address: 8 Fred St, Camp Hill QLD 4152, Australia

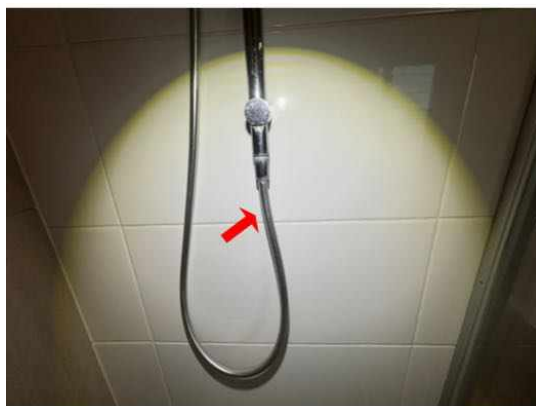
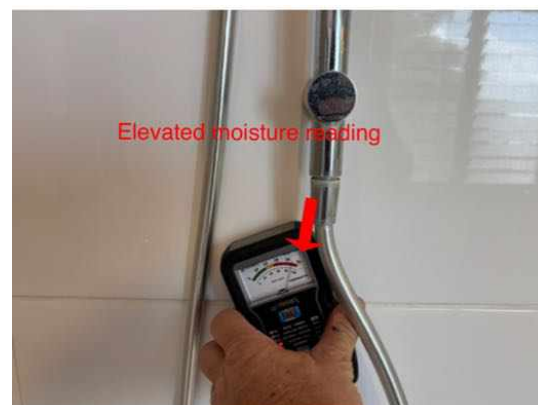
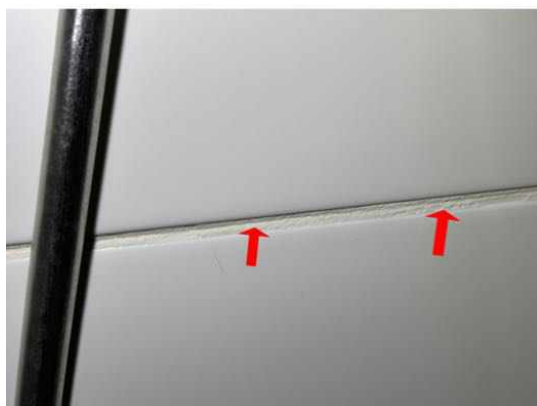
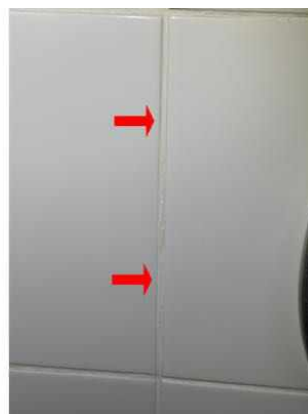
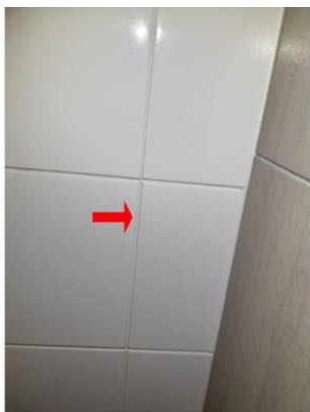
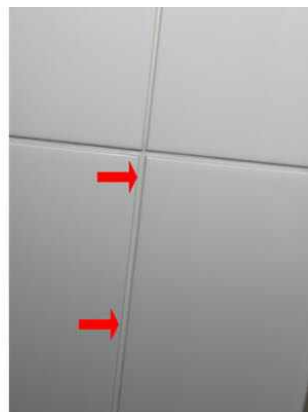
Finding 3.01

Finding: Ensuite - elevated moisture reading

Information: At the time of the inspection, it was noted that elevated moisture readings were recorded below the shower rail on the right hand side. It was found that there was a hairline crack to the grout in this area. Several other examples of hairline cracks to the grout were found. This may be allowing moisture to penetrate behind the wall tiles.

Moisture behind the wall tiles may weaken the tile glue which could lead to tiles becoming loose. Replacing the grout would prolong the life of the bathroom.

A bathroom specialist could be engaged to replace the grout and seal the wall and floor tiles. This should be done as a short term priority.

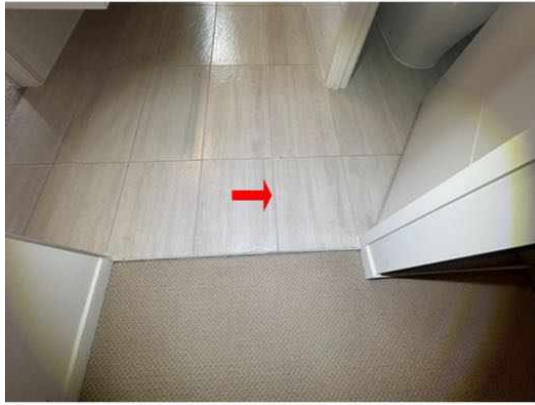
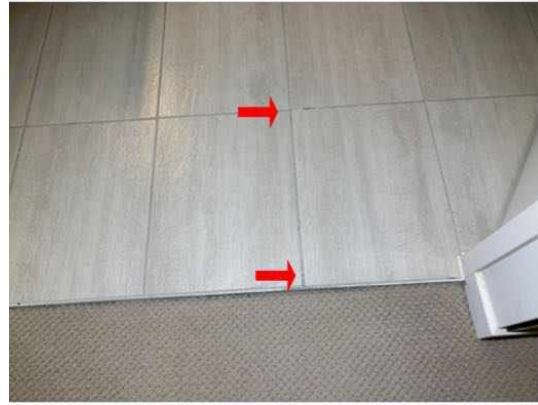
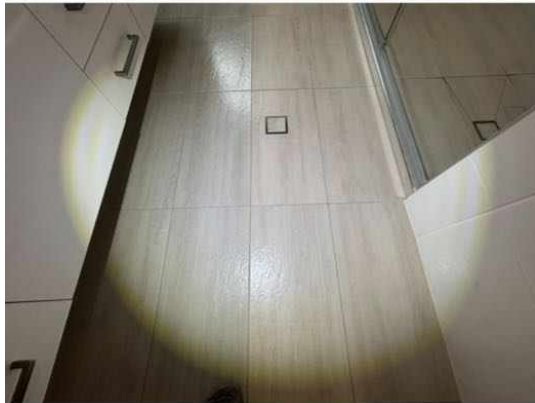
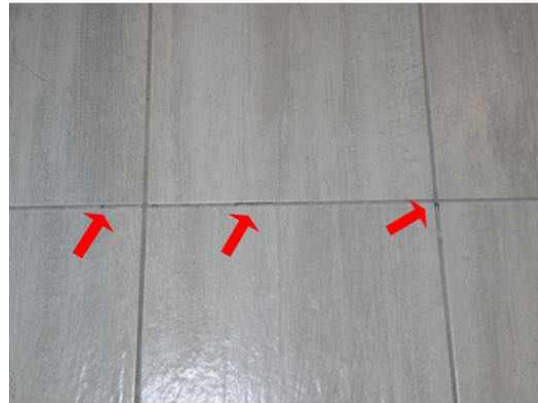
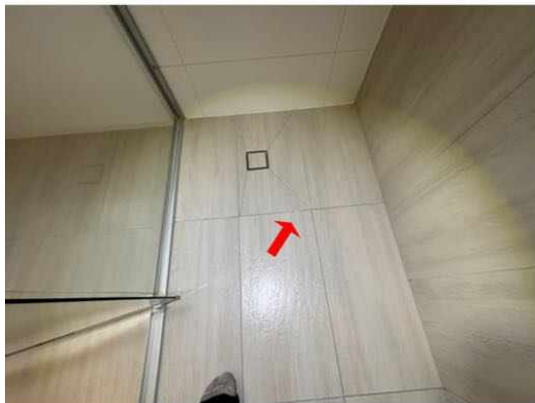
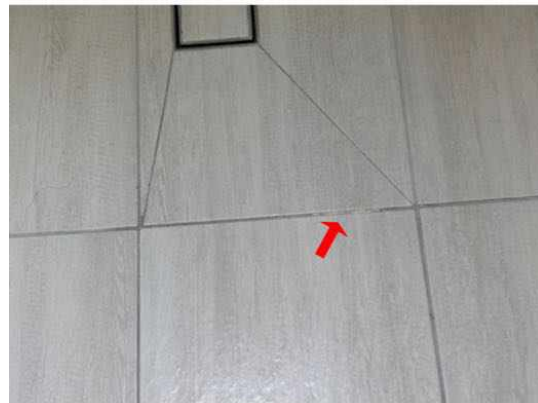
Finding 3.02

Building:	Main Building
Location:	Ensuite
Finding:	Ensuite - grout missing
Information:	At the time of the inspection, it was noted that there were sections of grout missing from the floor in the ensuite. This may be due to general wear and tear.

Continued deterioration of the grout may lead to damage to the floor tiles. Moisture may be able to penetrate beneath the floor tiles.

A building maintenance professional or bathroom specialist could be engaged to replace the affected grout. This should be done as a short term priority.

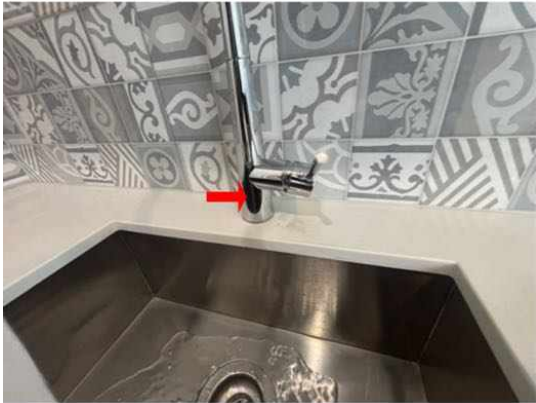
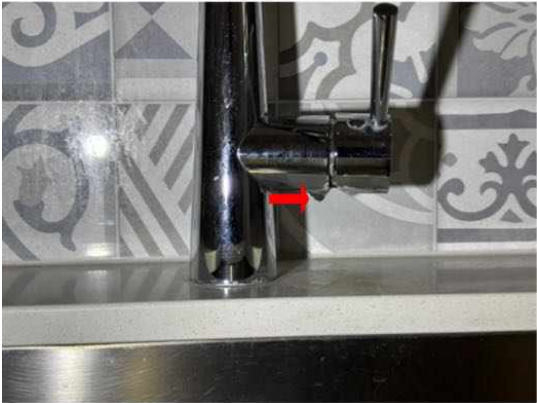
Finding 3.03

Building: Main Building
 Location: Laundry
 Finding: Laundry - mixer tap leaking
 Information: At the time of the inspection, it was noted that there was a water leak from the mixer tap in the laundry. This may be due to general wear and tear of the tap seals.

Evidence of a water mark can be seen on the bench top below the mixer tap.

A licensed plumber should be engaged to replace the laundry mixer tap. This should be done as a short term priority.

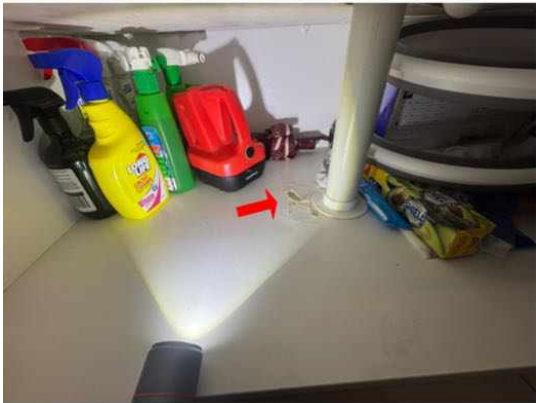
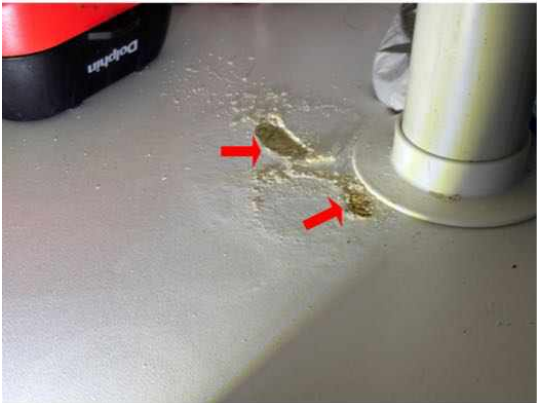
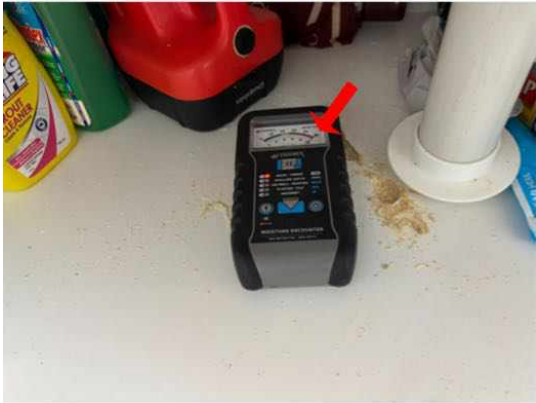
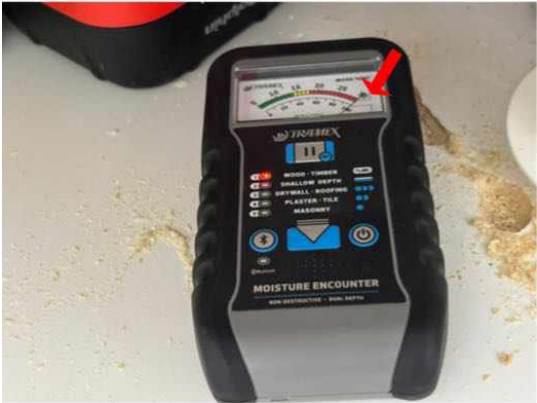
Finding 3.04

Building: Main Building
 Location: Laundry
 Finding: Laundry - damage to laundry cabinet
 Information: At the time of the inspection, it was noted that there was damage to the base of the laundry cabinet. Marking on the base suggests a corrosive substance may have caused the damage. High moisture readings were recorded in this area. No signs of a water leak were found.

A building maintenance professional could be engaged to repair the cabinet. This can be done at the clients discretion.

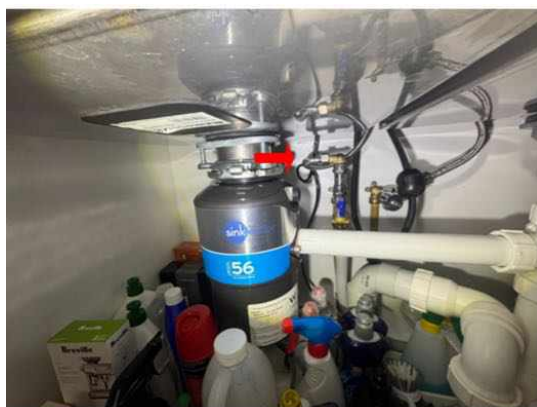
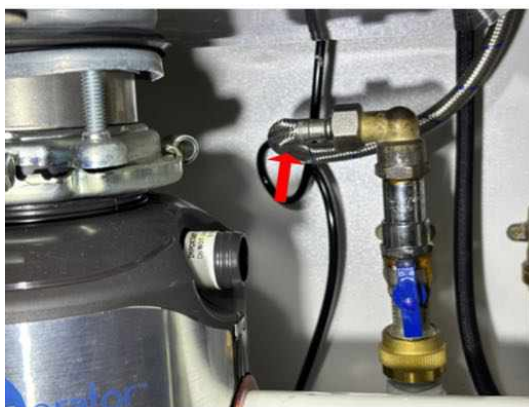
Finding 3.05

Building:	Main Building
Location:	Kitchen
Finding:	Kitchen - flexible hose has signs of kinking
Information:	At the time of the inspection, it was noted that a flexible hose to the kitchen mixer had signs of kinking. This may be due to the length of the hose.

Flexible hoses typically have a 5 - 10 year lifespan. It is recommended that they be changed if they have signs of bulging, fraying, kinking or rust.

A licensed plumber should be engaged to replace both the flexible hose to the kitchen mixer. This should be done as a matter of urgency.

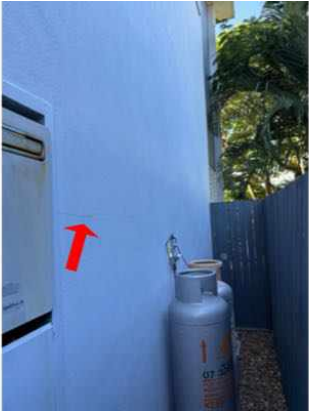
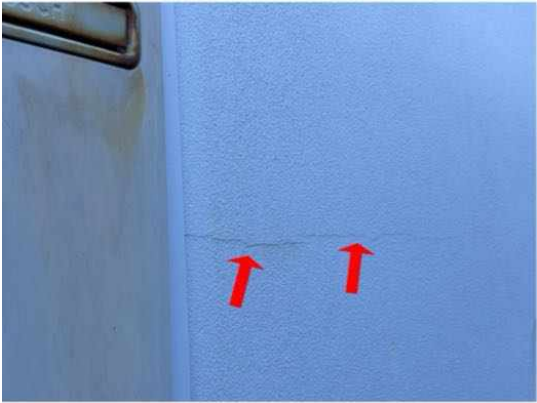
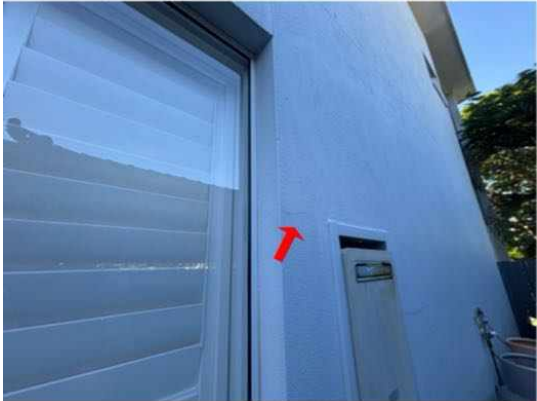
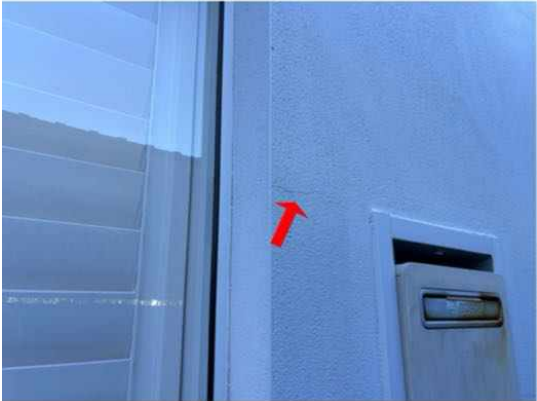
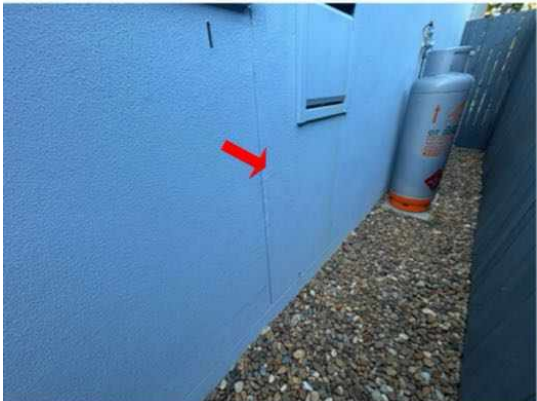
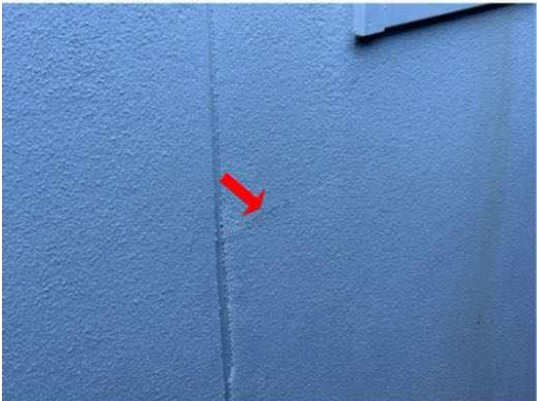
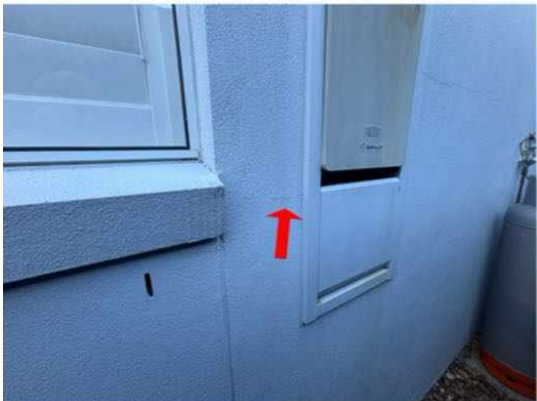
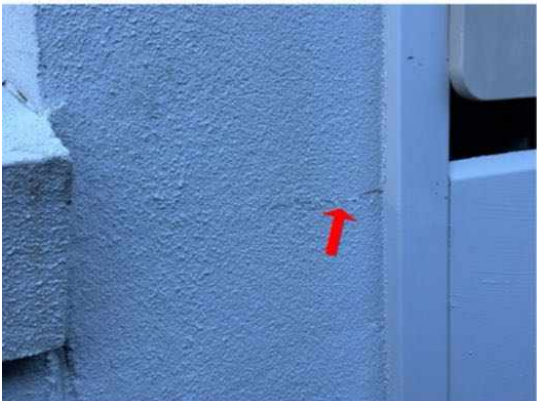
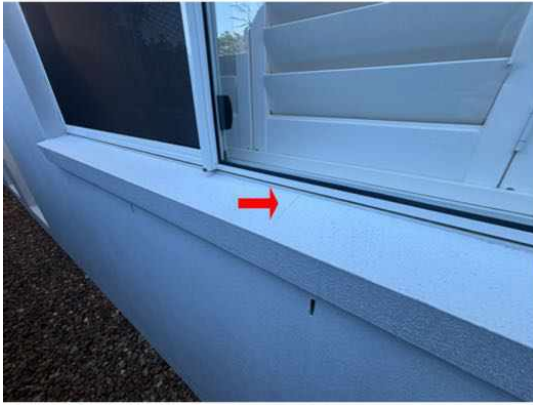
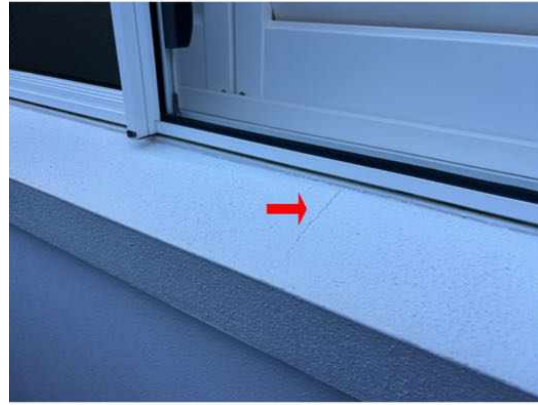
Finding 3.06

Building:	Main Building
Location:	Side elevation
Finding:	Render - minor cracking
Information:	At the time of the inspection, it was noted that there was minor cracking to the render on the right hand side of the dwelling. This may be due to the age of the materials.

A solid plasterer could be engaged to carry out these minor repairs. This can be done at the clients discretion.

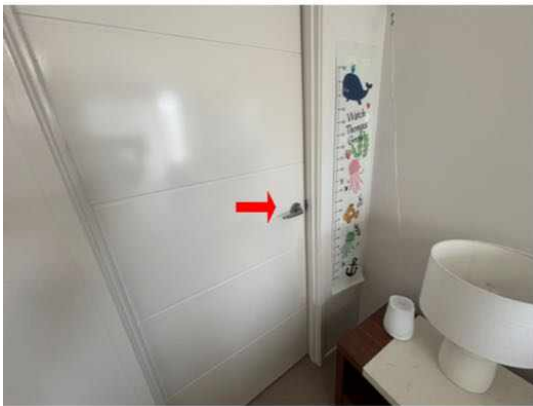
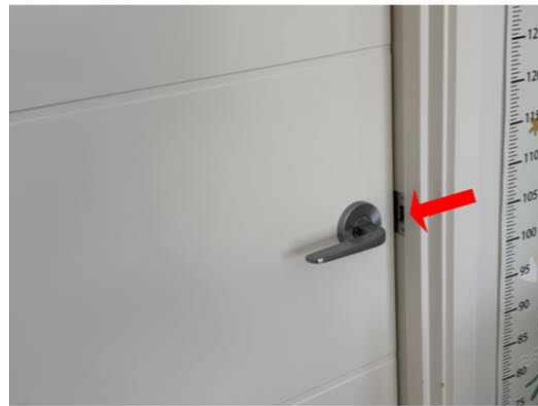
Finding 3.07

Finding: Bedroom 4 Walk in robe - door handle not latching

Information: At the time of the inspection, it was noted that the door to the walk in robe in bedroom 4 was not latching during normal operation. This detracts from the functionality of this door. This appears to be from general wear and tear.

A qualified carpenter or building maintenance professional may be appointed to perform rectification works as necessary, at client discretion. If left unattended, further functional impairment is likely to occur.

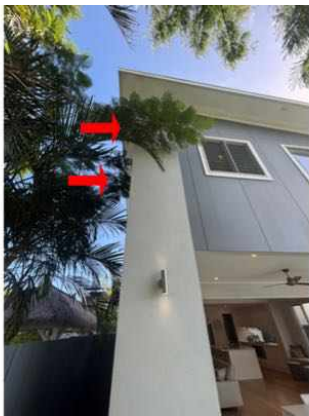
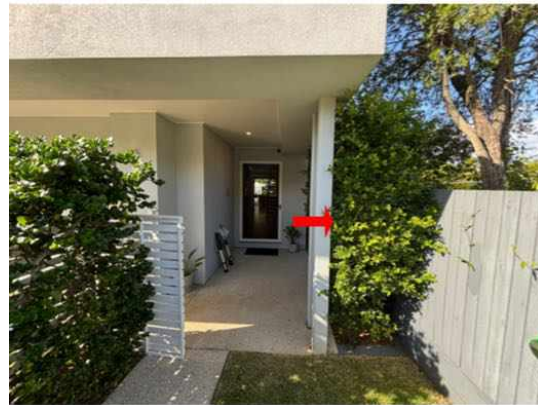
Finding 6.01

Building:	Main Building
Location:	All External Areas
Finding:	Vegetation touching the building
Information:	At the time of the inspection, it was noted that there was vegetation touching the building in several locations. This creates a potential access point for termites to enter the building undetected bypassing the physical termite barrier. This is a conducive condition for termite activity.

The client is to ensure that the vegetation is trimmed back to prevent undetected termite entry to the building and to provide a clear inspection area between the vegetation and the dwelling. This should be done as a short term priority.

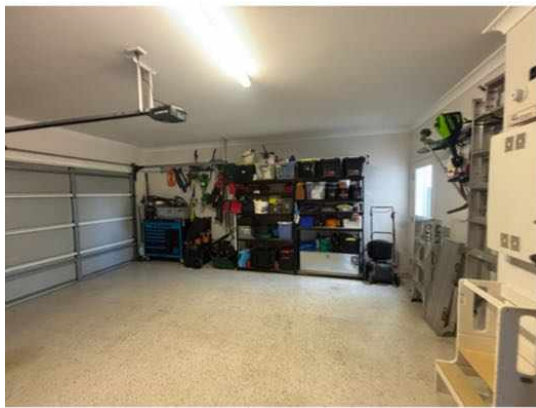
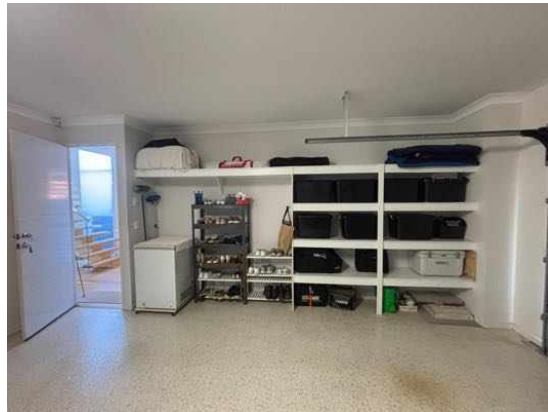
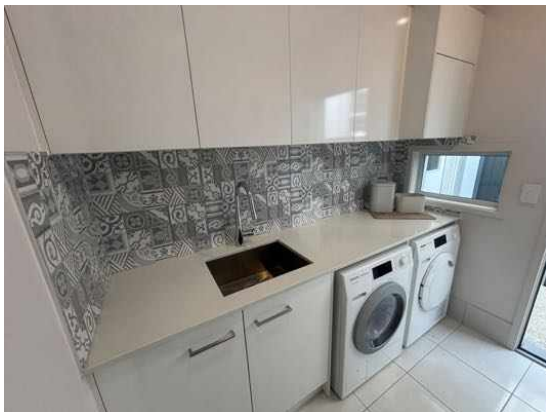
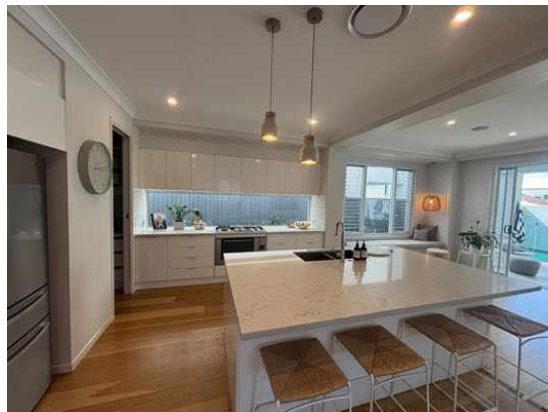
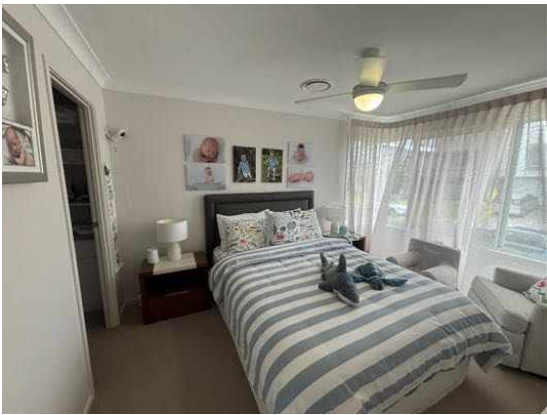
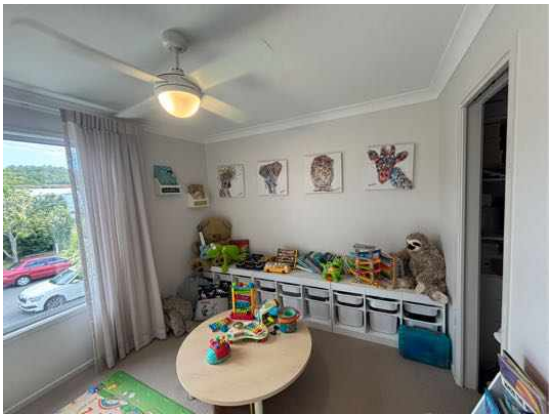
Building: Main Building
Location: All Internal Areas
Finding: Obstructions and Limitations - Internal areas
Information: These photographs are an indication of the obstructions and limitations which impeded full inspection of the property of the internal areas at the time of inspection. These obstructions can hide an array of defects and should be removed to allow full inspection to be carried out. A re-inspection is recommended once the areas are made accessible.

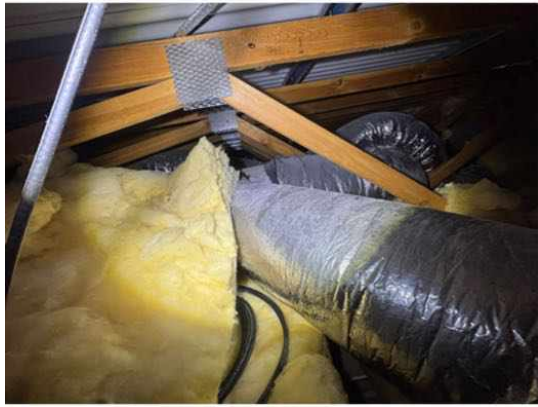
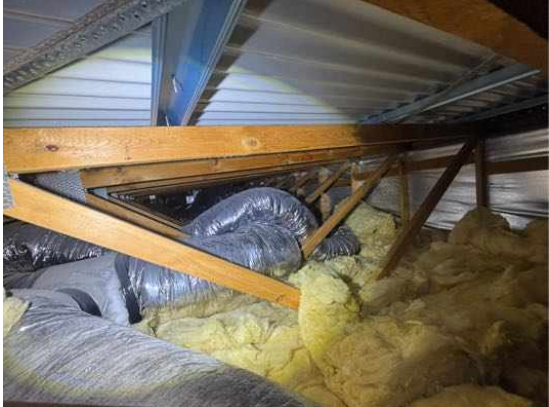
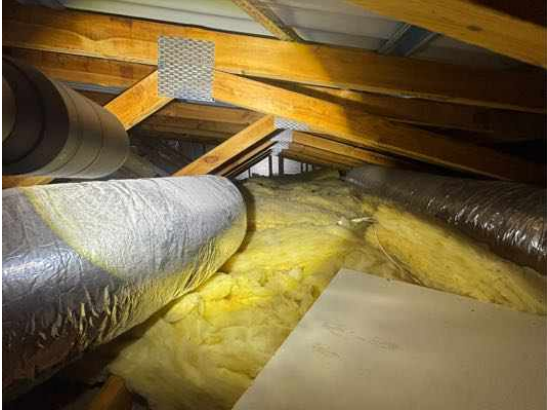
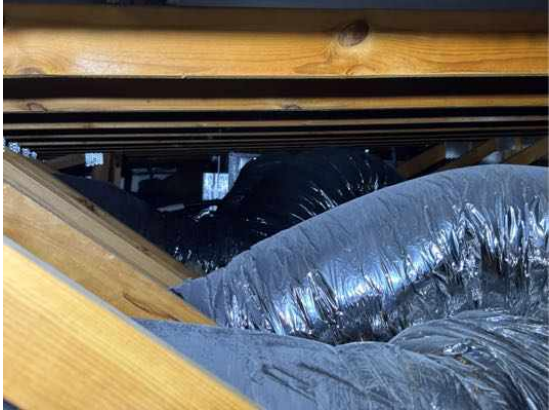
Building: Main Building
Location: Roof Void
Finding: Obstructions and Limitations - Roof cavity
Information: These photographs are an indication of the obstructions and limitations which impeded full inspection of the property of the roof cavity

at the time of inspection. These obstructions can hide an array of defects and should be removed to allow full inspection to be carried out. A re-inspection is recommended once the areas are made accessible.

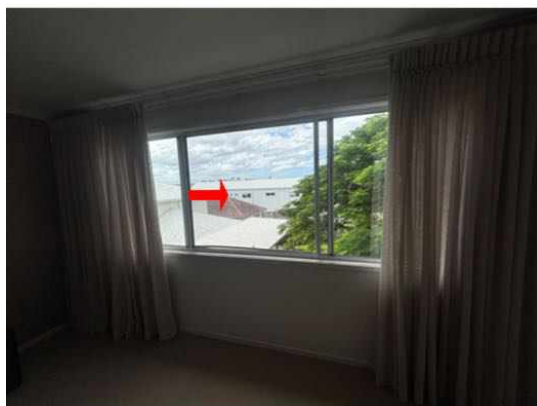
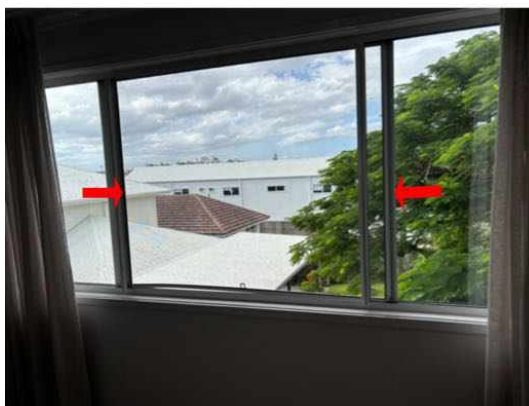
Building: Main Building
 Location: Master bedroom
 Finding: Master bedroom - window opening not restricted to 125mm
 Information: At the time of the inspection, it was noted that the window in the master bedroom was not restricted to opening to 125mm or less. It was able to be opened to the full extent of the opening. The window does not have a secure window screen, only a removable fly screen.

As of March 2018, windows that open, have a 2 metre or greater fall on the outside and are 1.7m or less from the internal floor level, are required to be restricted to an opening of no more than 125mm.

It is advisable to have window restrictors or secure security screens fitted to this window. This should be done as a short term priority.

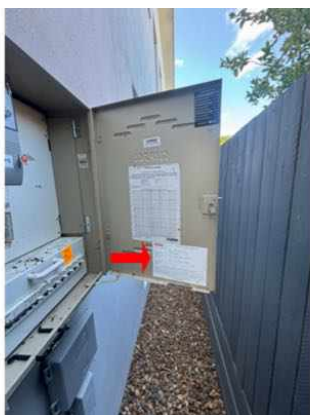
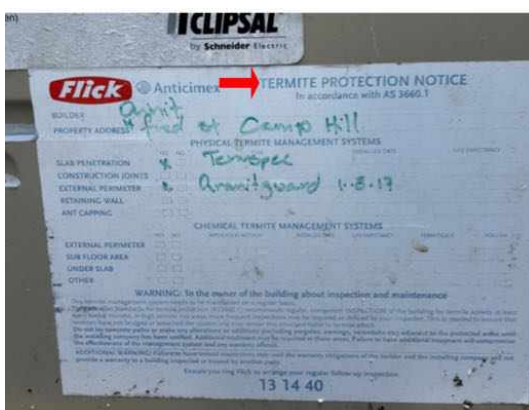
Finding: Evidence of a physical termite management system was identified.
 Information: At the time of the inspection, evidence of a physical termite management system was found by way of a durable notice in the electricity meter box.

A physical termite barrier was installed to the slab penetrations and perimeter during construction. The durable notice is dated the 01/08/2017.

A termite and timber pest technician should be engaged to carry out annual termite inspections as per AS 3660 in order to further protect the dwelling. Annual termite inspections must be carried out in partnership with any termite treatment system, physical or chemical, as no termite treatment system can be expected to be 100% effective.
