Building and Timber Pest Inspection Report

Inspection Date: Wed, 25 Mar 2026

Property Address: 17 Brunel St, Malvern East VIC 3145,
Australia

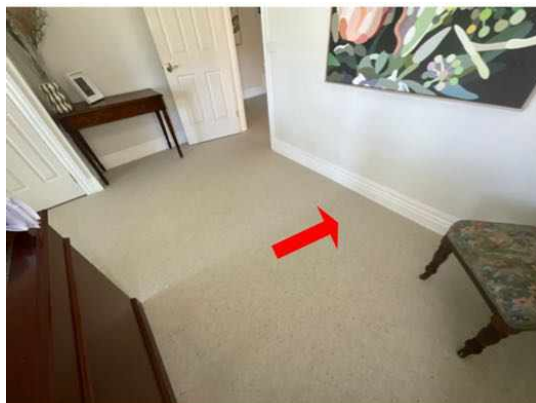
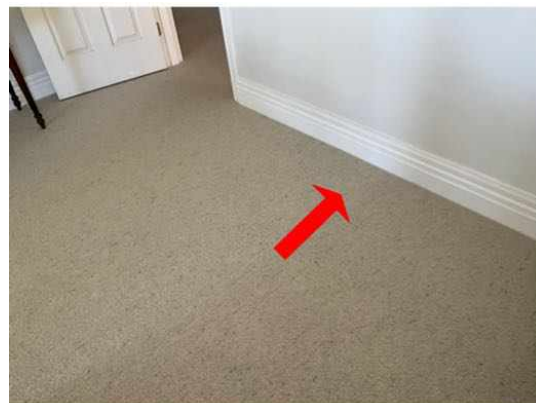
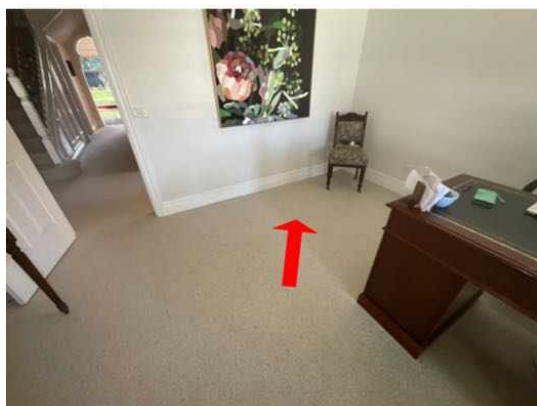
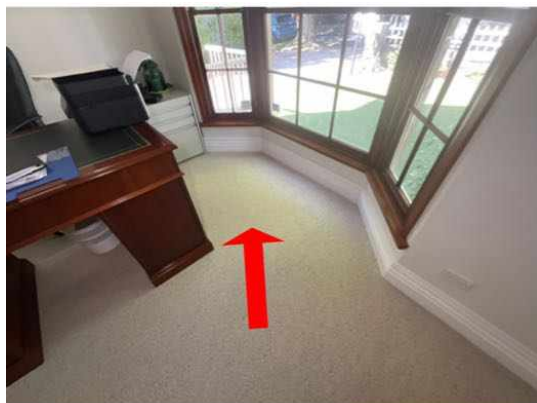
Information: The internal flooring in this area is out of level and uneven. Uneven flooring is likely to indicate minor defects such as expected movement of the foundations of the property, but may also indicate subsidence of the associated subfloor stumps.

It is advised that the flooring be closely monitored to identify any further movement. Where flooring remains relatively unchanged for an extended period of time (i.e. several months), it is likely that this defect has been caused by expected movement of the foundations of the property.

However, where flooring is uneven further, potentially invasive inspection of the subfloor structures and stumps in this area is required. In this case, works to repair are likely to be required, and would be carried out by a registered builder specialising in re-stumping.

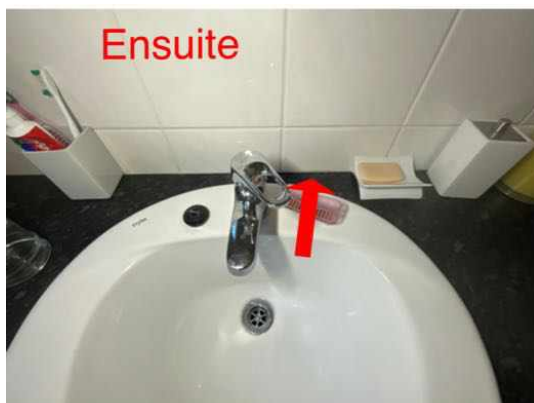
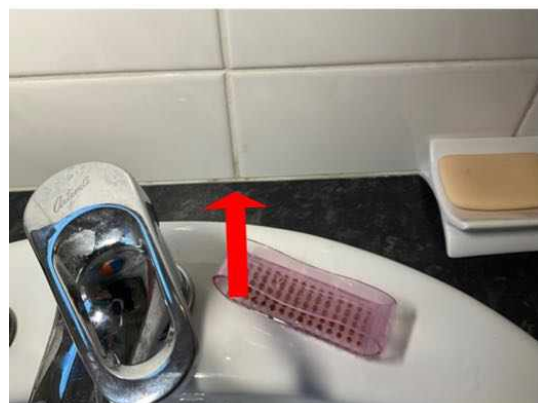
Finding: Grout / sealant - Missing or degraded within the bathroom area

Information: It was noted on inspection that grout and/or sealant is degraded to areas within the bathroom.

Different materials move at different rates, generally causing cracking to grout at this point. Build up of moisture in the bathroom can also cause grout and sealants to degrade and become mouldy.

Any damaged or degraded materials should be scraped out and flexible and mould resistant materials should be applied to affected areas to prevent any subsequent water damage that may occur. Regular maintenance and replacement of damaged or missing grout/ sealant is highly recommended to the wet areas, as this is a regular wear and tear defect. Both grout and sealant in areas that come into regular contact with water should be maintained for the long term care of your property.

A bathroom specialist or tiling contractor should be appointed to complete these works as a priority .

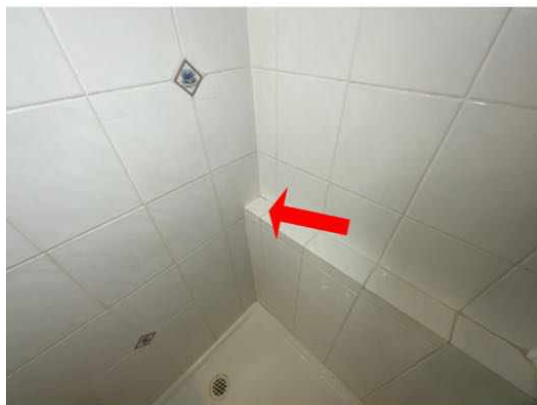
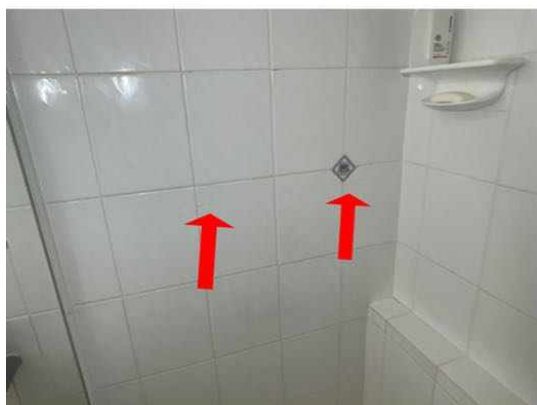
Finding: Wet area tiles - Cracked or damaged

Information: Cracking was evident to the tiling in this area at the time of inspection. While the cracking appears to be minor, this area is frequently exposed to water, allowing potential for water penetration into adjoining sections of walls or flooring.

If left unmanaged, water penetration to these areas may lead to subsequent water damage, which is likely necessitate repair work to affected building elements.

A tiling contractor should be appointed to ensure that no further water damage occurs. The re-application of silicone and grouting throughout remaining tile work is also advised, to further protect the area against water penetration.

Where water penetration has led to water damage, appointment of a relevant tradesperson may be required to repair damaged building elements.

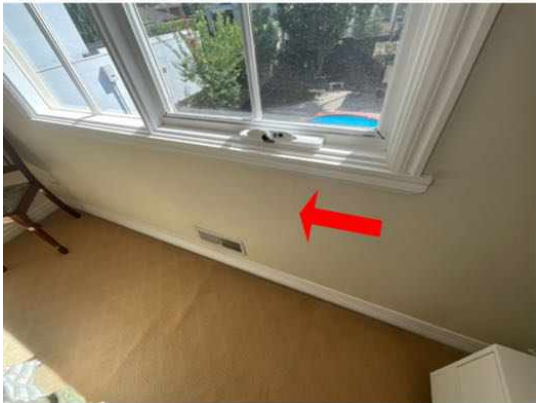
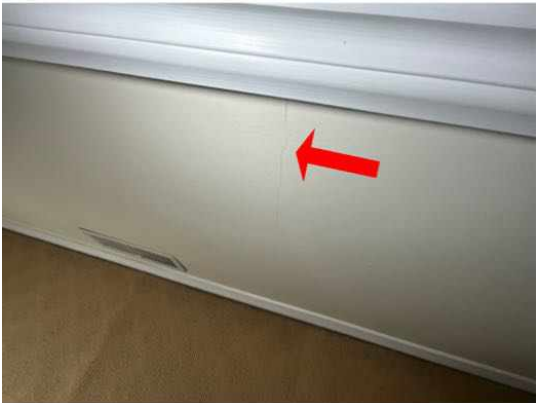
Building:	
Location:	All Areas
Finding:	Cracking - fine
Information:	Some fine cracking was noted throughout the property.

Although fine cracks are quite noticeable, they are often only considered to be an appearance defect, and usually do not indicate any structural damage. Generally, the cause of a fine crack is indicative of a separation between building materials and finishes (e.g. paint, plaster, etc.) along joins.

Note: photos included are indicative of fine cracking noted at the the time of inspection. Other fine cracks may be present but not recorded here.

Cracking of this nature can generally be repaired with minor sanding, filling and/or repainting. Such works should be performed by a qualified painter or a general handyman.

Monitoring of all cracking should be conducted frequently. Always contact a building inspector should cracks widen, lengthen, or become more numerous.

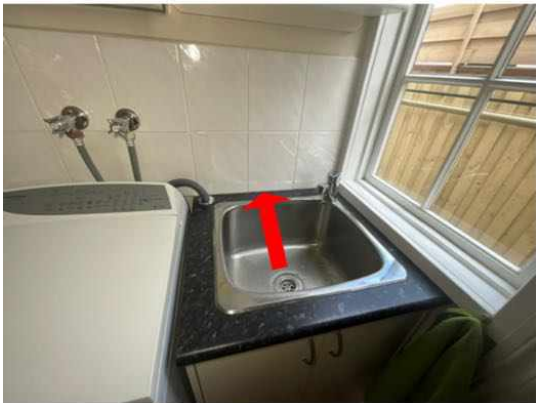
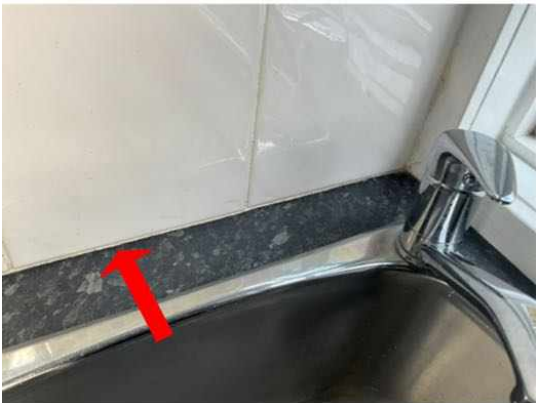
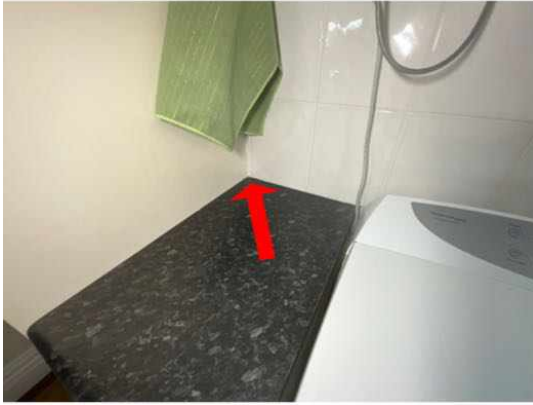
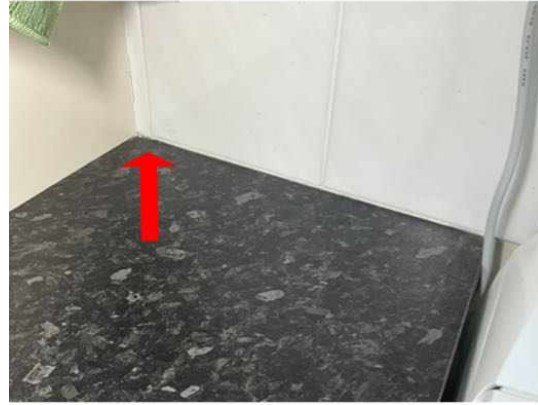
Building:
Location: Laundry
Finding: Sealant - Missing or degraded
Information: Sealant is missing or degraded in this area. Sealant is used to protect gaps and crevices in building materials to ensure that they are water-tight and prevent water penetration to the associated structures.

Where sealant is missing or degraded , a tiling contractor should be appointed immediately to re-apply any silicone where necessary. Failure to do so may lead to water damage to the surrounding area.

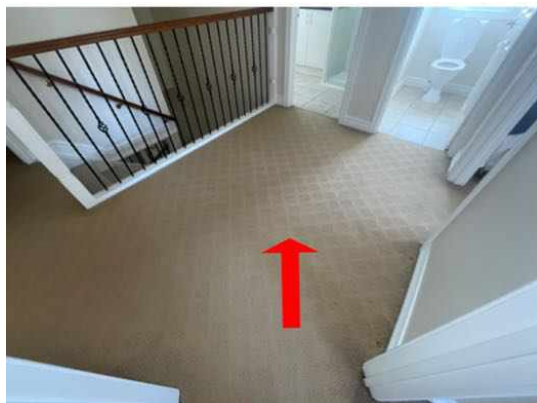
Creaking floors generally indicate that the floorboards or the subfloor structures are coming loose from the supporting structure that they are installed on.

The areas should be monitored for any changes or unevenness. Should this occur, consultation with a registered builder should be undertaken to determine the cause . The potential resolution may involve regluing and screwing the floor down through to replacement of subfloor support structures.

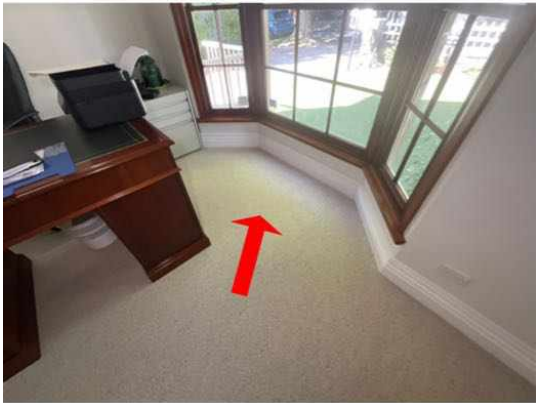
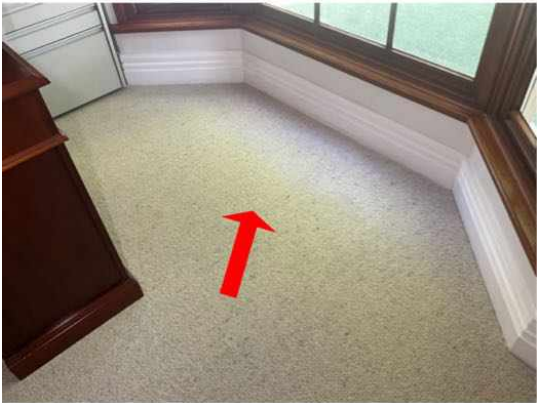
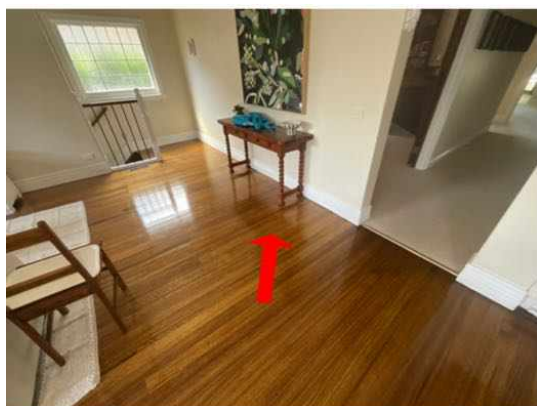
Bouncy floors generally indicate that the floorboards or the subfloor structures are coming loose from the joists that they are installed on. Bouncy flooring may also be the result of gaps between flooring and stumps or joist structures, which require packing.

Where necessary, the client is advised to seek quotations for required repairs from a Registered Builder specialising in re-stumping. The potential resolution may range from packing gaps in subfloor structures through to replacement of subfloors stumps and refixing of flooring.

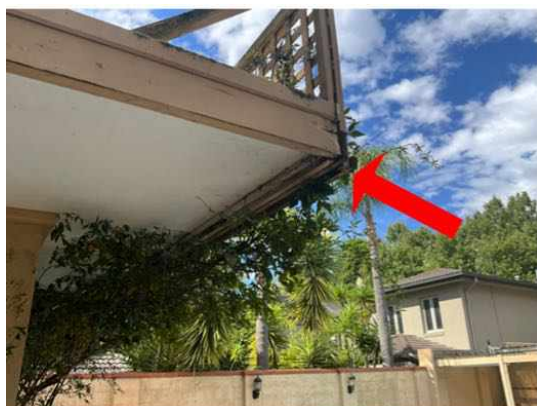
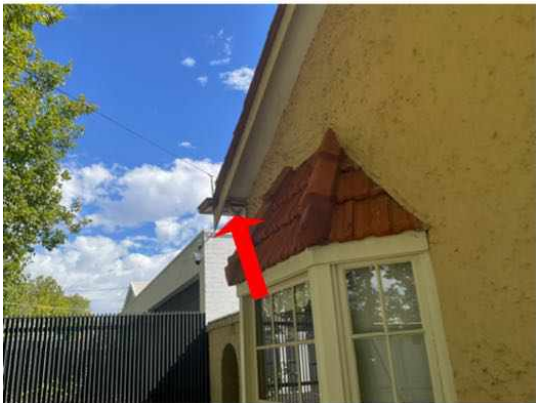
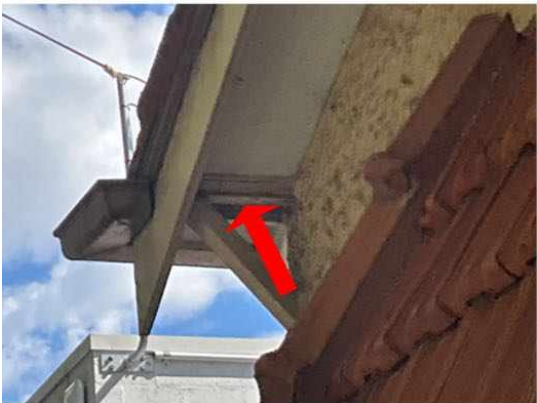
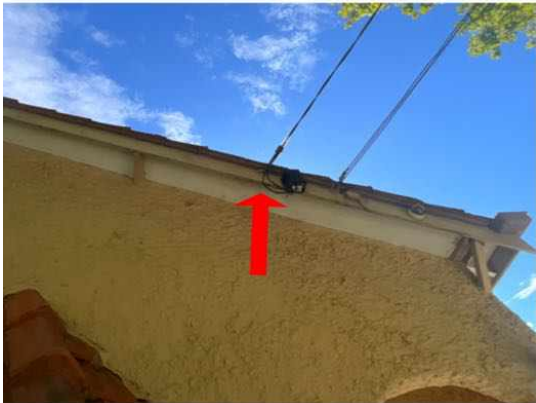
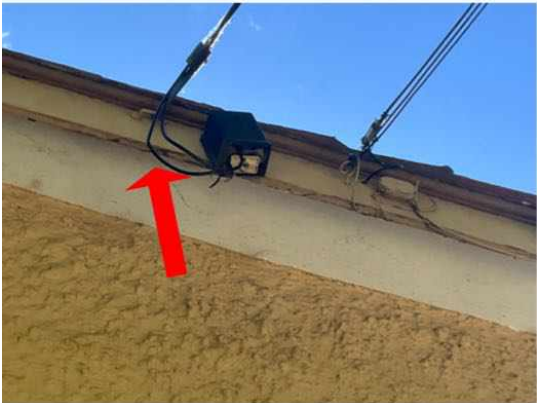
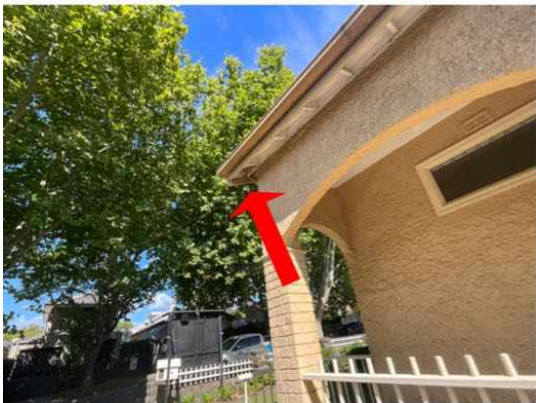
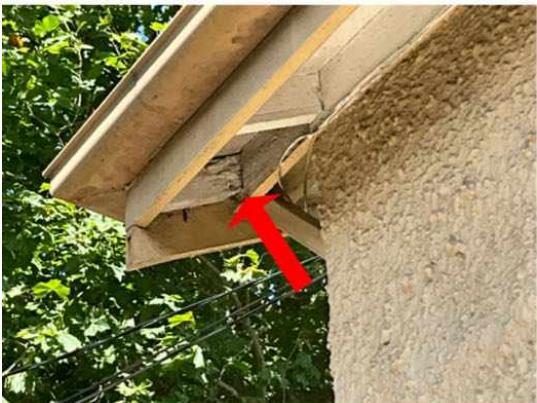
Building:
Location: All External Areas
Finding: Fascia and rafters - Wood rot noted
Information: Wood rot was found to be affecting the fascia and rafters in these areas. Wood rot, also known as Fungal Decay, occurs when timbers and other cellulose building materials are exposed to damp conditions on an ongoing basis.

It is likely that this wood rot has developed as a result of faults in the roof cover or plumbing, creating excessive moisture in this areas. Frequent exposure to rain and other weather conditions also make fascias and rafters susceptible to accelerated deterioration.

Early intervention and regular maintenance will prolong the useful life of these building elements. Prior to any works being performed, the cause of the moisture that has created the visible wood rot should be identified and addressed in a suitable manner.

It is advised that a roof plumber be appointed to inspect all roof plumbing and subsequently identify the cause of the wood rot. Replacement of affected fascias and barges may then be a necessary step in protecting surrounding building elements from such deterioration.

A qualified plumber may be appointed to assess the cause of excessive moisture and to provide advice on any remedial works as required. A qualified carpenter or registered builder may also be required to replace affected building materials.

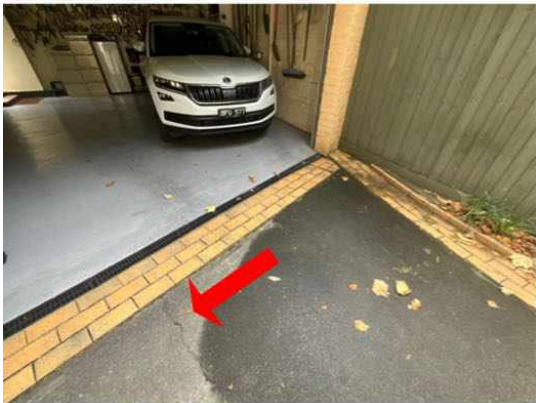
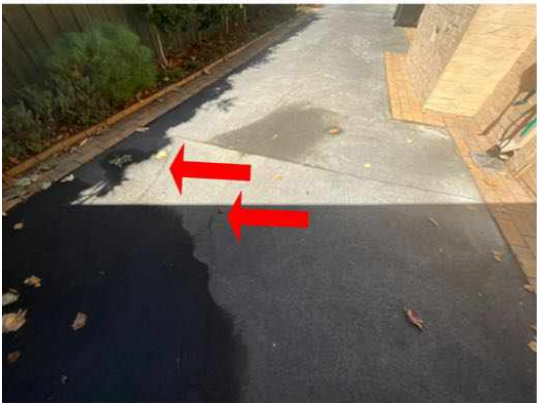
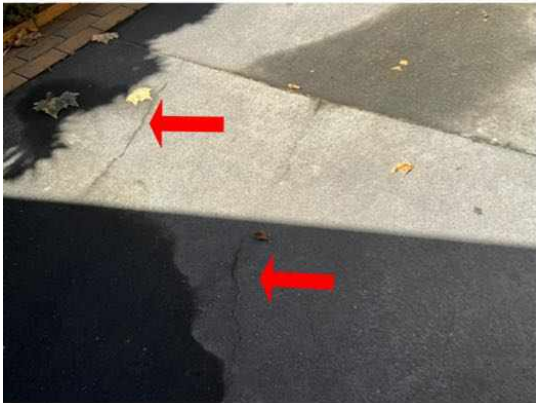
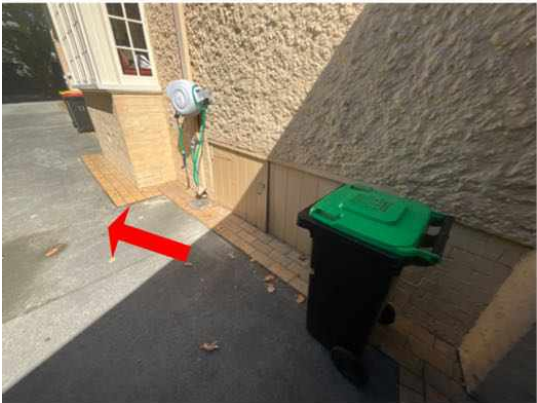
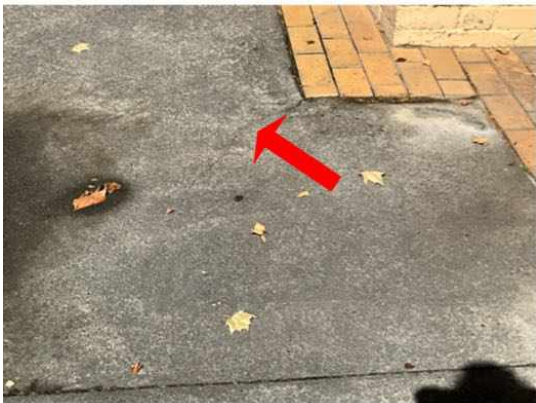
Building:	
Location:	Driveway
Finding:	Cracking - Noticeable cracking to driveway paving
Information:	Fine but noticeable cracks were identified in the concrete paving of the driveway. These cracks may lead to the development of tripping hazards and secondary defects if they develop further.

General age and expected deterioration of the paved areas is a common cause of this type of cracking. However, expansion and contraction of the driveway may also have occurred due to environmental factors. Such factors include variable moisture and weather conditions, the presence of trees and their roots having a settling or lifting affect on the soil, or the effect of load bearing, e.g. heavy vehicles over a sustained period of time.

Cracking to this degree may also be due to poor original installation of the driveway. Factors such as poor compaction of the sub surface and/or inadequate reinforcing of the slab may create cracking and other secondary defects. Noticeable cracks may also be due to subsidence of soils.

The area should be monitored for any changes that may occur and potentially cause tripping hazards. Should this occur, repair or replacement of the concrete paving may be necessary.

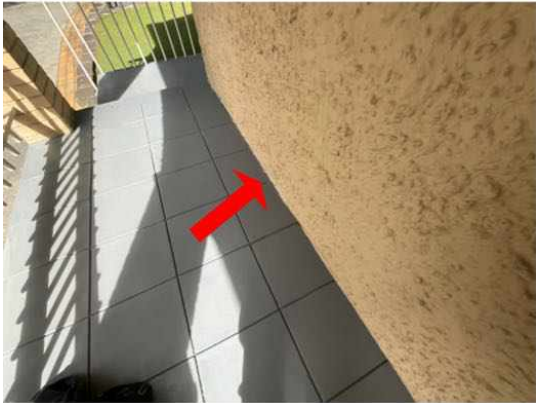
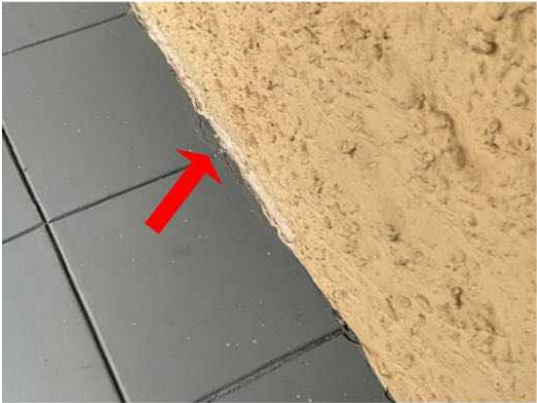
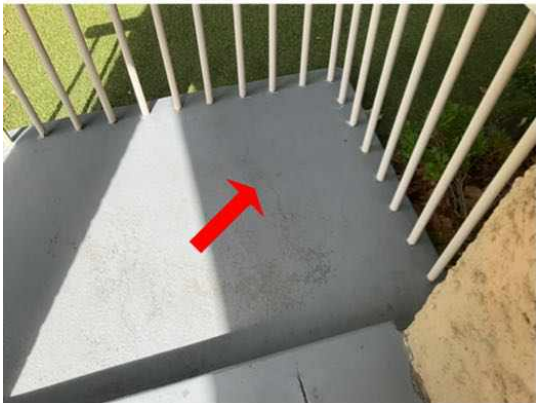
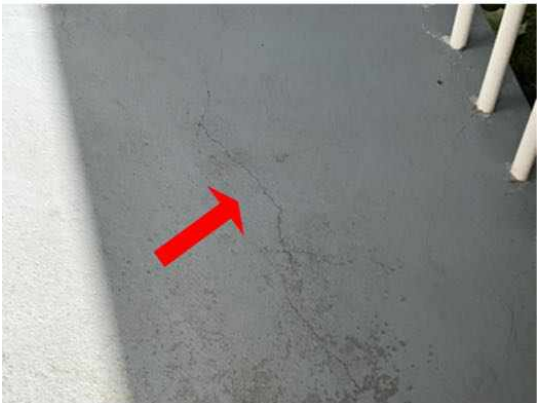
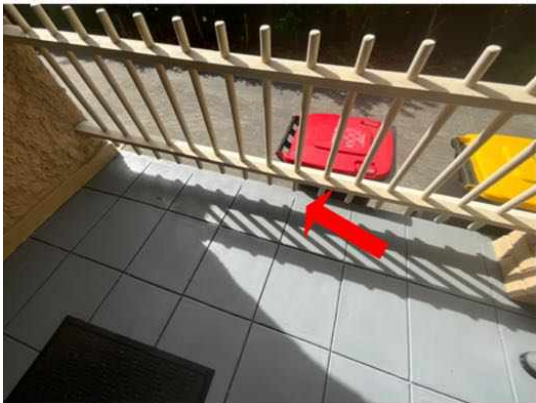
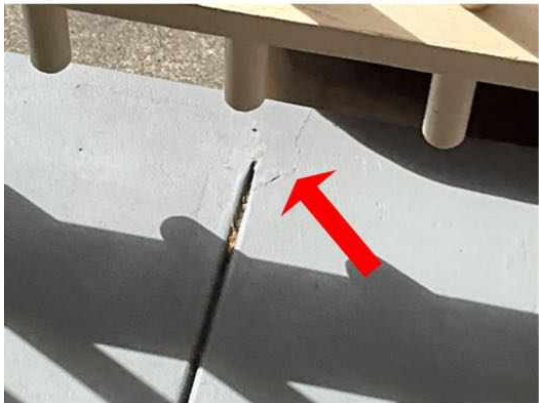
Building:
Location: All External Areas
Finding: Noticeable Cracking - External Concrete Paving
Information: Noticeable cracks were identified in the concrete paving around the property.

Cracking to this degree may also be due to poor original installation of the driveway. Factors such as poor compaction of the sub surface and/or inadequate reinforcing of the slab may create cracking and other secondary defects. Noticeable cracks may also be due to subsidence of soils.

Fine cracks may also be due to poor original installation of the concrete. Factors such as poor compaction of the sub surface and/or inadequate reinforcing of the slab may create cracking and other secondary defects.

Monitoring of all cracking should be conducted frequently. Always contact a building inspector should cracks widen, lengthen, or become more numerous.

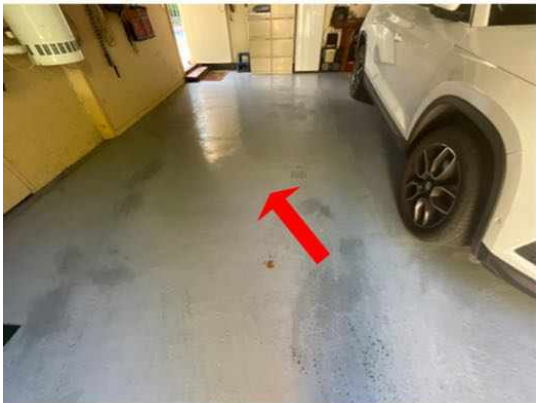
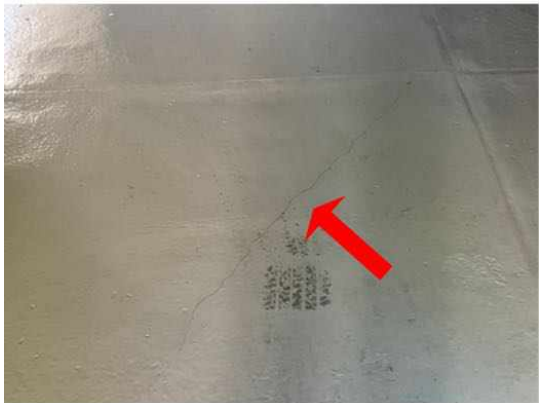
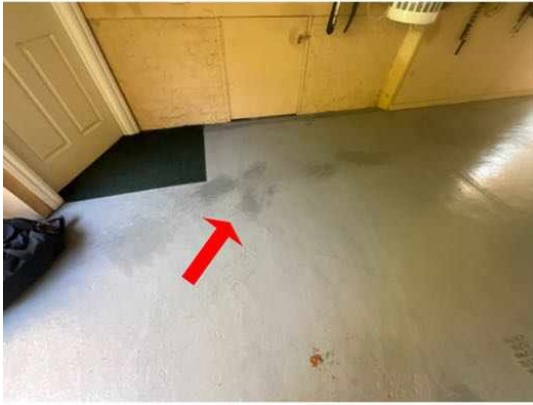
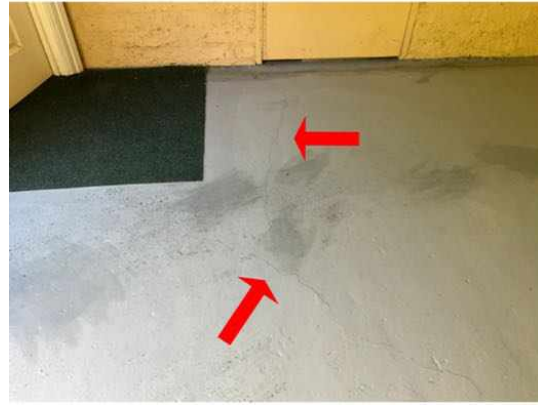
Building:
Location: Garage
Finding: Cracking - Concrete flooring within garage - Fine
Information: Fine cracks were identified in the concrete flooring of the garage . Although fine cracks are quite noticeable, they are often only considered to be an appearance defect, and usually do not indicate any structural damage.

Fine cracks may also be due to poor original installation of the concrete. Factors such as poor compaction of the sub surface and/or inadequate reinforcing of the slab may create cracking and other secondary defects.

Monitoring of all cracking should be conducted frequently. Always contact a building inspector should cracks widen, lengthen, or become more numerous.

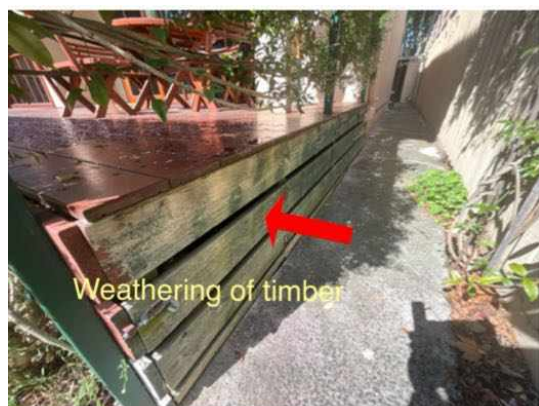
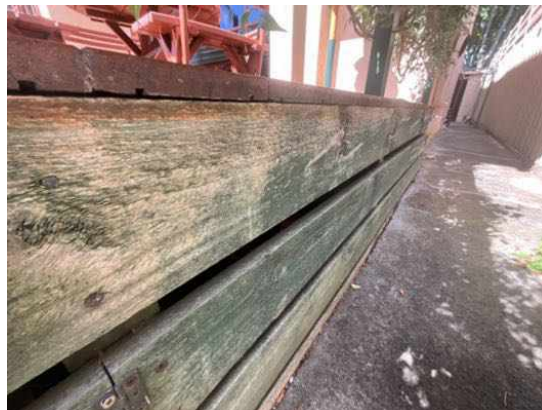
Building:
Location: All Areas
Finding: Additional Photos - minor defects
Information: Additional photos are provided for your general reference. Arrows have been included where necessary to highlight areas of importance.

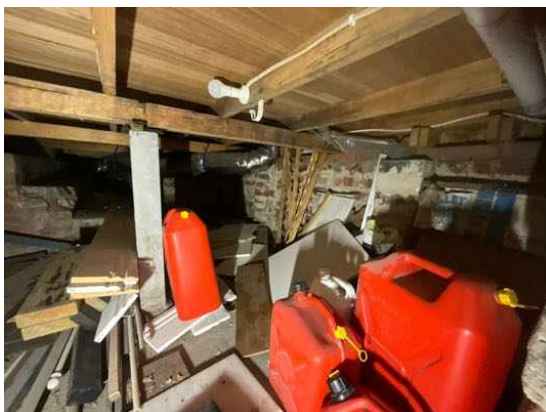
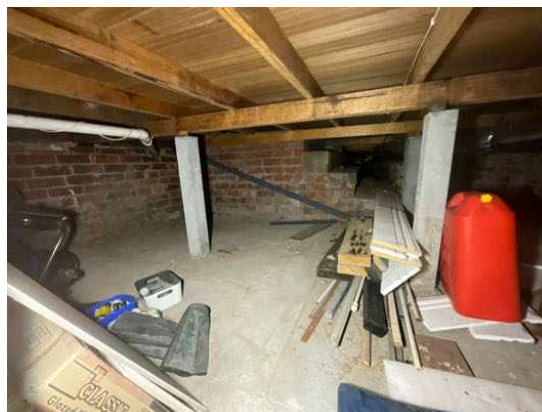
Please note: stored items and debris prevented full access to the subfloor area to inspect for any pest activity or defects.

Any stored items and debris in the subfloor should be removed as soon as possible.

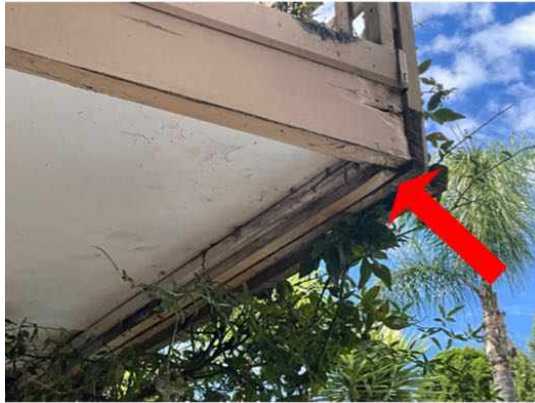
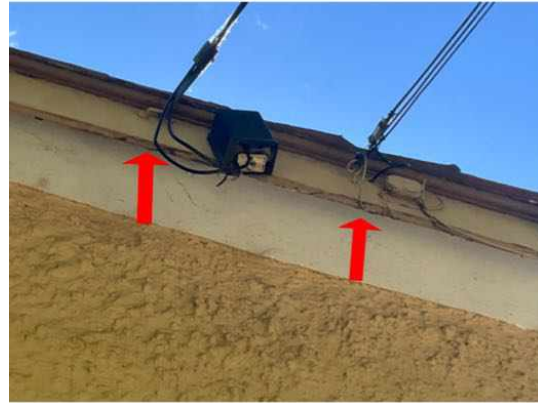
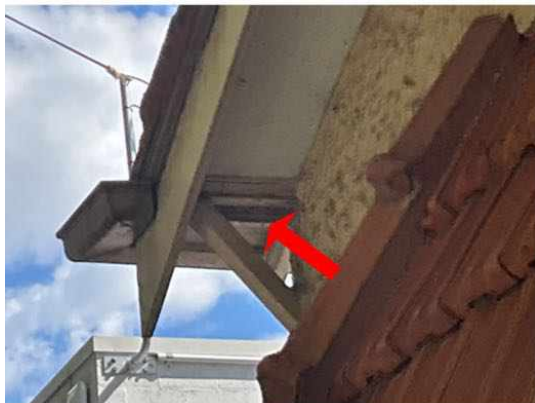
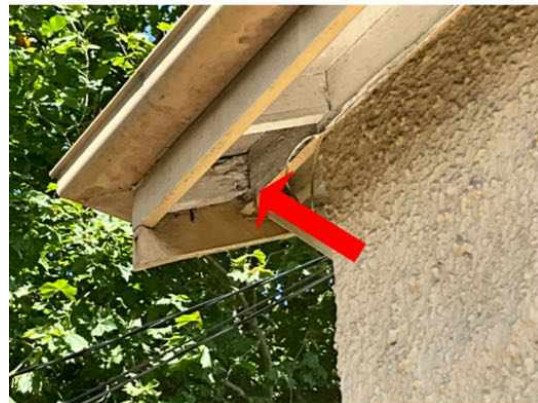
Generally fungal decay develops on timber elements that are in use in an external environment which are exposed to rain penetration.

Decaying timbers can create an environment conducive to timber pest attack. It is recommended that the decaying timbers be repaired / replaced to lessen the risk of timber pests.

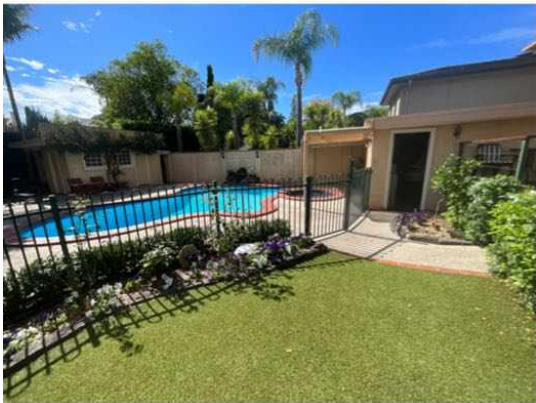
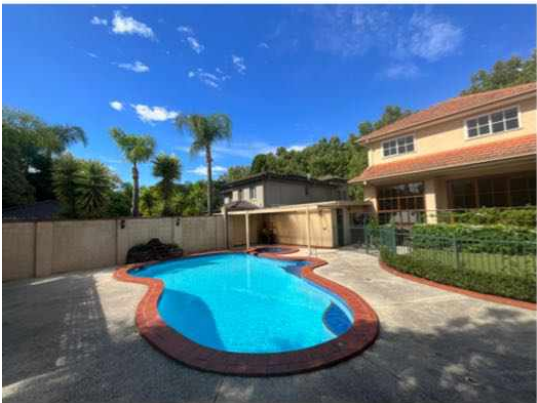
Building:
Location: Pool Area

Please note: it was observed at the time of inspection that the pool gate did not fully close which can become a safety hazard. Urgent action should be carried out to ensure the fence complies with minimum standards for safety.

It is highly advised that a pool specialist be appointed to inspect the pool and associated equipment and provide advice on compliance and any rectification works that may be required.
