Building and Timber Pest Inspection Report

Inspection Date: Thu, 22 Jan 2026

Property Address: 15 Barossa Wy, Thurgoona NSW 2640,
Australia

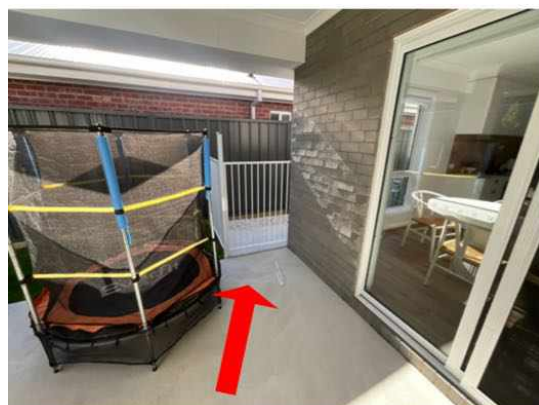
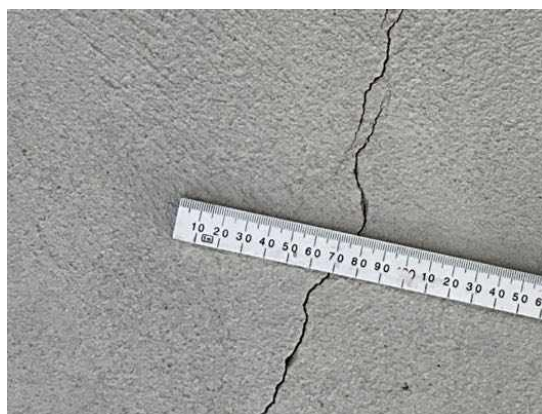
Finding 3.01

Building: Building 1
 Location: Alfresco
 Finding: Cracking - External Concrete Paving Damage Category 1 - Fine (less than 2mm)
 Information: Fine cracks were identified in external concrete paving. Although fine cracks are quite noticeable, they are often only considered to be an appearance defect, and usually do not indicate any structural damage. To be considered a Category 1 or fine crack, the crack is found to be less than 2mm in width.

Generally the cause of a hairline crack in existing concrete paving such as driveways and pathways is indicative of the expansion and contraction of the concrete. Such causes are generally due to environmental factors, such as moisture levels, weather conditions, root systems of nearby trees or the soil types on which they are laid.

Fine cracks may also be due to poor original installation of the concrete. Factors such as poor compaction of the sub surface and/or inadequate reinforcing of the slab may create cracking and other secondary defects.

Monitoring of all cracking should be conducted frequently. Always contact a building inspector should cracks widen, lengthen, or become more numerous.

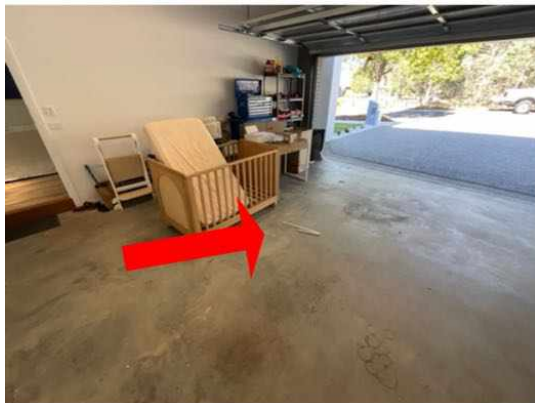
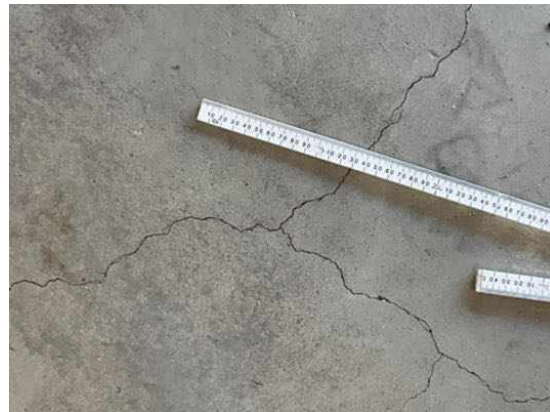
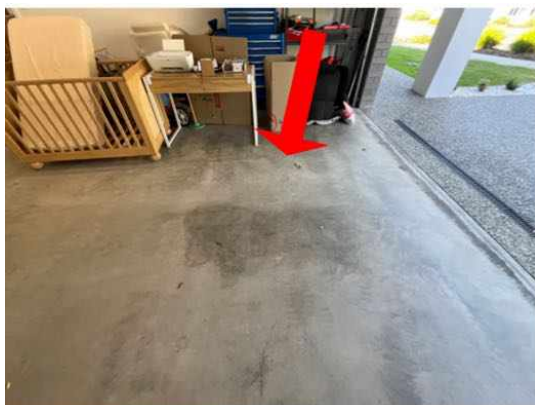
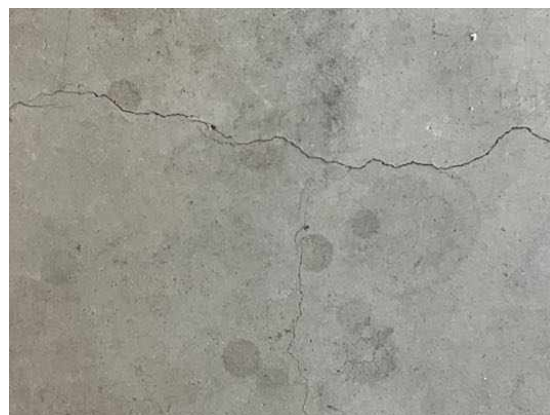
Finding 3.02

Building: Building 1
 Location: Garage
 Finding: Crack in concrete slab - Category 1
 Information: A crack coded as Category 1 was identified in the slab. A Category 1 crack is described as a fine but noticeable crack, with the slab at an otherwise reasonable level.

To be considered Category 1, the approximate width of the crack is less than 1.0mm, or a less than 10mm change in offset when a 3m straight edge is placed over the defect.

Category 1 cracks should be monitored for a period of 12 months. At the end of the monitoring period, identified cracks that are rated greater than Category 2 are considered defects, and require rectification.

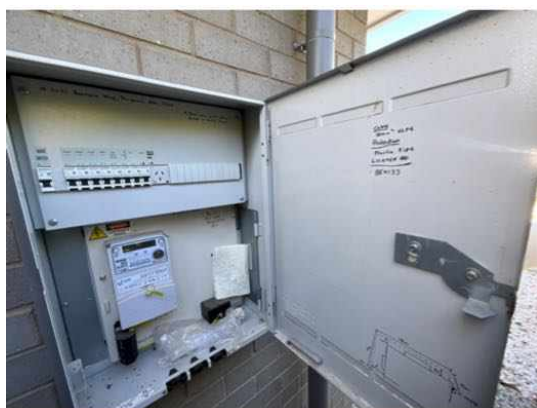
Finding 6.01

Building:	Building 1
Location:	All External Areas
Finding:	Termite Management System - no evidence of a chemical installation
Information:	The application of a post-construction chemical termite barrier is highly recommended for all properties, particularly if live termite activity has been found on the site previously. Such barriers are highly effective in preventing termite attack on any timber building elements throughout the property.

A durable notice should be placed in the switchboard unit to indicate current termite barriers. At the time of inspection, it appeared as though no termite management system has been installed, with no evidence to suggest preventative works taking place.

The client may consider gaining further advice from a pest controller as to the costs and procedures involved with this application. It is recommended that obtaining such advice be a short-term priority.

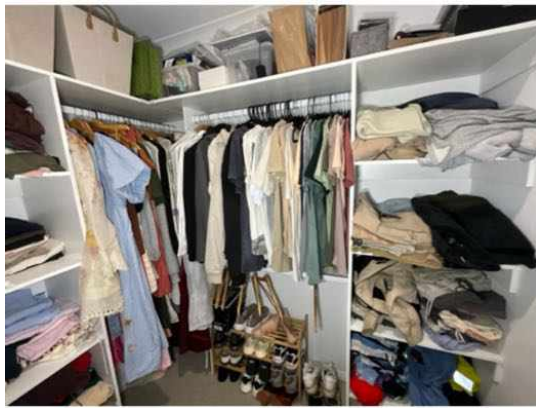
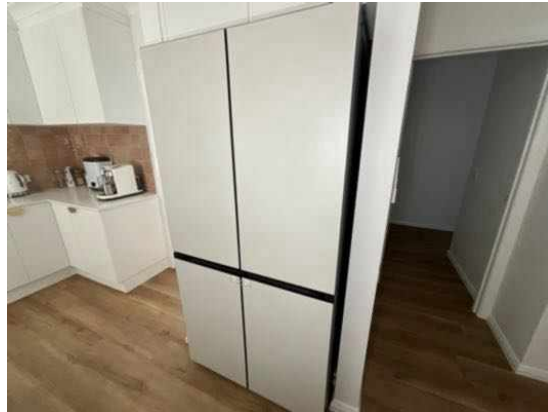
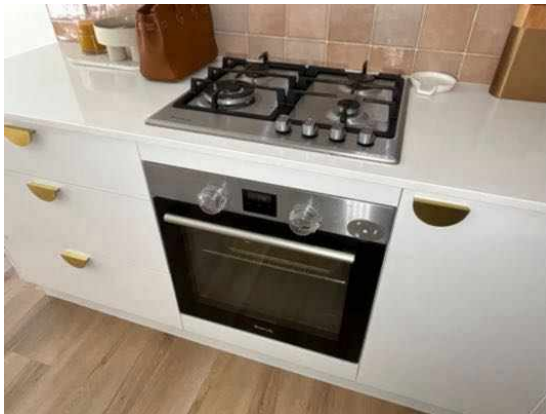
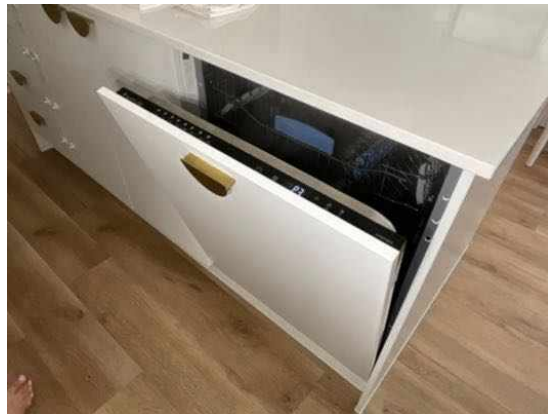
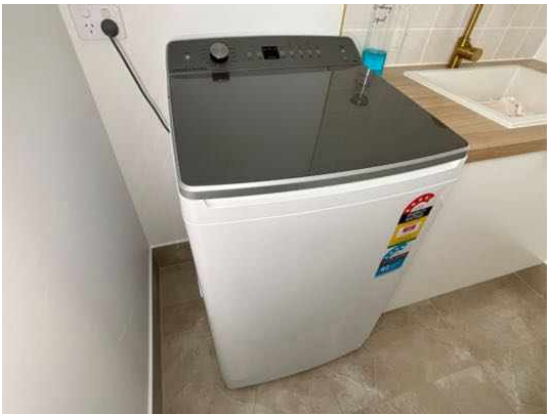
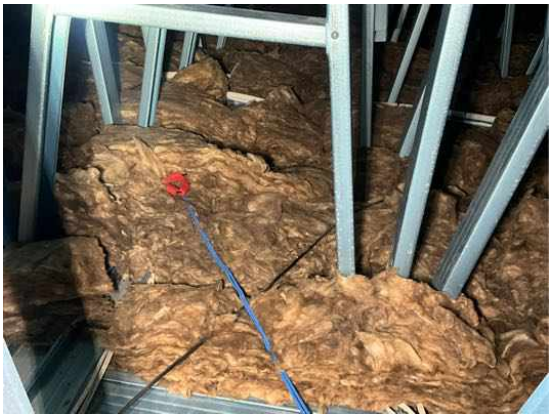
Noted Item

Building: Building 1
Location: All Areas
Finding: Additional Photos - Obstructions and Limitations
Information: These photographs are an indication of the obstructions and limitations which impeded full inspection of the property at the time of inspection. These obstructions can hide an array of defects and should be removed to allow full inspection to be carried out. A re-inspection is recommended once the areas are made accessible.
