# Building and Timber Pest Inspection Report

Inspection Date: Mon, 9 Feb 2026

Property Address: 23 Nurla Ave, Little Bay NSW 2036,  
Australia

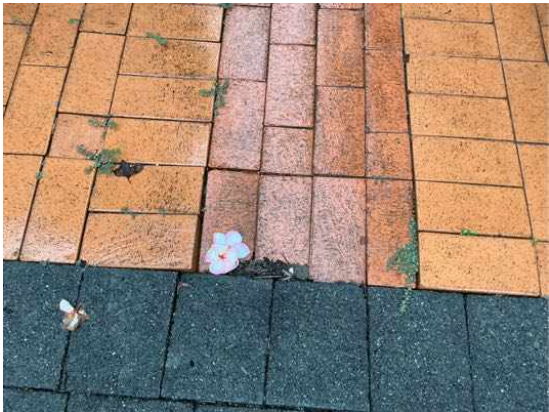
Building: Main Building  
Location: External paving- back yard and side passages  
Finding: Paving uneven  
Information: Sections of the external paved area are uneven, creating a potential trip hazard. It appears as though the area has been subject to rough installation, or that paving sections have lifted due to movements in the foundation of the property.

Where paving creates a trip hazard, personal injury may ensue if due caution is not taken by all persons within this area.

Re-paving of the area is required as soon as possible to remedy this situation. Further consultation with a specialist concreter is advised.

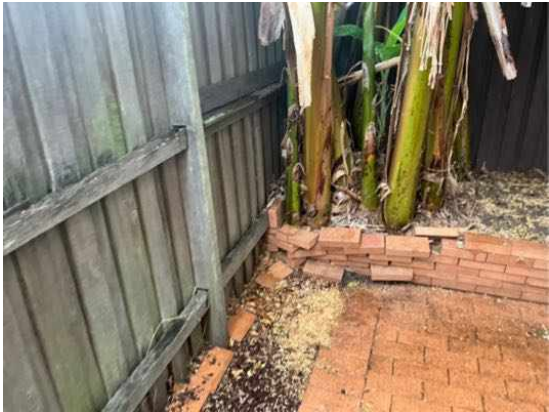
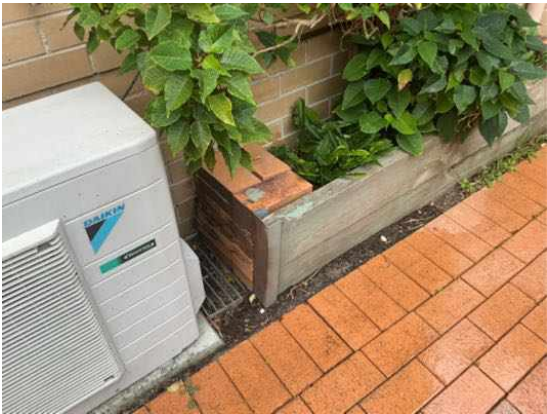
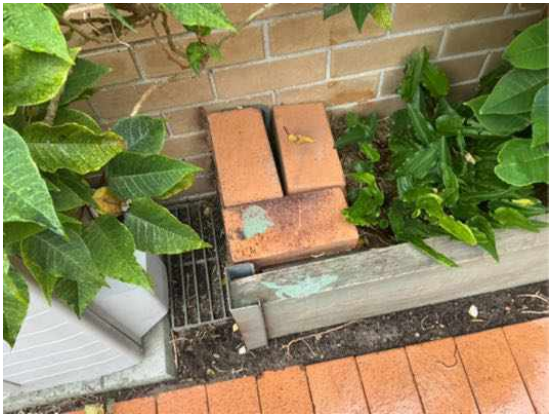
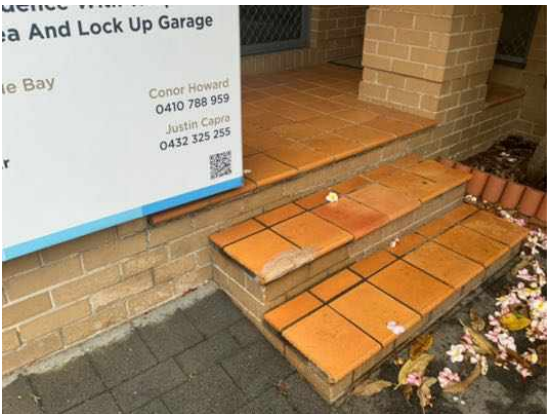
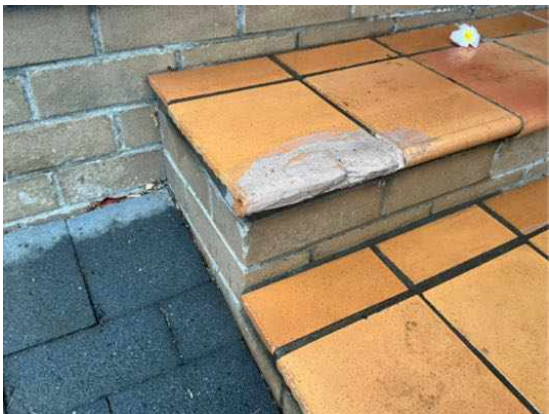
Building:	Main Building
Location:	Rear yard, front steps
Finding:	Incomplete or substandard works- external pavers not bound, repairs to front step not sanded/ dressed.
Information:	The works to this area appear to be incomplete or have been completed to a substandard level.

Works that have not been completed to a satisfactory level create potential for the development of building defects and may impede on the safety and integrity of the overall structure.

It is highly recommended that the relevant trades be appointed to complete these works and ensure the safety of the area and the longevity of all associated building elements.

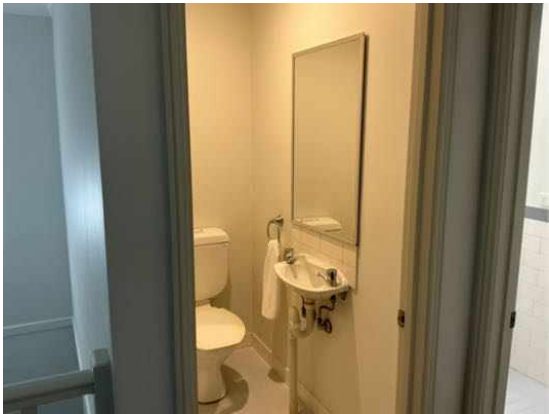
Building:	Main Building
Location:	All wet Areas- Laundry, bathrooms, toilets- up and downstairs
Finding:	Tiles cracked or damaged- (wet areas)
Information:	Cracking was evident to the tiling in this area at the time of inspection. While the cracking appears to be minor, this area is frequently exposed to water, allowing potential for water penetration into adjoining sections of walls or flooring.

If left unmanaged, water penetration to these areas may lead to subsequent water damage, which is likely necessitate repair work to affected building elements.

A tiling contractor should be appointed to ensure that no further water damage occurs. The re-application of silicone and grouting throughout remaining tile work is also advised, to further protect the area against water penetration.

Where water penetration has led to water damage, appointment of a relevant tradesperson may be required to repair damaged building elements.

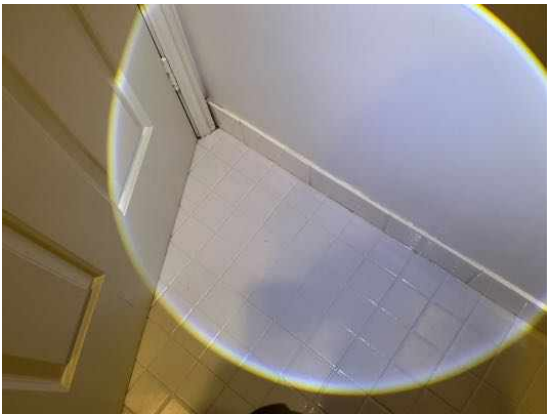
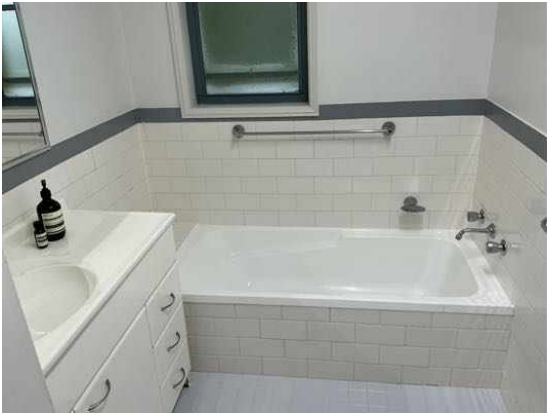
Building:	Main Building
Location:	Downstairs toilet, bathroom, laundry- upstairs bathroom, toilet- All wet areas throughout
Finding:	Tiles - Drummy
Information:	Drummy tiled areas were identified at the time of inspection. The term 'drummy' refers to tiles that have become detached from their fixing, despite otherwise being in relatively good condition. Such defects are generally caused by physical or moisture damage to the area. Drummy tiled areas may also be a direct result of poor workmanship during the construction process.

Tiled areas may swell and shrink with changes in air humidity if the area has sustained

moisture damage. Any exposure to moisture is capable of causing tiled areas to become drummy and/or cracked over a prolonged period of time. Drummy tiled areas generally require removal and replacement of affected tiles, with adequate sealant and grouting.

Specialist trades are available for these types of services. A registered builder may be required to undertake works if damage is extensive or if secondary building defects have resulted. Otherwise, it is advised that a tiling contractor be appointed to perform works as necessary. Immediate action is recommended to ensure that no further damage is sustained in the affected area.

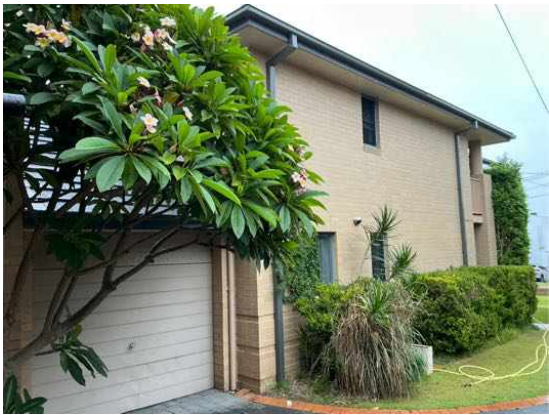
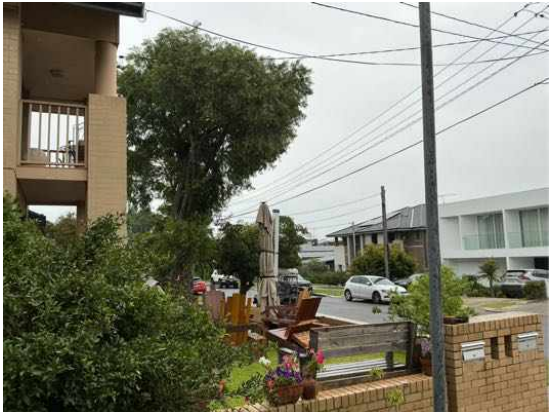
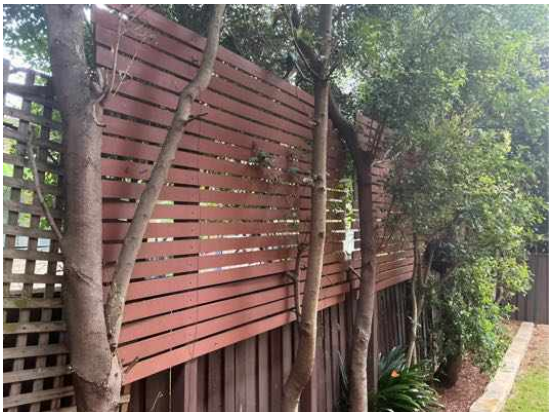
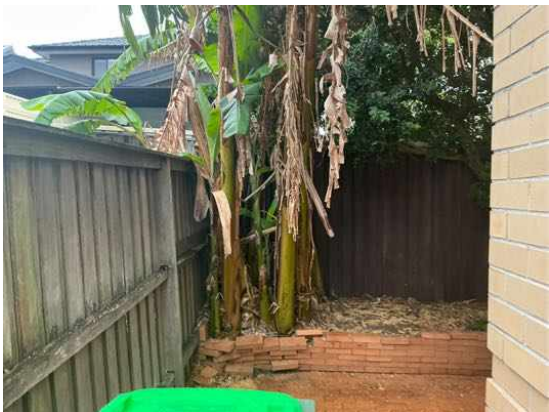
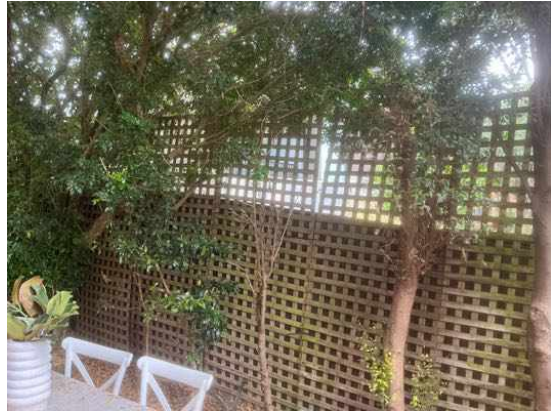
Building: Main Building  
Location: All Areas  
Finding: Trees to be inspected within the property.  
Information: Trees can be conducive to termite activity and nesting. Trees over 100mm on the property, should be drilled and tested for termite activity.

Regular inspections every 6-12 months- or advised by the termite management system installer.

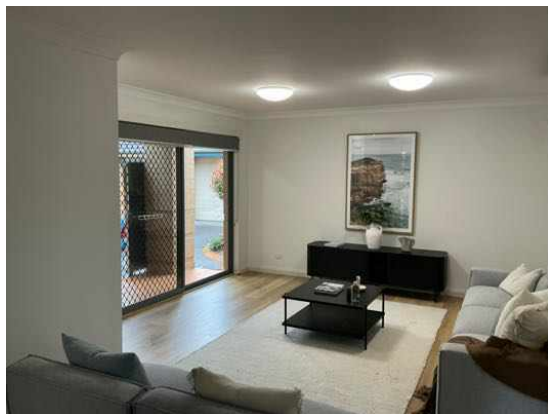
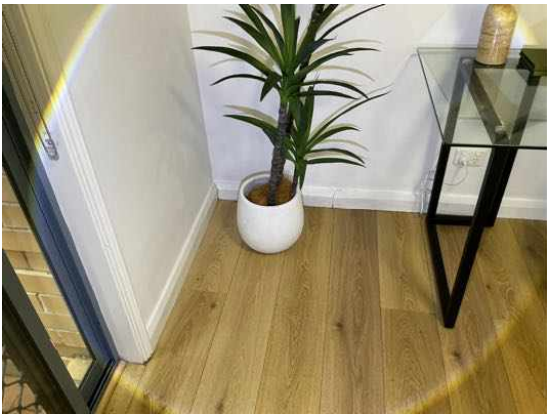
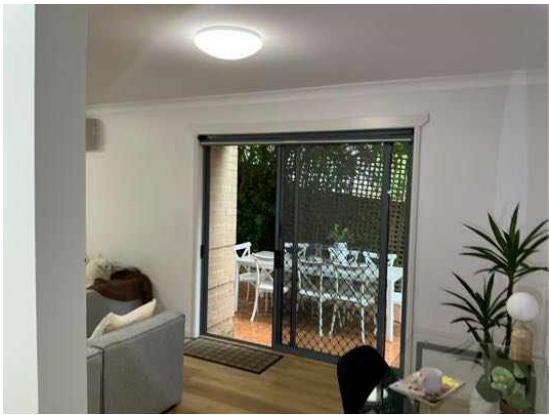
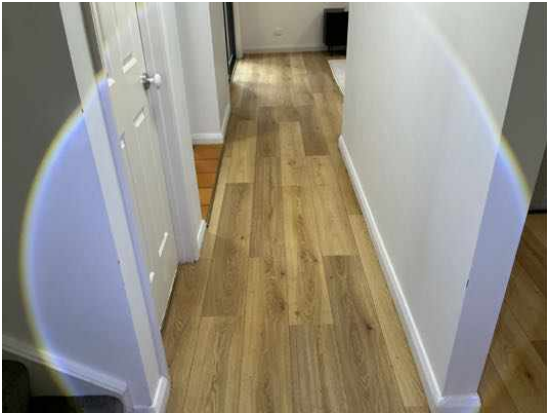
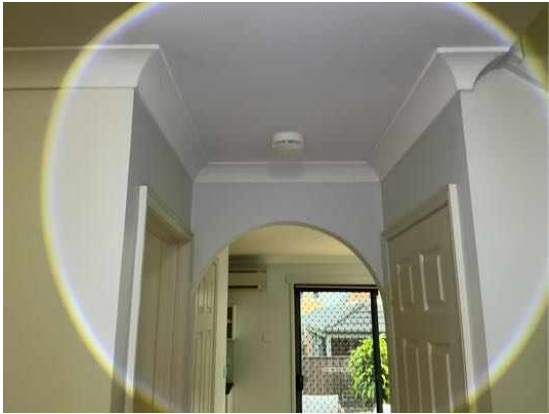
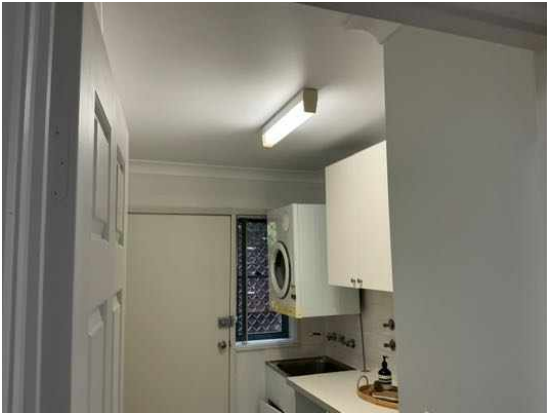
Building: Main Building  
Location: All Areas- internal  
Finding: Additional Photos - Obstructions and Limitations  
Information: These photographs are an indication of the obstructions and limitations which impeded full inspection of the property at the time of inspection. These obstructions can hide an array of defects and should be removed to allow full inspection to be carried out. A re-inspection is recommended once the areas are made accessible.

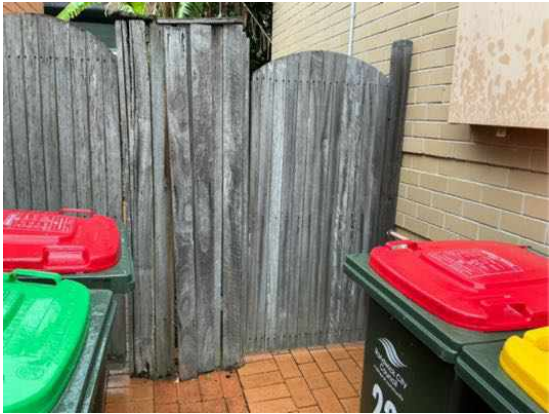
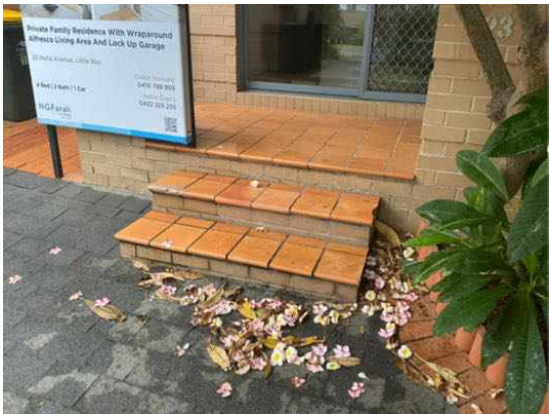
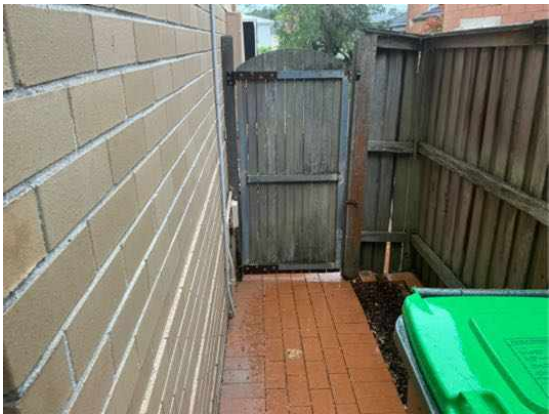
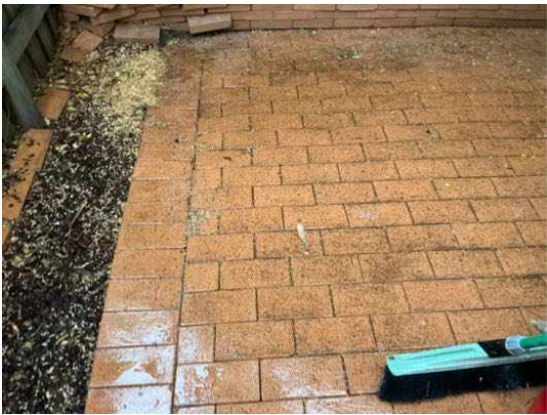
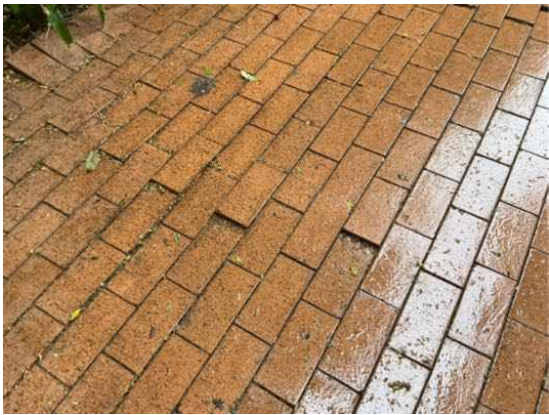
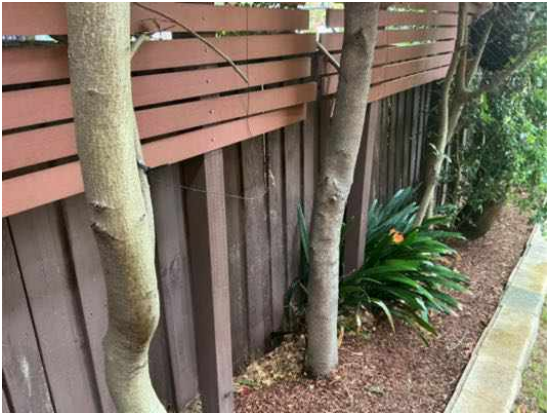
Building: Main Building  
Location: All Areas- external  
Finding: Additional Photos - Obstructions and Limitations  
Information: These photographs are an indication of the obstructions and limitations which impeded full inspection of the property at the time of inspection. These obstructions can hide an array of defects and should be removed to allow full inspection to be carried out. A re-inspection is recommended once the areas are made accessible.

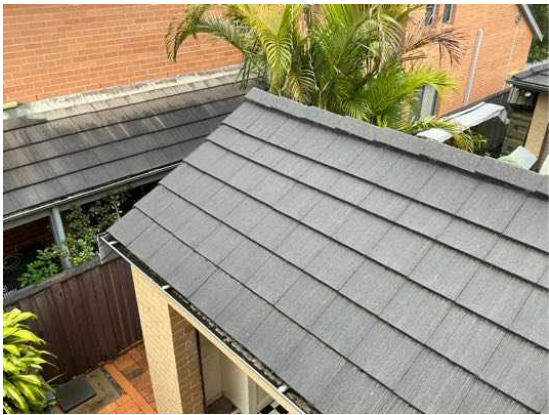
Building: Main Building  
 Location: Roof Exterior  
 Finding: Additional Photos - Obstructions and Limitations  
 Information: These photographs are an indication of the obstructions and limitations which impeded full inspection of the property at the time of inspection. These obstructions can hide an array of defects and should be removed to allow full inspection to be carried out. A re-inspection is recommended once the areas are made accessible.

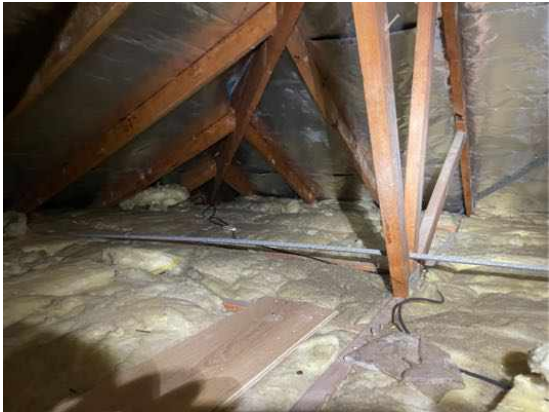
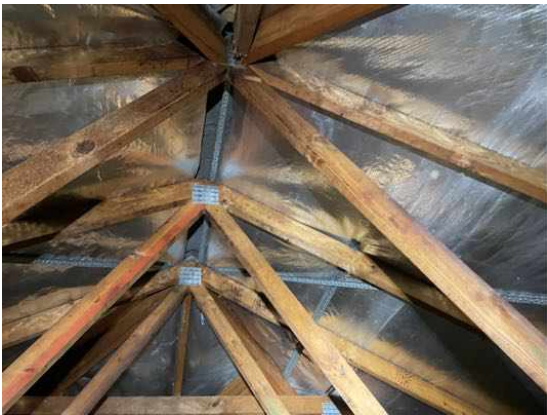
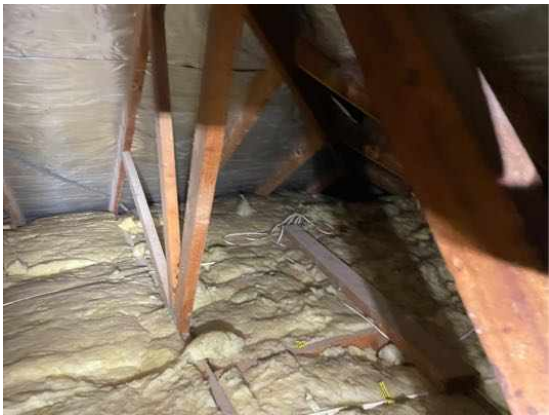
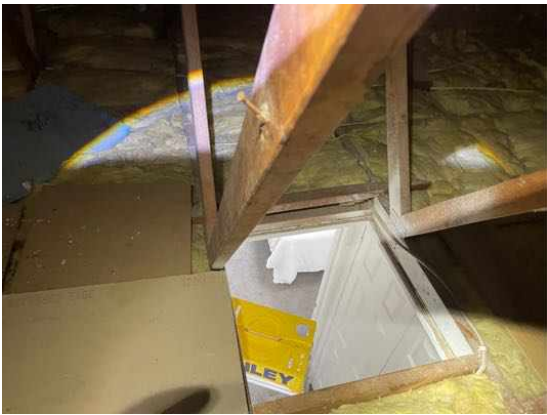
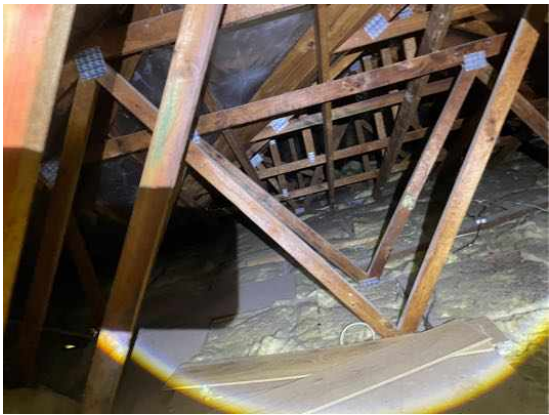
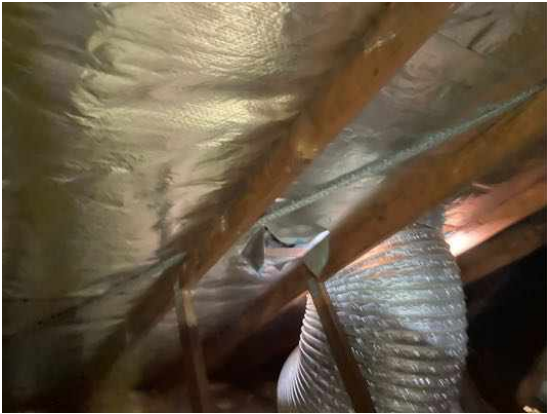
Building: Main Building  
Location: Roof Void  
Finding: Additional Photos - Obstructions and Limitations  
Information: These photographs are an indication of the obstructions and limitations which impeded full inspection of the property at the time of inspection. These obstructions can hide an array of defects and should be removed to allow full inspection to be carried out. A re-inspection is recommended once the areas are made accessible.
