Building and Timber Pest Inspection Report

Inspection Date: Mon, 16 Feb 2026

Property Address: 101 Mackellar St, Benalla VIC 3672,
Australia

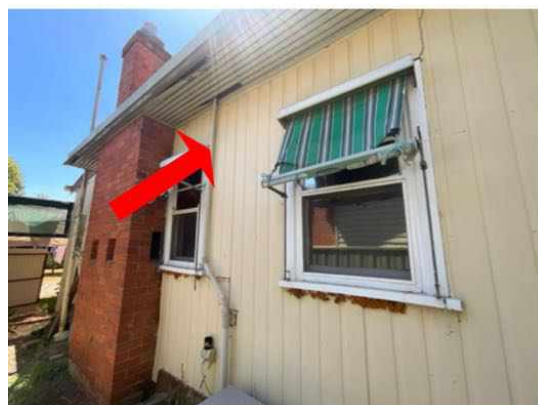
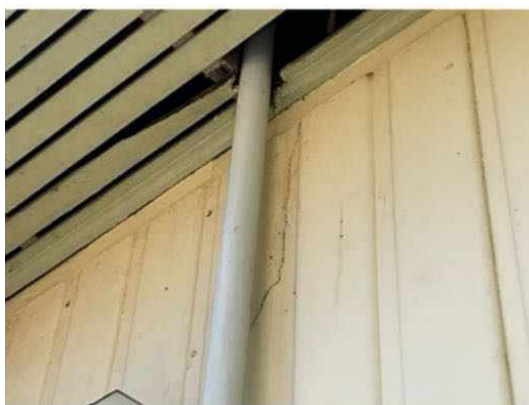
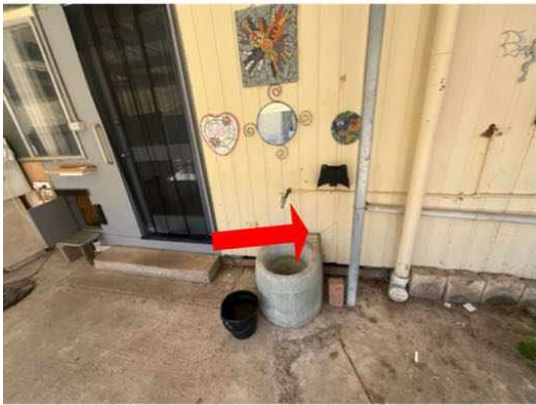
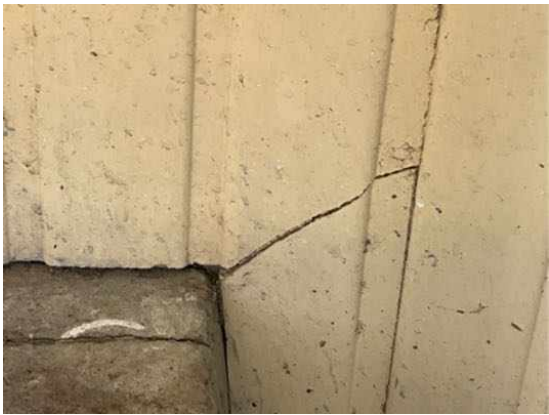
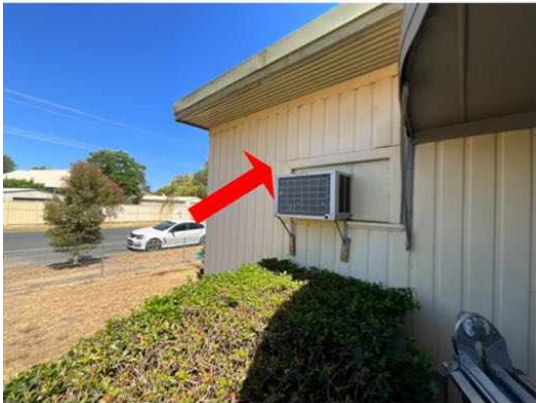
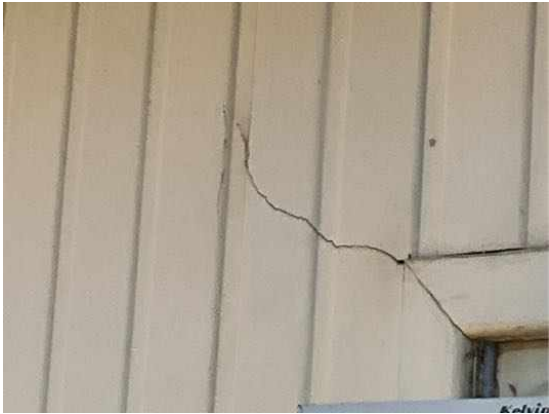
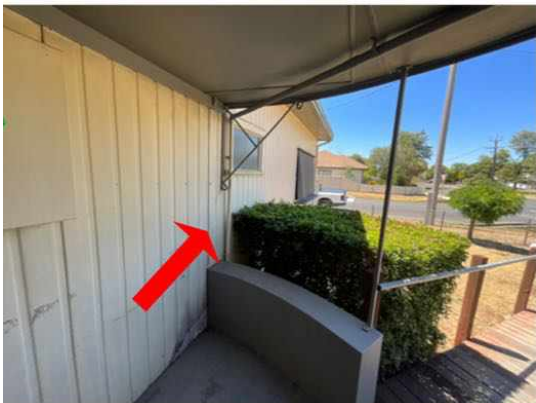
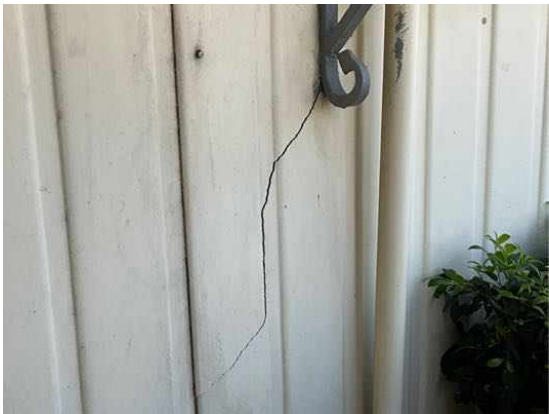
Finding 3.01

Building: Building 1
Location: Exterior cladding
Finding: Cladding- deteriorated
Information: The external cladding shows signs of damage in several areas. Although not serious at this point, monitoring should be undertaken at intervals to ensure no further damage occurs.

A cladding specialist or handyman could be contacted as needed to patch any damage to prevent further deterioration.

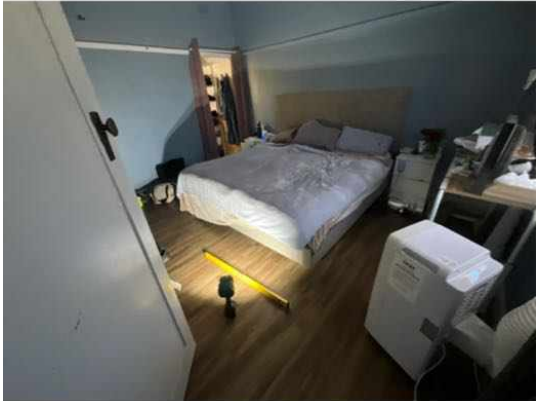
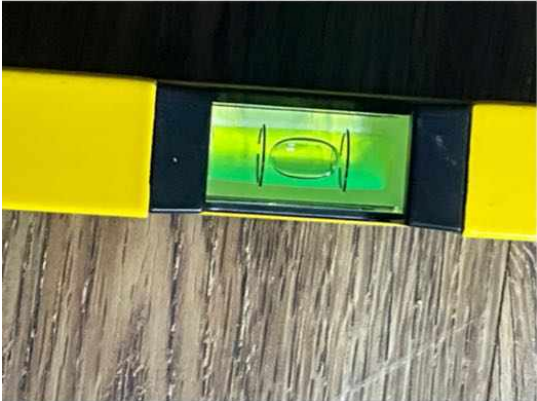
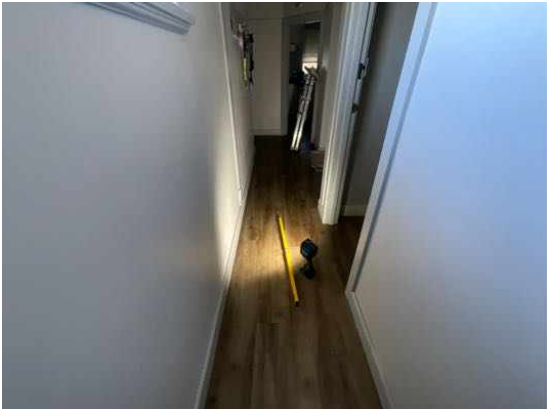
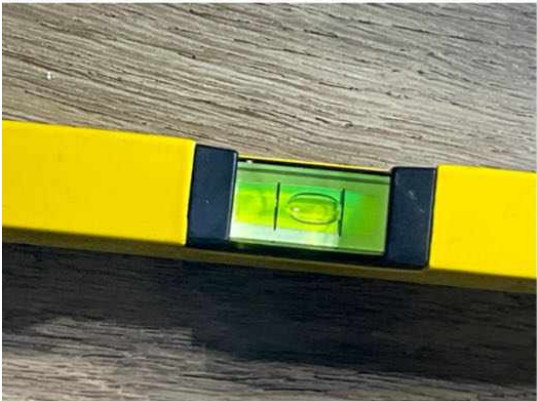
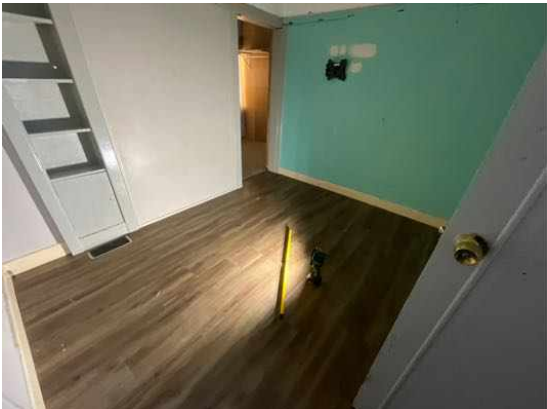
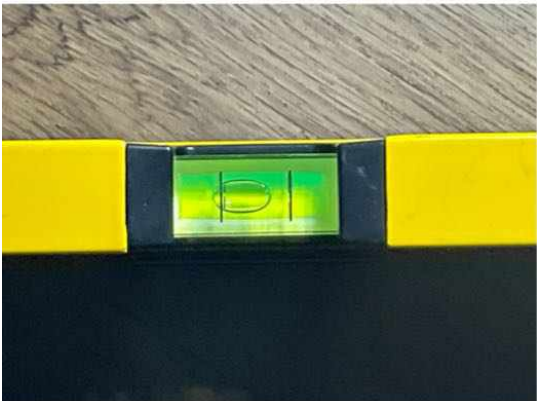
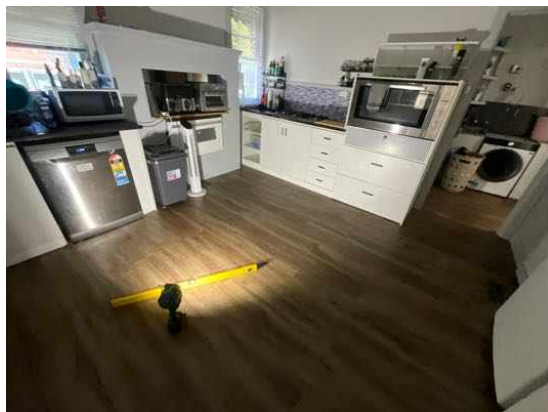
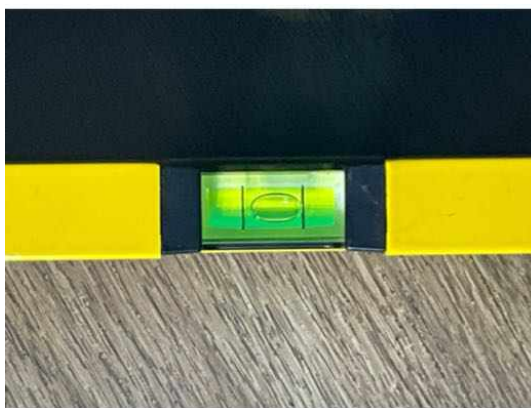
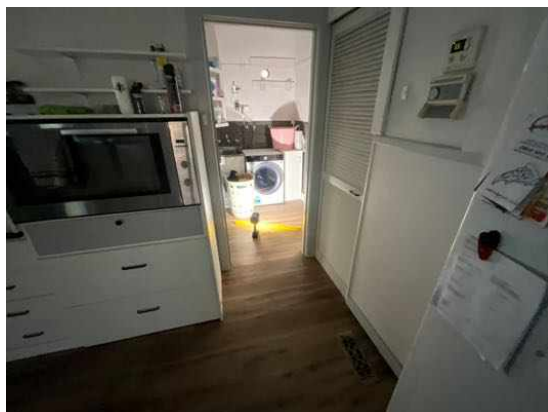
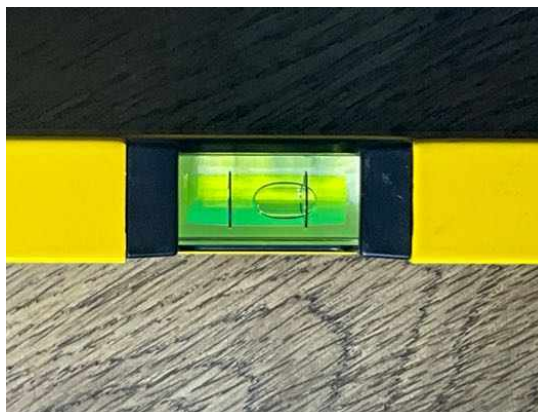
Finding 3.02

Building: Building 1
 Location: All Internal Areas
 Finding: Flooring - Uneven
 Information: The internal flooring in this area is out of level and uneven. Uneven flooring is likely to indicate minor defects such as expected movement of the foundations of the property, but may also indicate subsidence of the associated subfloor stumps.

It is advised that the flooring be closely monitored to identify any further movement. Where flooring remains relatively unchanged for an extended period of time (i.e. several months), it is likely that this defect has been caused by expected movement of the foundations of the property.

However, where flooring is uneven further, potentially invasive inspection of the subfloor structures and stumps in this area is required. In this case, works to repair are likely to be required, and would be carried out by a registered builder specialising in re-stumping.

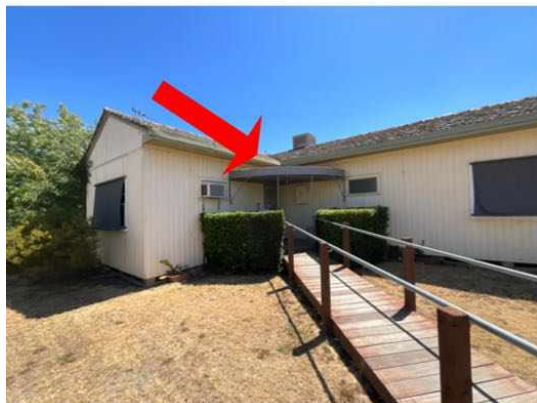
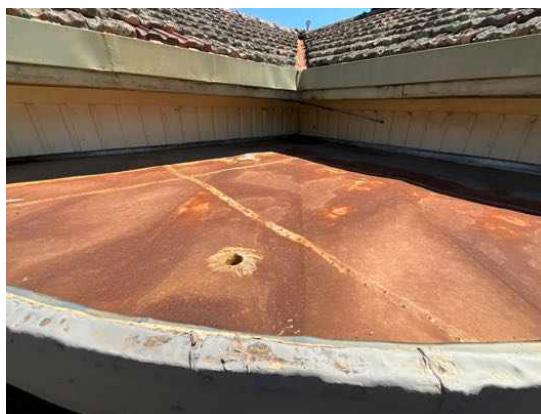
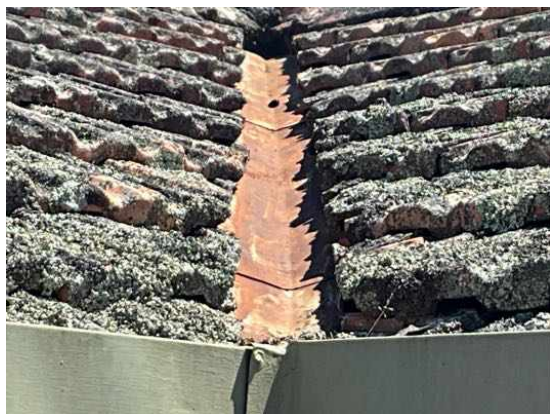
Finding 3.03

Building:	Building 1
Location:	Roof Exterior
Finding:	Roof sheets - Rusted
Information:	Metal roofs generally comprise numerous individual sheets, which join and overlap. These intersections are particularly prone to lift at the edge and consequently rust at these points.

Upon inspection of the exterior roofing structure, evidence of rust to these sections was identified. If left unmanaged, these degrading joins can allow water ingress to the internal roofing structures, potentially leading to secondary damage of building elements. Accelerated deterioration of the roofing sheets and any associated building elements is also likely to occur.

A roofing contractor should be appointed immediately to assess the damage to the roofing sheets and to perform remedial works as necessary. Works may include replacement of severely affected roofing sheets or minor works such as the application of rust-retardant surface protectors.

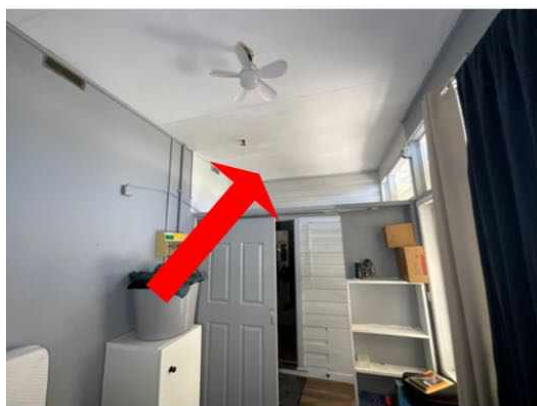
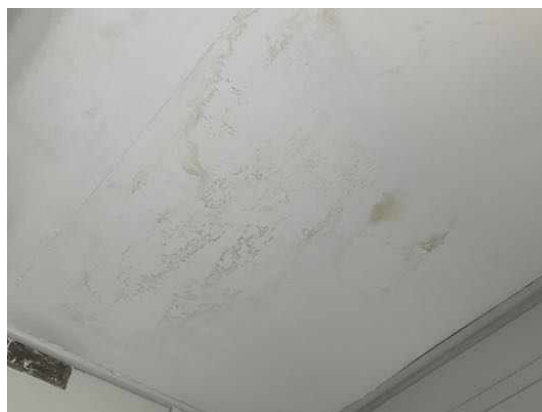
Finding 3.04

Building:	Building 1
Location:	Back room
Finding:	Ceiling - Water stained
Information:	Water staining to ceiling linings in this area was evident at the time of inspection. Water staining indicates that surfaces have been exposed to excessive moisture over time. The minerals and other elements in the water lead to staining, which may graduate to corrosion and deterioration if left unmanaged.

While mostly an appearance defect, water staining can be indicative of more serious defects, which may be currently concealed by interior ceilings.

Where water staining is active, a licensed plumber must be consulted to identify the cause of the staining and to provide advice on any reparation works that may be required. Replacement of any damaged structures is advised.

Conversely, where water staining is old and inactive, affected building materials may be repaired or replaced at client discretion.

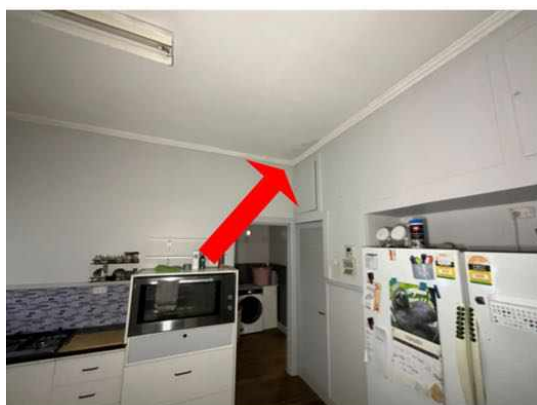
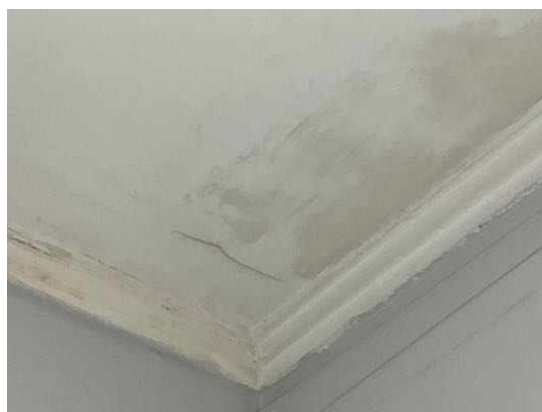
Finding 3.05

Building:	Building 1
Location:	Kitchen
Finding:	Paint- Flaking
Information:	Sections of paint in this area was found to have deteriorated. Paint flaking is generally an indication of excessive moisture in the area, that is currently hidden by the painted surface.

The presence of excessive moisture can have major implications on associated building elements if left unattended. While only seemingly minor at this stage, the damage cannot be determined due to the paint obstructing any further inspection of the damage.

A qualified Painter should be contacted at the Owner's discretion to re-paint the area.

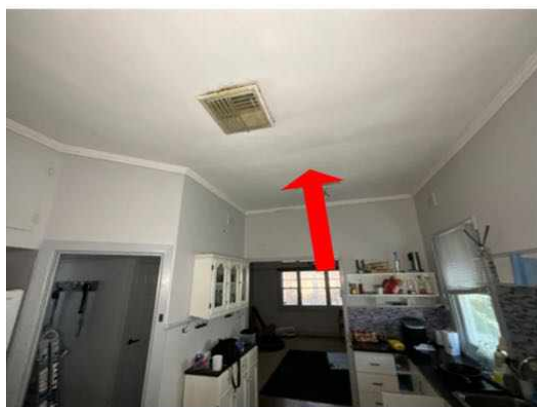
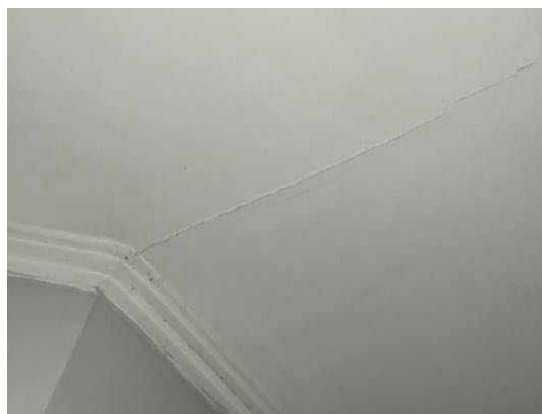
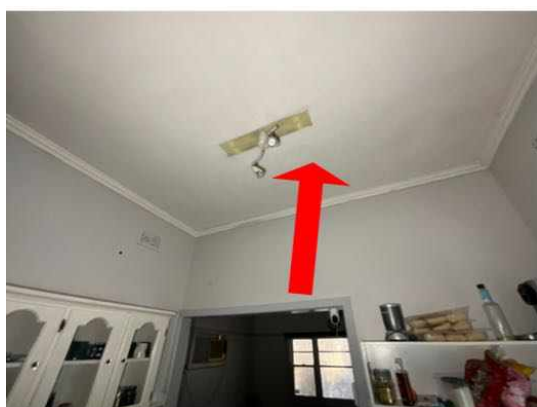
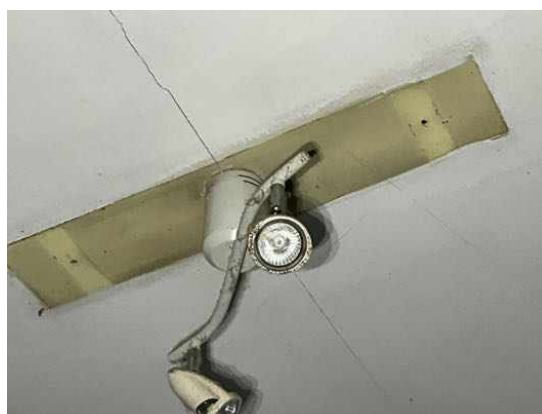
Finding 3.06

Building:	Building 1
Location:	Kitchen
Finding:	Cracking - Damage Category 1 - Fine (up to 1mm)
Information:	Although fine cracks are quite noticeable, they are often only considered to be an appearance defect, and usually do not indicate any structural damage. Generally, the

cause of a fine crack is indicative of a separation between building materials and finishes (e.g. paint, plaster, etc.) along joins.

Cracking of this nature can generally be repaired with minor sanding, filling and/or repainting. Such works should be performed by a qualified painter or a general handyman.

Monitoring of all cracking should be conducted frequently. Always contact a building inspector should cracks widen, lengthen, or become more numerous.

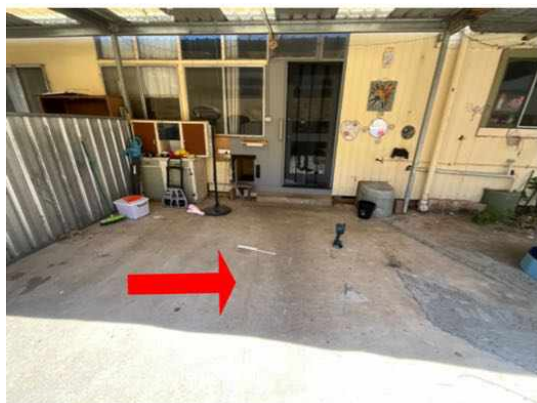
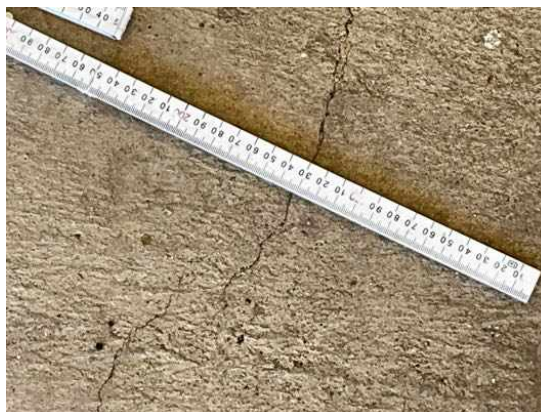
Finding 3.07

Building:	Building 1
Location:	Verandah
Finding:	Cracking - External Concrete Paving Damage Category 1 - Fine (less than 2mm)
Information:	Fine cracks were identified in external concrete paving. Although fine cracks are quite noticeable, they are often only considered to be an appearance defect, and usually do not indicate any structural damage. To be considered a Category 1 or fine crack, the crack is found to be less than 2mm in width.

Generally the cause of a hairline crack in existing concrete paving such as driveways and pathways is indicative of the expansion and contraction of the concrete. Such causes are generally due to environmental factors, such as moisture levels, weather conditions, root systems of nearby trees or the soil types on which they are laid.

Fine cracks may also be due to poor original installation of the concrete. Factors such as poor compaction of the sub surface and/or inadequate reinforcing of the slab may create cracking and other secondary defects.

Monitoring of all cracking should be conducted frequently. Always contact a building inspector should cracks widen, lengthen, or become more numerous.

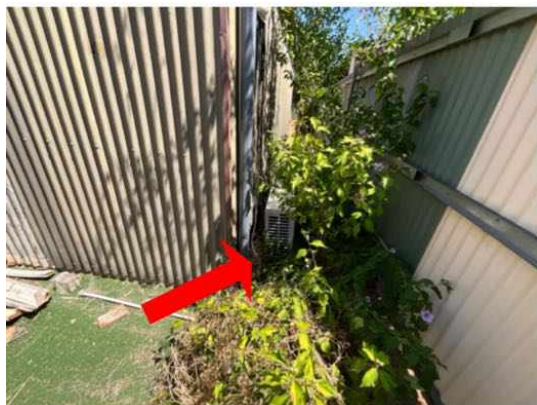
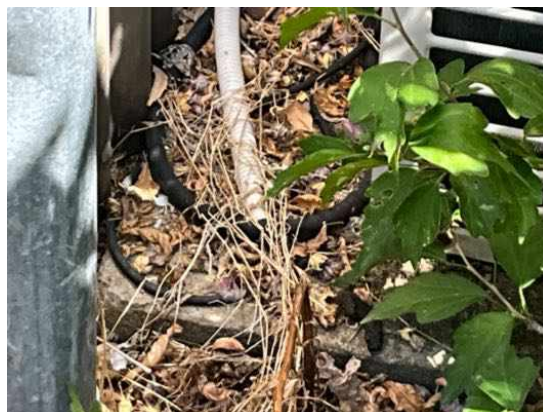
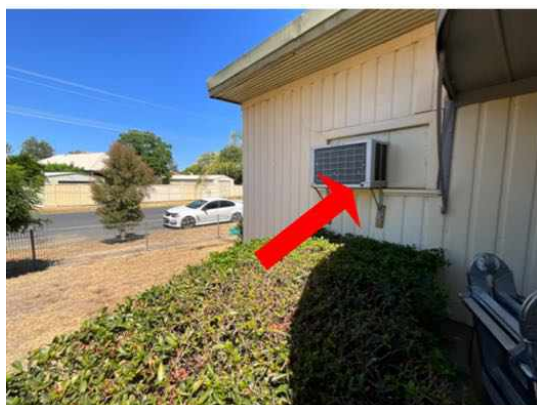
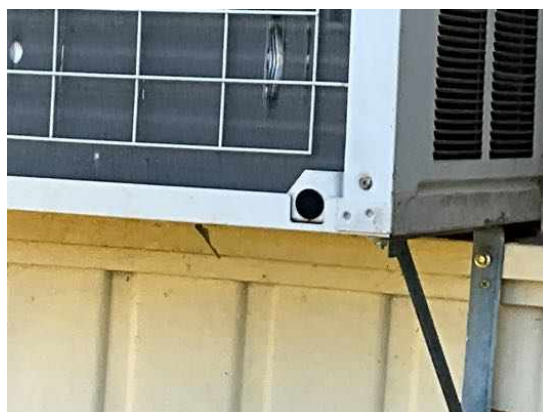
Finding 6.01

Building:	Building 1
Location:	Shed, living
Finding:	Air conditioner - Disconnected overflow
Information:	The Air Conditioner (A/C) overflow was found to be disconnected from storm water drainage and is creating excessive moisture in the surrounding area.

Such leaking creates an environment which is conducive to an array of defects, including water damage to associated building elements and the attraction of termite or timber pest infestation.

It is highly recommended that a licensed plumber be appointed to connect the A/C overflow in order to prevent such an environment from being created. These minor works should be carried out as soon as possible.

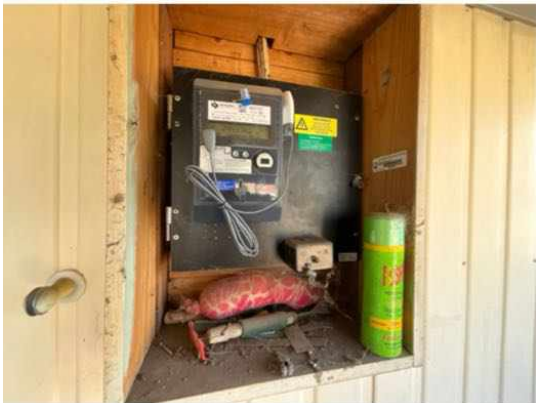
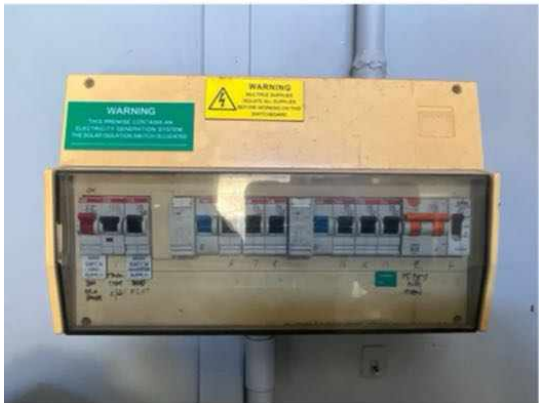
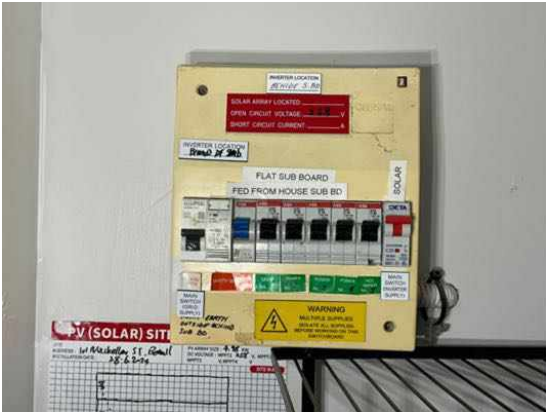
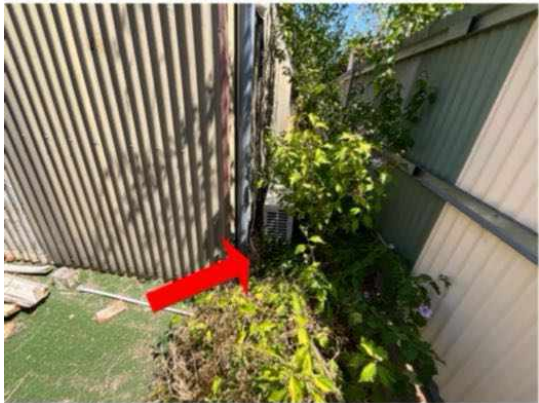
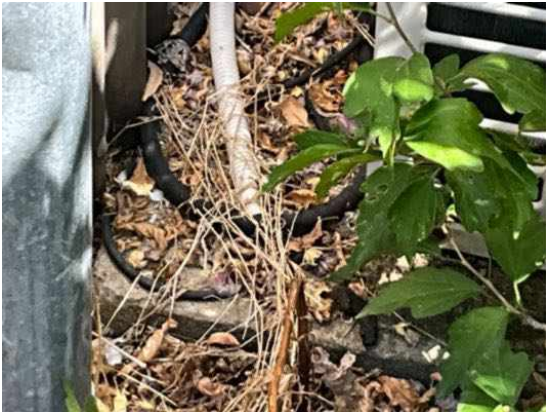
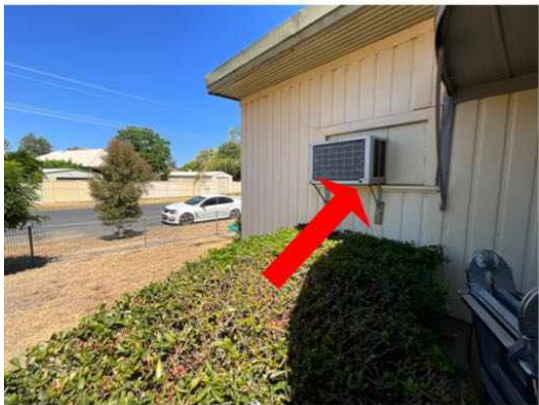
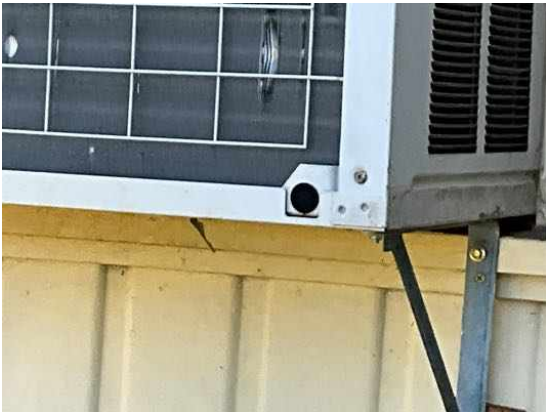
Finding 6.02

Building:	Building 1
Location:	All External Areas
Finding:	Termite Management System - no evidence of a chemical installation
Information:	The application of a post-construction chemical termite barrier is highly recommended for all properties, particularly if live termite activity has been found on the site previously. Such barriers are highly effective in preventing termite attack on any timber building elements throughout the property.

A durable notice should be placed in the switchboard unit to indicate current termite barriers. At the time of inspection, it appeared as though no termite management system has been installed, with no evidence to suggest preventative works taking place.

The client may consider gaining further advice from a pest controller as to the costs and procedures involved with this application. It is recommended that obtaining such advice be a short-term priority.

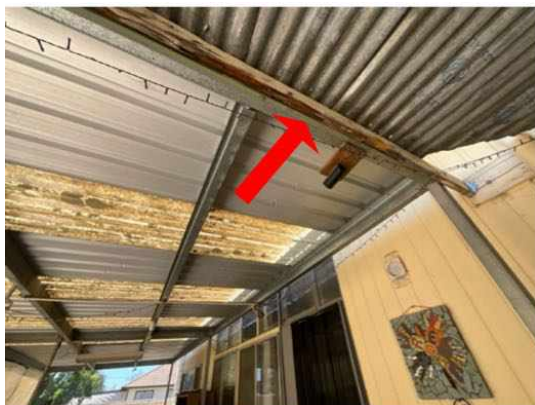
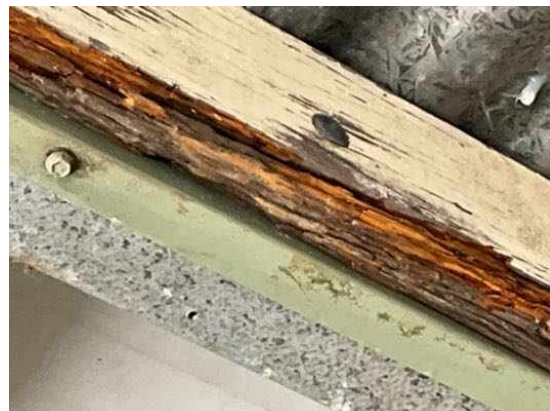
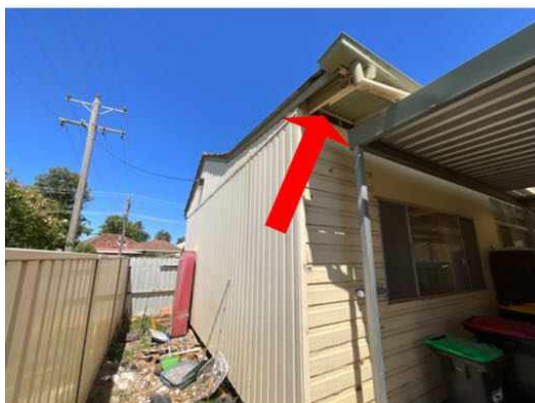
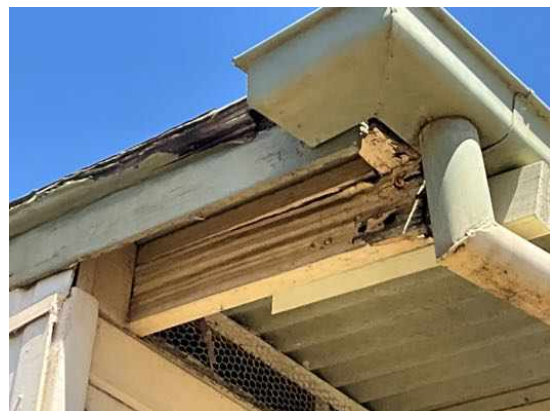
Finding 7.01

Building:	Building 1
Location:	Verandah, eaves
Finding:	Fungal decay - present (localised)
Information:	Fungal decay also known as wood decay or wood rot generally refers to the deterioration of timber elements when in contact with excessive levels of moisture for a prolonged period of time.

The development of fungal decay is accelerated by temperatures in the range of 5degreeC to 40degreeC as well as the presence of oxygen. Generally fungal decay develops on timber elements that are in use in an external environment which are exposed to rain penetration.

In this case although the affected timber element is in a decaying state the extent of any visible damage appears to be localised to a specific area and is yet to spread to other parts of the building element or affect adjoining structures. The fungal decay is therefore likely to be of a relatively superficial nature with minimal impact on the structural integrity or tensile strength of the timber element.

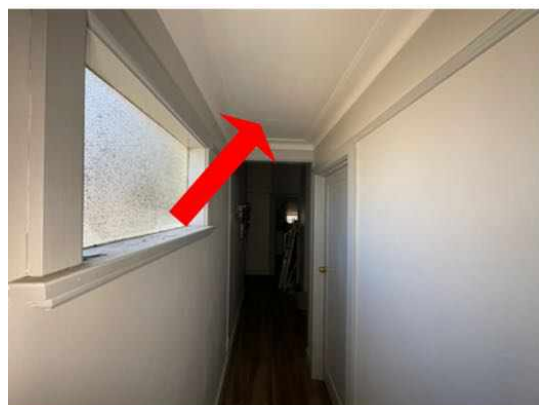
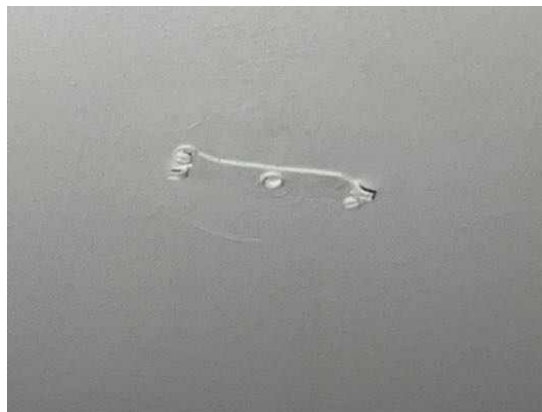
Building: Building 1
 Location: All Internal Areas
 Finding: Smoke Detectors and Alarms
 Information: Reporting on Smoke Detectors or Alarms, including hard wired smoke detection systems and their legislative requirements, is outside the Scope of this Report.

Please note that this defect is highlighted as a caution only. We suspect, based on our experience in the building industry, that the absence of smoke detectors, or their poor condition, should be addressed as a matter of urgency to improve occupant safety.

Further Inspection and/or advisory services is necessary to provide advice on the sufficiency, type and location of smoke detectors, and to test the functionality of all devices. Greater requirements for fire safety and detection exist for commercial buildings.

Always ensure sufficient working and suitable smoke detectors are installed prior to occupying any building. Additionally, it is advised that all smoke detectors be tested by the homeowner on a monthly basis.

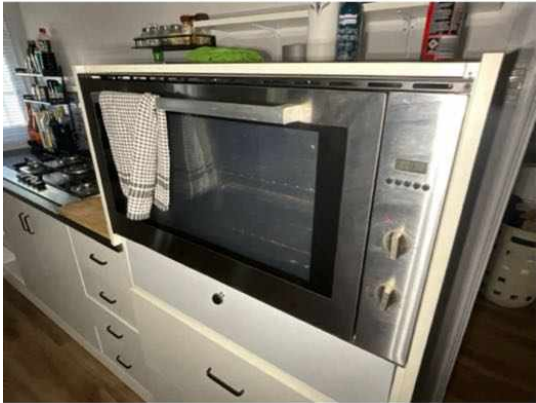
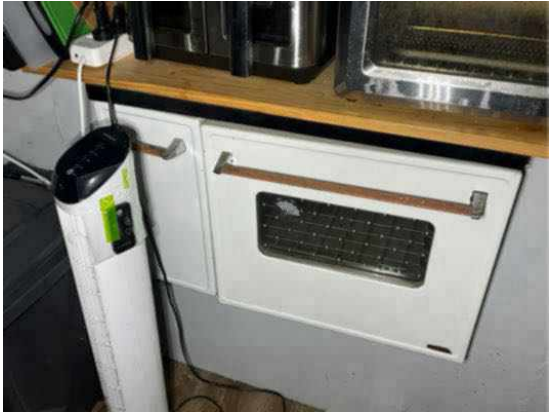
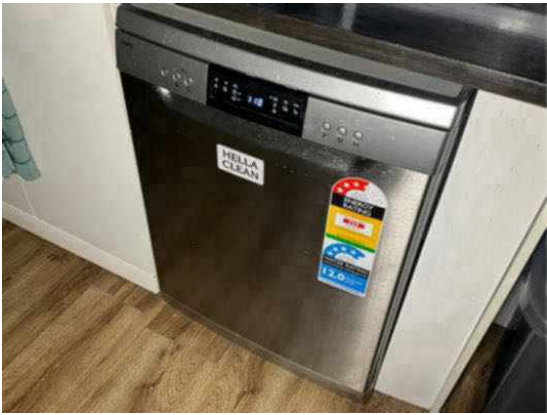
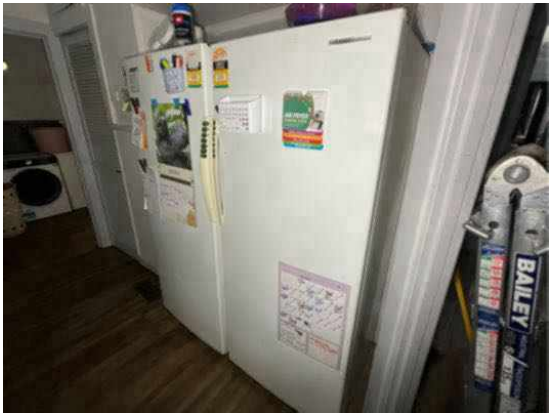
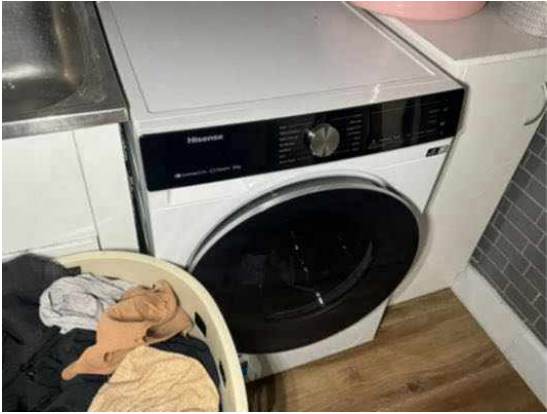
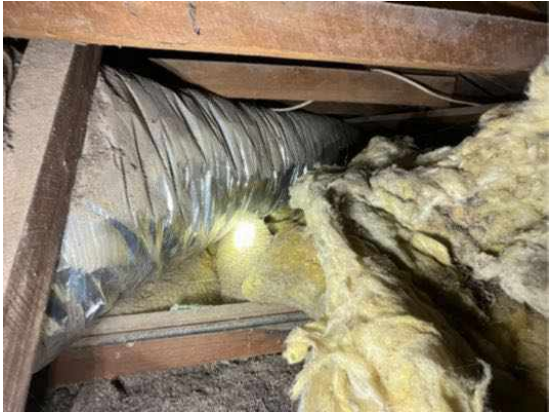
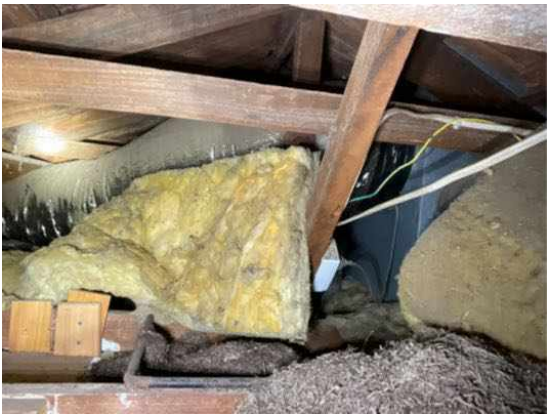
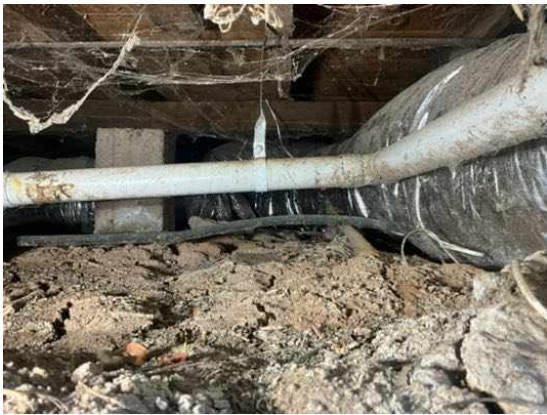
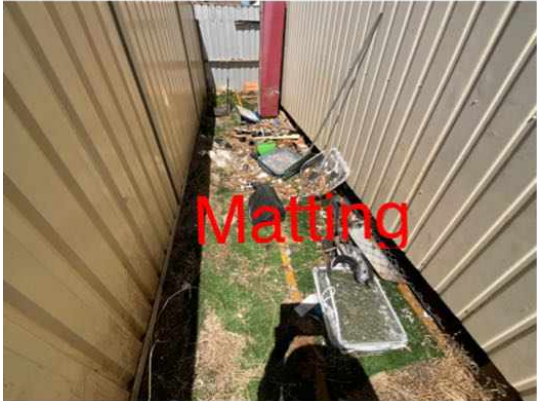
Building: Building 1
 Location: All Areas
 Finding: Additional Photos - Obstructions and Limitations
 Information: These photographs are an indication of the obstructions and limitations which impeded full inspection of the property at the time of inspection. These obstructions

can hide an array of defects and should be removed to allow full inspection to be carried out. A re-inspection is recommended once the areas are made accessible.
