Building Inspection Report VR

Inspection Date: Fri, 6 Mar 2026

Property Address: 47 Grafton St, Goulburn NSW 2580,
Australia

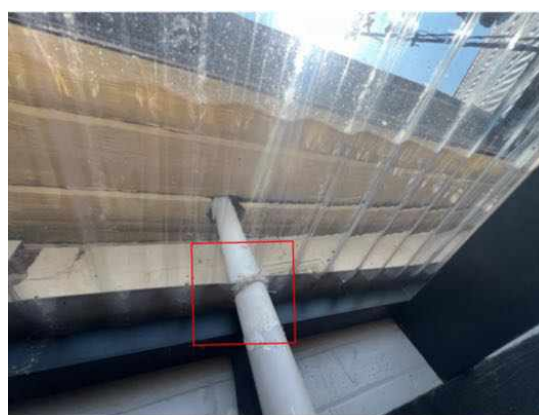
Defects 3.05

Building:	Main Building
Location:	Verandah, Pergola

Finding: Roof Penetrations - Substandard Installation
Information: Various service penetrations through the roof covering, including pipework and electrical conduits, were observed to be substandard in installation. Inadequate flashing, sealing, or general detailing was noted to these penetrations.

Poorly executed roof penetrations may compromise the weatherproofing of the roof system and increase the potential for water ingress around the affected areas. If left unmanaged, moisture may enter the roof space and contribute to deterioration of surrounding building elements.

It is recommended that a licensed roofing contractor be appointed to assess the penetrations and carry out necessary works to ensure the roof covering remains adequately sealed and protected against moisture ingress.

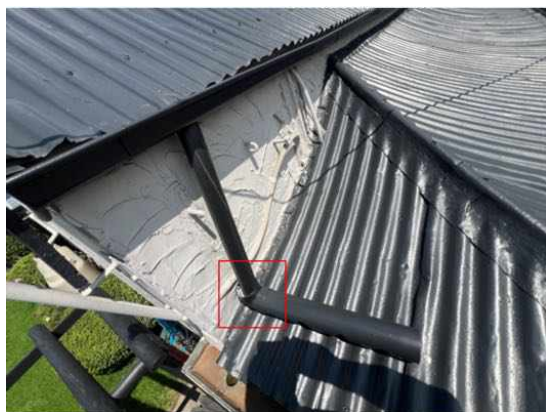
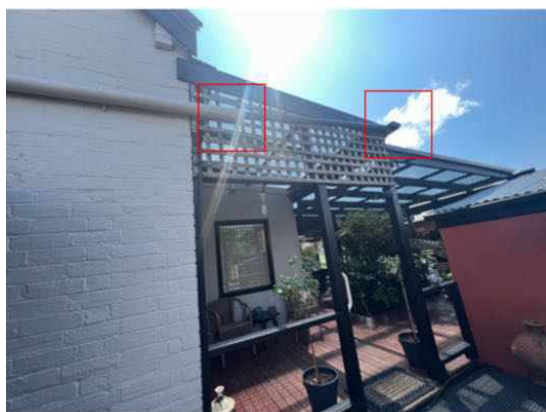
Defects 3.06

Building: Main Building
Location: Exterior walls - front, rear
Finding: Roof plumbing - Insufficient capacity
Information: It is suspected that the roof plumbing to the exterior roof is insufficient in capacity and is not adequately managing the volume of rainwater that it is required to drain. The result is generally that the plumbing overflows during periods of heavy rainfall, creating damp conditions against external surfaces and the base of the building perimeter.

If left unmanaged, the excess moisture in this areas may allow the formation and development of an environment that is conducive to rust, corrosion and rot, creating potential for secondary defects to all associated building elements. Damp conditions are also conducive to termite and pest activity, further exacerbating the risk of the environment.

Appointment of a roofing plumber is recommended to replace any inadequate drainage systems to ensure proper drainage to this area. In the interim, it is important to ensure that all roof plumbing is free of any debris or blockages.

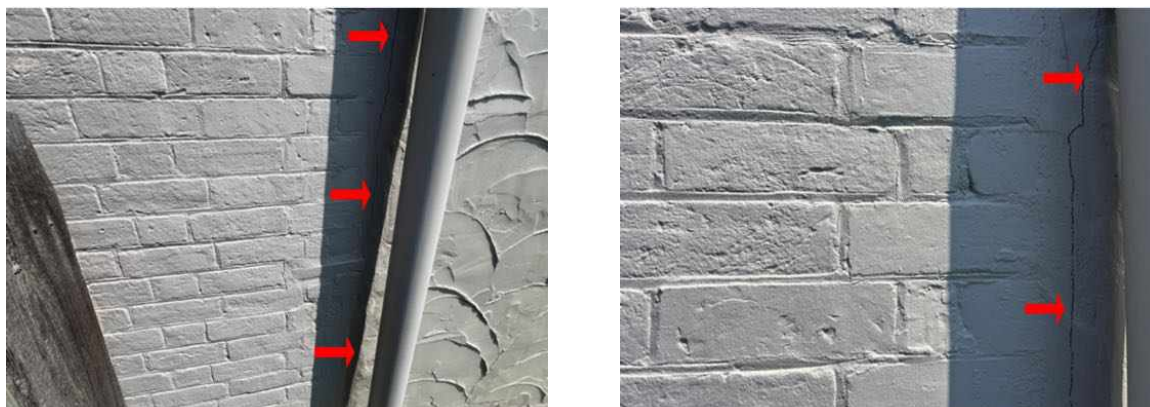
Defects 3.07

Building:	Main Building
Location:	Exterior walls - left side
Finding:	Render - Shrinkage Crack at Junction
Information:	A straight shrinkage crack was observed to the rendered wall surface along a junction line. This type of cracking commonly occurs where an expansion or control joint has not been provided within the render system, resulting in stress cracking as the material cures or undergoes minor building movement.

If left unmanaged, cracks within rendered surfaces may allow moisture penetration behind the render coating and may lead to further deterioration of the finish over time.

A rendering contractor should be appointed to assess the affected area and undertake repairs as required, including the installation of an appropriate control or expansion joint to accommodate movement.

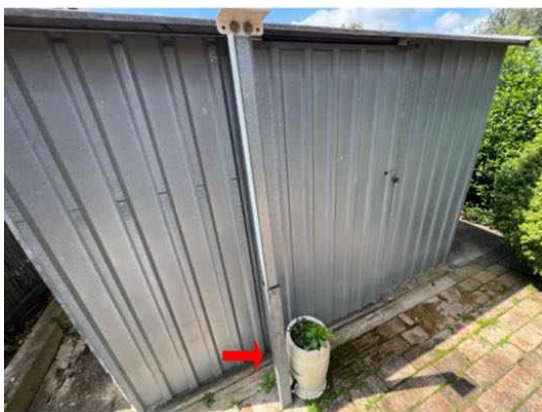
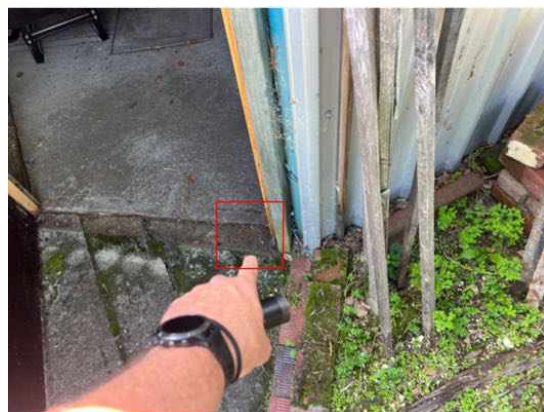
Defects 3.13

Building:	Out Building
Location:	Shed, Shed 3
Finding:	Doors - Binding/Jamming
Information:	Binding and/or jamming of doors were evident during standard operation. This defect inhibits the functionality of affected doors as well as creating potential for secondary defects to associated building elements, such as damage to flooring.

A qualified carpenter or general handyperson should be appointed to perform minor rectification works at client discretion.

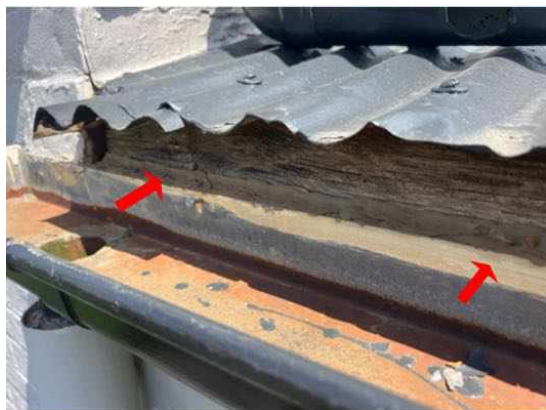
Defects 3.18

Building:	Main Building
Location:	Roof Exterior - Verandah
Finding:	Exterior roof - Inadequate repairs
Information:	It appears that interim roof repairs have previously been undertaken, which have included application of silicone to address roof leakage.

Further consultation with a roof restoration company is highly advised. Inadequate roofing repairs are not likely to prevent roof leakage in the long-term future.

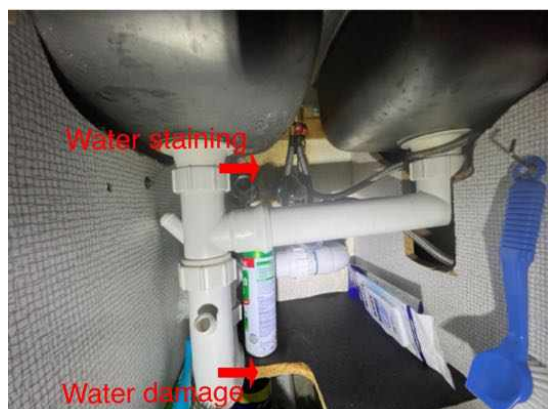
Defects 3.32

Building: Main Building
 Location: Kitchen
 Finding: Shelving - water damage
 Information: Water damage was observed to the shelving within the sink cabinet. This type of defect is typically caused by prolonged moisture exposure from minor plumbing leaks, condensation, or poor sealing around fixtures and fittings.

It is recommended that a licensed plumber be engaged to inspect the sink plumbing for leaks or seepage. A cabinetmaker or qualified joiner may also be required to replace the affected shelving or restore the unit where practical.

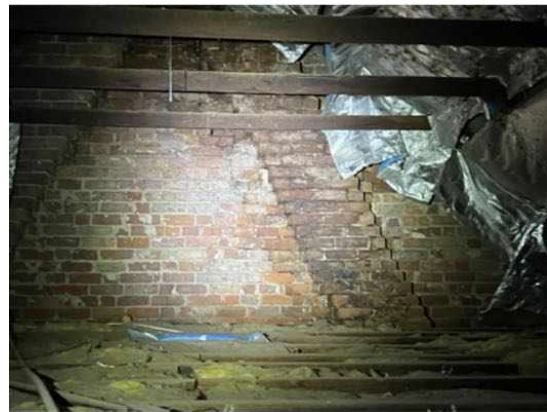
Noted Item

Building: Main Building
 Location: Roof Void

While the staining appears historic in nature, the area should be monitored for any future signs of moisture ingress. If staining progresses or moisture becomes evident, further assessment by a licensed roofing contractor may be required to identify the source.
