Building and Timber Pest Inspection Report

Inspection Date: Wed, 4 Feb 2026

Property Address: 21A Stafford St, Minto NSW 2566, Australia

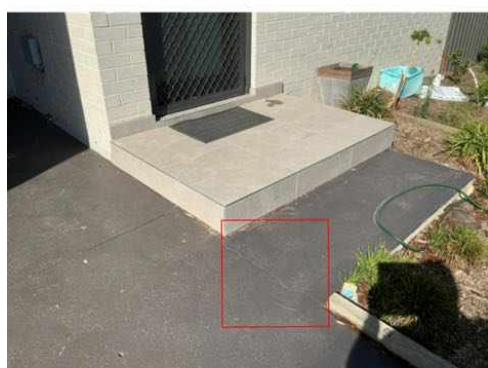
Building: Main Building
 Location: Front entrance
 Finding: Crack in concrete slab - Category 1
 Information: A crack coded as Category 1 was identified in the slab. A Category 1 crack is described as a fine but noticeable crack, with the slab at an otherwise reasonable level.

To be considered Category 1, the approximate width of the crack is less than 1.0mm, or a less than 10mm change in offset when a 3m straight edge is placed over the defect.

Category 1 cracks should be monitored for a period of 12 months. At the end of the monitoring period, identified cracks that are rated greater than Category 2 are considered defects, and require rectification.

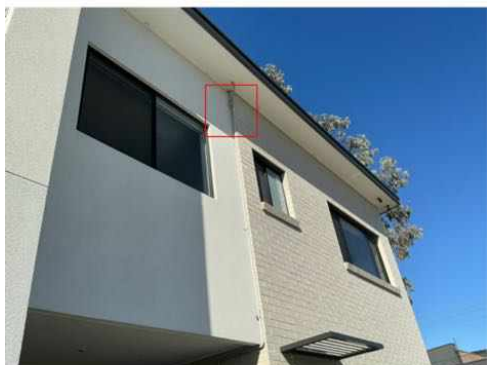
Building: Main Building
 Location: Above front entrance
 Finding: Building element - Broken or Damaged, wall bracket displaced.
 Information: Breakage occurs generally when the building materials have either aged and decayed, or as a result of damage (accidental or deliberate).

Repair and/or replacement of broken elements is advised to ensure that additional secondary defects do not arise as a consequence. Such works are necessary, as all building elements play a key role in the operation and function of the overall structure and its performance.

A relevant tradesperson should be appointed to repair or replace the affected building element prior to any subsequent damage being caused.

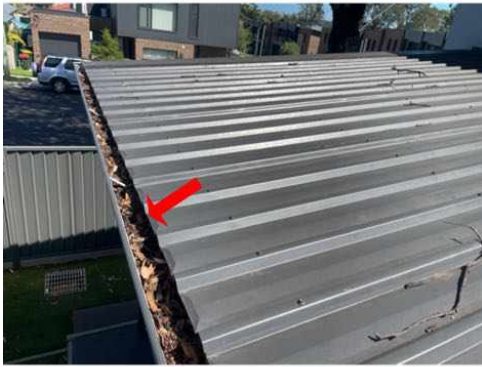
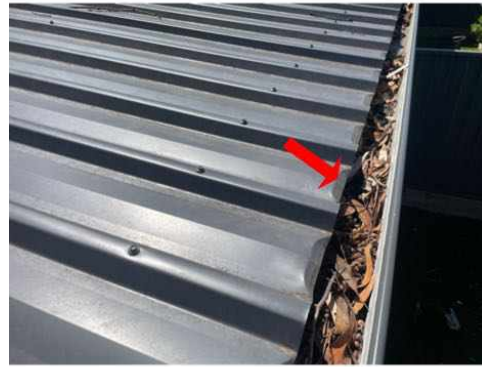
Finding 3.04

Building:	Main Building
Location:	Roof Exterior- lower back roof
Finding:	Gutters - Blocked
Information:	Roof plumbing structures, such as guttering and downpipes, should be free of all debris to prevent blockages. Blockages of the guttering and downpipes will lead to pooling and accumulated water overflows, which is likely to subsequently flood eaves and exterior walls.

Blocked gutters are likely to lead to high levels of moisture in the affected areas. Such moisture will not only cause rust and decay of the associated building materials, but can also provide conditions that are conducive to termite and timber pest activity. Blockages in gutters should therefore be removed immediately to ensure dry conditions are maintained.

Consult a Licensed Plumber for further specific advice on remedial works that may be required. In the interim, it is highly advised that blocked gutters be removed by the homeowner or a general handyperson as a matter of urgency.

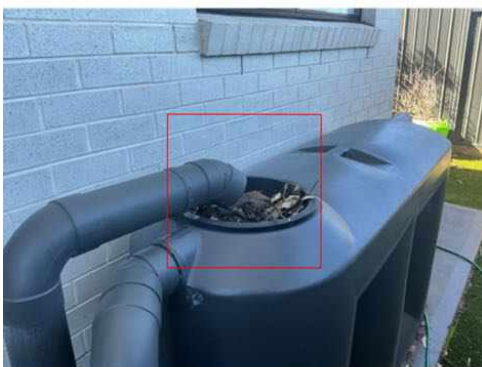
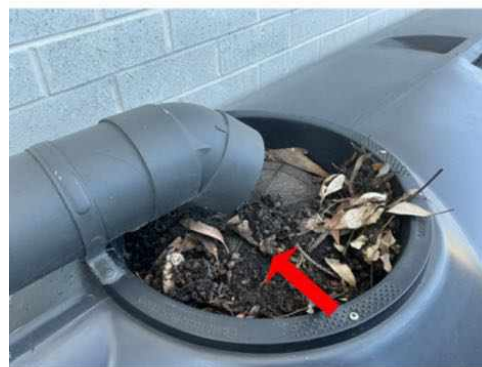
Finding 3.05

Building:	Main Building
Location:	Back yard and side passage.
Finding:	Drains and Water tank takeup - leaves and twigs built up
Information:	Blockages prevent building elements from operating as intended, detracting from the overall function of the affected building elements. Additionally, the lack of general maintenance may lead to the development of more significant defects, such as damage to surrounding building materials.

Blockages should be removed and addressed promptly, as they will lead to the development of secondary building defects. The blockage should be removed as the primary rectification works. Secondly, check for any secondary or concealed damage, and then attempt to address the cause of the blockage to prevent recurrence or any water damage to associated structures.

Depending on the location of the blockage and the building elements affected, a licensed plumber may be required to perform necessary remedial works.

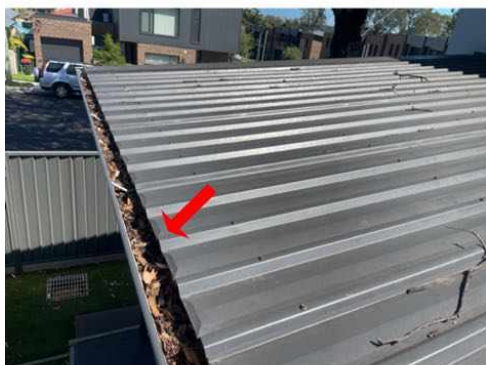
Blocked gutters are likely to lead to high levels of moisture in the affected areas. Such moisture will not only cause rust and decay of the associated building materials, but can also provide conditions that are conducive to termite and timber pest activity. Blockages in gutters should therefore be removed immediately to ensure dry conditions are maintained.

Consult a Licensed Plumber for further specific advice on remedial works that may be required. In the interim, it is highly advised that blocked gutters be removed by the homeowner or a general handyperson as a matter of urgency.

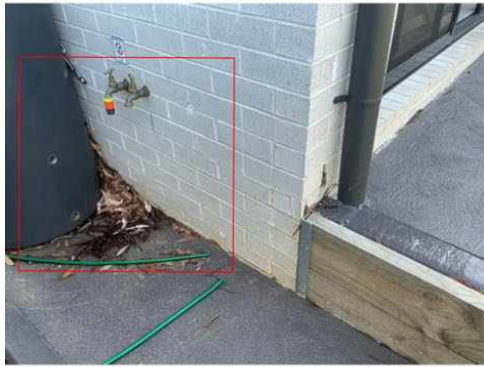
Finding 6.02

Building:	Main Building
Location:	All Areas
Finding:	Overflow - Not plumbed for drainage (Excessive Moisture)
Information:	The overflow is not plumbed or connected to suitable drainage, which has resulted in the surrounding area becoming excessively damp. These damp conditions can lead to secondary defects such as rot, rust or corrosion of associated building elements, the formation of fungal decay, or even the creation of potential slip hazards.

When coupled with poor site drainage, pooling of water may also attract termite activity to this area. It is highly recommended that a qualified plumber be appointed to install adequate drainage to the overflow. These works will ensure that the area remains dry and free of any secondary defects.

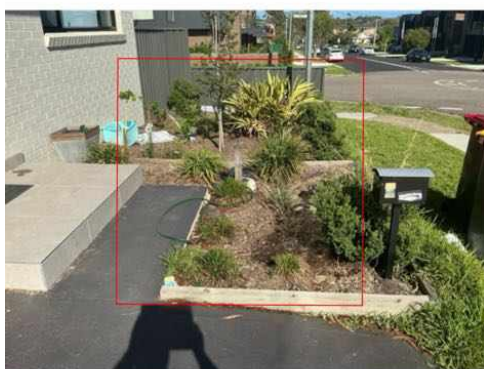
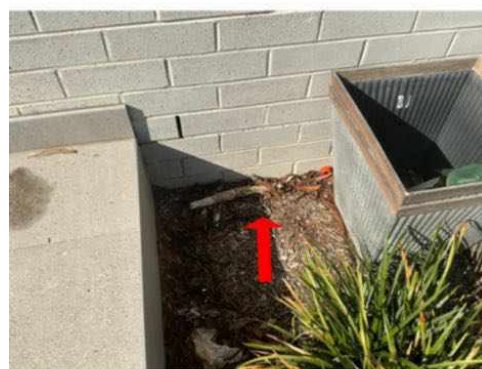
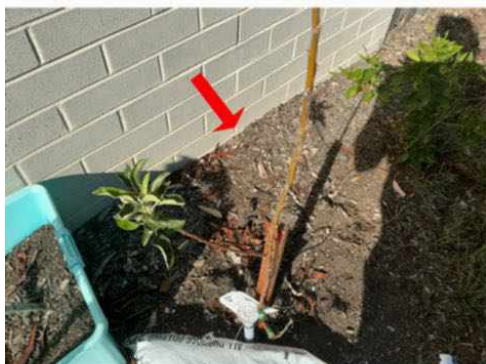
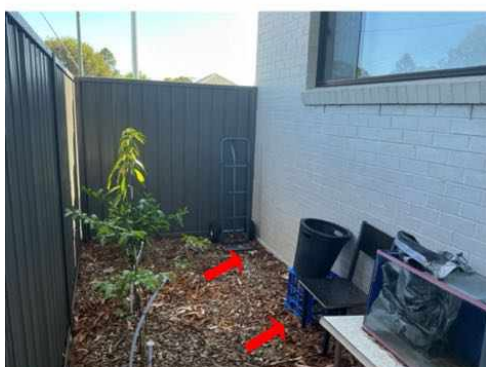
Finding 6.03

Building:	Main Building
Location:	Front garden, side passage
Finding:	Untreated or non-durable timbers in a hazardous environment (Timbers in ground contact)
Information:	To reduce the risk of timber pest attack it is essential that timber used in a hazardous environment (e.g. in direct contact with the ground or frequently exposed to damp conditions) is of sufficient durability and/or is adequately preservative treated.

Untreated timbers in direct contact with the ground are likely to develop severe wood rot and/or fungal decay if left unattended creating attraction for subterranean termites to infest the timbers from surrounding areas.

If untreated or non-durable timbers are found to be in a hazardous environment it is highly advised that replacement of these building elements be performed as soon as possible to aid the protection of the property against termite / timber pest attack.

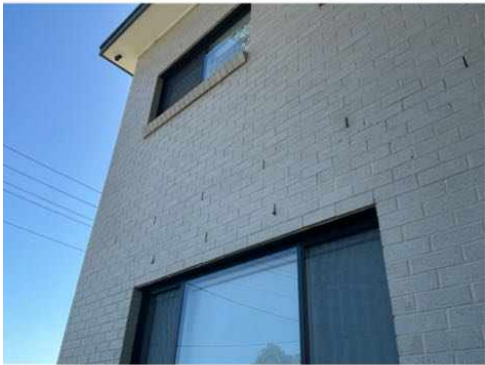
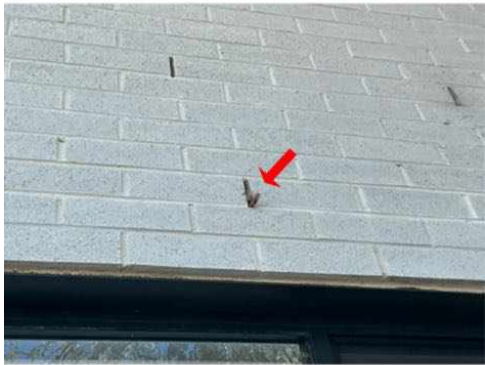
Finding 6.04

Building:	Main Building
Location:	Back yard and side passage walls
Finding:	Air vents - Blocked or inadequate
Information:	It was noted at the time of inspection that areas have blocked ventilation holes. Where air vents are blocked, either fully or partially, ventilation is decreased.

A well ventilated building is designed for maintaining dry conditions, preventing secondary damage such as wood rot and pest activity, as well as preventing the development of mould/fungi and mildew (which can lead to major respiratory issues or safety hazards for occupants, particularly the elderly, the very young and those with existing illnesses).

All air vents should be cleared of blockages to promote adequate air flow to the area. The owner or a handyman should be commissioned see to these vents being free from debris.

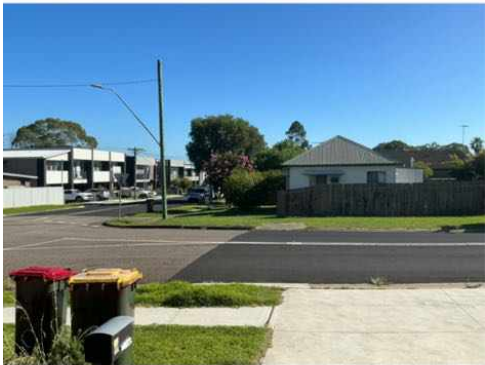
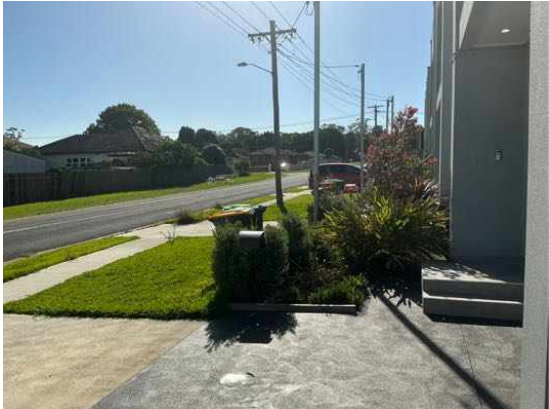
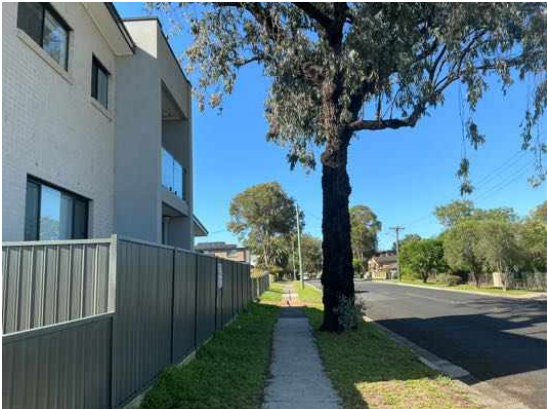
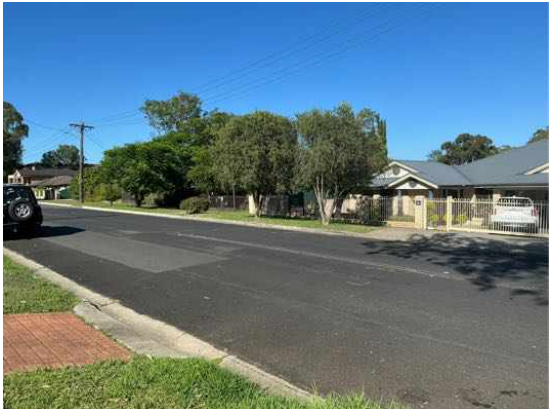
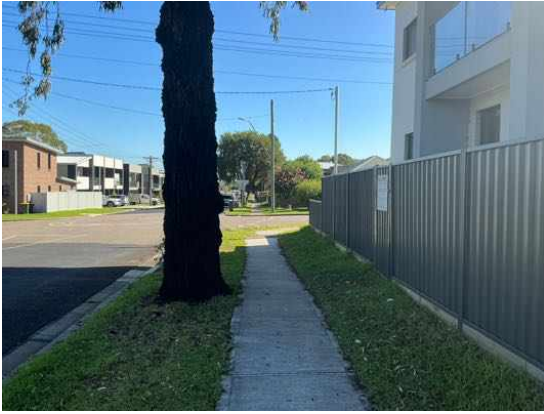
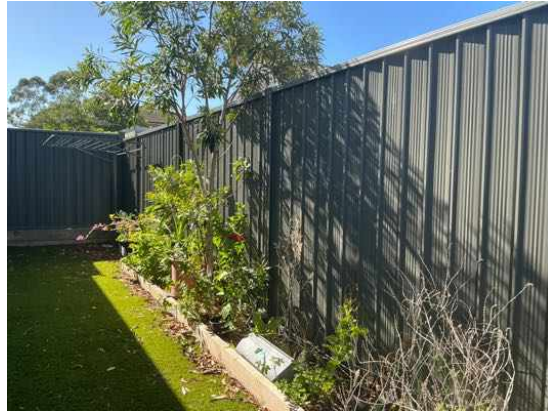
Finding 6.05

Building: Main Building
 Location: All Areas
 Finding: Trees to be inspected within the property.
 Information: Trees can be conducive to termite activity and nesting. Trees over 100mm on the property, should be drilled and tested for termite activity.
 Regular inspections every 6-12 months- or advised by the termite management system installer.
