Building Inspection Report

Inspection Date: Mon, 19 Jan 2026

Property Address: 398 Liverpool Rd, Strathfield South NSW
2136, Australia

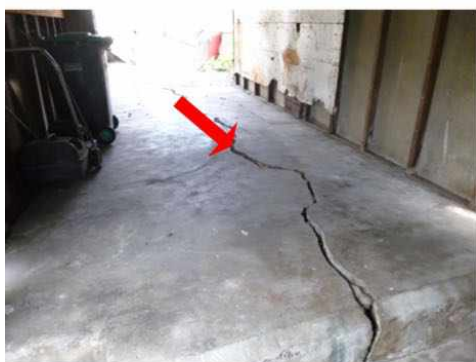
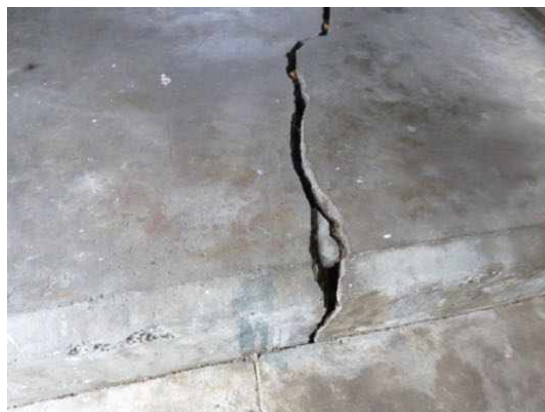
Defects 3.01

Building:	Main Building
Location:	Garage
Finding:	Cracking - External Concrete Paving Damage Category 4 - Gaps in Slab (4mm - 10mm +)
Information:	Gaps in the slab were identified in external concrete paving. Gaps in the slab are significant and are likely to lead to the development of safety hazards and secondary defects if left unmanaged, such as the creation of a trip hazard.

General age and expected deterioration of the paved areas is a common cause of this type of cracking. However, expansion and contraction of the slab may also have occurred due to environmental factors. Such factors include variable moisture and weather conditions, the presence of trees and their roots having a settling or lifting affect on the soil, or the effect of load bearing, e.g. heavy vehicles over a sustained

Cracking to this degree may also be due to poor original installation of the concrete. Factors such as poor compaction of the sub surface and/or inadequate reinforcing of the slab may create cracking and other secondary defects. Gaps in the concrete paving may also have a more significant structural cause, such as subsidence of soils.

Where gaps in the concrete paving are adjacent to structural elements of the building, the advice of a Structural Engineer is advisable before undertaking repairs. Significant repair and likely replacement of the concrete paving is probable.

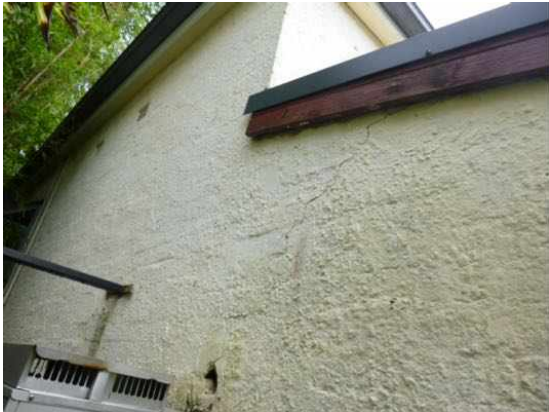
Defects 3.02

Building:	Main Building
Location:	Exterior walls
Finding:	Brickwork - Cracking noticeable
Information:	There were several cracks and or crack repairs evident to external brickwork.

Noticeable cracks are a common occurrence in external brickwork and are a likely result of age expected building movement, general expansion, and/or contraction of building materials in different weather conditions. Noticeable cracks in brickwork may develop if left unattended, with potential for necessitating major remedial works or replacement of the brickwork. Step cracking was identified to the brickwork in this area at the time of inspection. Step cracking, which is similar to other forms of cracking, has a variety of possible causes. However, the most common is the subsidence of adjacent footings.

Step cracking is a relatively common defect, and is most likely to occur adjacent to windows, doors and other openings. Mortar failure in the gaps between affected bricks indicates the stresses and tensions affecting the wall.

It is highly advised that a qualified bricklayer be appointed to provide necessary works to cracked brickwork to prevent any further damage. Such works should be conducted as soon as possible.

Always monitor these cracks and contact a building inspector should cracks widen, lengthen, or become more numerous.

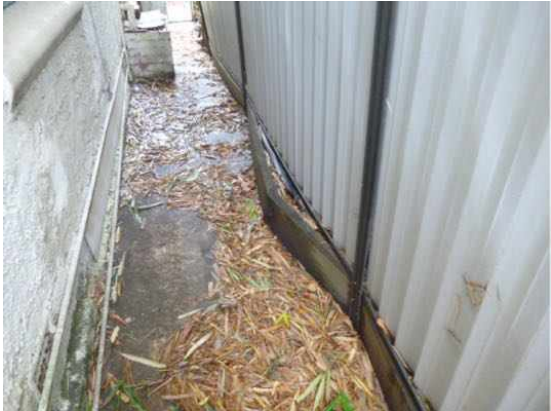
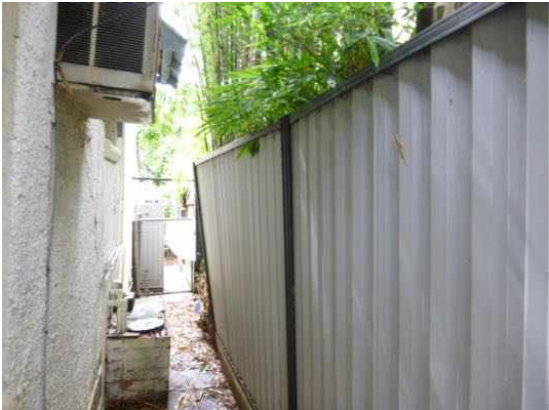
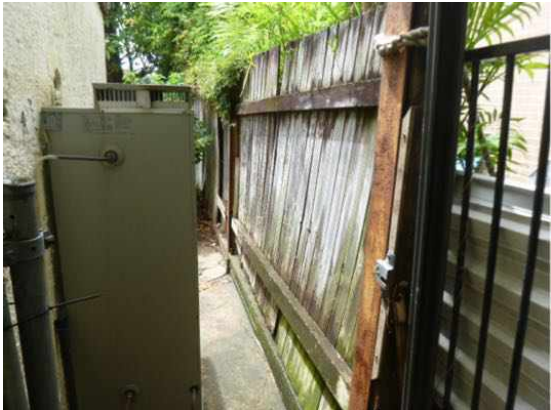
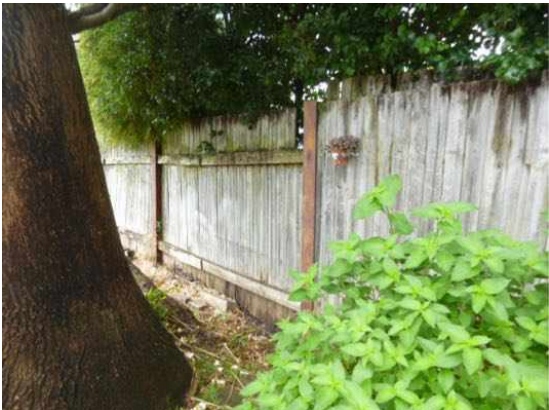
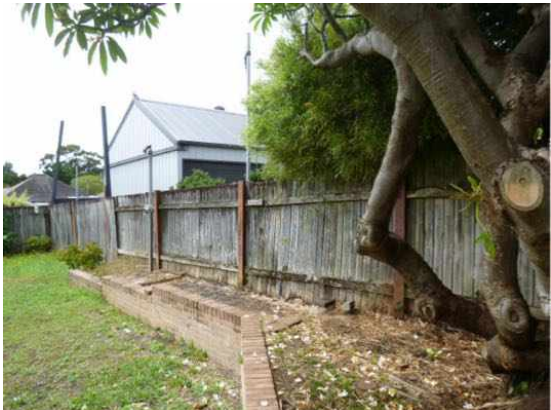
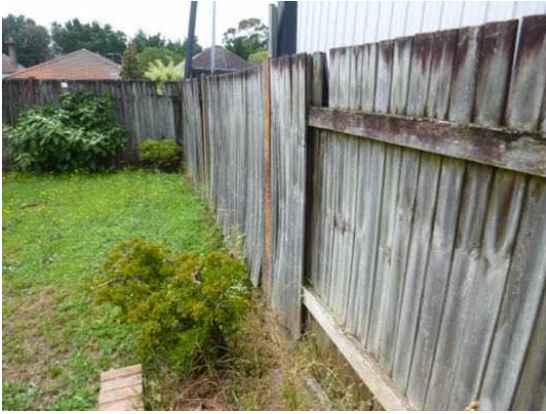
Defects 3.03

Building: Main Building
 Location: Fencing
 Finding: Fencing - Deteriorated
 Information:

It was noted at the time of inspection that sections of the fencing throughout the property have deteriorated. Typically fencing deteriorates due to age and or wear, rot and or rust which is generally expected for a structure of this age, due to prolonged exposure to weather conditions. Sometimes inadequate installation or maintenance can be to blame.

If left unattended, it is likely that further damage will occur. It is suspected that repair of several elements of the fencing may be required however replacement may be a

consideration of the client also.

A licensed fencing contractor should be appointed to provide further advice and perform rectification works as necessary.

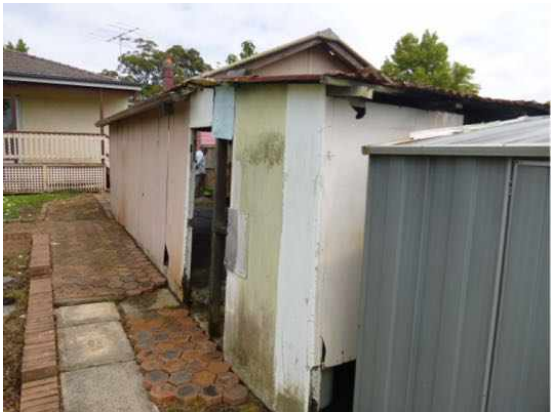
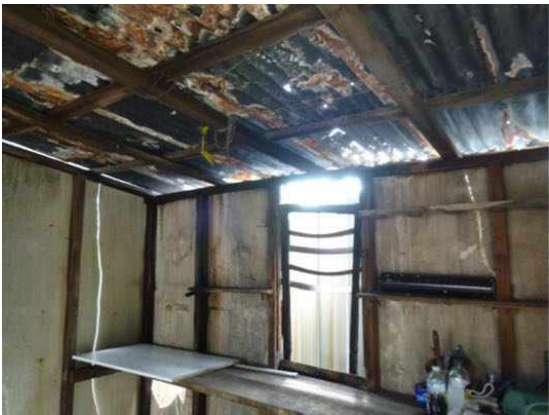
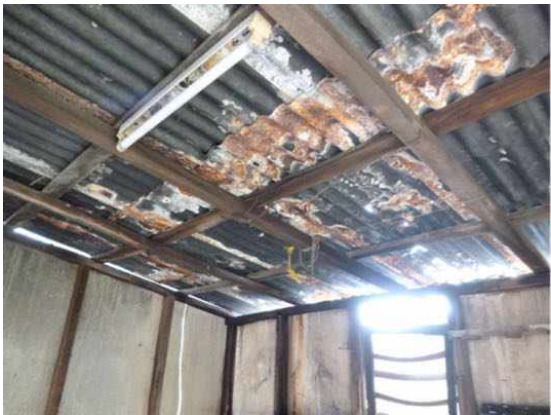
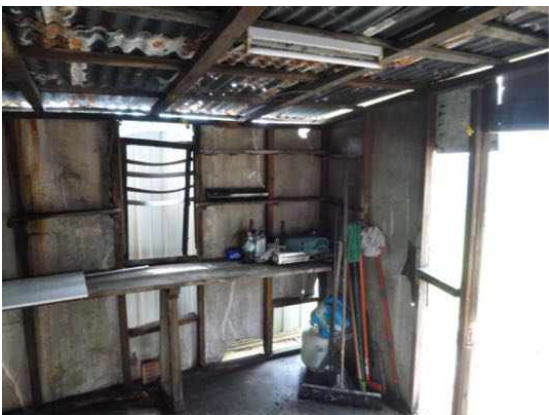
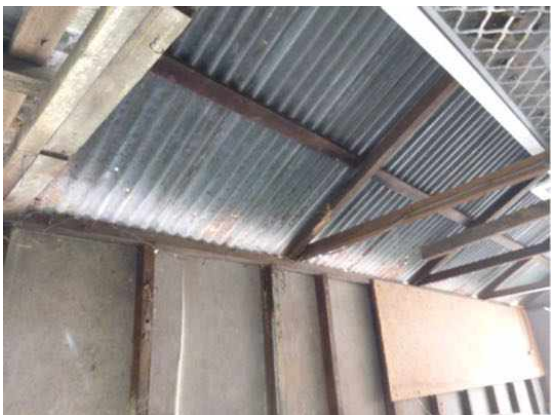
Defects 3.04

Finding: Roof sheets - Deteriorated

Information: Upon inspection of the exterior roofing, it was found that the roof sheets show signs of deterioration, with some sheets having come loose from their original fixing. The roofing has sustained an array of issues due to the age of the materials and a lack of general maintenance over time, including loose sheeting, lifting and sagging of sheets, and deterioration of associated building elements.

Loose, deteriorated and damaged roof sheets are susceptible to water penetration, exposing the surrounding associated area to internal roof leaks and water damage.

Re-fixing of all loose roof sheets should be conducted as soon as possible to ensure that no further damage occurs. Depending on the extent of the damage, replacement of sections of roof sheets or associated materials may be required. Engagement of a roofing restoration contractor is highly advised to perform remedial works as necessary.

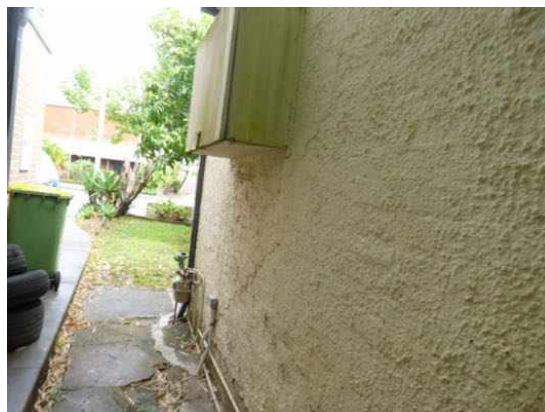
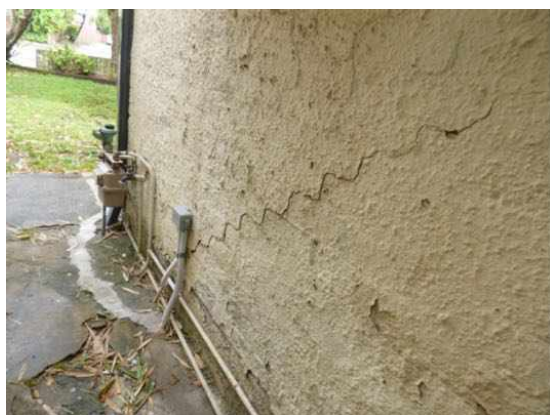
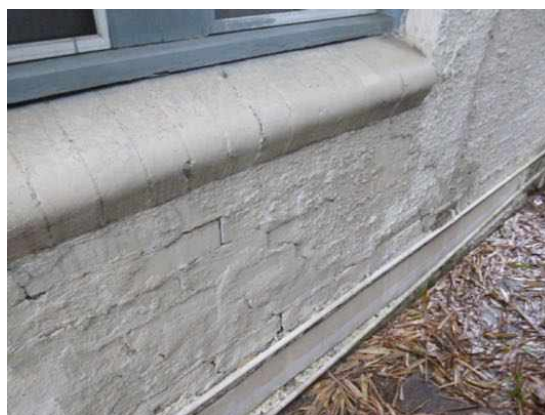
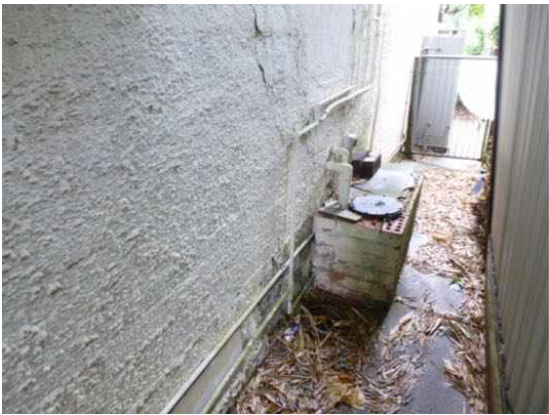
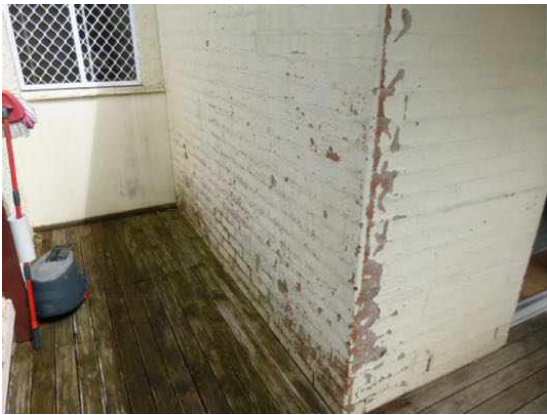
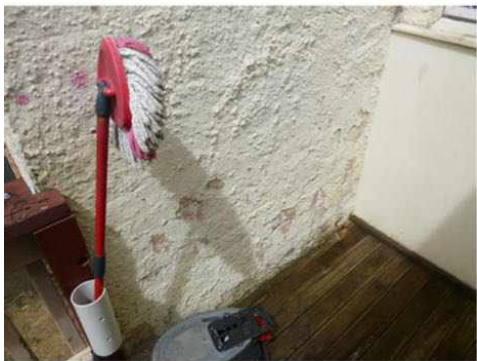
Defects 3.05

Building: Main Building
Location: Exterior walls

Information: Lateral penetrating damp refers to the sideways movement of moisture, predominantly from the surrounding ground, which tends to affect basement walls and other earth-retaining walls. The implications of unmanaged damp range from mould fungi growth, wood rot and decaying building materials, to finishes including lifting, bubbling, peeling and staining of paint, plaster and wallpaper.

Immediate consultation with a licensed plumber is advised to address the cause of the damp and to perform remedial works as necessary.

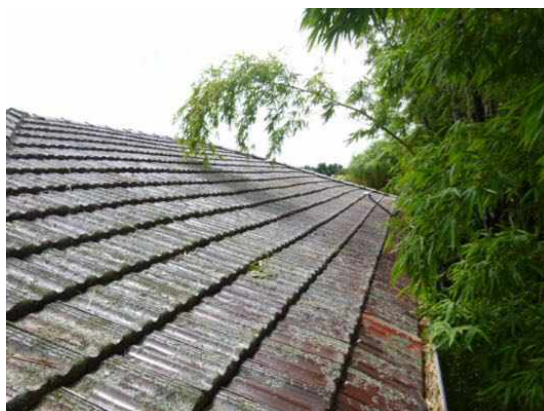
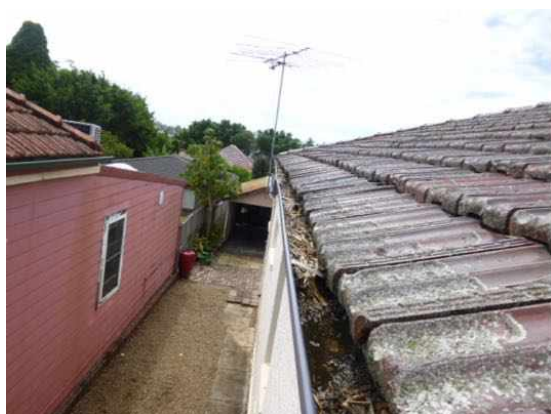
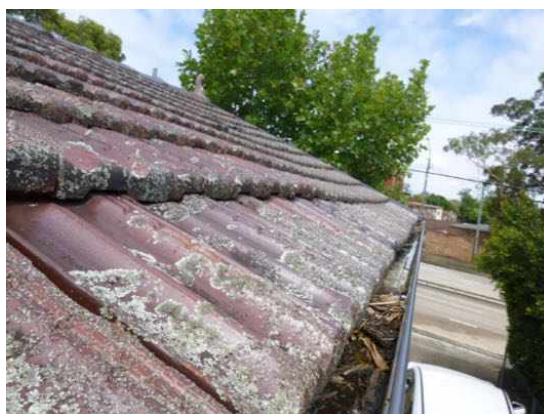
Defects 3.07

Blocked gutters are likely to lead to high levels of moisture in the affected areas. Such moisture will not only cause rust and decay of the associated building materials, but can also provide conditions that are conducive to termite and timber pest activity. Blockages in gutters should therefore be removed immediately to ensure dry conditions are maintained.

Consult a Licensed Plumber for further specific advice on remedial works that may be required. In the interim, it is highly advised that blocked gutters be removed by the homeowner or a general handyperson as a matter of urgency.

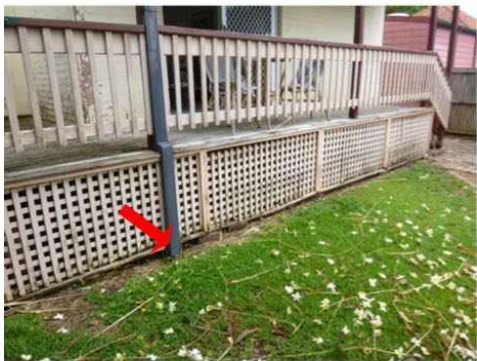
Defects 3.09

Where roof plumbing doesn't drain adequately, the area at the base perimeter can become excessively damp, potentially creating an environment that is susceptible to rust and corrosion of surrounding building elements, as well as attracting termites and other pests.

It is highly recommended that a plumber be appointed to further inspect the area and to install adequate drainage equipment where necessary.

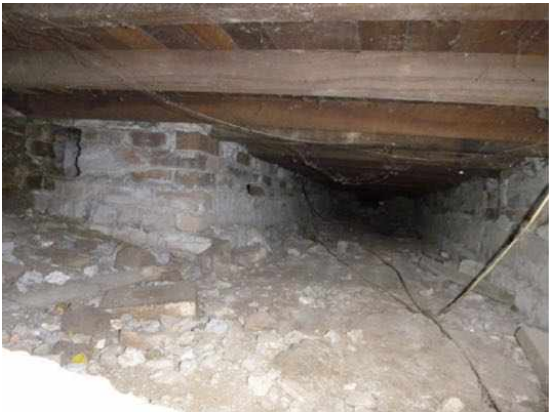
Defects 3.12

Building:	Main Building
Location:	Hallway Bed rooms
Finding:	Floors - bouncy & uneven
Information:	The internal flooring in this area was identified as being bouncy and uneven at the time of inspection. A bouncy floor surface generally presents as a discernible change in level as they are walked across, in noisy or creaking flooring, or in consequent movement of surrounding furniture and fixtures. Uneven flooring is likely to indicate minor defects such as expected movement of the foundations of the property, but may also indicate subsidence of the associated subfloor stumps.

Bouncy floors generally indicate that the floorboards or the subfloor structures are coming loose from the joists that they are installed on. Bouncy flooring may also be the result of gaps between flooring and stumps or joist structures, which require packing.

It is advised that the flooring be closely monitored to identify any further movement. Where flooring remains relatively unchanged for an extended period of time (i.e. several months), it is likely that this defect has been caused by expected movement of the foundations of the property.

However, where flooring is uneven further, potentially invasive inspection of the subfloor structures and stumps in this area is required. In this case, works to repair are likely to be required, and would be carried out by a registered builder specialising in re-stumping.

The client is advised to seek quotations for required repairs from a Registered Builder specialising in re-stumping. The potential resolution may range from packing gaps in subfloor structures through to replacement of subfloors stumps and refixing of flooring.

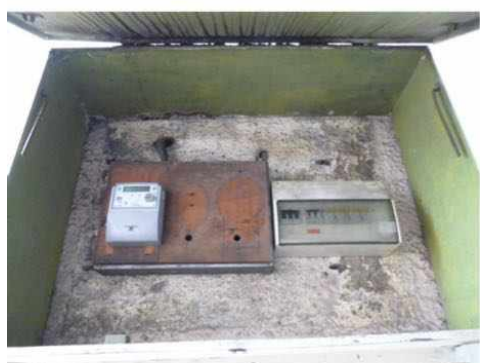
Building: Main Building
 Location: Meter Box
 Finding: Termite Management System - No evidence of installation
 Information: There are a number of factors which indicate the presence of a previously installed or applied termite barrier. The most common are a durable notice (to the inside of your meter box) observable physical barriers installed to building perimeter and in ground reticulation systems. The application of a post-construction chemical termite barrier is highly recommended for all properties, particularly if live termite activity has been found on the site previously. Such barriers are highly effective in preventing termite attack on any timber building elements throughout the property.

A durable notice should be placed in the switchboard unit to indicate current termite barriers. At the time of inspection, it appeared as though no termite management system has been installed, with no evidence to suggest preventative works taking place. Where a Termite Management System has been identified you should refer to the type of barrier date of installation warranty conditions and any documentation provided by a builder or past owner. Consult the company who installed the barrier to confirm whether the system is still under warranty. Most chemical termite management systems expire and require replenishment and all physical systems are primarily designed to prevent concealed entry.

The client may consider gaining further advice from a pest controller as to the costs and procedures involved with this application. It is recommended that obtaining such advice be a short-term priority.

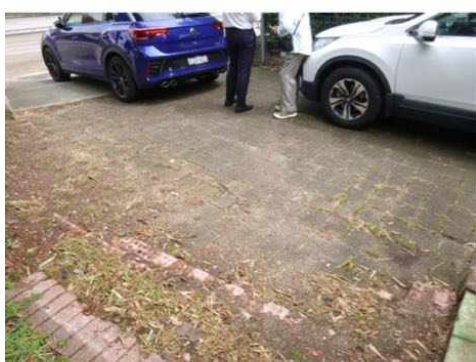
Building:	Main Building
Location:	Yard - Front
Finding:	Paving - Uneven
Information:	Sections of the external paved area are uneven, creating a potential trip hazard. It appears as though the area has been subject to rough installation, or that paving sections have lifted due to movements in the foundation of the property.

Where paving creates a trip hazard, personal injury may ensue if due caution is not taken by all persons within this area.

Re-paving of the area is required as soon as possible to remedy this situation. Further consultation with a specialist concreter is advised.

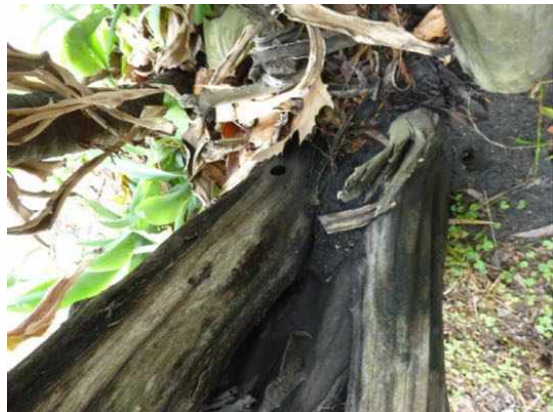
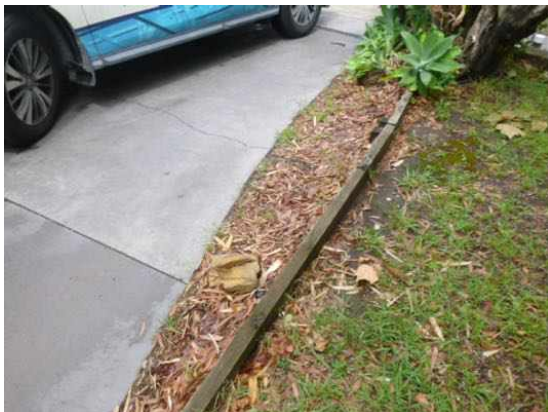
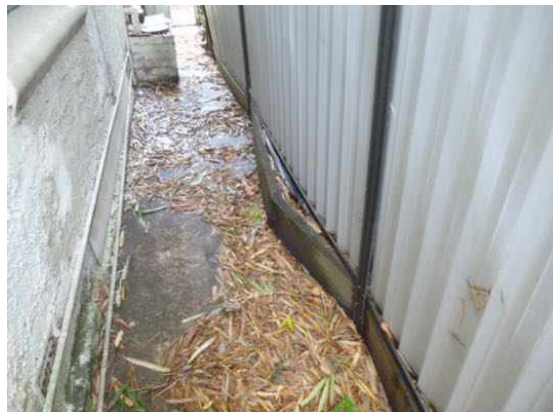
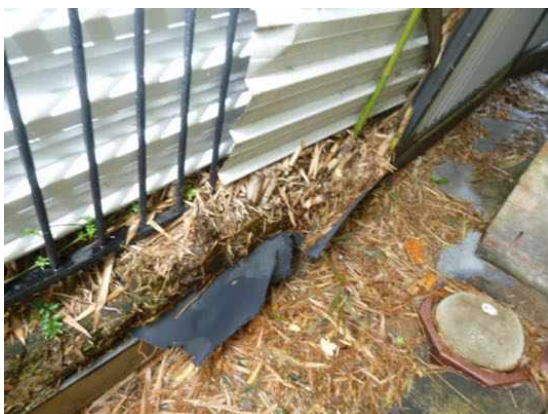
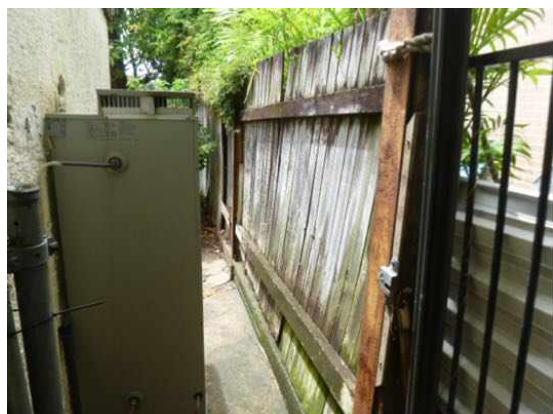
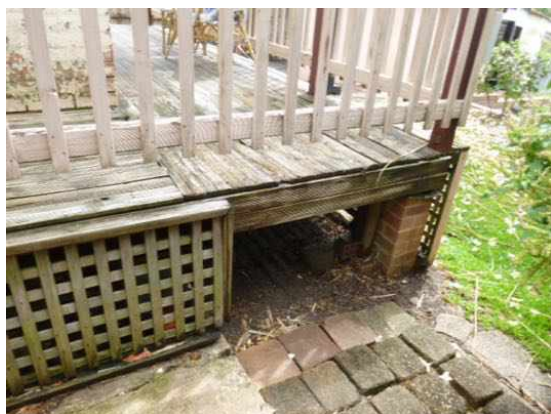
Building:	Main Building
Location:	All Areas
Finding:	Landscaping & stored timbre
Information:	Any timbers in direct ground contact provide opportunity for concealed termite entry and are likely to be subject to premature rot and decay as the soil retains moisture or damp conditions against the timbers. Remove untreated timber that is in direct contact with external grounds. If there is old tree stumps present frequent pest inspections are advised to readily identify any termite activity in these areas.

The storing of timbers in the subfloor space or around the external property increases the risk of termite activity being present. As they are likely to come into contact with weather conditions or excessive moisture wood rot is likely to develop on timbers that are not treated. It is highly recommended that any stored timbers be immediately removed from areas in which they may attract any termite / timber pest attack. Minimisation of risk / prevention of termite attack is far more adequate than dealing with the presence of termite activity.

Monitor treated landscape timbers within the garden area, as treated pine breaks down and rots over a period of time causing conducive conditions for termite activity.

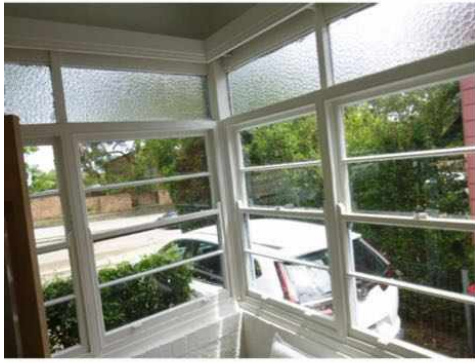
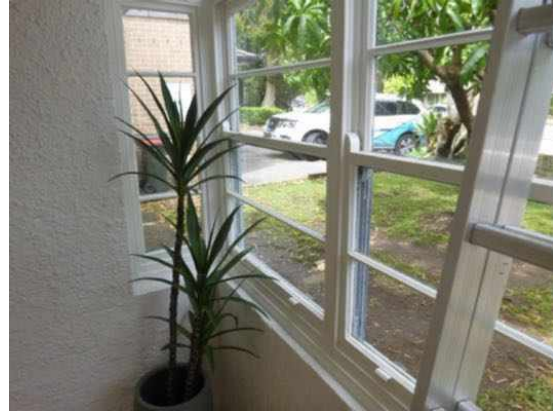
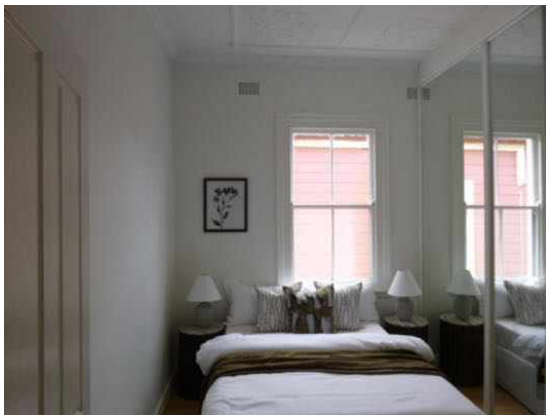
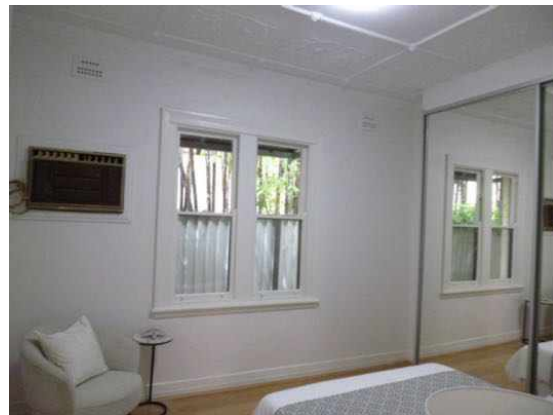
Building: Main Building
 Location: Bedroom windows
 Finding: Windows - Sash painted shut & Sash cords missing
 Information: Where window sashes have been painted shut, it is generally indicative of poor, rushed workmanship. Sashes are the moveable panes of windows that primarily slide vertically over each other to expose one half of the window area. Each sash is provided with springs balances and/or compression weather-stripping, which act to hold the window in place in one position.

To facilitate this operation the weight of the glazed panel is usually balanced by steel weights or counterbalances. The sash weight is connected by a cord or chain that runs over a pulley at the top of the frame. These cords are prone to degradation over time and replacement is required.

Where windows have been painted shut the seal of the paint needs to be broken. This is generally done by breaking the seal of the paint and then maintaining the sash tracks clearing and lubricating them with silicone. Remedial paint work will likely be required and can be completed along with the rest of the remedial works necessary by a general handyman. Repairing or replacing sash cords involves some work and is often best completed by an experienced carpenter or specialist window restorer. It is advised that such works be completed to improve the operational state of the affected window.

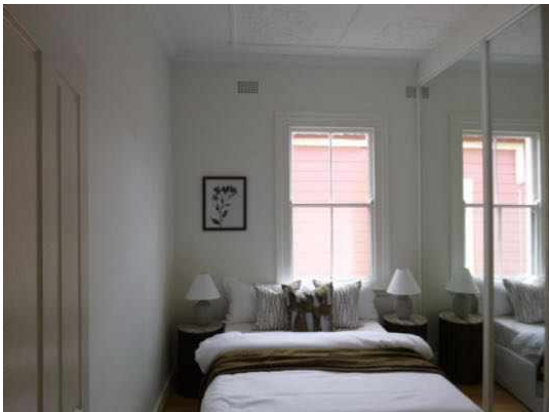
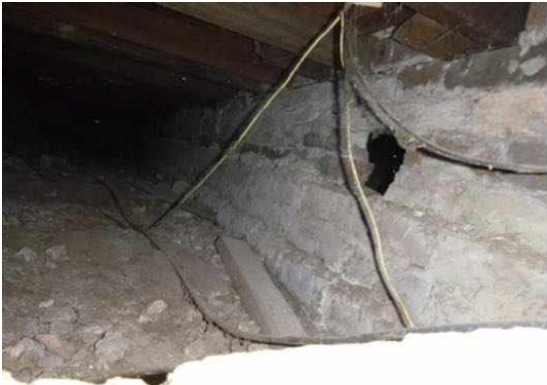
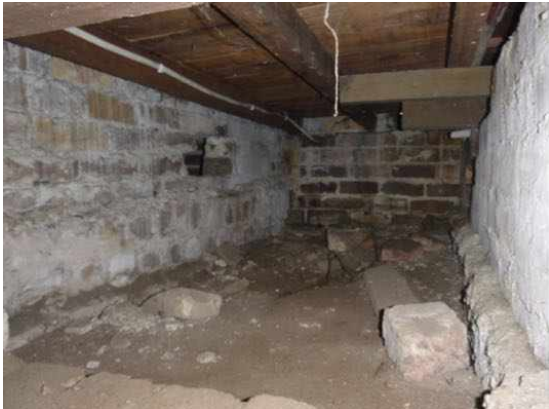
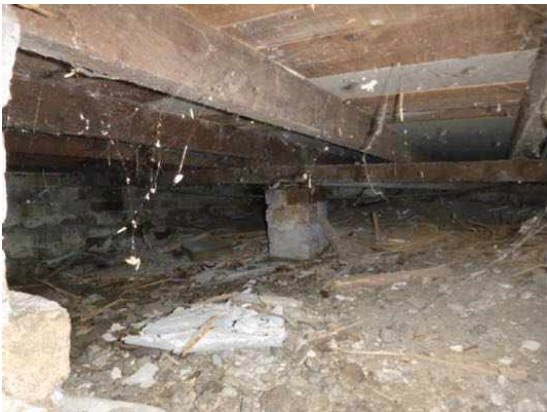
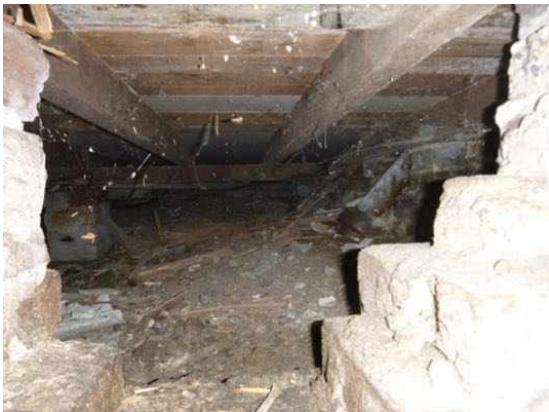
Building:	Main Building
Location:	All Areas
Finding:	Additional Photos - Obstructions and Limitations
Information:	These photographs are an indication of the obstructions and limitations which impeded full inspection of the property at the time of inspection. These obstructions can hide an array of defects and should be removed to allow full inspection to be carried out.

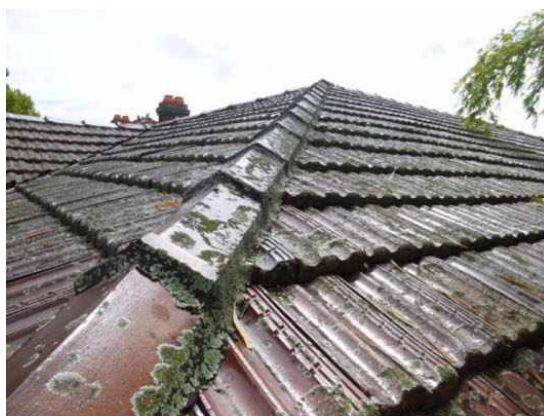
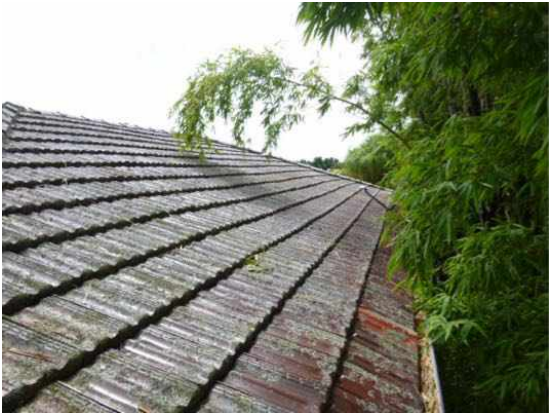
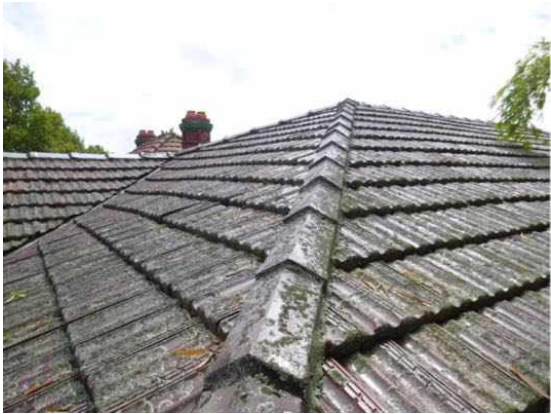
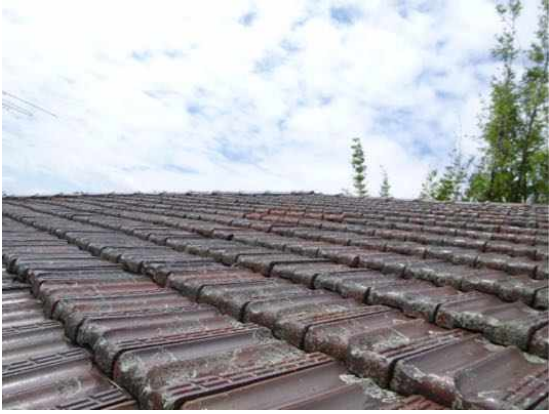
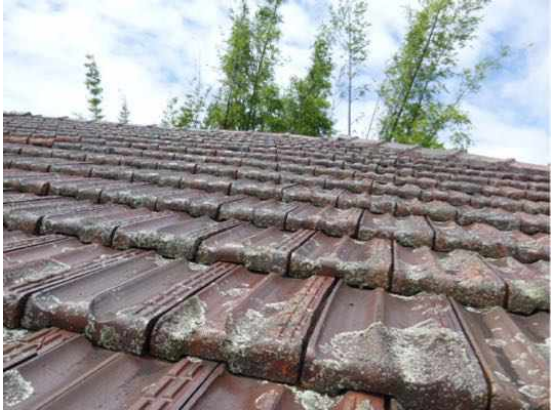
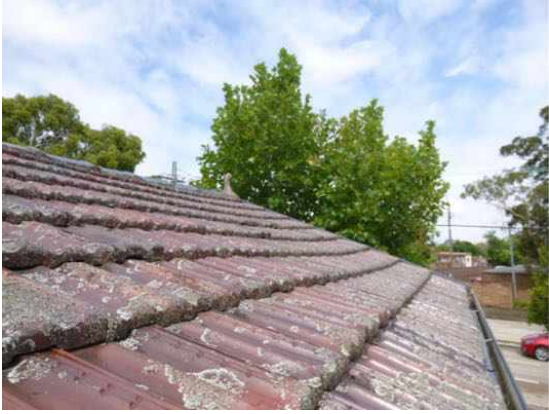
Where left unmanaged, deteriorating roof tiles are likely to lead to a number of secondary defects, including minor water leaks and weather exposure to internal roofing structures.

Consultation with a roofing contractor is highly advised to gain advice on cost of remedial works that may be required in the short to medium term. Remedial works are likely to increase the longevity of the exterior roofing structure.
