Building and Timber Pest Inspection Report

Inspection Date: Thu, 5 Feb 2026

Property Address: 159 Leicester St, Fitzroy VIC 3065, Australia

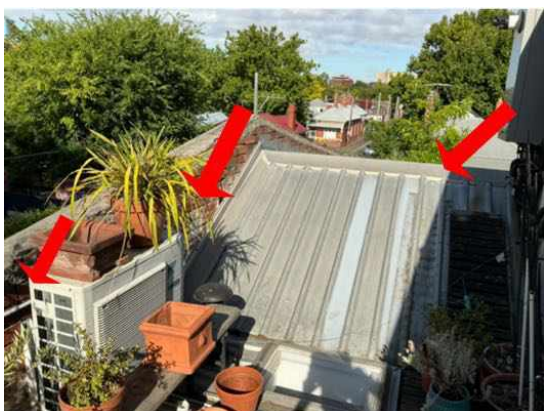
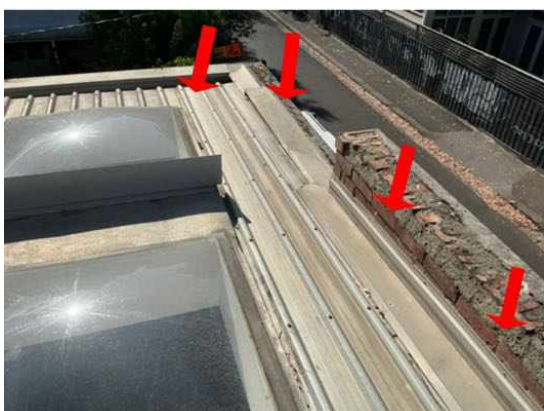
Building: Main Building
 Location: Study/Outside
 Finding: Fall Hazard/ Study/ Outside
 Information: During the inspection, it was observed that guardrails are installed on the perimeter of the building. This poses a significant risk of individuals falling from a height exceeding three metres.

The construction of the guardrails must be carried out by a Registered Builder or Carpenter.

It is strongly recommended that this matter be addressed as expeditiously as possible.

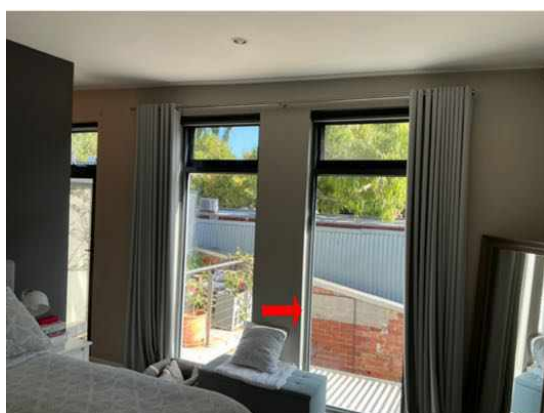
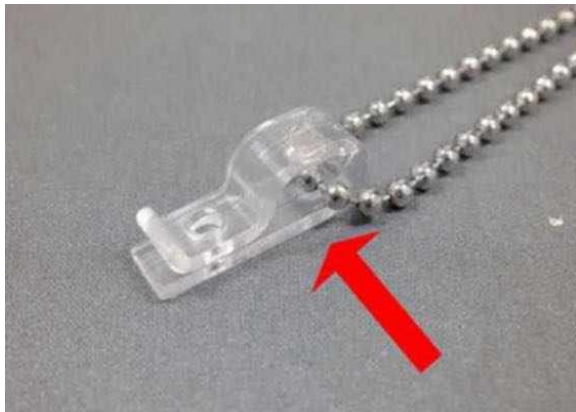
Finding 1.02

Building: Main Building
 Location: All Areas

Information: Looped curtain and blind cords pose a significant strangulation hazard for children as they can place the loop over their head and/or get tangled in the loose cords.

Check all the rooms in your house for any blinds or curtains with long cords that are either loose or looped. This includes any cords that are within children's reach at floor level or near furniture they can climb on.

Secure any loose or looped cords with cleats or tension devices – these can be purchased from your local curtain and blind retailer or hardware store. Do not put furniture such as cots, beds, highchairs, playpens, couches, chairs, tables or bookshelves near a window where children can reach the blind or curtain cord.

It is recommended that this defect be resolved immediately to avoid harm to occupants.

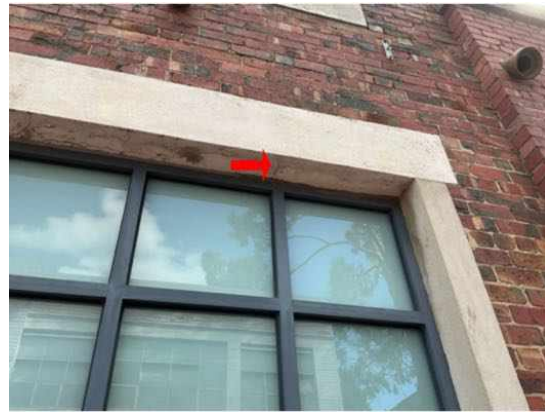
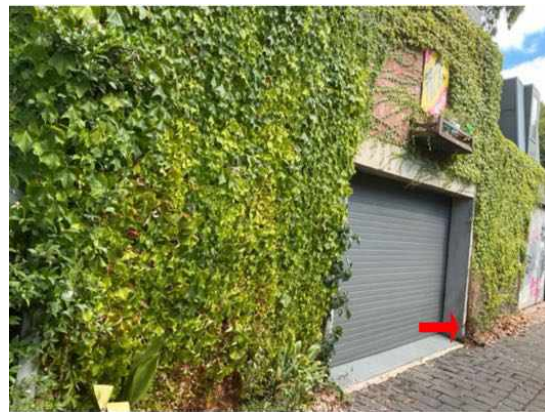
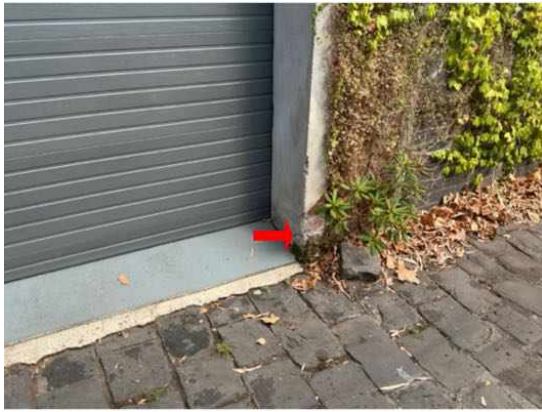
Building: Main Building
Location: All Areas
Finding: Cracks to external render - Category 1

Information: It has been observed that cracking to the external rendered surfaces has occurred. The degree of damage falls within Category 1, described as fine cracks that do not need repair and which are less than 1.0mm in width limit.

Although fine cracks are quite noticeable, they are often only considered to be an appearance defect, and usually do not indicate any structural damage. Generally, the cause of a fine crack is indicative of a separation between building materials and finishes (e.g. paint, plaster, render etc.) along joins.

Cracking of this nature can generally be repaired with filling or rendering. Such works should be performed by a qualified Renderer or a general Handyman.

Monitoring of all cracking should be conducted frequently. Always contact a Building Inspector should cracks widen, lengthen, or become more numerous.

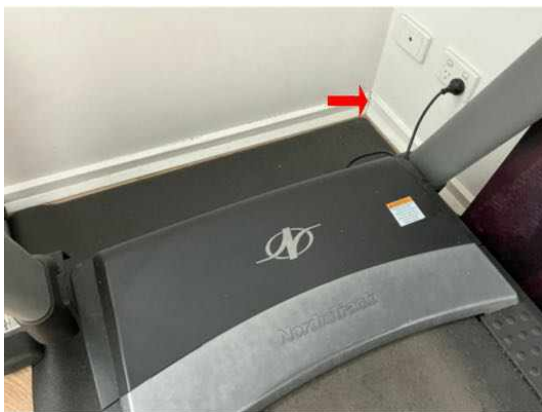
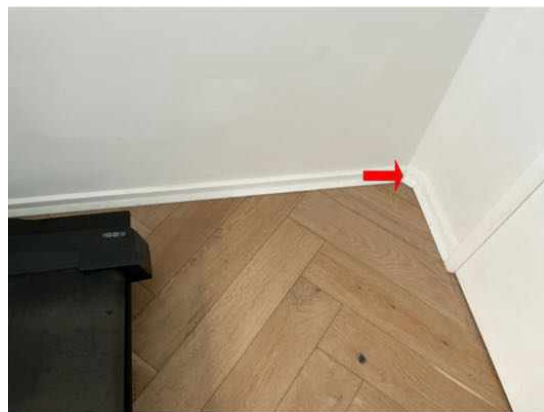
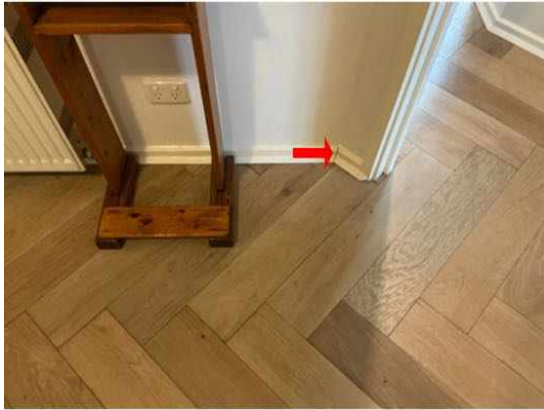
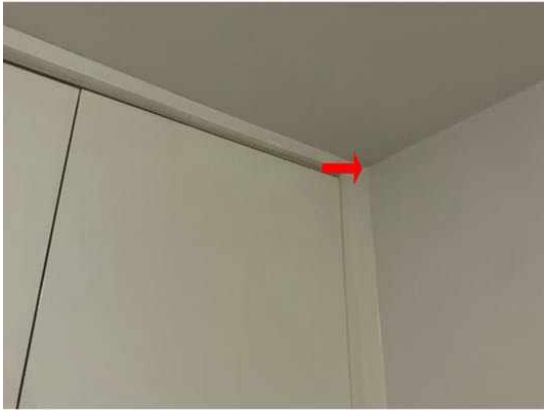
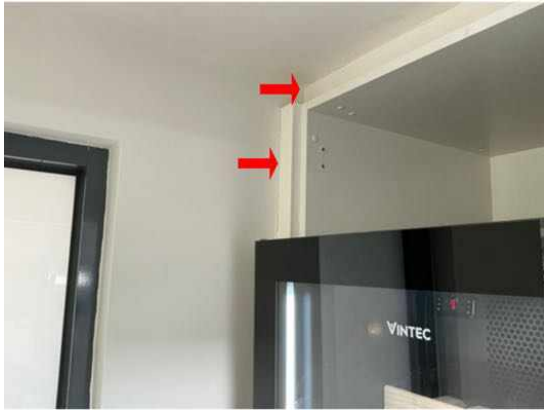
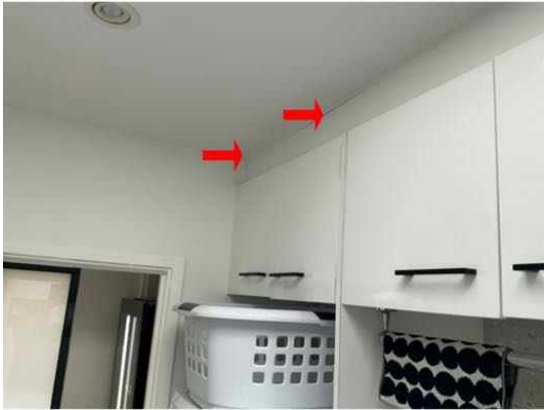
Finding 3.02

Building:	Main Building
Location:	All Areas
Finding:	Cracking - Damage Category 1 - Fine (up to 1mm)
Information:	Although fine cracks are quite noticeable, they are often only considered to be an appearance defect, and usually do not indicate any structural damage. Generally, the cause of a fine crack is indicative of a separation between building materials and finishes (e.g. paint, plaster, etc.) along joins.

In this instance client have indicate that these cracks become visible after roof leaks. However the leaks have been repaired, and hence no change in terms of sizes.

Cracking of this nature can generally be repaired with minor sanding, filling and/or repainting. Such works should be performed by a qualified Painter or a general Handyman.

Monitoring of all cracking should be conducted frequently. Always contact a Building Inspector should cracks widen, lengthen, or become more numerous.

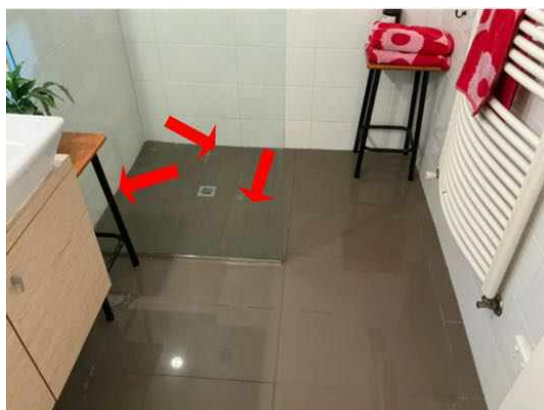
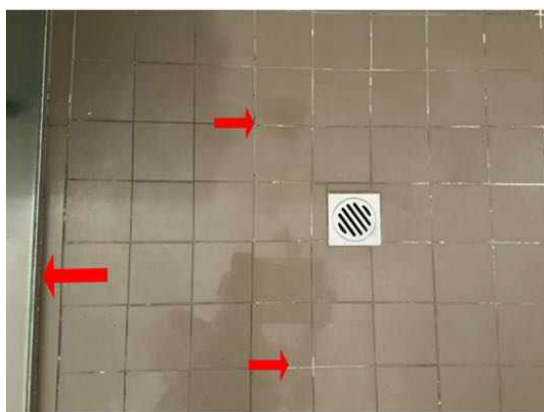
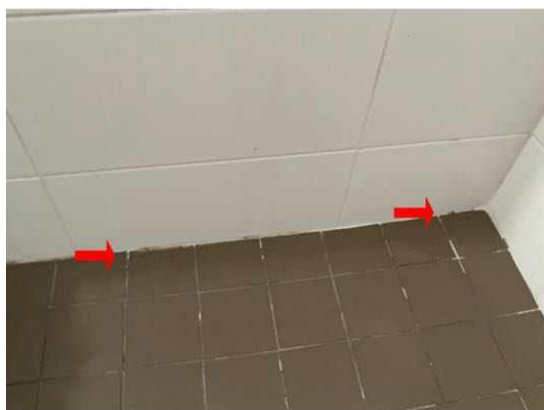
Finding 3.03

Building:	Main Building
Location:	Bathroom 2
Finding:	Sealant and grouting - Missing or damaged
Information:	It was noted on inspection that sealant or grout is degraded to the tiled shower alcove and or other areas of the bathroom . A flexible sealant is required to allow for expected expansion and contraction, while keeping the joint water tight and protective of all associated building materials.

The lack of sealant between tiles can cause water damp to the wall behind it.

Unmanaged damp in the bathroom area is likely to facilitate the formation and development of mould and fungi growth, decaying associated building materials and compromising their structural integrity of associated elements. It is important to address damp conditions , as the World Health Organisation notes that excess moisture leads - on almost all indoor materials - to growth of microbes such as moulds, fungi and bacteria, which subsequently emit spores and other matter into the indoor air. Exposure to these contaminants is associated with a wide range of respiratory and other health-related problems. Damp conditions also create a conducive environment for termite infestation.

Regular maintenance and replacement of damage or missing or damaged sealant and grout is highly recommended to the wet areas, as this is a regular wear and tear defect. Sealant and grouting in areas that come into regular contact with water should be maintained for the long term care of your property.

Consultation with a sealant specialist is advised immediately to perform remedial works as required.

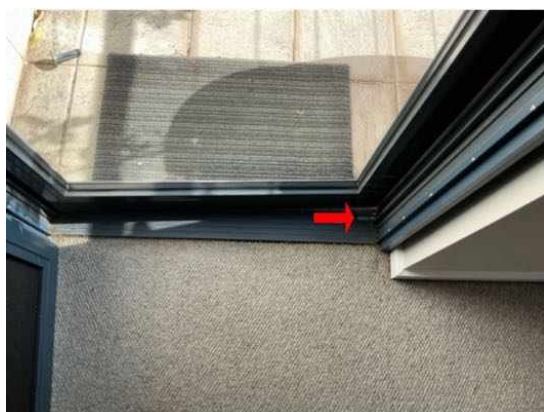
Finding 3.04

Building: Main Building
 Location: Bedroom - Master
 Finding: Door - Binding/jamming
 Information: Binding and/or jamming of this door is evident during standard operation. This defect inhibits the functionality of the affected door as well as creating potential for secondary defects to associated building elements, such as damage to the door frame.

A door that binds to the associated door frame may have several causes, ranging from minor defects, such as poor installation of the door or deteriorated hinges.

A registered Builder specialising in re-stumping should be appointed to provide an

estimate on the cost of rectification.

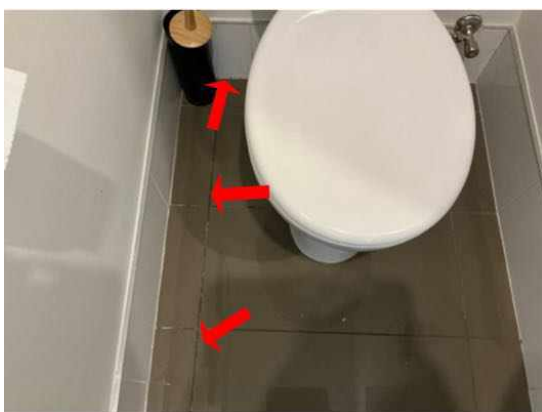
Building:	Main Building
Location:	Toilet (WC)
Finding:	Sealant and grouting -WC- Missing or damaged
Information:	During inspection, it was observed that sealant or grout is absent from the water cistern.

To prevent any potential water damage, flexible and mould-resistant materials should be applied to the affected areas. Regular maintenance and replacement of damaged or missing sealant and grout are strongly recommended for wet areas, as this is a common wear-and-tear issue. Sealant and grouting in areas frequently exposed to water should be maintained to ensure the long-term maintenance of your property.

It is advisable to appoint a sealant specialist or tiling contractor to complete these repairs as soon as possible.

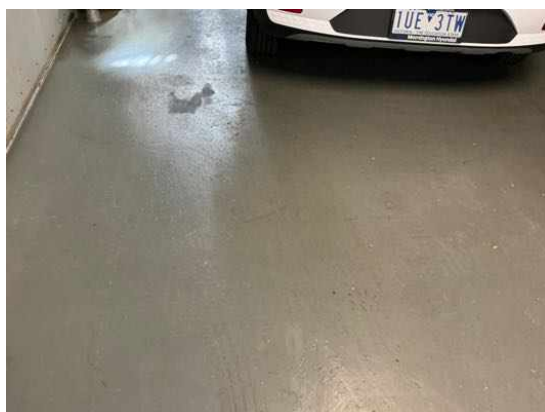
Finding 3.07

Building:	Main Building
Location:	Garage
Finding:	Crack in concrete slab - Category 1
Information:	A crack coded as Category 1 was identified in the slab. A Category 1 crack is

described as a fine but noticeable crack, with the slab at an otherwise reasonable level.

To be considered Category 1, the approximate width of the crack is less than 1.0mm, or a less than 10mm change in offset when a 3m straight edge is placed over the defect.

Category 1 cracks should be monitored for a period of 12 months. At the end of the monitoring period, identified cracks that are rated greater than Category 2 are considered defects, and require rectification.

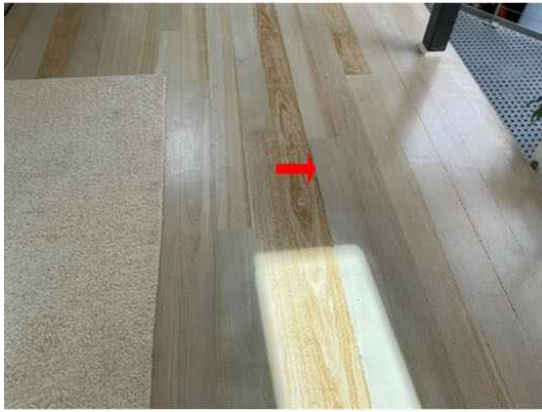
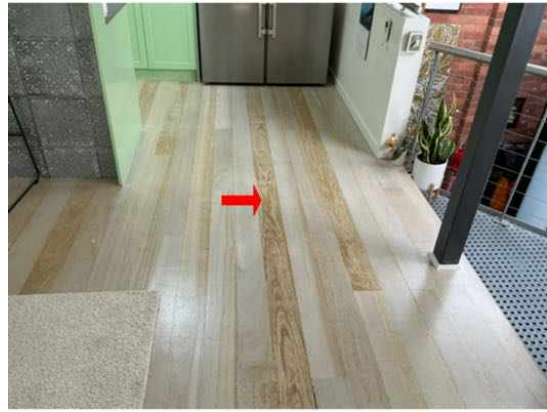
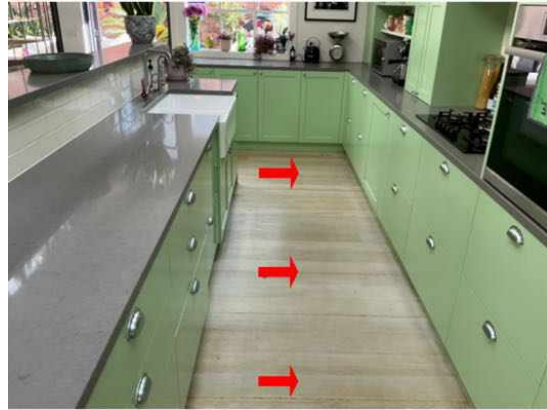
Finding 3.08

Building:	Main Building
Location:	Kitchen
Finding:	Laminate flooring - Weathered
Information:	Upon inspection of the laminate flooring appears to be weathered. While this weathering is consistent with the age of the property, maintenance works are necessary.

If left unmanaged, deteriorating laminated flooring is likely to result in several secondary defects, including minor trip hazards.

Consultation with a flooring contractor is highly recommended to obtain advice on the cost of remedial works that may be required in the short to medium term. However, complete changes of flooring are ultimately up to the client's discretion.

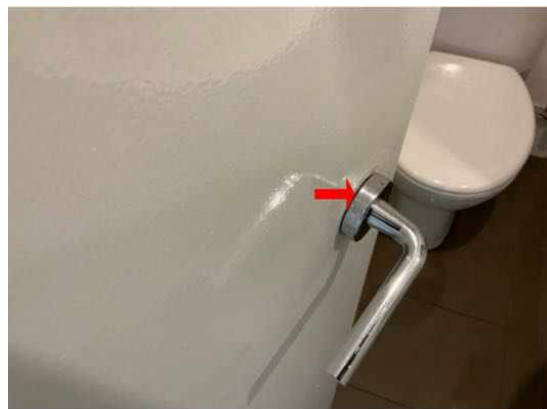
Finding 3.09

Building:	Main Building
Location:	Toilet (WC)
Finding:	Door handle - loose
Information:	During the inspection, a loose door handle was identified. While this may appear minor, it compromises the door's functionality and poses a potential safety hazard being locked inside.

A General Handyperson or Carpenter should be appointed to rectify the issue at the client's discretion. If left unattended, further functional impairment is likely to occur.

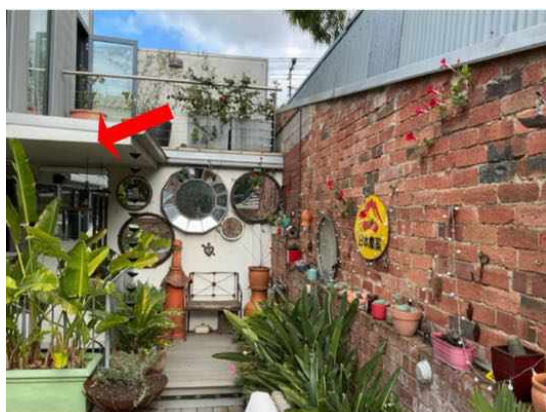
Finding 3.10

Building:	Main Building
Location:	Verandah
Finding:	Ceiling - Water Damage
Information:	Water Damage to ceiling linings in this area was evident at the time of inspection. Water damage indicates that surfaces have been exposed to excessive moisture over time.

While mostly an appearance defect, water damage can be indicative of more serious defects, which may be currently concealed by interior ceilings.

Where water damage is active, a Licensed Plumber must be consulted to identify the cause of the damage and to provide advice on any reparation works that may be required. Replacement of any damaged structures is advised.

Conversely, where water damage is old and inactive, affected building materials may be repaired or replaced at client discretion.

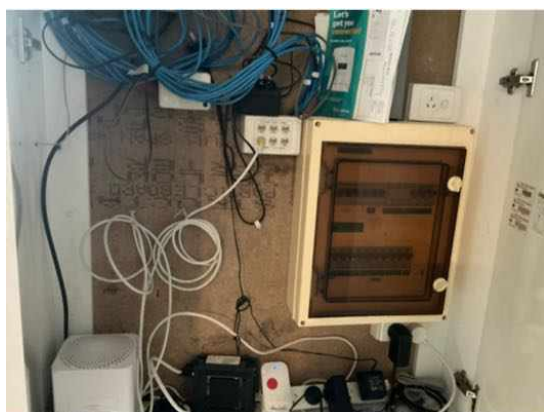
Information: The application of a post-construction chemical termite barrier is highly recommended for all properties, particularly if live termite activity has been found on the site previously. Such barriers are highly effective in preventing termite attack on any timber building elements throughout the property.

A durable notice should be placed in the switchboard unit to indicate current termite barriers. At the time of inspection, it appeared as though no termite management system has been installed, with no evidence to suggest preventative works taking place.

The client may consider gaining further advice from a pest controller as to the costs and procedures involved with this application. It is recommended that obtaining such advice be a short-term priority.

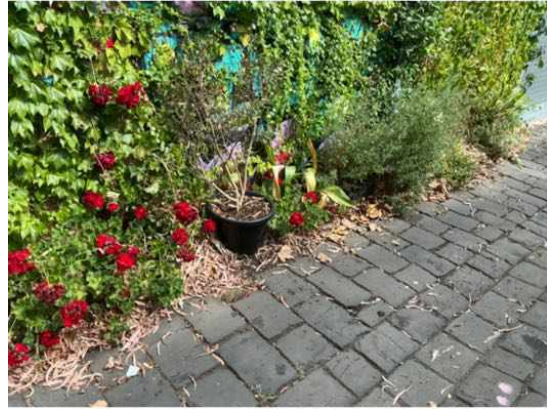
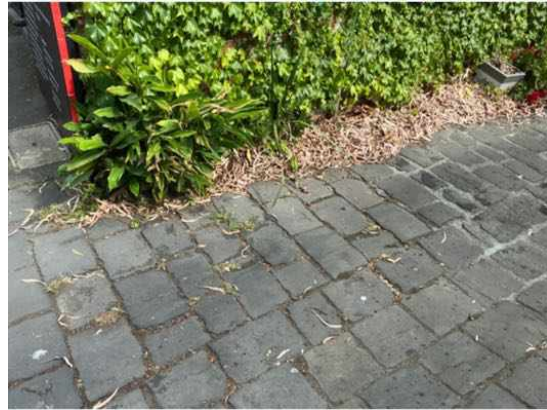
Finding 6.02

Finding: Garden Beds - Conditions Conducive to Termite Attack

Information: Garden beds were found to be evident in close proximity to the building. Garden beds immediately adjacent to the perimeter of the building block the visual inspection of these areas, providing a concealed termite entry point.

Garden beds can include untreated timber and a combination of moisture from watering, which produce conditions conducive to termite activity and ingress.

Further advice from a Timber Pest Technician is required to ensure appropriate Termite Management systems are implemented.
