Building and Timber Pest Inspection Report

Inspection Date: Mon, 30 Mar 2026

Property Address: 16 Latona St, Pymble NSW 2073, Australia

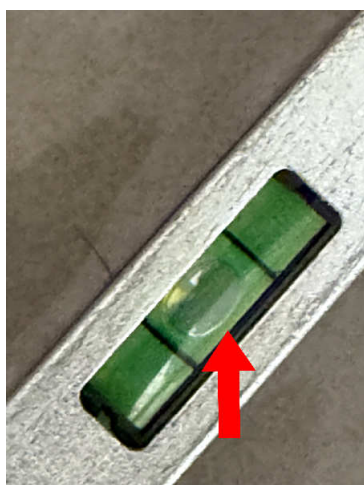
Information: Evidence of water pooling around the floor waste in the shower recess was noticed at the time of inspection. It is suspected that this excessive moisture is attributed to insufficient fall in the shower floor tiles.

Pooling water around floor wastes can create a slip hazard in extreme cases and create conditions that are conducive to mould growth over time. Where left unmanaged, the degradation of sealant and grouting is also likely to occur, possibly necessitating further repair works.

Remedial works may involve some sections of tiling and flooring repair and replacement.

A tiling contractor or bathroom specialist should be appointed to provide further advice on reparation options and to perform works as necessary.

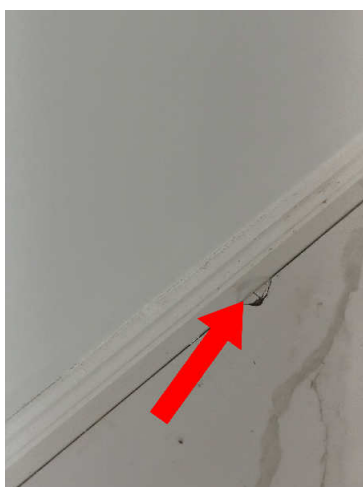
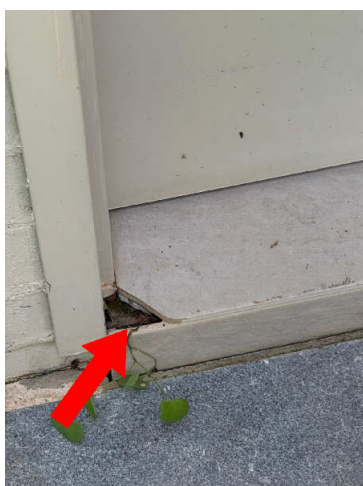
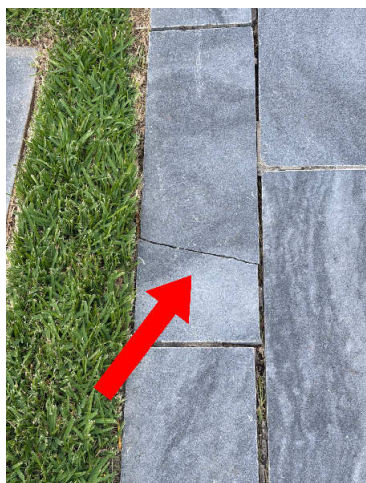
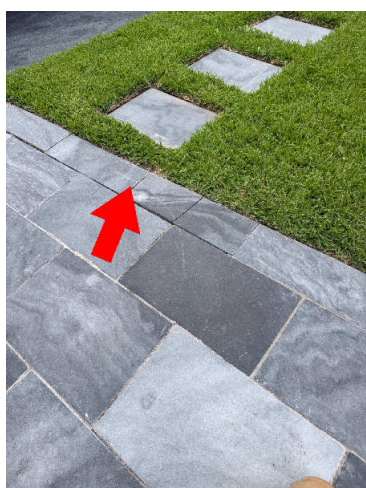
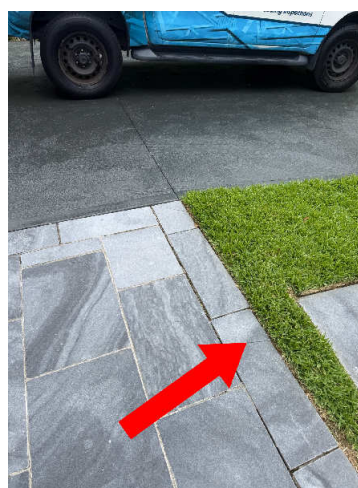
Finding 3.02

Finding: Cracked floor tiles

Information: Cracking in the floor tiles was evident in this area at the time of inspection. It is suspected that this cracking has occurred as a result of minor settlement or shrinkage of the slab.

Cracked tiles throughout the household detract from the overall appearance of the affected areas however it is unlikely to create or lead to any secondary defects.

While not considered a matter of urgency, replacement of cracked floor tiles is recommended at the clients discretion.

A tiling contractor may be appointed to perform these works. Where cracks become more numerous, contact a licensed building inspector for further investigation.

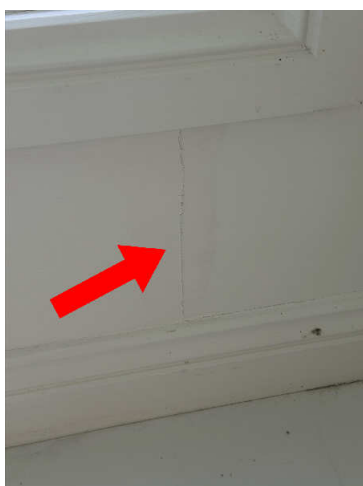
Finding 3.03

Finding: Cracking - Damage Category 2 - Noticeable (up to 5mm)

Information: Noticeable cracks are a common occurrence as a result of many primary defects. Such causes may include age, general wear and tear, expected building movement, general expansion/contraction of building materials in different weather conditions, and/or minor failings in the installation or application of building materials.

Noticeable cracks may result in minor sticking or jamming of associated doors and windows, which require easement. However, noticeable cracks are easily filled and repaired.

A plasterer can be consulted to install an expansion joint at this point to allow for this movement during different weather conditions.

Monitoring of all cracking should be conducted frequently. Always contact a building inspector should cracks widen, lengthen, or become more numerous. Additionally, your building inspector should also be contacted if associated building elements such as doors and windows become more difficult to operate over time.

Relevant tradespeople, such as carpenters, painters and plasterers, should be appointed to perform remedial works, as deemed necessary.

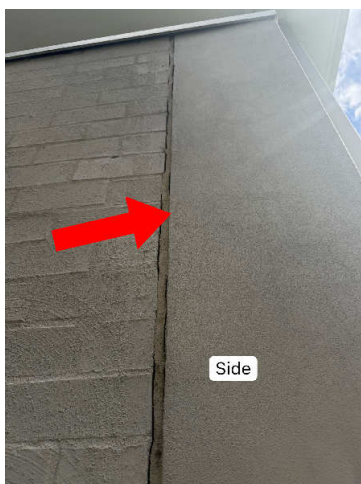
Information: It was noted on inspection that sealant to the expansion joint in this area is missing or deteriorated, which may lead to potential issues if left unaddressed.

Their importance lies in their ability to accommodate the natural movement and expansion and contraction of structures or materials due to changes in temperature, moisture, or other factors.

A sealant specialist or tiling contractor should be appointed to complete these works as soon as possible

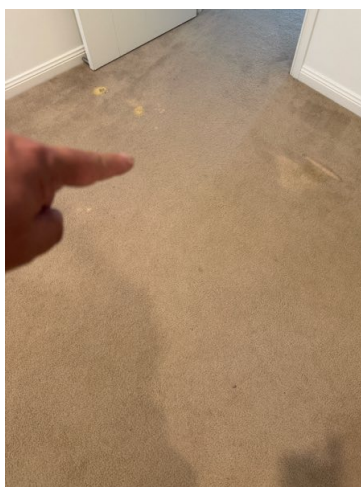
Information: The first-floor timber flooring in this area produces audible squeaking/noise when walked upon. This is typically indicative of movement between floor components, such as loose floorboards, inadequate fixing, or friction between structural elements within the suspended timber floor system.

A qualified tradesperson should inspect the flooring to identify the source of the noise.

Rectification may include re-fixing loose boards, tightening fixings, installing additional fasteners, or applying suitable lubricants between components. If the issue is widespread, further investigation of the subfloor framing may be required.

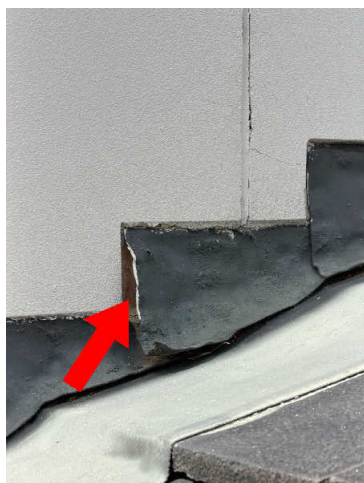
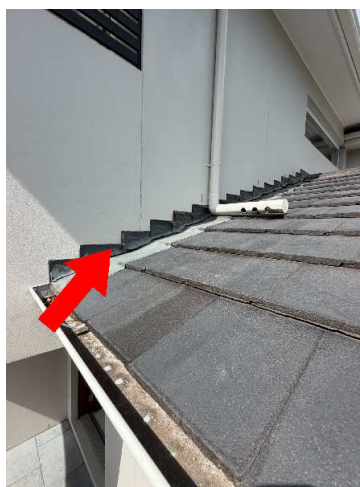
Finding: Roof plumbing - Flashing inadequate

Information: Some sections of the roof are missing or have inadequate roof flashings. Flashings are metal and other materials which are applied to seals and intersections between roof coverings and building elements. They are designed to aid in weatherproofing of roof joins.

Flashings that are not installed adequately or are missing are likely to result in water penetration to the interior of the property, as well as creating excessively damp conditions against the exterior surfaces and around the base perimeter of the building.

Premature ageing and secondary building defects are imminent where roof plumbing is missing or inadequately installed. Additionally, water pooling also creates an environment that is susceptible to termite and pest infestation.

A roofing plumber should be appointed as soon as possible to install relevant roof plumbing materials, ensuring that no further damage is sustained.

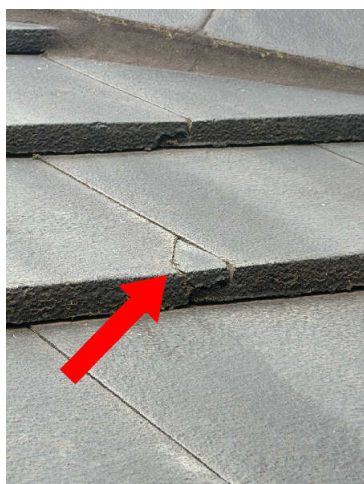
Finding 3.13

Finding: Roof tiles - Broken

Information: Upon inspection of the exterior roof covering, broken roofing tiles were identified. Broken and friable roof tiles are generally the result of ageing and weathering of what is essentially a porous material.

If left to further deteriorate, broken and brittle roof tiles are likely to lead to water penetration via the roof into the ceiling space, causing secondary damage to ceiling linings, insulation and roof structures.

Broken roof tiles are also likely to detract from the effectiveness of the roof drainage system, creating potential for secondary damage to the exterior roof covering and roof plumbing.

Replacement of broken tiles is required and should be performed by a roofing contractor as soon as possible.

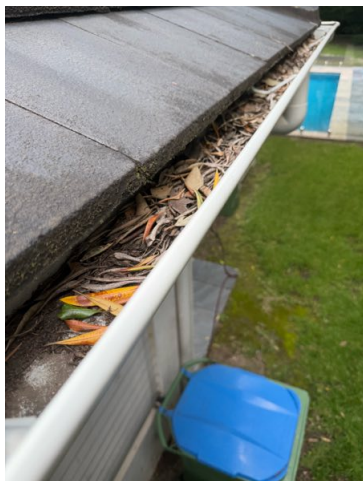
Finding 3.14

Information: Rubbish was found in the gutter during the time of inspection.

Remove rubbish in order to prevent blockage of the gutter and down pipes.

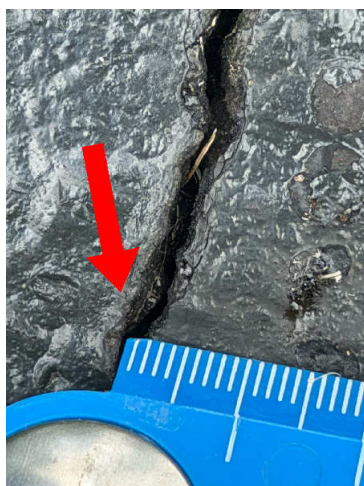
Finding: Cracking - External Concrete Paving Damage Category 3 - Wide Cracks (2mm - 4mm)

Information: Wide cracks were identified in external concrete paving. Wide cracks are significant and are likely to lead to the development of safety hazards and secondary defects if left unmanaged.

General age and expected deterioration of the paved areas is a common cause of this type of cracking. However, expansion and contraction of the slab may also have occurred due to environmental factors.

Such factors include variable moisture and weather conditions, the presence of trees and their roots having a settling or lifting affect on the soil, or the effect of load bearing, e.g. heavy vehicles over a sustained period of time.

Cracking to this degree may also be due to poor original installation of the concrete. Factors such as poor compaction of the sub surface and/or inadequate reinforcing of the slab may create cracking and other secondary defects.

Wide cracks may also have a more significant structural cause, such as subsidence of soils.

Where the crack is located adjacent to structural elements of the building, the advice of a Structural Engineer is advisable before undertaking repairs. Significant repair and likely replacement of the concrete paving is probable.

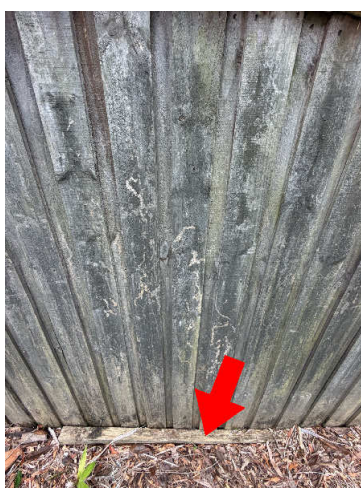
Finding: Wood rot

Information: This building element shows evidence of wood rot. Wood rot, also known as Fungal Decay, occurs when timbers and other cellulose building materials are exposed to damp conditions on an ongoing basis. This could be the result of exposure to weathering over a prolonged period of time, or the attraction of excessive moisture from other abutting building materials. Contributing factors also include poor air ventilation in the area.

Wood rot is often associated with general damp problems and is evidenced by a 'musty' smell or mould and mildew occurring on surfaces. If left unmanaged, damp conditions can lead to further health problems and the decay of timbers will continue.

Prior to any works being performed, the cause of the moisture that has created the visible wood rot should be identified and addressed in a suitable manner. Replacement of affected timbers may then be a necessary step in protecting surrounding building elements from such deterioration.

A qualified plumber may be appointed to assess the cause of excessive moisture and to provide advice on any remedial works as required.

A qualified carpenter or registered builder may also be required to replace affected building materials.

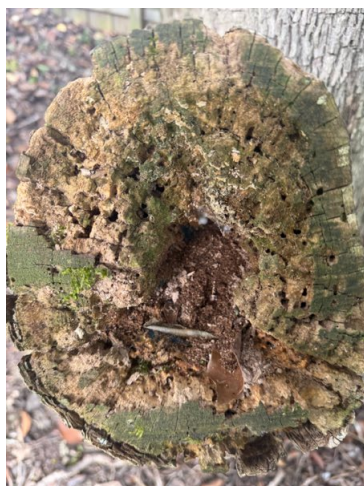
Finding 8.01

Information: Wood borers small beetles that colonise in exposed timber elements are a common timber pest that are regularly mistaken for termites. Although wood borer activity is generally not detrimental to the affected timber they may lead to serious damage and necessitate replacement of certain building elements if left unattended.

The other commonly known borer the Anobium borer is more likely to attack floorboards and may cause severe structural damage to flooring areas.

As no live wood borer activity was identified treatment is not required at this time.

Replacement of affected timbers may be considered by the client for superficial reasons.

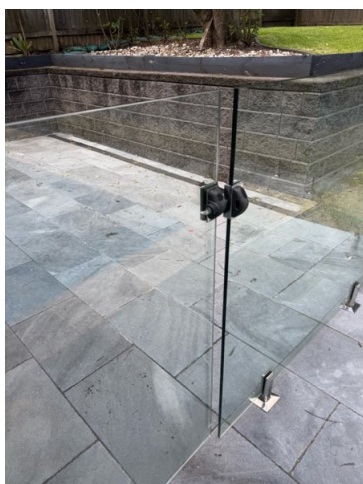
Location:	All External Areas
Finding:	Pool fencing - Inspection required
Information:	Please note that this inspection does not cover pool fencing and other pool fittings and fixtures. It is highly advised that a specialist be appointed to inspect the pool and surrounding area and provide advice on rectification works that may be required.
