Building and Timber Pest Inspection Report

Inspection Date: Wed, 25 Feb 2026

Property Address: 16 Burdekin Dr, Albion Park NSW 2527,
Australia

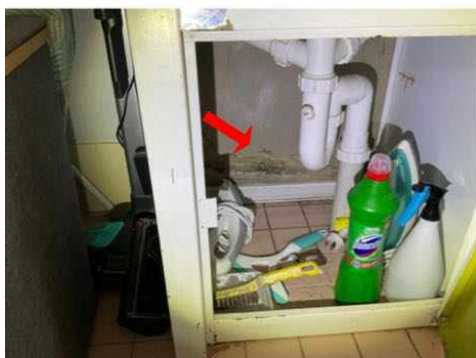
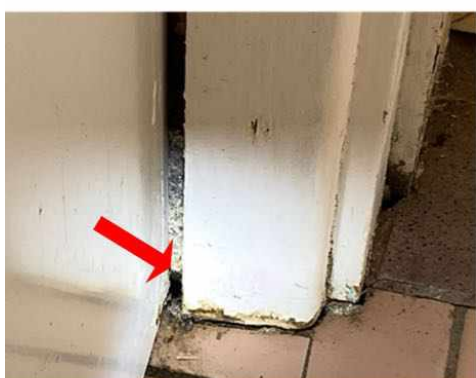
Building: Building 1
Location: Laundry
Finding: Mould present and excessive moisture
Information: Where evidence of mould growth and high moisture was noted under the laundry tub, there may be environmental, biological or health issues associated with the report. A specialist inspection by a suitably qualified environmental health inspector is warranted, where mould is extensive or where any queries regarding air quality spores or other related issues apply.

The reason for this mould is suspected to be the lack of fall to the laundry tiles under the tub. Any water leaked or spilled here will pool against the rear wall and not reach the floor waste. It is also possible a leak may also be within this wall in the laundry plumbing. A moderately high moisture reading of 57.3 was recorded in this area of mould with no other significant readings found in the house and all nearby laundry areas recording zero.

Any mould found during the inspection should be cleaned immediately by a cleaning contractor or the homeowner as applicable.

A qualified plumbers inspection is recommended to determine the reason for this leak. The external brick wall was tested behind this area and most water reached the rear left external strip drain.

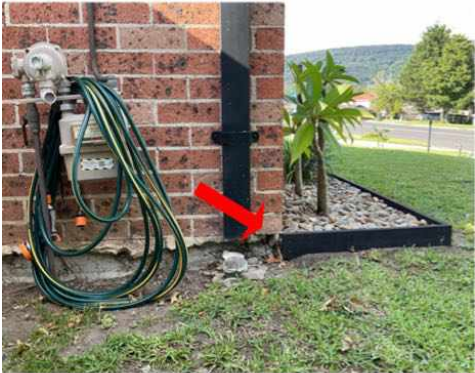
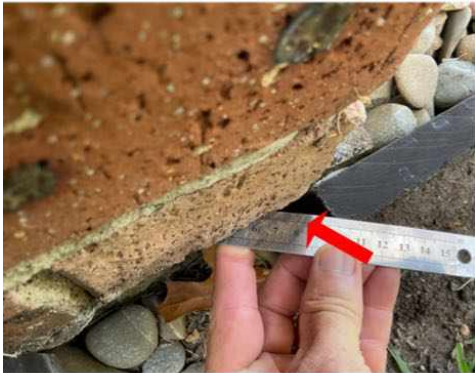
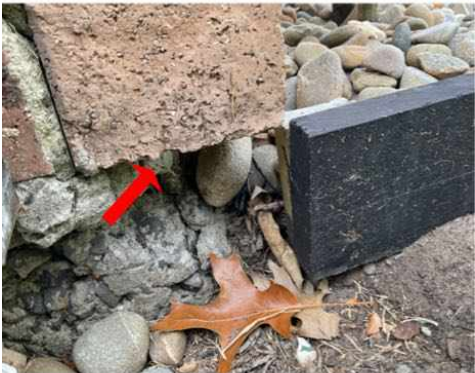
Finding 3.02

Building: Building 1
 Location: Exterior front left wall
 Finding: Masonry overhanging concrete slabs
 Information: The front bedroom external wall overhangs the slab by over 80mm.

‘ A masonry course is defective if it is laid on a concrete slab or strip footing so as to project over the edge of the slab or footing by more than 15mm ‘

This wall area needs restrengthening by a licensed builder or concreter.

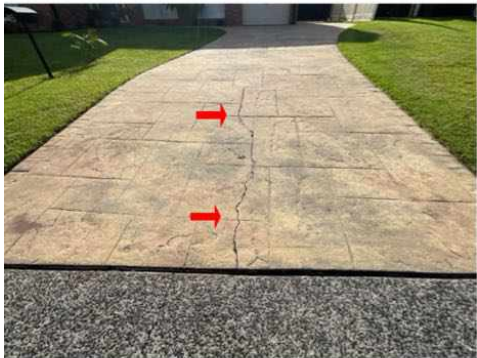
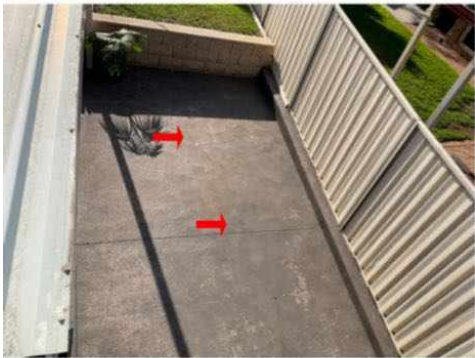
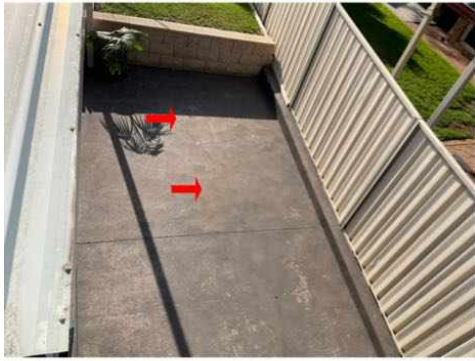
Finding 3.05

Building: Building 1
Location: Slabs at front, garage and rear
Finding: Crack in concrete slab - Category 3
Information: Various cracks coded as up to Category 3 of 3-4 mm was identified in the front driveway slab. Very minor cracks were also found in the garage and rear areas.

A Category 3 crack is described as a wide crack with obvious curvature or change in level, affecting the slab.

The approximate width of the crack to be considered Category 3 is greater than 2.0mm, or a change in offset of 15-25mm when a 3m straight edge is placed over the defect.

Category 3 cracks to slabs exceed allowable Standards and Tolerances, and are considered defects requiring rectification.

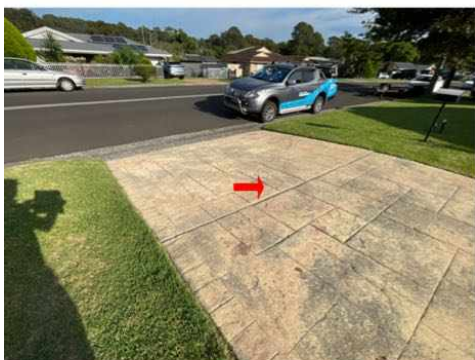
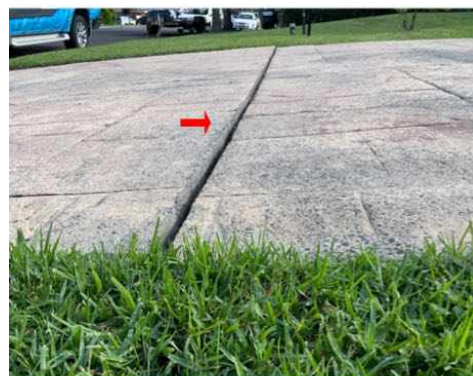
Finding 3.06

Building:	Building 1
Location:	Driveway
Finding:	Subsidence - monitor annually
Information:	It appears that this some paved areas has been affected by movement, often referred to as sinking or subsidence. General subsidence is usually initiated by changes in soil moisture content. The most critical factor is identifying the specific causes, and identifying if this is a recurring or ongoing problem, or one that has been resolved by previous works in the past.

At this point it is recommended to contain storm water flows, ensure pavements flow away from buildings to lessen any excessive wetting and drying effects.

A concreting contractor can repair this area when convenient.

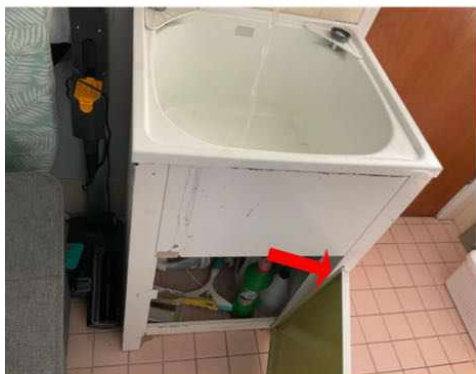
Finding 3.07

Building:	Building 1
Location:	Laundry & kitchen
Finding:	Building elements - Damaged
Information:	Evidence of minor missing or damaged areas was identified at the time of the inspection. These include -

1. The laundry tub door needs repair.
2. The laundry floor under the tub falls back to the wall and not to the drain.
3. There is minor moisture damage in kitchen sink cupboard with no leaks found.

A carpenter would be the trade responsible for rectification of these areas when convenient.

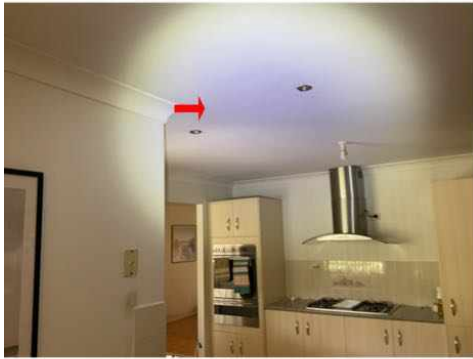
Finding 3.08

Finding: Cracking - Damage Category 1 - Fine (up to 1mm)

Information: Although fine cracks are quite noticeable, they are often only considered to be an appearance defect, and usually do not indicate any structural damage. Generally, the cause of a fine crack is indicative of a separation between building materials and finishes (e.g. paint, plaster, etc.) along joints.

Cracking of this nature can generally be repaired with minor sanding, filling and/or repainting. Such works should be performed by a qualified painter or a general handyman.

Monitoring of all cracking should be conducted frequently. Always contact a building inspector should cracks widen, lengthen, or become more numerous.

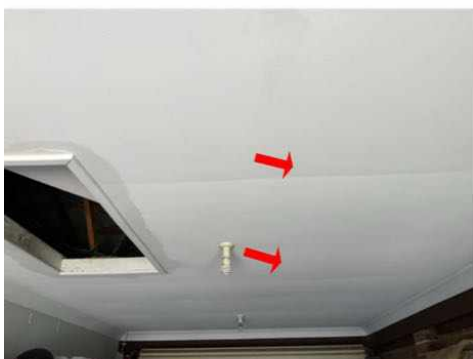
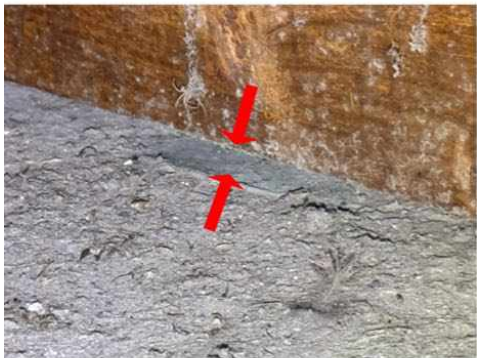
Finding 3.09

Building:	Building 1
Location:	Garage
Finding:	Ceiling - Sagging and nails popping
Information:	Sections of the garage ceiling were found to be sagging at the time of inspection. Sagging to the fixed ceiling structure generally indicates that the building materials have swollen, due to contact with water, or that fixings (e.g. nails or glue) have become loose and require reattachment.

Where minor sagging is evident, comparatively minor works, such as re-gluing of ceiling sheets, may be required. Such works may be performed by relevant tradespeople, such as plasterers and painters. Where excessive moisture has caused the roofing structure to swell and sag, the source of the water leak should primarily be identified prior to any remedial works being performed.

The appropriate action should be taken by the client as soon as possible to ensure that any potential further damage is limited. As no moisture was evident, renailing / screwing this ceiling up is required to support it in the long term.

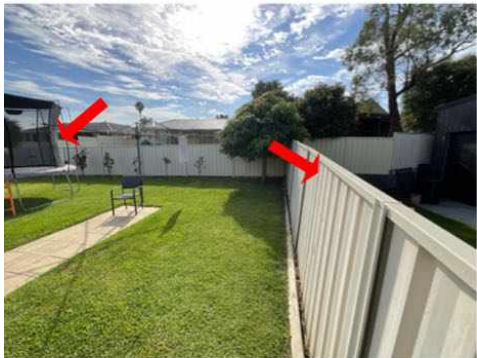
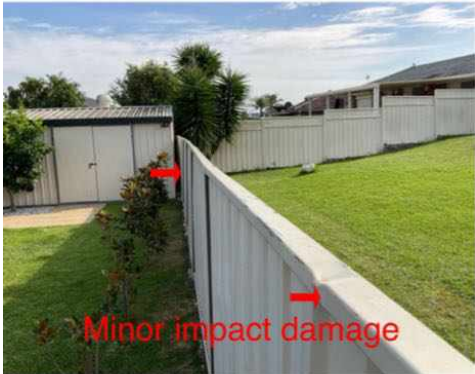
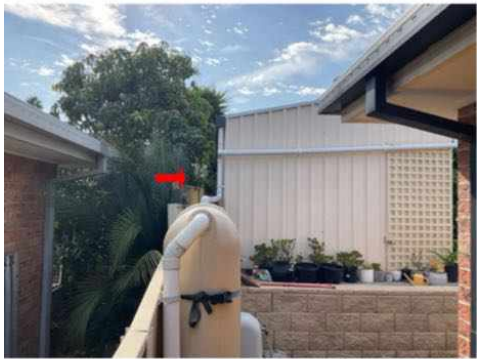
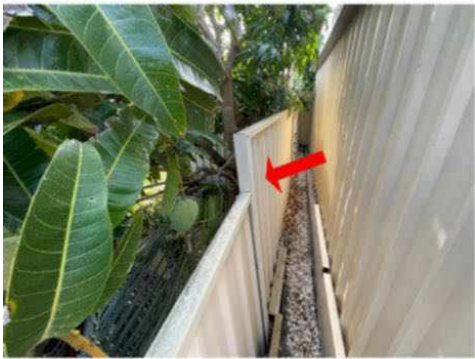
Finding 3.10

Building: Building 1
 Location: Pictured fences
 Finding: Fences damaged - leaning
 Information: Evidence of damage to the pictured fences was identified at the time of the inspection. The likely cause of these rear fences leaning is not enough concrete used in the post footings. If left unmanaged this fence may deteriorate further.

It is suggest a fencing contractor be engaged for rectification when convenient.

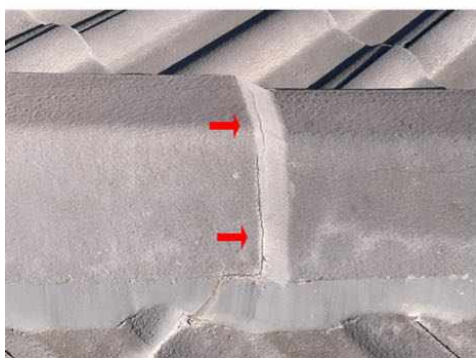
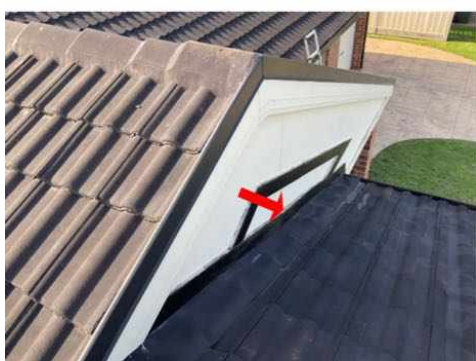
Finding 3.11

Building:	Building 1
Location:	Roof Exterior
Finding:	Roof tiles - Weathered
Information:	Upon inspection of the exterior roofing, the majority of roof tiles were considered to be in a good condition. While weathering of the tiles is consistent with the age of the property, maintenance works are required.

Where left unmanaged, deteriorating roof areas are likely to lead to a number of secondary defects, including minor water leaks and weather exposure to internal roofing structures.

Consultation with a roofing contractor is highly advised to gain advice on cost of remedial works that may be required in the short to medium term. Remedial works are likely to increase the longevity of the exterior roofing structure.

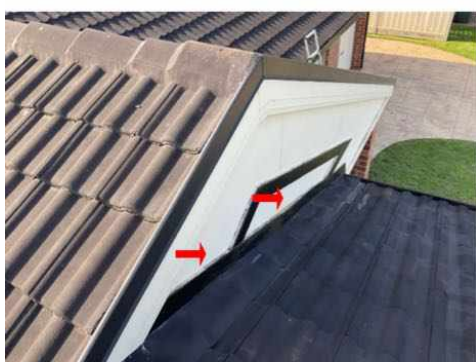
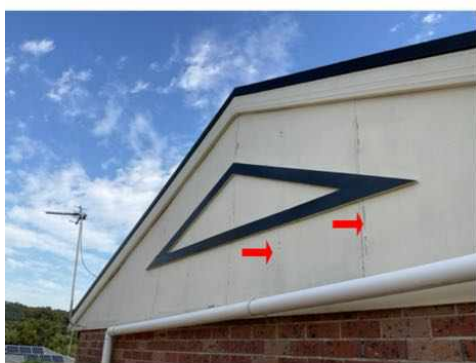
Finding 3.12

Location: Exterior roof walls
 Finding: Sealant (external) - missing and paint degraded
 Information: It was noted on inspection that areas of external sealant and paint were missing to small areas.

Flexible sealants should be applied to these affected areas to prevent any subsequent water damage that is likely to occur.

A sealant specialist or skilled handy person should be appointed to complete these works as soon as possible

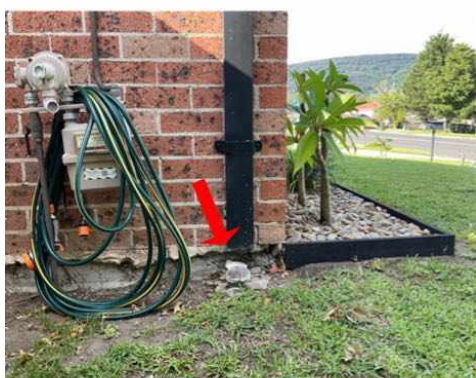
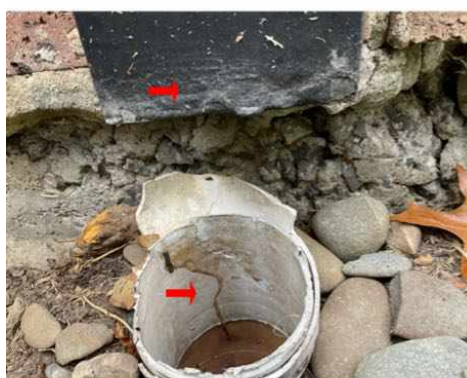
Finding 3.13

Building: Building 1
 Location: Walls
 Finding: Site drainage - Inadequate
 Information: The site drainage in these areas was found to be inadequate at the time of inspection, creating potential for subsequent water damage to associated building elements.

The front downpipe boot has cracked requiring replacement.

It is important that water does not lie against the base of walls; surrounding paths and ground levels should be sloped to drain water away from walls. Downpipes should not discharge stormwater onto lower walls or plinths. Stormwater should be carried away by large, regularly cleaned drains. Ground levels may need to be lowered to expose a buried DPC.

Where site drainage is inadequate, installation of an Agricultural (Aggie) Drain may be required. A qualified plumber should be appointed to further inspect the property and perform any remedial works as necessary. Secondary defects are likely to occur if left unmanaged.

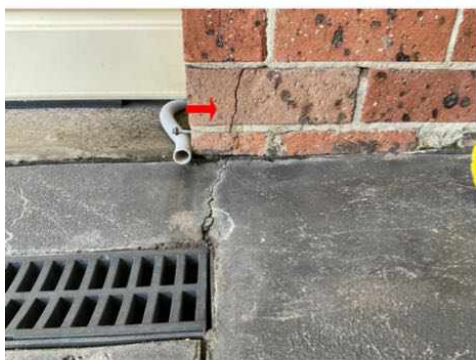
Finding 3.14

Building:	Building 1
Location:	Exterior rear wall
Finding:	Step cracking to brickwork (minor)
Information:	Step cracking was identified to the brickwork in this area at the time of inspection. Step cracking, which is similar to other forms of cracking, has a variety of possible causes. However, the most common is the subsidence of adjacent footings.

Step cracking is a relatively common defect, and is most likely to occur adjacent to windows, doors and other openings. Mortar failure in the gaps between affected bricks indicates the stresses and tensions affecting the wall.

Where step cracking is extensive or severe, the client is advised to consult a structural engineer. This minor step cracking can be used as a warning sign to address factors causing stress to the wall, which can include the effect of surrounding trees, water leaks, soil erosion, or even the presence of reactive soils in the surrounding area.

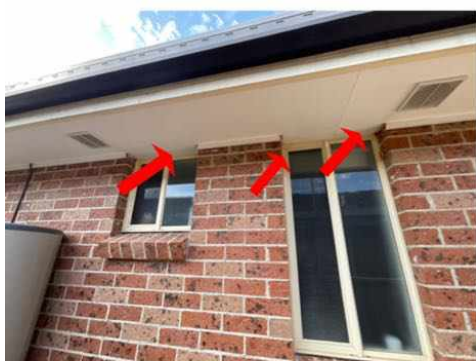
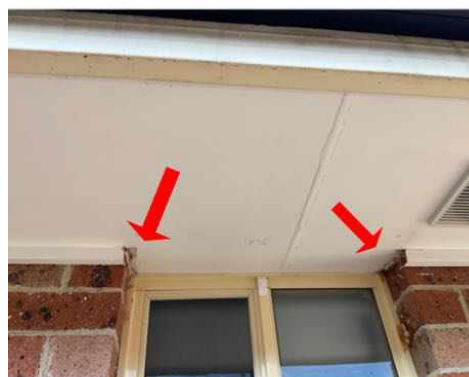
Finding 3.15

Building:	Building 1
Location:	Exterior walls
Finding:	Trim missing
Information:	The trim in this left side area is loose and requires replacement.

A carpenter should be appointed to perform these rectification works at discretion of the client.

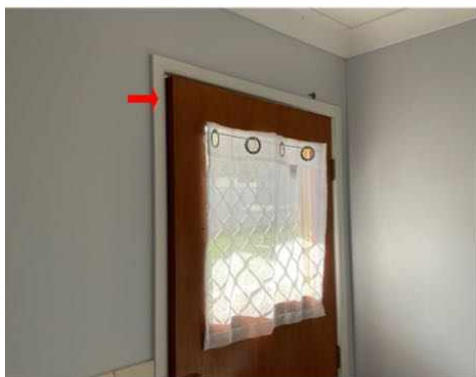
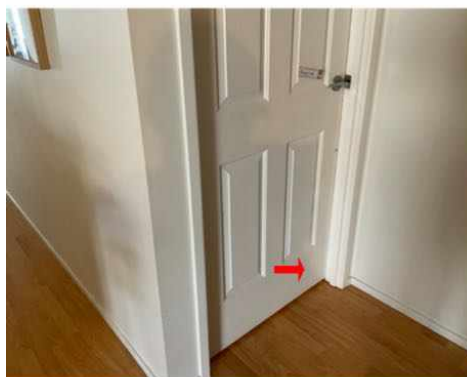
Finding 3.16

Building:	Building 1
Location:	Laundry, middle bedroom (very minor)
Finding:	Doors - Binding/jamming and delaminating at base (laundry)
Information:	Binding and/or jamming of this laundry and bedroom door was evident during standard operation. This defect inhibits the functionality of the affected doors as well as creating potential for secondary defects to associated building elements, such as damage to the floor covering.

A door that binds to flooring or to the associated door frame may have several causes, ranging from minor defects, such as poor installation of the door or deteriorated hinges, through to major structural issues, such as damage to subfloor

structures.

For minor causes as this appears to be as missing screws were found, a qualified carpenter or general handyperson should be appointed to perform minor rectification works at client discretion. The base of this door is also delaminating from moisture damage and it may need replacement in future years.

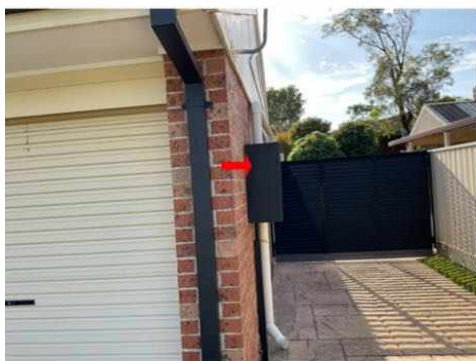
Building:	Building 1
Location:	Meter Box
Finding:	Termite Management System - no evidence of a chemical installation
Information:	The application of a post-construction chemical termite barrier is highly recommended for all properties. Such barriers are highly effective in preventing termite attack on any timber building elements throughout the property.

The client may consider gaining further advice from a pest controller as to the costs and procedures involved with a 'chemical' application. It is recommended that

obtaining such advice be a short-term priority.

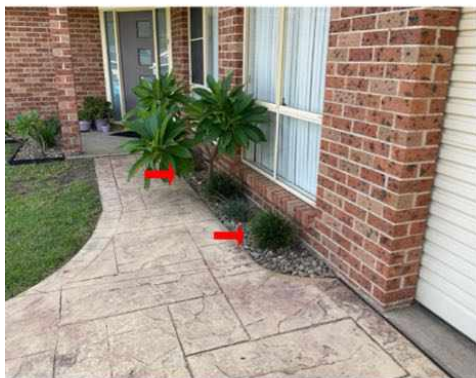
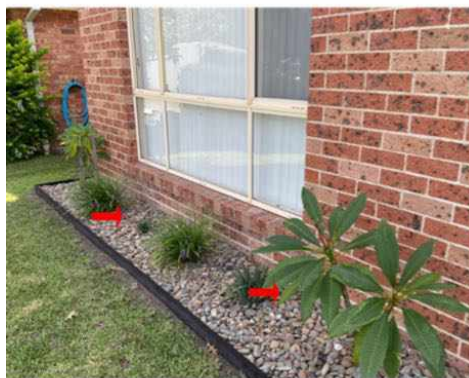
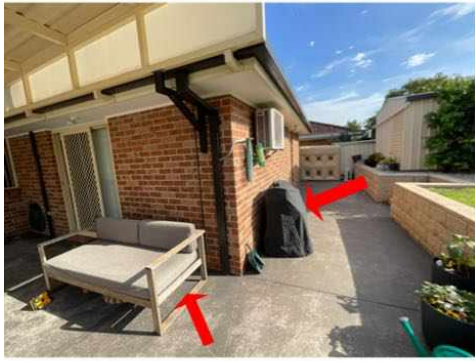
Finding 6.02

Building:	Building 1
Location:	Exterior walls
Finding:	Slab Edge - Exposure
Information:	An inspection zone of at least 75mm in relation to the exposed slab edge, between the bottom brick and the perimeter pavement, is required. This inspection zone should be maintained in order to force termites into the open where they can be detected more readily during regular inspections. The slab edge should not be concealed by anything that may prevent inspection of the area, including render, landscaping, soil, turf, paving, concrete cladding or other structures.

If the slab edge is not properly exposed there is a high risk of termite attack. Sometimes, in order to determine the type of slab, a suitably qualified person such as an architect or builder may be required to consult the construction plans.

Where the slab edge cannot be properly inspected, it is highly recommended that termite or timber pest inspections be carried out every 6-12 months to aid protection of the property against infestation.

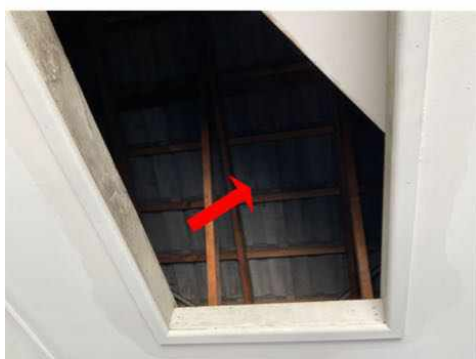
Building: Building 1
 Location: Roof Void
 Finding: Sarking - Missing
 Information: Sarking is missing under the roof sheeting. Sarking acts as an insulator that helps with noise reduction and protects against water penetration. Sarking plays a key role in the operation and function of the overall roofing structure and its performance.

Although not a requirement at the time of construction, replacement of any missing building element is advisable (although this can be quite expensive to do after the time of construction). Where sarking is missing, regular inspections of the roof tiles for cracking and potential moisture penetration is required. Often when rain falls with wind blowing, rainwater can enter the roof void “uphill” through small gaps in tiles.

Sarking may be retrospectively fitted by a registered builder at the discretion of the client.
