Building and Timber Pest Inspection Report

Inspection Date: Sat, 24 Jan 2026

Property Address: 14/27 Mangerton Rd, Wollongong NSW
2500, Australia

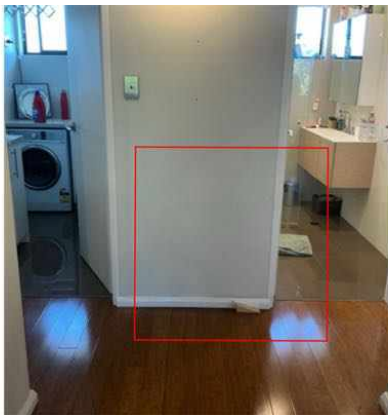
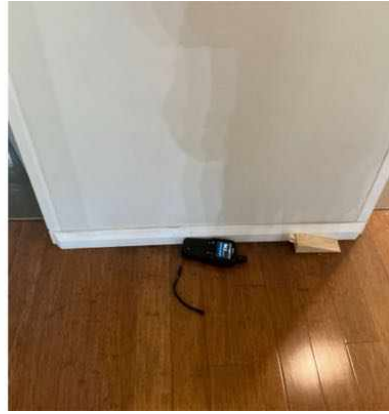
Finding 2.01

Building: Main Building
Location: Bathroom
Finding: Elevated Moisture Bathroom & Back of shower
Information: Elevated moisture levels were detected to tiled surfaces in bathroom/shower areas. This may be due to porous or missing grout, cracked tiles or recent use, however the possibility of waterproofing membrane failure or plumbing leaks cannot be excluded. Persistent moisture ingress can lead to concealed damage, including timber rot and mould growth. Further investigation by a licensed plumber and/or waterproofing contractor is recommended as soon as possible. The back of shower area also showed elevated moisture but no visible deterioration was evident at the time of inspection.

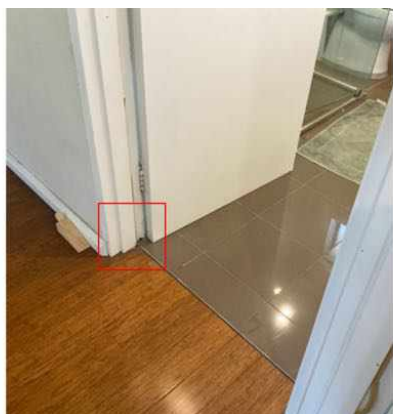
Finding 3.01

Building:	Main Building
Location:	All Internal Areas
Finding:	Wet-Area Door Jambs – Moisture Staining / Decay
Information:	Minor moisture staining and early signs of deterioration were observed at the base of the wet-area door jamb and architraves. This is commonly due to water splashing or moisture tracking from the bathroom floor into adjacent joinery.

It is recommended that the door junctions be resealed with a suitable moisture-resistant sealant and that ventilation and drainage within the bathroom be maintained to reduce further dampness. Where timber swelling or decay has progressed, localised repair or replacement using moisture-resistant materials (H3-treated or equivalent) should be undertaken.

For information only — further inspection by a licensed carpenter or waterproofing contractor is recommended to confirm the extent of deterioration and verify whether remedial sealing or minor replacement works are warranted.

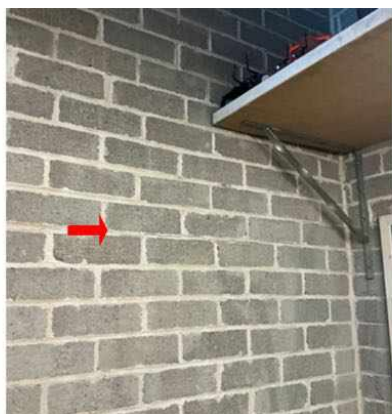
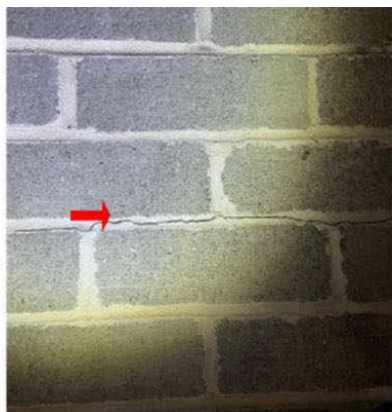
Finding 3.02

Building:	Main Building
Location:	Store Room
Finding:	Brickwork - Cracking noticeable
Information:	Noticeable cracks are a common occurrence in external brickwork and are a likely result of age expected building movement, general expansion, and/or contraction of building materials in different weather conditions. Noticeable cracks in brickwork may develop if left unattended, with potential for necessitating major remedial works or replacement of the brickwork.

It is highly advised that a qualified bricklayer be appointed to provide necessary works to cracked brickwork to prevent any further damage.

Always monitor these cracks and contact a building inspector should cracks widen, lengthen, or become more numerous.

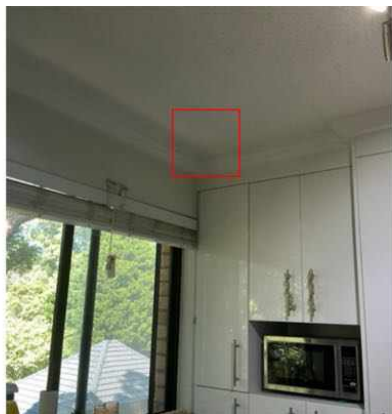
Finding 3.03

Finding: Water staining

Information: Water staining was evident in this area at the time of inspection. Water staining indicates that surfaces have been exposed to excessive moisture over time. The minerals and other elements in the water lead to staining, which may graduate to corrosion and deterioration if left unmanaged.

While mostly an appearance defect, water staining can be indicative of more serious defects, which may be currently concealed by other building elements.

Where water staining is active, a licensed plumber must be consulted to identify the cause of the staining and to provide advice on any reparation works that may be required. Replacement of any broken or damaged structures is advised.

Conversely, where water staining is old and inactive, affected building materials may be repaired or replaced at client discretion. A qualified carpenter or registered builder may be appointed to perform these works.

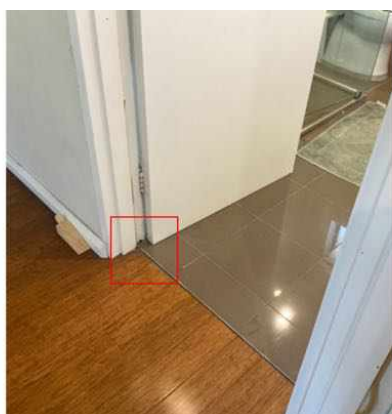
Finding 3.04

Building:	Main Building
Location:	All Internal Areas - Bathroom door frame
Finding:	Building element - Rusted or corroded
Information:	This building element shows evidence of rusting and corrosion, which is likely to have developed as a result of excessive exposure to moisture and or inadequate coatings.

As surface rust provides no protection to the underlying iron, the deteriorating condition is likely to worsen if not addressed in the short-term future.

Where possible, the use of galvanized (treated) metals or aluminium coated metals aid in rust prevention, as does regular general maintenance. Rust formation can be controlled with coatings, such as paint, that isolate the iron from the environment.

Rusting and corrosion should be managed by ideally removing or limiting the affected surface from exposure to moisture. A registered builder may be appointed to replace any building elements that have been severely affected by rust or water damage.

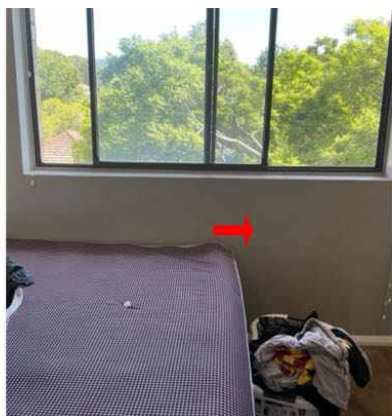
Building: Main Building
 Location: All Internal Areas - Bedroom 2 Right
 Finding: Cracks to internal render - Category 1
 Information: It has been observed that cracking to internal rendered surfaces has occurred. The degree of damage falls within Category 1, described as fine cracks that do not need repair and which are less than 1.0mm in width limit.

Damage of this category is not considered a defect for rectification. Always contact your building inspector should cracks widen, lengthen, or become more numerous.

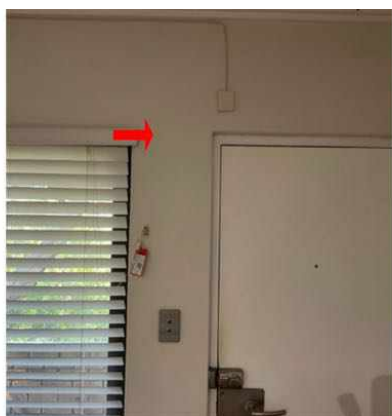
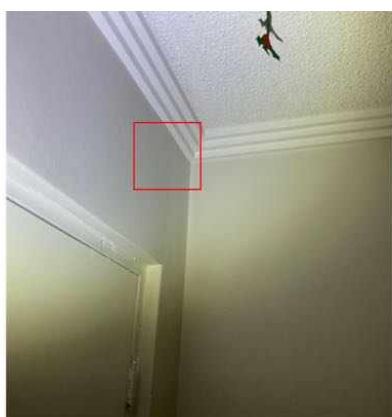
Finding 3.07

Building:	Main Building
Location:	All Internal Areas
Finding:	Paint finish and hairline cracking
Information:	The paint finish in this area was identified as being incomplete at the time of inspection including some hairline minor cracking.

Whilst incomplete or missing paint finish is generally an appearance defect, it can also lead to the development of secondary building defects over time. Incomplete areas of paint finish expose the area to moisture, potentially accelerating the deterioration of underlying building materials.

Incomplete paint finishes should be sanded back, filled, leveled and painted, as applicable. Where inadequate or missing paint protection has led to the deterioration of the associated building element, repair and/or replacement of this building element may be required.

A painting contractor should be appointed as soon as possible to perform necessary works to aid the appearance of the affected area and to ensure the area is protected against further deterioration. Alternatively, the homeowner following manufacturer instructions may perform these works.

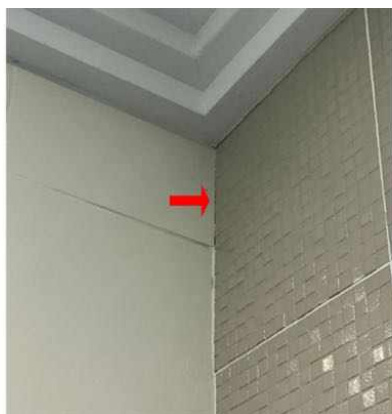
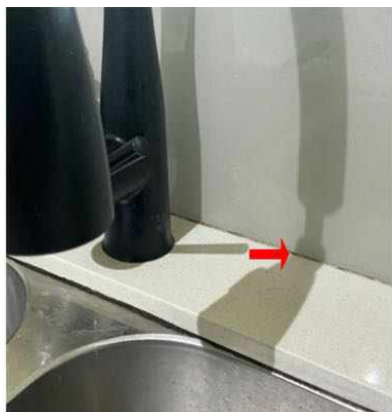
Finding 3.08

Building:	Main Building
Location:	All Internal Areas
Finding:	Sealant and grouting - Missing or degraded
Information:	It was noted on inspection that sealant or grout is degraded. There is also evidence of poor workmanship and excessive use of sealant. Silicone should never be used as a first line of defence against waterproofing. Further inspection by a licensed waterproofing contractor is highly recommend

Different materials and floor areas move at different rates, generally causing cracking to grout or sealant at this point. A flexible sealant is required to allow for expected expansion and contraction, while keeping the joint water tight and protective of all associated building materials.

There appears to be excessive mould to the sealant and grout which will likely require scraping out and replacement.

Flexible and mould resistant materials should be applied to affected areas to prevent any subsequent water damage that is likely to occur. Regular maintenance and replacement of damage or missing or damaged sealant and grout is highly recommended to the wet areas, as this is a regular wear and tear defect. Sealant and grouting in areas that come into regular contact with water should be maintained for the long term care of your property.

A sealant specialist or tiling contractor should be appointed to complete these works as soon as possible

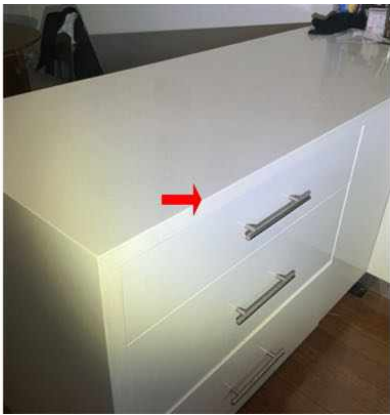
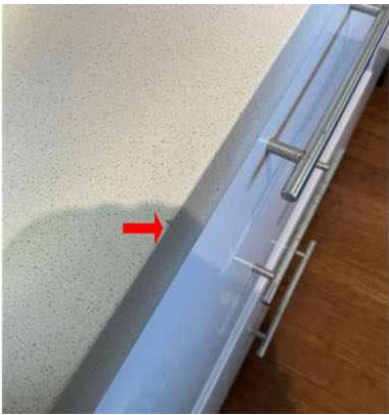
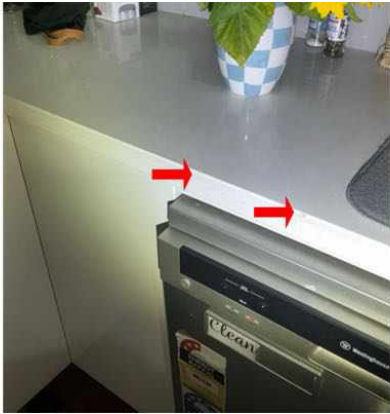
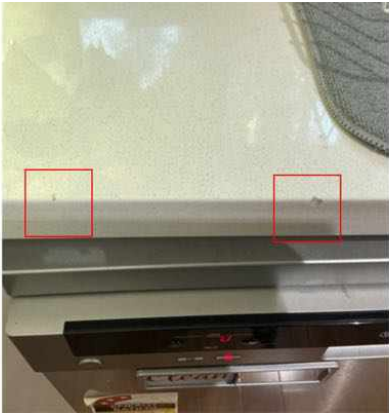
Finding 3.09

Building:	Main Building
Location:	All Internal Areas - Kitchen
Finding:	Building element - Damaged - Stone top chipped
Information:	Breakage occurs generally when the building materials have either aged and decayed, or as a result of damage (accidental or deliberate).

Repair and/or replacement of broken elements is advised to ensure that additional secondary defects do not arise as a consequence. Such works are necessary, as all building elements play a key role in the operation and function of the overall structure and its performance.

A relevant tradesperson should be appointed to repair or replace the affected building element prior to any subsequent damage being caused.

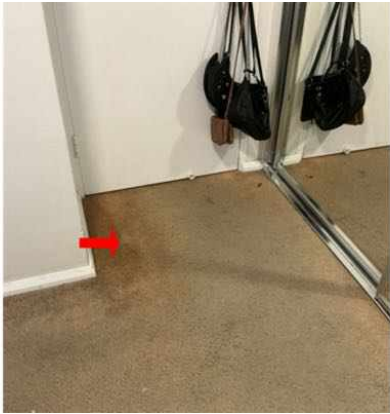
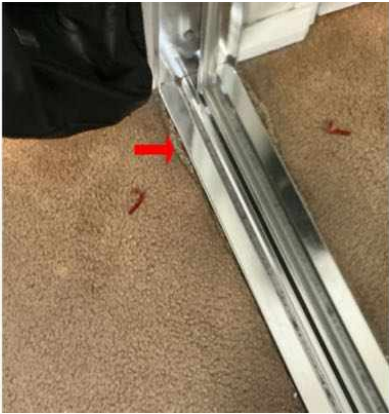
Finding 3.10

Building: Main Building
Location: All Internal Areas
Finding: Carpet Wear and Shading
Information: Carpet throughout shows pile flattening/shading,/staining/lifting and/or visible traffic patterns.

Condition is consistent with normal wear and tear. Professional steam cleaning is recommended to improve appearance.

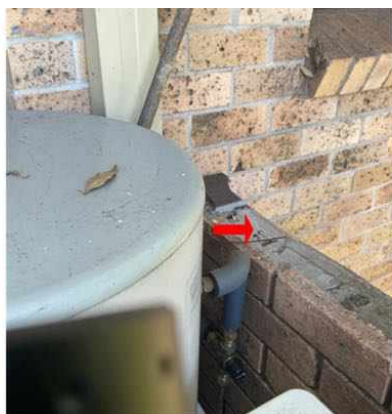
Finding 3.11

Finding: Building element - Missing - Tiles missing

Replacement of any missing building element should be conducted as soon as possible to ensure that no damage or functional issues occur to associated building materials.

The appropriate tradesperson should be appointed as soon as possible to replace the missing building element.

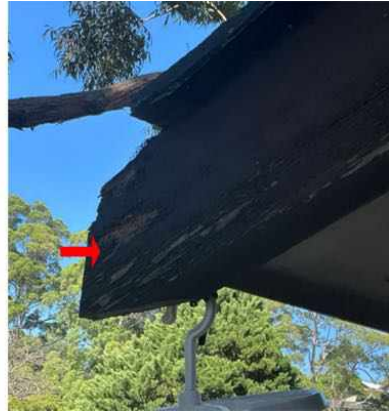
Finding 3.12

Building:	Main Building
Location:	Balcony
Finding:	Fascias - Wood rot
Information:	Wood rot was found to be affecting fascias and barges in this area, evidenced by the presence of mould on the surface in some areas. Wood rot, also known as Fungal Decay, occurs when timbers and other cellulose building materials are exposed to damp conditions on an ongoing basis.

It is likely that this wood rot has developed as a result of faults in the roof plumbing, creating excessive moisture in this areas. Frequent exposure to rain and other weather conditions also make fascias and barges susceptible to accelerated deterioration.

Early intervention and regular maintenance will prolong the useful life of these building elements. Prior to any works being performed, the cause of the moisture that has created the visible wood rot should be identified and addressed in a suitable manner.

It is advised that a roof plumber be appointed to inspect all roof plumbing and subsequently identify the cause of the wood rot. Replacement of affected fascias and barges may then be a necessary step in protecting surrounding building elements from such deterioration.

A qualified plumber may be appointed to assess the cause of excessive moisture and to provide advice on any remedial works as required. A qualified carpenter or registered builder may also be required to replace affected building materials.

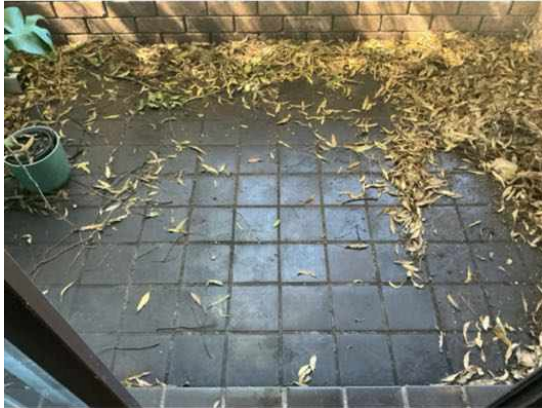
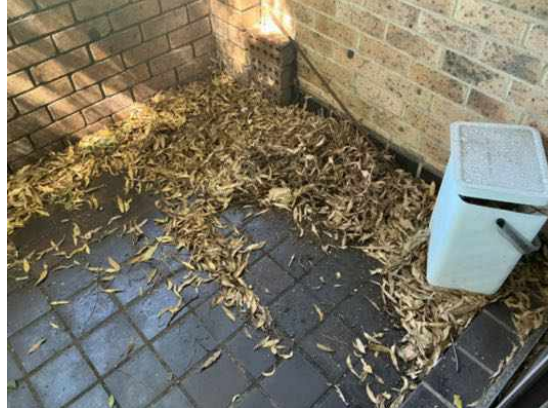
Finding: Debris

Information: The balcony area shows accumulated leaf litter and organic debris, restricted drainage gaps at the slab-to-wall junction, and close proximity of combustible material to the building fabric. These conditions collectively increase the risk of moisture retention, which may contribute to surface deterioration, mould growth, and reduced durability of adjoining materials over time, as well as a low-to-moderate fire risk due to the presence of dry combustible debris, particularly during hot or dry conditions.
