Building and Timber Pest Inspection Report

Inspection Date: Mon, 30 Mar 2026

Property Address: 8 Cross St, Raceview QLD 4305, Australia

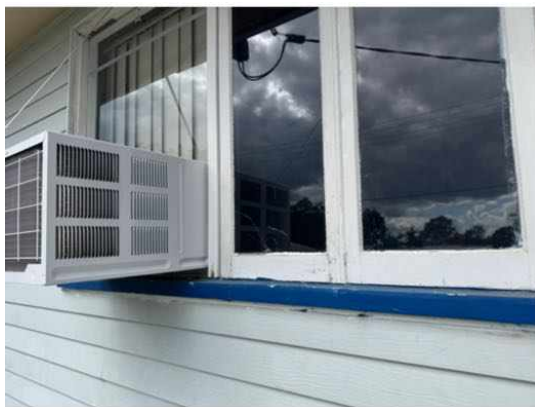
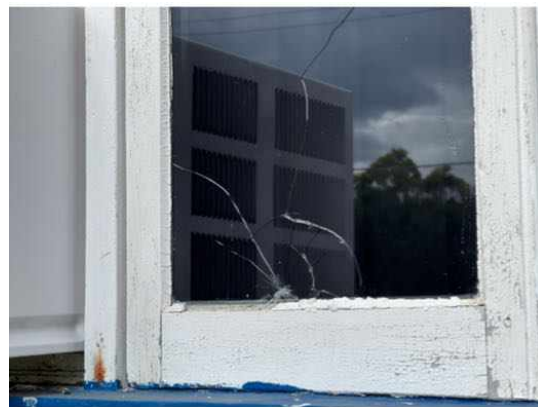
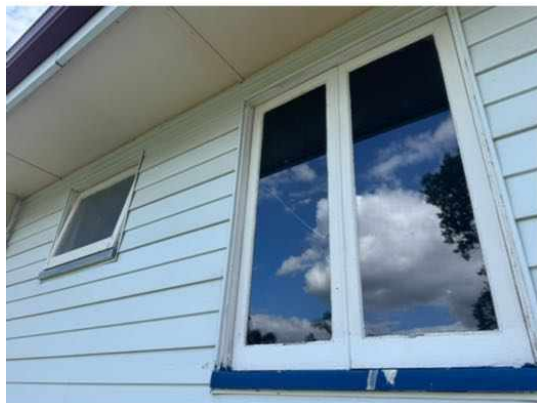
Building:	Main Building
Location:	Front & Rear Elevations
Finding:	Windows - Cracked
Information:	At the time of inspection cracking in a number of windows located at both the front and rear of the building was identified.

Cracking in windows is generally the result of impact damage, and is likely to develop further when left unmanaged.

The likelihood of this windowpane further cracking and shattering is increased exponentially, providing a safety hazard in the area. The cracked window also impairs the weather tightness of the building, creating potential for minor water leaks.

A qualified glazier is required to repair the window as soon as possible. Depending on the extent of the cracking, replacement of the window may be required.

Please be advised that any persons coming into contact with the cracked window should do so with due caution to avoid any personal injury that may ensue.

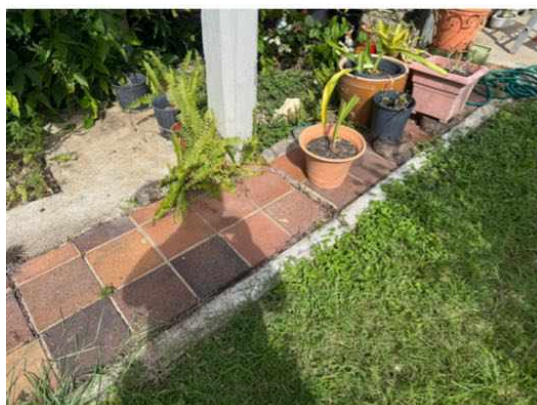
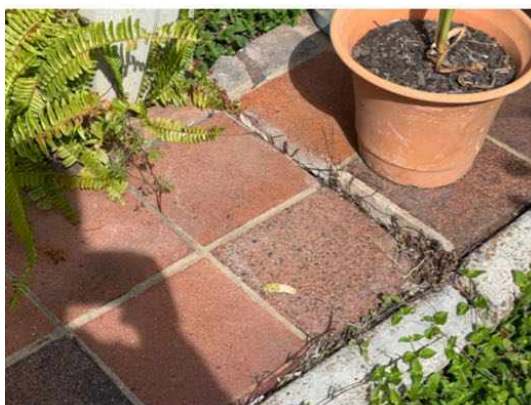
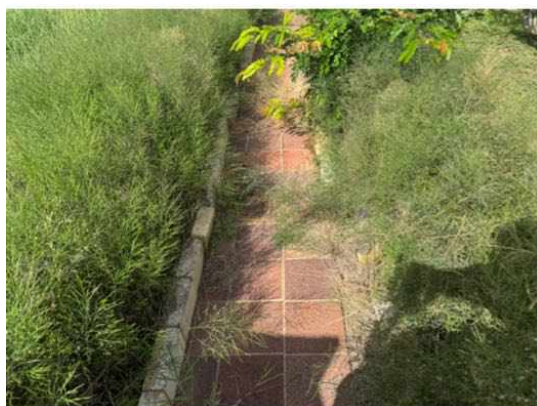
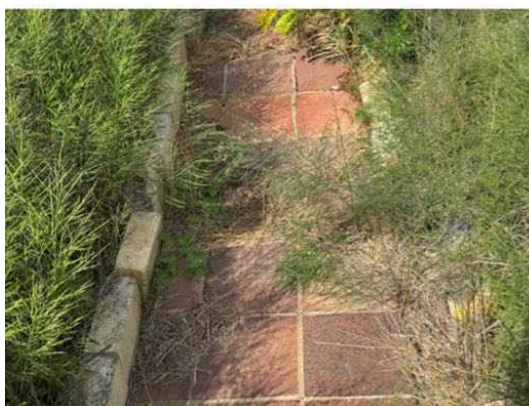
Finding 1.02

Building: Yard
Location: Yard - Front
Finding: Paving - Uneven
Information: Sections of the external paving located in the front of the property are uneven, creating a potential trip hazard.

It appears as though the area has been subject to rough installation, or that paving sections have lifted due to movements in the foundations.

Where paving creates a trip hazard, personal injury may ensue if due caution is not taken by all persons within this area.

Re-paving of the area is required as soon as possible to remedy this situation. Further consultation with a specialist concreter is advised.

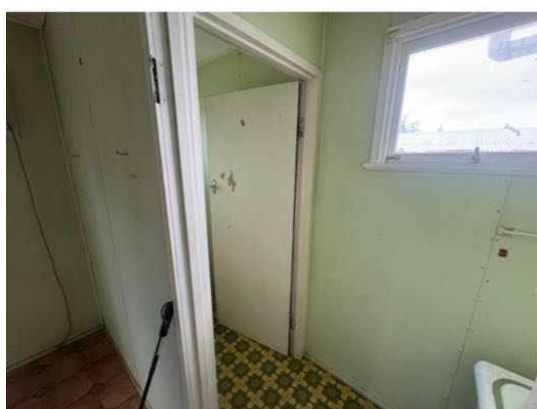
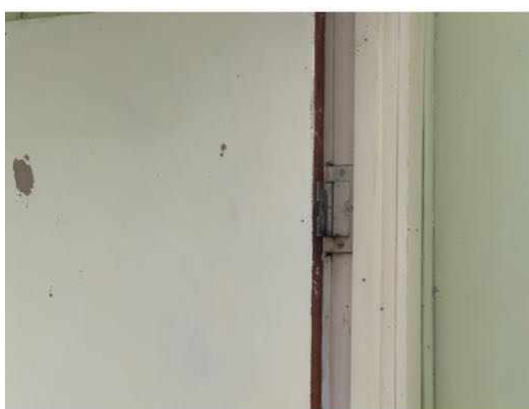
Finding 1.03

Building:	Main Building
Location:	Toilet (WC)
Finding:	Door - Safety Hinges Missing
Information:	At the time of inspection the toilet door was found to be missing safety hinges.

An inward swinging toilet door with lift-off hinges will typically have a gap between the top of the door and the underside of the head of the door frame. This is to allow sufficient movement upward, so the pin in the door hinges can slip out of the hinge blades screwed to the side of the door frame or stile. A suitable door latch allows the door to be lifted upward and away.

Installation of safety hinges to the door should be carried out as soon as possible by a licensed carpenter or general handyman.

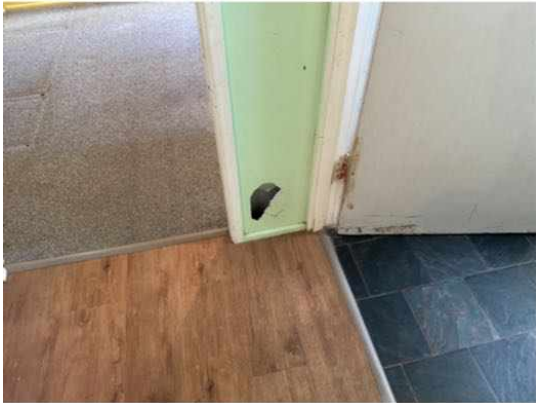
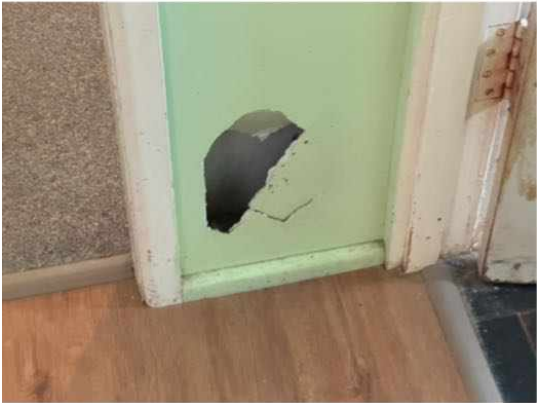
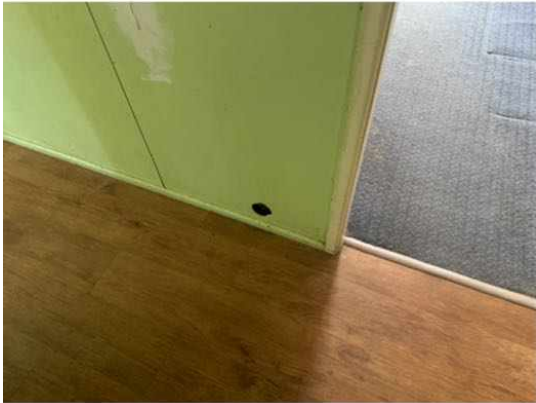
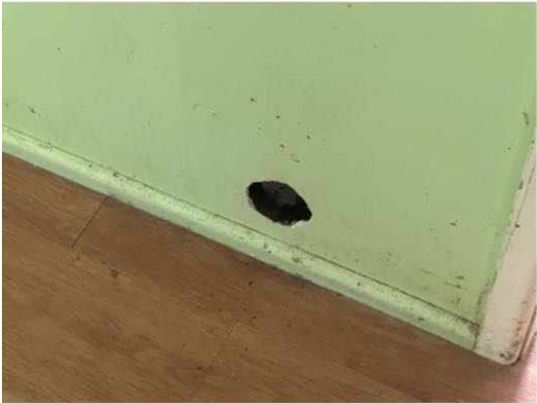
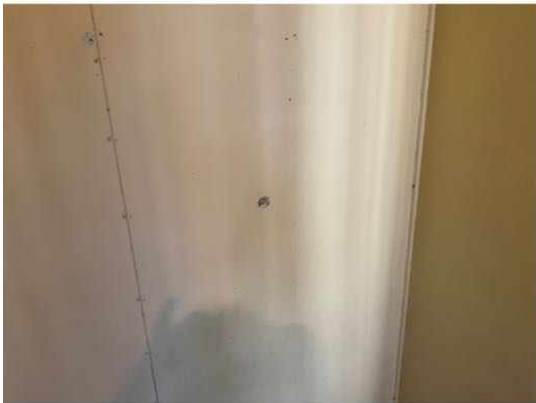
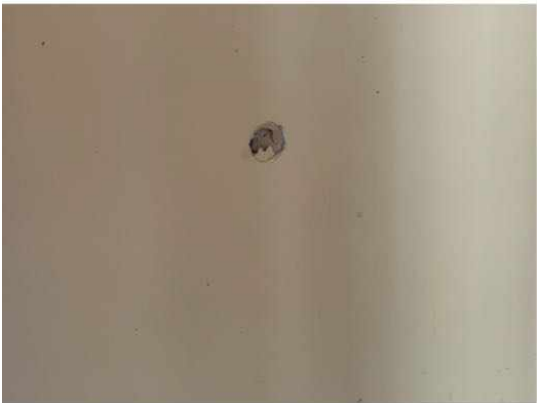
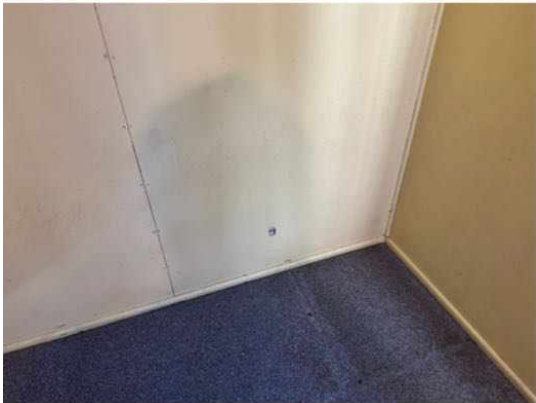
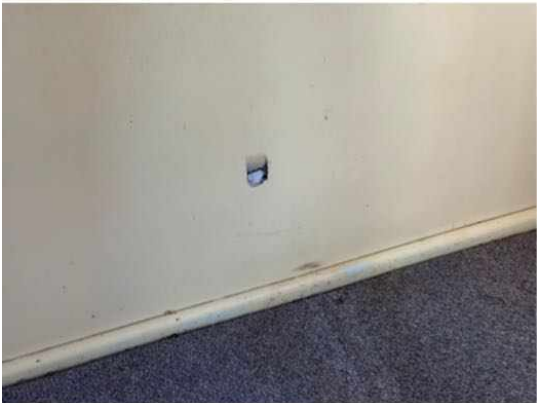
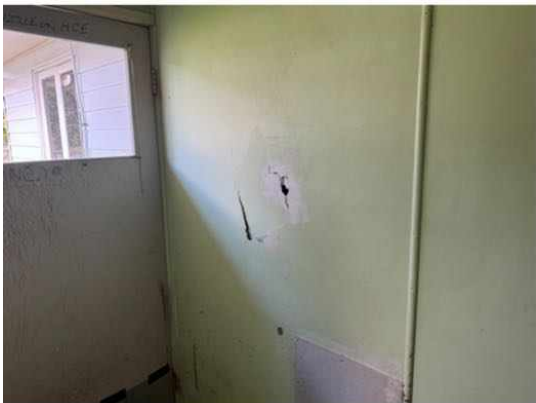
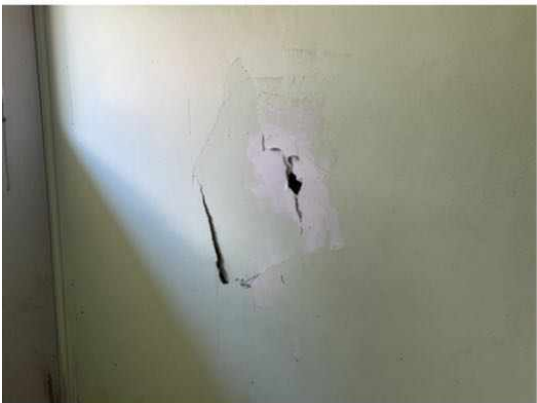
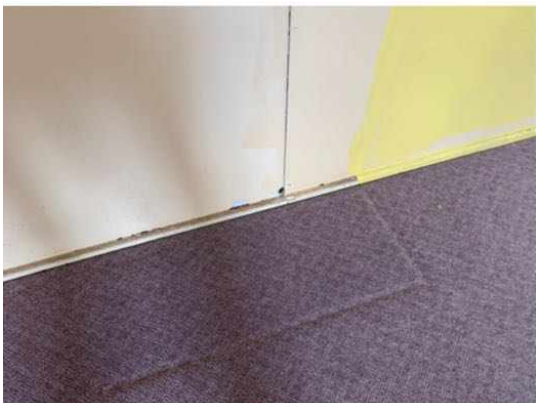
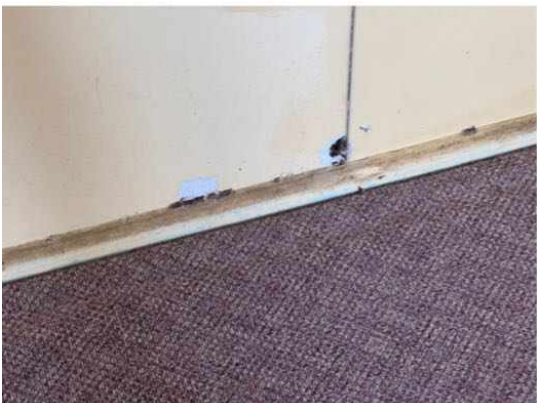
Finding 1.04

Building: Main Building
Location: All Areas
Finding: Asbestos - Suspected ACM in Hazardous Condition
Information: Reporting on Asbestos Containing Materials (ACM) is outside the Scope of this Report. This suspected defect is highlighted as a caution only. We suspect, based on our experience in the building industry, that there is a high risk of the internal wall linings containing asbestos. Furthermore the materials in question are considered to be in a hazardous condition.

As Asbestos Reporting is outside the scope of this report, we advise that you consider a separate Asbestos Inspection and Condition Audit, which can include the taking of samples for definitive confirmation of the presence of Asbestos.

In the interim, the client is advised to act with caution, especially when considering any damage to building materials general wear and tear renovations extensions demolition and general maintenance activities due to the suspected presence of Asbestos.

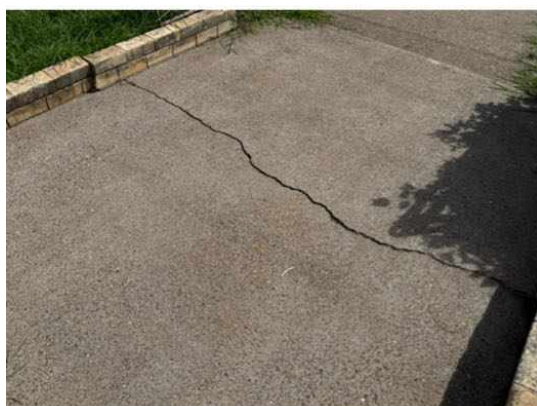
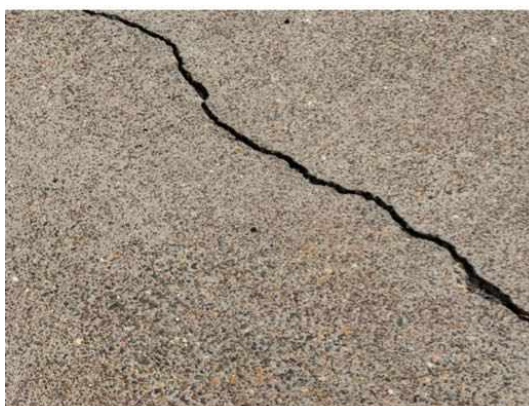
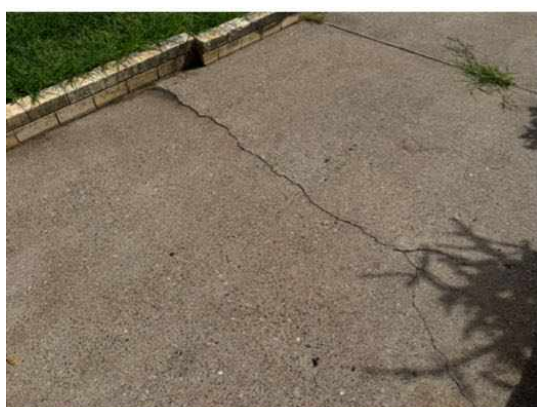
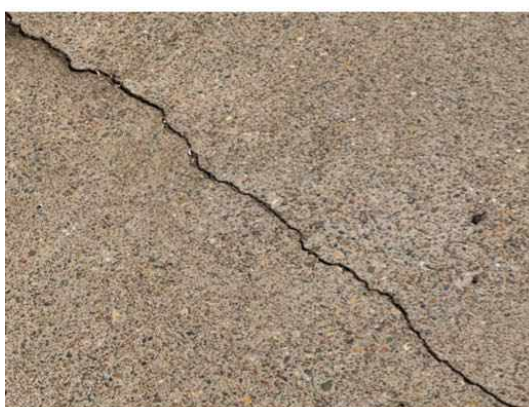
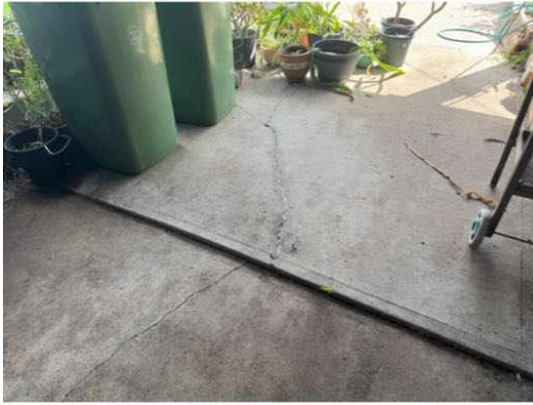
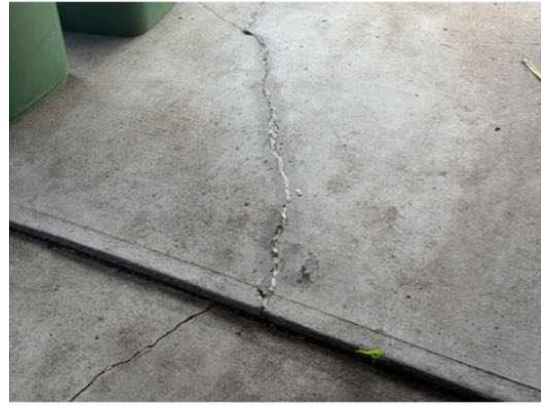
Finding 2.01

Building:	Yard
Location:	Yard - Front
Finding:	Cracks in Concrete Slab - Category 3
Information:	A number of cracks coded as Category 3 were identified in the driveway slab.

A Category 3 crack is described as a wide crack with obvious curvature or change in level affecting the slab. The approximate width of the crack to be considered Category 3 is greater than 2.0mm, or a change in offset of 15-25mm when a 3m straight edge is placed over the defect.

Category 3 cracks to slabs exceed allowable Standards and Tolerances, and are considered defects requiring attention. At a minimum these cracks should be filled with a flexible sealant to prevent water entry points.

A qualified concreter or general handyman should be engaged to perform rectification works as required.

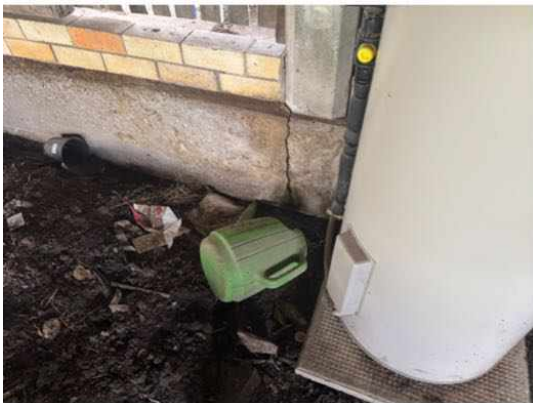
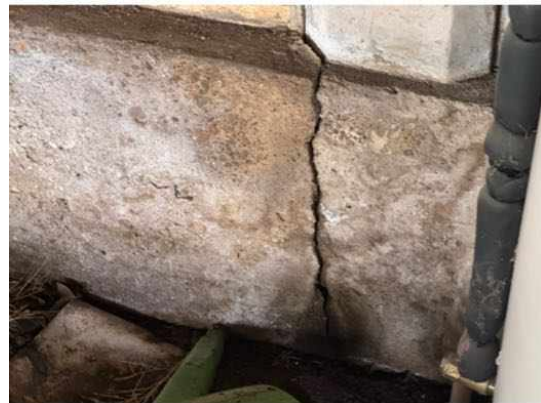
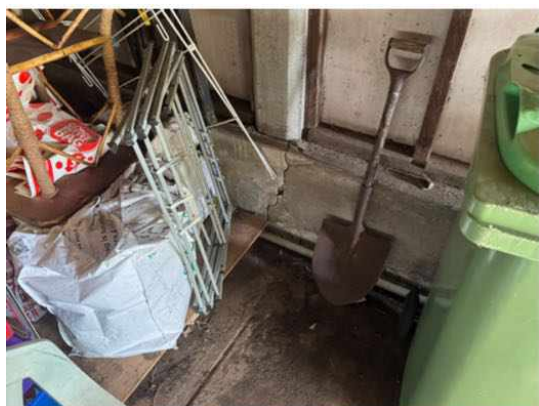
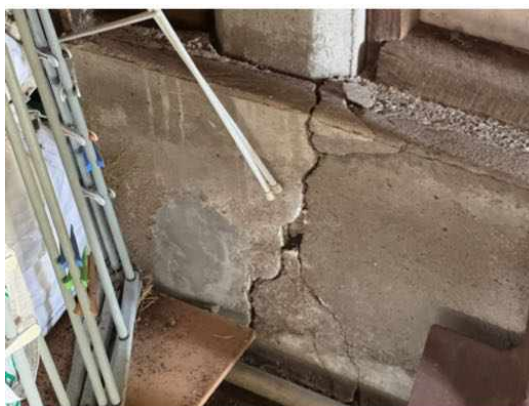
Finding 2.02

Building:	Main Building
Location:	Subfloor
Finding:	Cracks in Concrete Wall - Category 4
Information:	A number of cracks coded as Category 4 was identified in the concrete retaining walls located in the subfloor of the building.

A Category 4 crack is described as a crack that appears as a gap in the concrete with disturbing curvature or change in level affecting the wall.

The approximate width of a category 4 crack or gap is 4mm-10mm or a change in offset of greater than 25mm when a 3m straight edge is placed over the defect.

A structural engineer should be engaged to provide advice on any remedial works required.

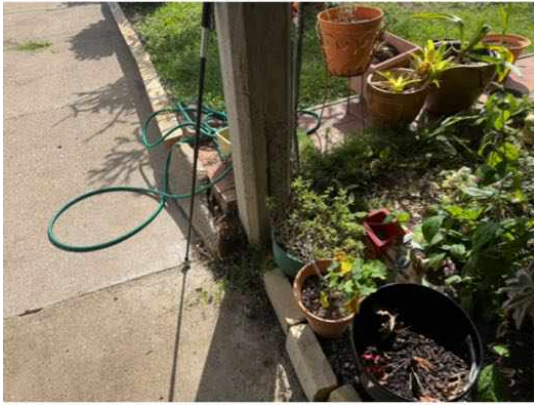
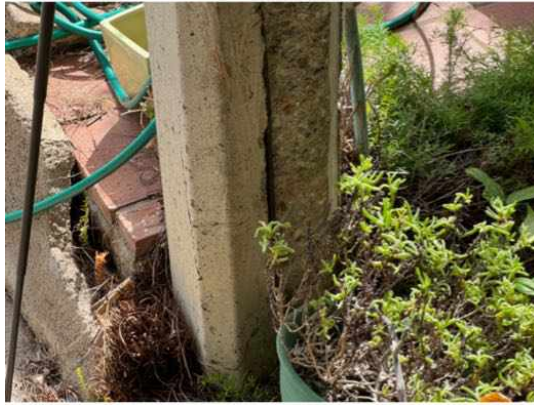
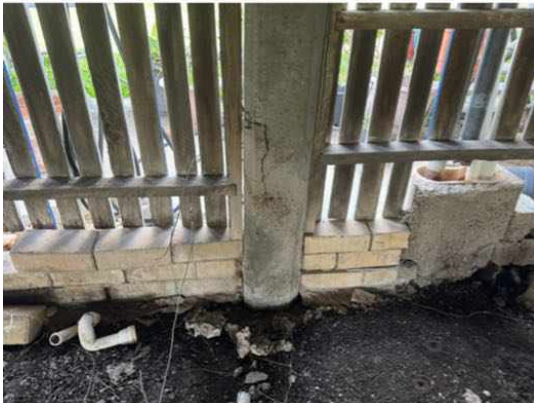
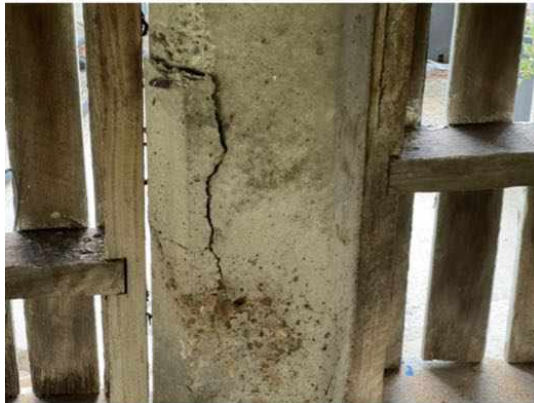
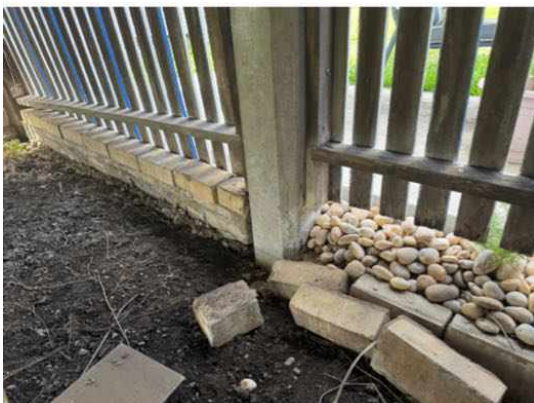
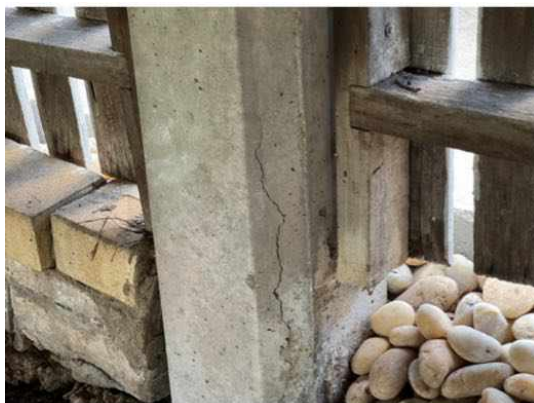
Finding 2.03

Building:	Main Building
Location:	Subfloor
Finding:	Concrete Stumps - Spalling
Information:	At the time of inspection a number of concrete stumps located throughout the subfloor area were found to have deteriorated with spalling, also known as concrete cancer.

Concrete cancer is the common term used to describe a number of factors which cause concrete construction to deteriorate. Generally water penetration causes the concrete reinforcement to rust and expand, creating stresses on the surrounding concrete and in turn causing it to spall (or break away). Concrete cancer may also originate from poor water proofing, inferior quality concrete, improper concrete curing or chemical reactions to alkaline in the soil.

Ultimately the cause of the concrete cancer must also be addressed otherwise the problem is likely to reoccur. Treatment of concrete cancer can be expensive and if left unmanaged the problem is likely to worsen over time, potentially leading to the development of major structural defects or safety hazards.

In some instances repairs are possible, however repairs will generally involve extensive works including removal of affected concrete and the treatment or replacement of any exposed steel. Some injection of resins or special mortars may also be possible, however this depends on the size and extent of consequent damage.

The client is advised to exercise caution and to prepare for the potential cost of remedial or replacement works. A registered builder specialising in re-stumping of houses should be appointed to assess the condition of the concrete stumps and provide advice on remedial works required. This defect should not be left unmanaged.

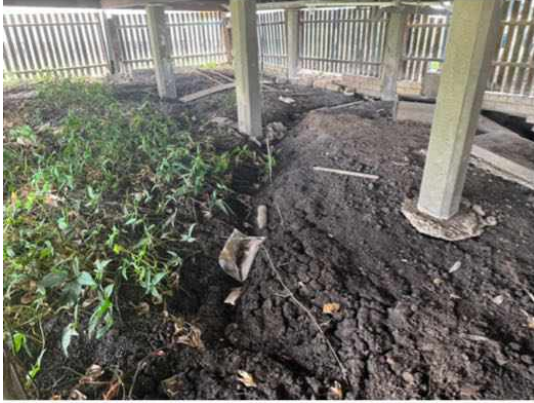
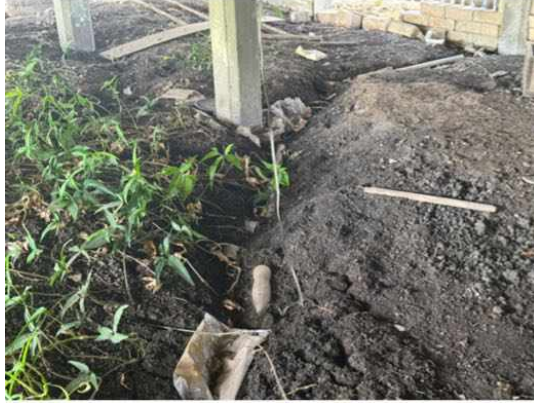
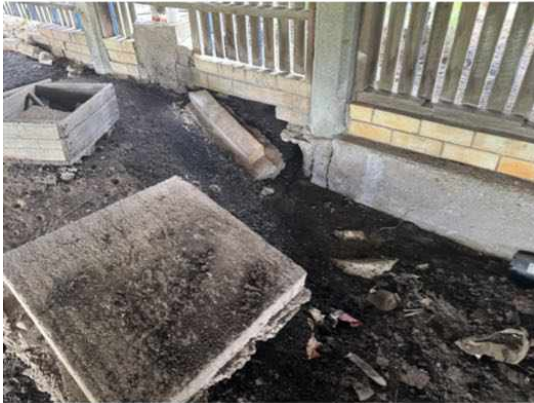
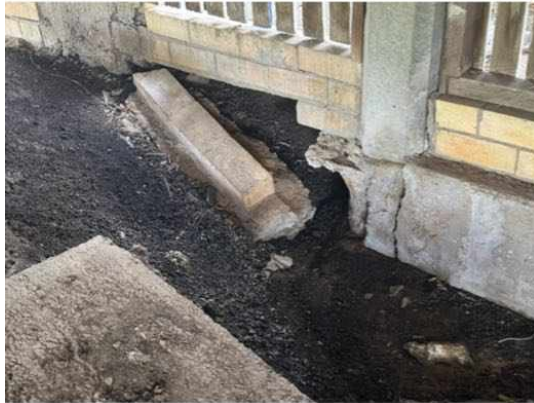
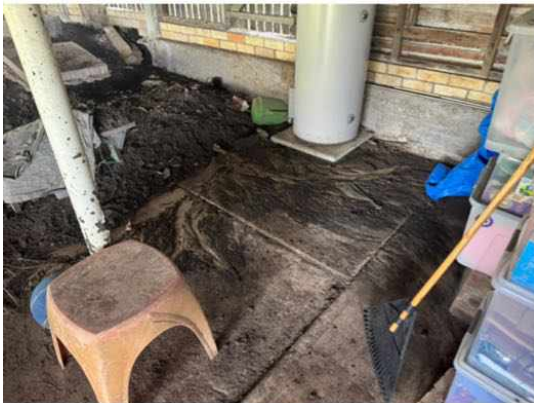
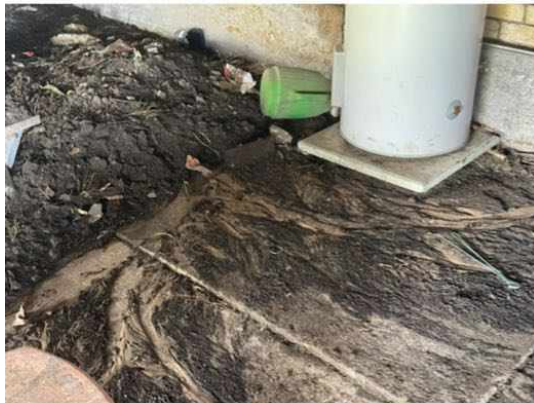
Finding 2.04

Building:	Main Building
Location:	Subfloor
Finding:	Subfloor Drainage - Inadequate
Information:	The site drainage in the subfloor area was found to be inadequate at the time of inspection creating potential for subsequent water damage to associated building elements.

Where site drainage is inadequate a qualified drainage plumber should be appointed to further inspect the property and perform any remedial works as necessary. Water damage and secondary defects are likely to occur if left unmanaged.

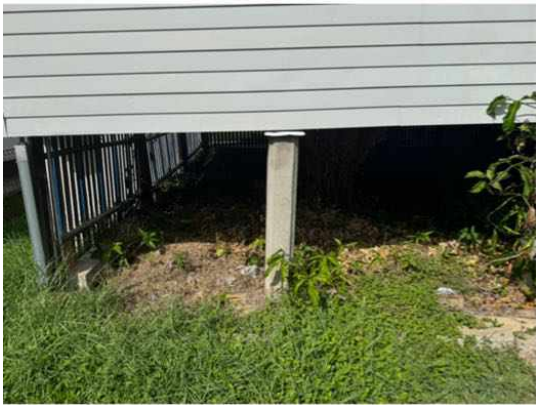
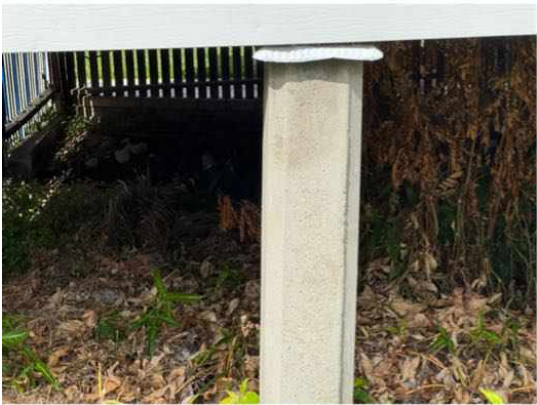
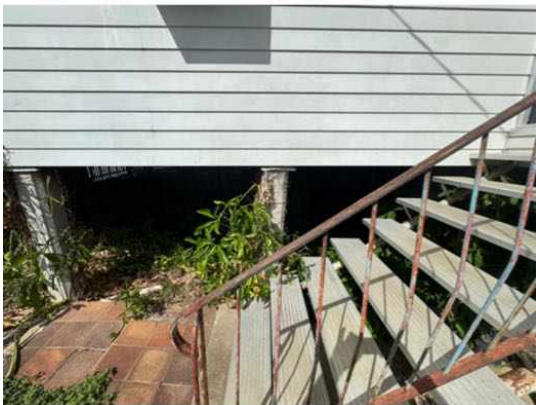
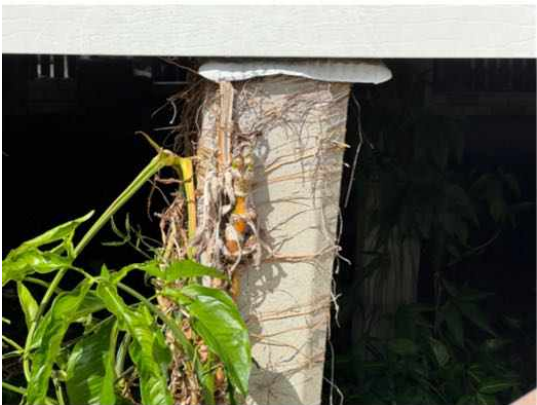
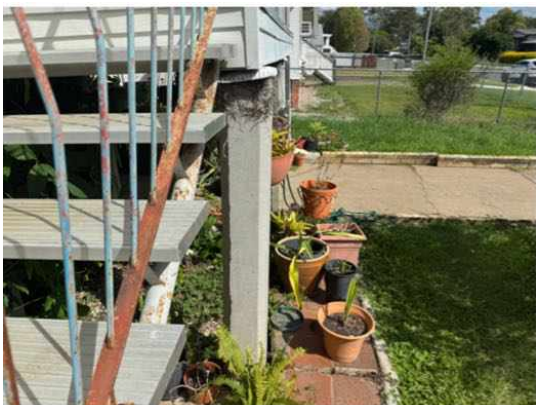
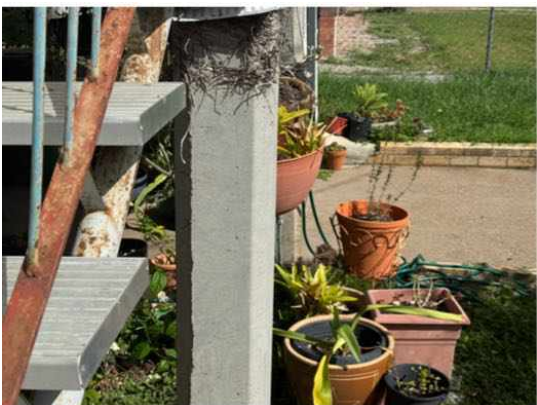
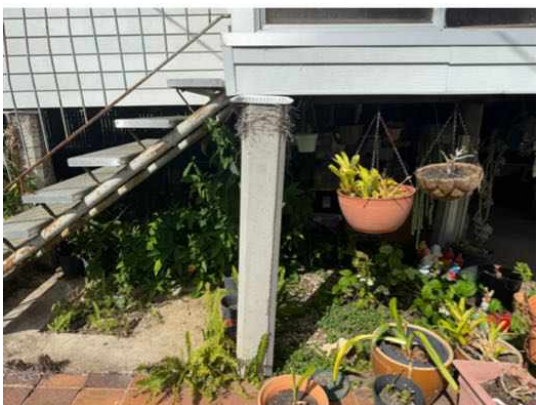
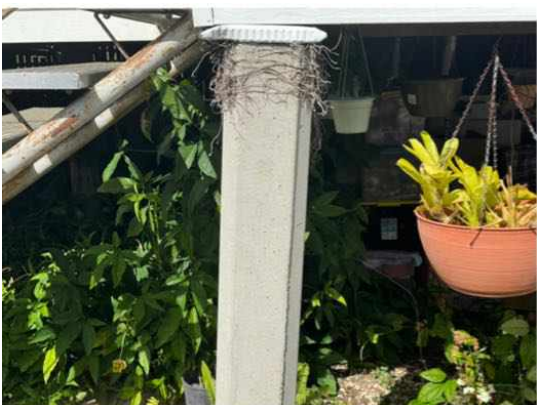
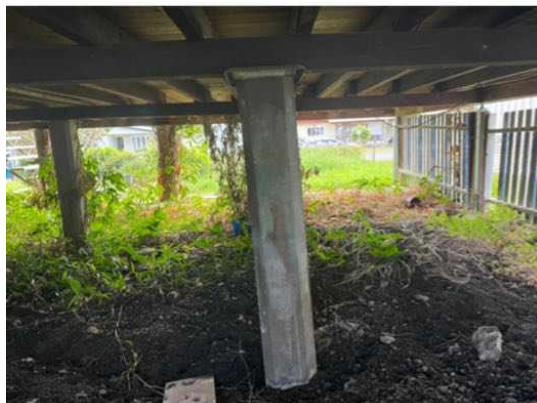
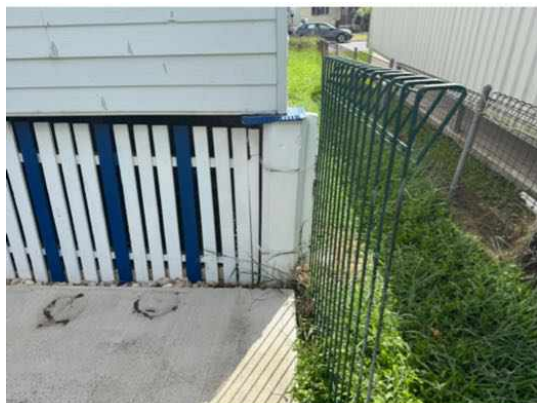
Finding 2.05

Information: It was noted at the time of inspection that a number of the concrete piers located in

This defect is not common and is suspected to have been caused by subsidence of the adjacent footings.

Some of the secondary defects associated with leaning piers include uneven flooring, visually-observable subsidence or major cracking within the property.

A structural engineer may be appointed to provide advice on the structural integrity of the piers.

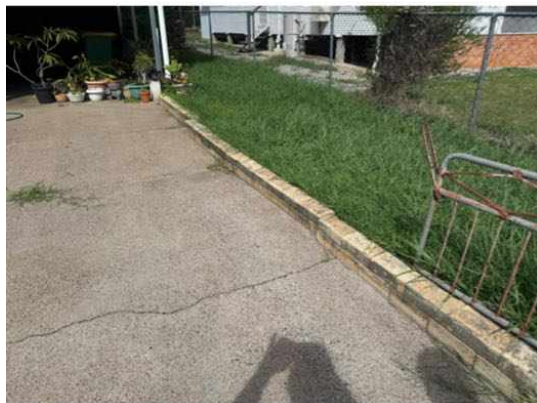
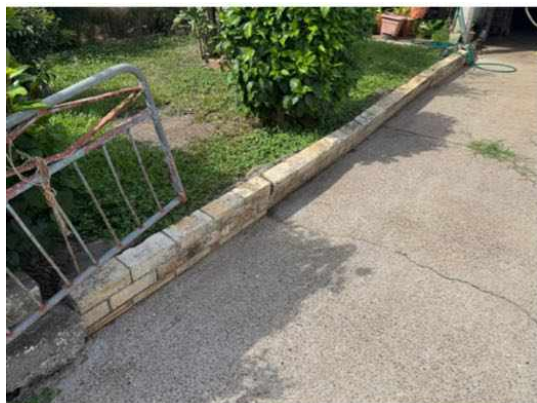
Finding 3.01

Building:	Yard
Location:	Yard - Front
Finding:	Retaining Walls - Leaning
Information:	It was noted at the time of inspection that the brickwork retaining walls located either side of the driveway have developed a significant lean.

Typically retaining walls deteriorates due to age and or wear, rot and or rust which is generally expected for a structure of this age, due to prolonged exposure to weather conditions. Sometimes inadequate installation or maintenance can be to blame.

If left unattended, it is likely that further damage will occur. It is suspected that repair of several elements of the retaining wall may be required however replacement may be a consideration of the client also.

A contractor specialising in the installation of retaining walls should be appointed to provide further advice and perform rectification works as necessary.

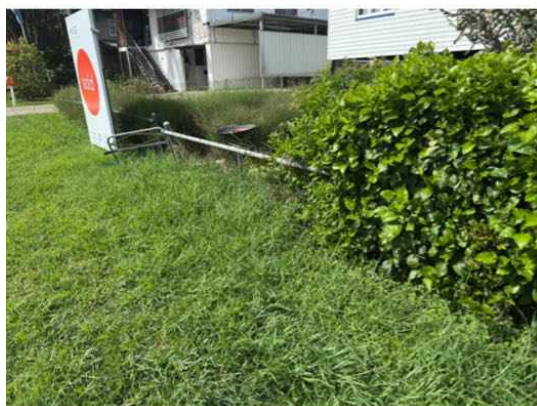
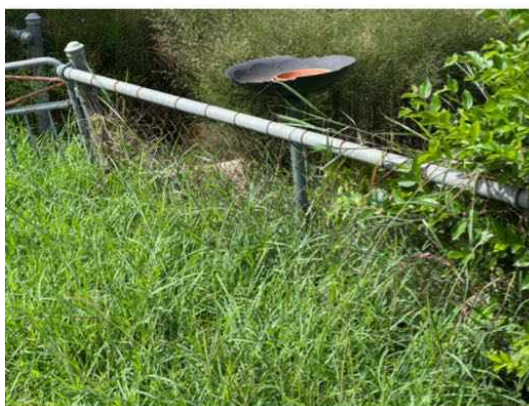
Finding 3.02

Building:	Yard
Location:	Yard - Front
Finding:	Fencing - Leaning
Information:	It was noted at the time of inspection that a section of the fencing located along the front of the property has developed a significant lean.

Typically fencing deteriorates due to prolonged exposure to weather conditions. Sometimes inadequate installation or lack of maintenance can be to blame.

If left unattended, it is likely that further damage will occur. It is suspected that repair of several elements of the fencing may be required however replacement may be a consideration of the client also.

A licensed fencing contractor should be appointed to provide further advice and perform rectification works as necessary.

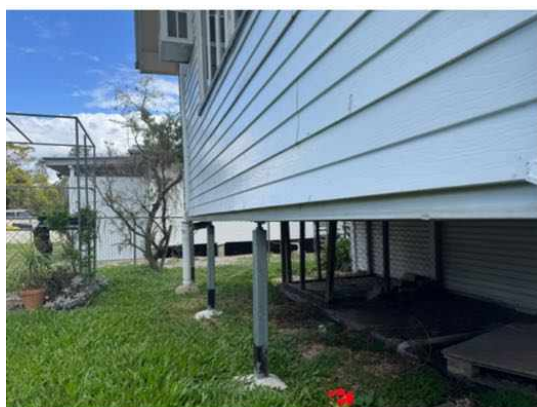
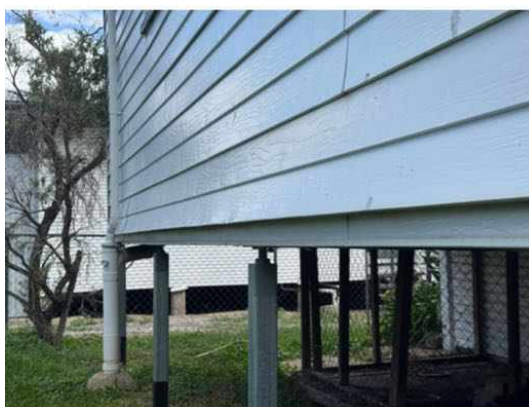
Finding 3.03

Building:	Main Building
Location:	Rear Elevation
Finding:	Cladding - Loose
Information:	At the time of inspection a section of the external cladding located at the rear of the building was found to be loose.

It appears that either the adhesive or the fixings designed to hold the cladding in place have failed.

A licensed carpenter or general handyman should be engaged to rectify this defect.

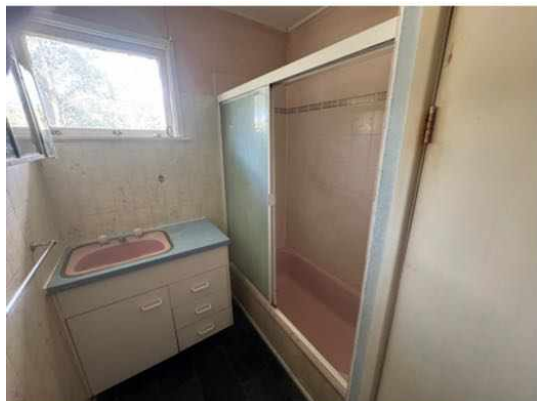
Finding 3.04

Building:	Main Building
Location:	Bathroom
Finding:	Shower Screen - Stiff to Slide
Information:	The shower screen in the bathroom was jammed and difficult to operate at the time of the inspection.

Factors such as general age of the building element and a lack of maintenance are the usual causes for this type of defect.

Replacement of shower screen hardware or frame may be required, as well as minor repairs and cleaning.

A contractor specialising in shower screen installations should be engaged to perform repair works.

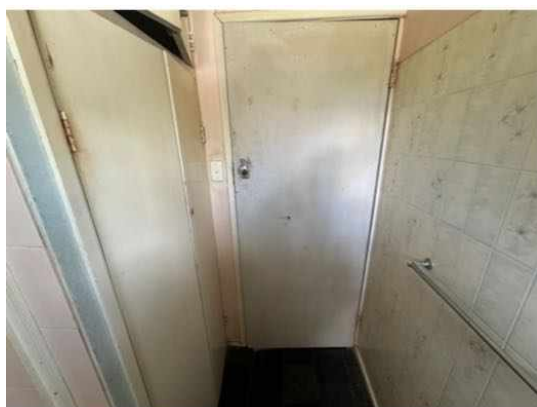
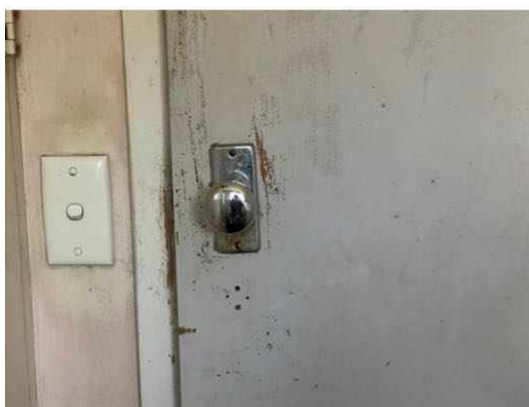
Finding 3.05

Building:	Main Building
Location:	Bathroom
Finding:	Door Handle - Not Latching
Information:	At the time of inspection it was noted that the bathroom door was not latching during standard operation.

It is suspected that this defect has occurred due to minor issues with the associated hinges, or possibly the positioning of the striker plate.

A qualified carpenter or general handyperson may be appointed to perform rectification works as necessary, at client discretion. If left unattended, further functional impairment is likely to occur.

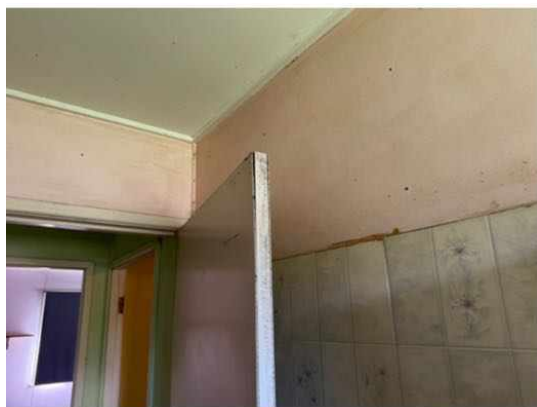
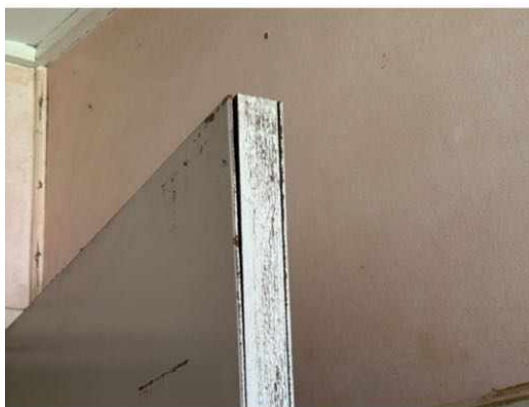
Finding 3.06

Building:	Main Building
Location:	Bathroom
Finding:	Door - Delamination of Timbers
Information:	At the time of inspection the door associated with the bathroom showed signs of delamination.

Delamination is one means by which composite materials (e.g. layered timber composites) may fail over time. In laminated materials, repeated cyclic stresses may lead to the formation of mini-structures of separate layers, with significant loss of mechanical toughness. Water penetration or the presence of excessive moisture also generally contributes to delamination.

Where building materials have become delaminated, they lose their structural strength, and are likely to have a variety of appearance and serviceability defects as a result.

Delamination of timbers may be repaired where the area affected is minor and/or easily accessible, by gluing and screwing layers back together. However, this is an interim repair, and where delamination has occurred, the client should plan for the replacement of affected timbers sooner than would otherwise be expected.

All timber structures affected by delamination should be replaced as soon as possible to avoid any further damage. Repair and replacement estimates should be sought from a registered builder or qualified carpenter.

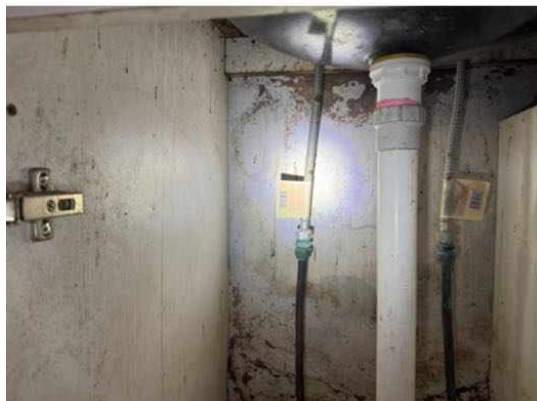
Finding 3.07

Building:	Main Building
Location:	Bathroom
Finding:	Braided Lines - Rusted or Corroded
Information:	At the time of inspection the braided water lines under the vanity basin in the bathroom showed evidence of rusting and corrosion, which is likely to have developed as a result of excessive exposure to moisture and or inadequate coatings.

As surface rust provides no protection to the underlying iron, the deteriorating condition is likely to worsen if not addressed in the short-term future.

Rusting and corrosion should be managed by ideally removing or limiting the affected surface from exposure to moisture.

A registered plumber should be appointed to replace these elements as soon as possible.

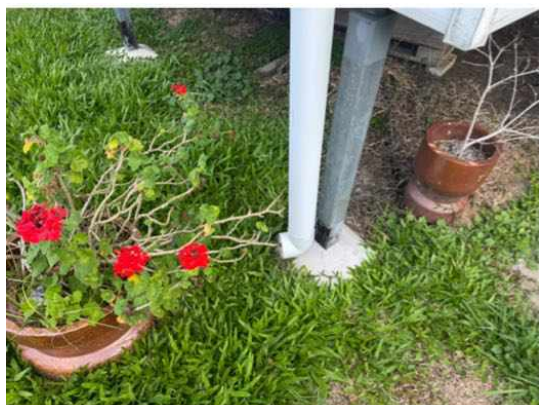
Where roof plumbing doesn't drain adequately, the area at the base perimeter can become excessively damp, potentially creating an environment that is susceptible to rust and corrosion of surrounding building elements, as well as attracting termites and other pests.

It is important that water does not lie against the base of walls. Surrounding paths and ground levels should be sloped to drain water away from the building.

It is highly recommended that a plumber be appointed to further inspect the area and to install adequate drainage equipment where necessary.

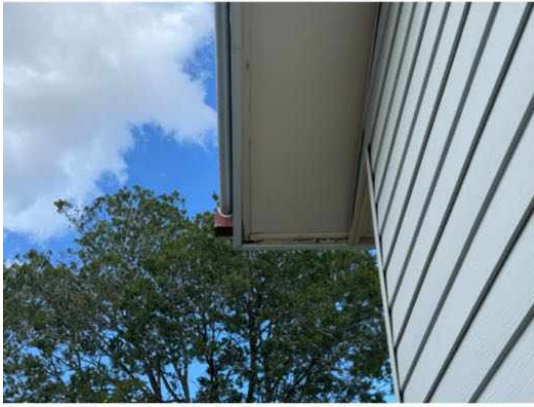
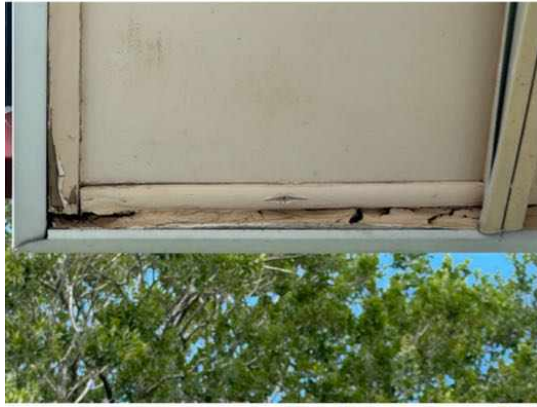
Finding 7.01

Building:	Main Building
Location:	Eaves
Finding:	Fungal Decay - Localised
Information:	At the time of inspection a section of eaves trim located at the back left hand corner of the building was found to be affected with fungal decay.

Fungal decay also known as wood decay or wood rot generally refers to the deterioration of timber elements when in contact with excessive levels of moisture for a prolonged period of time.

Fungal decay is often associated with general damp conditions and may be evidenced by a musty smell or mould and mildew occurring on the surface. Generally fungal decay develops on timber elements that are in use in an external environment which are exposed to rain penetration.

Timber elements affected with fungal decay also create an environment that is conducive to termite activity.

In this case although the affected timber element is in a decaying state the extent of any visible damage appears to be localised to a specific area and is yet to spread to other parts of the building element or affect adjoining structures. The fungal decay is therefore likely to be of a relatively superficial nature with minimal impact on the structural integrity or tensile strength of the timber element.

A qualified carpenter should be appointed to repair or replace any affected areas prior to any further deteriorating.

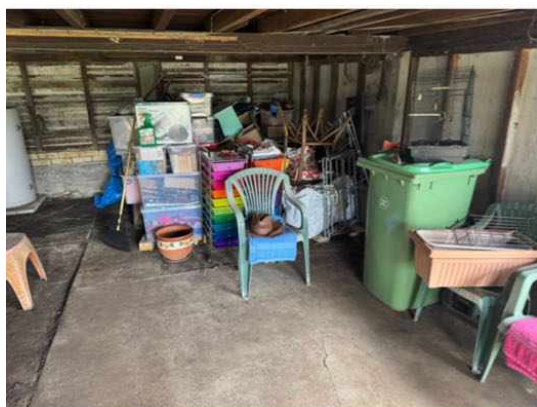
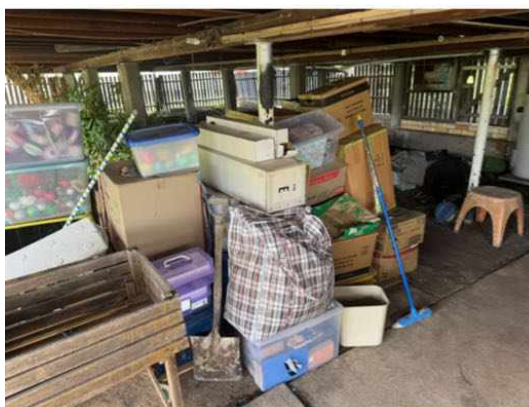
Building:	Main Building
Location:	Subfloor
Finding:	Obstructions and Limitations - Subfloor
Information:	These photographs are an indication of the obstructions and limitations which impeded full inspection of the subfloor at the time of inspection. These obstructions can hide an array of defects and should be removed to allow full inspection to be carried out. A re-inspection is recommended once the areas are made accessible.
